FINAL REPORT

ARCE Groundwater Lowering Response Project, Luxor

“Conservation of the Euergetes Gate”

Christie Pohl, Chief Conservator, ARCE Luxor

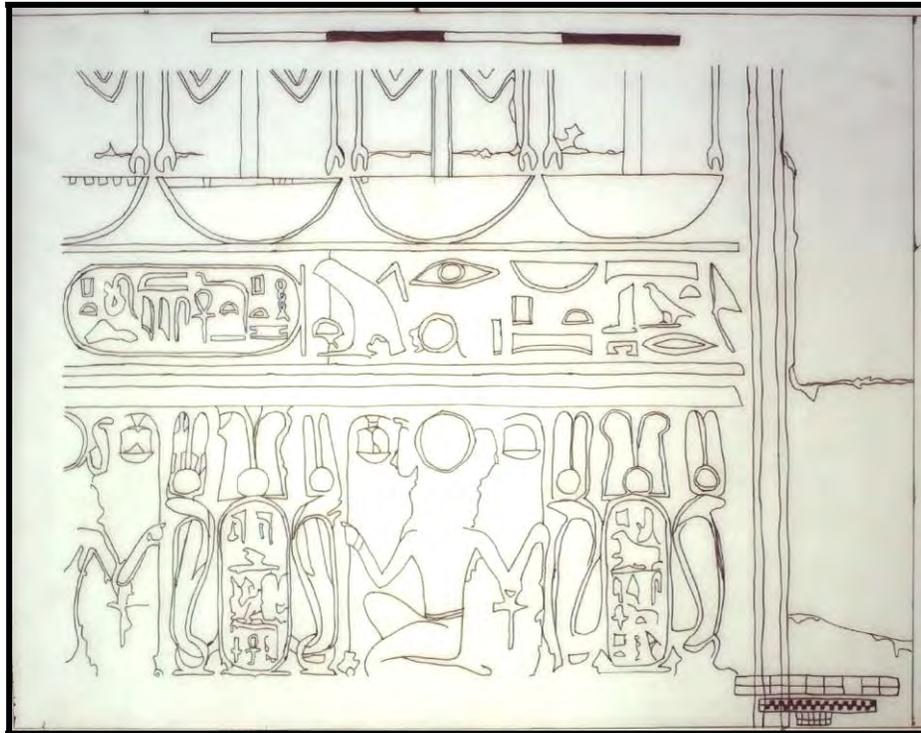
Figure 4. A base drawing of the B2 register - Eastern jamb of the Euergetes Gate

For the condition maps, base drawings are created by the technicians that outline the major features of a wall register or level of a column. The drawings are created on tracing paper from a photograph (figure 4) and then photocopied to be used as condition maps. These maps document the different types of deterioration. A condition map is created beginning with any previous interventions (Layer 1) and additional maps are made which record superficial deterioration (Layer 2) support/stone deterioration (Layer 3), preparatory/plaster deterioration (Layer 4) and paint deterioration (Layer 5).

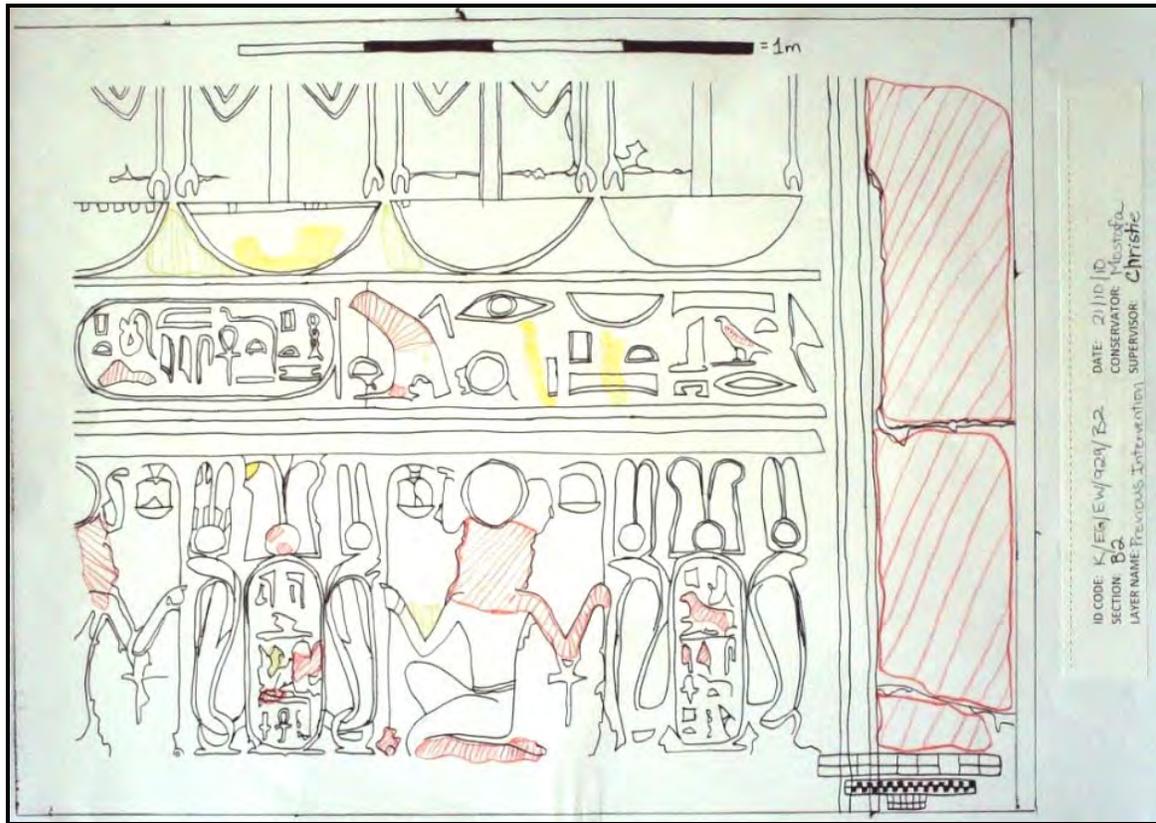
Figure 5. Condition map and key - Layer 1 - showing areas where there were previous interventions or treatments completed.

The different categories are noted using colored patterns and symbols. Figures 5-9 show examples of the condition maps for the B2 register on the Eastern jamb of the Euergetes Gate.

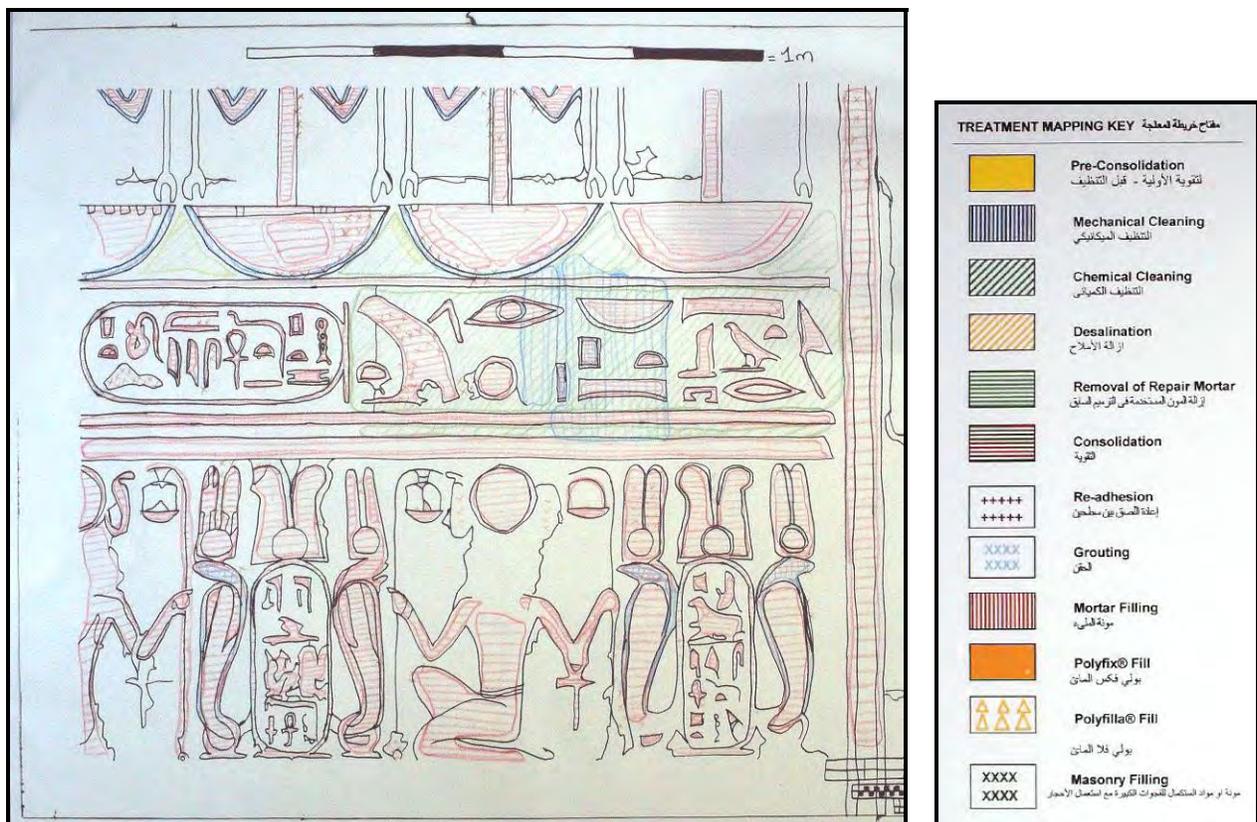
Figure 10. The treatment map and key documenting the work that was completed in register B2 on the Eastern jamb of the Euergetes Gate.

A corresponding treatment map (figure 10) is made during the conservation work which shows exactly where and what conservation methods were used for the treatment. There are different methods for condition reporting and mapping, some of which use more high-tech programs such as Photoshop® or AutoCAD®. However, ARCE conservators wanted to implement a sustainable documentation system that can be done by individuals with different skill levels, using materials that are inexpensive and readily available in Egypt (figure 11).

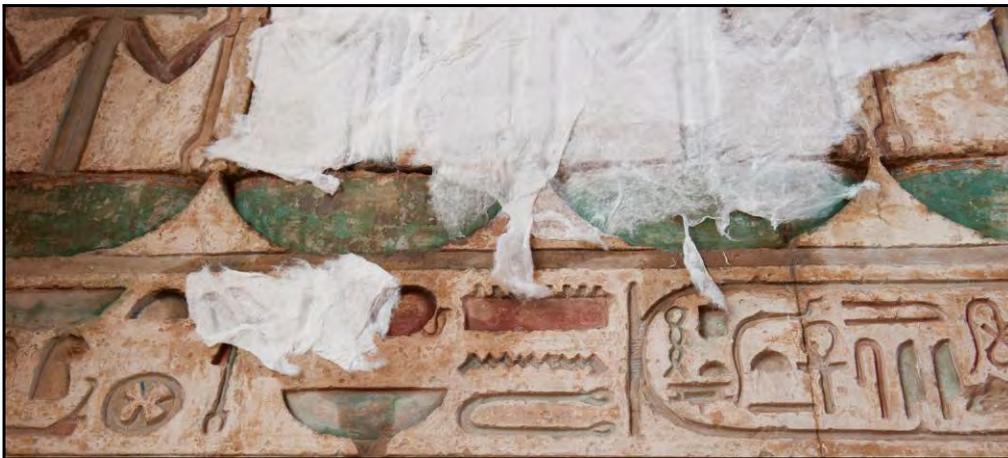
Figure 15: A section of wall showing cotton sheets saturated with distilled water.

The previous cleaning method is a variation of *poulticing*, a technique which aims to remove dirt and staining from archaeological surfaces. However, the large amounts of

distilled water used to rinse and clean the wall did not allow for much control or the ability to protect areas containing water-sensitive original pigment.

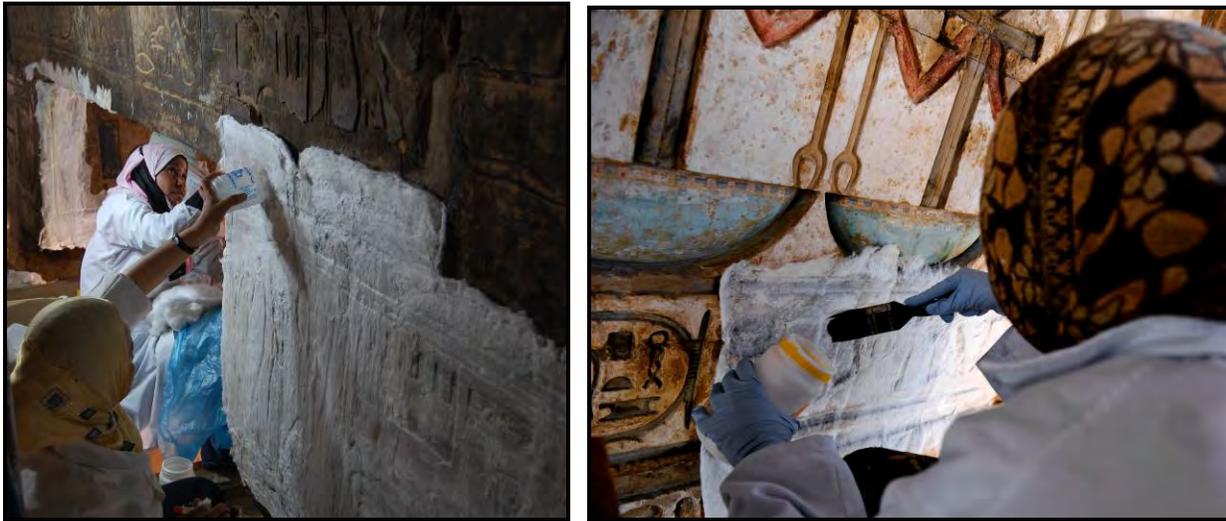
Figures 16 and 17. Students applying solutions to cotton sheets during the 2009-2010 field season

As a result of the use of very saturated cotton for the poulticing of the jambs (figures 16 and 17), the green pigment “migrated” away from its original position in many places. The excessive moisture activated the pigment which then travelled into the surrounding sandstone support layer. The end result was sections of decorative scenes where the green pigment became a halo around the original carvings and features (figures 18 and 19). The green pigment is particularly susceptible to water; fortunately, no other colors appeared to have bled into the surrounding sandstone.

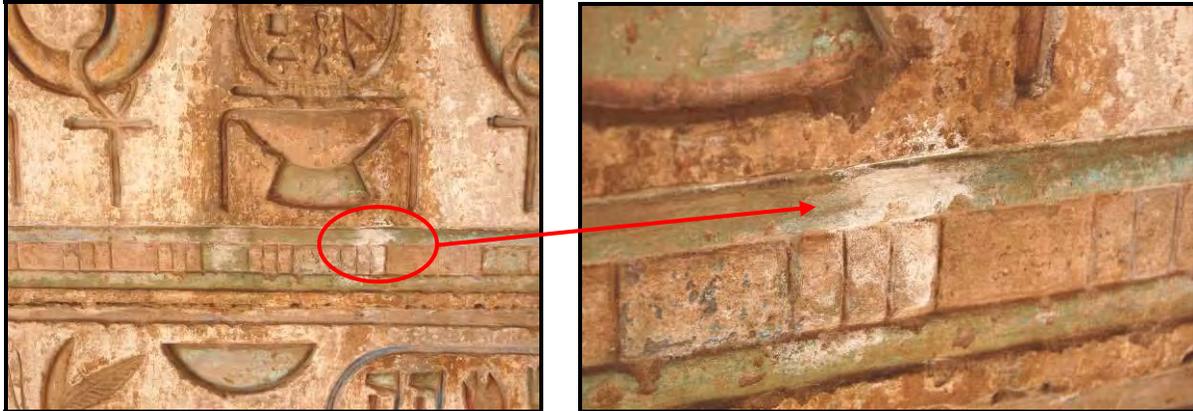
Figures 20 and 21. An example of the unknown white residue on the Euergetes Gate

An unknown white residue was observed in several registers of the Eastern and Western jambs (figures 20 and 21). Two different methods were used to try and remove the white residue: dry cleaning sponges and swabbing of the area with distilled

water. Two separate areas were selected for the tests: register A2 on the Eastern jamb (figure 22) and one area on the ceiling. The sponges worked moderately well to remove the residue, but the swabs and distilled water were very effective for removing the residue completely. Since it was easy to remove the residue in both areas using the same method, the conclusion was that the residue was likely remains of the solution used to clean the wall during the 2009-2010 season. Ammonium carbonate was an ingredient in the solution and it is possible for this to appear as a white residue if it is not properly removed.

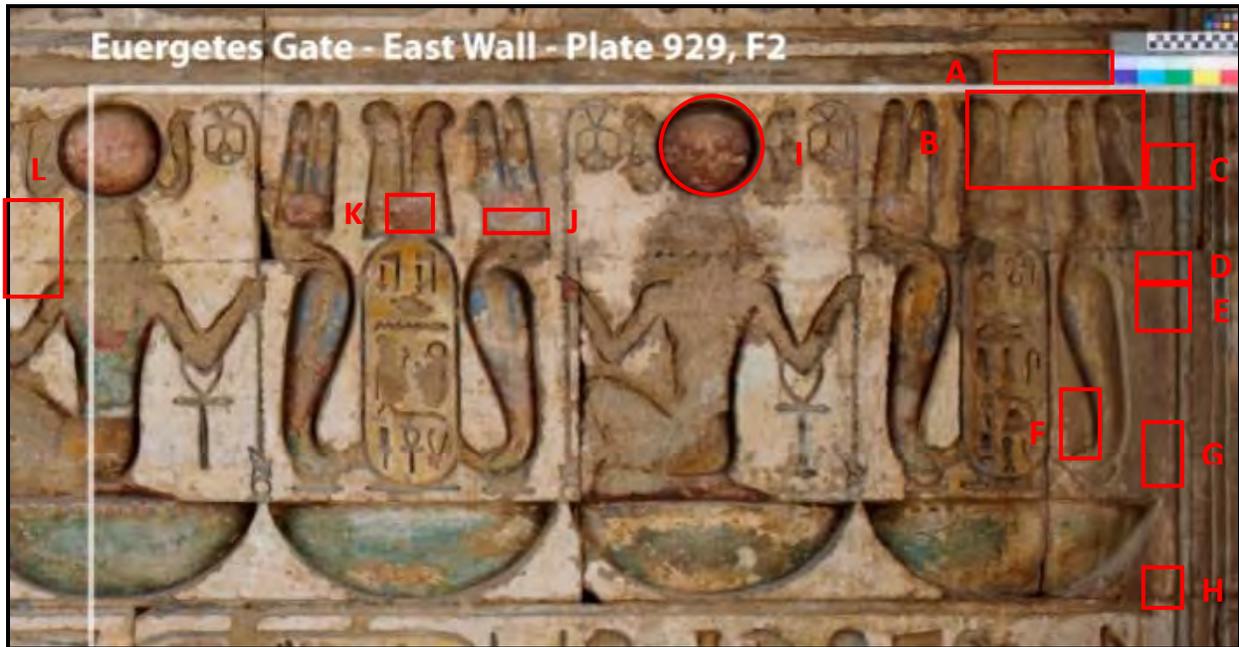
Figure 23. Map of the cleaning tests and sampled areas before treatment – Euergetes Gate – Eastern jamb – Register F2 – November 2010.

Several different cleaning tests were completed in register F2 on the East wall. The objective of the tests was to try and find a method for removing both hard layers of dirt and staining from the plaster and stone surfaces. The following map (figure 23) shows where the cleaning tests were completed, it also includes the location where the two samples of salt were taken. The map is followed by a chart which details the different materials used for the cleaning tests.

CLEANING TESTS AND AREAS SAMPLED: EAST WALL – Register F2 - November 2010	
LOCATION	CLEANING TEST/MATERIAL SAMPLED
A	Removed dirt with H ₂ O poultice
B	Removed dirt with H ₂ O poultice
C	Poultice: Japanese tissue, 6% carboxymethyl cellulose (CMC), 5% cellulose powder and 3% ethylenediaminetetraacetic acid (EDTA) in H ₂ O, covered with Mylar (second attempt using this mixture)
D	Poultice: Japanese tissue, 6% CMC, 5% cellulose powder and 3% EDTA in H ₂ O, covered with Mylar (first attempt using this mixture, left poultice on for 2 hours)
E	Poultice: Japanese tissue, 4% ammonium carbonate, 2% EDTA in H ₂ O, covered with layer of 5% CMC and Mylar, left poultice on for 1 hour
F	Poultice: Japanese tissue, 4% cellulose powder, 1.5% EDTA, 6% CMC in H ₂ O with Mylar cover, left poultice on for 2 hours
G	Poultice: Japanese tissue and 3% EDTA in H ₂ O, left poultice on for 1 hour
H	Poultice: Japanese tissue, 4% ammonium carbonate, 2% EDTA in H ₂ O, covered with layer of 5% CMC and Mylar (second attempt using this mixture, left poultice on for 1 hour)

I	Poultice to remove salt: 5% CMC in H ₂ O
J	Area where salt sample was taken for testing (positive for chlorides)
K	Area where salt sample was taken for testing (positive for chlorides)
L	Poultice to remove yellow staining from plastered area: Japanese tissue, 4% cellulose powder, 1.5% EDTA, 6% CMC in H ₂ O with Mylar cover

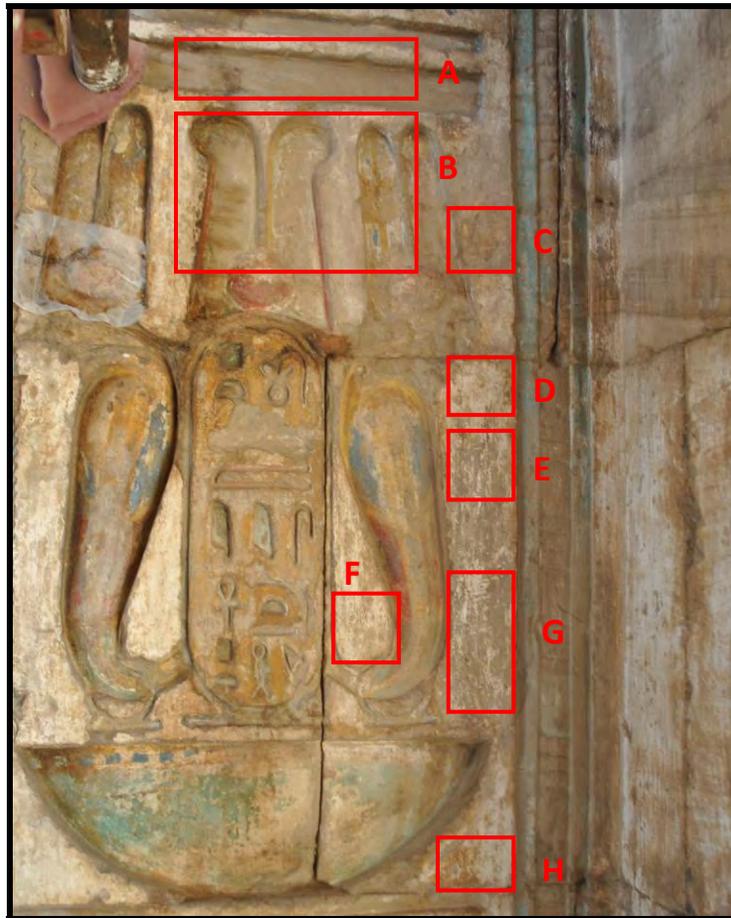
Figure 24. After the completion of the cleaning tests.

The following map (figure 24) shows the test areas after cleaning.

Out of all of the tests for removing staining from the plaster and stone surfaces, the poultice using Japanese tissue, 4% cellulose pulp, 1.5% EDTA, 6% CMC in distilled water (covered with Mylar) was the most successful. Figures 25 and 26 show a larger test area on the Western jamb (register D1) before and after poulticing a stained area of plaster.

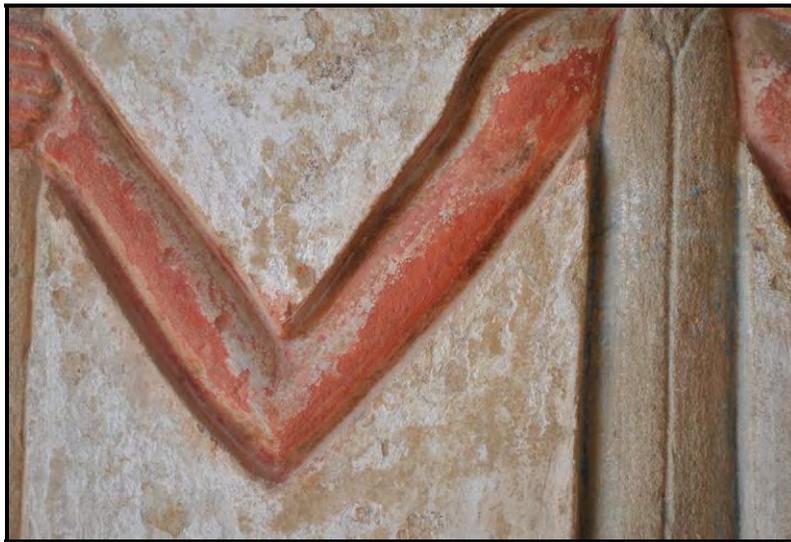
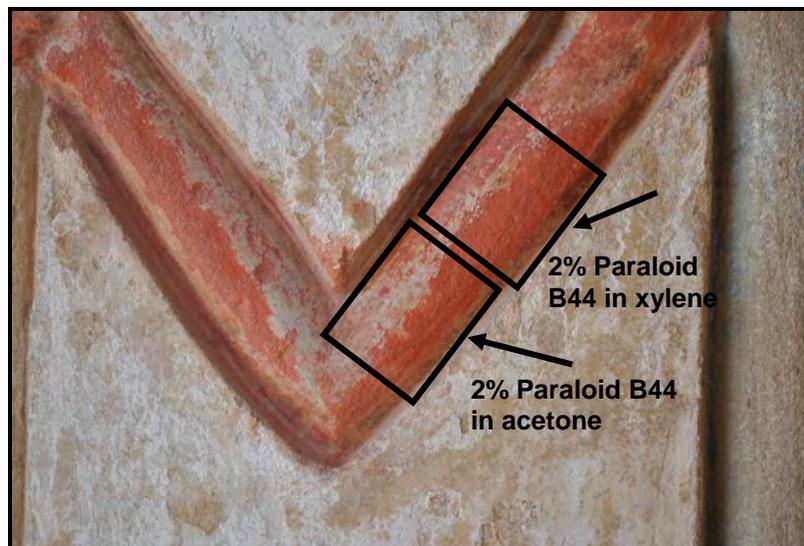
Figure 27. The area selected for the consolidant tests.

Two tests were completed in an effort to find the most effective consolidant for the remaining paint layer (figures 27 and 28). The goal was to find a concentration that

strengthened the paint layer without altering the color. 2% Paraloid® B44 in acetone and 2% Paraloid® B44 in xylene were selected for testing. Paraloid® B44 was selected as it has a high glass transition temperature (60 Tg°C) and this is necessary due to the high temperatures in Egypt. The results showed that the solution containing acetone darkened the color of the pigment slightly. There was no change to the color where the xylene solution was applied. Also, xylene helps the B44 penetrate further into the paint layer. The paint consolidation process will be discussed further in the treatment section of this report.

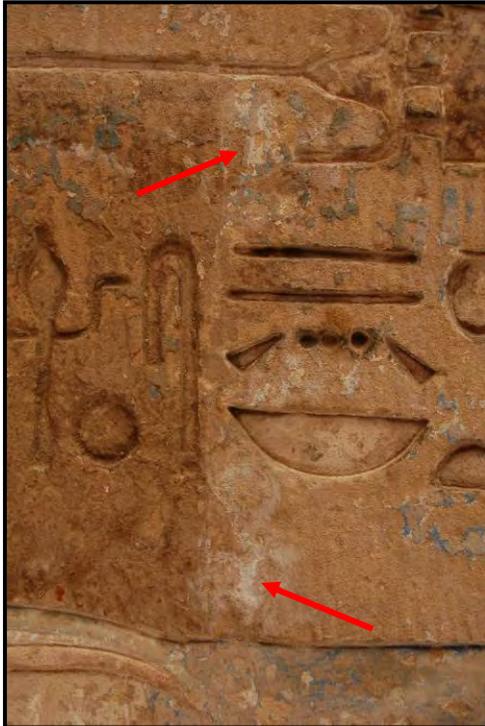
Figure 29. Examples of white residue on the ceiling.

As mentioned previously in the initial testing section, the white residue left behind on the surface of the ceiling and walls (figure 29) was easily removed using cotton swabs and distilled water (figure 30).

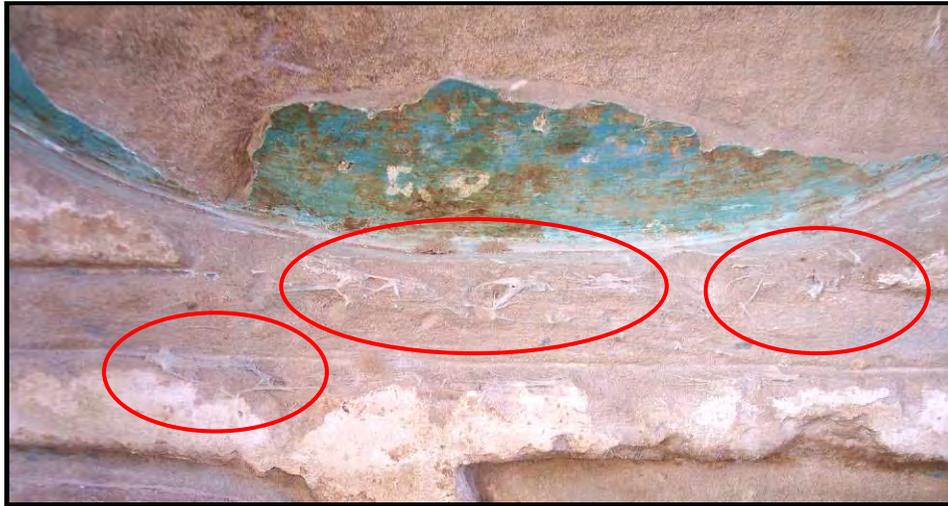
Figure 31. Cotton remains from the previous cleaning of the gate

As a result of the copious amounts of cotton that were used for cleaning the gate during the 2009-2010 season, there was a significant amount of cotton left behind on the surface of the walls and ceiling (figure 31). All of the bits of cotton were removed by hand using tweezers (figure 32) and were collected in a plastic bag. It was also necessary in some places to wet the cotton slightly and then remove it with a stiff brush as some of the cotton had hardened and become fixed to the surface.

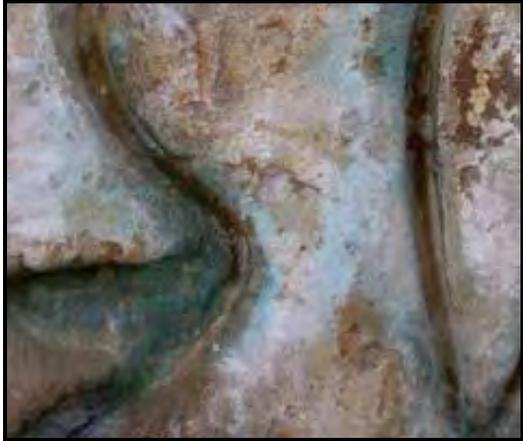
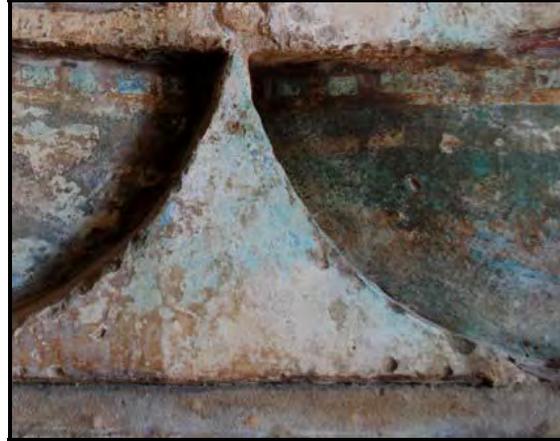
Figures 33 and 34. Examples of green pigment that migrated from its original location

As mentioned in the previous section of this report on the past cleaning methods, many instances of green pigment migration occurred on the Eastern and Western jambs (figures 33 and 34).

A poulticing method was discovered during the June 2010 tests which successfully removed the green pigment that migrated away from its original location. At the beginning of the season, ARCE conservation supervisors Christie Pohl and Claire D'Izarny demonstrated the technique to their teams of technicians who worked on the gate (figure 35).

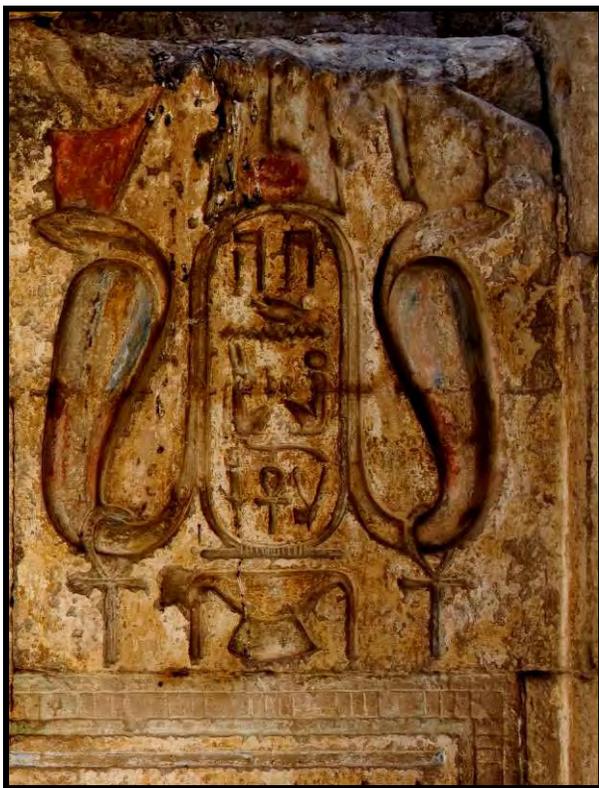
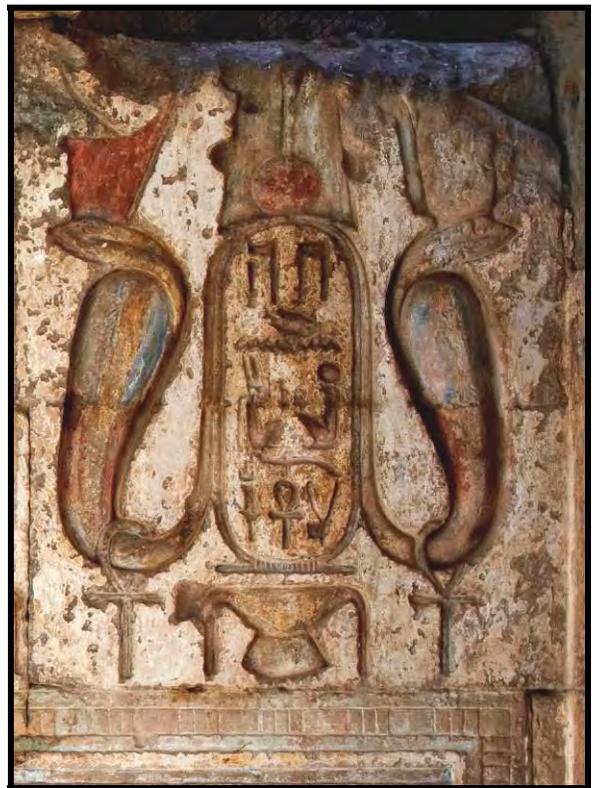
Figures 40 and 41. Before poulticing of the plaster background (left) and after treatment (right).

The effectiveness of this treatment was discovered mid-way through the work on the gate, so registers that had been completed were revisited in order to reduce the staining on the plaster background. Overall the work on the gate progressed faster than anticipated so it was possible to spend some additional time doing poulticing work. The end result was a more homogeneous looking surface on both the Eastern and Western jambs. Figures 40 and 41 show a section of the A2 register on the Eastern jamb before and after poulticing of the plaster surfaces.

After the discovery that the paste used to remove the green pigment successfully reduced some of the yellow staining from the plaster background, this treatment was incorporated into the overall scope of work. The method for applying and cleaning the poultice used on the plaster background is the same as the method described on page 25: a paste made from 4% cellulose powder/pulp, 1.5% EDTA, and 6% CMC in a liter of distilled water applied on top of a sheet of Japanese tissue and covered with Mylar®, then cleaned with cotton swabs and distilled water.

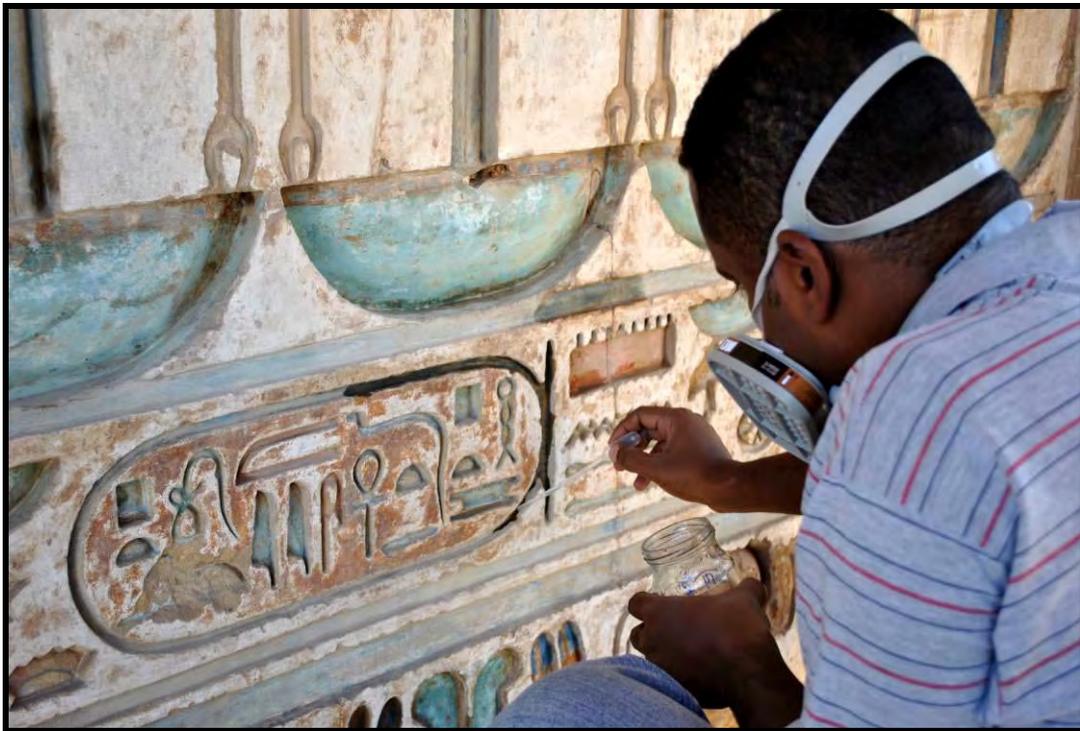
Figure 42. A conservation technician applies consolidant to an area containing fragile blue pigment.

The surviving paint on the jambs and ceiling of the gate is extensive. In general, the green and blue pigment is more fragile than the yellow and red pigment. After experimenting with two solutions (previously described in the testing section of this report) a solution of 2% Paraloid® B44 in xylene was selected for the consolidation of the paint layer. Because of the fragile nature of the blue and green pigment a plastic pipette was used to apply the solution; a brush is more likely to remove flaking areas, whereas the use of a pipette keeps the contact with the paint layer to a minimum (figure 42). Respirators were worn by the technicians during the consolidation process due to the toxic nature of xylene.

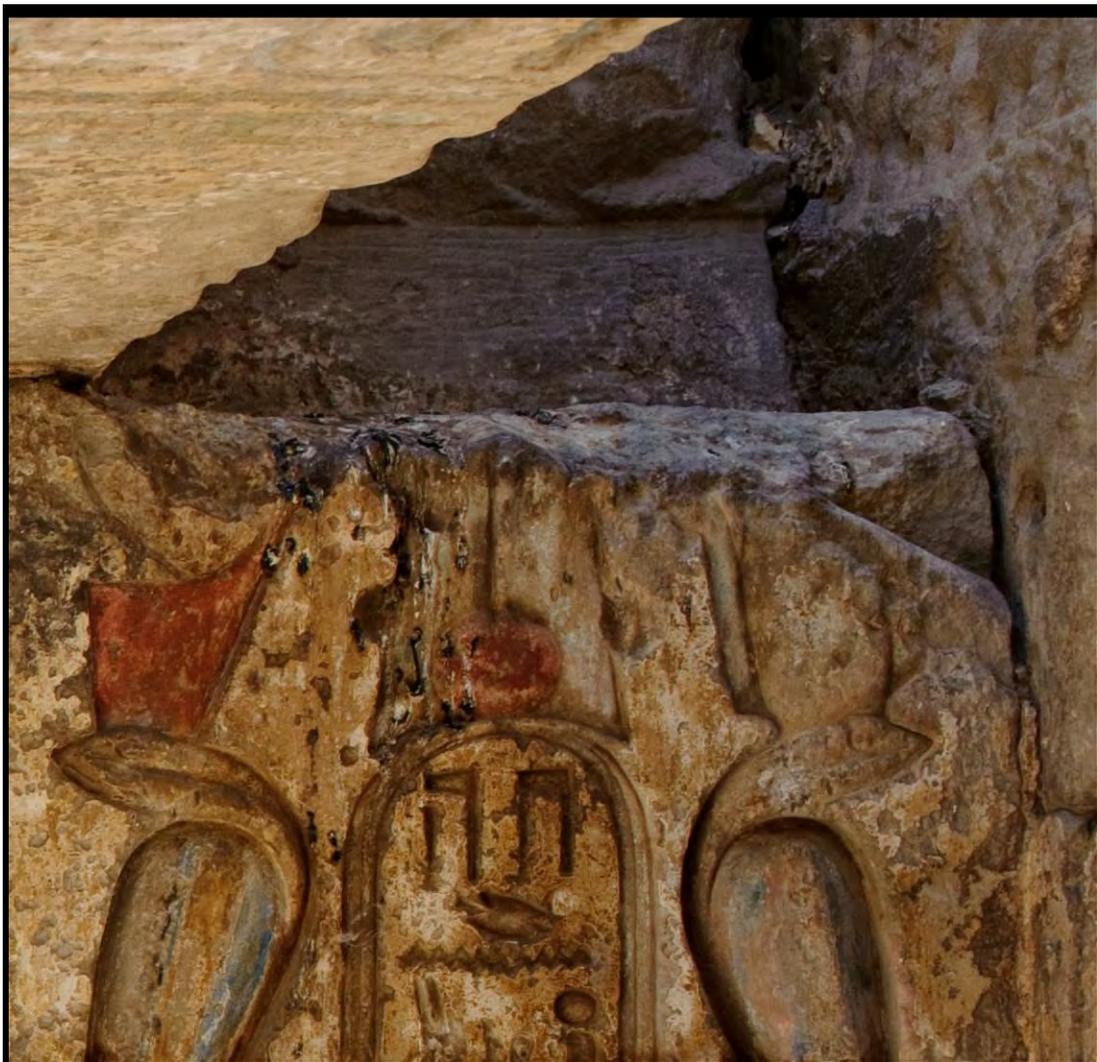
Figure 43. The upper corner of the Eastern jamb showing the flat area where pigeons could perch and soil the decorated surface with their droppings.

There were two areas in the upper corners of the monument (the A2 register on the Eastern jamb and the A1 register on the Western jamb) where pigeons would perch and leave behind their droppings (figure 43). In order to prevent the birds from accessing these areas, wooden frames and metal screens were custom made to fit inside of the corners. These screens were made to be removable since the corner on the Eastern side is the only access point to the roof. Figure 44 shows the upper corner of Register A2 on the Eastern side after conservation treatment and installation of the screen.
