ANNUAL REPORT

October 17, 2010 – July 31, 2011

“ARCE Groundwater Lowering Response Project, Luxor”

The Egyptian Antiquities Conservation Project (EAC)
USAID Agreement No. 263-A-00-04-00018-00

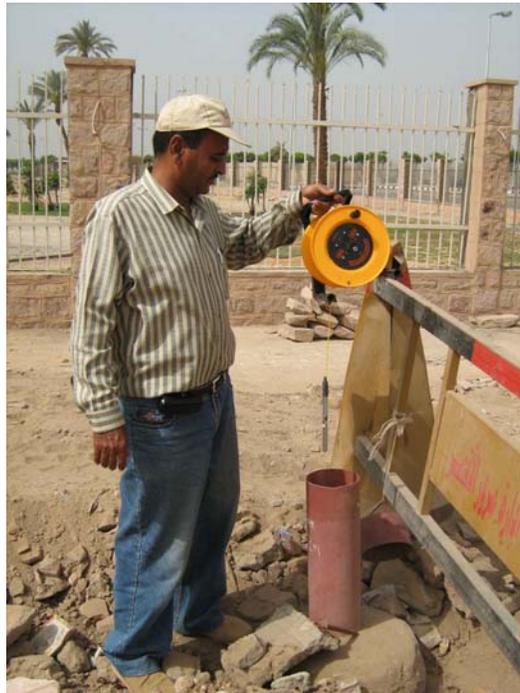
Measuring groundwater level at the Piezometer

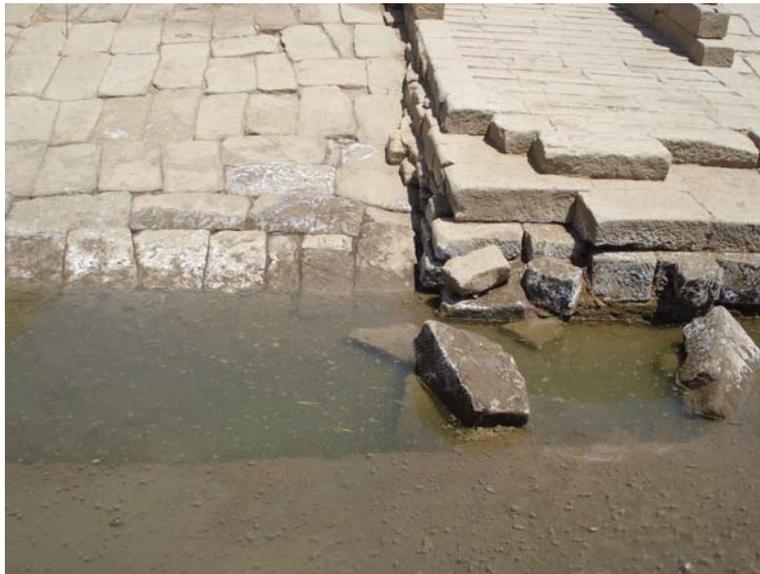
The front of the ramp (looking east) before dewatering

During SCA excavations in front of the entrance to Karnak Temple a boat ramp was exposed. During the course of excavation, groundwater was encountered. The SCA requested dewatering pumps and during the 2008-2009 Season, two were placed in this area. During the 2009-2010 Season, the piping was completed and the pumps were placed on line which lowered the groundwater thus allowing the SCA to continue their excavation. The pumps were handed over to the SCA for monitoring and maintenance.

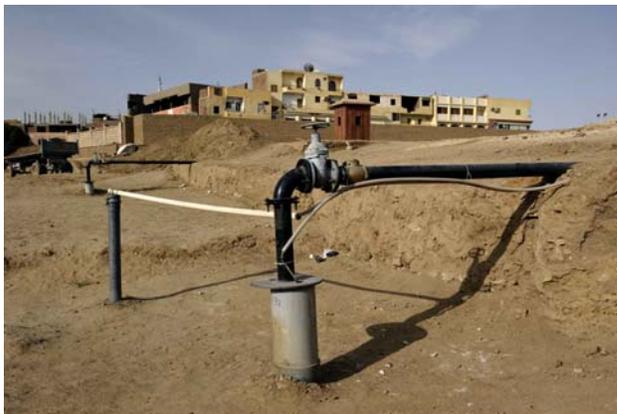
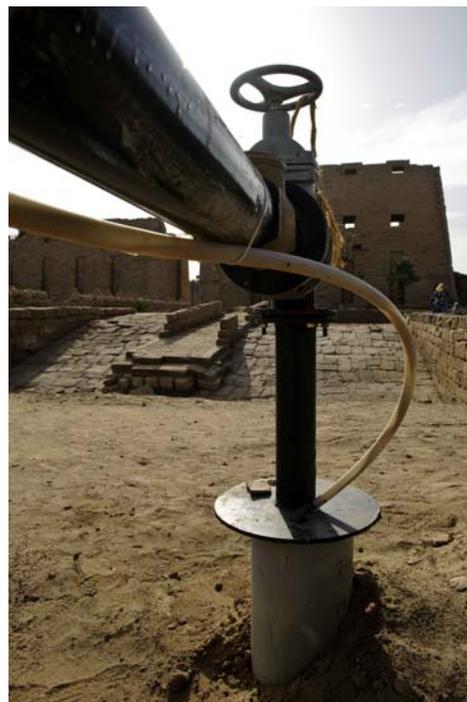
The dewatering pumps (looking southwest (photo left) and looking east (photo right))

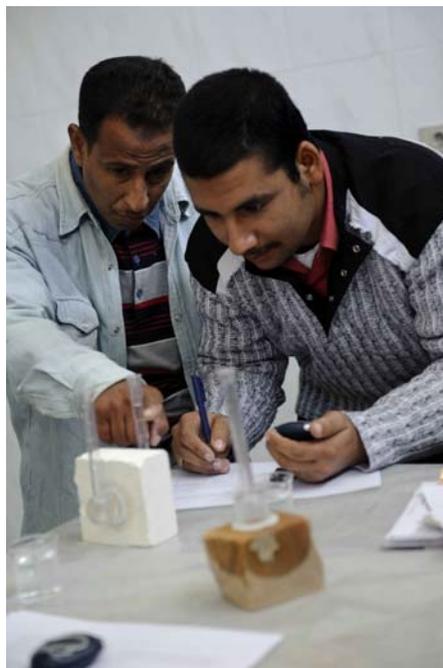
Students in the laboratory calculating the water absorption rate of different stone.

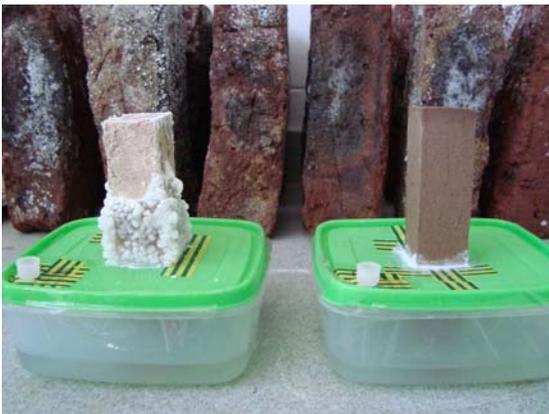
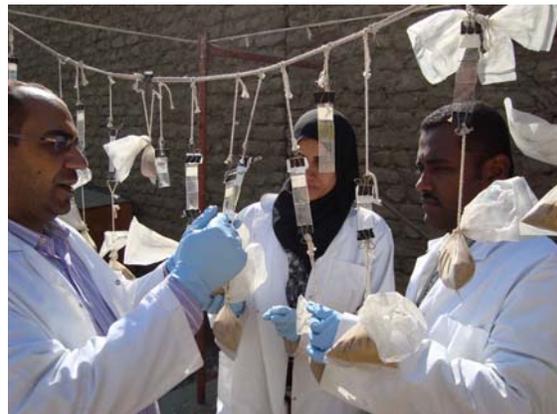
Laboratory experiments showing sandstone reaction with salt (left sample) and water (right sample) and red brick (background) (left photo) and experiments on how different adhesives react to the Luxor weather (right photo)

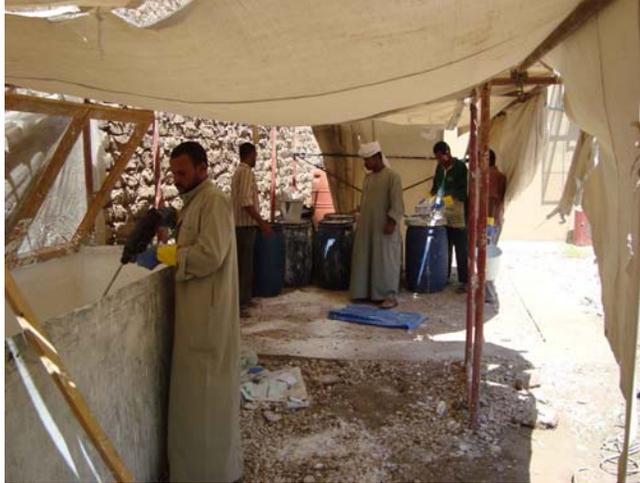
Lime slacking operation behind the laboratory

At the end of the field season, the laboratory is used to prepare for the next season's activity. The slacking of lime is important for the quality of the lime mortar. The operation is performed just outside the laboratory at the east end.

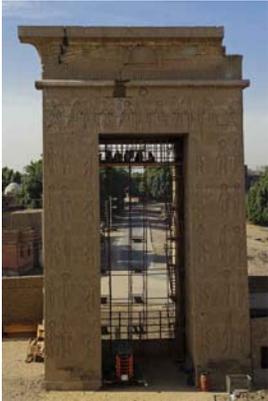
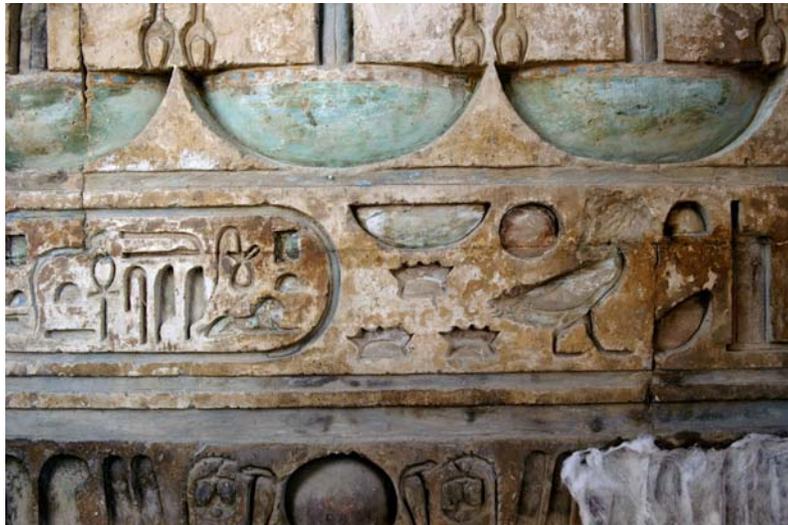
Euergetes Gate (photo left) and detail of cleaning results (photo right)

The gate in front of Khonsu Temple was erected by Ptolemy III Euergetes who ruled Egypt from 246 to 222 BCE. ARCE's conservation students started cleaning by focusing on the ceiling and the jambs. The result was the reappearance of many colors.

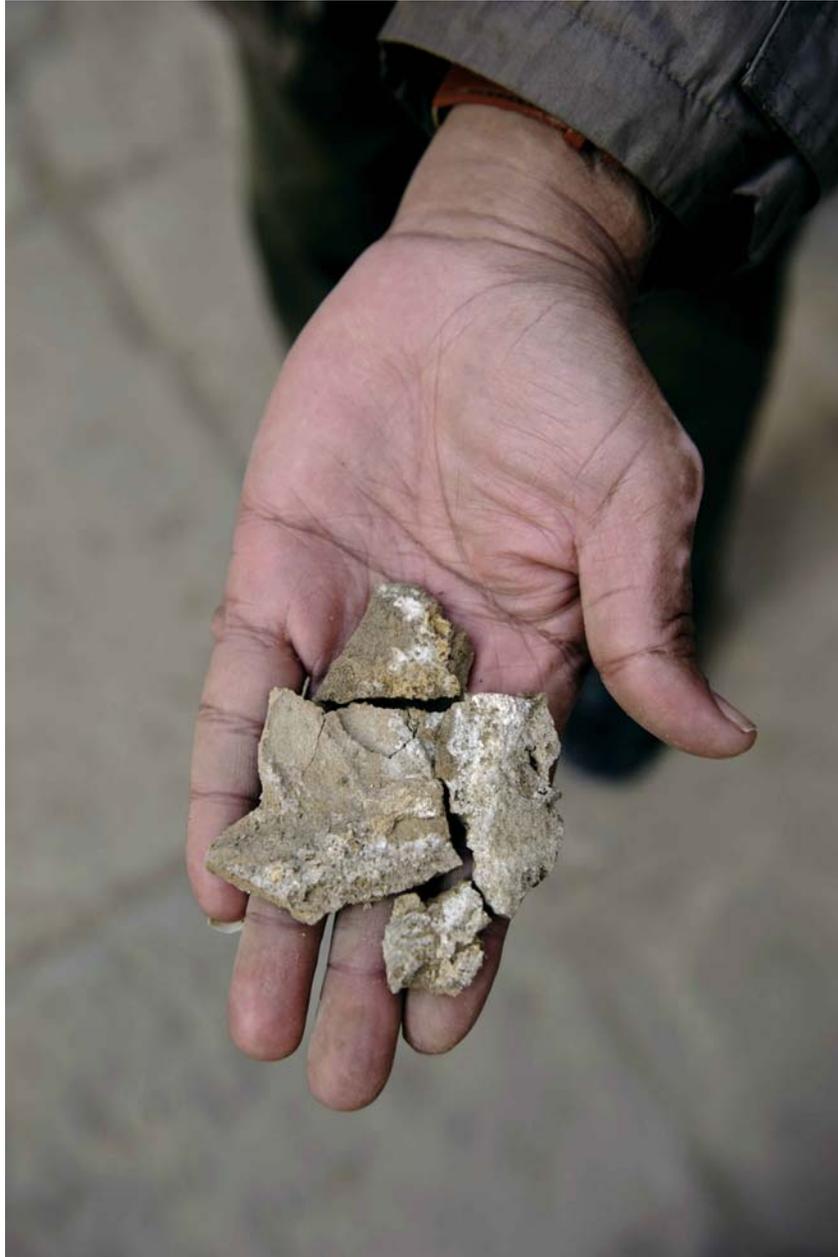
Hiba clay poutice after removal showing the salt removed

The Second Pylon was in desperate need of desalination as the salts from the groundwater were damaging the stone. ARCE and its student crew lead by Christie Pohl performed the removal of old cement patches, performed the necessary desalination techniques and re-patched where necessary using lime mortar. One of the methods used in desalination was a hiba poutice. Hiba clay is applied to the surface to draw out the salt. When the clay dries it is removed along with quantities of salt.

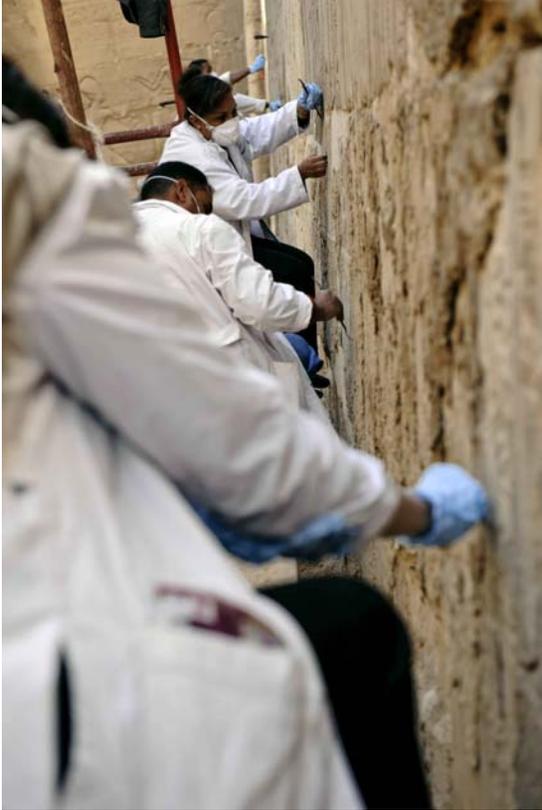
Students mechanically cleaning the wall

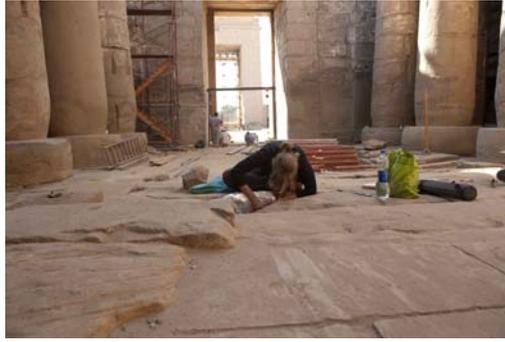
Applying aluminum foil in joint to obtain rub details

Chicago House recorded the exposed stone elements as a result of ARCE’s activity associated with the roof work and the new flooring. A large portion of the exposed areas were almost inaccessible. Chicago House overcame this by sliding aluminum foil in the joints between the stone slabs and utilizing a hand made tool. They then proceeded to obtain a rub of the fragment. This allowed them to then draw the impression to record the finding which provided additional information on the temples history.

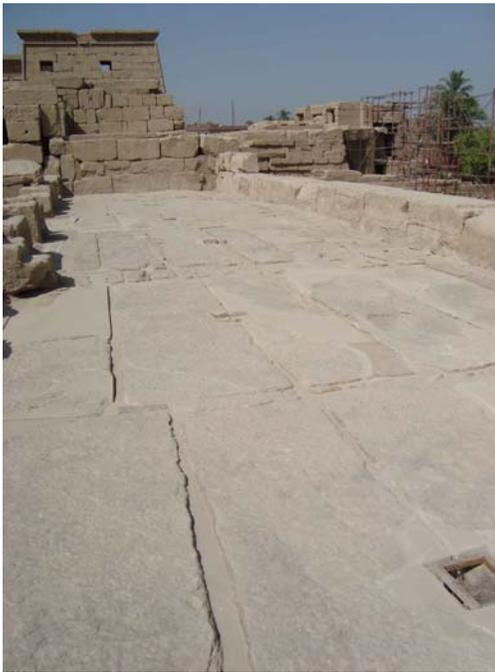
Northwest section roof repairs

Much stone masonry work was needed for structural repair as well as tourist enhancement. This season, ARCE with Dany Roy's team performed repairs on the northwest section of the roof as well as install new flooring in the main court. They also rebuilt the remains of a contra chapel at the north exterior end of the Khonsu Temple. Tourists will now have easy access with the installation of stone walks around the east side of the temple, running to the front entrance as the walks were completed this season.

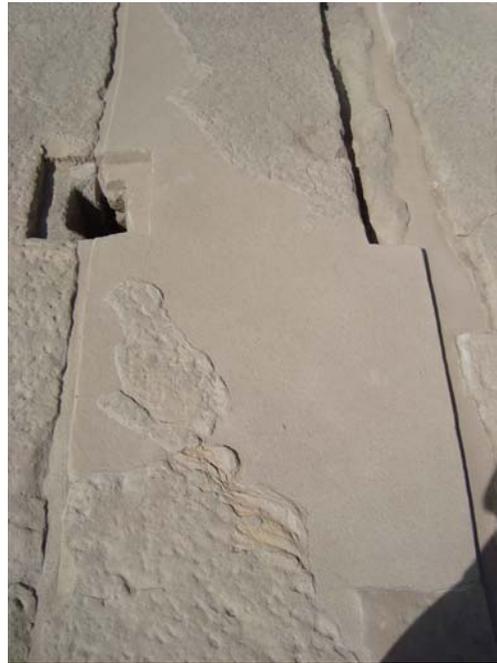
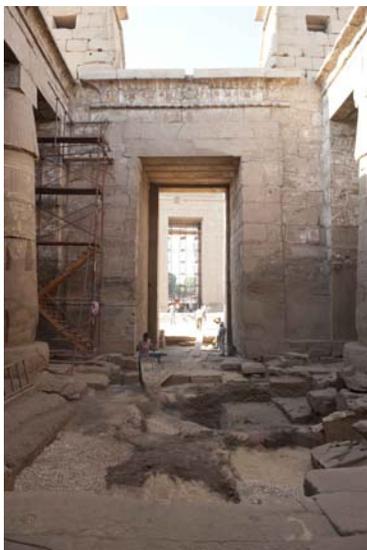
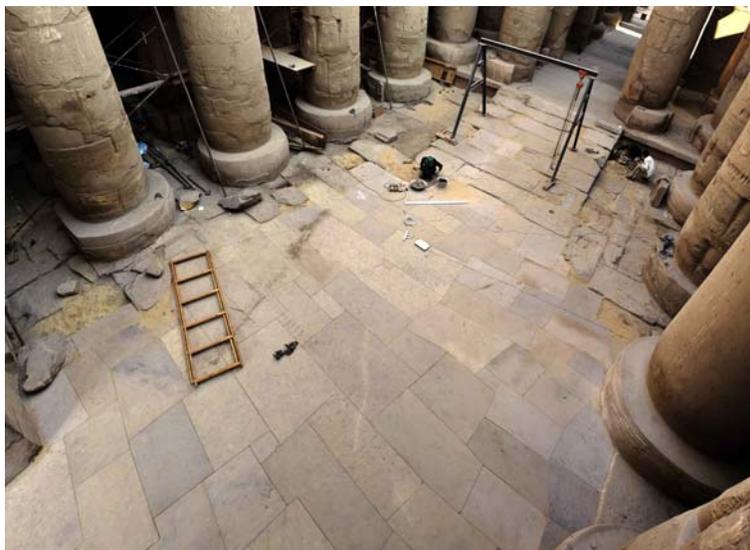
Main Court flooring before (left photo) and after paving (right photo)

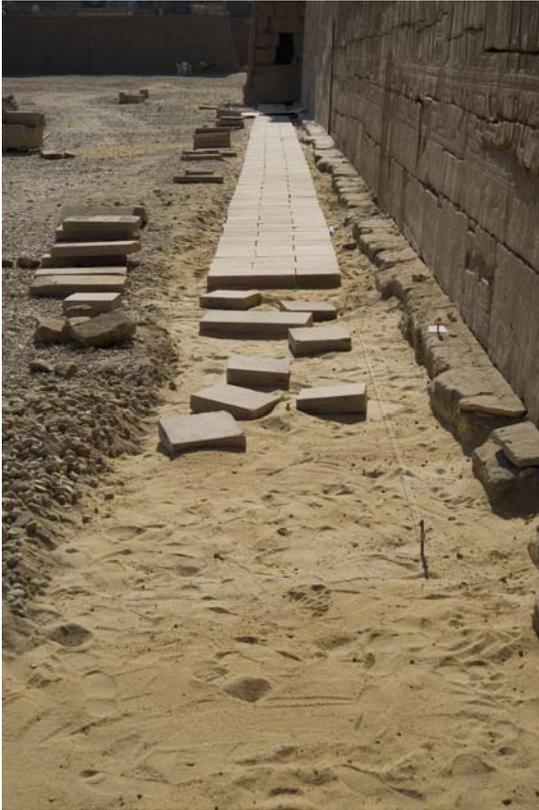
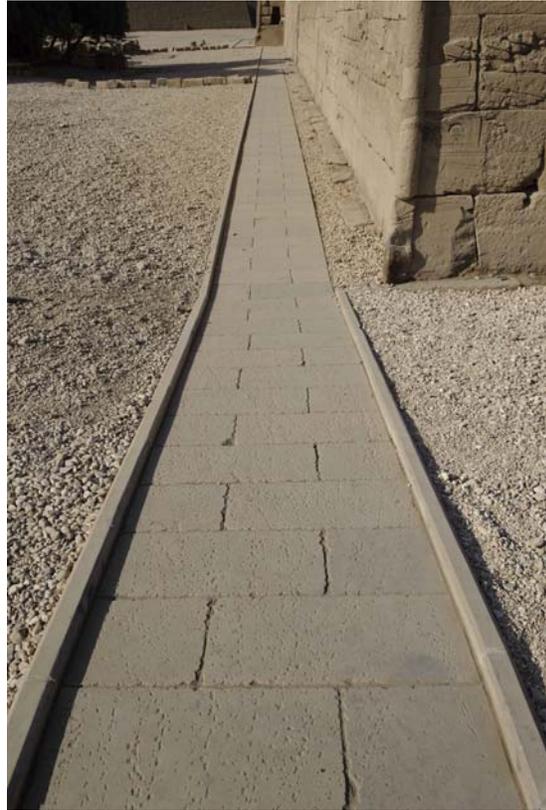
Walks at the exterior of Khonsu Temple during installation (left photo) and completed

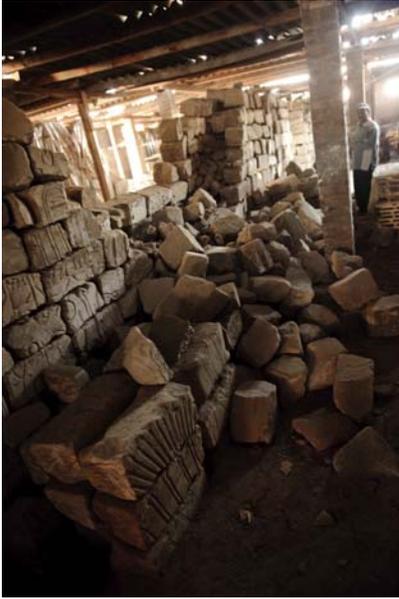
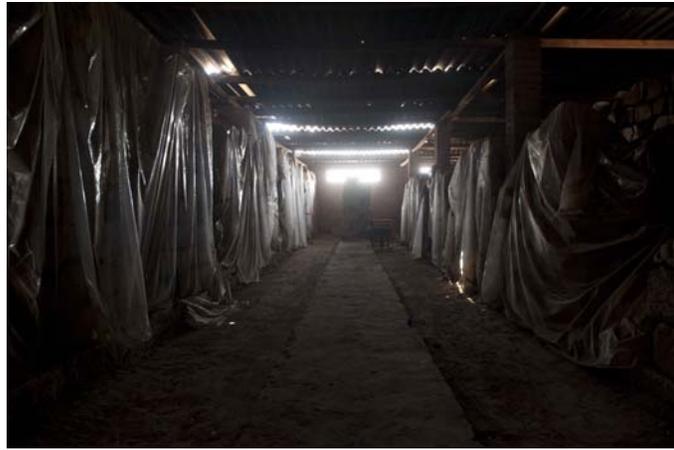
Talatat blocks shown as a consequence of fox burrows undermining the existing mastabas (left photo). Processed and covered talatat blocks neatly stacked on new mastabas (right photo).

The Pharaoh Akhenaten built his structures out of smaller blocks. Today they are referred as “talatat”. This season culminated the final season for the field work portion of this project. Over 16,000 talatat blocks were removed from the magazine, cleaned and conserved, recorded, photographed and neatly restacked and covered on new mastabas. Some of the stacks were found in disarray due to fox burrows undermining the existing mastabas. New mastabas were constructed along with new floor sections to discourage future fox burrows. Many structural repairs of the building were also made.

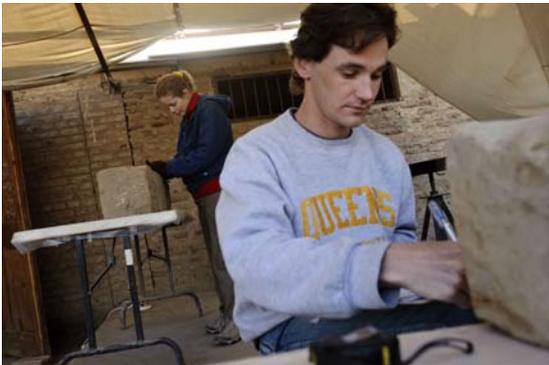
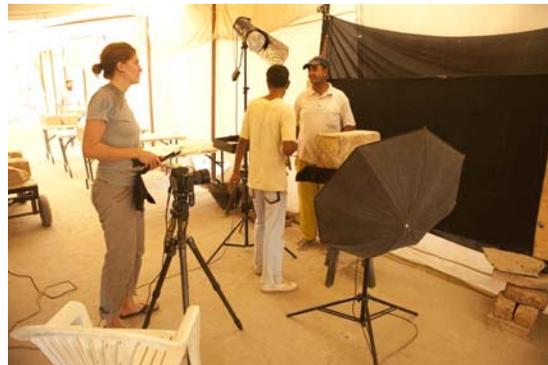
Talatat blocks being cleaned, conserved and cataloged (left photo). Talatat block being photographed (right photo).

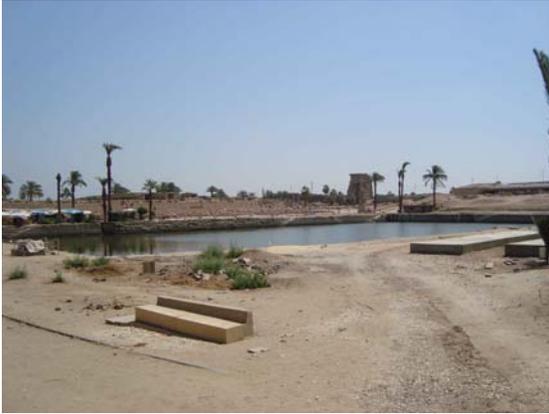
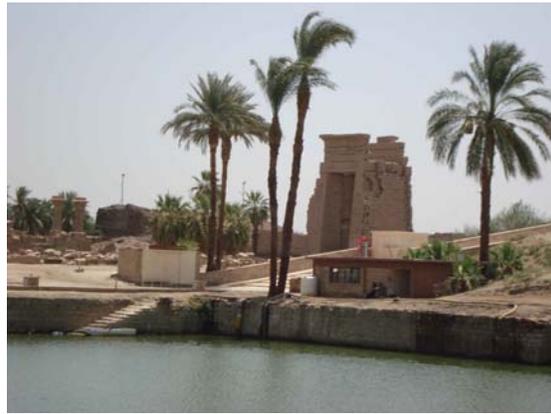
Karnak Sacred Lake looking northeast (left photo). Karnak Sacred Lake showing pump station and treatment building in the northeast corner of the lake (right photo).

Before the Groundwater Lowering Project became a reality, the Sacred Lake at Karnak was normally refilled with Nile water. This caused a large weed buildup throughout the lake. ARCE shut off the Nile water and replaced it with cleaner groundwater. After removing the weeds, chemically treating and implementing a maintenance routine, ARCE handed the clean lake back to the SCA to maintain in April 2010.

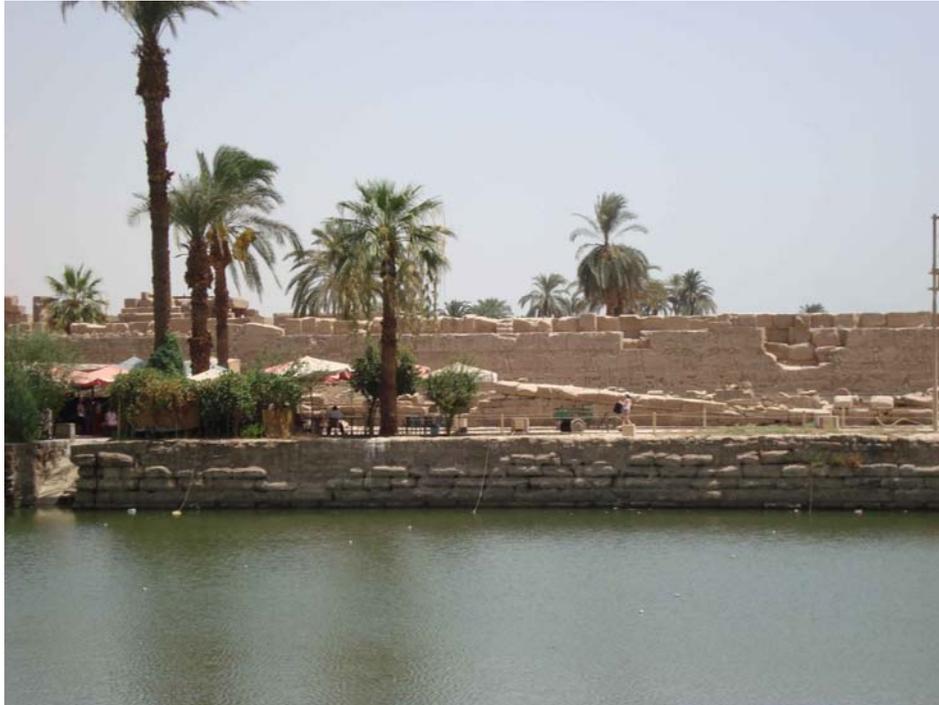
Side view of the Nileometer in relation to Karnak Sacred Lake showing proximity to the outdoor café with the canopies to the left

On the North side of Karnak's Sacred Lake is a long narrow structure running parallel to the side of the lake. This structure is a Nileometer, originally built by the Pharaoh Taharqo. Due to the structure being so close to the café at Karnak, trash and other debris has been deposited on the stairs and down in the lower part of the well. Complaints of foul odors were also expressed by the tourists to the SCA. ARCE cleaned out the structure and set up a sump pump with piping to Karnak's Sacred Lake to keep the well refreshed. To prevent further debris from being deposited in the structure, metal screening with wood frames was placed over the openings. The work was performed over the Christmas holiday. (Also see drawing in Appendix C).

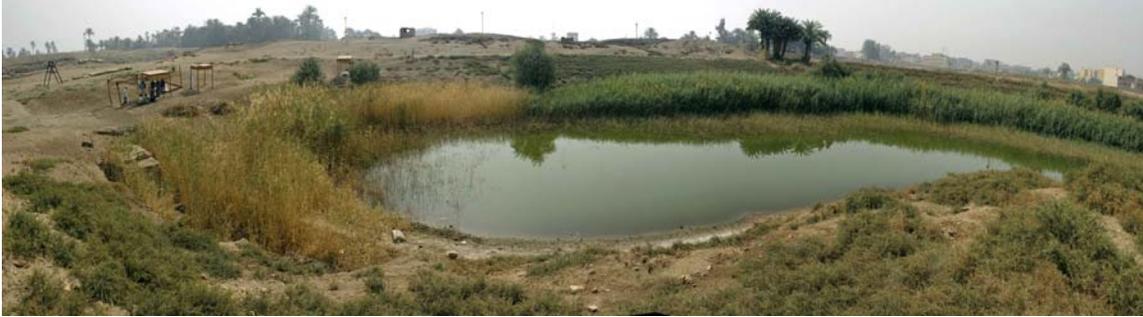
Mut Temple Sacred Lake showing the weed growth on the embankment.

The Sacred Lake at Mut Temple had many problems with weed infestation surrounding the lake and in the lake itself. This season, ARCE staff led by Magdy Mokhtar with assistance from Betsy Bryan, developed test areas on the embankment to eliminate the weeds with the constraint of low maintenance after the weed removal. Although the testing is still ongoing, it seems that a thick plastic liner will eliminate weed regrowth on the embankment. During the next season, all the weeds will be removed from the embankment and the liner will be installed. The lake will also be drained, refreshed and treated.

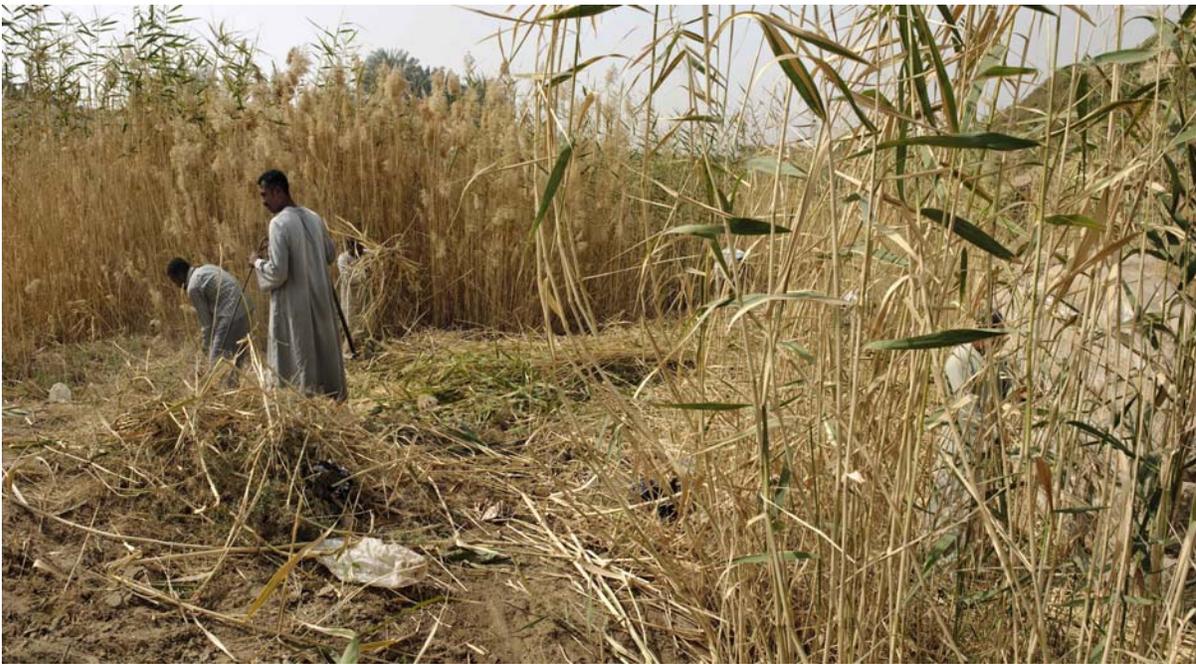
Removing the weeds for the test sections

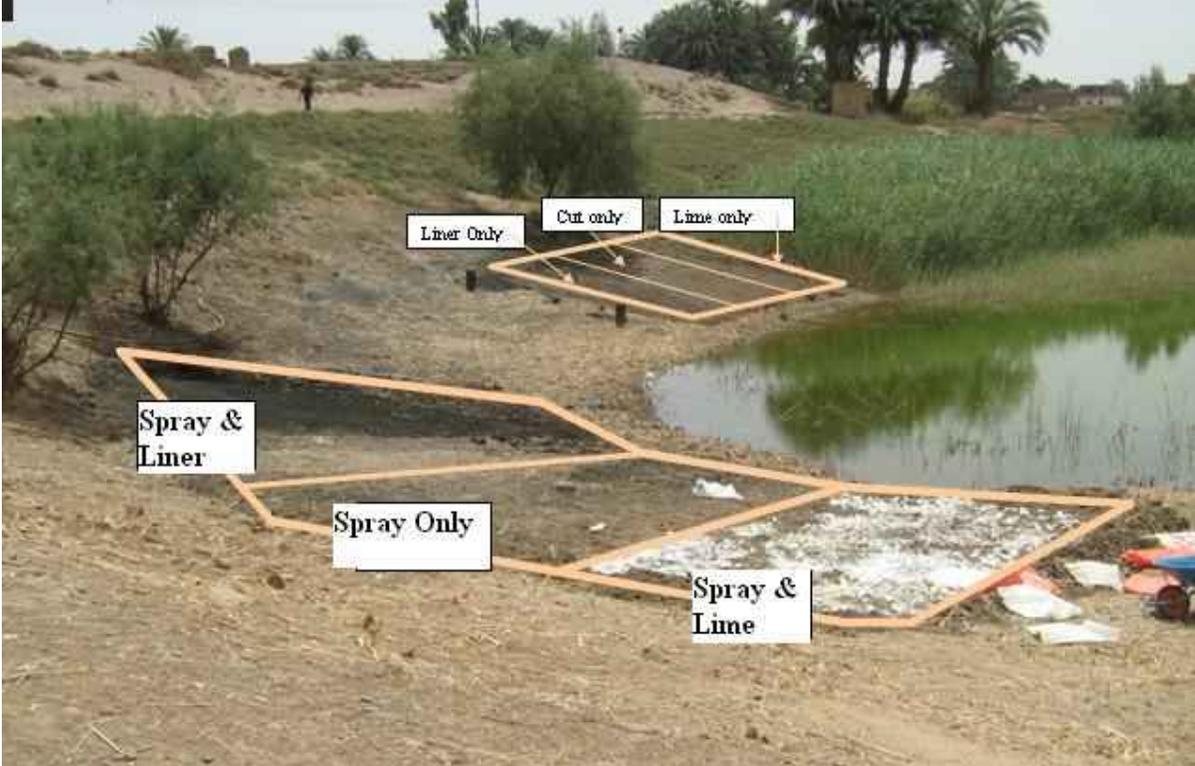
Test section areas to determine the strategy for next season.

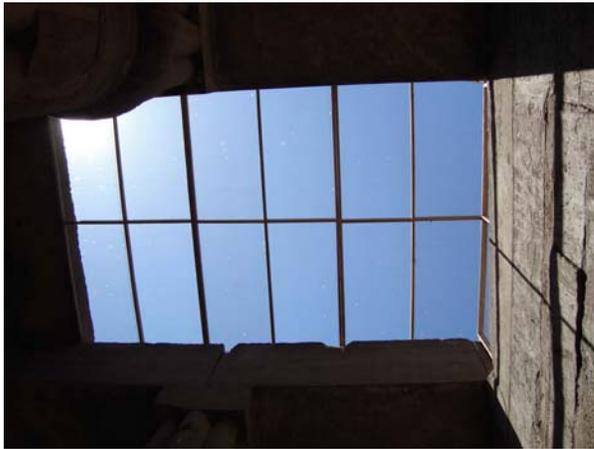
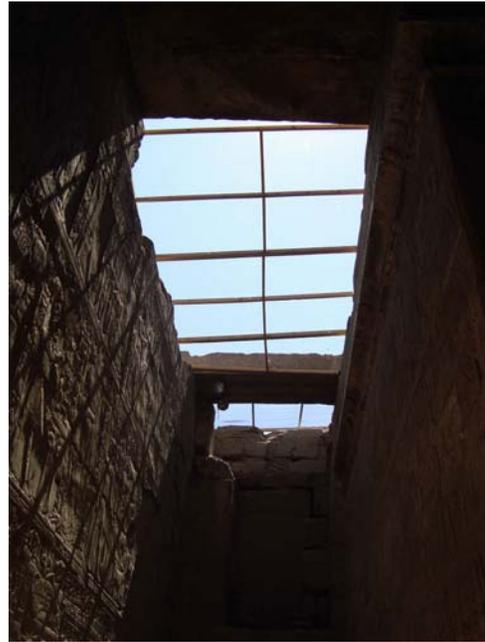
Examples of framed metal netting over roof sections

Pigeon and bat droppings continue to plague many monuments throughout Egypt. Luxor Temple is not the exception. In order to reduce the damage, pest netting was installed in the ante chapel of the Sanctuary of Amun and the Sanctuary itself, this dating from the time of Alexander, to suppress the pests and thus reduce the droppings on the walls and columns.
