# FINAL REPORT

ARCE Groundwater Lowering Response Project, Luxor

“Mut Temple Foundations”

Betsy M. Bryan

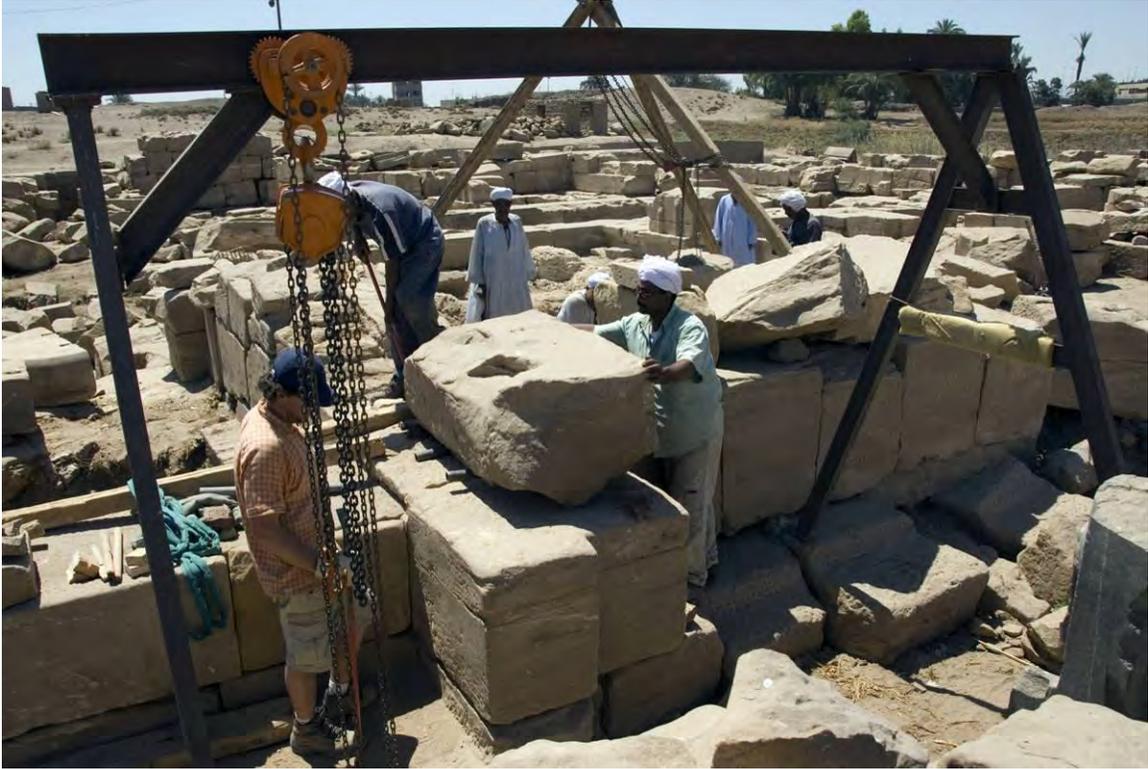
Fig. 3 West wall at beginning of removal. Note foundation slippage.

Dismantling the front east-west wall and the north half of the west wall of the Mut Temple took place in May and June. (Figs. 3-7) This work was carried out by Mr. Franck Burgos, formerly stone mason at the CFEETK. First the walls were drawn to scale and photographed, the blocks were numbered and then removed in levels. The blocks were put atop the enclosure wall to the west. Then the paving was removed from beneath the level of the two walls in order to expose the slipped foundation blocks. These will be reset by Mr. Burgos in January, and then the walls will be rebuilt. The west wall which had been in disarray for many years had a large inscription on its exterior, and the rebuilding will allow that text to be visible and intact again. Further the possibility to waterproof the foundations on the west side has been made all the more necessary by the prevent intermittent rising and lowering of the water table. The soil has been very wet in the temple this summer, and the lake level was as high as before pumping began. Thus, any efforts that we take to protect the monument when water levels surge is worthwhile. During this work and during the cleaning of the sub-pavements nearby two fragments of statues were found. The lower half of a granodiorite face, some 11 cm in height, dating certainly to the reign of Amenhotep III was found in a crevice between foundation blocks. (Fig. 6) In addition, a fragmentary limestone element containing the nomen (son of Re)

The west wall of the temple proper, where it joins the front wall of the temple proper has been affected by wet foundations. The foundation stones have slipped out from under the wall along an area of some five meters. This section will be entirely dismantled in May-June 2007 and after consolidation and conservation of the decorated blocks (a major inscription exists on this wall section), the wall will be rebuilt with new masonry base and impermeable layers.

Dismantling of the two walls (1. And 2.) of the temple on the west side due to their poor condition and displaced western foundations took place in June and July 2007. Rebuilding, although scheduled between January and March, 2008 has been postponed until January 2009 when an additional stone mason will be available to assist. The result of the dismantling work has demonstrated even more than anticipated, that the intermittent rise and fall of the lake over many centuries had caused subsidence on the west side of the temple, creating a more than 7 centimeter slippage in the north-south running wall, on the north half of the temple and more than 10 cm in the south area to be completed in early 2009. Stabilization of the foundations following this subsidence appears to have taken place, but to assure that the newly rebuilt walls will be entirely at harmony with the remainder of the temple and the site – particularly given the fault line through Egypt – an iron and concrete belt will be attached to the rebuilt walls where the greater subsidence has taken place. For this purpose a second stone mason will come from France to assist Franck Burgos in January and February of 2009.

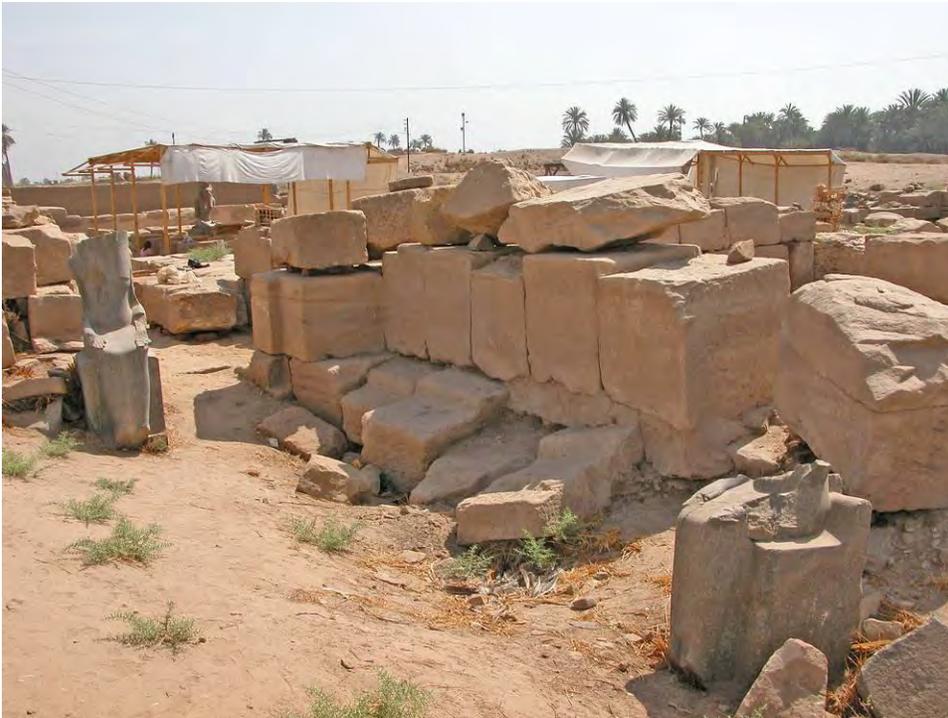
Fig. 4 Mut Temple west wall before dismantling. Note foundation.

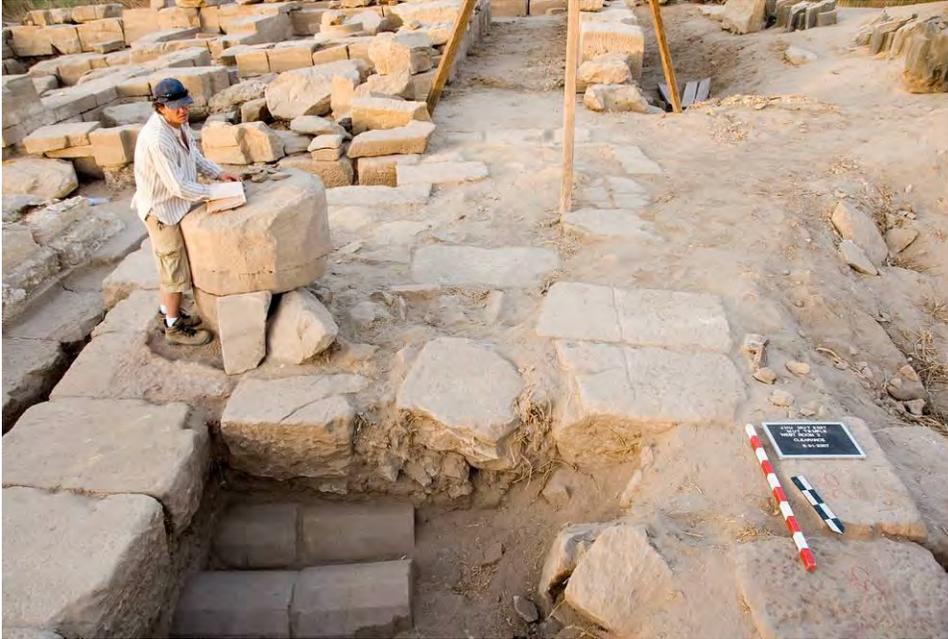
Fig. 5 West and east-west walls after partial removal and exposure of columns Beneath.

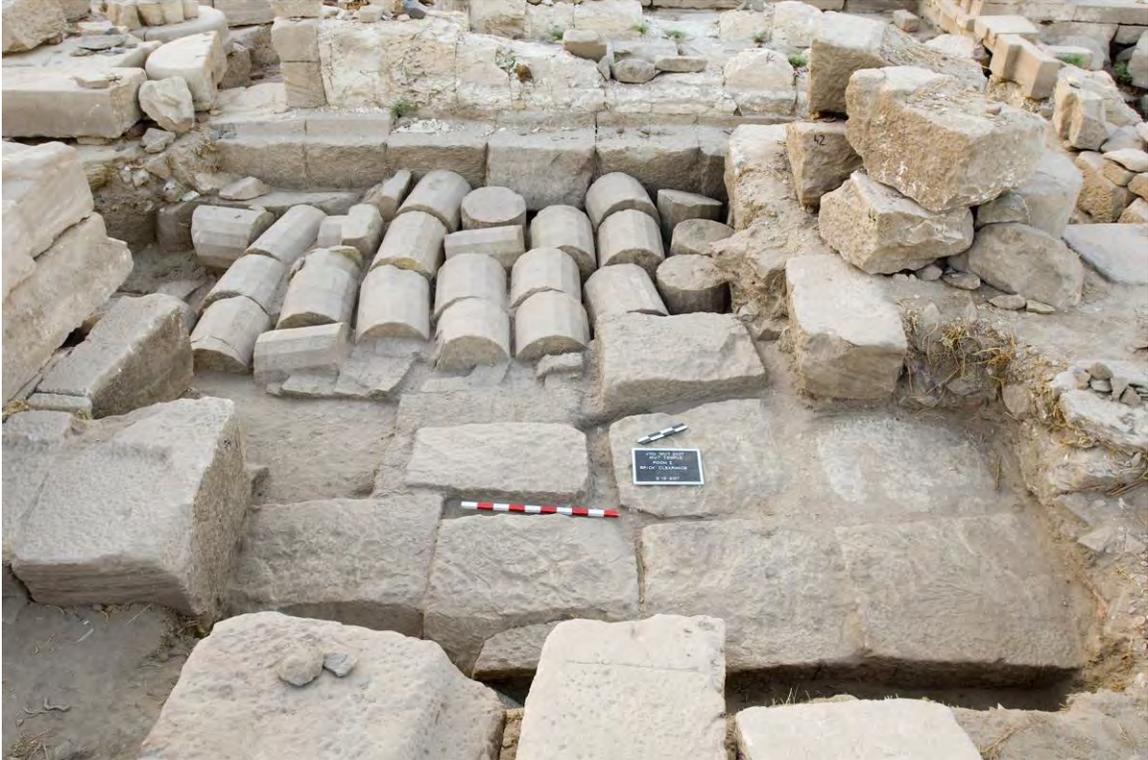
Fig. 8 Column parts of porch of Hatshepsut, revealed following wall removals, June 2007.

Column drum elements of a porch of Hatshepsut and Thutmose III (Figs. 8-9) from their coregency were first found in 2004. More were found in 2006, and at the end of that season were seen to extend beneath the stone temple in a foundation built from them. That foundation extends the Thutmoside platform to the west and runs from the north end of the 18<sup>th</sup> Dynasty porch southward at least as far as the walls of the limestone chamber still in the temple. Due to a small test trench inside the temple proper carried out in March 2006, we were aware that the column foundation extended this far, and we therefore anticipated the work this season beneath the dismantled walls. The columns in the porch area, removed in 2004 and 2006 had been mortared into position with mud pisé strengthened by limestone and sandstone chip. Pottery was rare, but when it was found it was invariably of early 18<sup>th</sup> Dynasty type. This year the foundation was found within the temple proper to consist of a deep bed of pure sand, and the sand was also the primary filler between the column drums. Although there was some mud mortar used, it was less evident, and this made the later removal of the drums easier. The column foundation deposit was bordered on the west side, at the same elevation, by a combination of paving stones and mud bricks that appear to have been deliberately laid to enclose the drums. All of this material was placed in the foundation DURING THE REIGN OF THUTMOSE III and not later. The name of Hatshepsut is intact everywhere, are is the names of Mut and Amun. Thus destruction by both the proscriptions of the queen by Thutmose III and that of Amun and Mut by Akhenaten are not in evidence, allowing us to date the column deposit early. Indeed, this was a means of enlarging the temple's platform width soon after its original building and should be accounted for by our architectural description of the early stone temple.

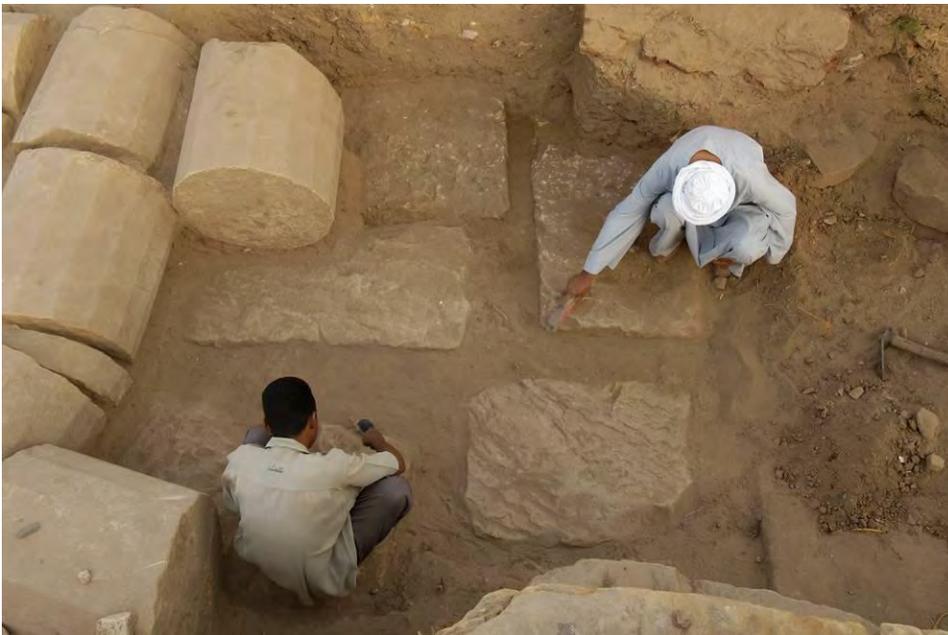
Fig. 9 Subpavement found beneath Hatshepsut column drums across west extension of the temple.

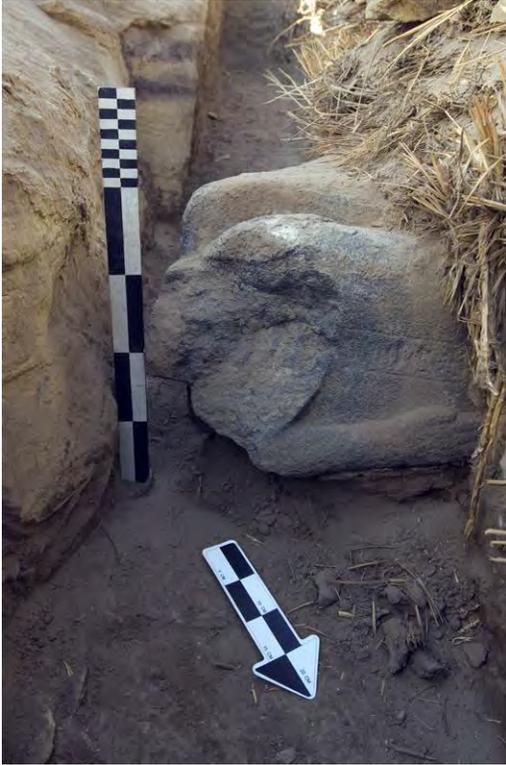
Fig. 12  
North side of porch showing mudbrick wall running  
east and west.  
View from west to east.

Mud brick walls in the north porch of the Temple. Continued investigation of the mud brick walls underlying the stone foundations of the porch and its Late Period extension have revealed a mud brick gate of the Second Intermediate Period or earlier (2006) and large mud brick walls of the Middle Kingdom and Second Intermediate Period beneath the northeast part of the porch (2006-2008). A small wall that runs east and west from the west borders the subpavement that underlay the foundations containing Hatshepsut's column drums. This wall was also found to extend westward outside the limits of the present temple porch. The subpavement does as well, and this finding will necessitate further sounding in that west corridor beside the porch during the next season. The date of this wall and the subpavement must belong to the time of Hatshepsut and Thutmose III, and everywhere that it is found it is overlying the Second Intermediate Period remains. Inside the temple porch further to the east, however, this small wall is not found, but a larger mud brick feature, at least a meter in thickness (that is all that can be seen because of the stone platform) remains along the north of the porch. This feature appears to be overlain at the east by another mud brick wall, perhaps built atop it to add to or repair it. The lowest levels are clearly associated with Second Intermediate Period pottery. This brick, along

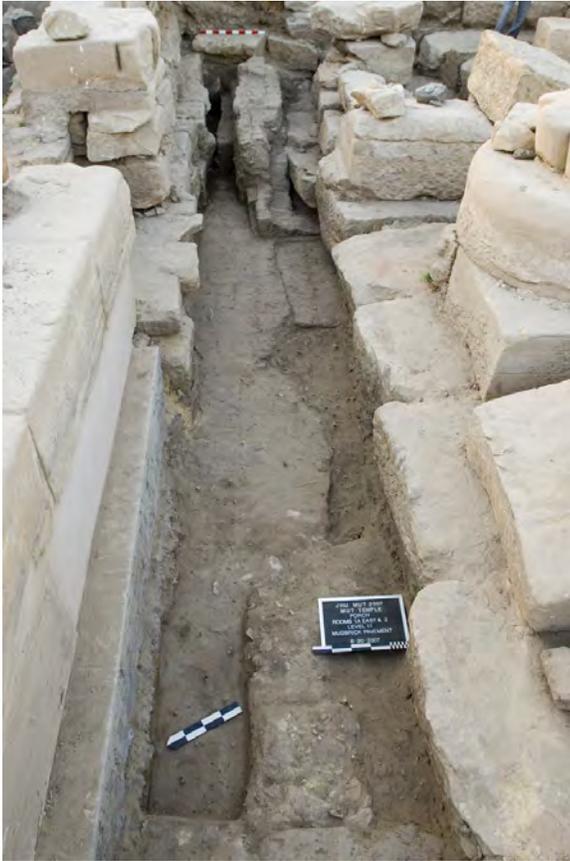
Fig. 13 Mud brick temple gate (east flank) of  
Second Intermediate Period.

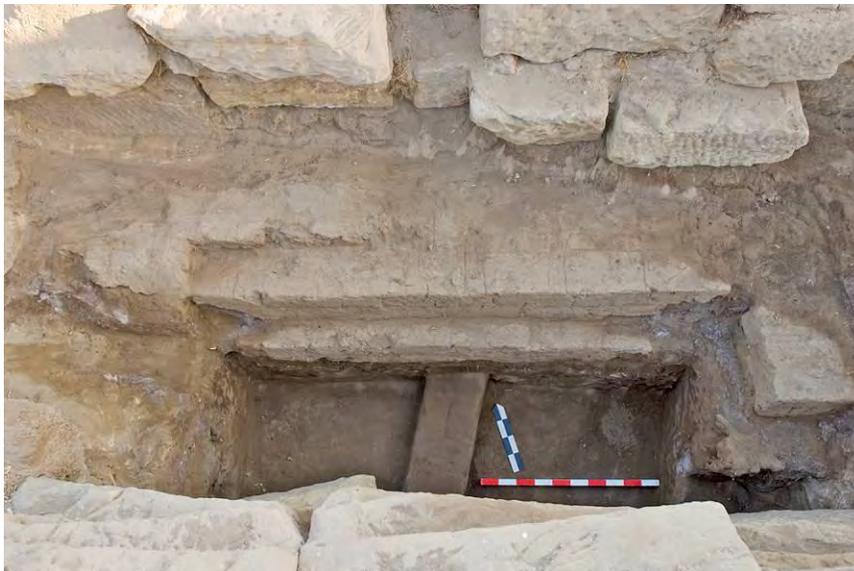
Fig. 14 Subpavement (beneath column drums) on west side behind north wall of porch. Small brick wall borders the pavement and may have been a construction wall.

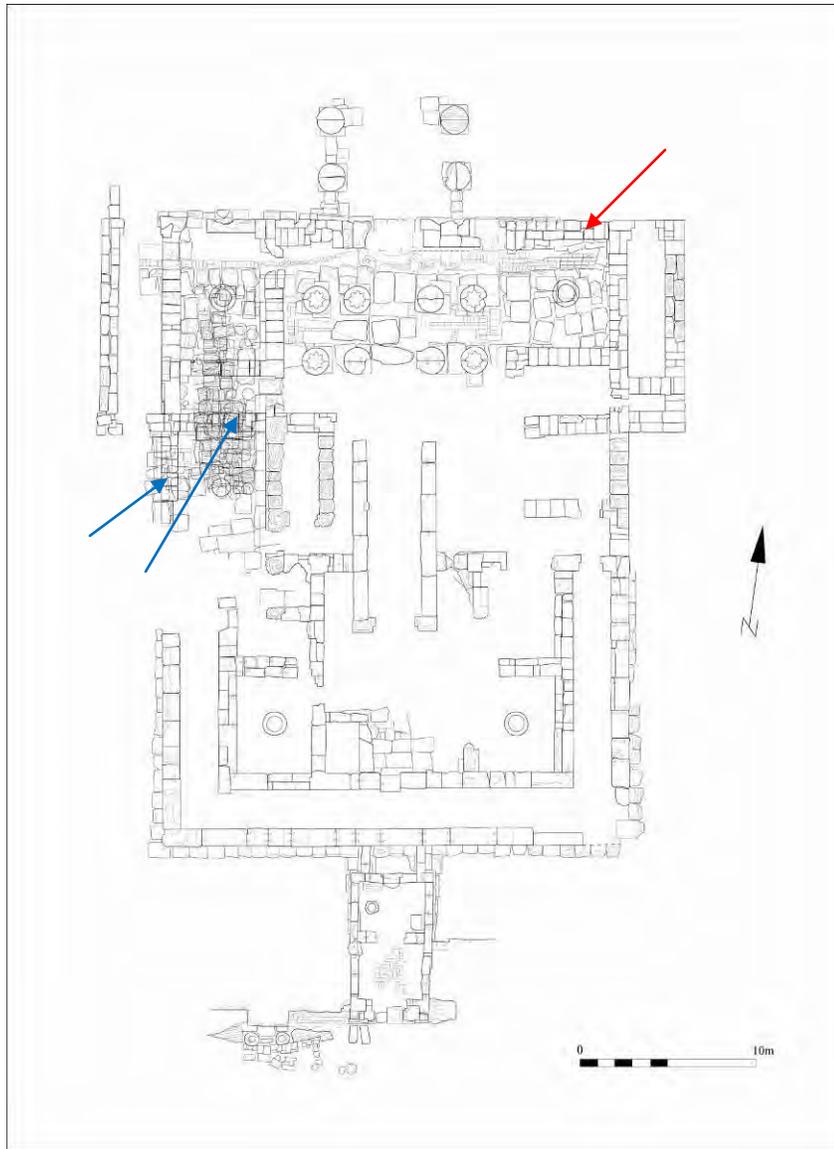
Figure 1. Mut Temple with red arrow indicating east end of North Porch. Dismantled and rebuilt 2008-09. On west are walls dismantled and now rebuilt indicated with blue arrows. Note column drums shown beneath. This is the area where the columned Porch/Hall of Drunkenness once stood.

During winter of 2008 the east end of the north porch wall (see Fig. 1) was dismantled and a number of decorated blocks were removed for conservation and restoration. The lower masonry courses of this wall were rebuilt in February and March, 2008, and the upper courses utilizing in most cases the original 25<sup>th</sup> Dynasty blocks, were replaced. The new stones that filled gaps left by deteriorated or decorated blocks were set in position, but Mr. Burgos wanted to wait to “age” those stones until after the actual wind and sand from the environment had cured the stone somewhat. He instead turned his attention to the west walls that had been dismantled in 2007. Upon further inspection of this area, Mr. Burgos determined that the subsidence of the foundations was even more severe than he had originally recognized, and the rebuilding would require additional expert masons to be carried out along with the remainder of the work. He therefore requested that we wait until the next winter season and bring in additional stone masons. That brings the project to the beginning of January 2009 and Phase 2.

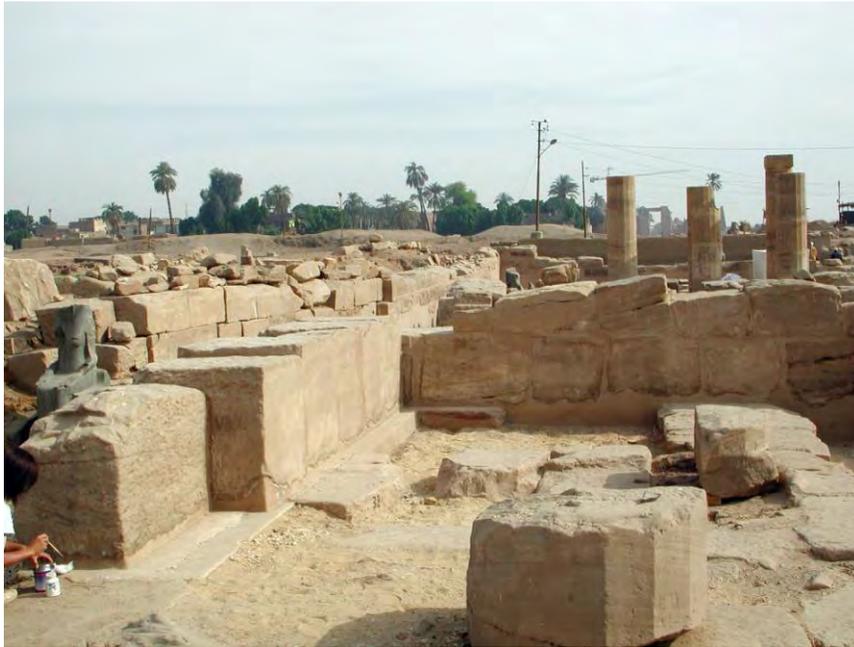
Figure 2. West and north walls of Temple rebuilt, April 2009.

The work on the west walls was accomplished in March 2009 (Fig. 2), after which all three experts worked on the columns due to the demands of this work. Two concrete pads were built to house the columns, (Fig. 3) and two shipments of newly quarried sandstone from Gebel Silsila arrived at the precinct. The large blocks were trimmed outside the main gate of the Temple, and the stone was fork-lifted one block at a time into the First Court. In the Court M. Chini and M. Lecocq cut the stone into column drums according to specifications determined by Dr. Bryan and Mr. Burgos. The drums completed the gaps in the columns, estimated to be about 30-40 %. There are twelve columns (Fig. 4), and therefore the masons worked this stone into actual drums of the same type as the originals. Figs. 5-6 show examples of this work. There were some columns from which only a small amount of inscription has been retrieved. If that inscription derives from the lower part of the column, then only the lower portion of a column has been reconstituted. If the text, however, is from the top part, the entire column below was recreated. A few column parts were not placed in the reconstructed columns, but I intend to place them later, because we now are sure of their original settings. The columns were set on the two pads in two rows of three to the east and west of the central temple aisle. Those columns with inscriptions facing right were placed on the east (left) and those with text facing left on the west. All were placed with the inscription facing north, i.e., toward a person entering the temple. This is the decision despite our lack of information as to the original orientation of the inscriptions. We believe now that the porch stood on the west side of the earlier mud brick temple that stood until Hatshepsut herself built a stone one atop it. Thus she dismantled her own columned “hall/porch of drunkenness”. We cannot erect it where it originally stood and thus placed it so that it forms an elegant entrance to the Mut Temple. This work was completed in April 2009 (see below).

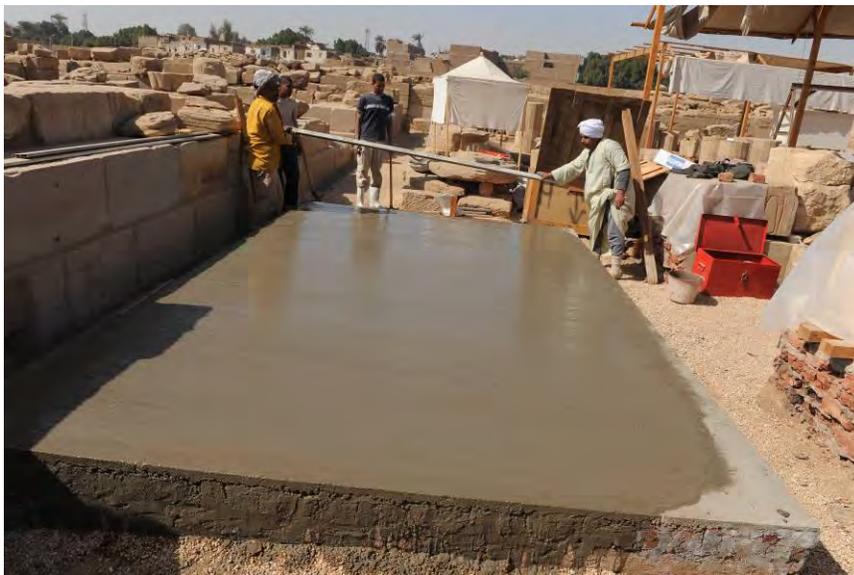
Fig. 3. Eastern cement pad built to hold columns of the Porch of Drunkenness, in front of the east façade of the Mut Temple Porch.

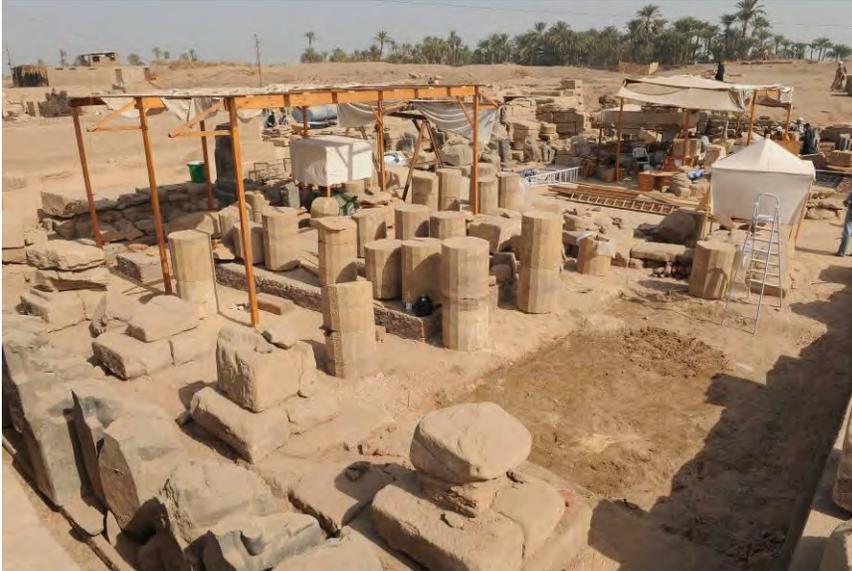
Fig. 4. West side of the Court showing columns and the second cement pad area being laid out on January 25, 2009.

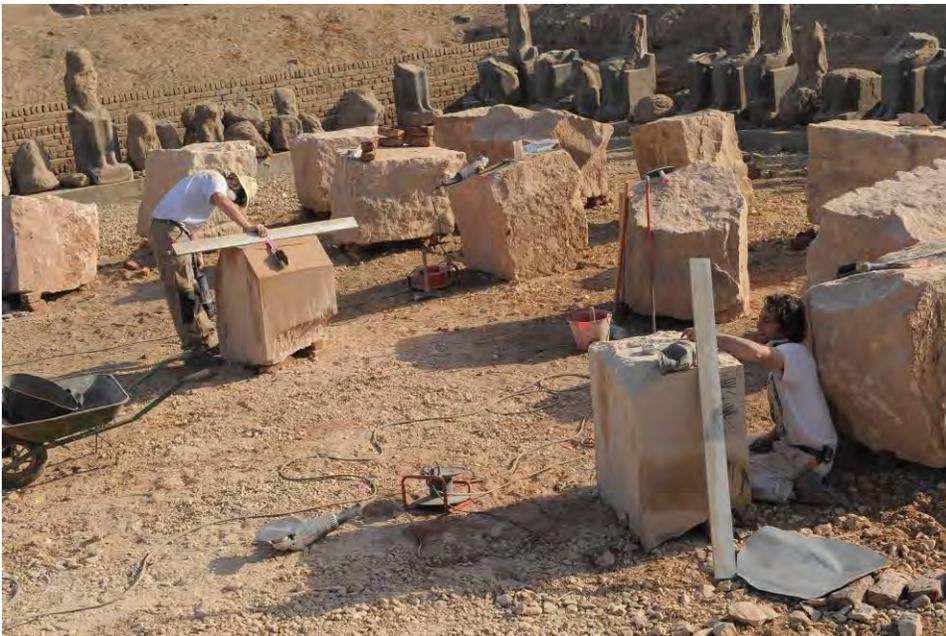
Fig. 5. Laurent and Christophe cutting new sandstone into column drums.

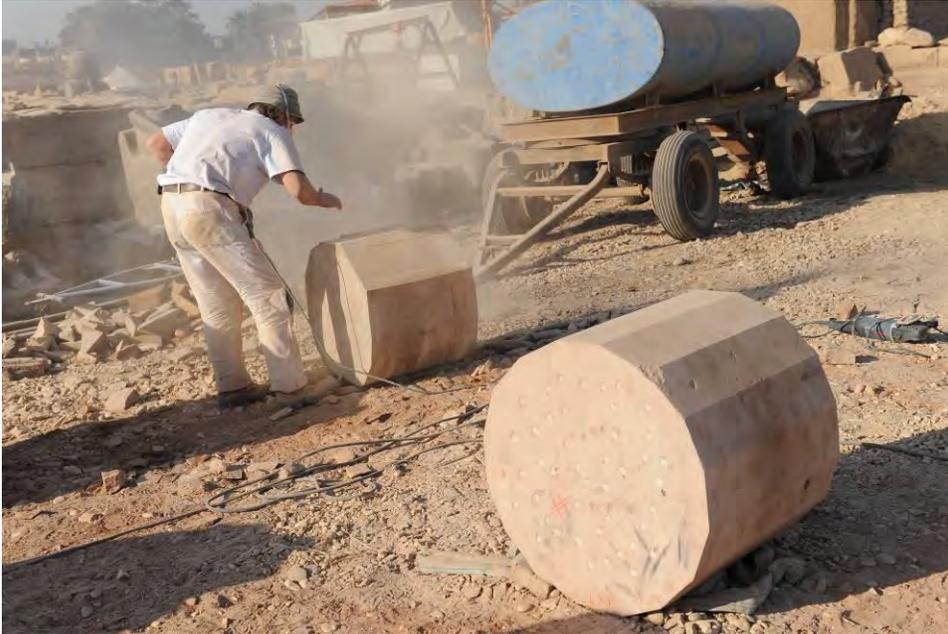
Fig. 6. A complete new column drum and Laurent working on another.

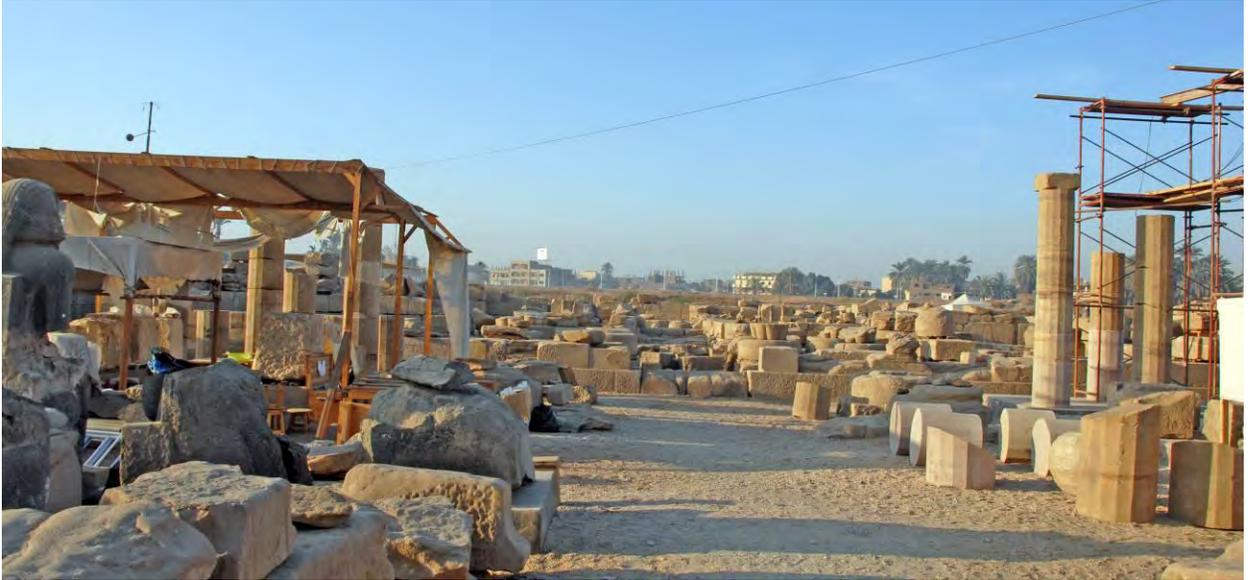
Figure 10. Columns of the Porch of Drunkenness during reconstruction, March 2, 2009

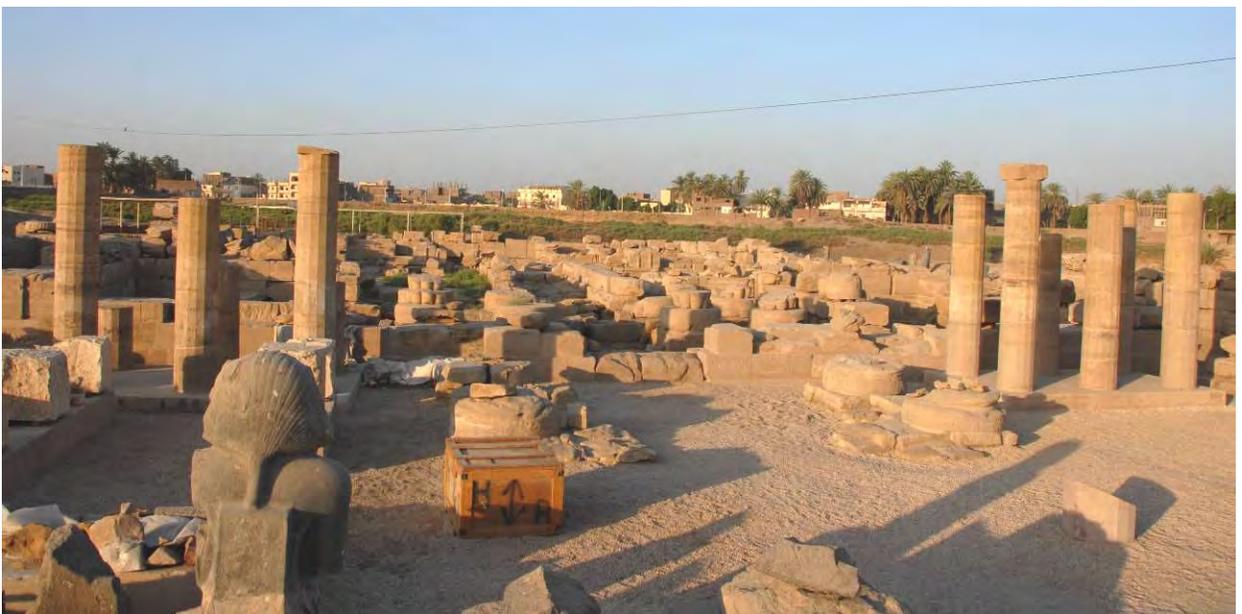
Figure 11. Columns in the Second Court, completed May 2009

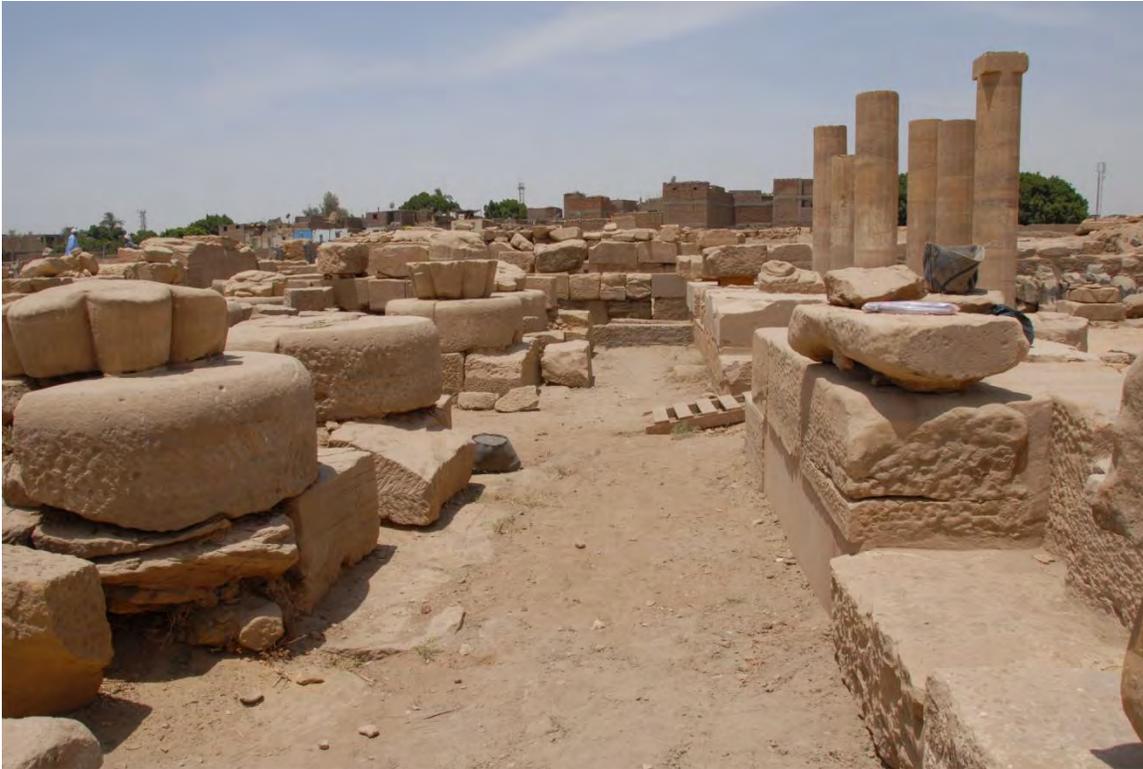
Figure 13 shows the temple in late April 2010 as cleaning work was beginning again, including refilling the floor of the porch atop the mud brick walls found there in 2006-08. A small amount was accomplished in February of this year. Figure 14 is of the same area during excavation in 2007, and the amount of fill that was put in can be deduced from comparing

Figure 13. Mut Porch looking west during refilling of excavation area. 28-04-2010

them. It was decided this year not to bring the floor up to the level at the time excavation began in 2006, so as to allow the construction methods in the porch to be somewhat visible.

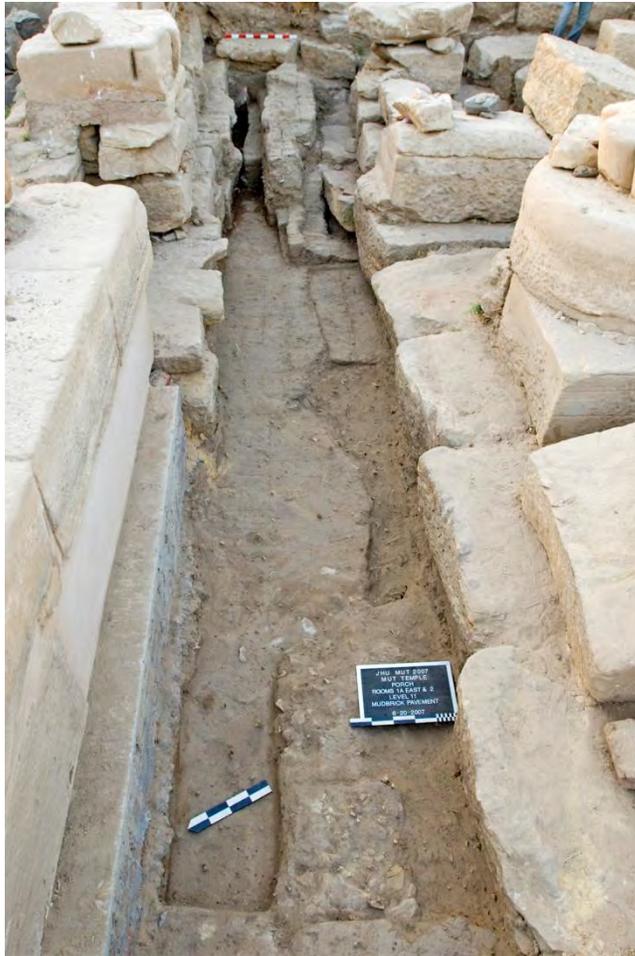
Figure 14. Mut Porch 2007 during mud brick wall excavation

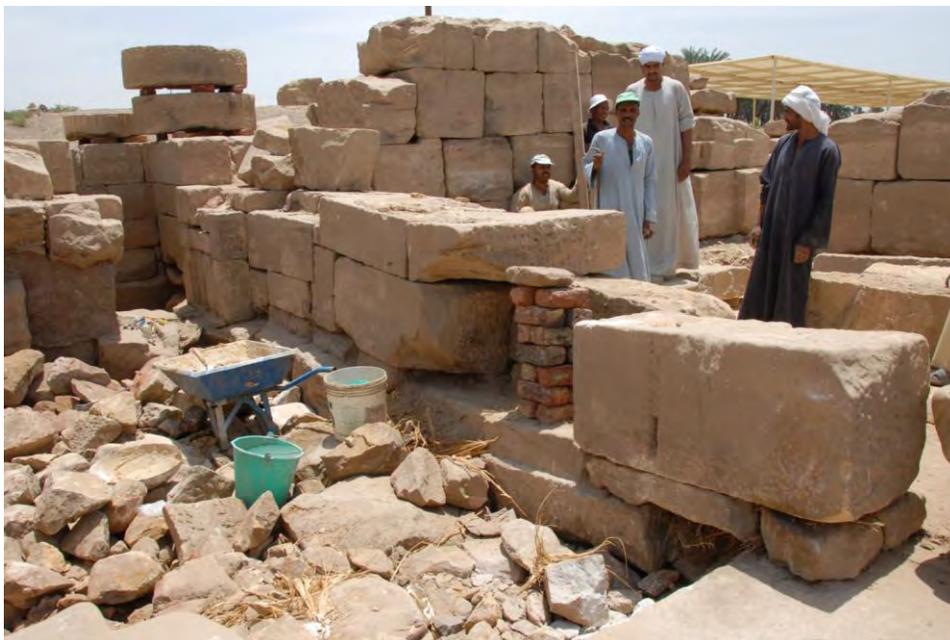
Figure 15. East side of Temple during floor leveling and before wall and masonry repairs. 04-2010

The floor areas had not been excavated in the area shown by Figure 15, but the unevenness was significant, and the decision was made to build the floors from stone rubble and redim, topped by clean sand and then gravel. All of this is easily reversible if further investigation is desired in the future. This same method of filling was used in the central area of the temple and on the west side of the porch. The remainder of the porch was filled with redim, sand, and gravel only, in order to protect the mud brick features found during the excavation of the area.

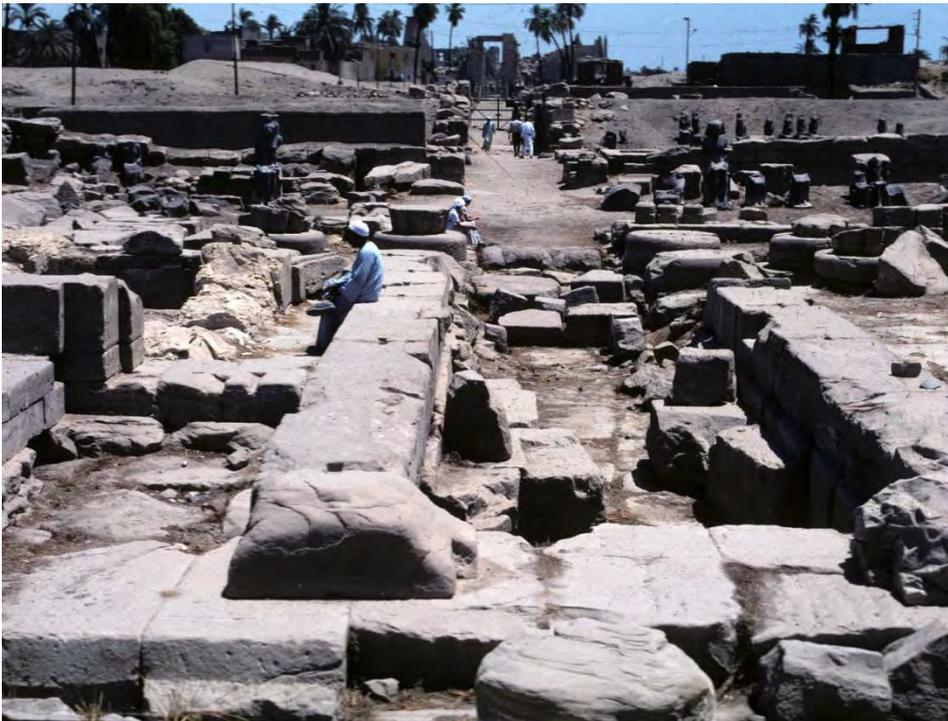
Figure 16. 2003

Figure 16 was a photo taken from the rear of the temple in 2003 and illustrates how uneven the floors were, even before excavation of the porch area took place. In order to open the temple to visitors, it was decided to even them to protect both the temple's fragile fragmentary remains and the tourists who might have difficulty walking. Figure 17 shows the same area now that the floors have been leveled, and both sand and gravel have been placed atop.

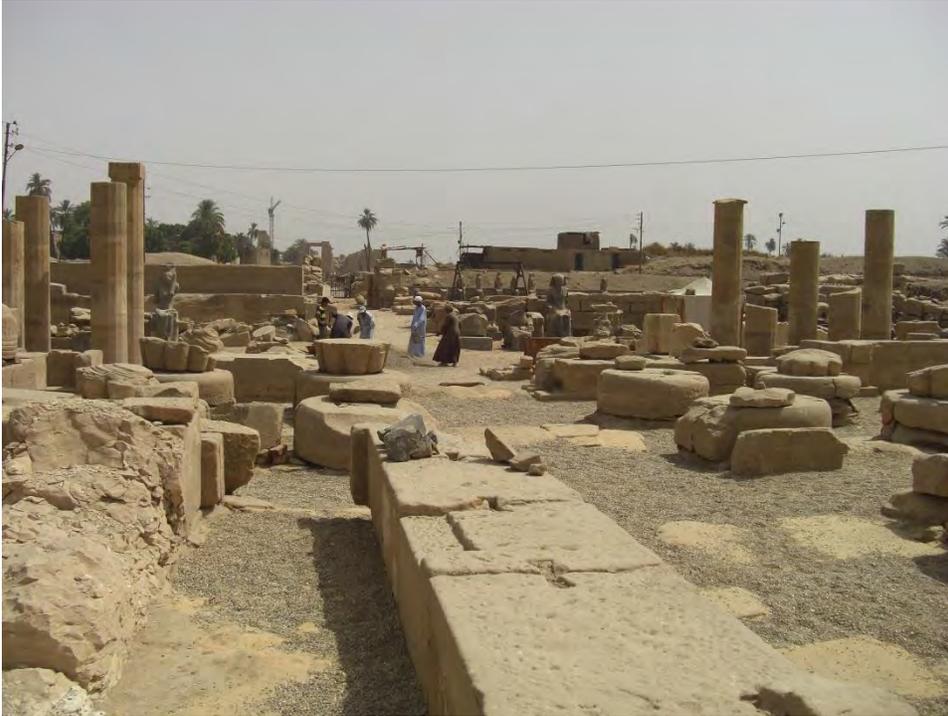
Figure 17. View from central shrine looking north after placement of gravel. 17-05-2010

In May 2010 the porch and temple were leveled with sand, after which gravel was placed as a surface. Walls were repaired. Figures 18-19 show the porch and temple during this process.

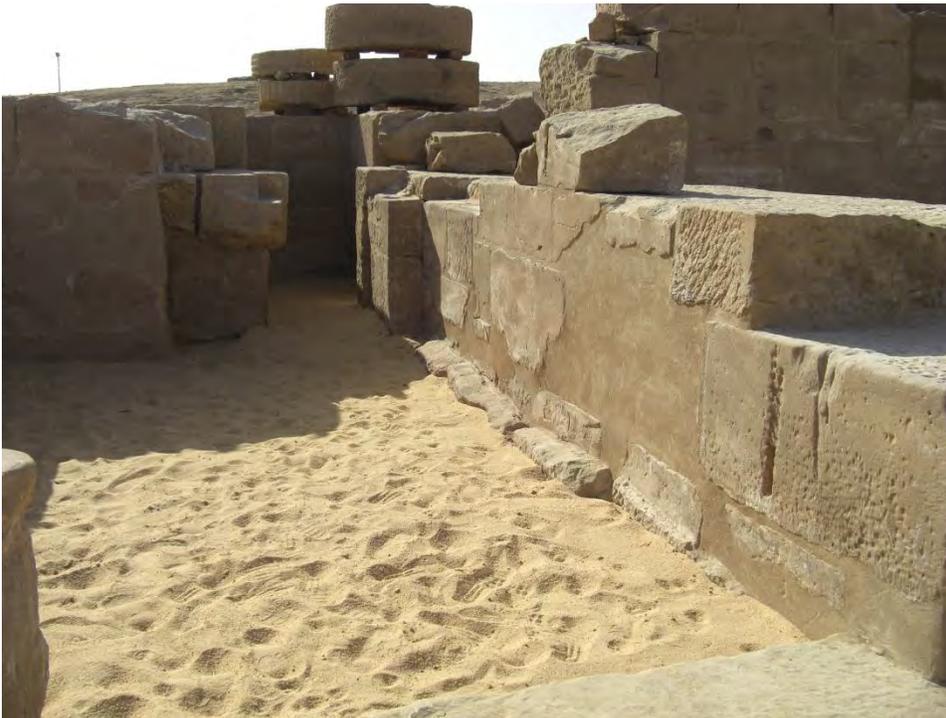
Figure 19. The area shown in Figure 15 on the east side after floor leveling and repair of walls. May 15, 2010.

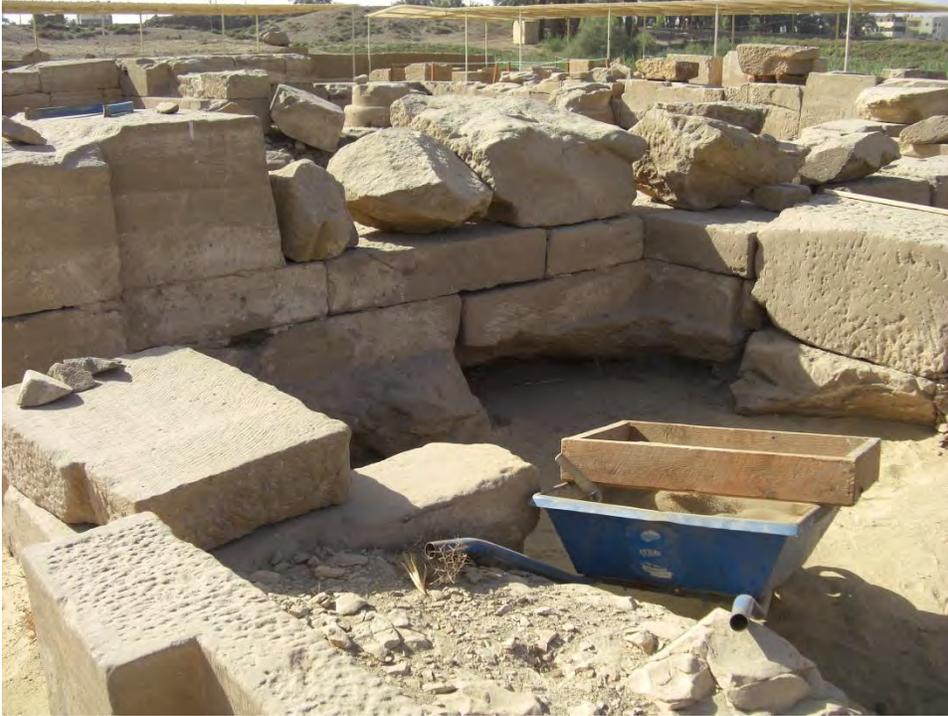
Figure 20. West side of temple showing wall repairs beginning. May 15, 2010.

Repair to lower wall areas was also done on the west side of the temple, in the area abutting the central sanctuary. Figures 20-21 show this work in progress; 22-23 completed.

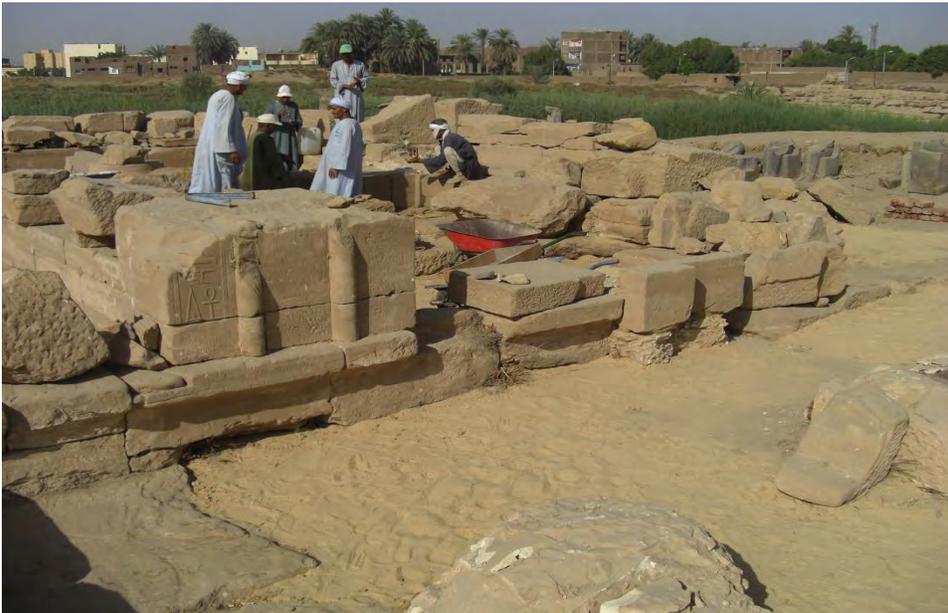
Figure 21. West side of temple showing masonry repair underway. May 15, 2010.

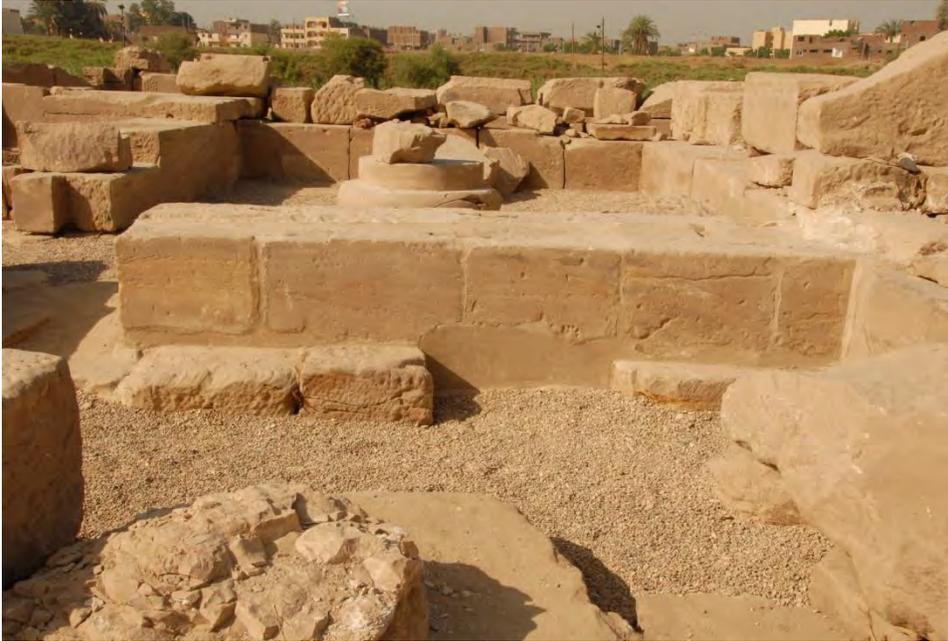
Figure 22. Repaired walls on east side of temple. 25-05-2010

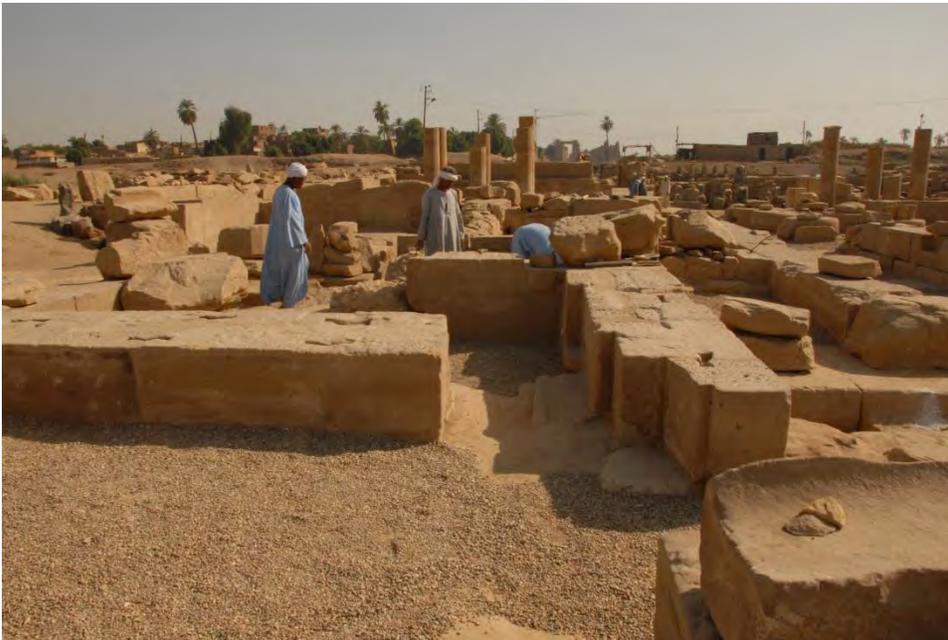
Figure 23. Walls on east straightened and patched.

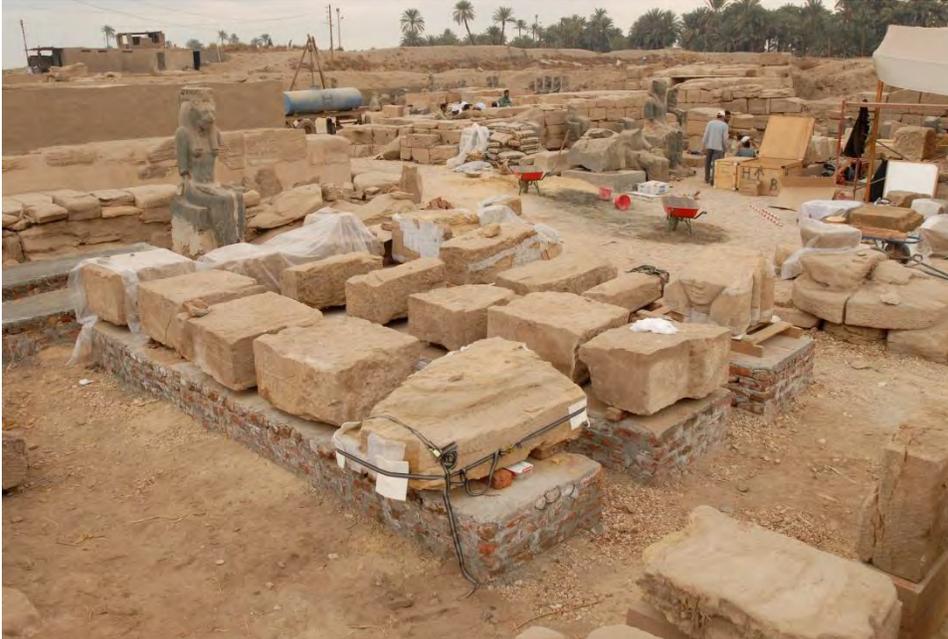
Figure 24. Second Court in 2006 after dismantling of north porch wall.

The Second Court was used as a storage area for newly found reused blocks during the dismantling and restoration of the porch walls from 2004-2008. Figure 24 shows the west side of the court full of mastabas holding the New Kingdom temple blocks retrieved from the porch.

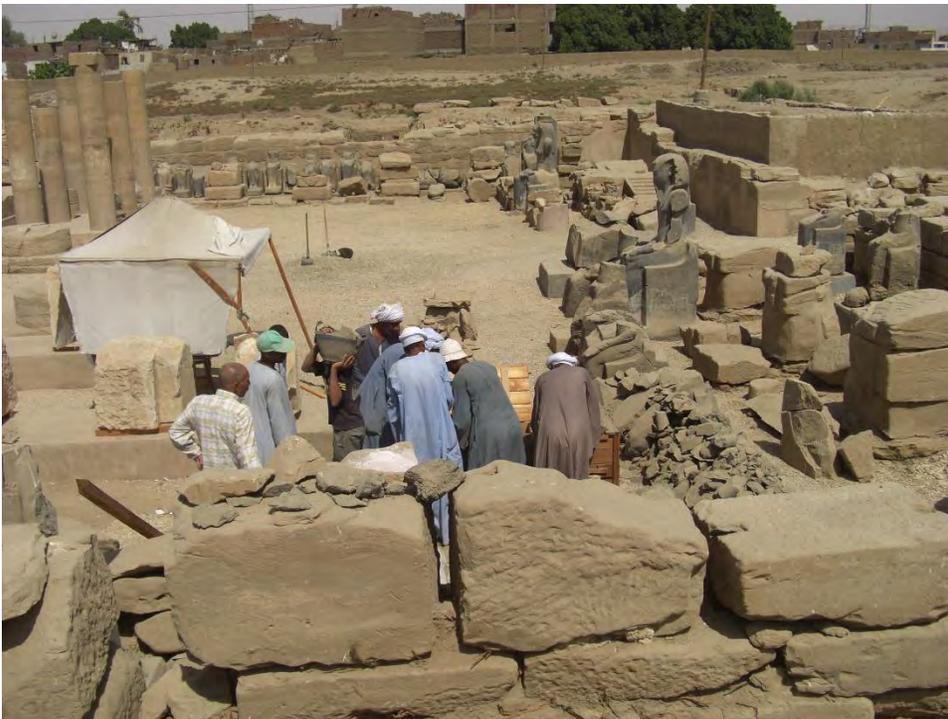
Figure 27. Transfer of small granite Sakhmet fragments from the Second Court to a new space on the wall to the east.

In addition to removing all mastabas, save those with Sakhmets and the blocks of the limestone gate of Hatshepsut (to be reconstructed in winter 2011), small fragments of the Sakhmet statues and other stone relief held in wood boxes, were moved from the court. A walled area was created on the east enclosure wall and was designed to be large enough also to allow sorting of the fragments. The boxes and stones were first moved up; then the wall was constructed.
