# FINAL REPORT

ARCE Groundwater Lowering Response Project, Luxor

“Mut Temple Foundations”

Betsy M. Bryan

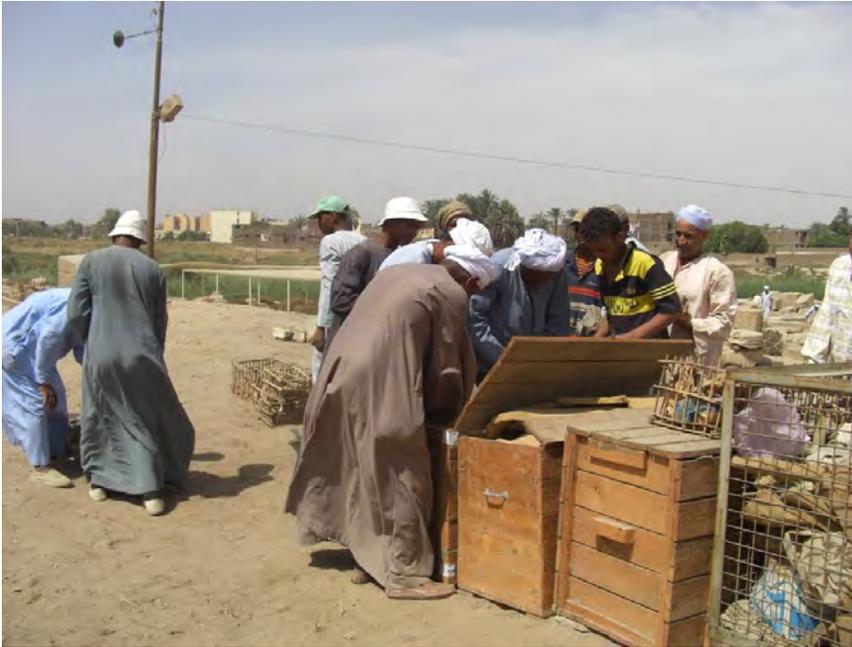
Figure 28. Boxes containing granite fragments moved to top of east wall.

In addition to removing all mastabas, save those with Sakhmets and the blocks of the limestone gate of Hatshepsut (to be reconstructed in winter 2011), small fragments of the Sakhmet statues and other stone relief held in wood boxes, were moved from the court. A walled area was created on the east enclosure wall and was designed to be large enough also to allow sorting of the fragments. The boxes and stones were first moved up; then the wall was constructed.

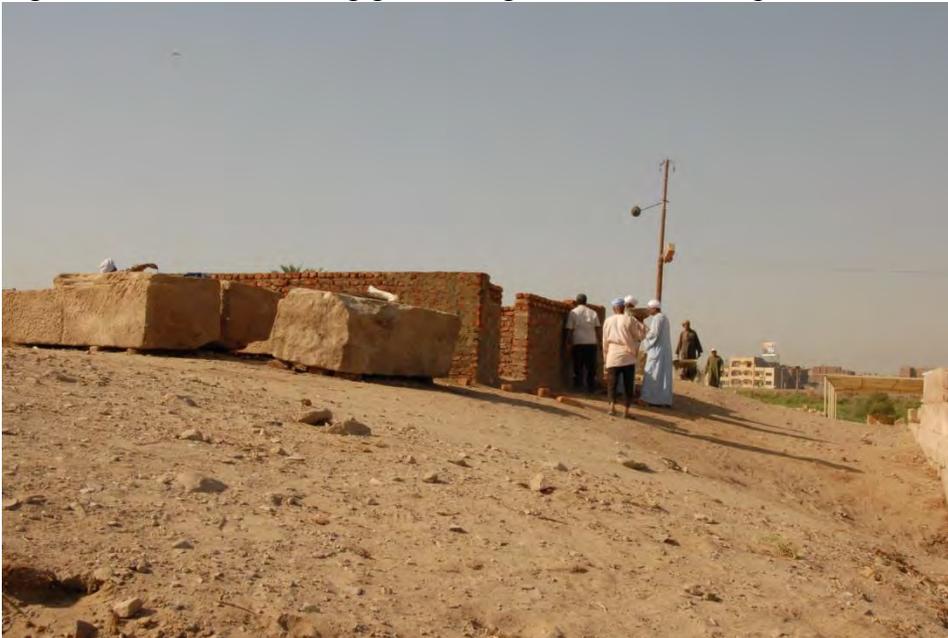
Figure 29. A walled area was created around the boxes of stone fragments.

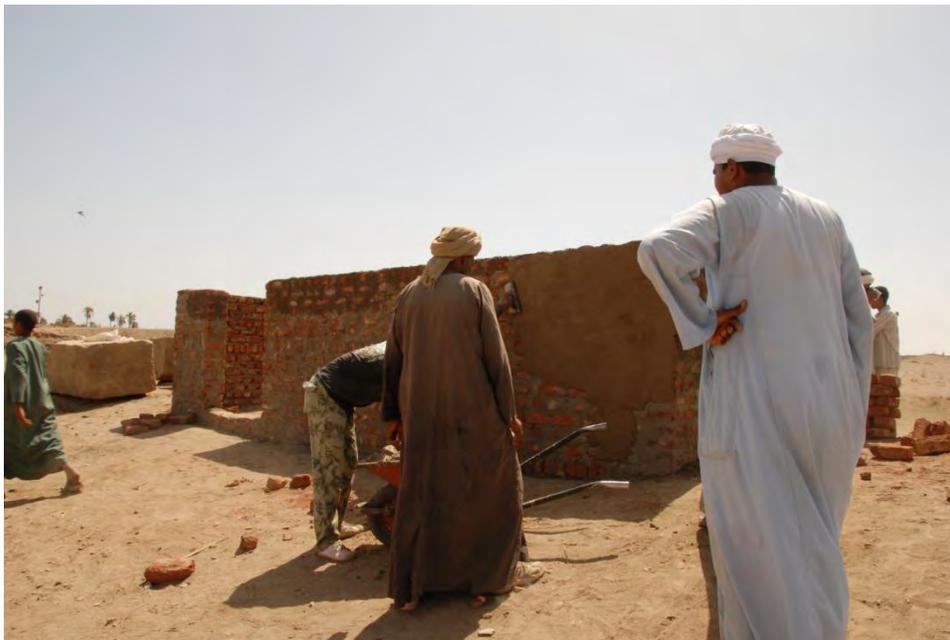
Figure 30. Applying muna plaster to walled area.

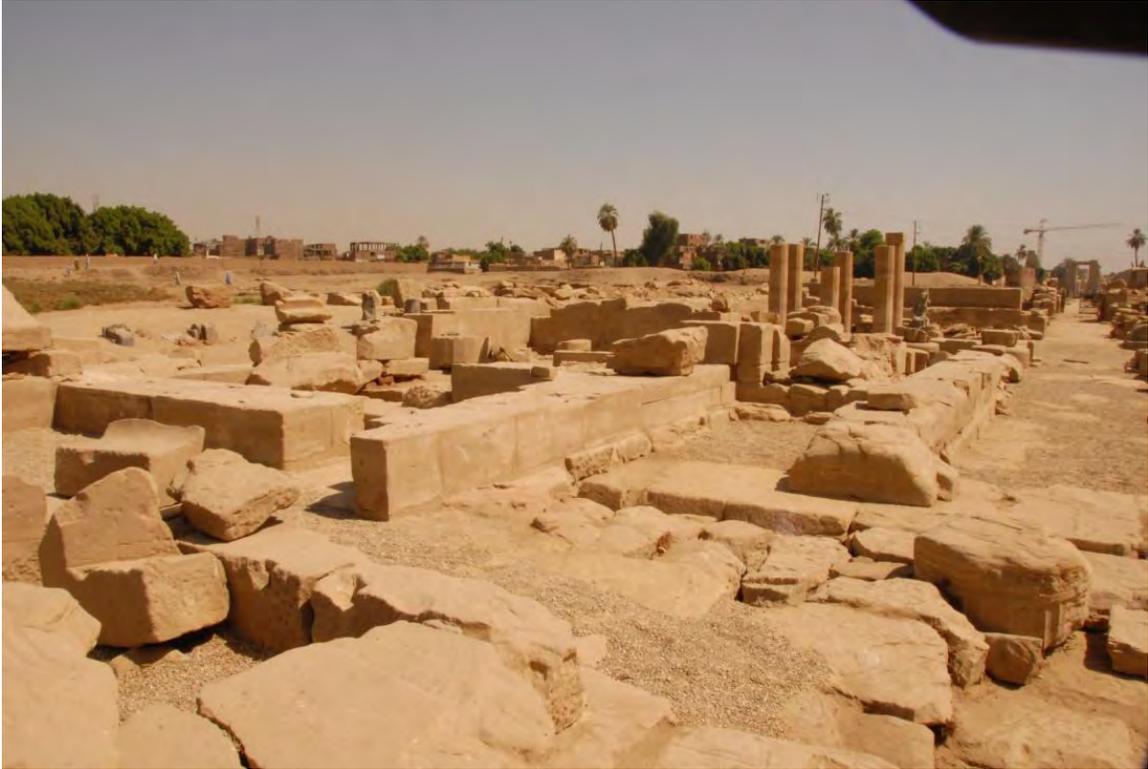
Figure 31. View from south looking north showing repaired east walls and level floors.

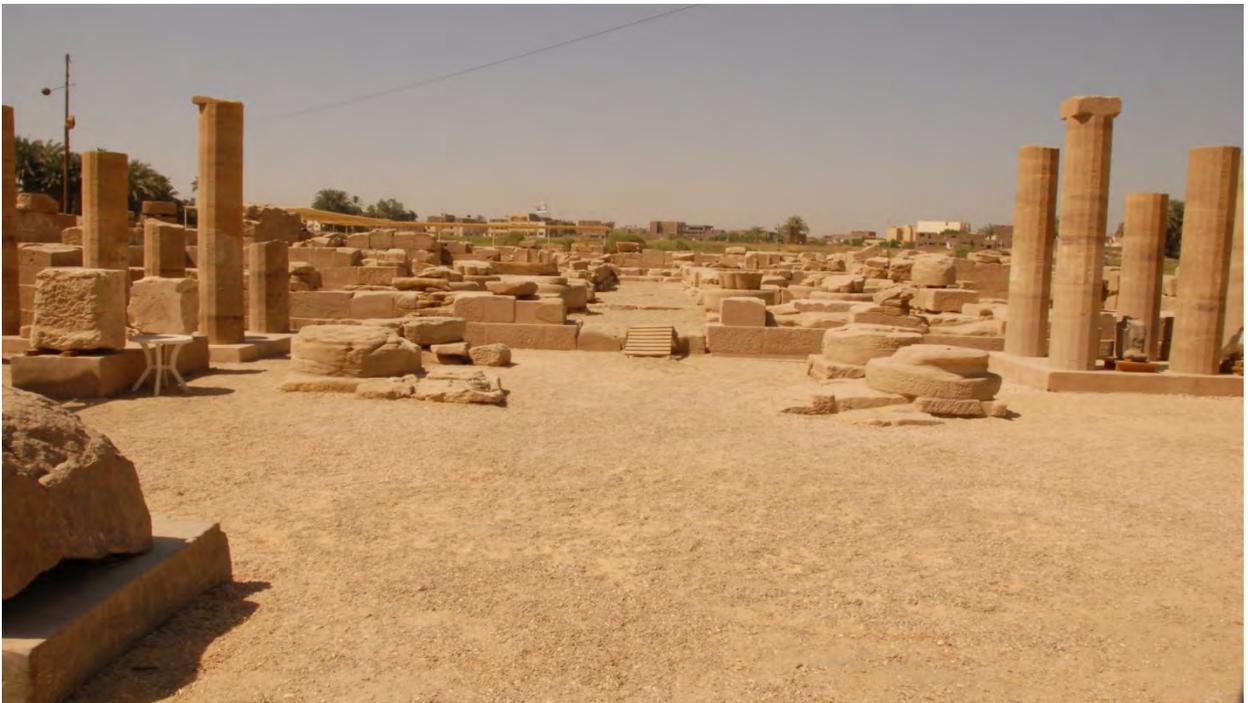
Figure 32. View of temple from Second Pylon showing completed work. 30-05-2010

The temple as of June 1, 2010 is ready for a site management plan to be put into action. Signage will be composed and created for the area. We will be working on that in the next weeks to be submitted for SCA approval. Figures 31-33 show the temple concession of JHU with cleaning finished.

With the exception of the limestone blocks of the gate of Hatshepsut and Thutmose III seen, in part, on the mastaba at left, the only mastabas left in the Second Court hold the original Sakhmet statues found in the Court. A view of the Court in 2003 before work began shows both the difference in the rebuilt porch wall (visible behind the columns in Figure 32) and the newly restored open space.

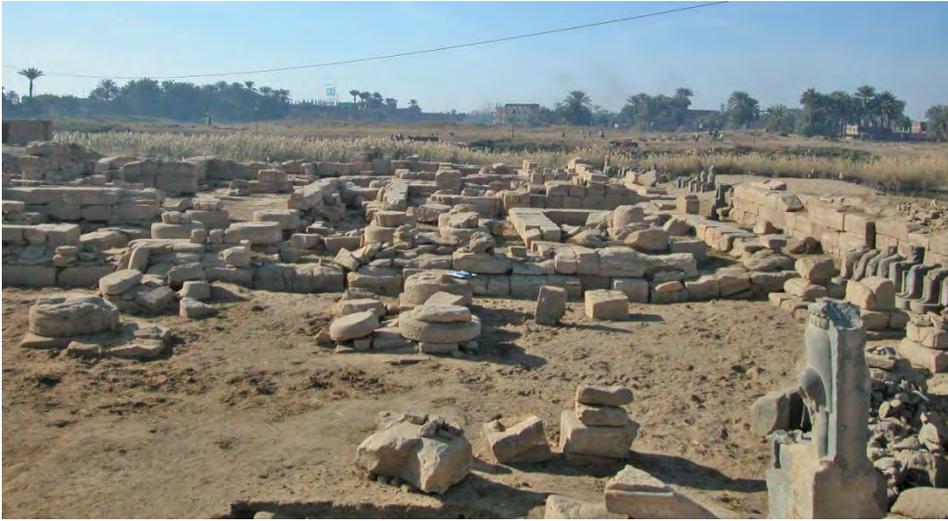
Figure 33. View of Second Court looking south in 2003 before restoration began.

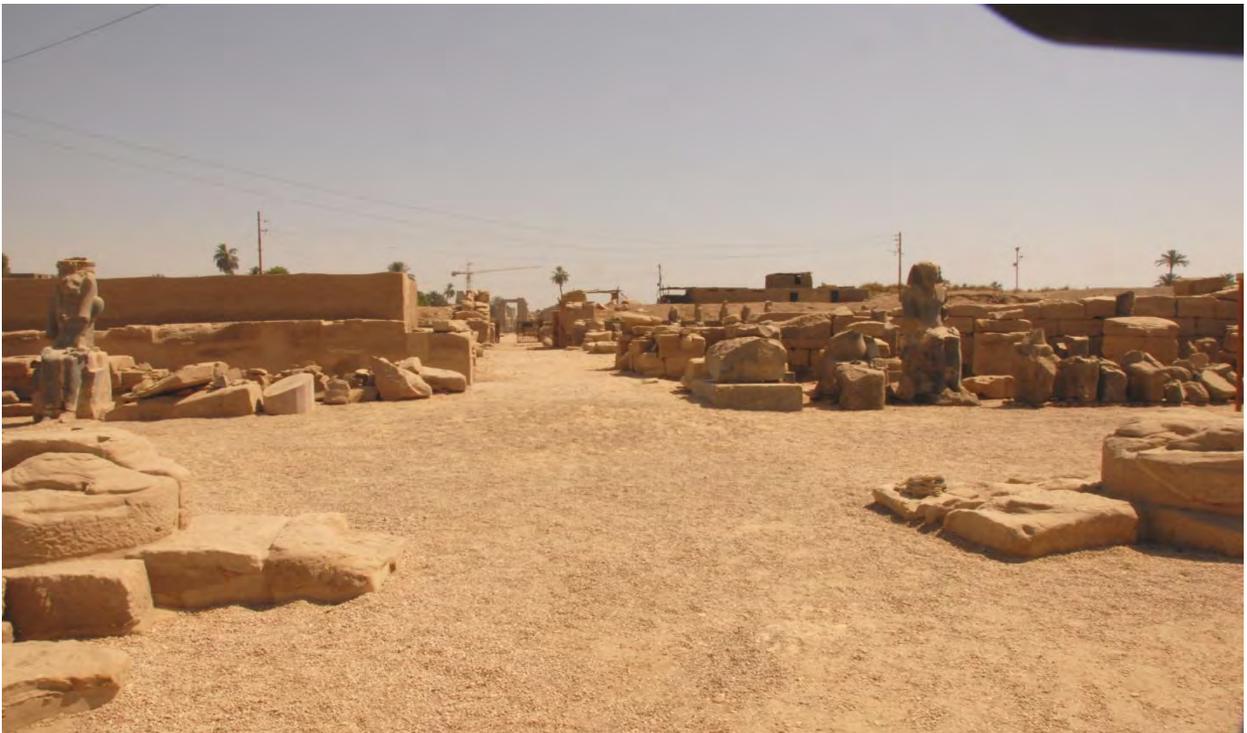
Figure 34. View of Second Court from temple porch showing result of removing mastabas and small stones.
