### Environmental Impact Assessment Approval Sheet

**Project Name:** Municipal Infrastructure Rehabilitation Project, Roads Rehabilitation

Environmental Impact Assessment Addendum

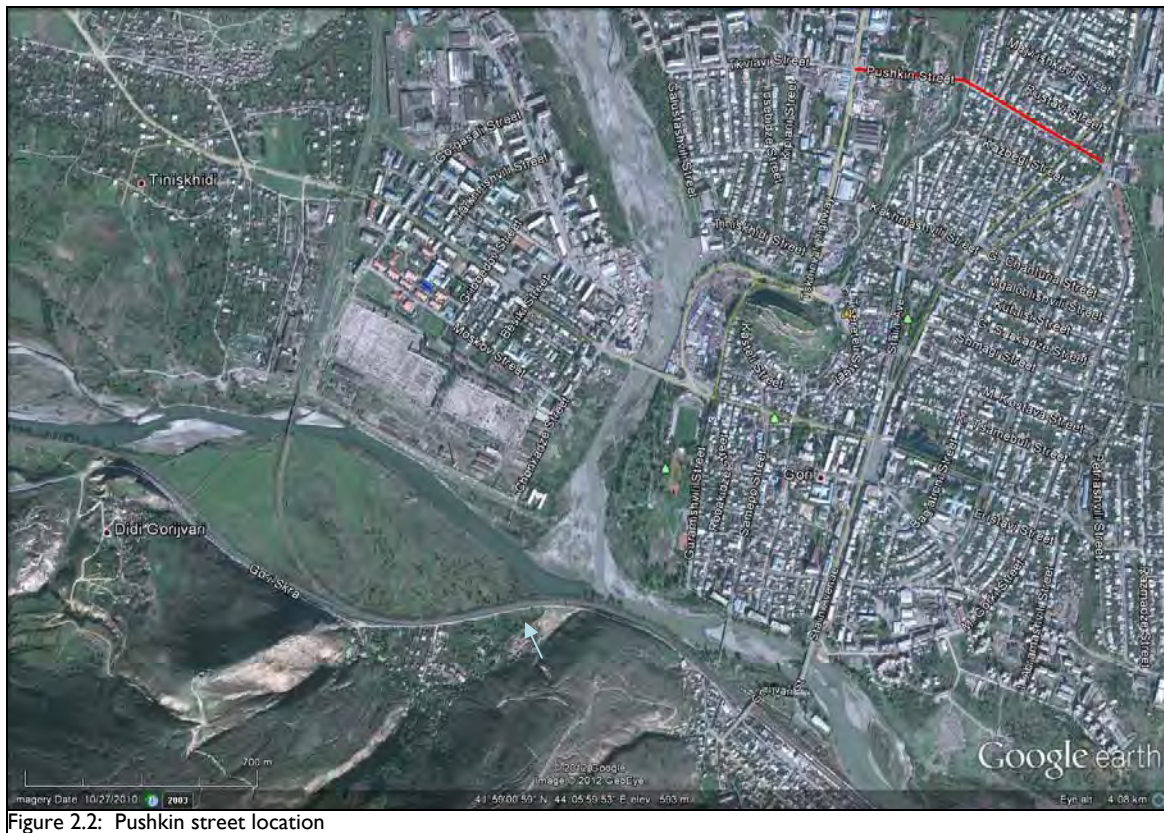
Figure 2.2: Pushkin street location

- **Pushkin Street in Gori Municipality:** The length of this rehabilitation project is 915 m. The existing roadbed (12 – 20 m wide) is in satisfactory condition, but the roadway pavement (7.9 – 10.5 m wide) has various kinds of damage, waves, small and large pits, linear and lateral cracks and poor slopes. The existing reinforced-concrete bridge is in good condition, but there is some damage where the bridge connects to the roadway. Existing drainage pipe is in good shape but some additional pipe is needed. Also, new concrete curbs are needed and sidewalks need to be raised and replaced, including new stairs. This project involves Road Improvement Type IV. The damaged roadway will be milled totally and rehabilitated with two layers of asphalt-concrete pavement. The location of Pushkin Street is shown in Figure 2.2.

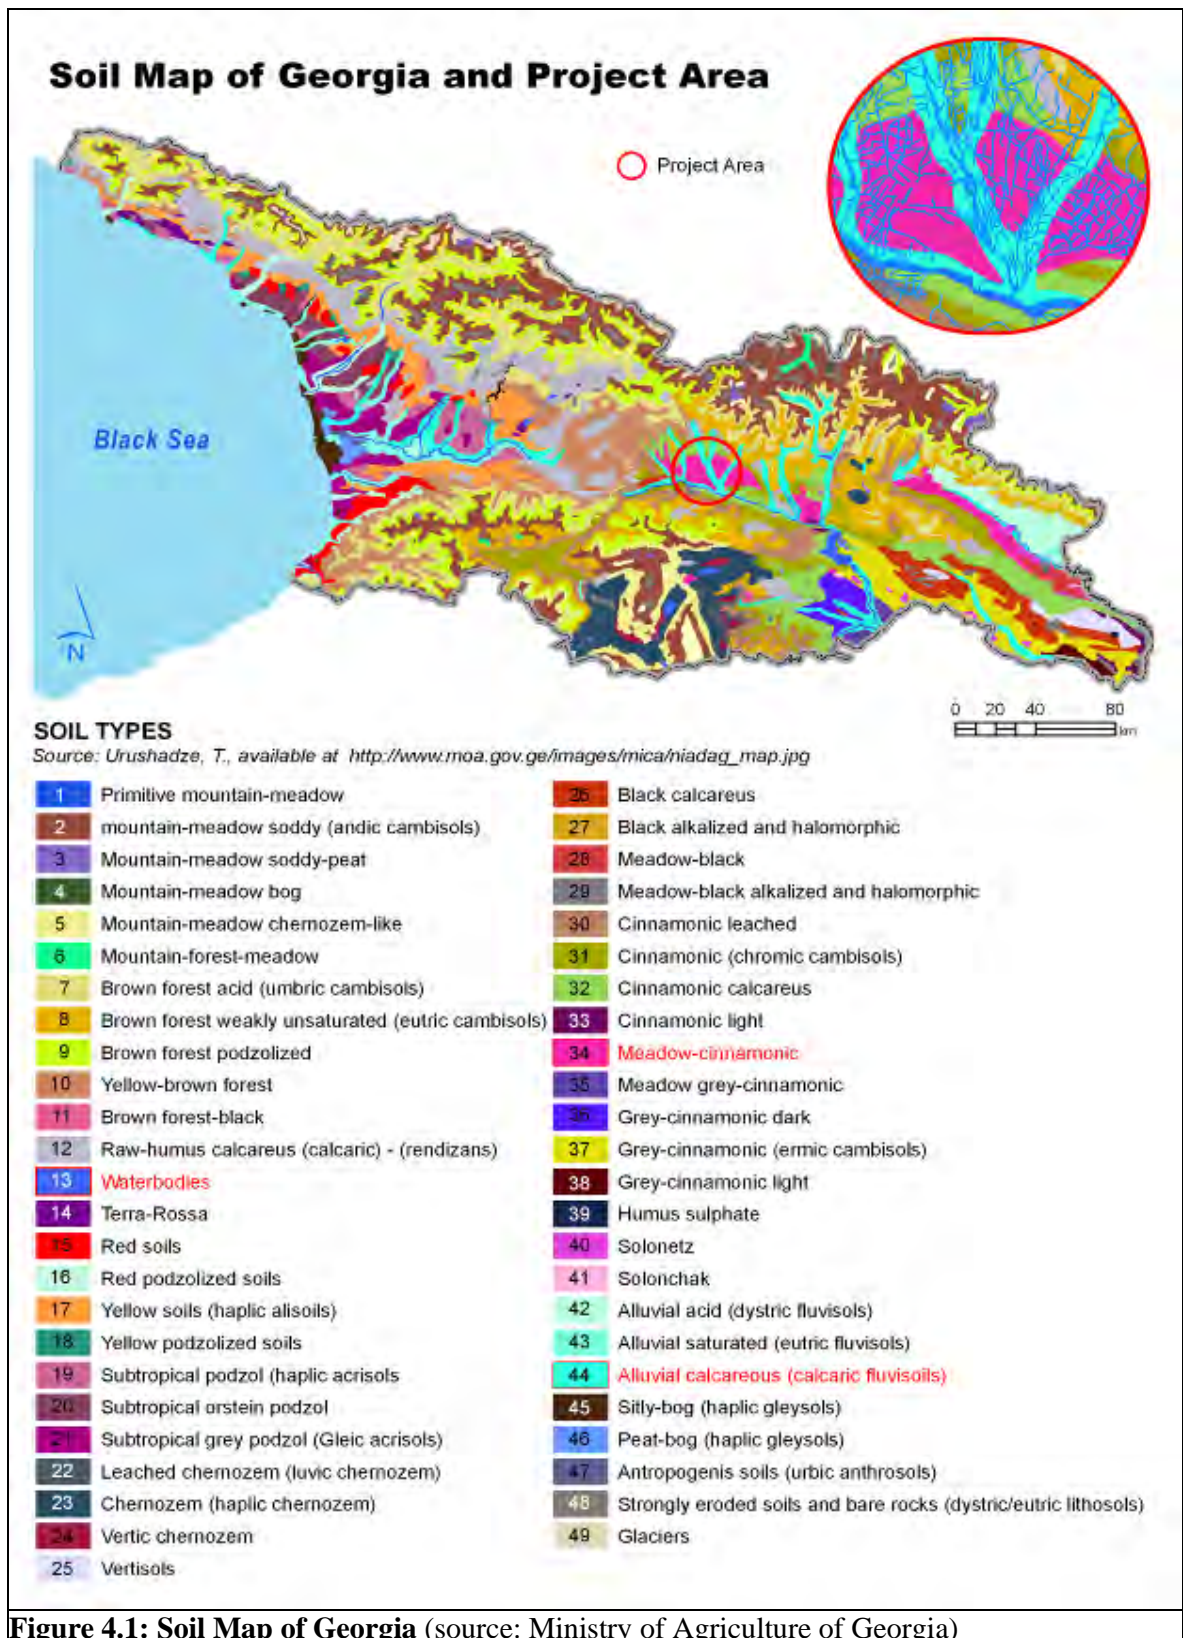
**Figure 4.1: Soil Map of Georgia** (source: Ministry of Agriculture of Georgia)

The soils in the Gori project area are thought to have normal soil erosion activities with average sediment transport behavior. Their normal erosion/transport behavior is influenced by the soil consistency and content of yellow clay, macro-porous/rough particle sand, crushed rock and pebbles, break-stone and conglomerates.

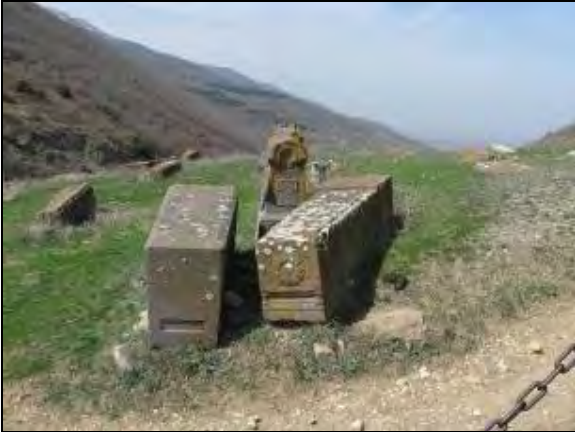
| Tombs from graves | Georgian Mkhedruli encryption |

Gorijvari Road ends at Gorijvari Monastery. During rehabilitation of Gorijvari Road, mitigations should insure protection of ruins of medieval settlements, the old fortification stone fence, damaged graves and family vaults, old clay pipeline fragments and churches/monastery. Road grading and excavation should not disturb these resources. If

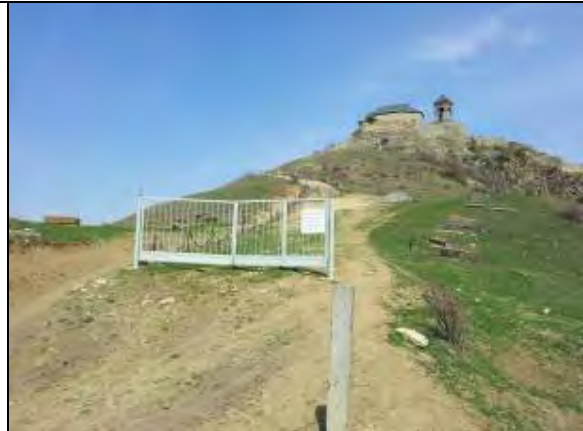
End point of the road to Gorijvari. Land cover shows signs of erosion despite very small 'catchment' of the concrete trail to the Church.

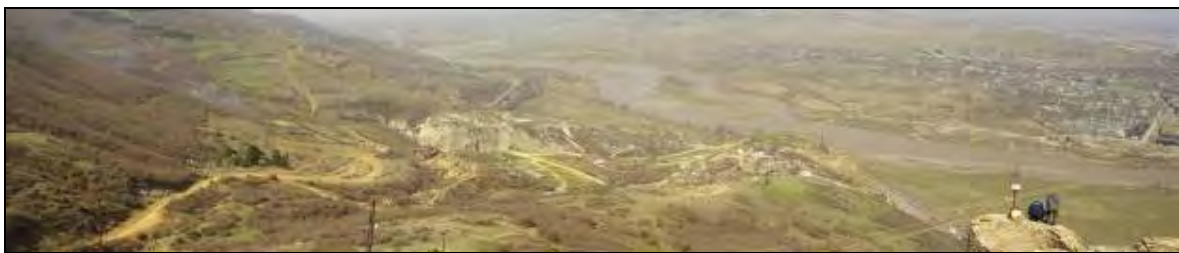
Scars in the landscape are essentially the Gorijvari road. Erosion is significant across the entire section and locals inform (and is evident from site inspection), that downhill movement of the water during storm events should be a significant factor in completing the road design.

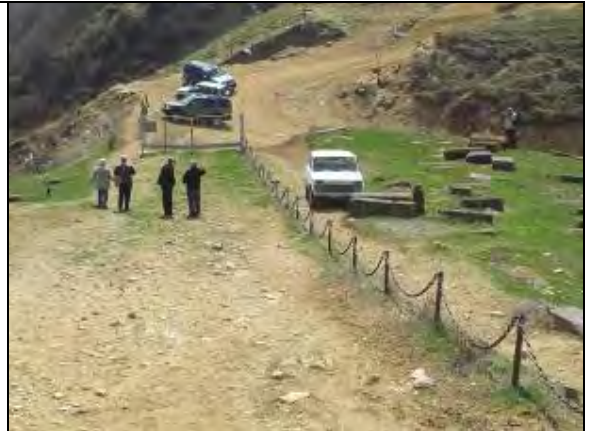
Cars should be blocked from accessing the cemetery. No excavations allowed between two separated sections of the old cemetery.

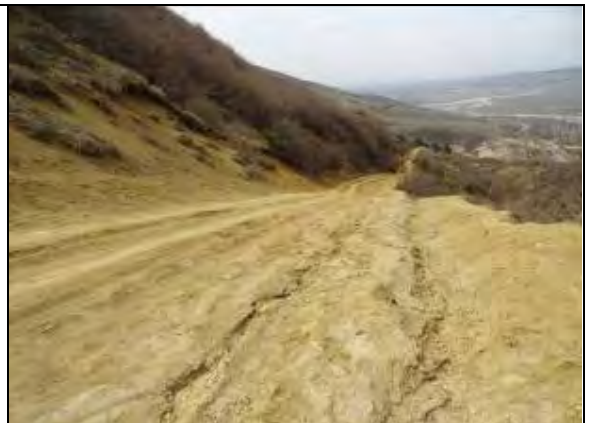
Erosion is a typical pattern all along the route.

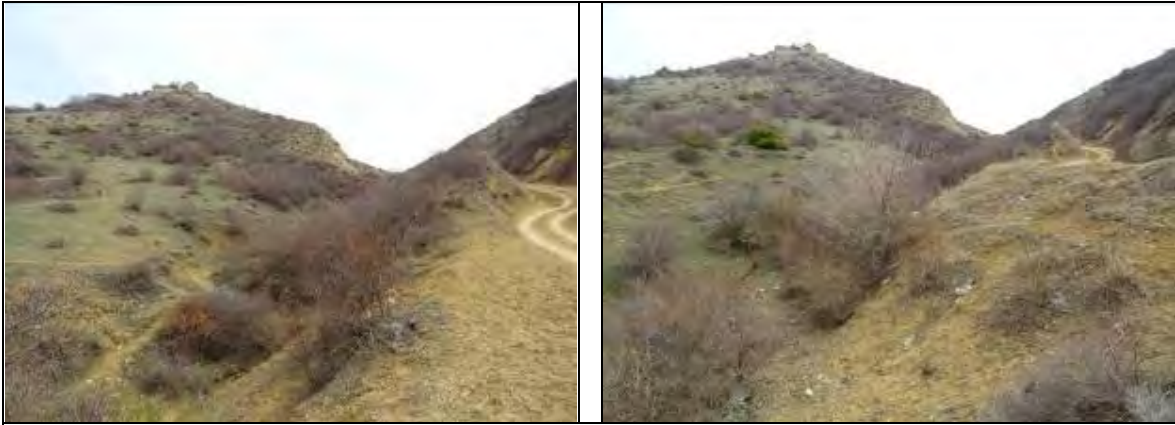
This natural drainage shape should be maintained with due erosion control to divert excess water

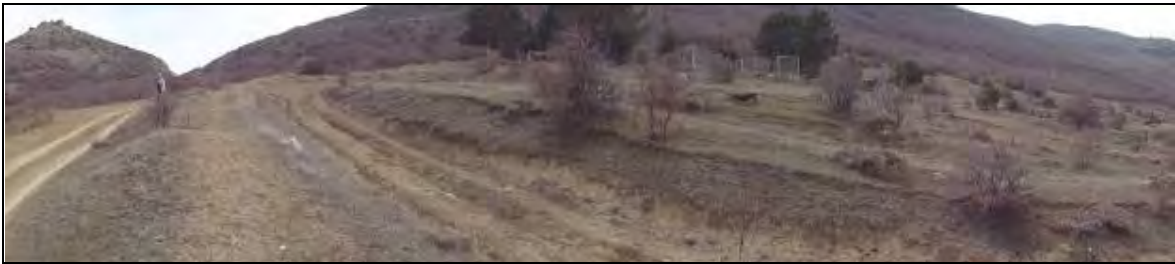
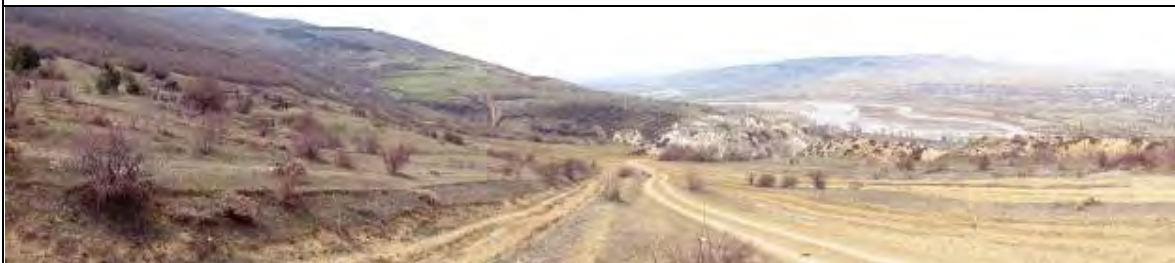
Upward and downward panoramas show severe erosion due to vehicle movement damage in the middle section of the road (see steep slope 2 mark on the Figure 1). All damaged area outside the road route should be recontoured to natural shape, ripped, revegetated and stabilized.

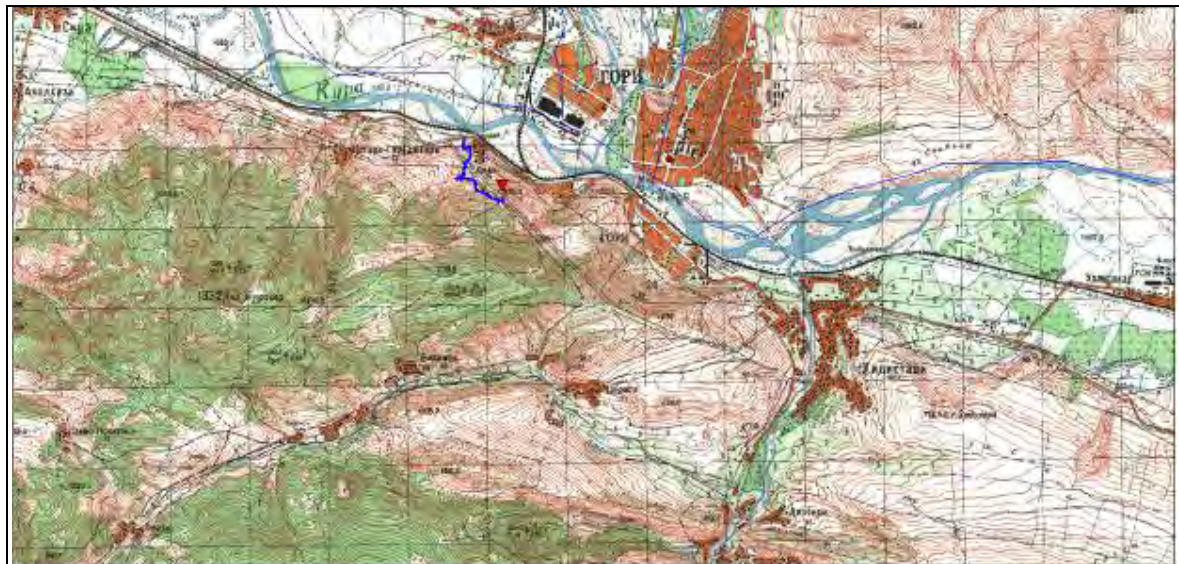
**Map I.** General view on the Project area

Blue line – the line of the project of the road rehabilitation  
Red triangle – Goriyvari monastery

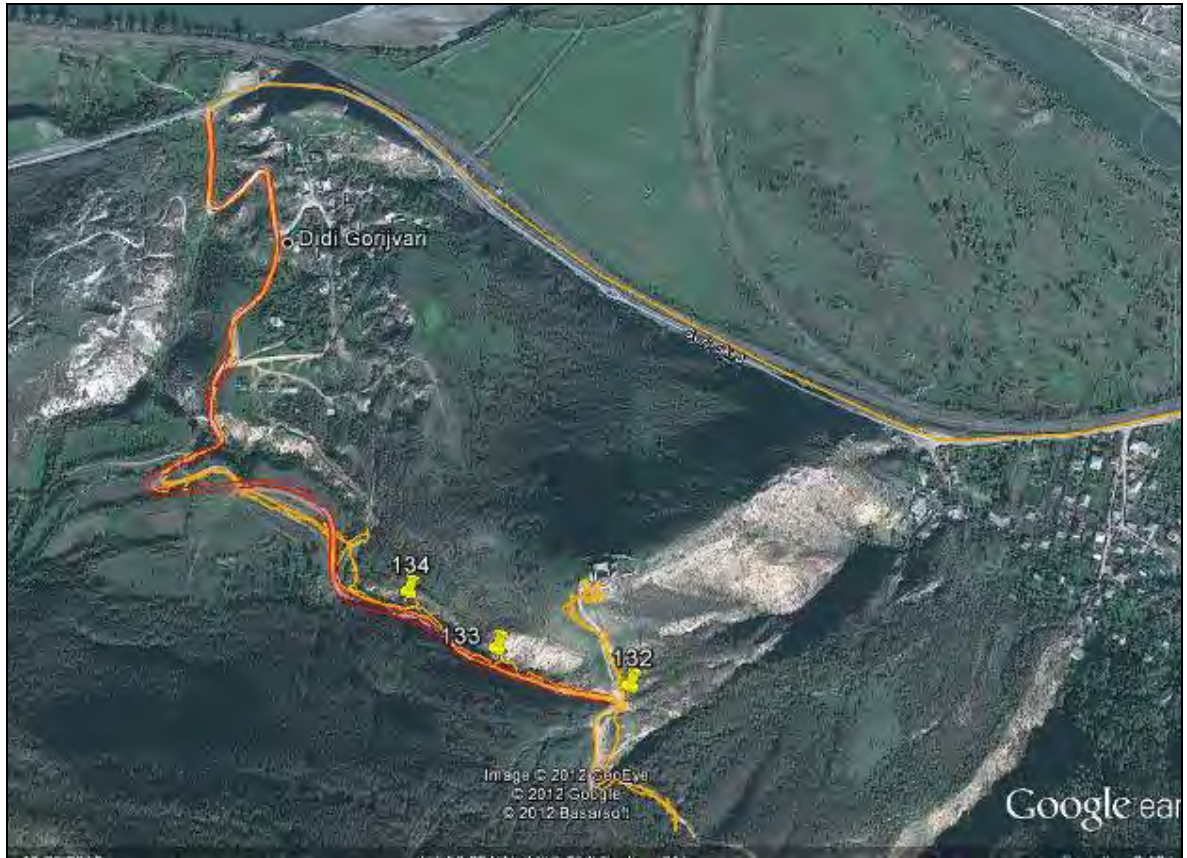
**Map 3.** Field trip route and the line of the road rehabilitation project

Field trip route – orange; Road rehabilitation line – red; Observation points - yellow

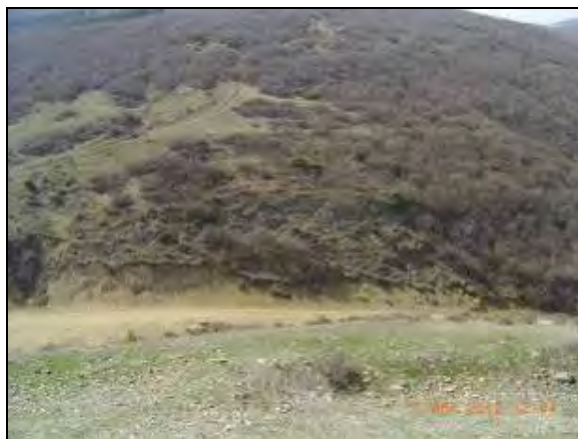
Site #132 Landslide at the upper end of road

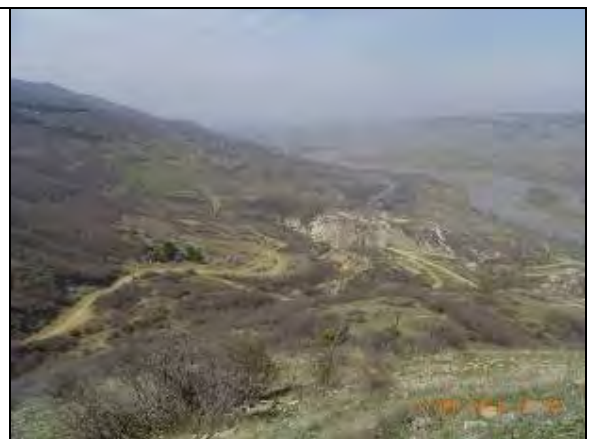
View on the existing road

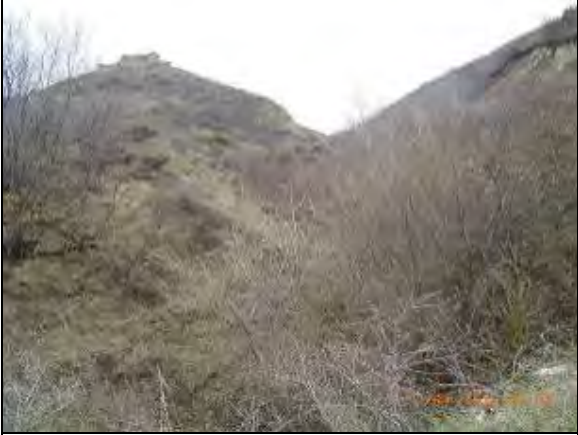
| Site #133 Dense bushes in dry gully on right (northern) side of the road. | Site #134 Covered with bushes dry channel on the left (southern) side of the road. |
