IDARA (INSTITUTING WATER DEMAND MANAGEMENT IN JORDAN)

WEPIA-ESTABLISHED WATER-WISE PARKS ASSESSMENT REPORT

October 10, 2007

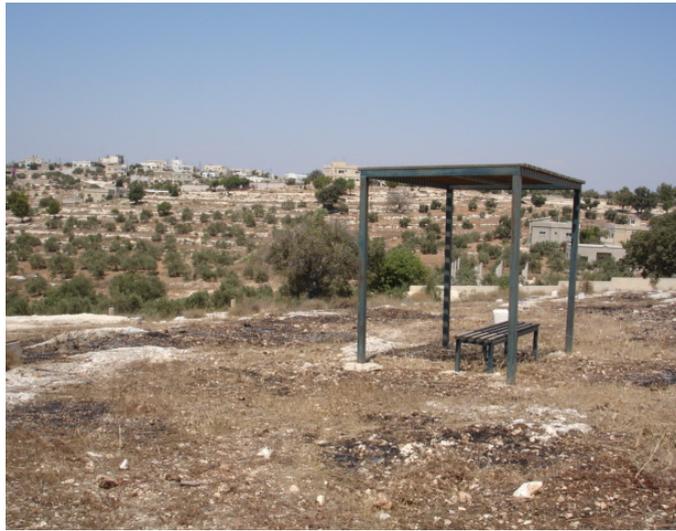
Figure 1

The park is in very poor condition. There are clear signs of neglect, significant plant losses, poor maintenance practices, and vandalism (Figure 1).

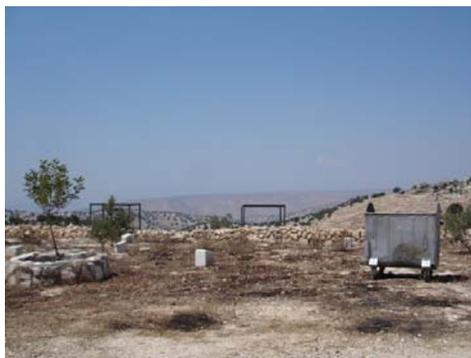
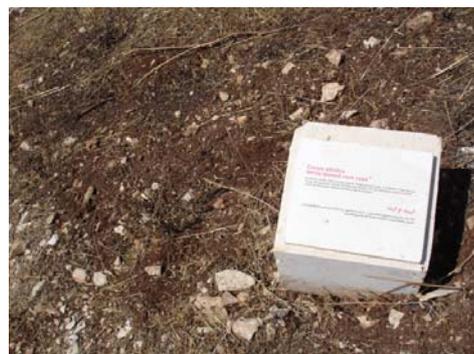
Figures 2 & 3

- A significant portion of the native vegetation on the site has been burned instead of weeded and pruned. This has destroyed the concept of the park which was to preserve and draw attention to the existing native vegetation. The few surviving signs installed to label the various plant types have now been rendered meaningless (Figures 2 & 3).

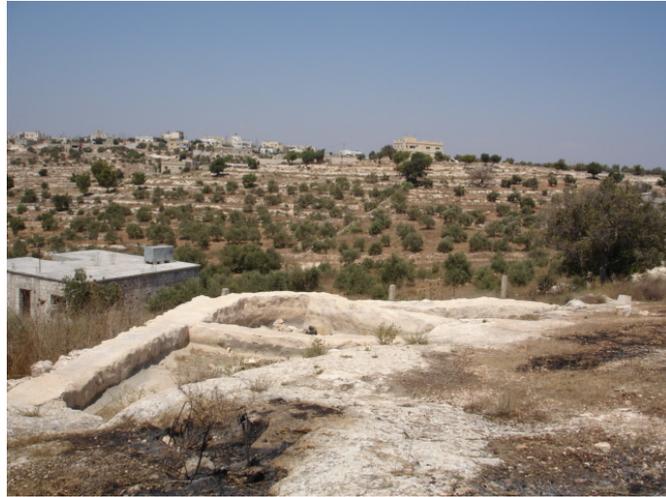
Figure 4

- The pumps on the water harvesting wells have also been dismantled but are being stored on the center premises (Figure 4).

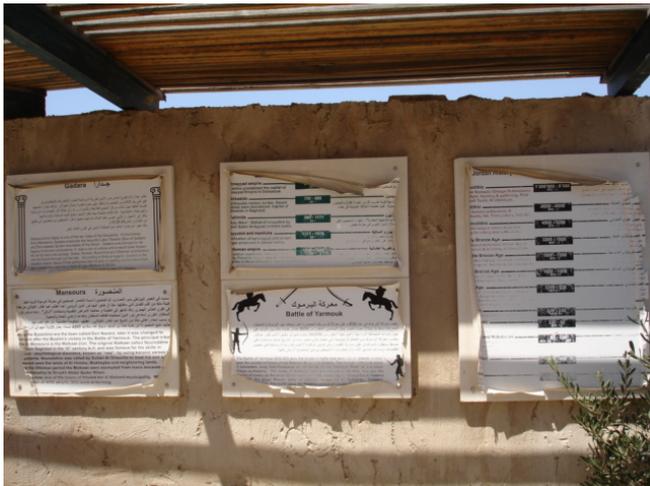
- All signage is in poor condition. Most of the small plant signs are broken and the larger interpretive signs are peeling off (Figure 5).
- Many of the lighting fixtures are broken and have not been fixed or replaced (Figure 6).

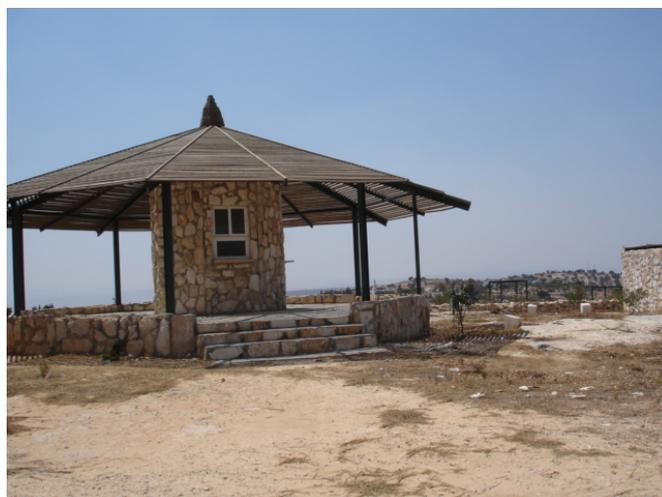
Figure 7

- The café kiosk that was built is not occupied by a private sector company. Efforts to rent it have either failed or were not pursued properly (Figure 7).

The café kiosk has not been leased to a private enterprise as originally intended during the planning stages of the park. The café was a key attraction that would have activated the recreational component and supplied funds (through income from leasing) for the maintenance and upkeep of the park.

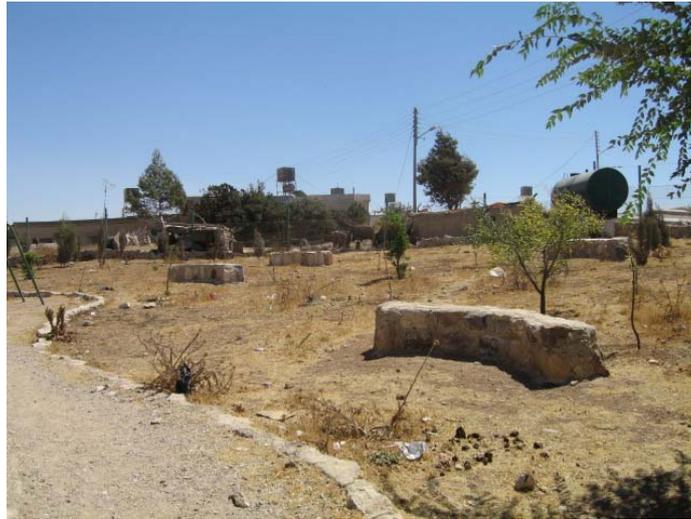
Figure 8

The park is in extremely poor condition. There are clear signs of neglect, significant plant losses, no evidence of maintenance practices, and signs of vandalism (Figure 8):

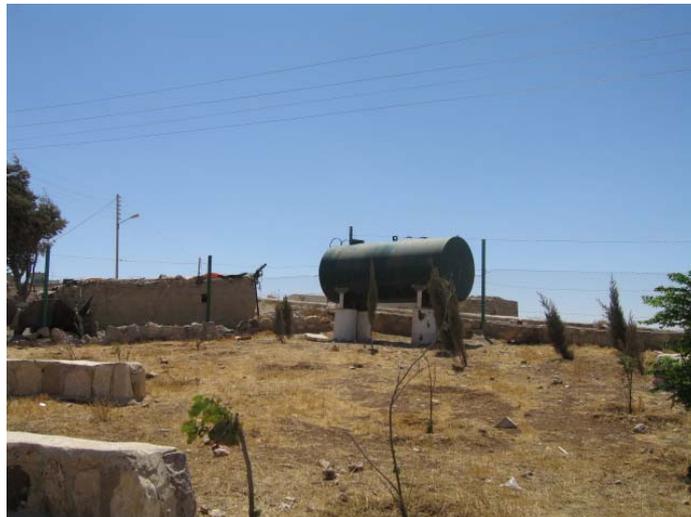
Figure 9

- The irrigation system has been dismantled, but the storage tank is in place (Figure 9).

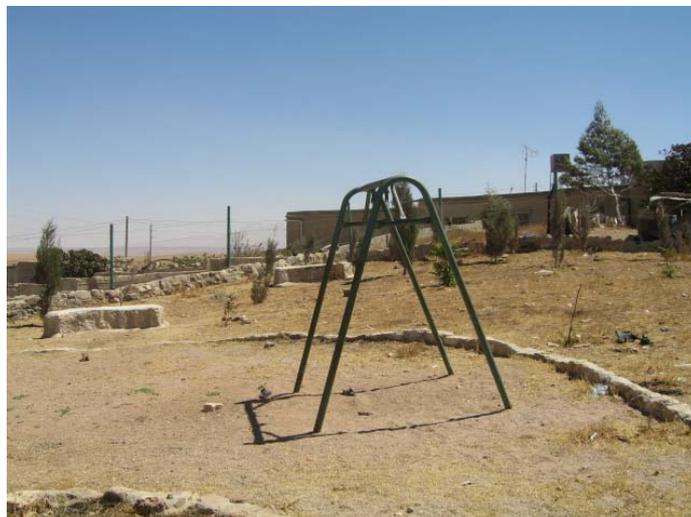
Figure 10

- The play equipment has been dismantled and is in unusable condition (Figure 10).

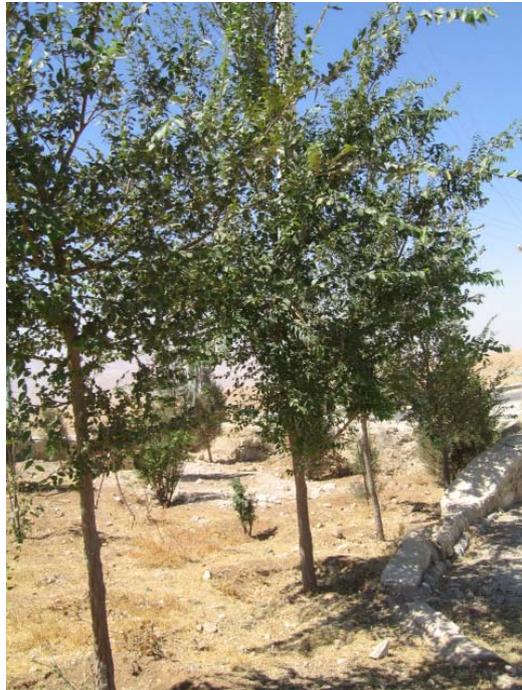
Figure 11

- Some of the trees have survived and are in fairly good condition considering the lack of maintenance and harsh site conditions (Figure 11).

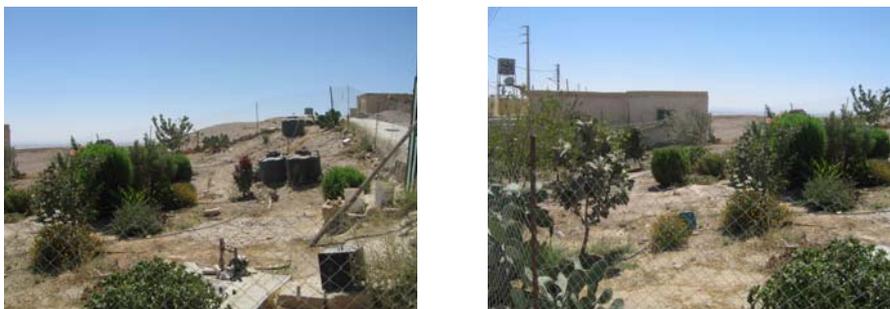
Figure 12

The park is within walking distance from most of the residences in the village. Most residences, however, have a small garden and/or outdoor terrace that satisfy the need to spend time outdoors, typical of rural villages in Jordan. As evident from the exceptional condition of the private gardens, the residents expend significant energy in the upkeep of their gardens and none towards the maintenance of the public park (Figure 12).

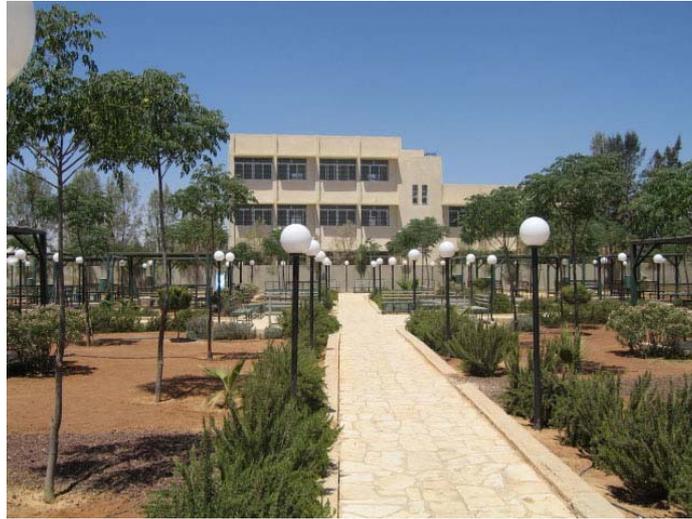
Figure 13

The park is in extremely good condition especially when compared to other public parks in Jordan. There are signs of good maintenance practices, significant plant growth, and no signs of vandalism (Figure 13).

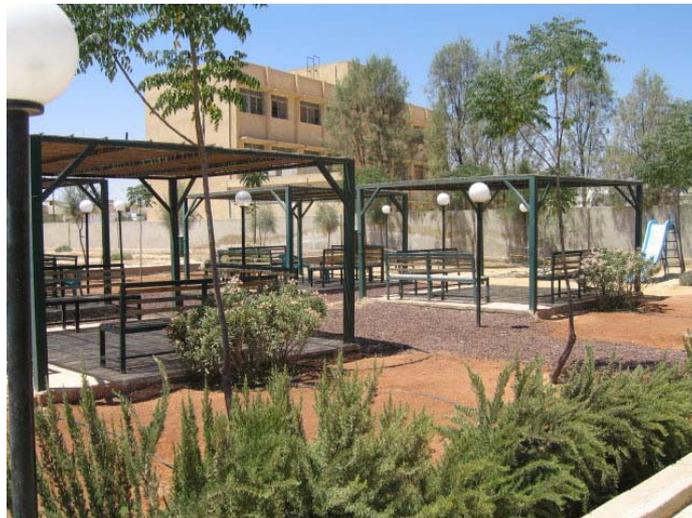
Figure 14

- The plants are in extremely good condition. There are minimal losses which appear to have happened early on, during the establishment period. This has not affected the overall appearance of the park (Figure 14).

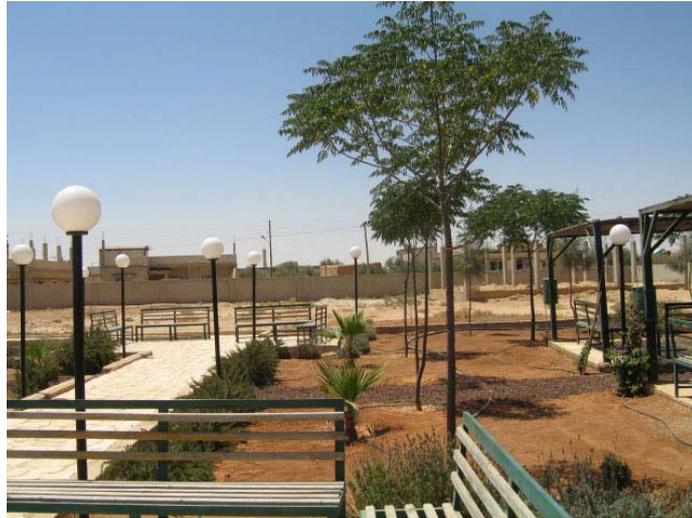
Figure 15

- The planting shows significant growth and is in vigorous condition showing no signs of stress or disease (Figure 15).

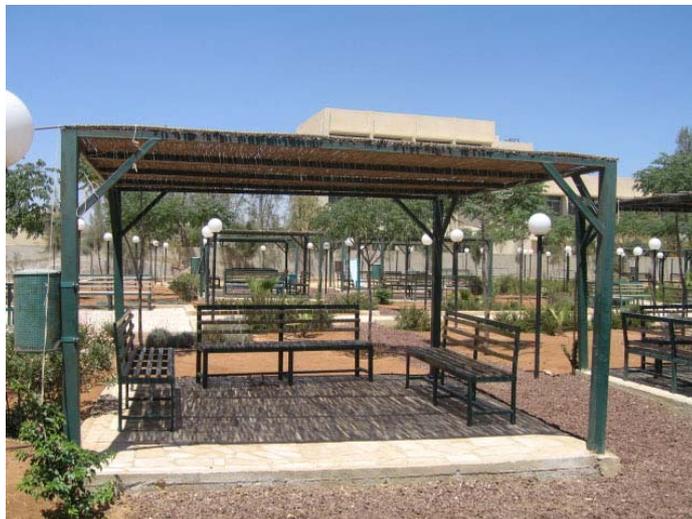
Figure 16

- The park is extremely clean. Waste disposal is done daily and effectively.
- There are no signs of vandalism or significant wear-and-tear to the park structures (with the exception of the play equipment). The benches, light fixtures, shade structures, waste receptacles, pathways, and inorganic mulches, are all in good condition (Figure 16).

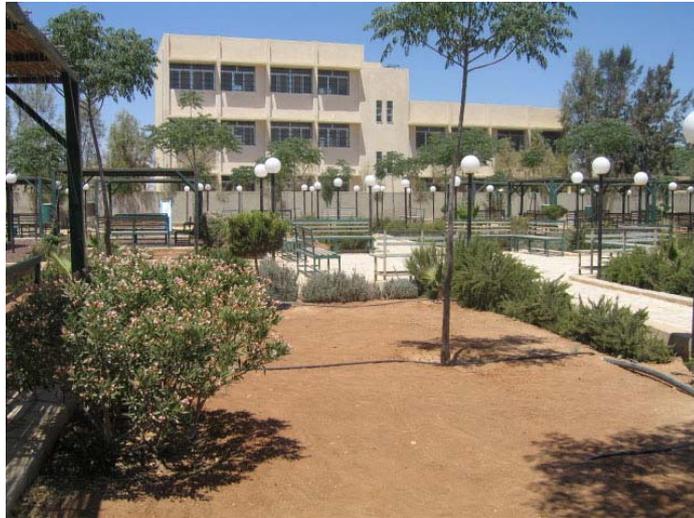
Figure 17

- The irrigation system is still functioning. The drip lines have deliberately been moved around to keep them away from children’s reach. The lines were originally buried underground but have surfaced due to unsupervised children’s play. The custodian moves the lines to their original locations near the plants before he turns on the irrigation system. Given the good health of the plants this system seems to work (Figure 17).

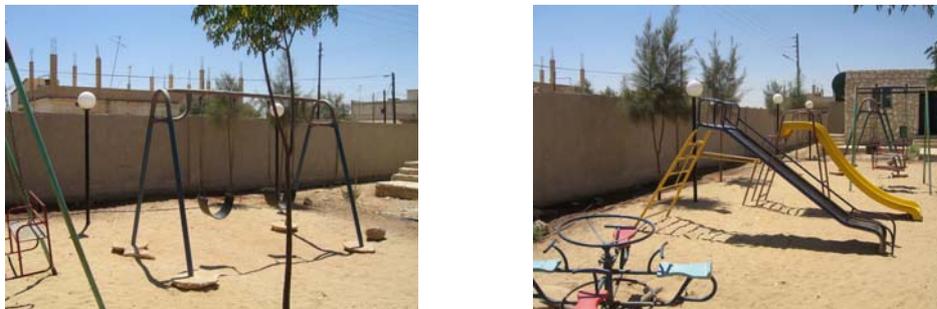
Figure 18

- The play equipment is in poor condition. The merry-go-rounds are not functioning and the swing foundations are exposed (Figure 18).

There is room for improvement, however, especially in maintaining the play equipment. The center director is aware of this shortcoming, and will need to secure more funds for maintaining the equipment⁸.

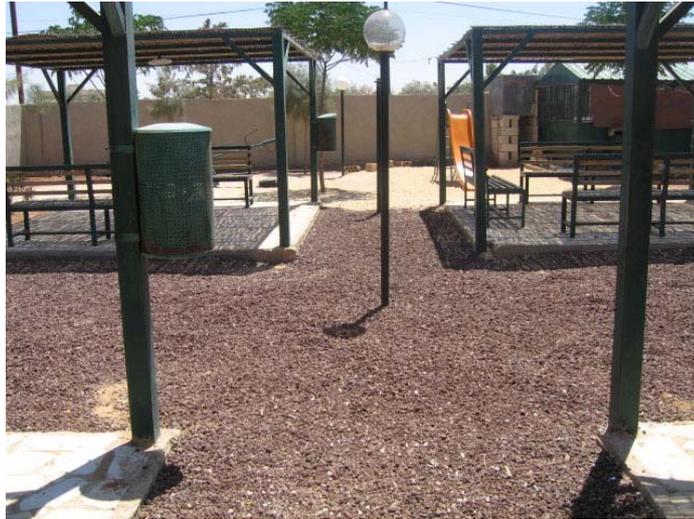
Figure 19

- The sand in the children’s areas needs replacement (it has not been replaced since the initial construction)
- The inorganic mulch is in good condition, although difficult to clean of cigarette butts (Figure 19).

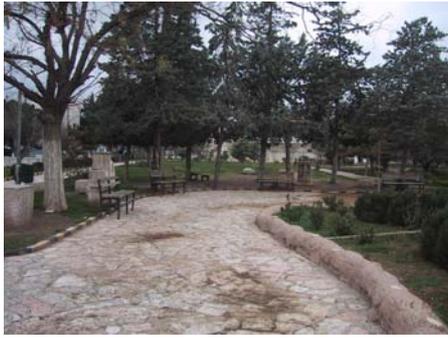
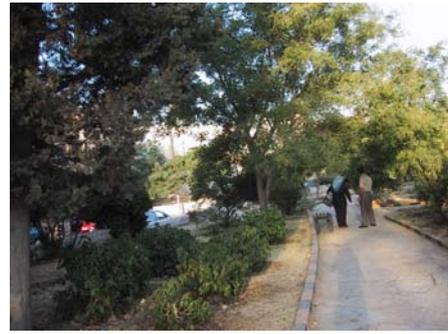
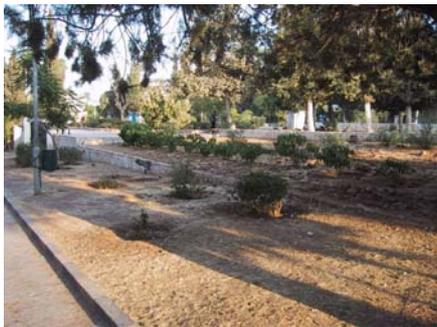
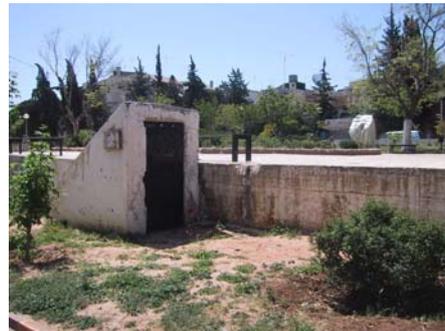
Over the years, the park had suffered from poor maintenance and neglect, and consequently greatly deteriorated, but had not lost its elegance and charm (Figures 20-23).

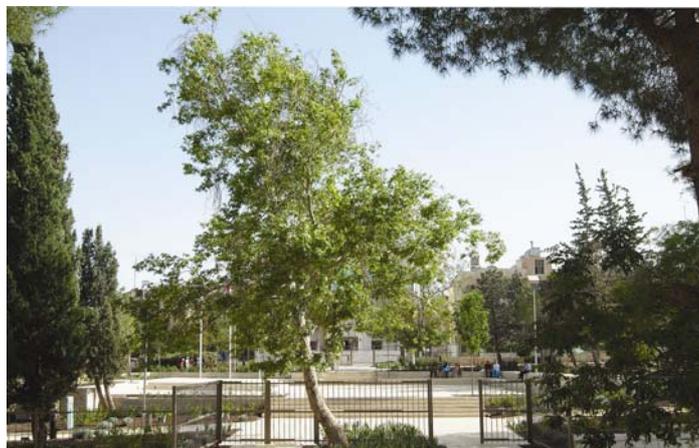
Figure 24

In early 2002, CSBE proposed a project for the rehabilitation and development of the park. After securing commitments for supporting the project from the USAID-supported WEPIA Project and the Greater Amman Municipality, construction work on the park began in the spring of 2004, and the work was completed about a year later, in May 2005 (Figure 24). The rehabilitated park, which continues to be open to the public, includes outdoor sculpture displays, children's play areas, a performance/exhibition space, a café/restaurant, and model educational gardens demonstrating water conservation landscape practices.

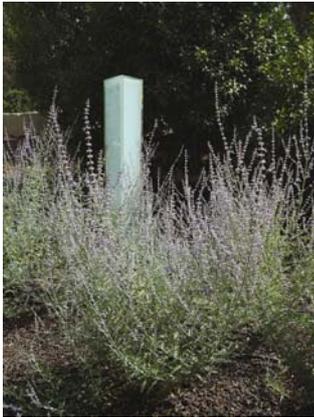
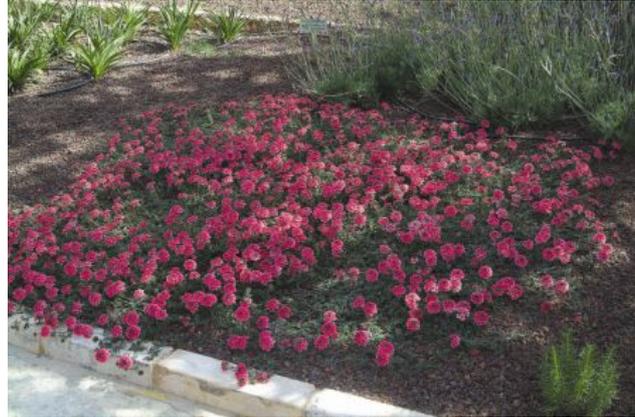
Figures 25 & 26

The park also was intended as a model water-conserving park that informs the public about water conserving landscape practices. The park consequently includes a 160 cubic-meter reservoir that has the capacity to harvest rainwater, and that is connected to an efficient drip irrigation system. The park features water-conserving plants that need minimal irrigation and in many cases limited maintenance, as well as gravel-covered areas that require no irrigation (Figures 25, 26, and 27). A special turf grass (Bermuda grass) also has been used in one part of the park to minimize water consumption (Figure 28).

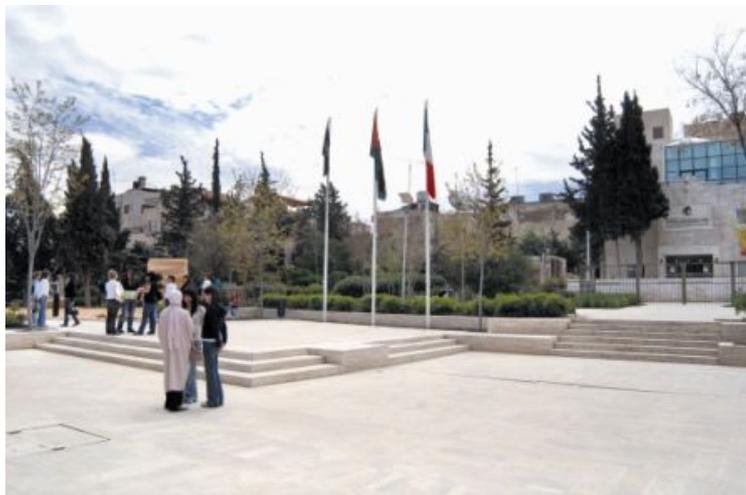
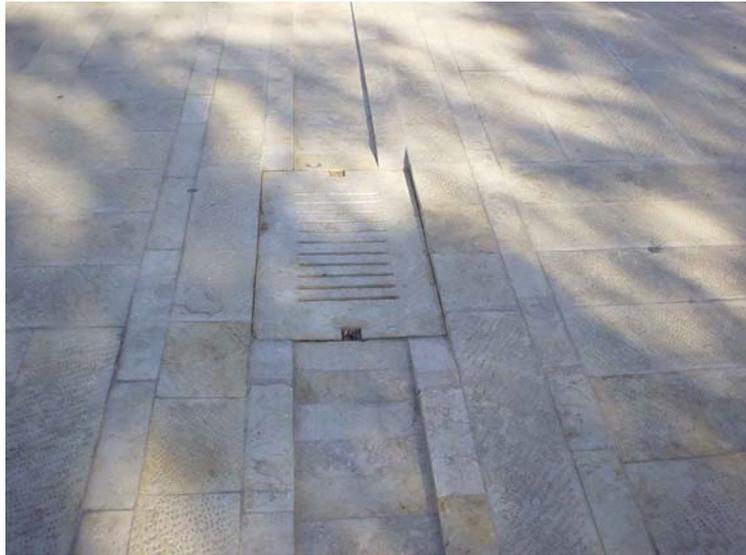
The design of the park concentrated on a central 250 square-meter platform/performance area, which functions as a focal congregational space within the park, and also provides spatial and functional links between the original building of the National Gallery and the extension building (Figure 28). Moreover, this central platform is located over the park's rainwater harvesting reservoir, and includes built in stone grills through which the rain water is directed to the reservoir (Figures 29 & 30).

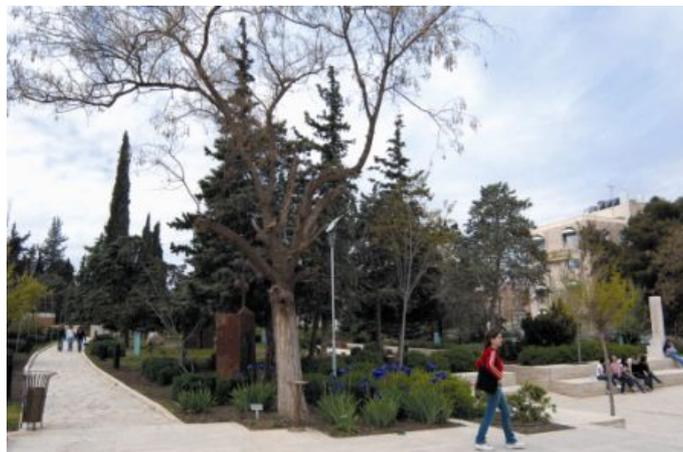
Figure 31

The paths springing out of the central platform area follow the route of the pre-existing paths of the old park. The original irregularly-shaped stone panel paving was maintained to provide a visual and textural link to the original character of the pre-existing park (Figure 31).

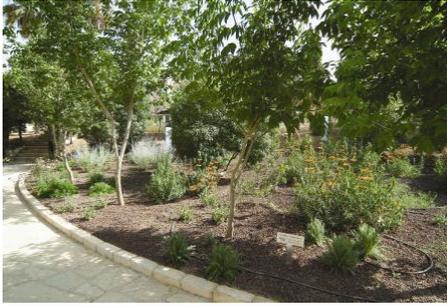
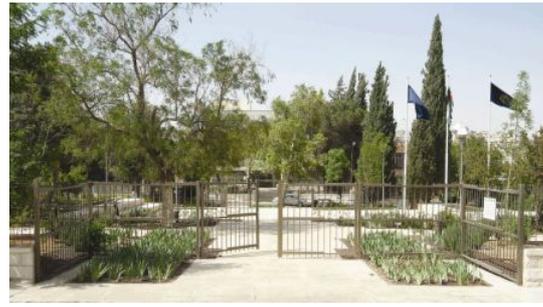
Figures 32 & 33

All the original trees and mature ornamental plants of the park were preserved and integrated within the new design. These original plants have been supplemented by a wide range of additional water-conserving trees, ornamental plants, and ground covers (Figures 32 & 33).

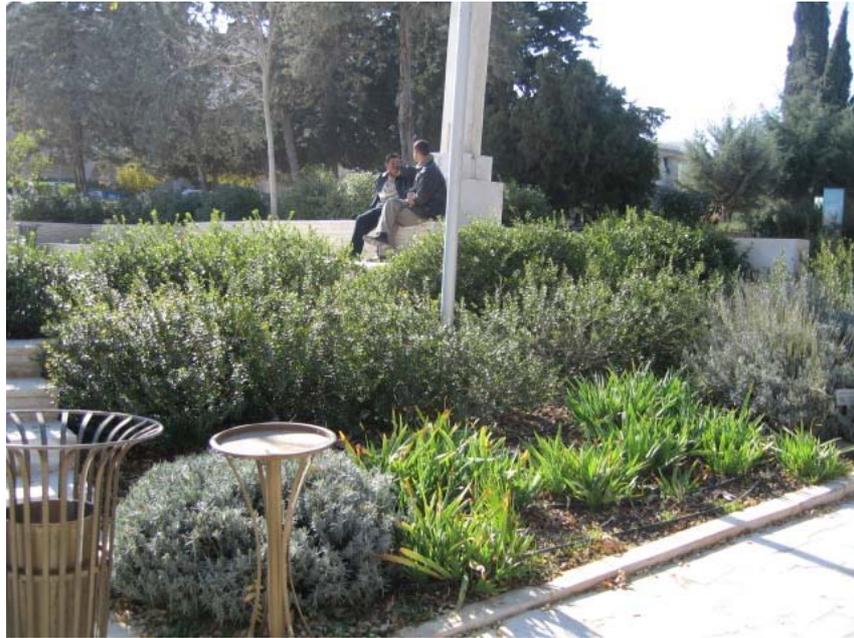
Figure 34

- The planting is well maintained and shows significant growth (Figure 34).

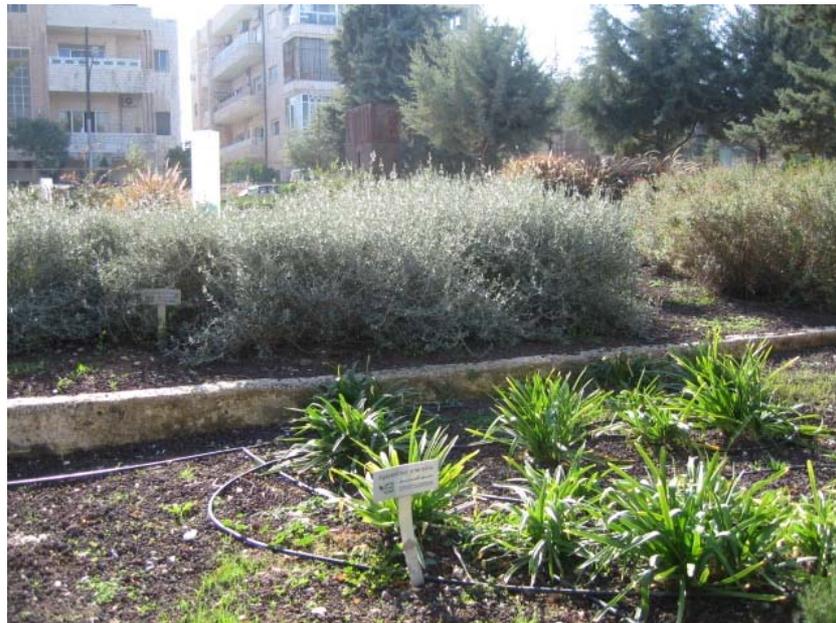
Figure 35

- The irrigation system is intact and is regularly maintained by the staff (Figure 35).

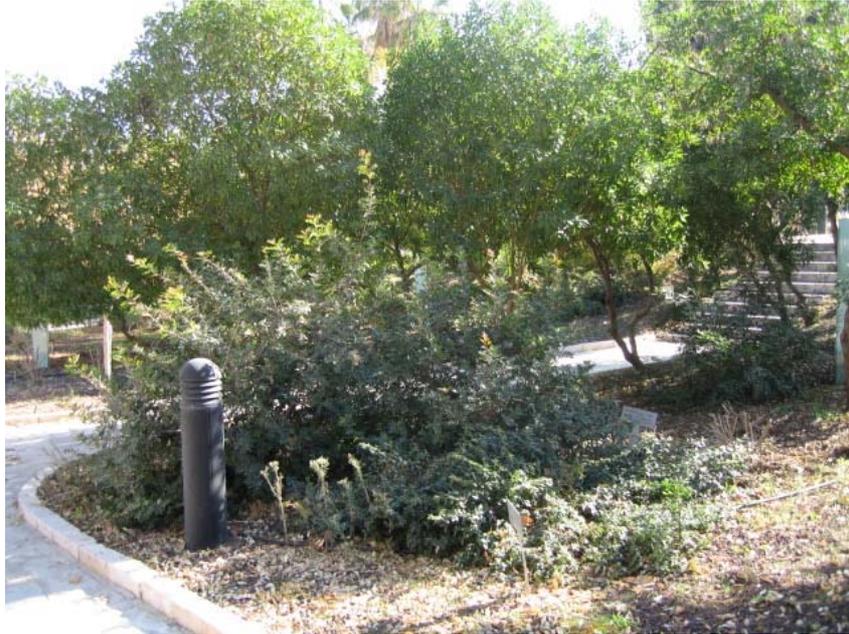
Figure 36

- Lighting fixtures are in place (Figure 36).

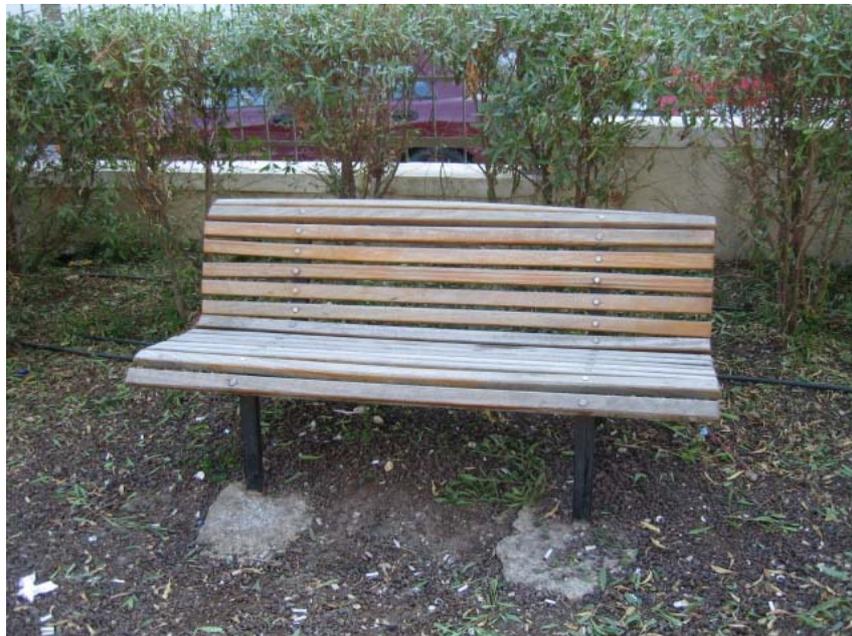
Figure 37

- Benches are in good condition (Figure 37).

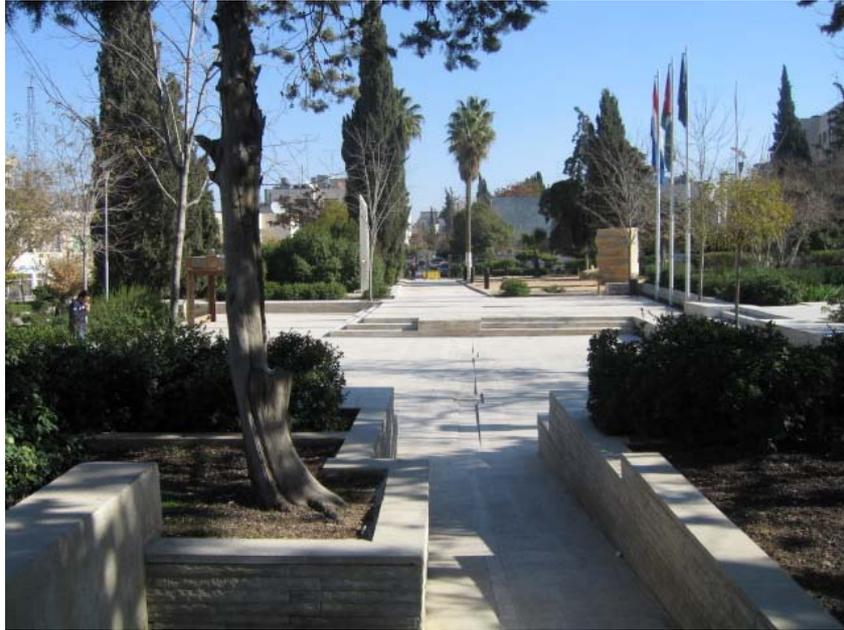
Figure 38

- Paving is in good condition, with the exception of two small areas (Figure 38).

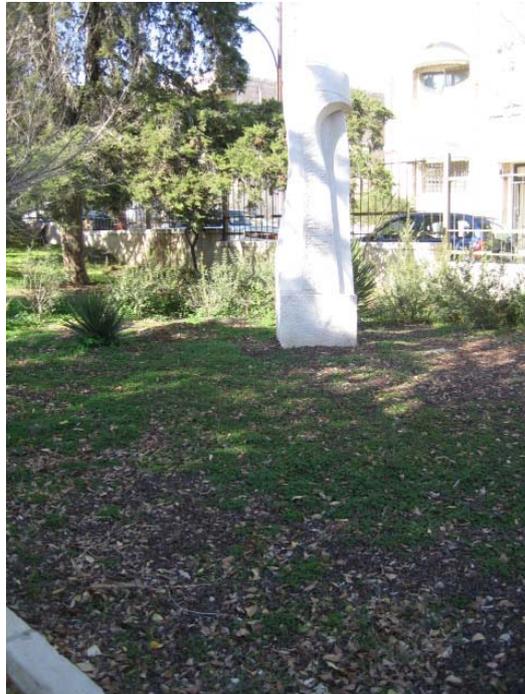
Figure 39

- The mulch (Tuff stone) surfaces are in fair condition (Figure 39).

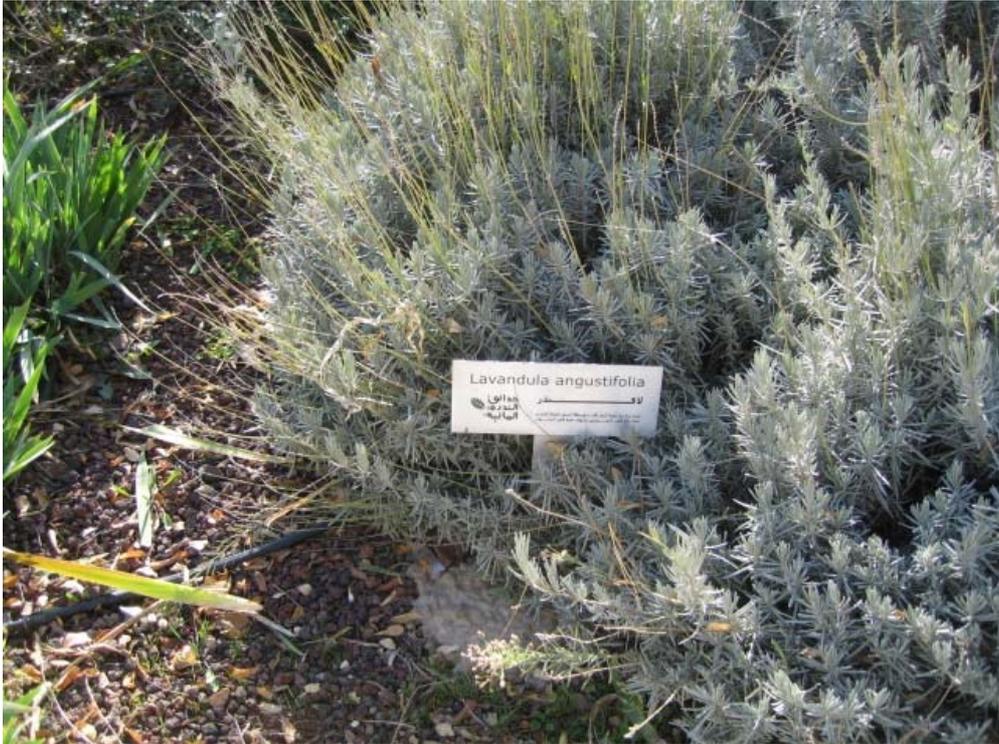
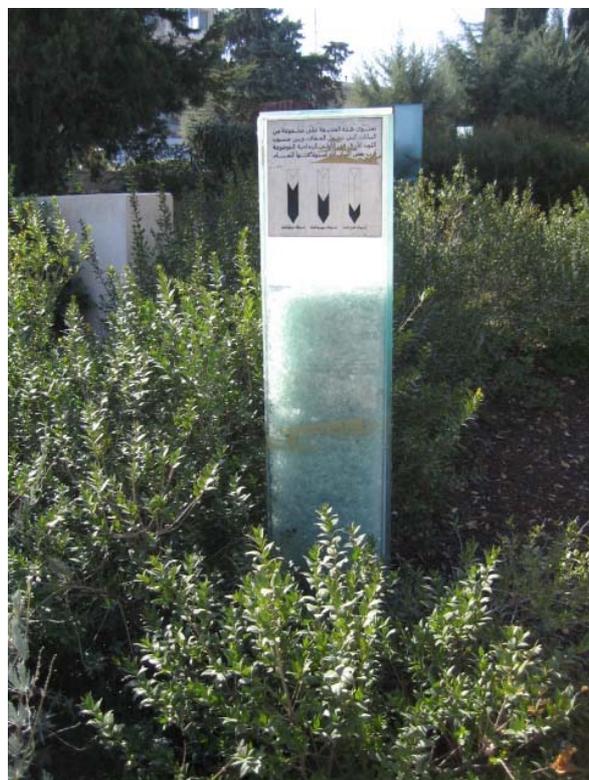
- Most of the signage is still intact (Figures 40 & 41).

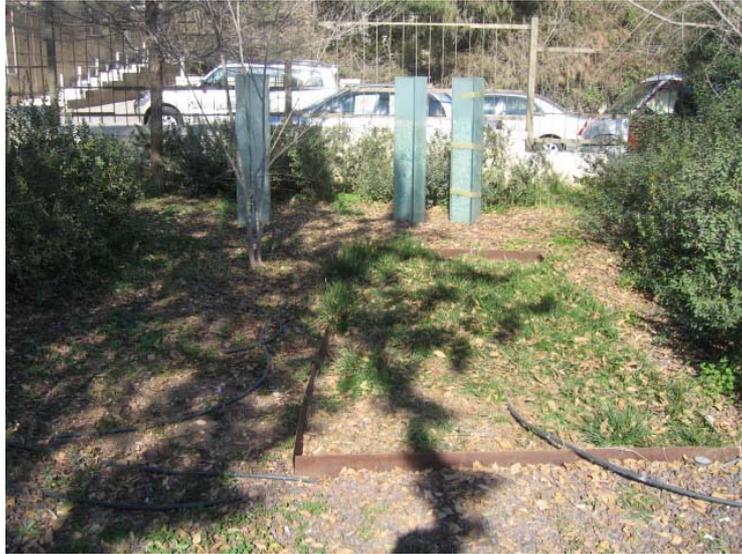
Figure 42

- One of the demonstration displays is in poor condition (Figure 42).

There are minor maintenance issues which still need to be addressed. One of the displays needs replanting and some of the light bulbs also need replacement.

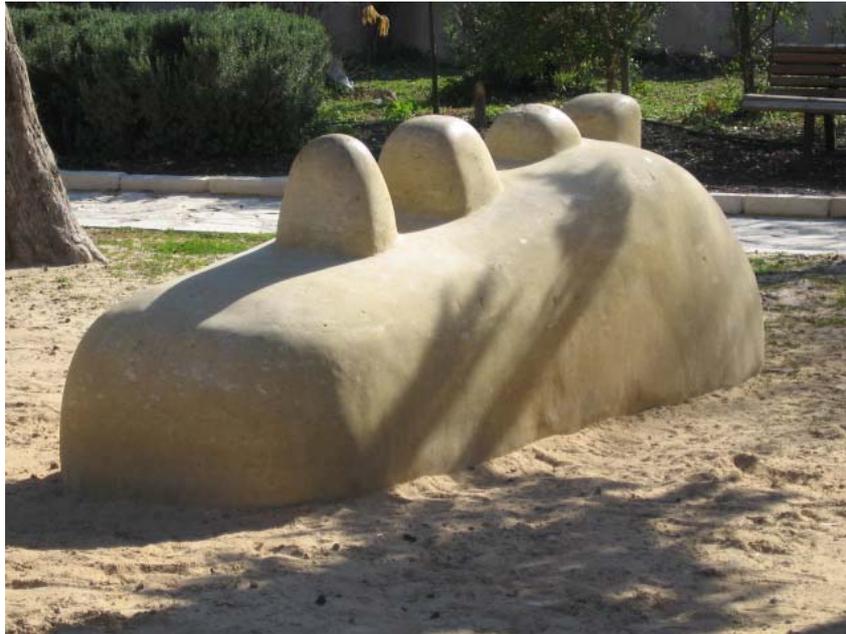
Figure 43

The children's play equipment consisting of swings, slides, and a merry-go-round broke down during the first few months after the opening of the park. After consultation with CSBE and the neighborhood stakeholder group, the National Gallery asked GAM not to replace the play equipment and decided to commission play sculptures instead (Figure 43).
