# USAID | WEST BANK/GAZA

## FINAL REPORT

MULTIPLE ROADS PROJECT IN THE SOUTH

August 2014 AID-294-TO-13-00004

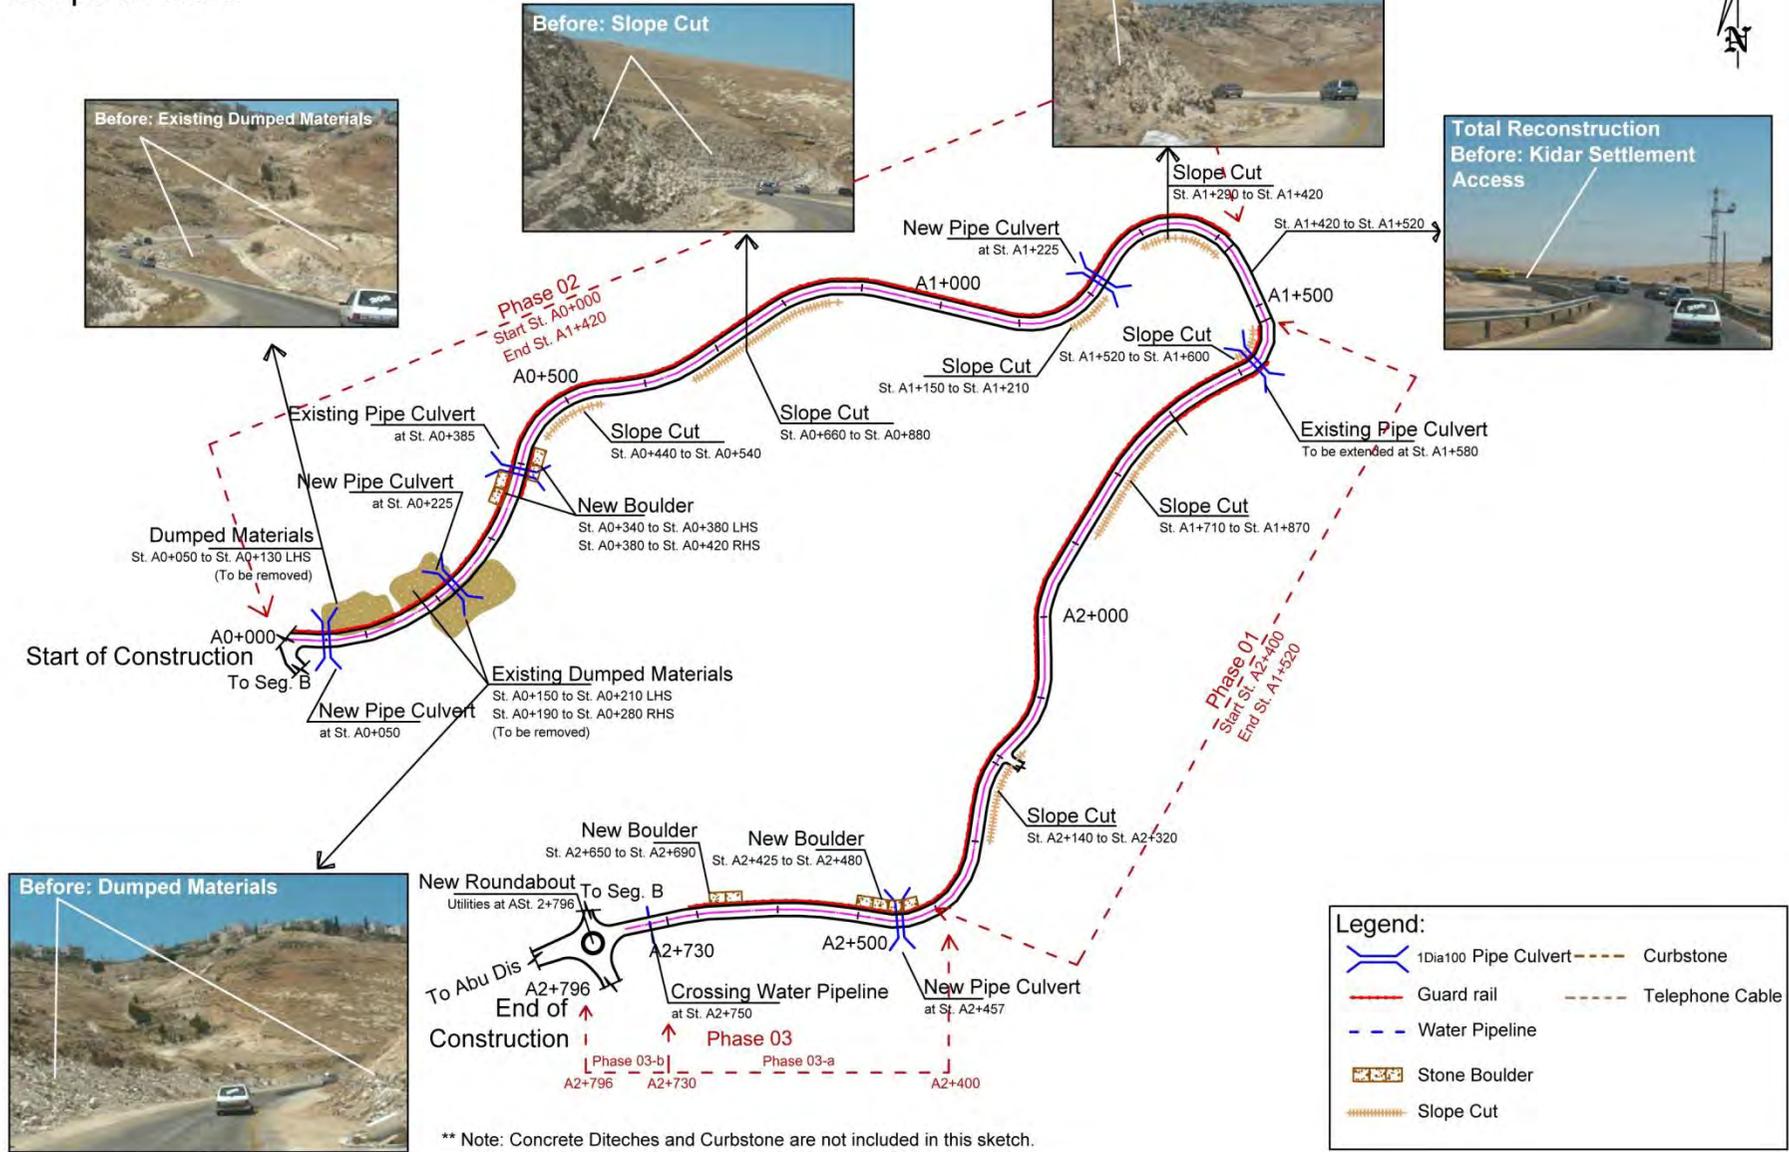
Figure 1.4: Project 01- Wadi Al Jeer–Al Sawahira Al Sharqiya Road (Segment A) **original scope** of work.

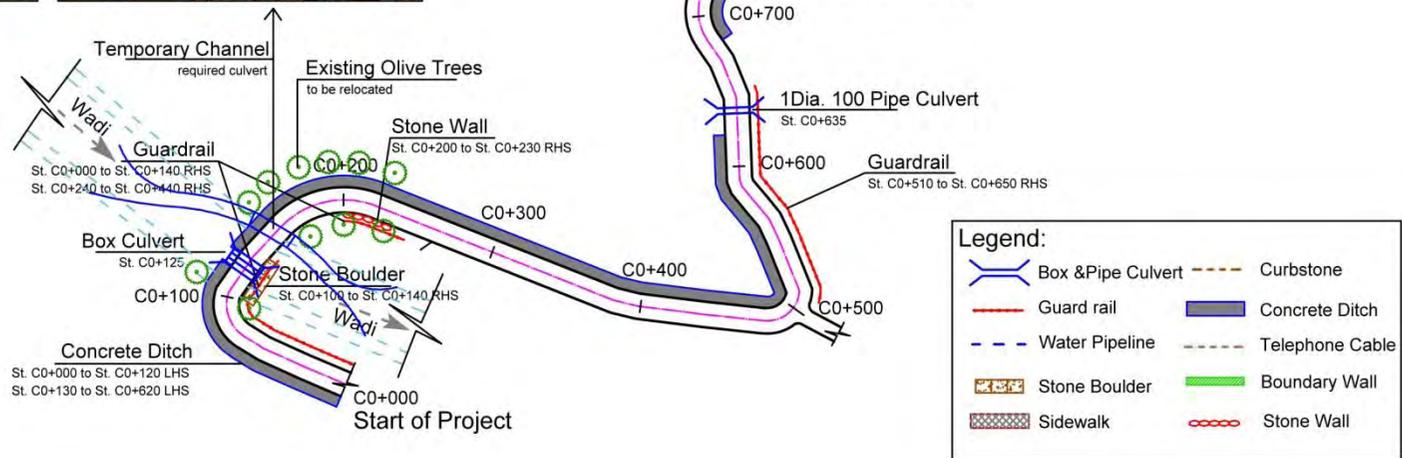
**Note:**  
- Gravity concrete retaining walls were constructed instead of stone boulder between St.0+936 to St.1+057 RHS per RFI-13-00004-MRS-010

Figure 1.10: Project 03- Al Sawahira Al Sharqiya-Sheikh Sa'ed Road (Segment C) **original scope** of work.

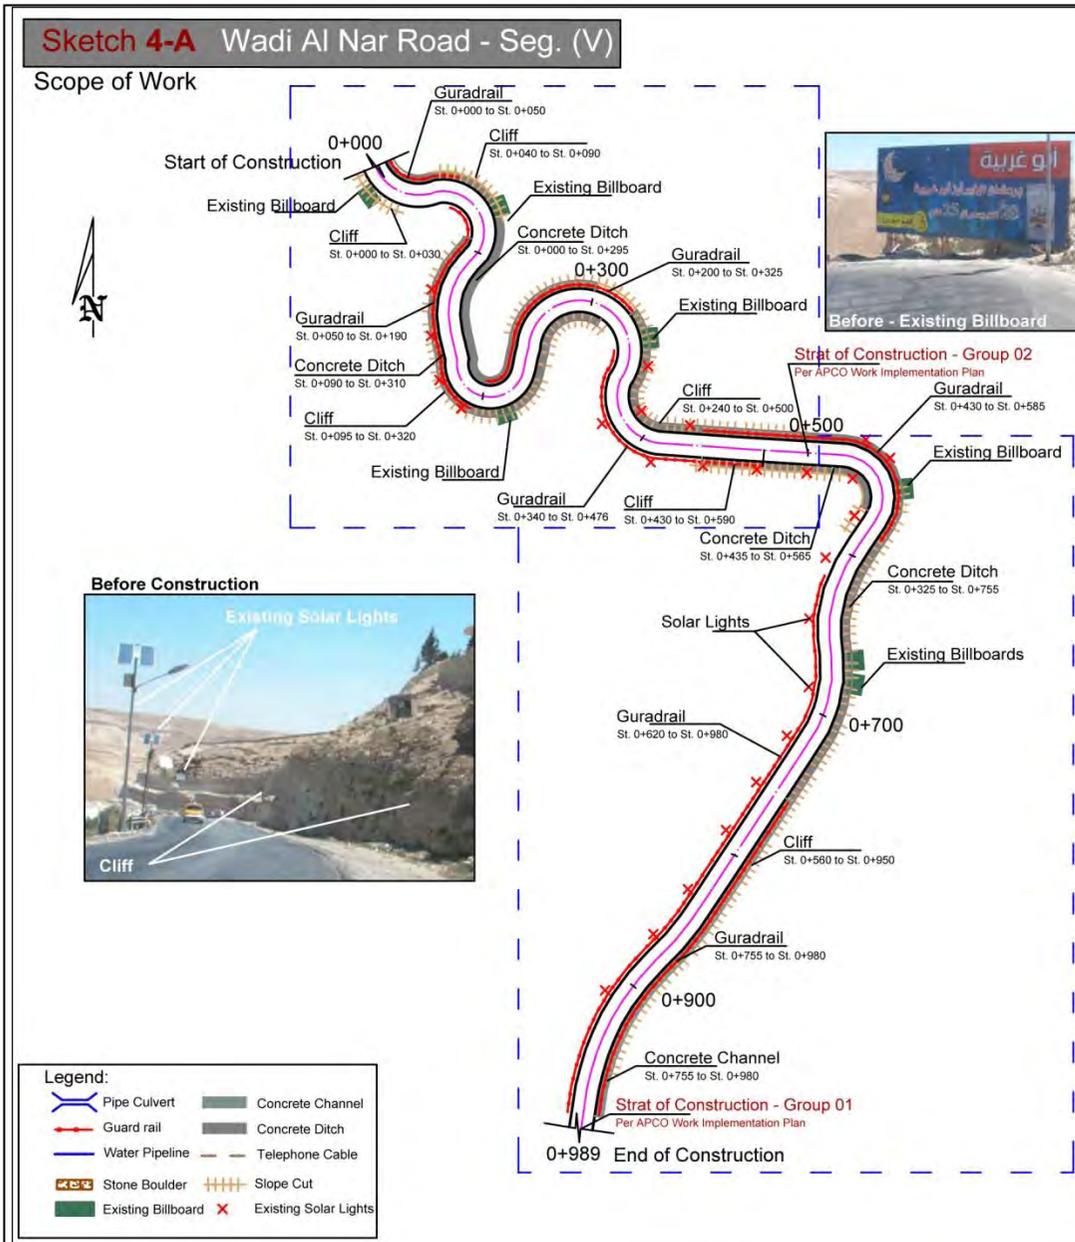
Figure 1.13: Project 04- WNV- Wadi Al Nar Road (Seg. V) Original scope of work.

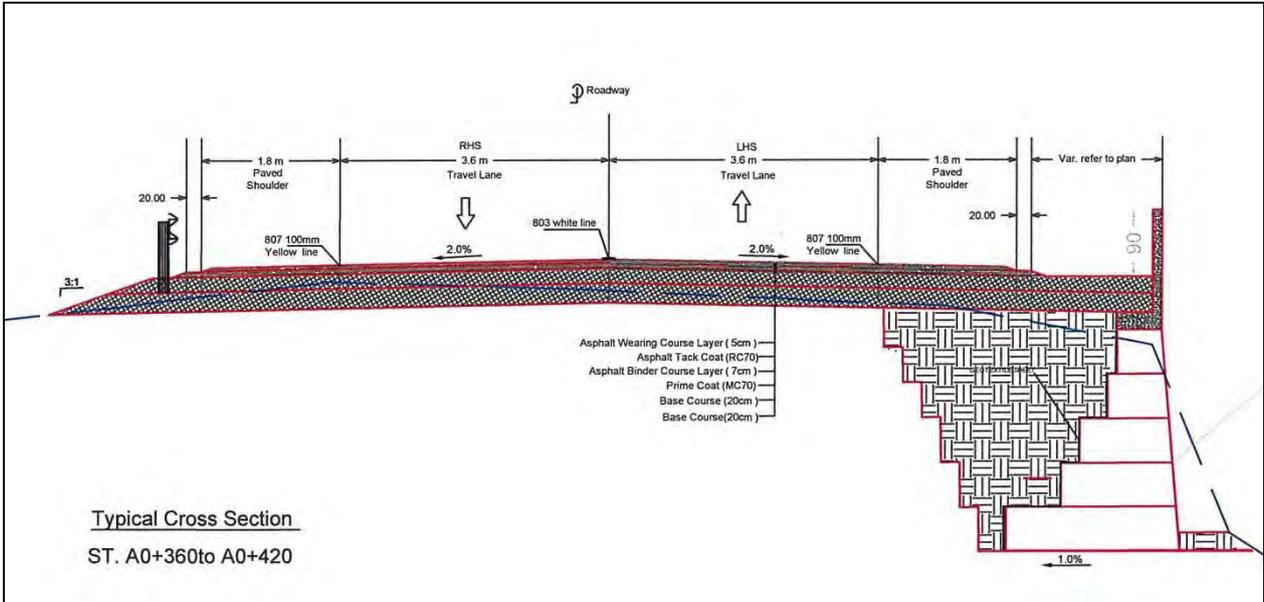
Figure 1.22: Project 01- WJA- Typical cross section from St. A0+360 to St. A0+420.

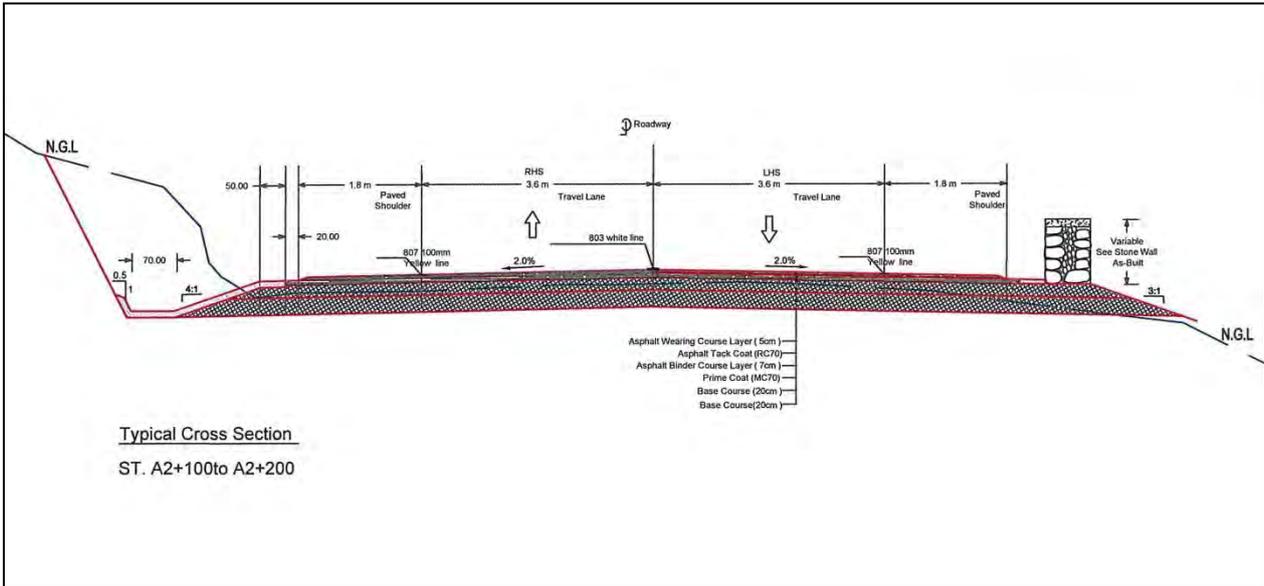
Figure 1.23: Project 01- WJA- Typical cross section from St. A2+100 to St. A2+200.

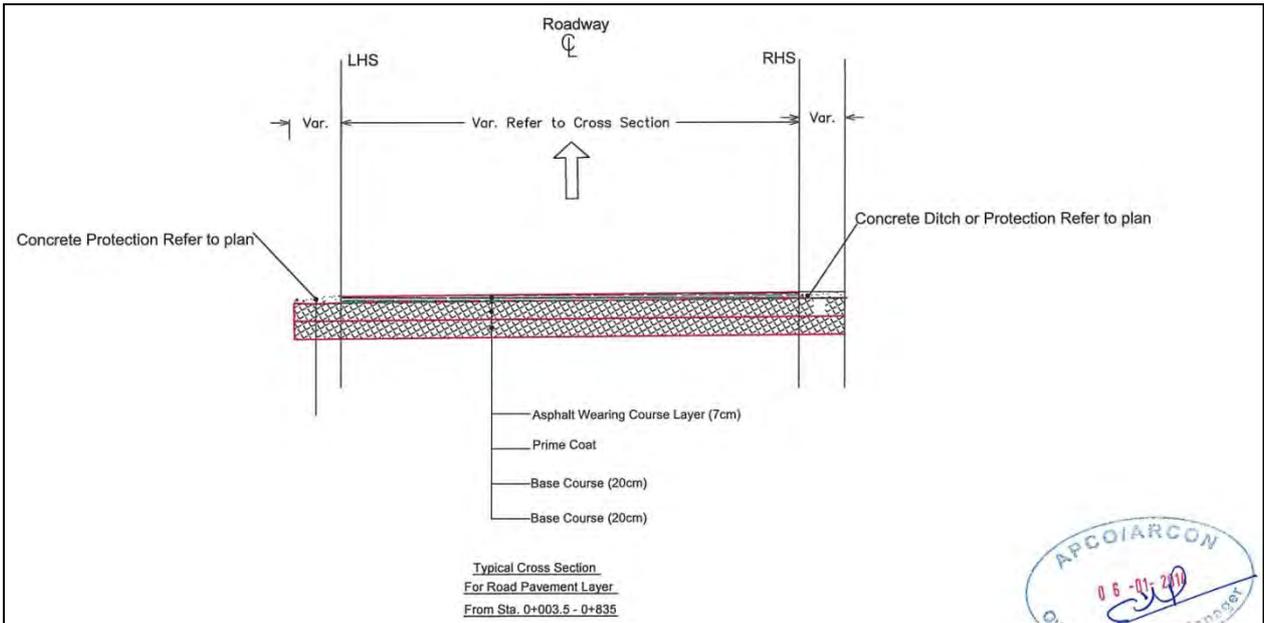
Figure 1.24: Project 02- WJB- Typical cross section from St. 0+003 to St. 0+835.

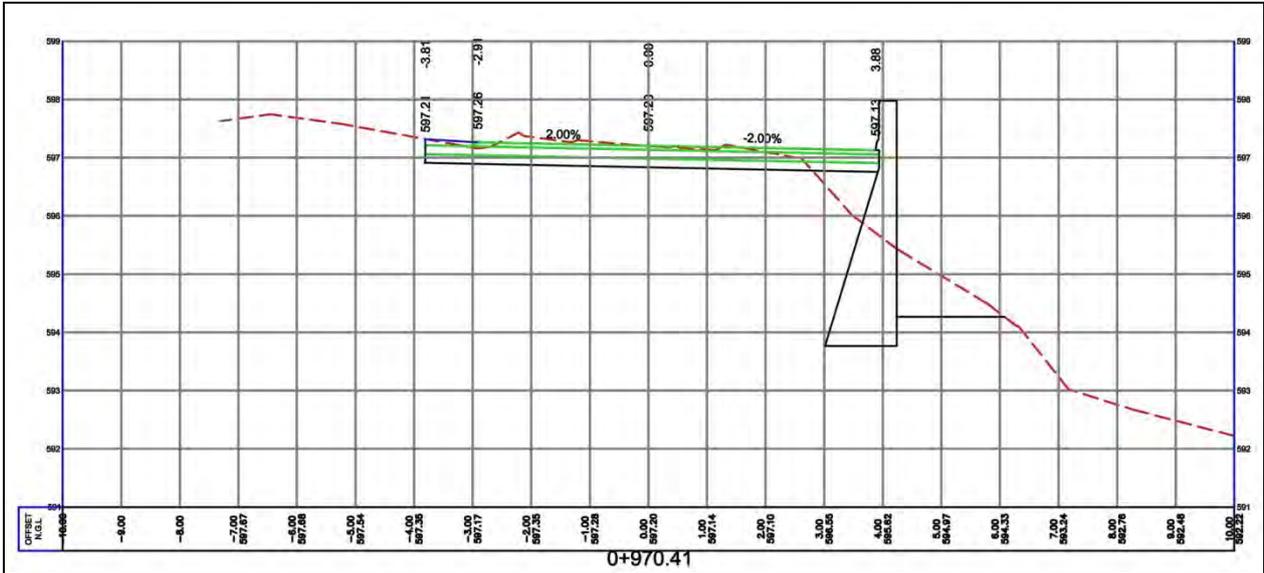
Figure 1.28: Project 03- SSC- Typical cross section at St. 0+970.41.

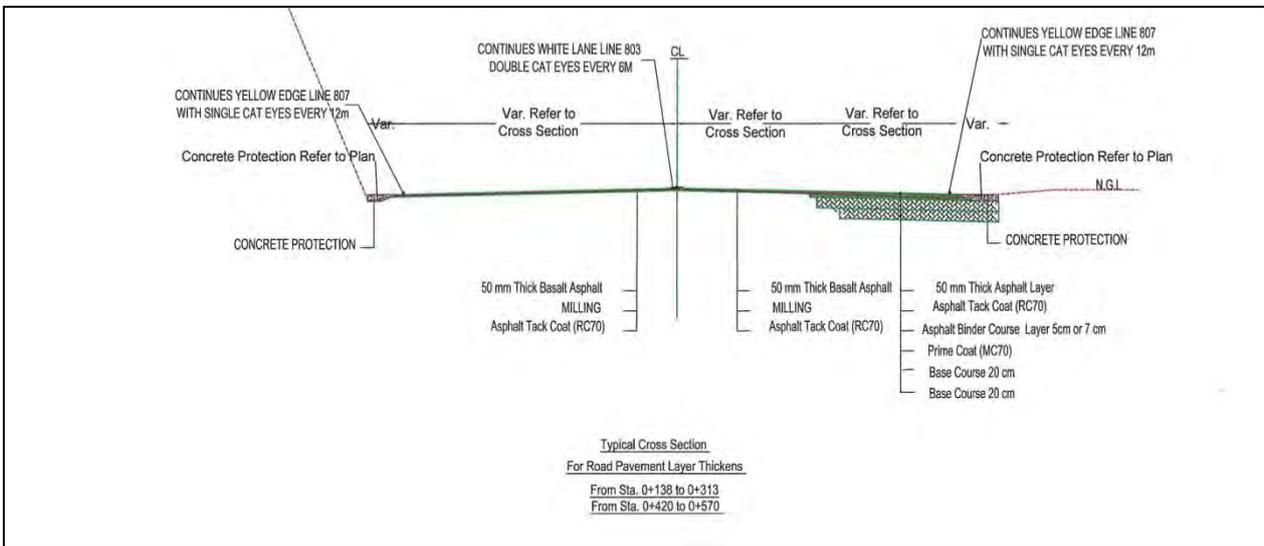
Figure 1.29: Project 04- WNV- Typical cross section from St. 0+138 to St. 0+313 and from St. 0+420 to St. 0+570.

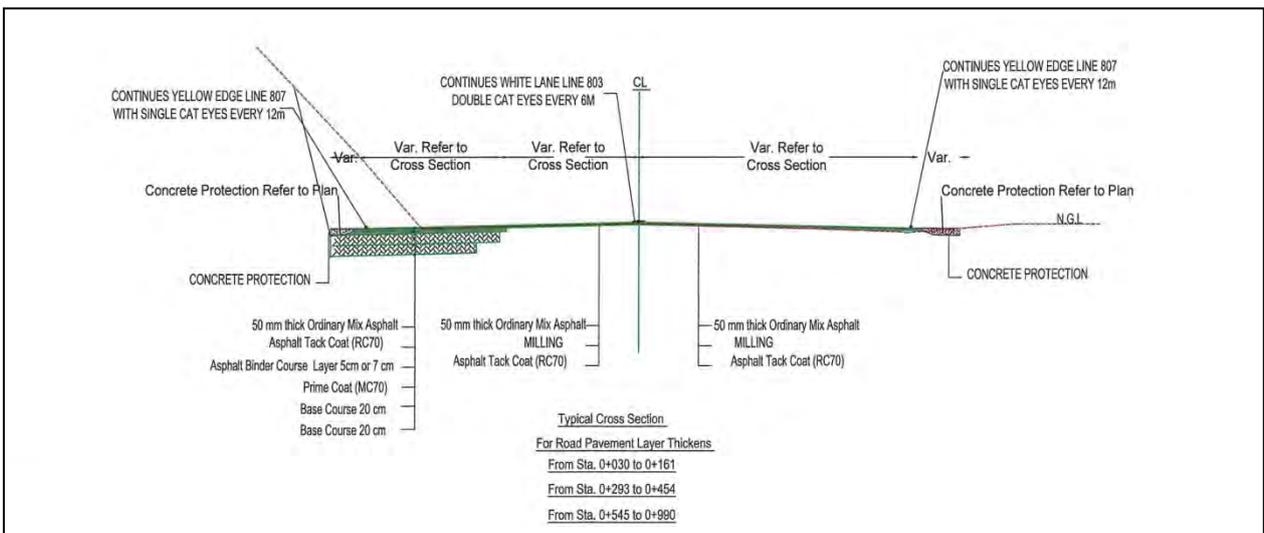
Figure 1.30: Project 04- WNV- Typical cross section from St. 0+030 to St. 0+161, from St. 0+293 to St. 0+454 and from St. 0+545 to St. 0+990.

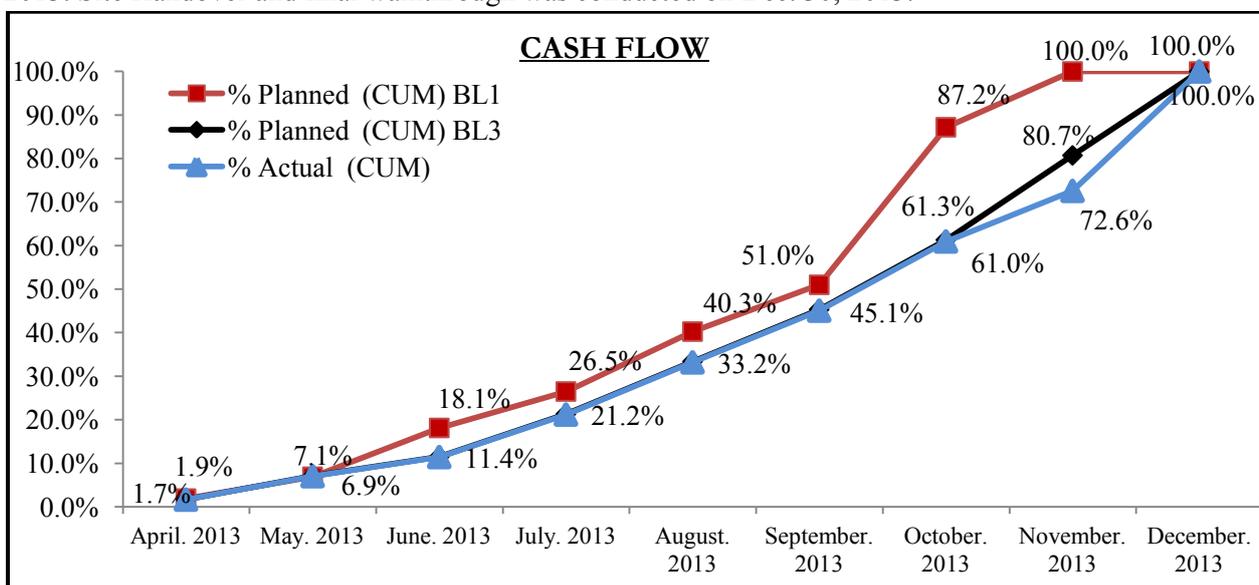
Figure 2.1: Wadi Al Jeer–Al Sawahira Al Sharqiya Road (Segment A) Construction Works Progress – S-curve

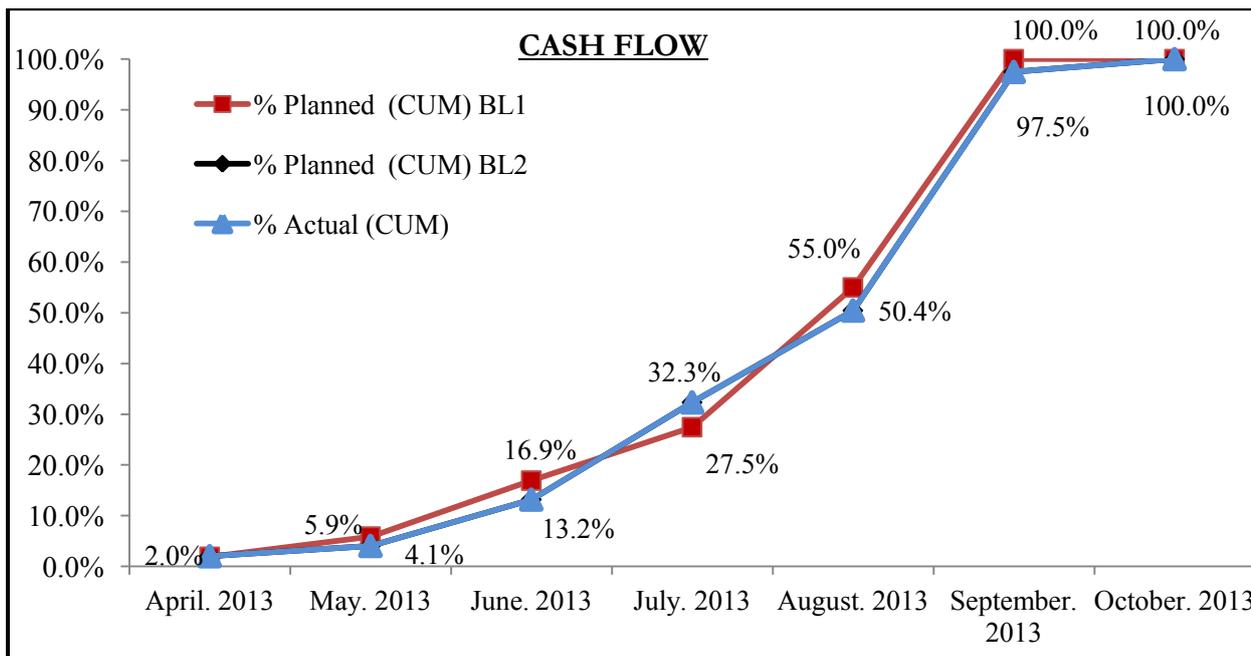
Figure 2.2: Wadi Al Jeer–Al Sawahira Al Sharqiya Road (Segment B) Construction Works Progress – S-curve

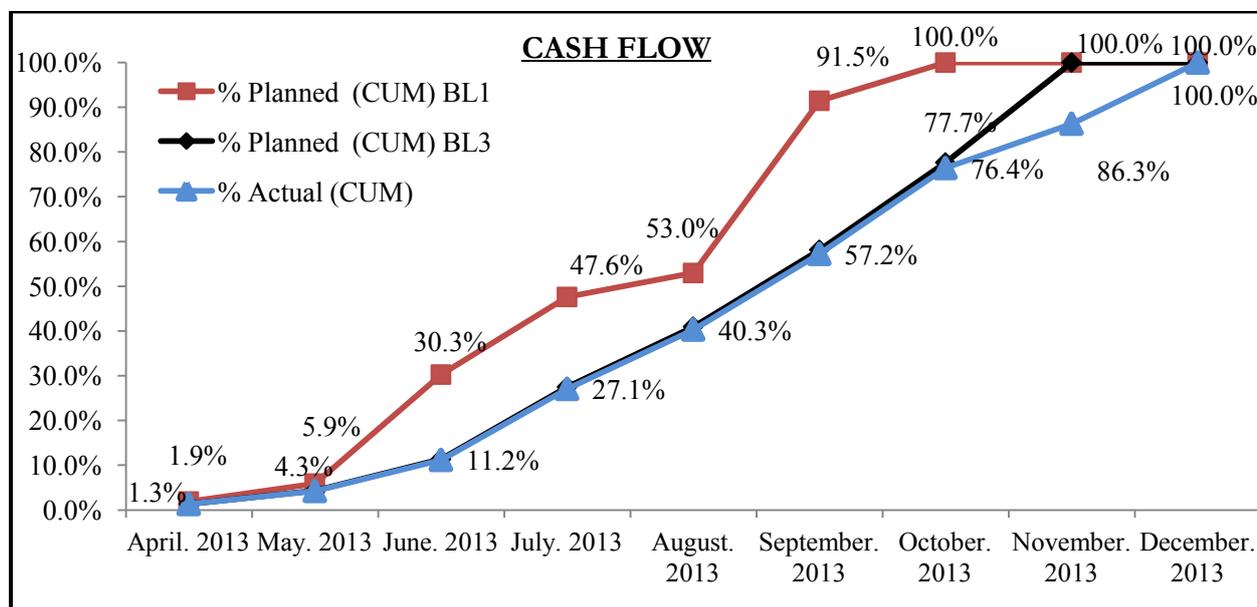
Figure 2.3: Al Sawahira Al Sharqiya-Sheikh Sa'ed Road (Segment C) Construction Works Progress – S-curve

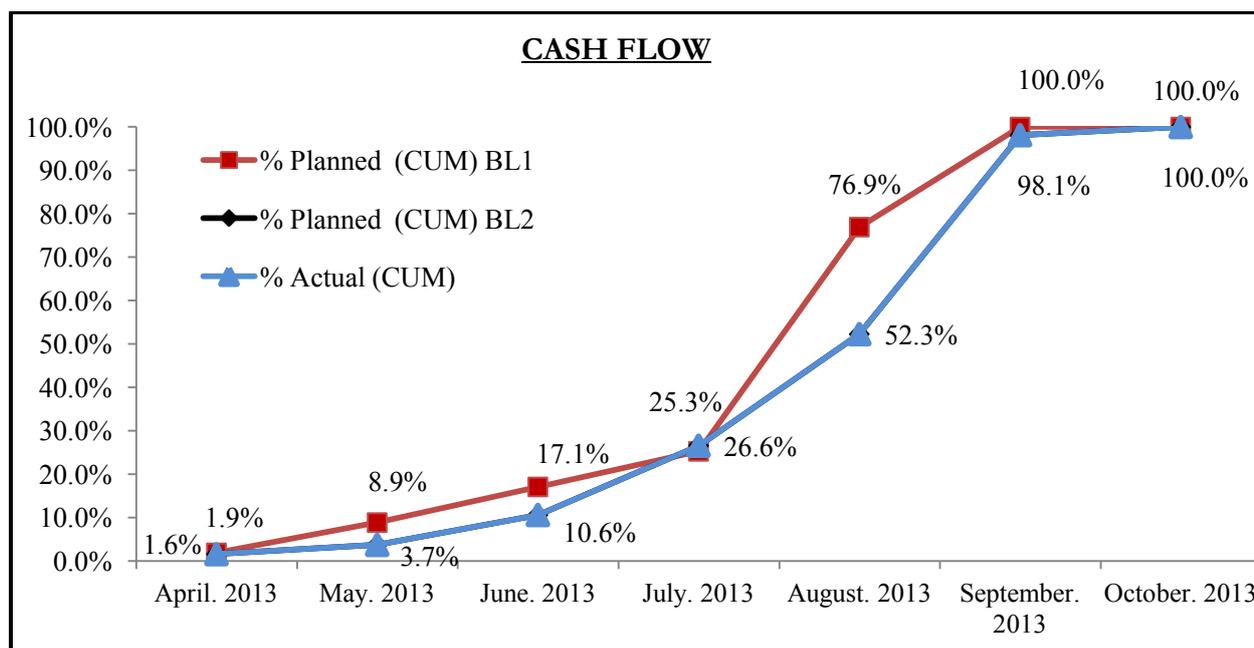
Figure 2.4: Wadi Al Nar Road (Segment V) Works Progress – S-curve

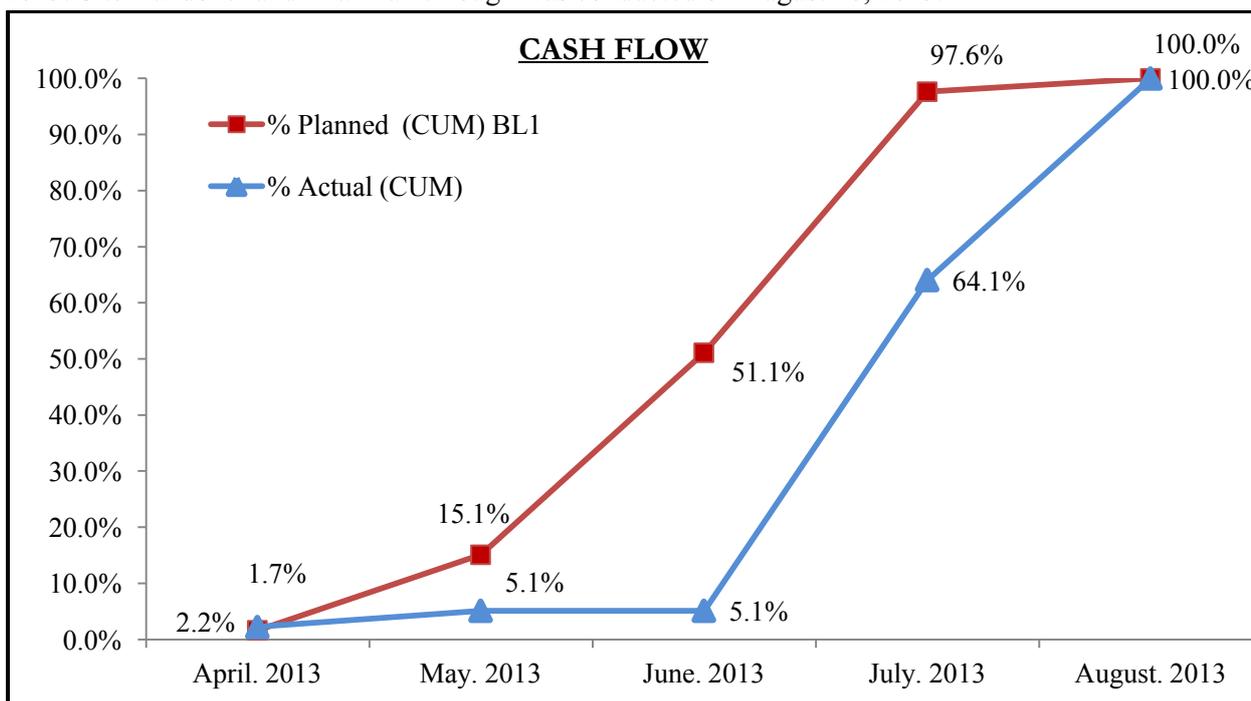
Figure 2.5: Qalandiya-Jabaa Road Safety Enhancement Works Progress – S-curve

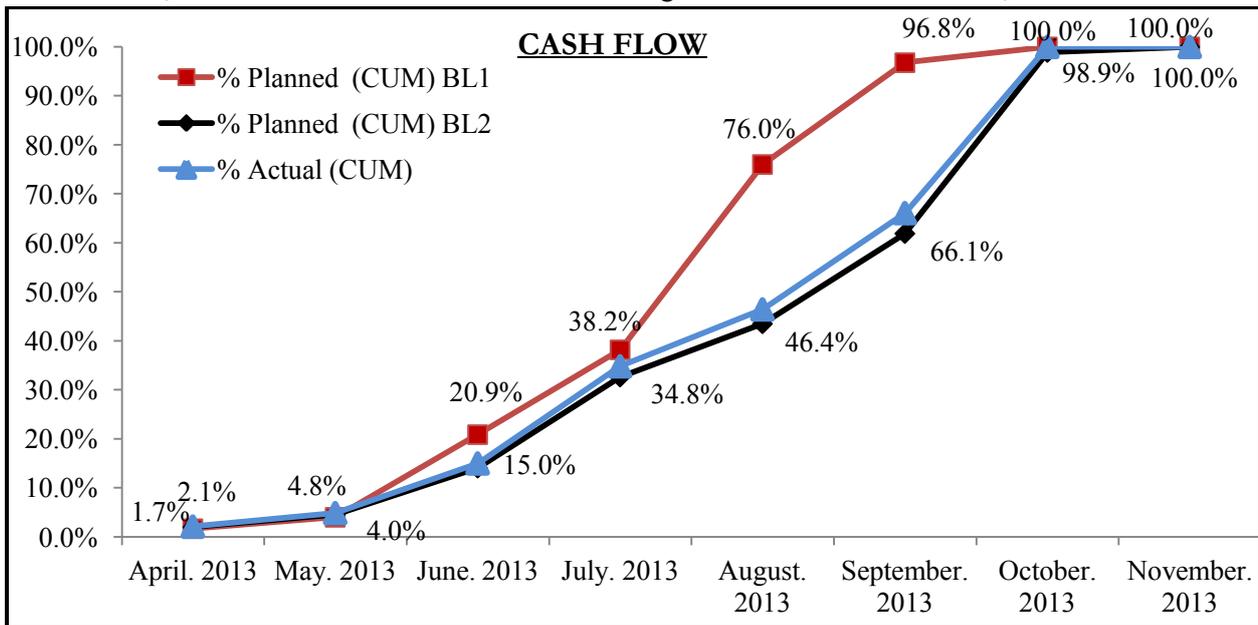
Figure 2.6: Al Thirwa Schools Road and Roads Retaining Structures Works Progress – S-curve

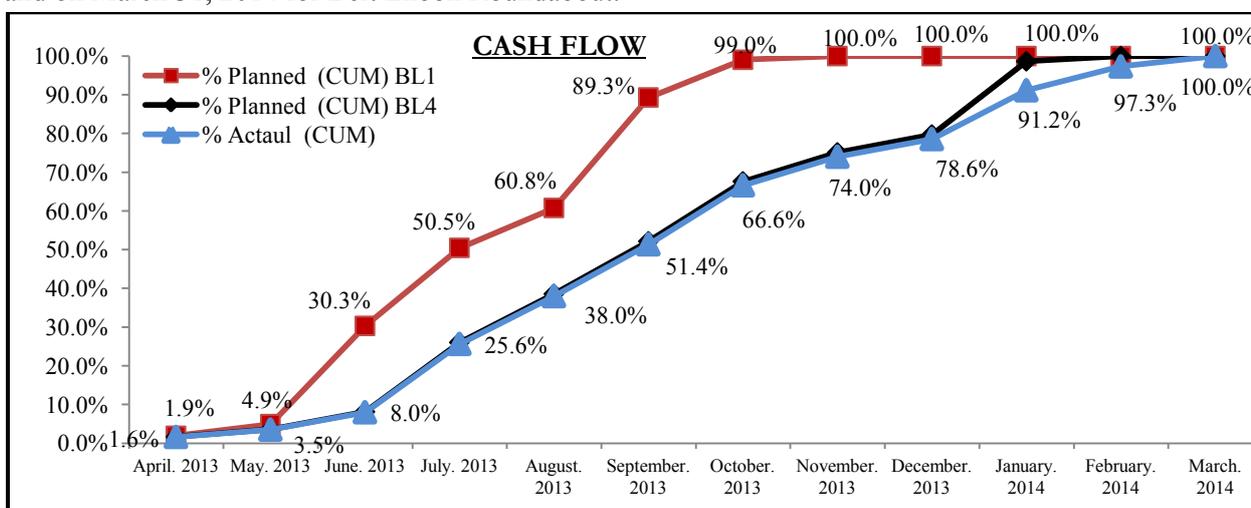
Figure 2.7: Milling and Overlay of Hebron Internal Roads Works Progress – S-curve

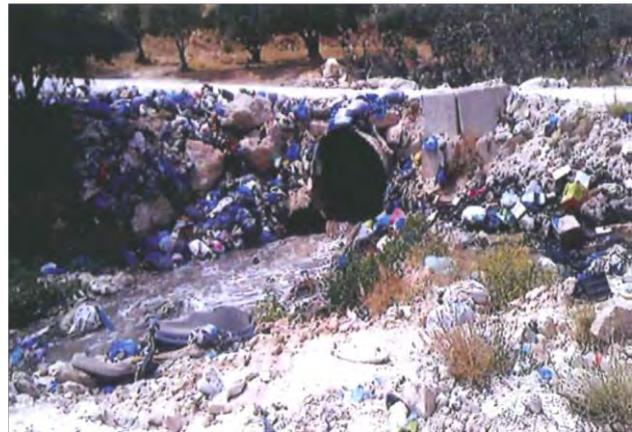
4.2 Existing Asbestos containing culvert encasement: after discovery of existing Asbestos containing culvert at St. C0+122, CMC site memo No. SM-13-00004-SSC-E-C-011 instructed the contractor to encapsulate the existing culvert with concrete in a safe method that protects the workers, the public and the environment. Activity Hazard Analysis (AHA) was prepared including proper method to encase

Figure 3.5: Existing Asbestos containing culvert at St. C0+122.

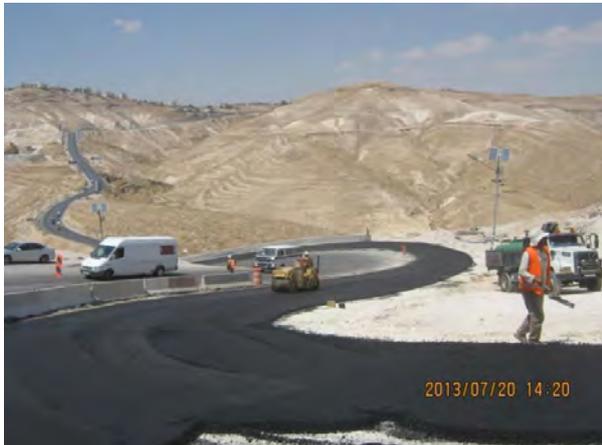
1- **Heavy Traffic:** one of the most serious challenges during this road implementation was performing the construction activities and managing the heavy traffic within a major thoroughfare connecting the northern and southern governorates in the West Bank. Traffic and safety plans were planned and strictly implemented to eliminate any safety hazard on motorists and labors. Asphalt works were challenging due to heavy traffic and steep slopes, coordination with Bethlehem police and safety plan was prepared to control asphalt works, the works finished with zero accidents.

Figure 3.8: Challenging asphalt works due to heavy traffic and steep slopes.

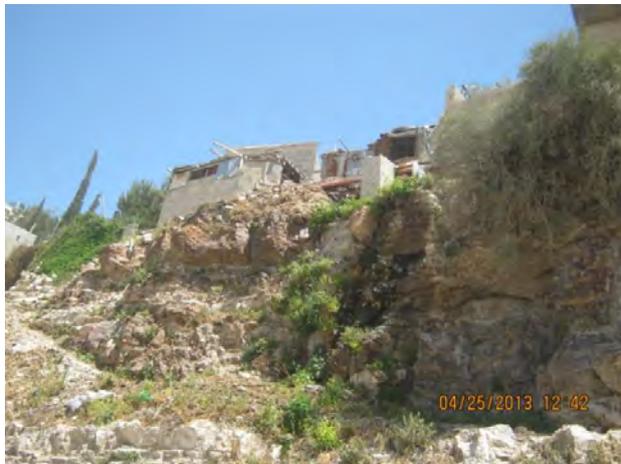
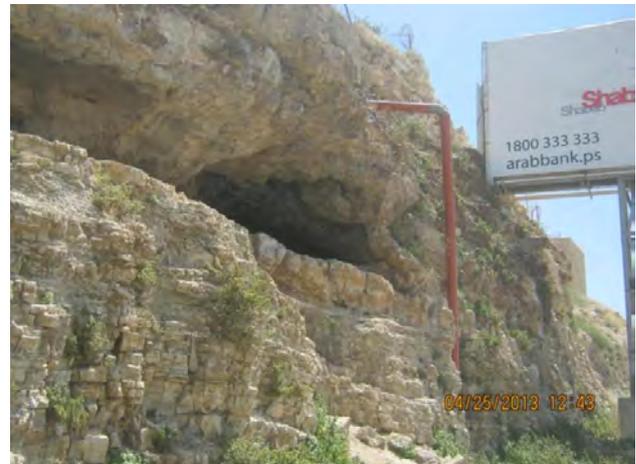
Figures 3.12 and 3.13: Existing hazards presented by high cliffs (residential area) over work area.

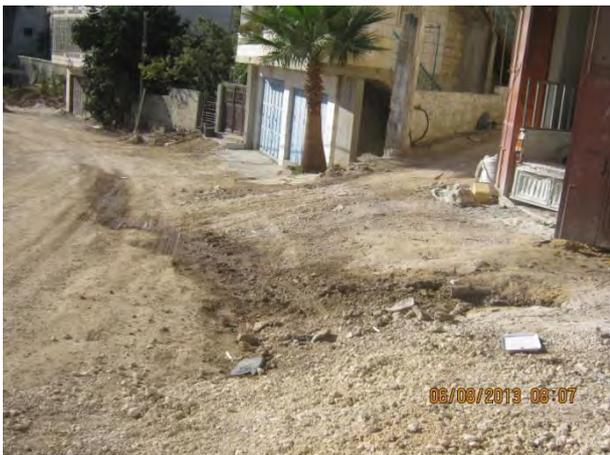
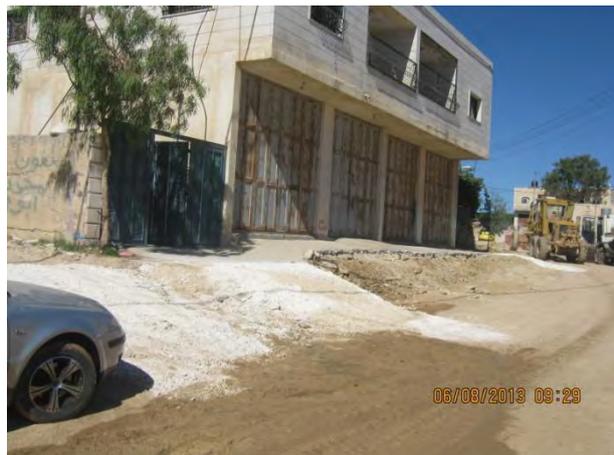
Figures 3.17 and 3.18: Leakage of Existing Septic tanks along Segment A.

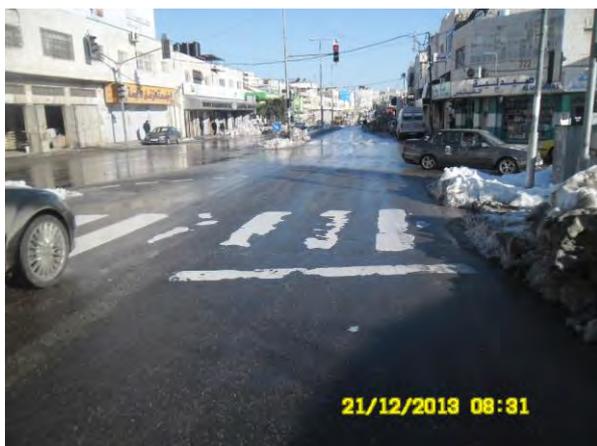
Figure 3.26: Damages of thermoplastic road marking caused by Hebron municipality snow removal at Al Salam Road.

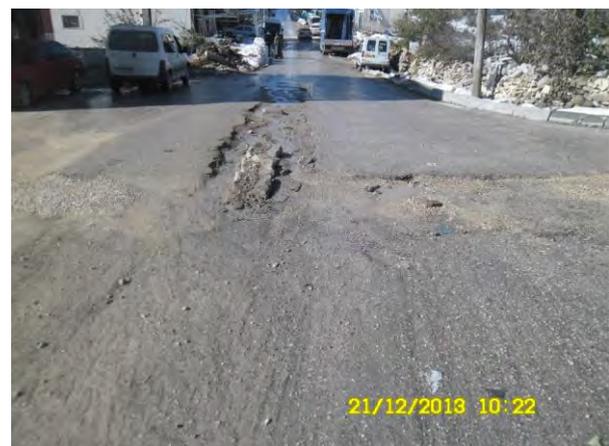
Figure 3.27: Removal of constructed median in University Road #2 after Hebron municipality removed snow from the road.

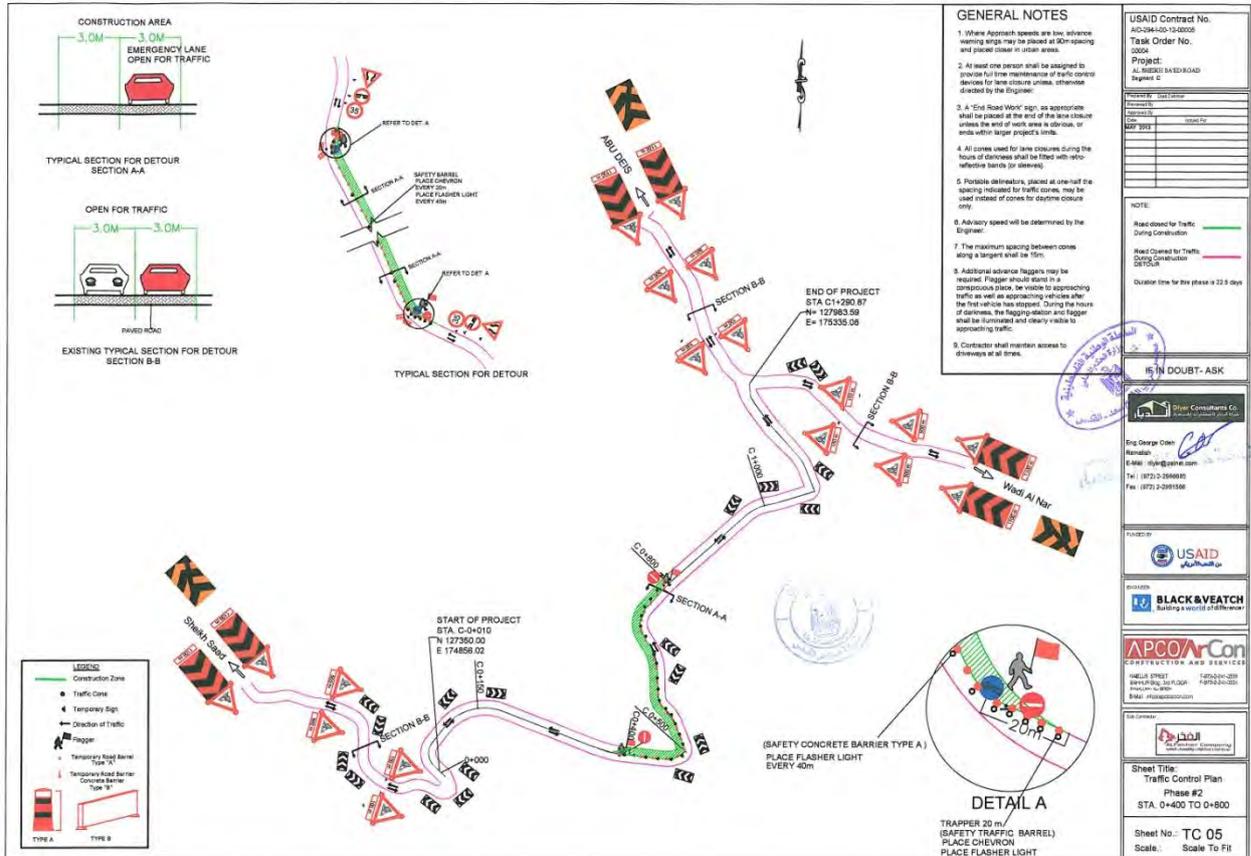
Figure 5.5: Sample sheet of approved traffic control plan for Project 03- with the required approvals and stamps from all related authorities.

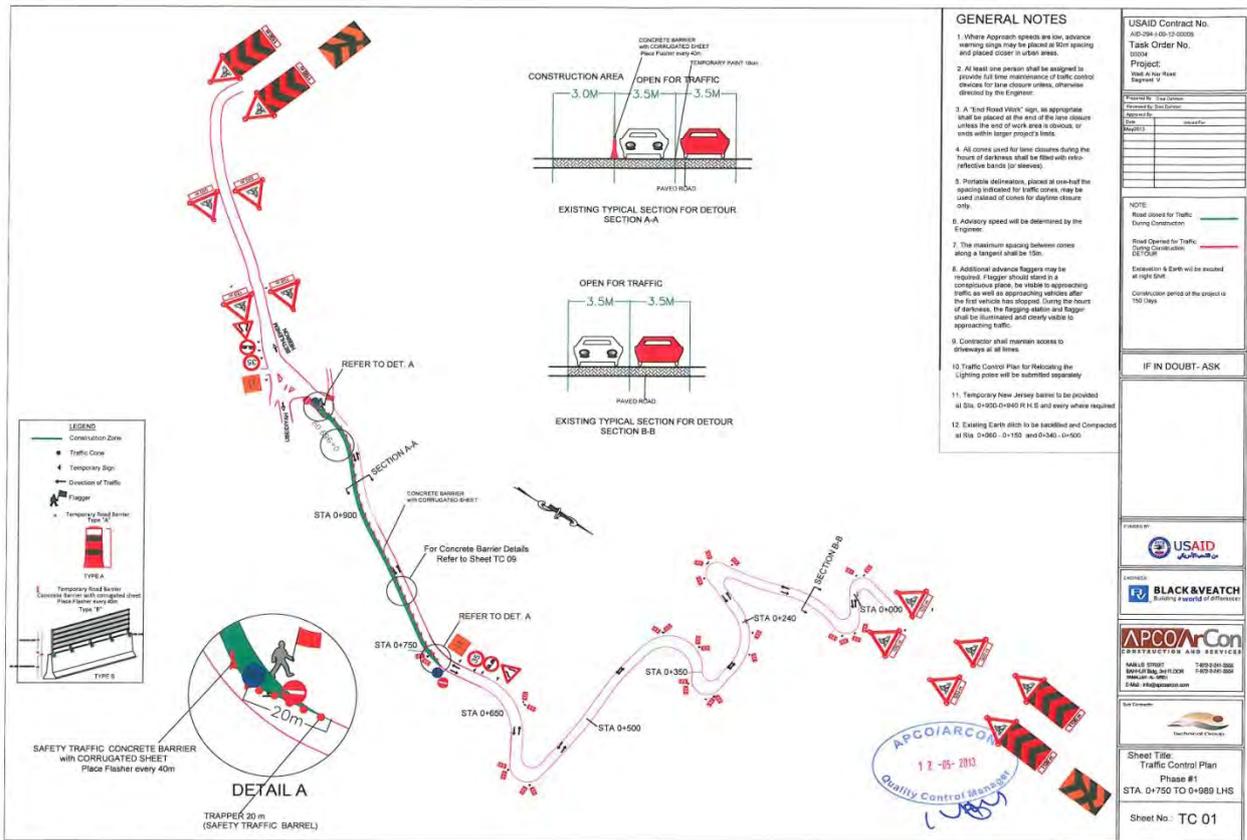
Figures 5.6: Project 04- WNV- Sample sheet of approved traffic control plan.

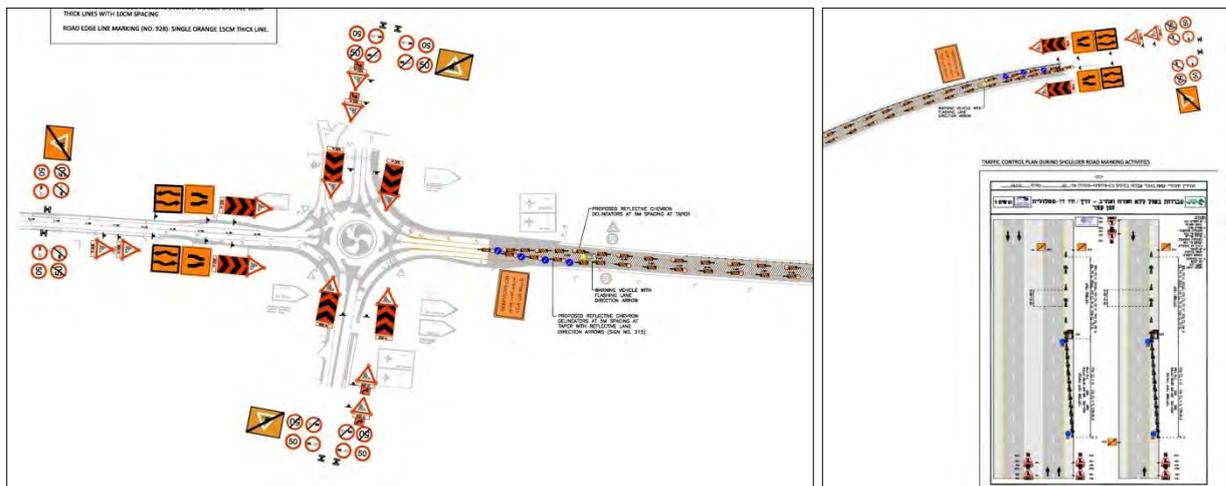
Figures 5.7: Project 05- QAL- Sample sheet of approved traffic control plan.

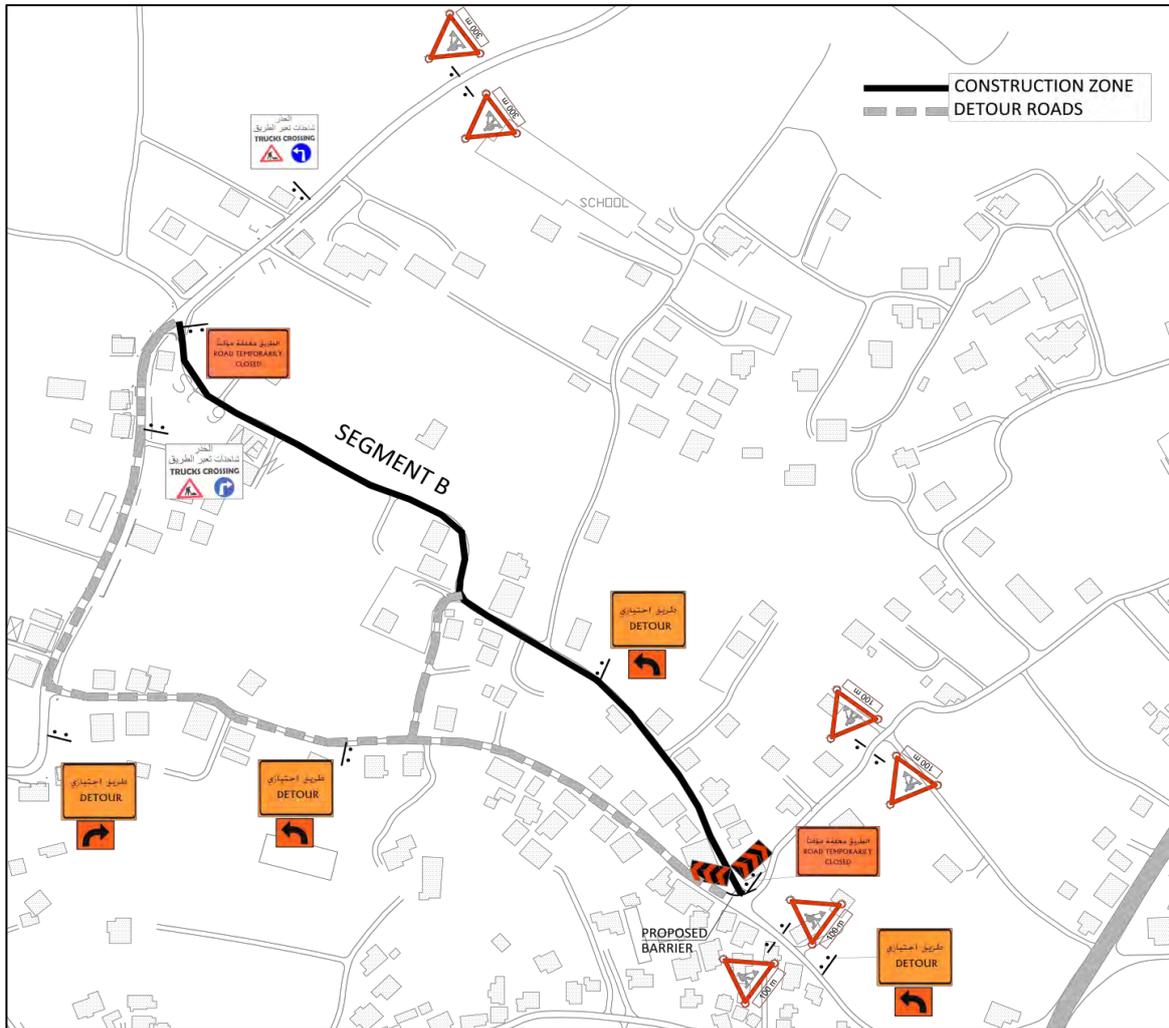
Figures 5.8: Project 06-THR- Sample sheet of approved traffic control plan – Segment B.

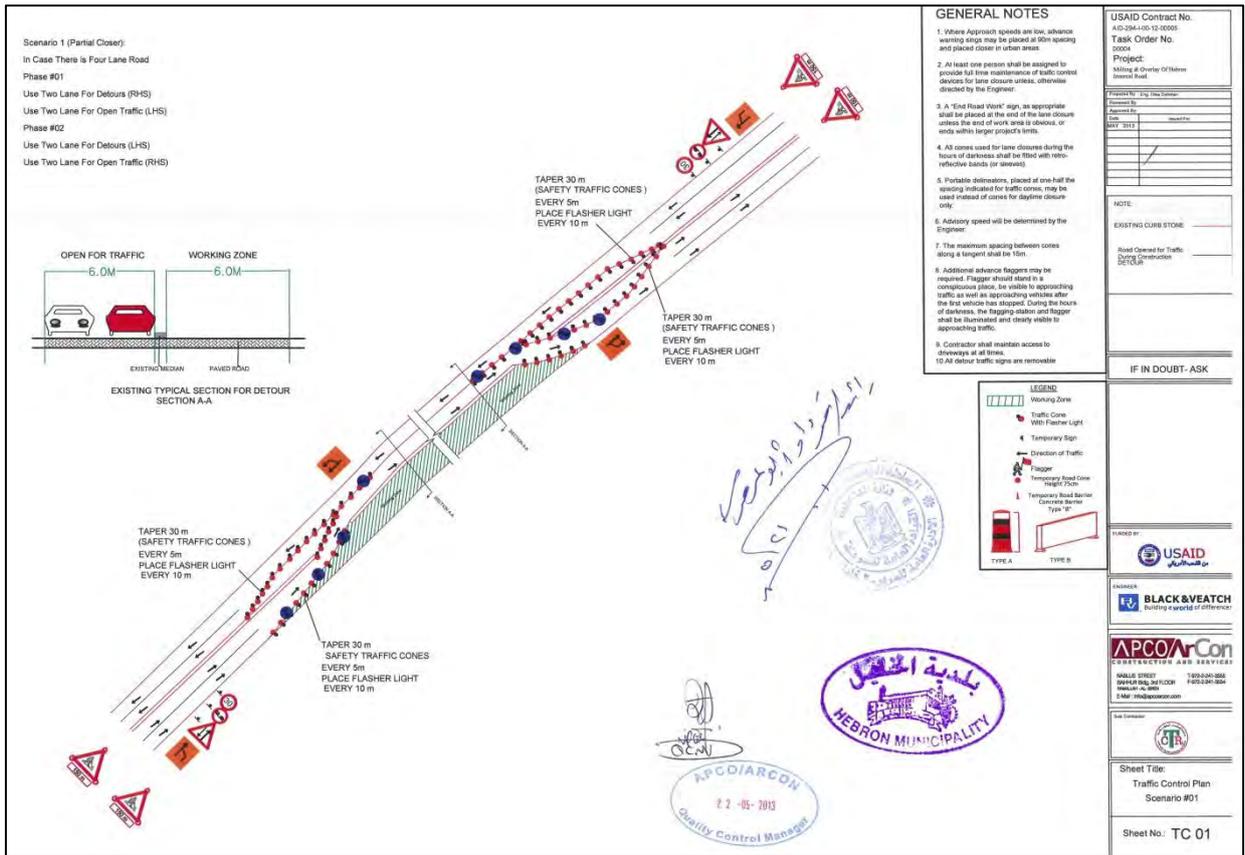
Figures 5.9: Project 07-HEB- Sample sheet of approved traffic control plan – LHS/RHS for 4 lane road.

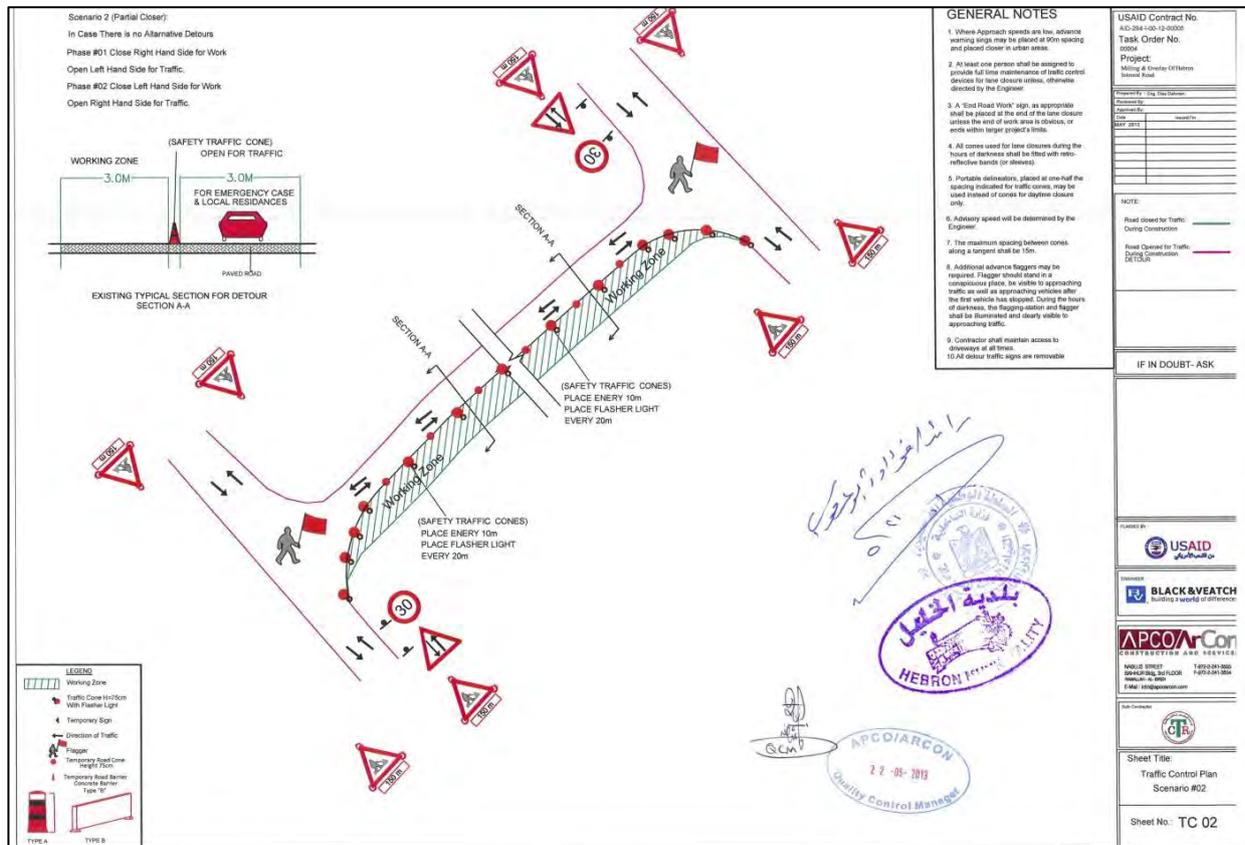
Figures 5.10: Project 07-HEB- Sample sheet of approved traffic control plan – Partial closure for roads when no alternative detours were available.
