# USAID | WEST BANK/GAZA

## FINAL REPORT

MULTIPLE ROADS PROJECT IN THE SOUTH

August 2014 AID-294-TO-13-00004

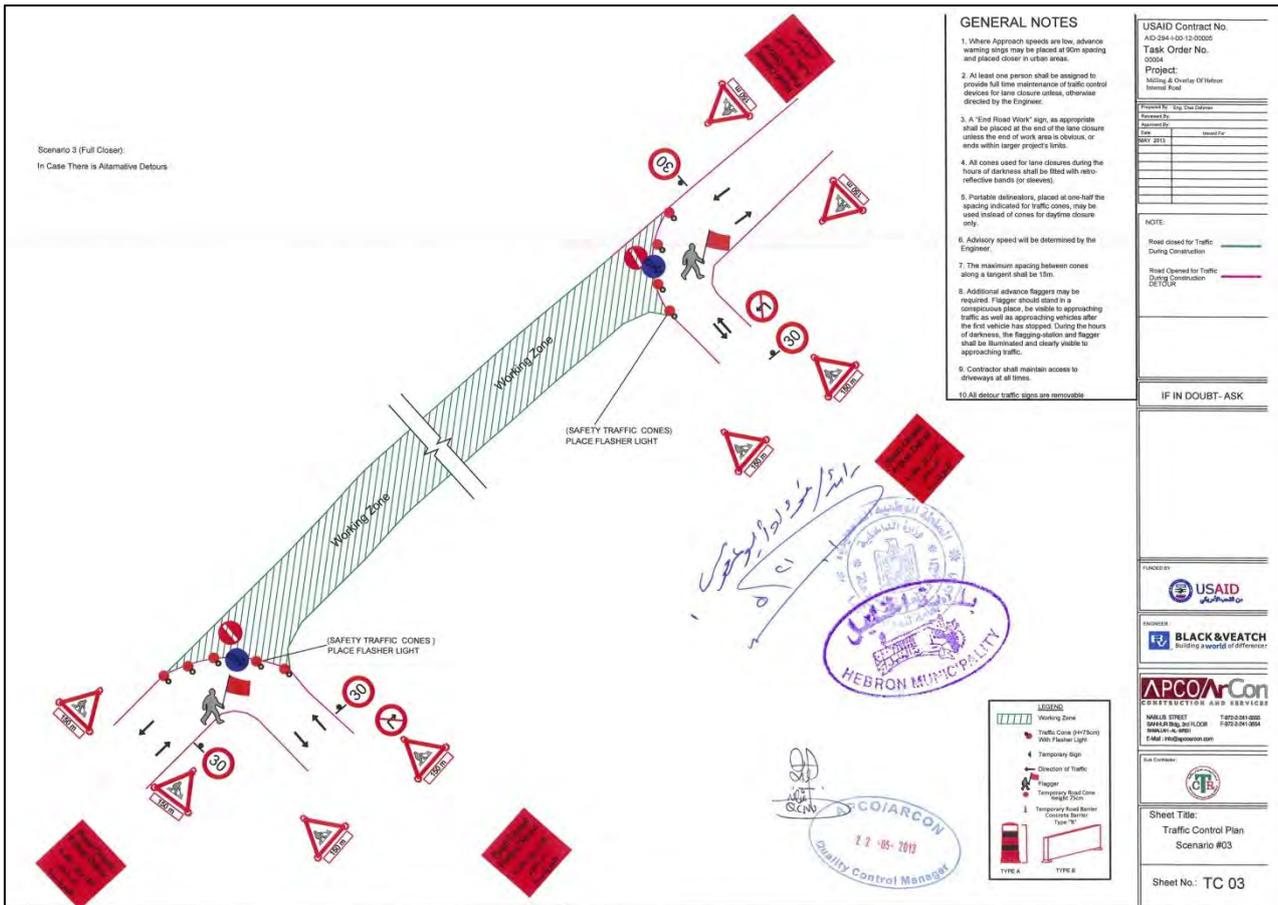
Figures 5.11: Project 07-HEB- Sample sheet of approved traffic control plan – Total close: when existing local roads were available as temporary detours.

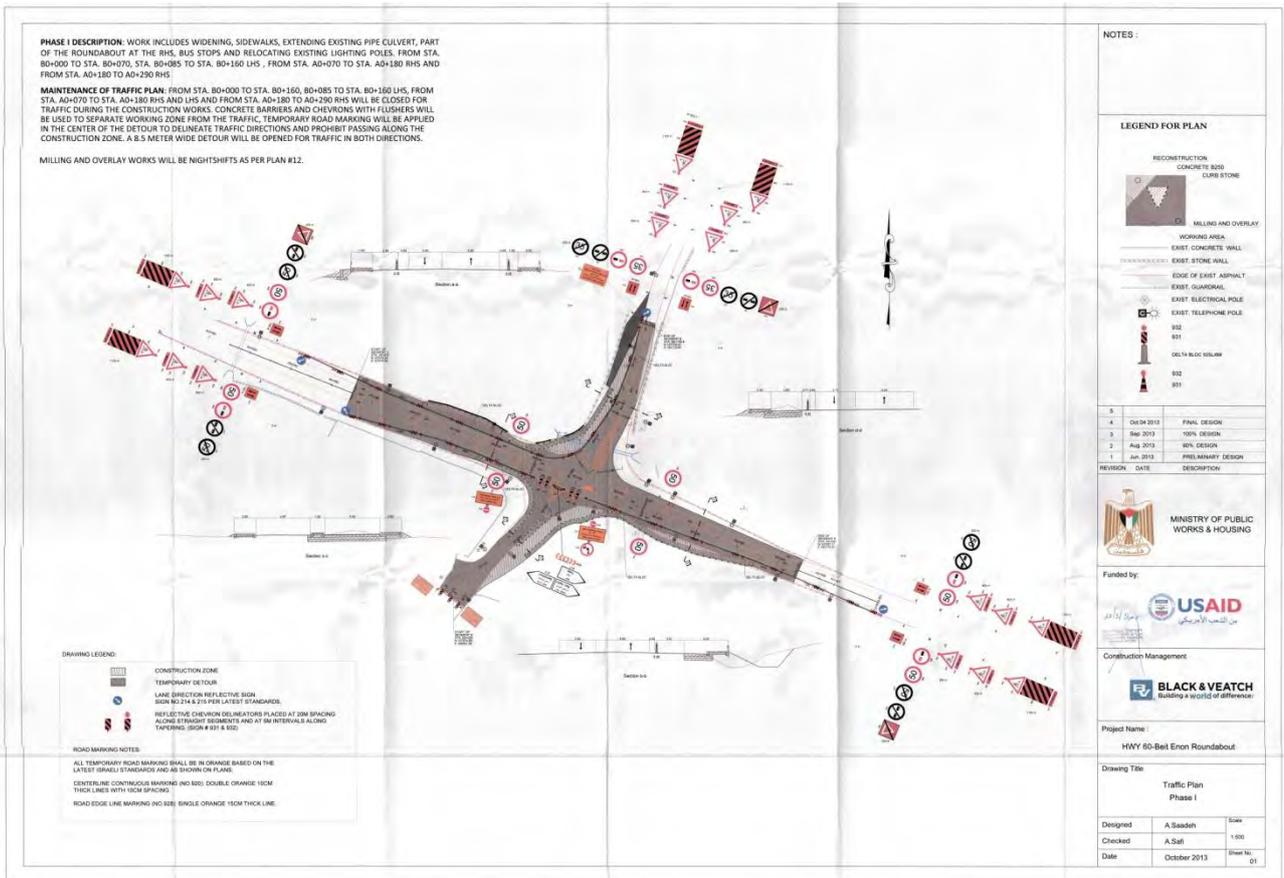
Figures 5.12: Project 07-HEB- Beit Enoon Roundabout – approved traffic control plan – Phase I.

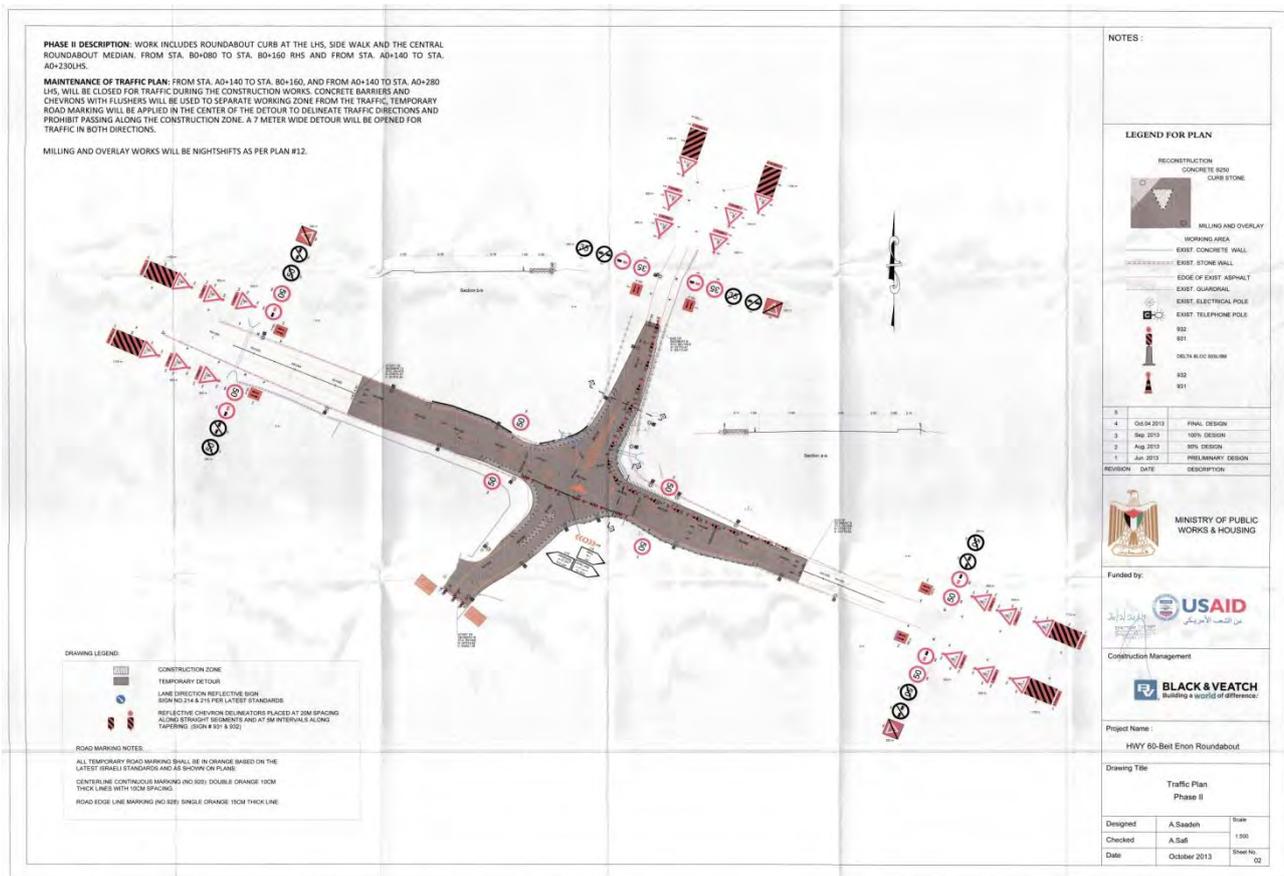
Figures 5.13: Project 07-HEB- Beit Enoon Roundabout – approved traffic control plan – Phase II.

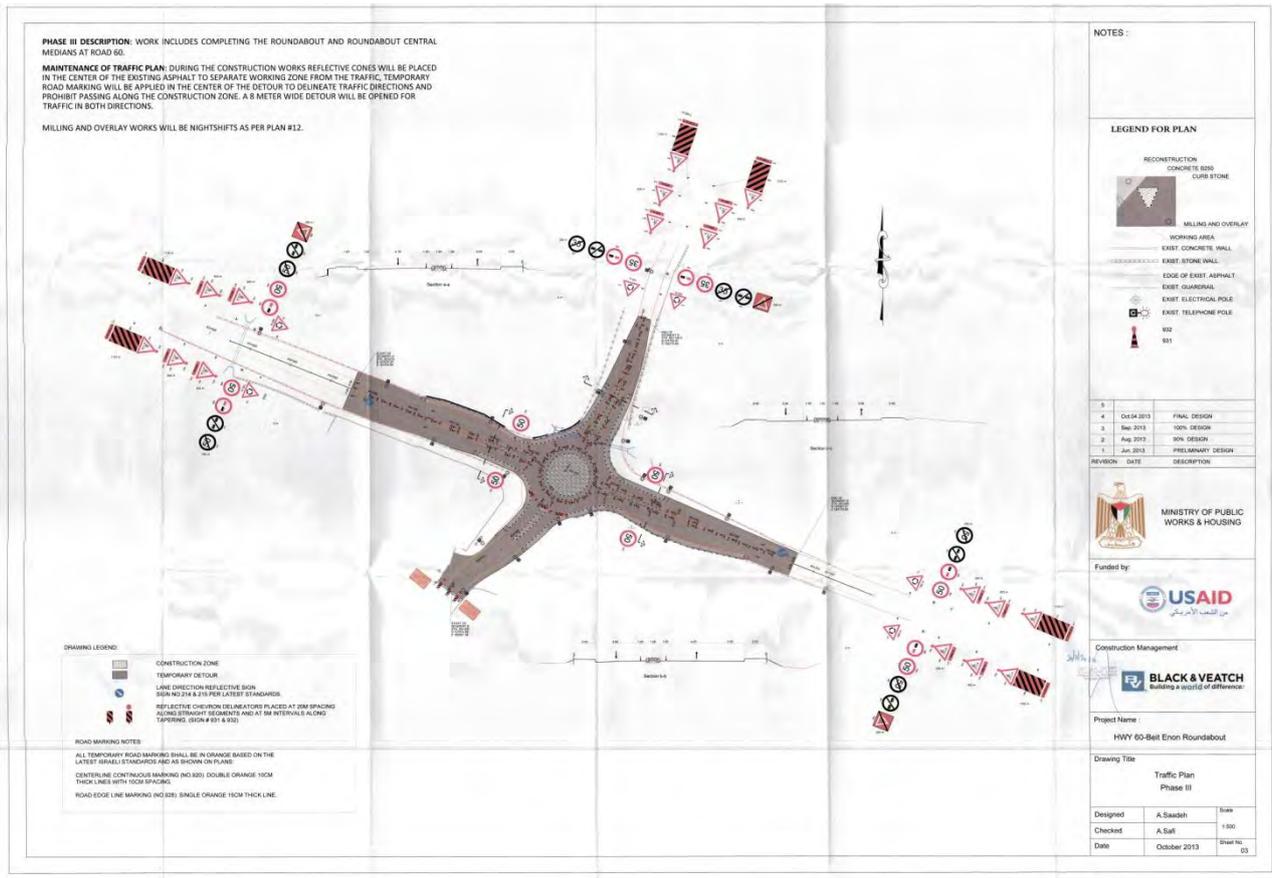
Figures 5.14: Project 07-HEB- Beit Enoon Roundabout – approved traffic control plan – Phase III.

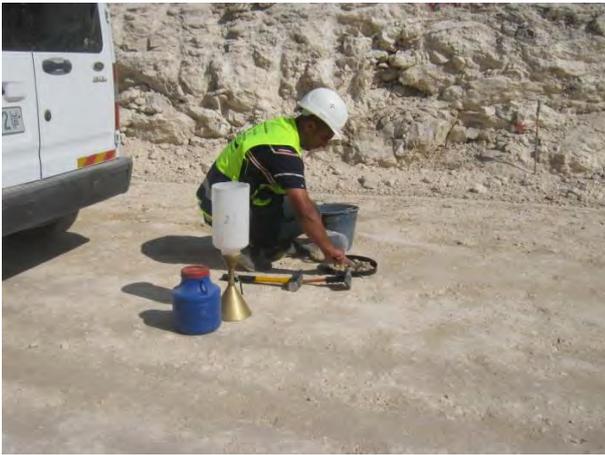
Figure 6.1: Subgrade Compaction Test -Project 01.
