**Enterprise Energy Efficiency - 3E**

***PILOT PROJECT PROPOSAL No. B3-2***  
***BIHAC CULTURAL CENTER COMPLEX***

**SITE VISIT REPORT**  
**AND**  
**PILOT PROJECT PROPOSAL EVALUATION**

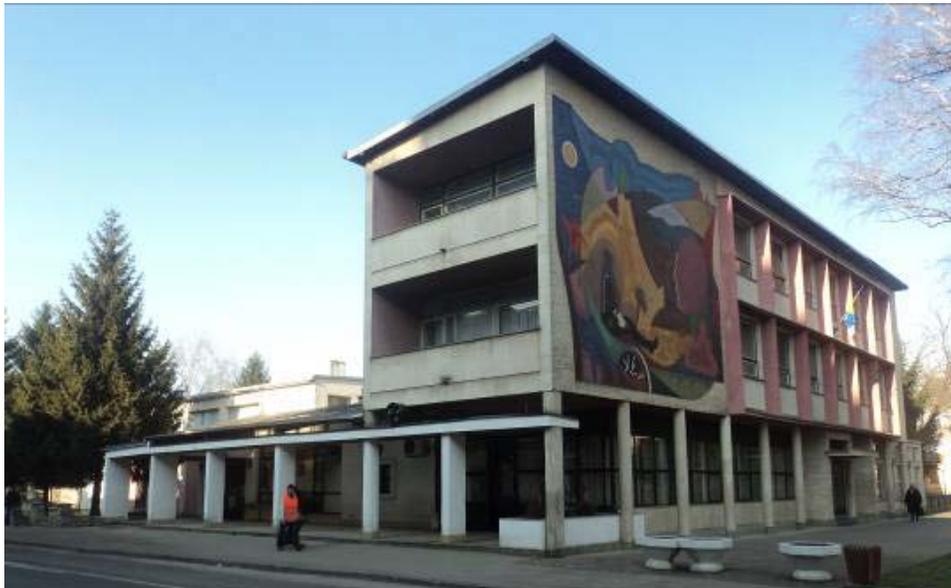
Figure 1 Cultural Center in Bihac

Figure 1). It houses the largest auditorium used for concerts, plays and exhibitions. The complex used to be owned by the army but is now used and financed by the Municipality of Bihac. The Cantonal Museum and the Art School are located in close proximity to each other and to the Cultural Center. In Figure 3 the yellow building on the left side is the Cantonal Museum and the grey building is the side of the Art School.

The Cultural Center was built in the 1960s according to the building code requirements of the time, which means that the building is energy inefficient by today's standards. The roof and façade are not insulated and most of the windows are in poor condition causing high heat loss. The building has 3 floors with a total surface area of 1276 m<sup>2</sup>. The heating for the Cultural Center, Cantonal Museum and the Art School used to be supplied by a district heating system with a heating substation located in the basement of the Cultural Center (Figure 5). This system is not working, and the heating is provided by firewood and electricity in a decentralized heating system, which is highly inefficient. Also, stockpiles of firewood in the yard between the buildings in downtown Bihac are an eyesore. There are radiators installed in the buildings, but they are not working.

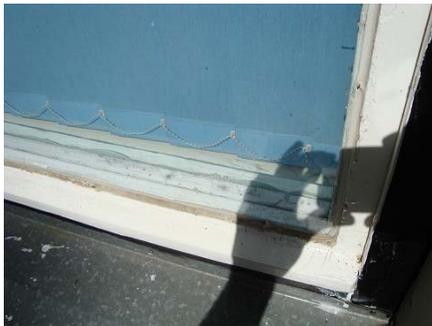
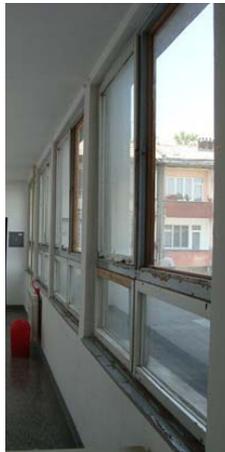
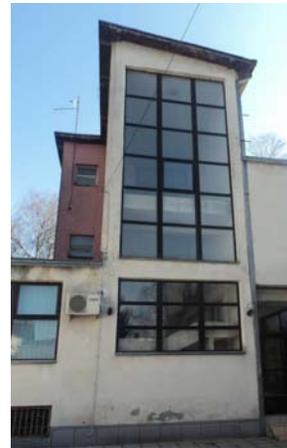
The only EE measure implemented to date was the replacement of about one quarter of all windows in late 1990's. They were replaced by double paned, aluminum framed windows. The rest of the windows haven't been properly maintained and are in poor condition (Figure 4).

**Figure 4 Old windows (left and center) and new windows (right) of the Cultural Center in Bihac**

effective alternative to satisfy today's building code requirements and make them energy efficient is to replace the glass with low-E glass package.

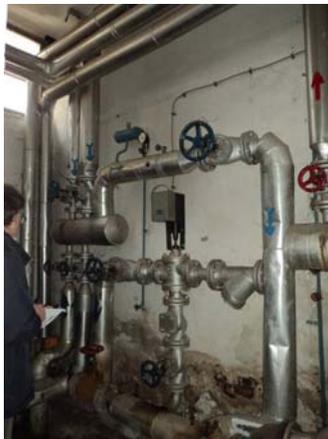
**Figure 5 Heating substation in the Cultural Center in Bihac**
