FINAL REPORT

TO 13-00005-SWN-SOUTHWEST NABLUS VILLAGES WATER SUPPLY PROJECT & AZ ZAWIEH NETWORK PROJECT (ZWN)

PROJECT 1-SOUTHWEST NABLUS VILLAGES WATER SUPPLY
PROJECT (SWN)

PROJECT 2-AZ ZAWIEH NETWORK PROJECT (ZWN)

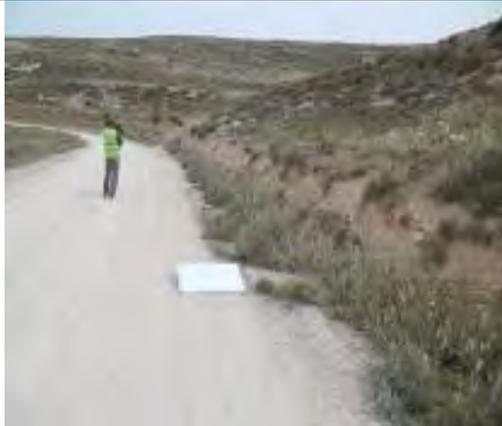
<p>Photo #: 1 - SWT Video Tape Along The Route of Transmission Pipeline May 18 2013</p>	<p>Photo #: 2 - SWT Excavation work for Foundations of the Temporary Project Sign for the Transmission Pipeline June 03 2013</p>

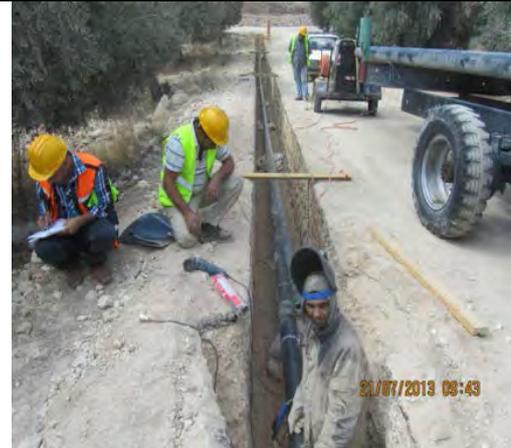
<p>Photo #: 3 - SWT Pipe Installation -Transmission Pipeline July 21 2013</p>	<p>Photo #: 4 – SWT Trench Excavation-Transmission Pipeline August 13 2013</p>

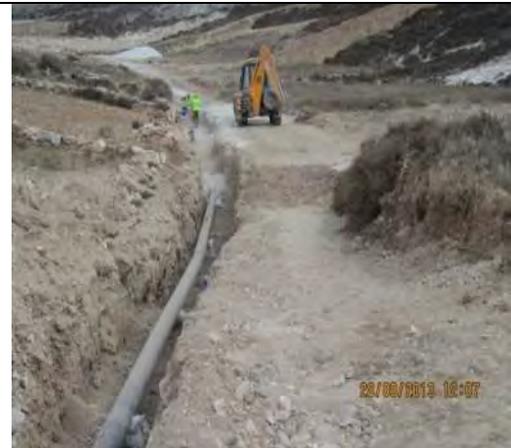
<p>Photo #: 5 – SWT Transmission Pipeline installation from Bureen Reservoir. September 28 2013</p>	<p>Photo #: 6 – SWT Installation of 4” &6” pipes-Transmission Pipeline October 27 2013</p>

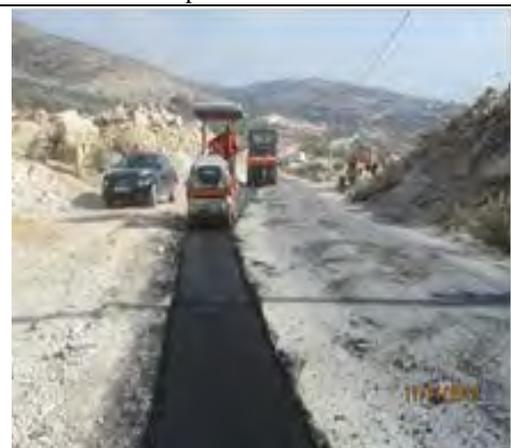
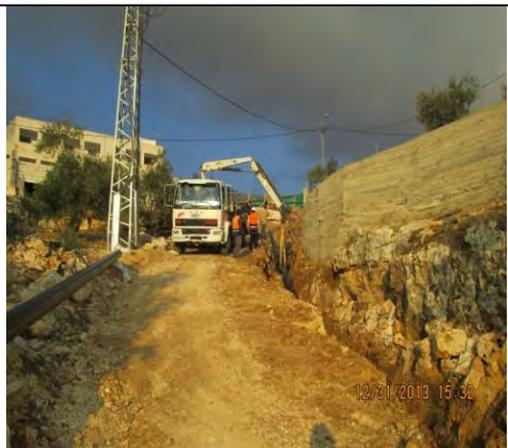
<p>Photo #: 7 – SWT Applying & compacting wearing asphalt layer November 17 2013</p>	<p>Photo #: 8 – SWT Installation of 8” steel pipes December 31 2013</p>

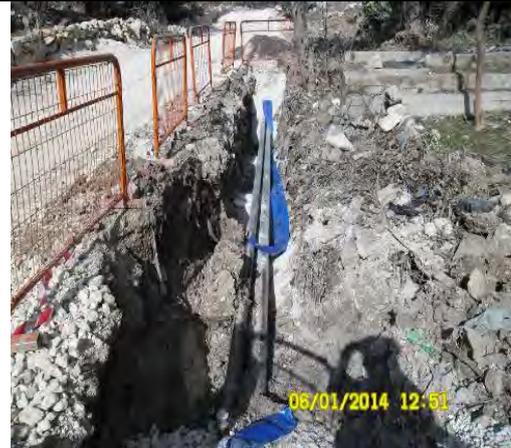
<p>Photo #: 9 – SWT Installation of 8” & 4” steel pipes (double trench) January 06 2014</p>	<p>Photo #: 10 – SWT Excavation to install a precast manhole February 23 2014</p>

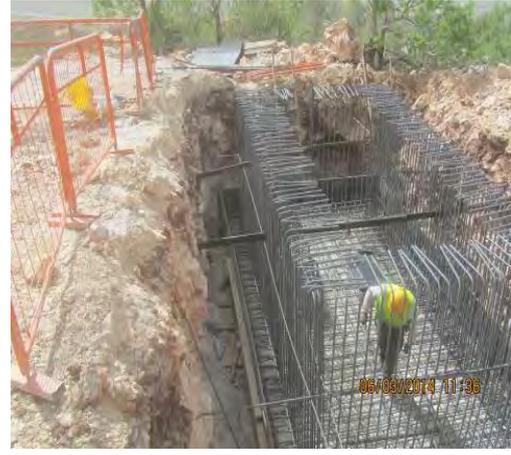
<p>Photo #:11– SWT Fixing steel reinforcement for walls of the inlet and outlet connection chamber near Burien reservoir. March 06 2014</p>	<p>Photo #:12– SWT Welding work for 6” steel pipeline in the presence of the CWI April 20 2014</p>

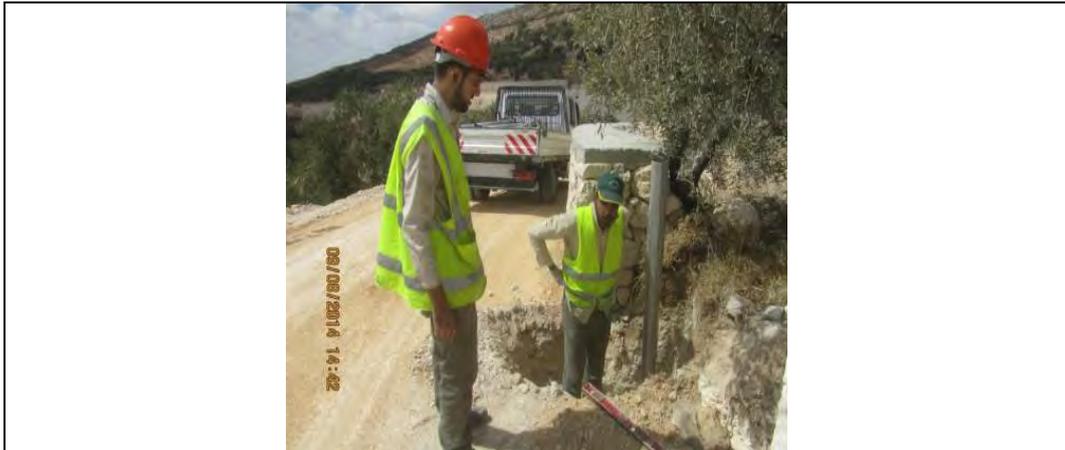
Photo #:15- SWT
 Installation of the marker post.
 August 09 2014

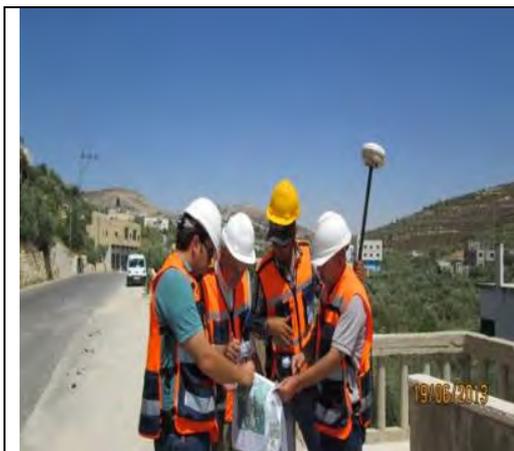
Photo #: 1 - MDN
 Video Tape Along The Route of Transmission
 Pipeline
 June 13 2013

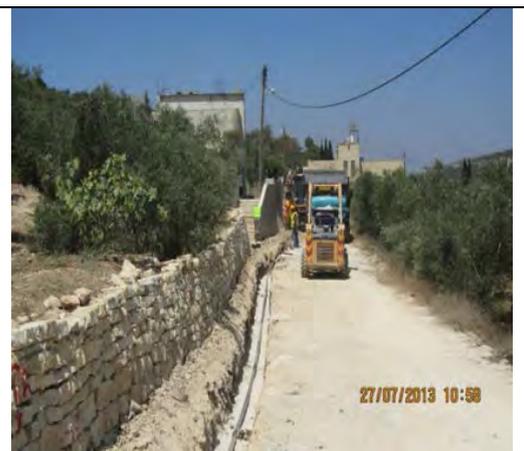
Photo #: 2 - MDN
 Pipe Installation
 July 27 2013

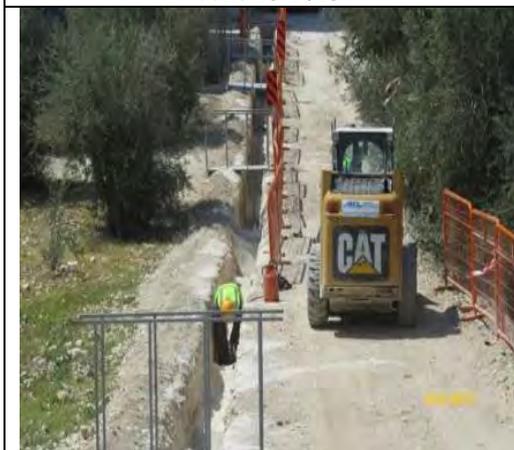
<p>Photo #: 3 - MDN Installation of 2" pipes, bedding materials along (M2-001-2) August 13 2013</p>	<p>Photo #: 4 – MDN Pipe Installation September 11 2013</p>

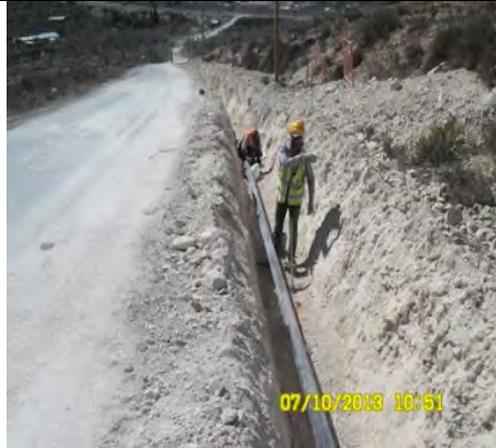
<p>Photo #: 5 – MDN Installation of 4" Pipes along M4-032 – MDN October 07 2013</p>	<p>Photo #: 6 – MDN Installation of Manholes and internal valve and fitting November 17 2013</p>

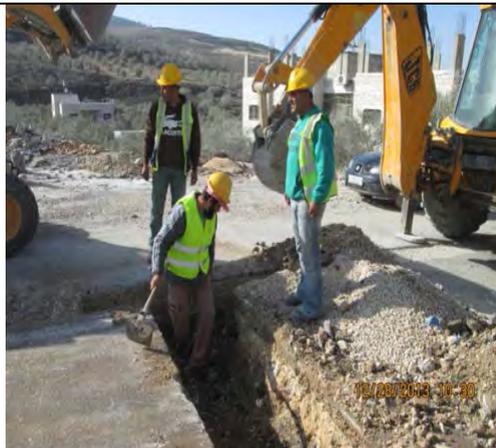
<p>Photo #: 7 – MDN Excavation works for future connection December 23 2013</p>	<p>Photo #: 8 – MDN Installation of house connection. January 01 2014</p>

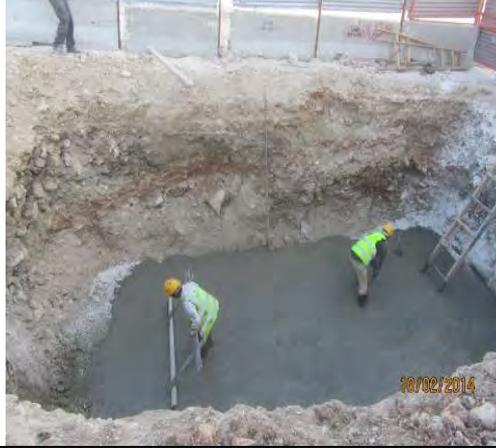
<p>Photo #: 9 – MDN Leveling the blinding concrete layer under the base slab of the PRV chamber. February 10 2014</p>	<p>Photo #: 10 – MDN Compacting the base course material layer. March 4 2014</p>

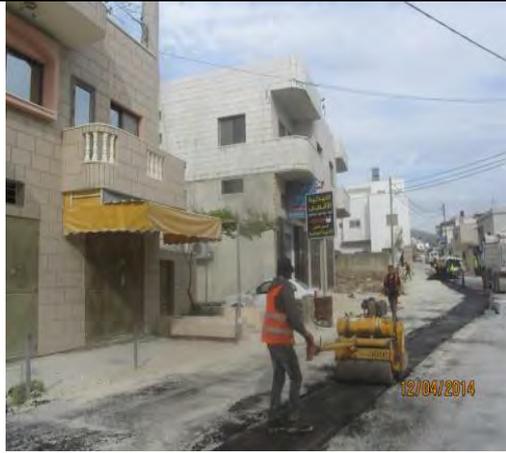
<p>Photo #:11– MDN Compacting the first layer of asphalt using steel roller. April 12 2014</p>	<p>Photo #:12– MDN Residents and children of Madama village raising the USAID leaflets during the asphalt activity. May 17 2014</p>

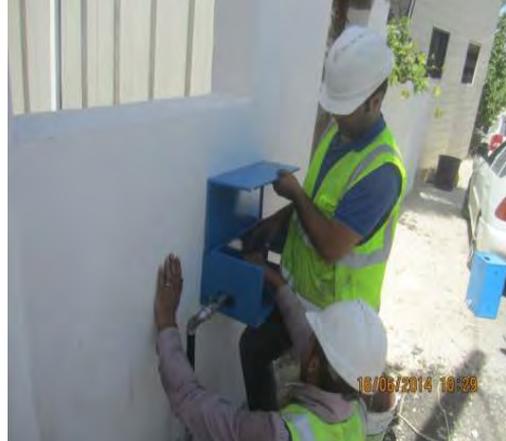
<p>Photo #:13– MDN Installation of prepaid water meters enclosures. June 16 2014</p>	<p>Photo #:14– MDN Filling the water network prior to conducting disinfection. July 16 2014</p>

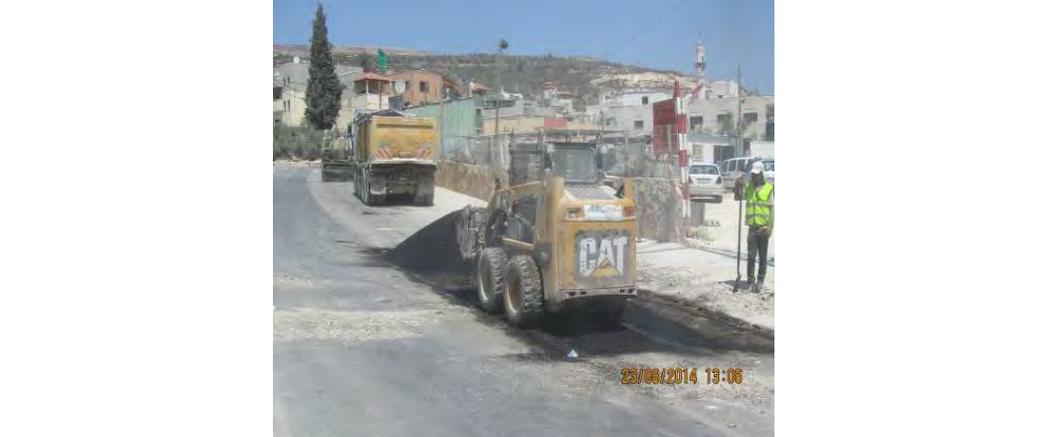
<p>Photo #:15– MDN Paving asphalt layers for trench reinstatement near Madama storage yard. August 23 2014</p>

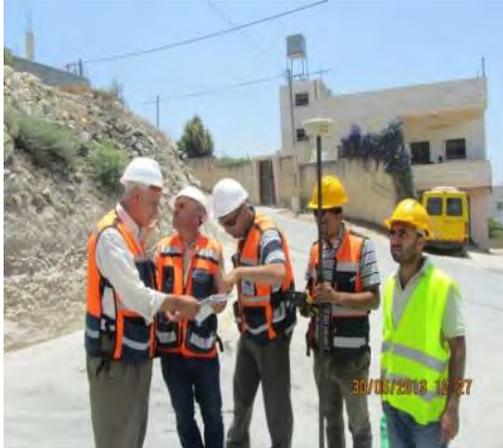
<p>Photo #: 1 - AQN Field walkthrough at Asira Al Qibliya June 30 2013</p>	<p>Photo #: 2 - AQN Pipe Installation September 23 2013</p>

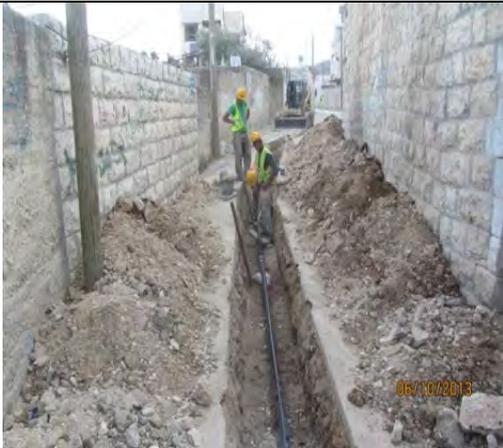
<p>Photo #: 3 - AQN Installation of 2" along (A2-009) October 06 2013</p>	<p>Photo #: 4 - AQN Welding of 4" steel pipes November 10 2013</p>

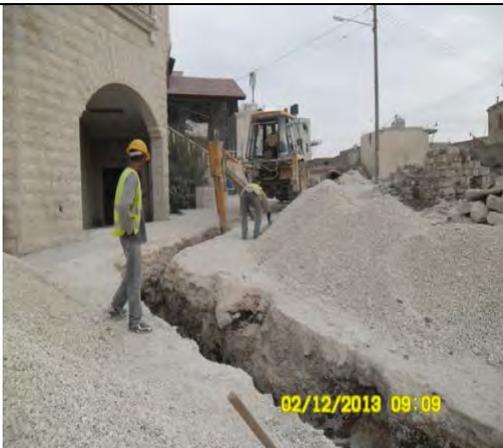
<p>Photo #: 5 - AQN I Excavation works for trench pipeline December 02 2013</p>	<p>Photo #: 6 - AQN Placed bedding material and warning tape. January 12 2014</p>

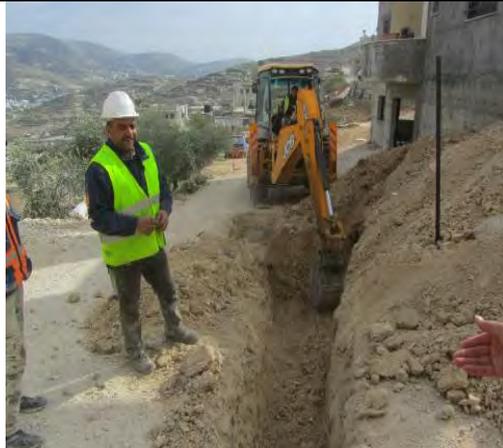
<p>Photo #: 7 – AQN Excavation work for 2’’ galvanized steel pipes by using JCB. February 03 2014</p>	<p>Photo #: 8 – AQN Casting concrete of the roof slab for the precast PRV. March 12 2014</p>

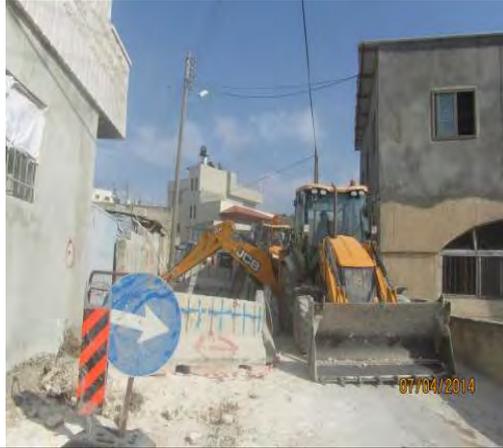
<p>Photo #: 9 – AQN L Excavation and installation of Pressure Release Valve. April 07 2014</p>	<p>Photo #: 10 – AQN Welding work for connecting the gate valve manhole with the 3’’ installed steel pipeline. May 4 2014</p>

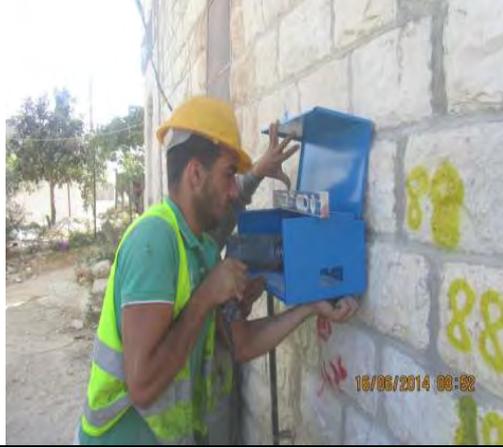
<p>Photo #:11– AQN Installation of prepaid water meters enclosures. June 16 2014</p>	<p>Photo #:12– AQN Casting concrete for the road shoulder at Asira village. July 22 2014</p>

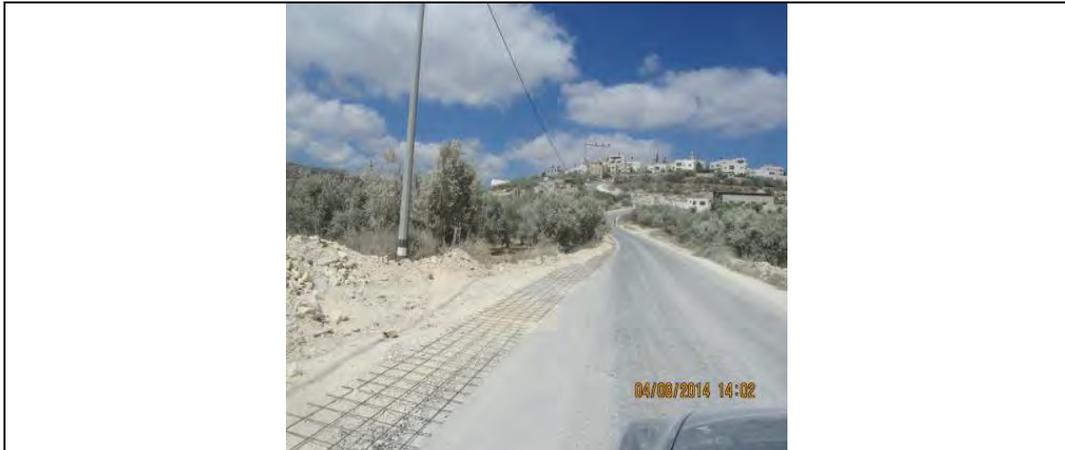
Photo #:13- AQN
 Placed steel wire mesh along the roads for concrete protection.
 August 04 2014

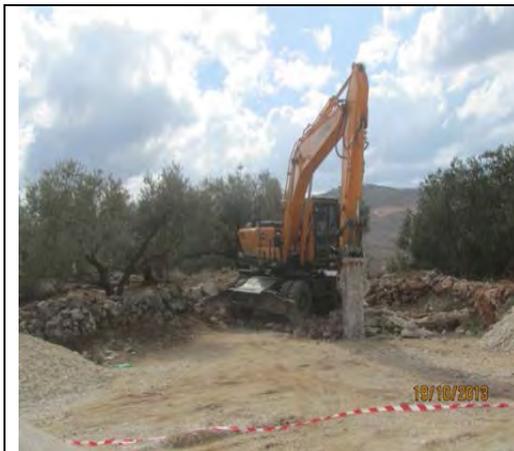
Photo #: 1 - URN
 Rock breaking using JCB along (UR2-031)
 October 19 2013

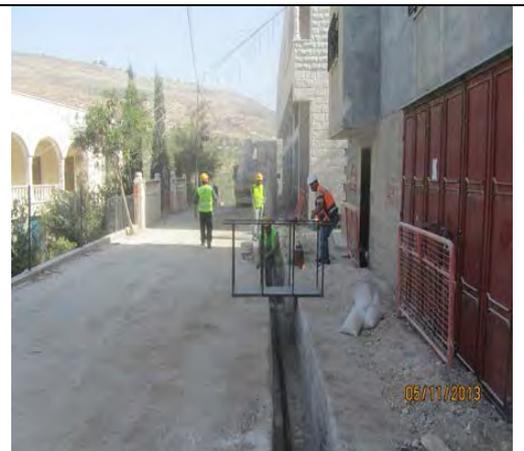
Photo #: 2 - URN
 Trench excavation using small trencher and
 installation of 2" galvanized steel pipes
 November 05 2013

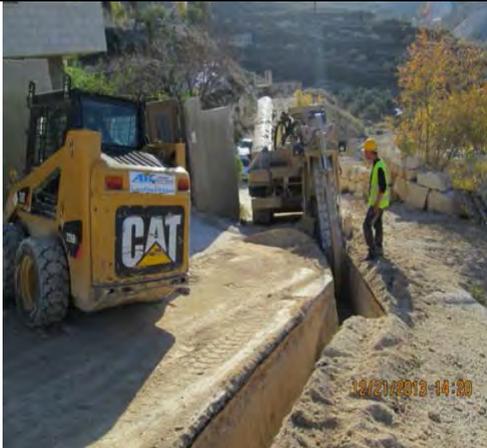
<p>Photo #: 3 - URN Trench excavation using small trencher December 21 2013</p>	<p>Photo #: 4 – URN Excavation work for the 2” GIPs using the small Trencher January 22 2013</p>

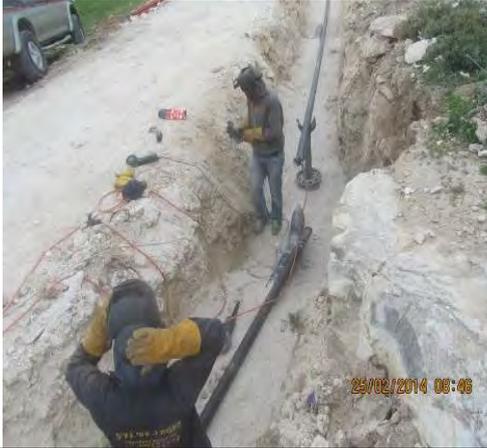
<p>Photo #: 5 – URN Welding work for 3” steel pipe February 25 2013</p>	<p>Photo #: 6 – URN Excavation work for house connections March 09 2014</p>

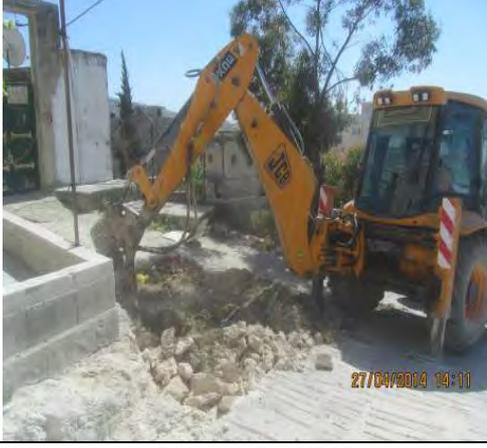
<p>Photo #: 7 – URN Excavation for house connection using JCB April 27 2014</p>	<p>Photo #: 8 – URN Excavation for the precast manhole May 18 2014</p>

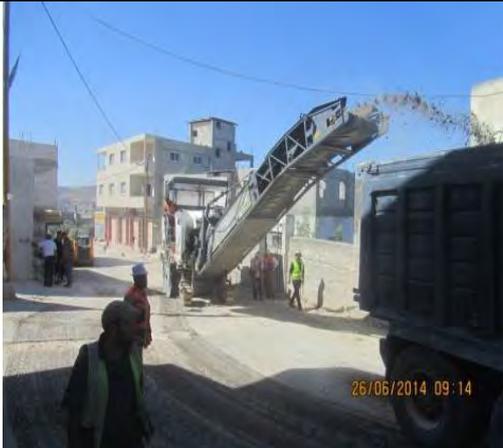
<p>Photo #: 9 – URN Start of milling activity for the internal roads at Urif village June 26 2014</p>	<p>Photo #: 10 – URN Cleaning the road prior to paving asphalt layer using unskilled labor and Bobcat July 05 2014</p>

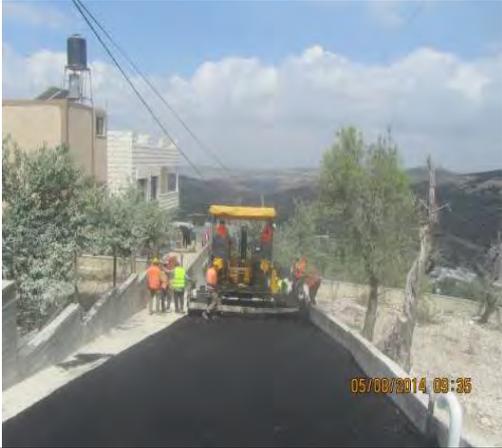
<p>Photo #:11– URN Spreading the asphalt in Urif internal roads using asphalt finisher August 05 2014</p>

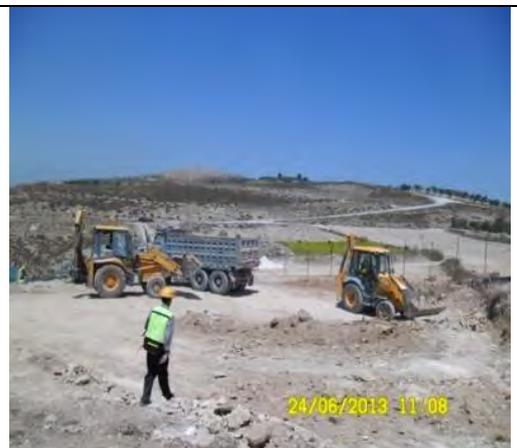
<p>Photo #: 1 - MDR Main Storage Yard May 24 2013</p>	<p>Photo #: 2 - MDR Excavation works for Madama reservoir foundation</p>

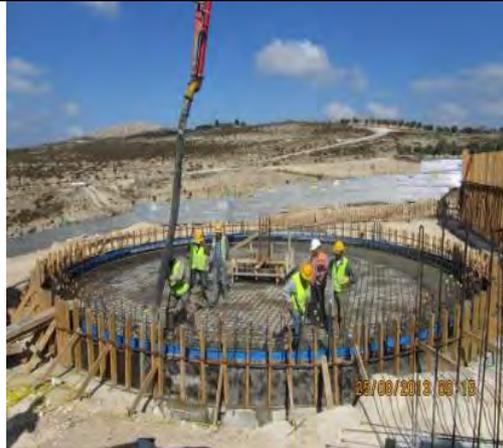
<p style="text-align: center;">Photo #: 3 - MDR Pouring of rubble concrete under foundation for Madama reservoir July 24 2013</p>	<p style="text-align: center;">Photo #: 4 – MDR Casting Concrete for the Ground Slab Madama Reservoir August 21 2013</p>

The Geotechnical Laboratory conducted a geotechnical inspection and testing at Madama and Asira Al Qibaliya Reservoirs' sites to investigate and validate the actual soil conditions underneath the reservoirs' base slabs. The testing results recommended improving the bearing capacity of the soil by providing a 40 cm rubble concrete layer under the reservoirs' base slabs. This was necessary to provide a uniform support for the reservoirs base slab while improving the soil bearing capacity.

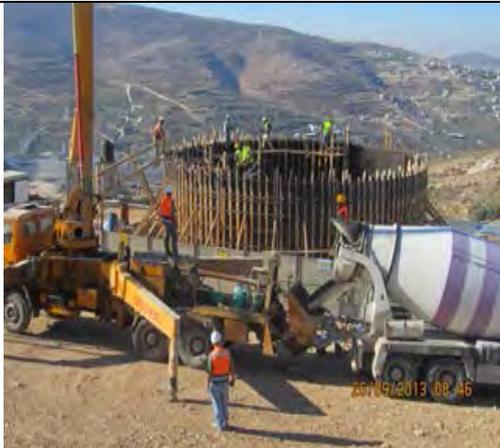
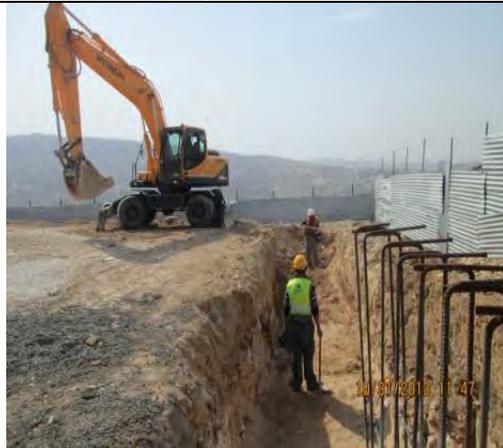
<p style="text-align: center;">Photo #: 5 – MDR Casting concrete for part one of the walls September 26 2013</p>	<p style="text-align: center;">Photo #: 6 – MDR Excavation works for retaining wall for Madama Reservoir October 31 2013</p>

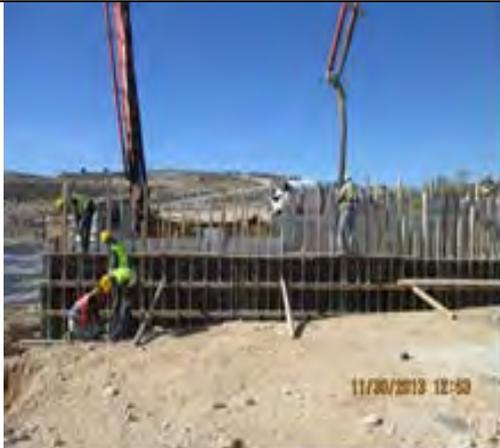
<p style="text-align: center;">Photo #: 7 – MDR Casting concrete for retaining walls Madama Reservoir November 16 2013</p>	<p style="text-align: center;">Photo #: 8 – MDR HC Installation December 31 2014</p>

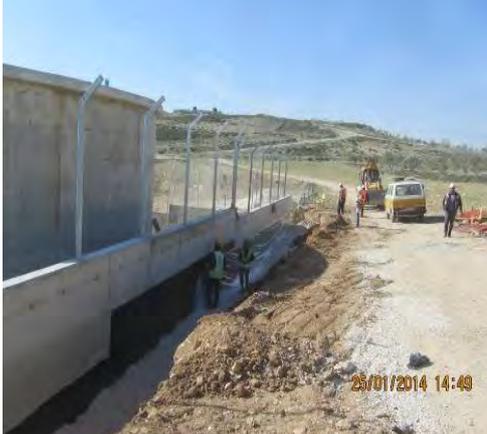
<p>Photo #: 9 – MDR Placing polyethylene sheets to protect the Nit proof 230 coating prior to backfilling January 25 2014</p>	<p>Photo #: 10 – MDR Fixing steel reinforcement for the base slab of the inlet and outlet connection chamber. February 24 2014</p>

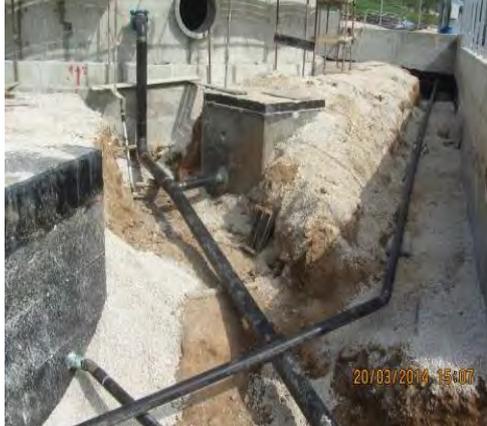
<p>Photo #:11– MDR Installation of the inlet & outlet pipelines inside the yard. March 20 2014</p>	<p>Photo #:12– MDR Preparations of steel reinforcement of the electrical duct banks April 22 2014</p>

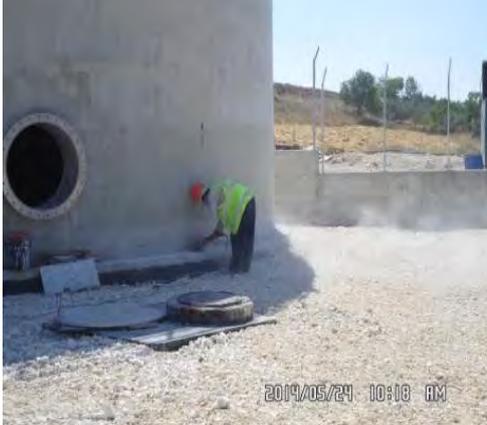
<p>Photo #:13– MDR Preparation of reservoir external wall for insulation. May 24 2014</p>	<p>Photo #:14– MDR Casting concrete of the external steps and the walkway June 11 2014</p>

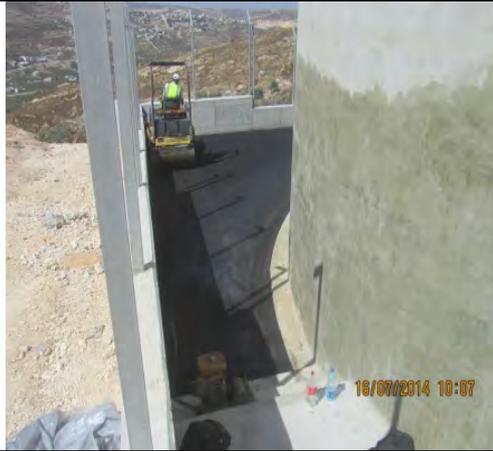
<p>Photo #:14- MDR Compacting the asphalt layer at reservoir yard using steel roller July 16 2014</p>	<p>Photo #:14- MDR Epoxy painting for the external wall of the reservoir August 07 2014</p>

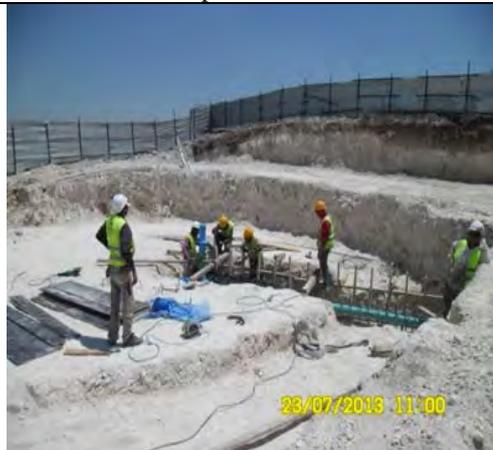
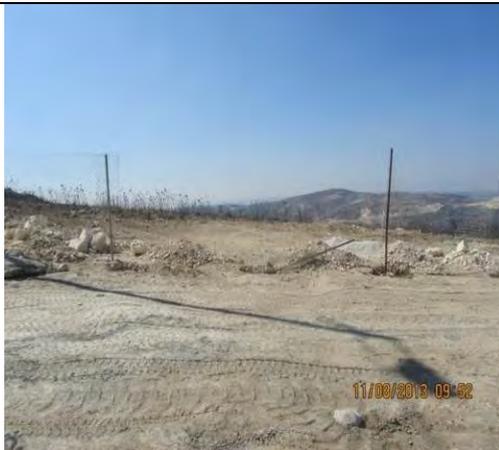
<p>Photo #: 3 - AQR Form work erection and steel fixing for washout piping- Asira Al Qibliya Reservoir July 23 2013</p>	<p>Photo #: 4 - AQR Settlers damaged the fence August 11 2013</p>

Following commencement of site works at Asira Al Qibaliya and Urif reservoirs, settlers from a nearby settlement have attacked and vandalized the sites on several occasions; these attacks have placed the project staff at risk and caused damages to the temporary facilities (fence, storage container and project sign). Therefore, and after due consultation between all parties, it was determined to replace the cast in situ retaining wall by a 3m high pre-cast concrete boundary wall (that is faster to erect) and a 1m solid metal fence on top of the concrete wall. Also, the fenced gate specified in the original design was replaced by a solid metal motorized entrance gate. These security modifications aimed at protecting the safety of project staff, material, equipment and ultimately USAID's investment.

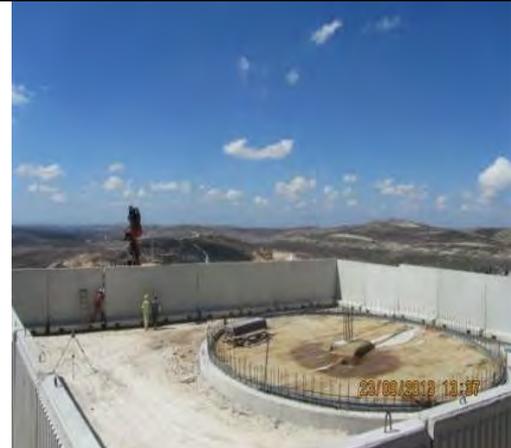
<p>Photo #: 5 – AQR completing installation of precast boundary walls September 23 2013</p>	<p>Photo #: 6 – AQR Fixing steel reinforcement of reservoir wall October 06 2013</p>

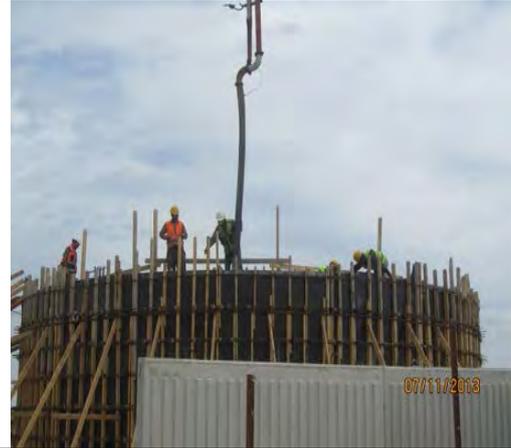
<p>Photo #: 7 – AQR Second stage of casting of reservoir wall November 07 2013</p>	<p>Photo #: 8 – AQR Installation of external scaffolding December 07 2013</p>

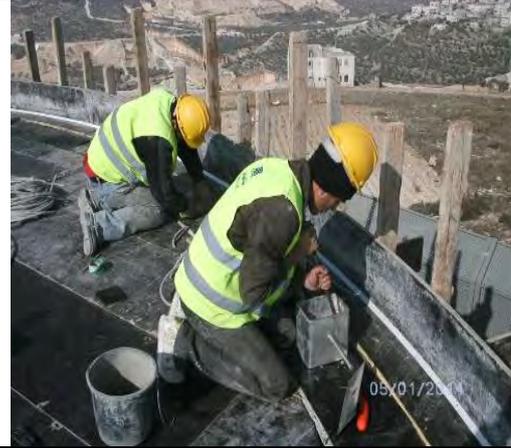
<p>Photo #: 9 – AQR Installation of the seismic cans & filling with Combextra HF grout January 05 2014</p>	<p>Photo #: 10 – AQR Installed precast washout chamber inside the reservoir yard February 17 2014</p>

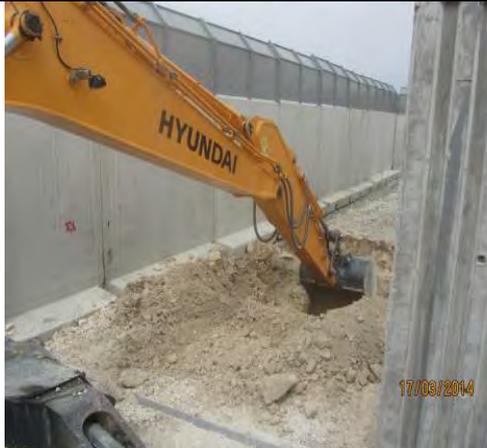
<p>Photo #:11– AQR Excavation works for inlet and outlet connection chamber March 17 2014</p>	<p>Photo #:12– AQR Casting concrete for the base slab of the inlet and outlet connection chamber April 08 2014</p>

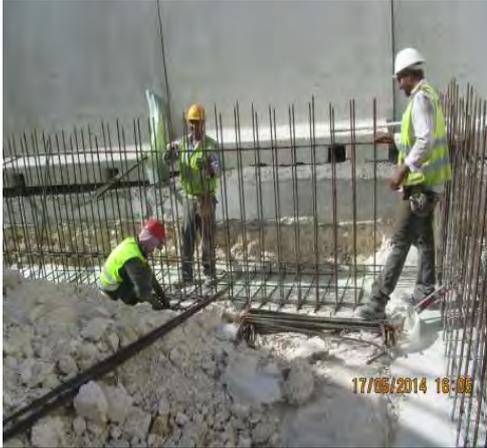
<p>Photo #:13– AQR Installation of the formwork for the walls of the internal retaining walls May 17 2014</p>	<p>Photo #:14– AQR casting concrete for the electrical duct banks June 09 2014</p>

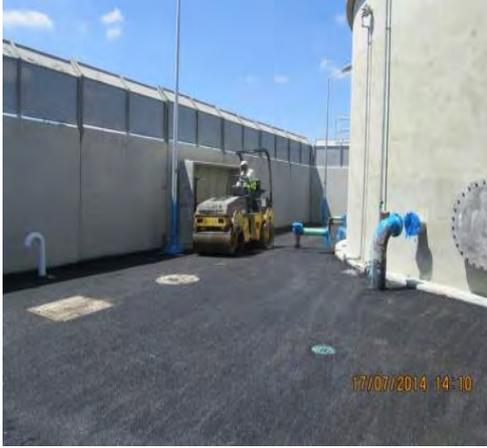
<p>Photo #:15– AQR Compacting asphalt layer at reservoir yard using steel roller July 17 2014</p>	<p>Photo #:16– AQR Painting the pipes and fittings inside the reservoir yard August 14 2014</p>

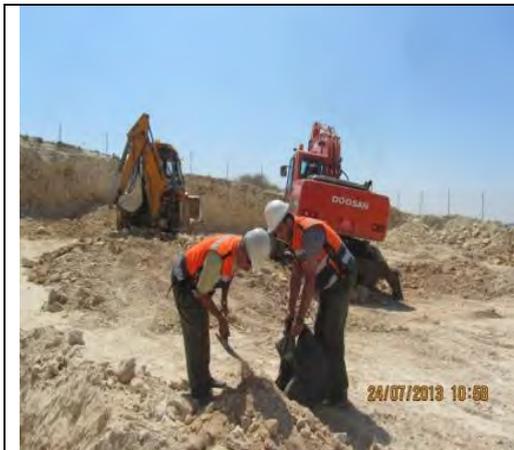
Photo #: 1 - URR
 Excavation Works & Taking Soil Sample
 July 24 2013

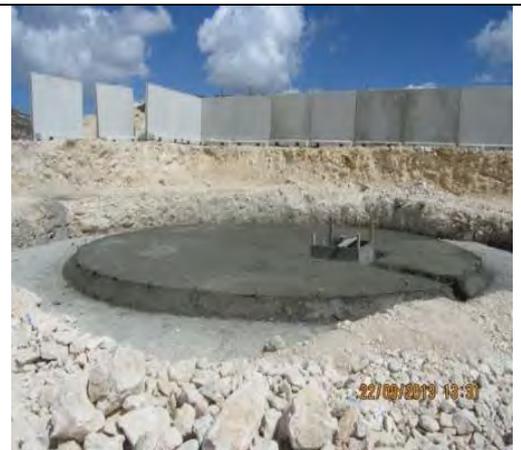
Photo #: 2 - URR
 rubble concrete completing under base slab
 September 22 2013

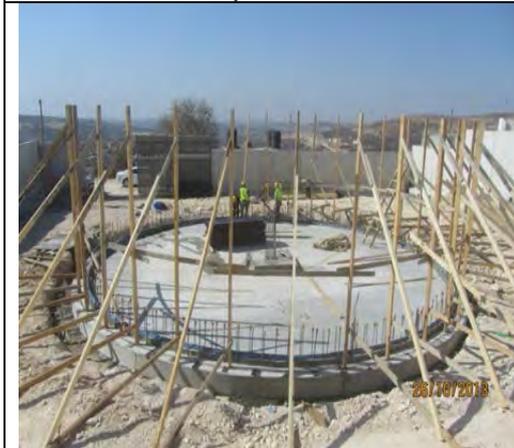
Photo #: 3 - URR
 Continue formwork, fixing steel reinforcement
 for reservoir wall
 October 30 2013

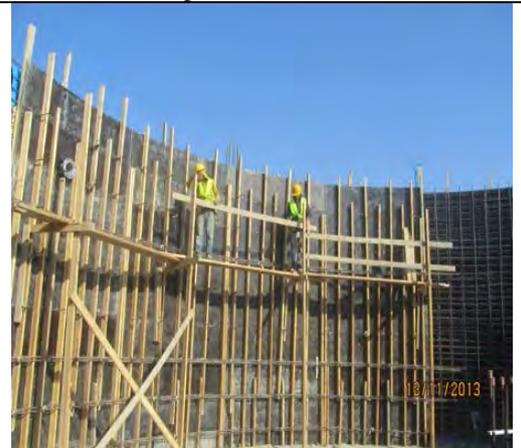
Photo #: 4 – URR
 Formwork installation for inner face
 November 13 2013

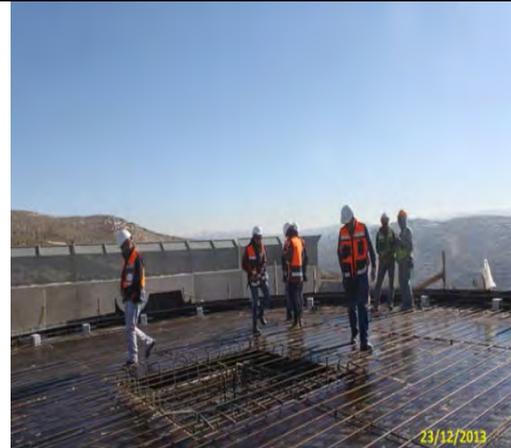
<p>Photo #: 5 – URR Fixing steel for reservoir roof slab December 23 2013</p>	<p>Photo #: 6 – URR Fixing steel reinforcement of reservoir wall January 19 2014</p>

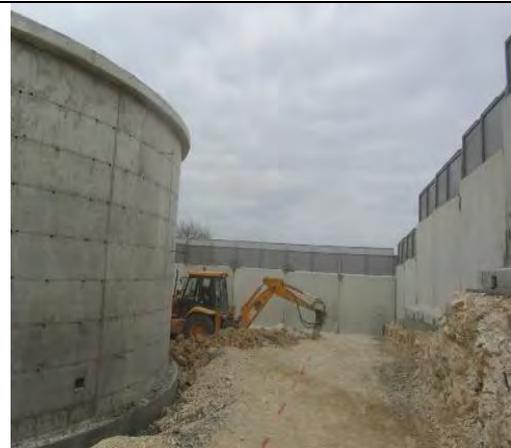
<p>Photo #: 7 – URR Excavation work to reduced level around the reservoir using JCB February 04 2014</p>	<p>Photo #: 8 – URR Casting concrete for walls of the inlet and outlet connection chamber March 17 2014</p>

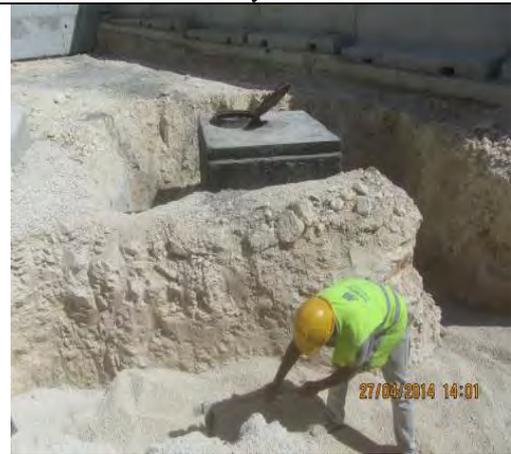
<p>Photo #:9– URR Unskilled labor spreading bedding material (Somsom) over the installed steel pipes. April 27 2014</p>	<p>Photo #:10– URR Backfilling behind the internal walls at Urif reservoir yard using JC May 25 2014</p>

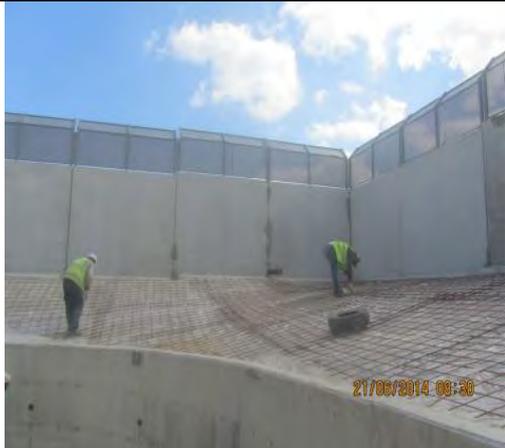
<p>Photo #:11– URR Installation of wire mesh reinforcement between the boundary walls and landscaping walls. June 21 2014</p>	<p>Photo #:12– URR Paving the asphalt layer at the reservoir yard using Bobcat. July 12 2014</p>

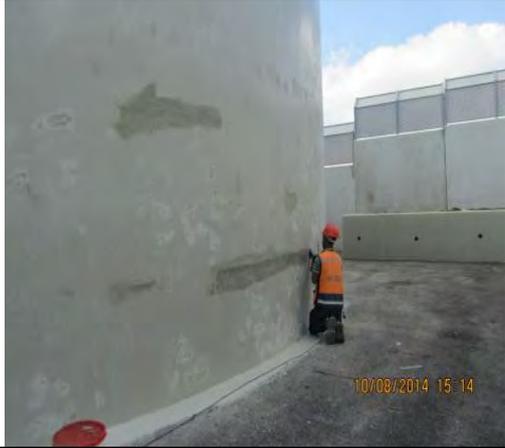
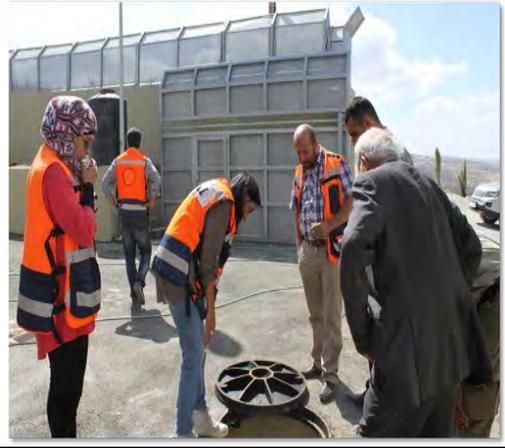
<p>Photo #:13– URR Repair the applied coat of epoxy paint August 10 2014</p>	<p>Photo #:14– URR The USAID COR inspecting the inlet and outlet chamber in URR at the project final handing over & walkthrough September 22 2014</p>

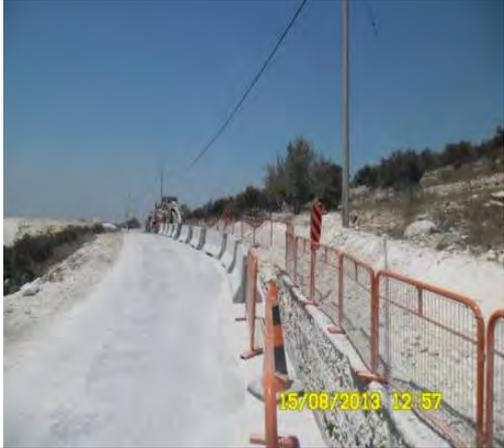
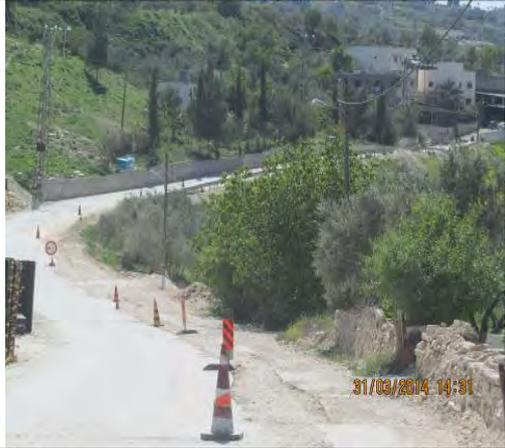
<p>Photo #1: SWT- Follow up the safety at SWT August 15 2013</p>	<p>Photo #2: SWT- Safety Arrangement March 31 2014</p>

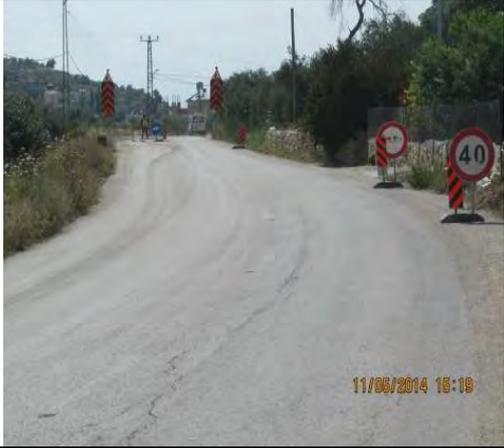
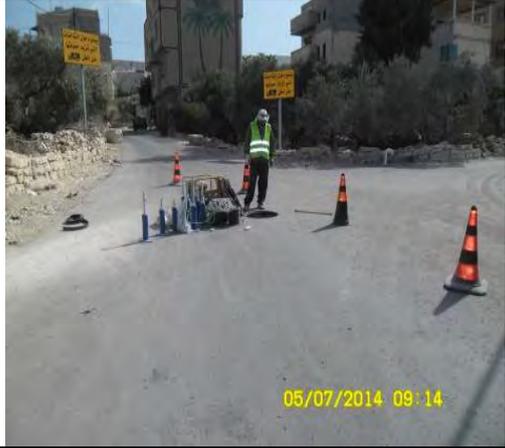
<p>Photo #3: MDN- Safety arrangement prior to asphalt work for line M3-39. May 11 2014</p>	<p>Photo #4: MDN- Safety and traffic arrangement while working inside the water chambers. July 05 2014</p>

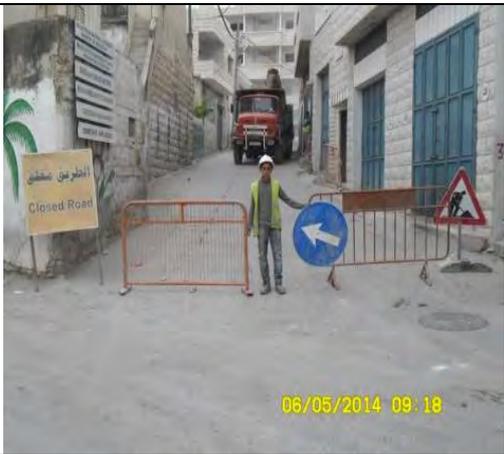
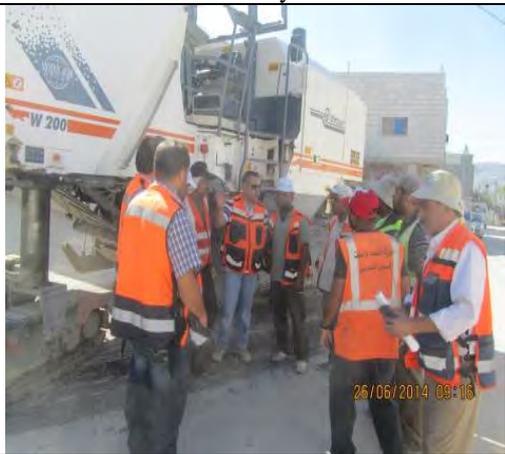
<p>Photo #5: URN -</p>	<p>Photo #6: URN-</p>

<p>Photo showing safety arrangement. May 06 2014</p>	<p>IRD SECO holding a safety toolbox meeting. June 26 2014</p>

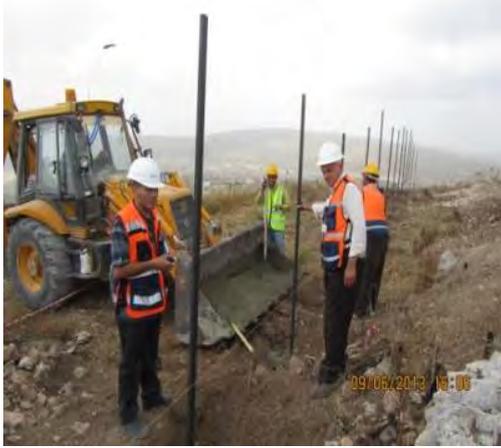
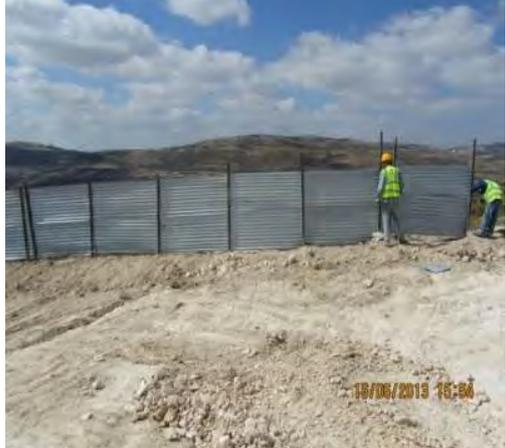
<p>Photo #7: AQR- Works of Excavation & Installing Posts of Safety Fence for Asira Al Qibliya Reservoir June 09 2013</p>	<p>Photo #8: AQR- Installation of Temporary Safety Fence at Asira Al Qibliya Reservoir June 16 2013</p>

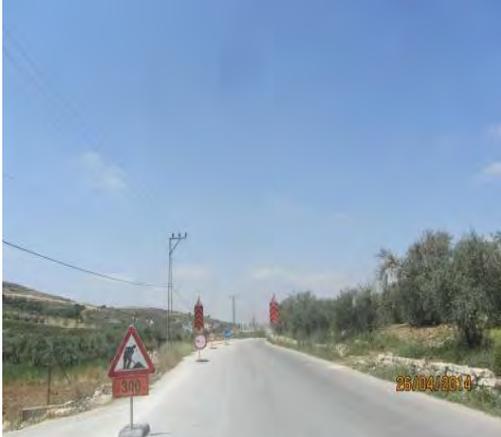
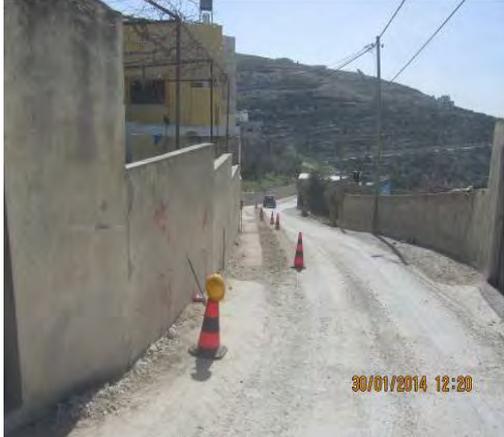
<p>Photo #9: MDN- Safety arrangement along the trench. April 26 2014</p>	<p>Photo #10: AQN- Safety January 30 2014</p>

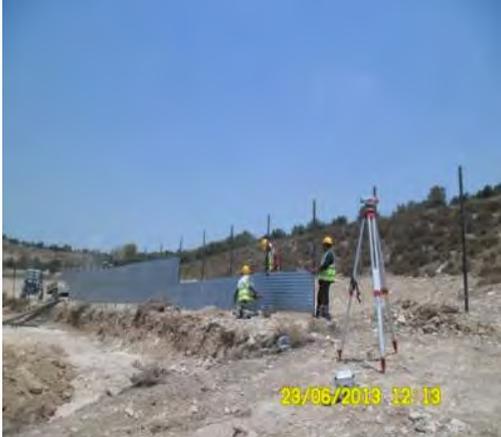
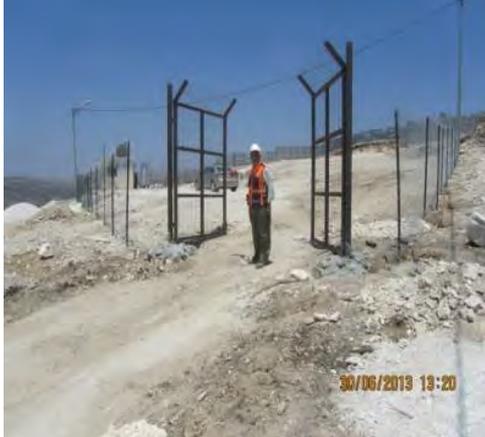
<p>Photo #11: MDR- Installation of the Safety fence at Madama Reservoir. June 23 2013</p>	<p>Photo #12: AQR- Temporary safety fence for Asira Al Qibliya Reservoir June 30 2013</p>

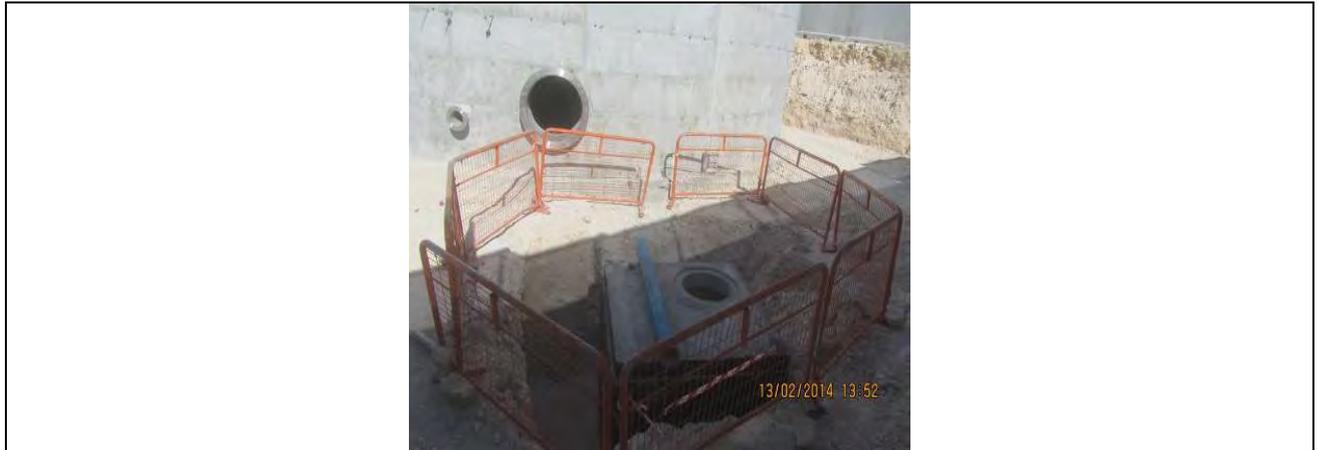
Photo #13: URR-
Installation of precast washout chamber and safety mini guards around.
February 13 2014

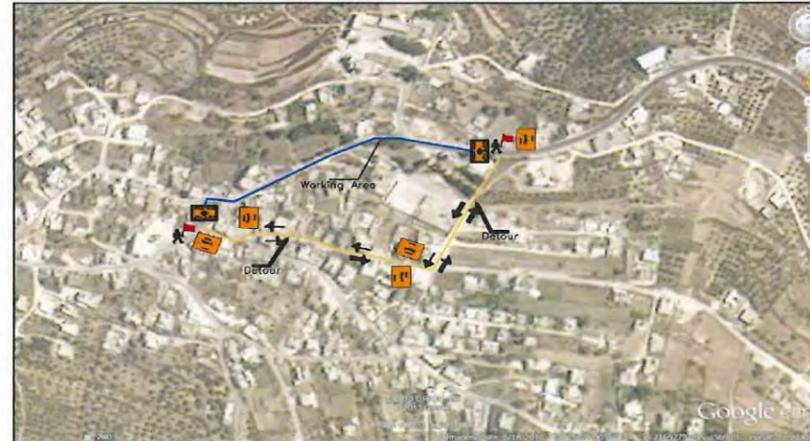
Typical plan Detour Inside Asira Qibliya Villiage
For Transmission Pipeline and Network

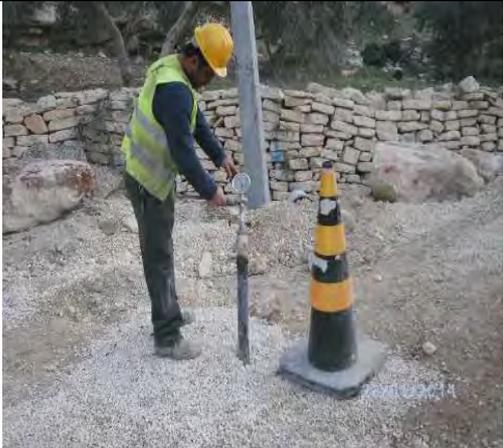
<p>water line. July 13 2014</p>

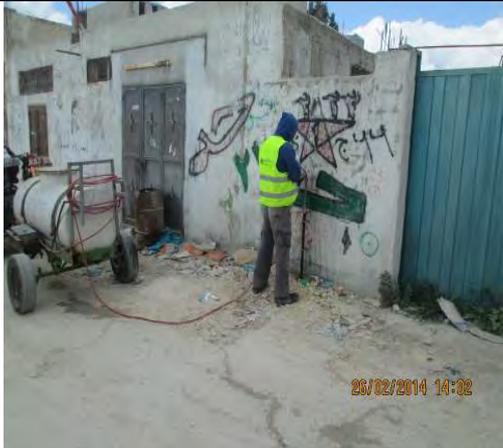
<p>Photo #3:AQN- Conducting of hydrostatic pressure test. January 23 2014</p>	<p>Photo #4: AQN- Flushing of the line in preparation for hydrostatic pressure test. February 26 2014</p>

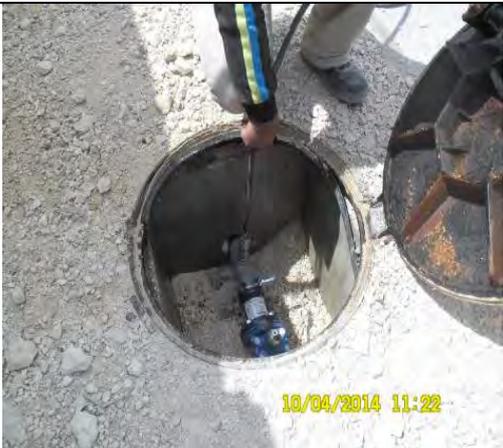
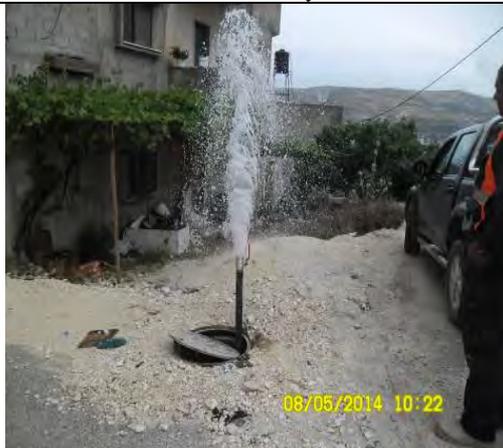
<p>Photo #5: AQN- Conducting pressure and flushing tests along line (A2-22). April 10 2014</p>	<p>Photo #6: AQN- Monitoring of flushing test along line (A3-07). May 08 2014</p>

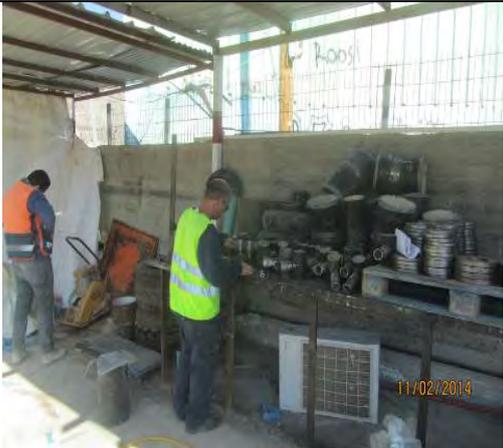
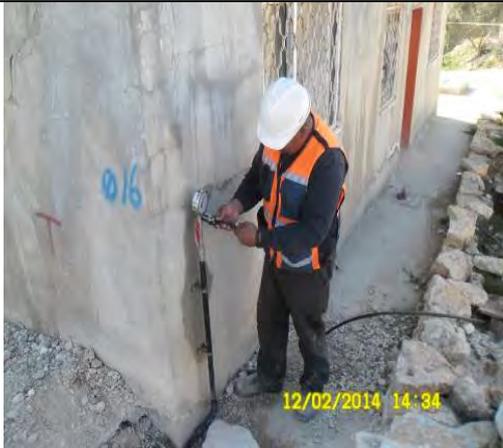
<p>Photo #7:URN- MOREX technician preparing for RT test in Madama storage yard.</p>	<p>Photo #8:URN- Conducting of hydrostatic pressure test. February 12 2014</p>

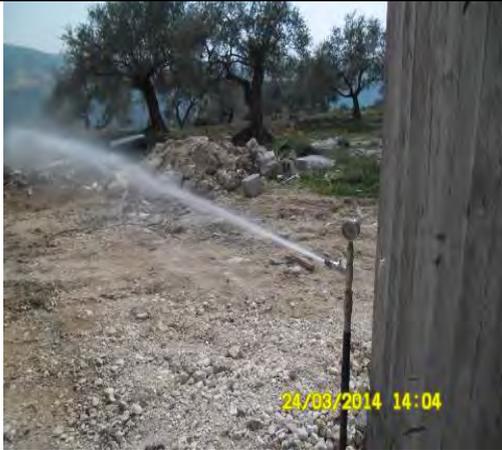
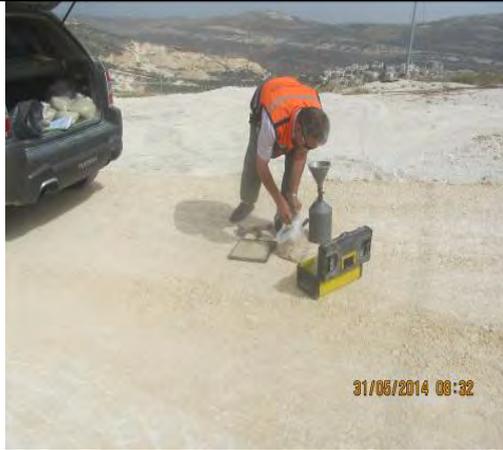
<p>Photo #9: URN- Flushing of the line in preparation for hydrostatic pressure test. March 24 2014</p>	<p>Photo #10: URN- Testing laboratory (Building Center) technician collecting sample from compacted base course layer. May 31 2014</p>
