FINAL REPORT

TO 13-00005-SWN-SOUTHWEST NABLUS VILLAGES WATER SUPPLY PROJECT & AZ ZAWIEH NETWORK PROJECT (ZWN)

PROJECT 1-SOUTHWEST NABLUS VILLAGES WATER SUPPLY
PROJECT (SWN)

PROJECT 2-AZ ZAWIEH NETWORK PROJECT (ZWN)

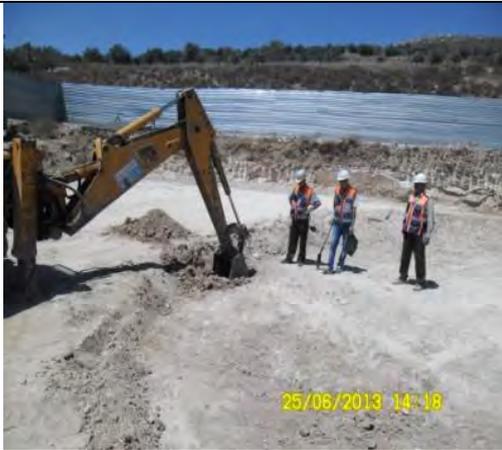
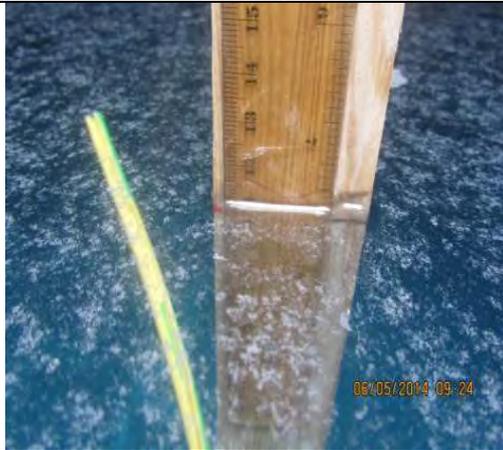
<p>Photo #11: MDR- Pit excavation for taking sample for bearing capacity test at Madama Reservoir June 25 2013</p>	<p>Photo #12: MDR- Checking the water level inside the reservoir for water tightness testing. May 06 2014</p>

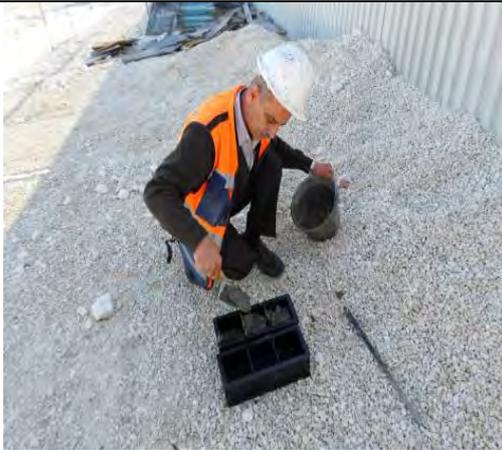
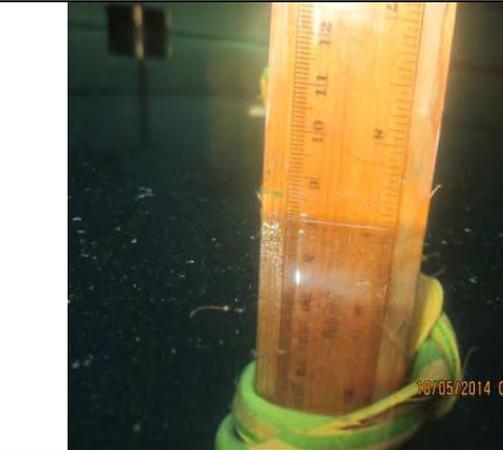
<p>Photo #13: AQR- Testing laboratory (Building Center) technician taking cubes from the delivered concrete for laboratory testing. May 14 2014</p>	<p>Photo #14: AQR- Checking the water level inside the reservoir for water tightness testing. May 18 2014</p>

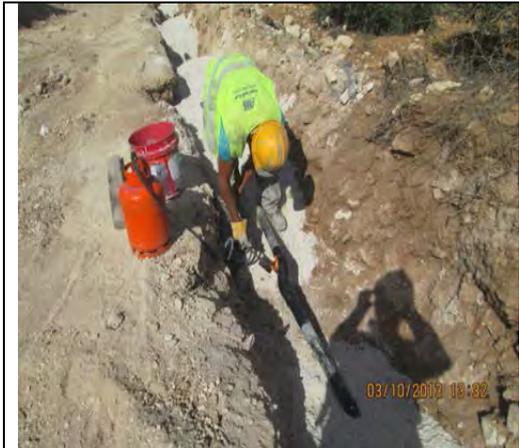
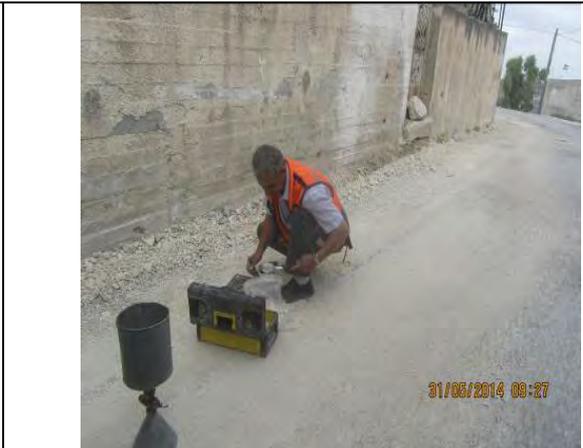
<p>Photo #15: AQN- Holiday Test for 2” –AQN October 03 2013</p>	<p>Photo #16: AQN- Testing laboratory (Building Center) technician collecting sample from compacted base course layer. May 31 2014</p>

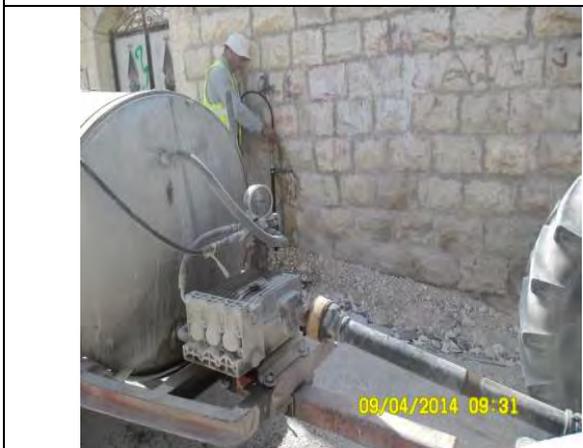
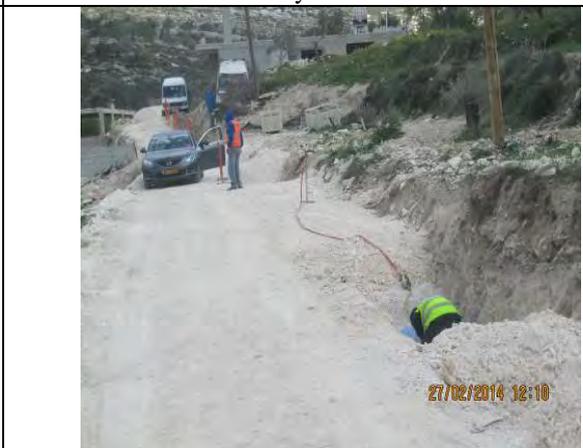
<p>Photo #17: AQN- Conducting flushing test along line (A2-06-03). April 09 2014</p>	<p>Photo #18:URN- MOREX technician preparing for RT test. February 27 2014</p>

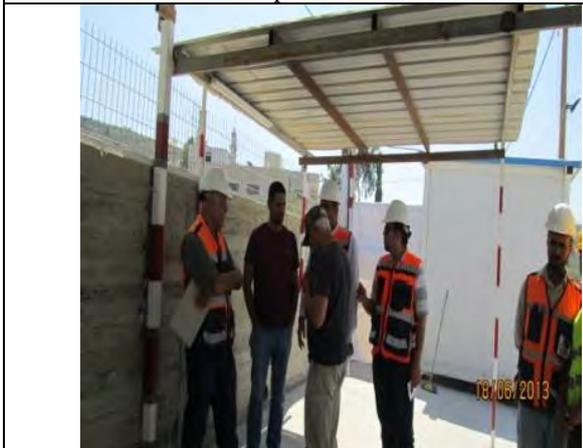
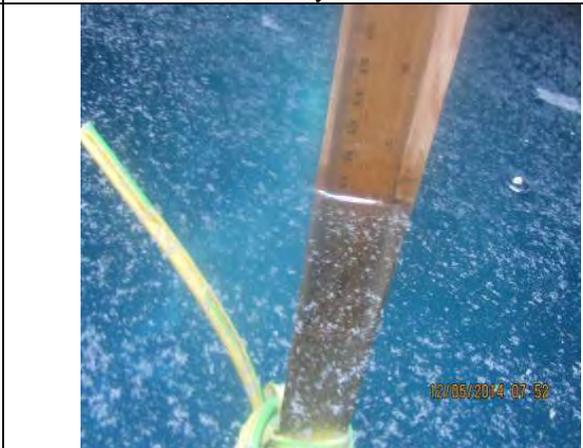
<p>Photo #19: MDR- B&V and IRD conducted qualification welding test at Madama June 18 2013</p>	<p>Photo #20: MDR- Checking the water level inside the reservoir for water tightness testing. May 12 2014</p>

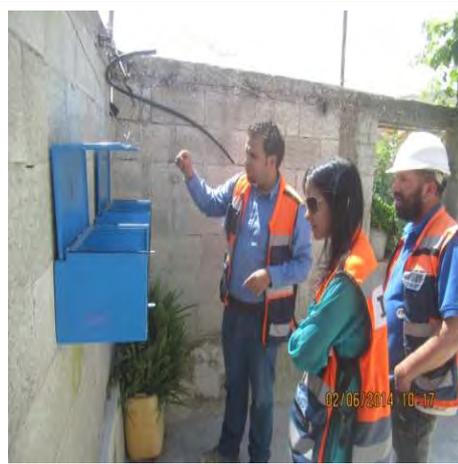
Photo #2: MDN-
 USAID COR inspecting the installed
 prepaid water meter enclosure.
 June 02 2014

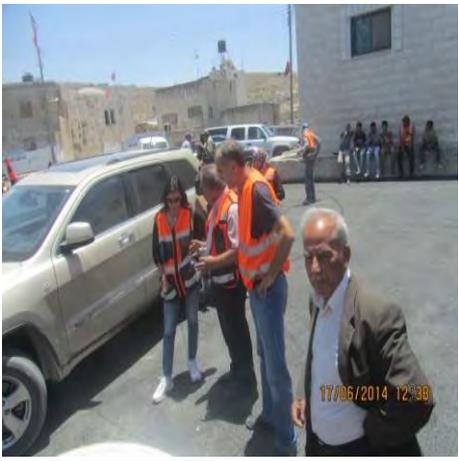
Photo #5: AQN-
 USAID COR inspecting the asphalted
 yard near the mosque June 17 2014

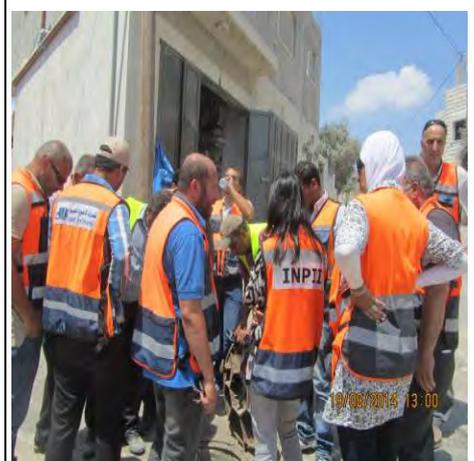
Photo #6: URN-
 USAID COR inspecting the water
 chambers in Urif village.
 August 19 2014

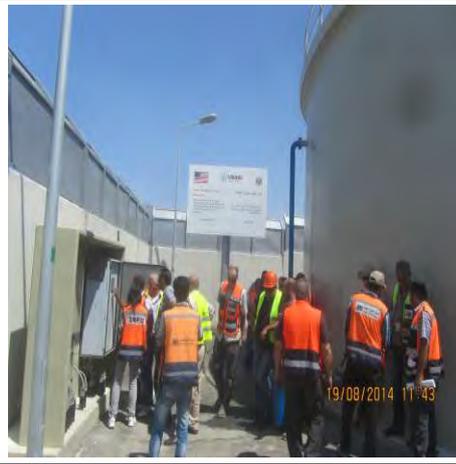
Photo #11: AQR-
USAID COR inspecting the RTU and
PLC panel in Asira reservoir. August 19
2014

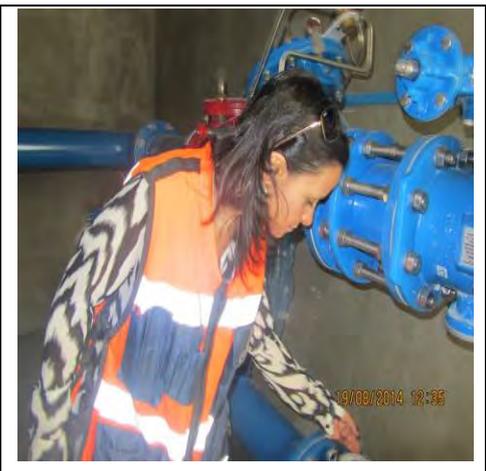
<p>Photo #13: AQR- USAID Mission Director making a speech to the attendance at the project opening ceremony September 09 2014</p>	<p>Photo #14: URR- COR visiting Urif reservoir site. July 10 2014</p>	<p>Photo #15: URR- USAID COR inspecting the fittings and valves inside the inlet-outlet connection chamber in Urif reservoir. August 19 2014</p>

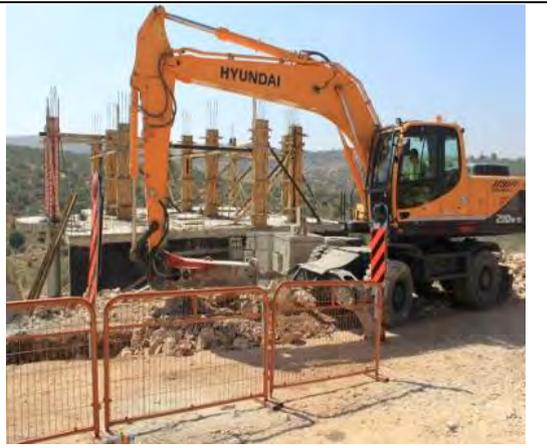
<p>Photo No.1-ZWN: Pre-excavation work in Az Zawieh Photo Date: June 27, 2013</p>	<p>Photo No.2-ZWN: Installation of traffic safety signs Photo Date: June 27, 2013</p>

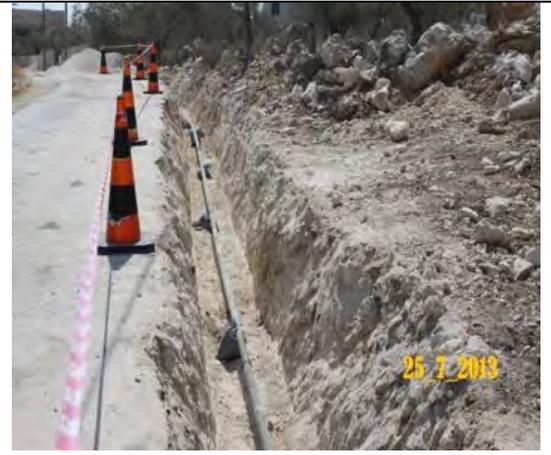
<p>Photo No.3-ZWN: Installation of permanent traffic signs at the main entrance Road to Az Zawieh Photo Date: June 22, 2013</p>	<p>Photo No.4-ZWN: Az Zawieh Network Pipe Installation Photo Date: July 25, 2013</p>

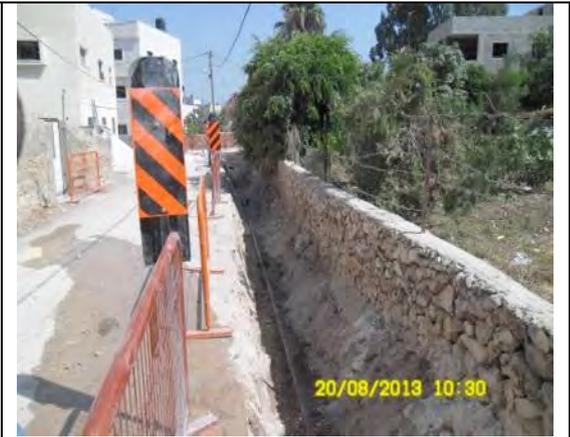
<p>Photo No.5-ZWN: Earth breaking At Az Zawieh Photo Date: July 21, 2013</p>	<p>Photo No.6-ZWN: Installation of 2'' Pipes, Bedding Materials Photo Date: 20 August, 2013</p>

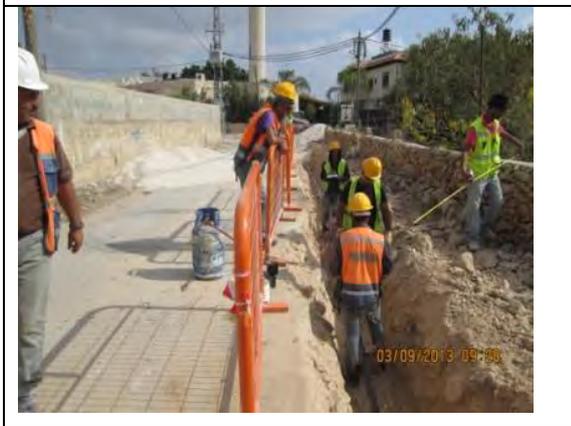
<p>Photo No.7-ZWN: Installation of 2'' Pipes at Z2-15 Photo Date: 03 September, 2013</p>	<p>Photo No.8-ZWN: Excavation for 3'' Pipes, at Z3-43 Photo Date: 03 September, 2013</p>

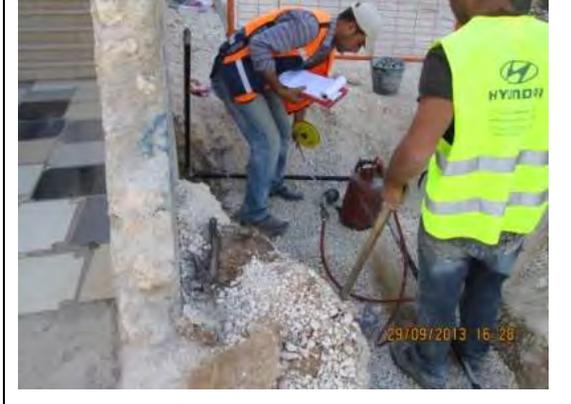
<p>Photo No.9-ZWN: House Connection Road Z2-004 Photo Date: 29 September, 2013</p>	<p>Photo No.10-ZWN: Installation of 3'' Pipes, Bedding Materials Photo Date: 08 October, 2013</p>

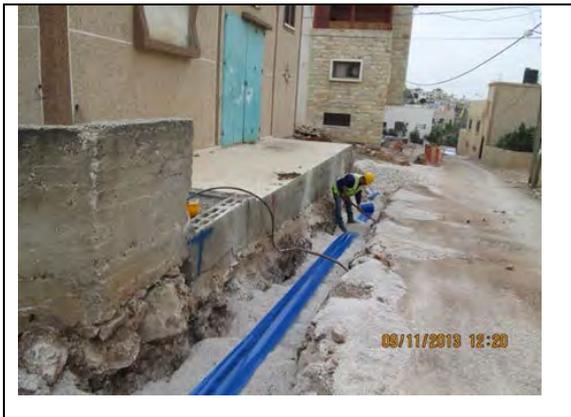
<p>Photo No.11-ZWN: Installation of 3" Pipes, Bedding Materials Photo Date: 09 November, 2013</p>	<p>Photo No.12-ZWN: Pressure test along (Z2"-18-1) Photo Date: 24 November, 2013</p>

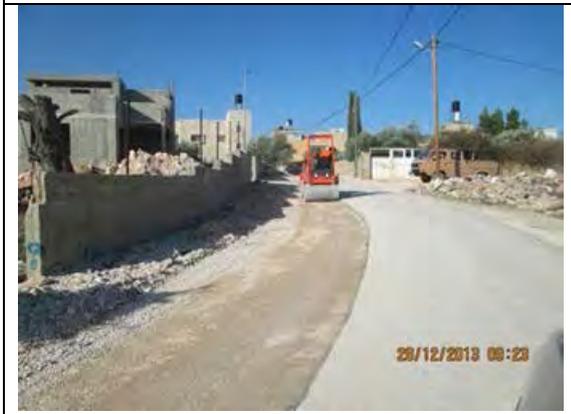
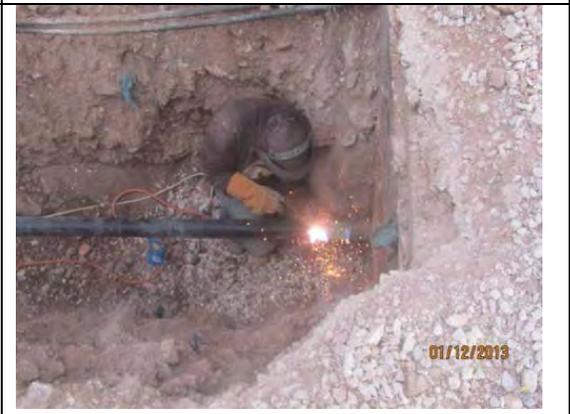
<p>Photo No.13-ZWN: Compacting the base course layer in preparation for applying first layer of asphalt wearing course Photo Date: 28 December, 2013</p>	<p>Photo No.14-ZWN: Welding of 3" steel pipes executed from precast Manholes Photo Date: 01 December, 2013</p>

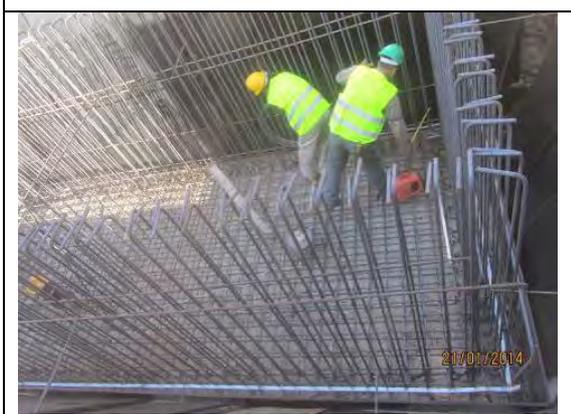
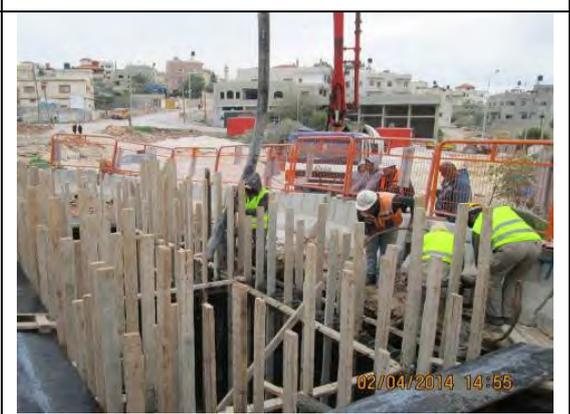
<p>Photo No.15-ZWN: Installation of steel bars for walls of the main connection chamber. Photo Date: 21 January, 2014</p>	<p>Photo No.16-ZWN: Casting concrete for walls of the main connection chamber. Photo Date: 04 February, 2014</p>

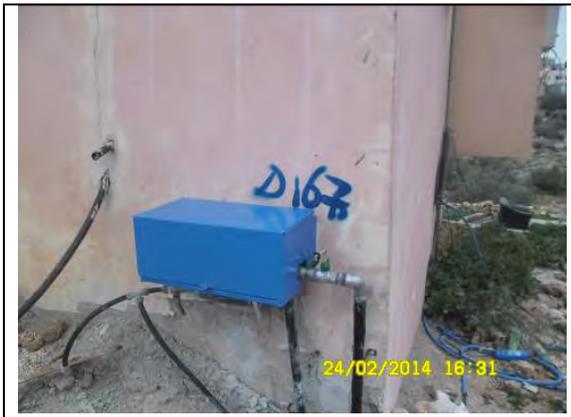
<p>Photo No.17-ZWN: Installation of prepaid water meter. Photo Date: 24 February, 2014</p>	<p>Photo No.18-ZWN: Paving the second layer of the asphalt. Photo Date: 27 February, 2014</p>

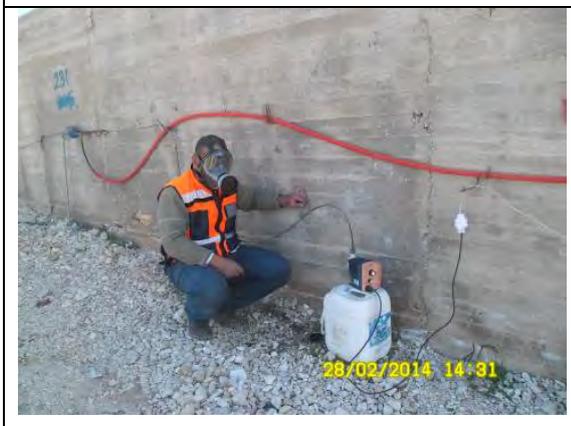
<p>Photo No.19-ZWN: Disinfection works. Photo Date: 28 February, 2014</p>	<p>Photo No.20-ZWN: Installation of fittings inside the main connection chamber. Photo Date: 06 March, 2014</p>

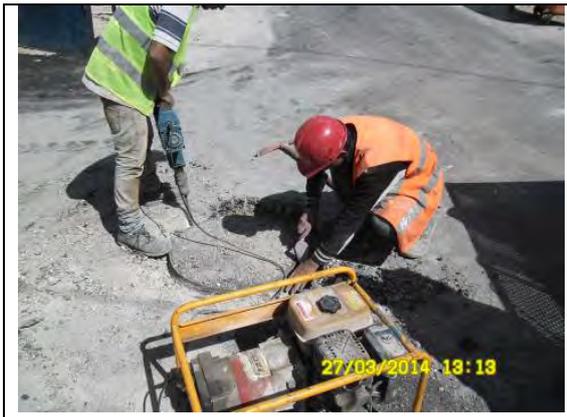
<p>Photo No.23-ZWN: Adjusting manholes covers level. Photo Date: 27 March, 2014</p>	<p>Photo No.24-ZWN: Disinfection works. Photo Date: 08 March, 2014</p>

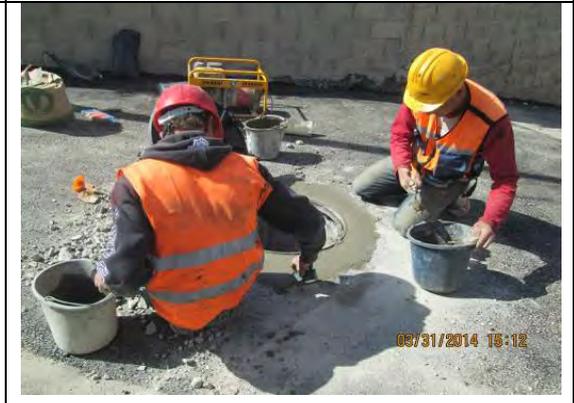
<p>Photo No.25-ZWN: Asphalt works Photo Date: March 31, 2014</p>	<p>Photo No.26-ZWN: Adjusting manhole cover level Photo Date: March 31, 2014</p>

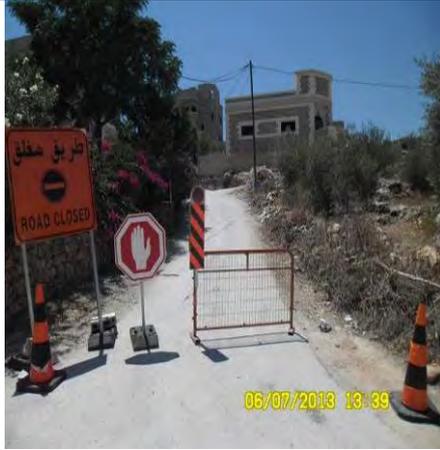
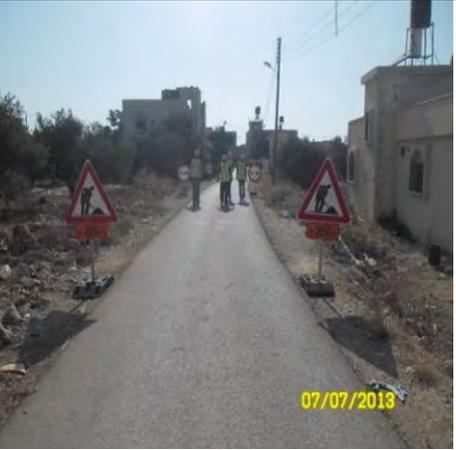
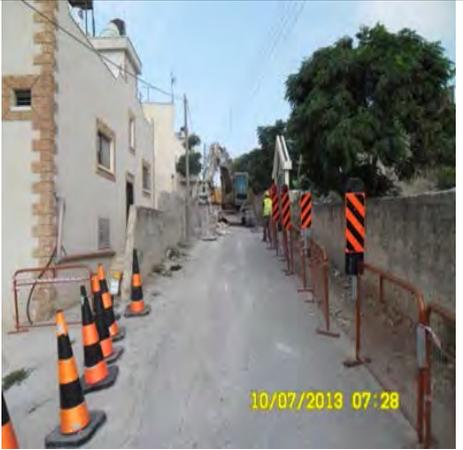
<p>Photo #1: ZWN- Safety temporary traffic signs. July 06 2013</p>	<p>Photo #2: ZWN- Traffic signs. July 07 2013</p>	<p>Photo #3: ZWN- Safety steel barriers and cones before excavation of the trench. July 10 2013</p>

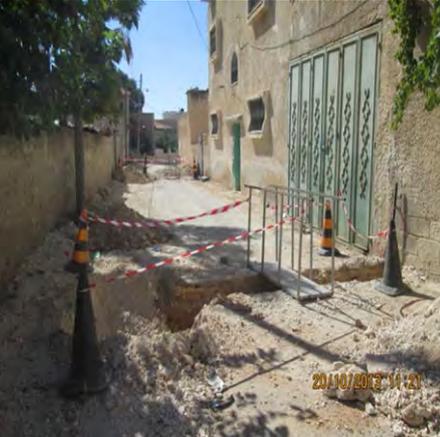
<p>Photo #7: ZWN- Safety pedestrian cross over trench. October 20 2013</p>	<p>Photo #8: ZWN- Safety steel barriers December 05 2013</p>	<p>Photo #9: ZWN- Unskilled labor cross the kids. February 23 2014</p>

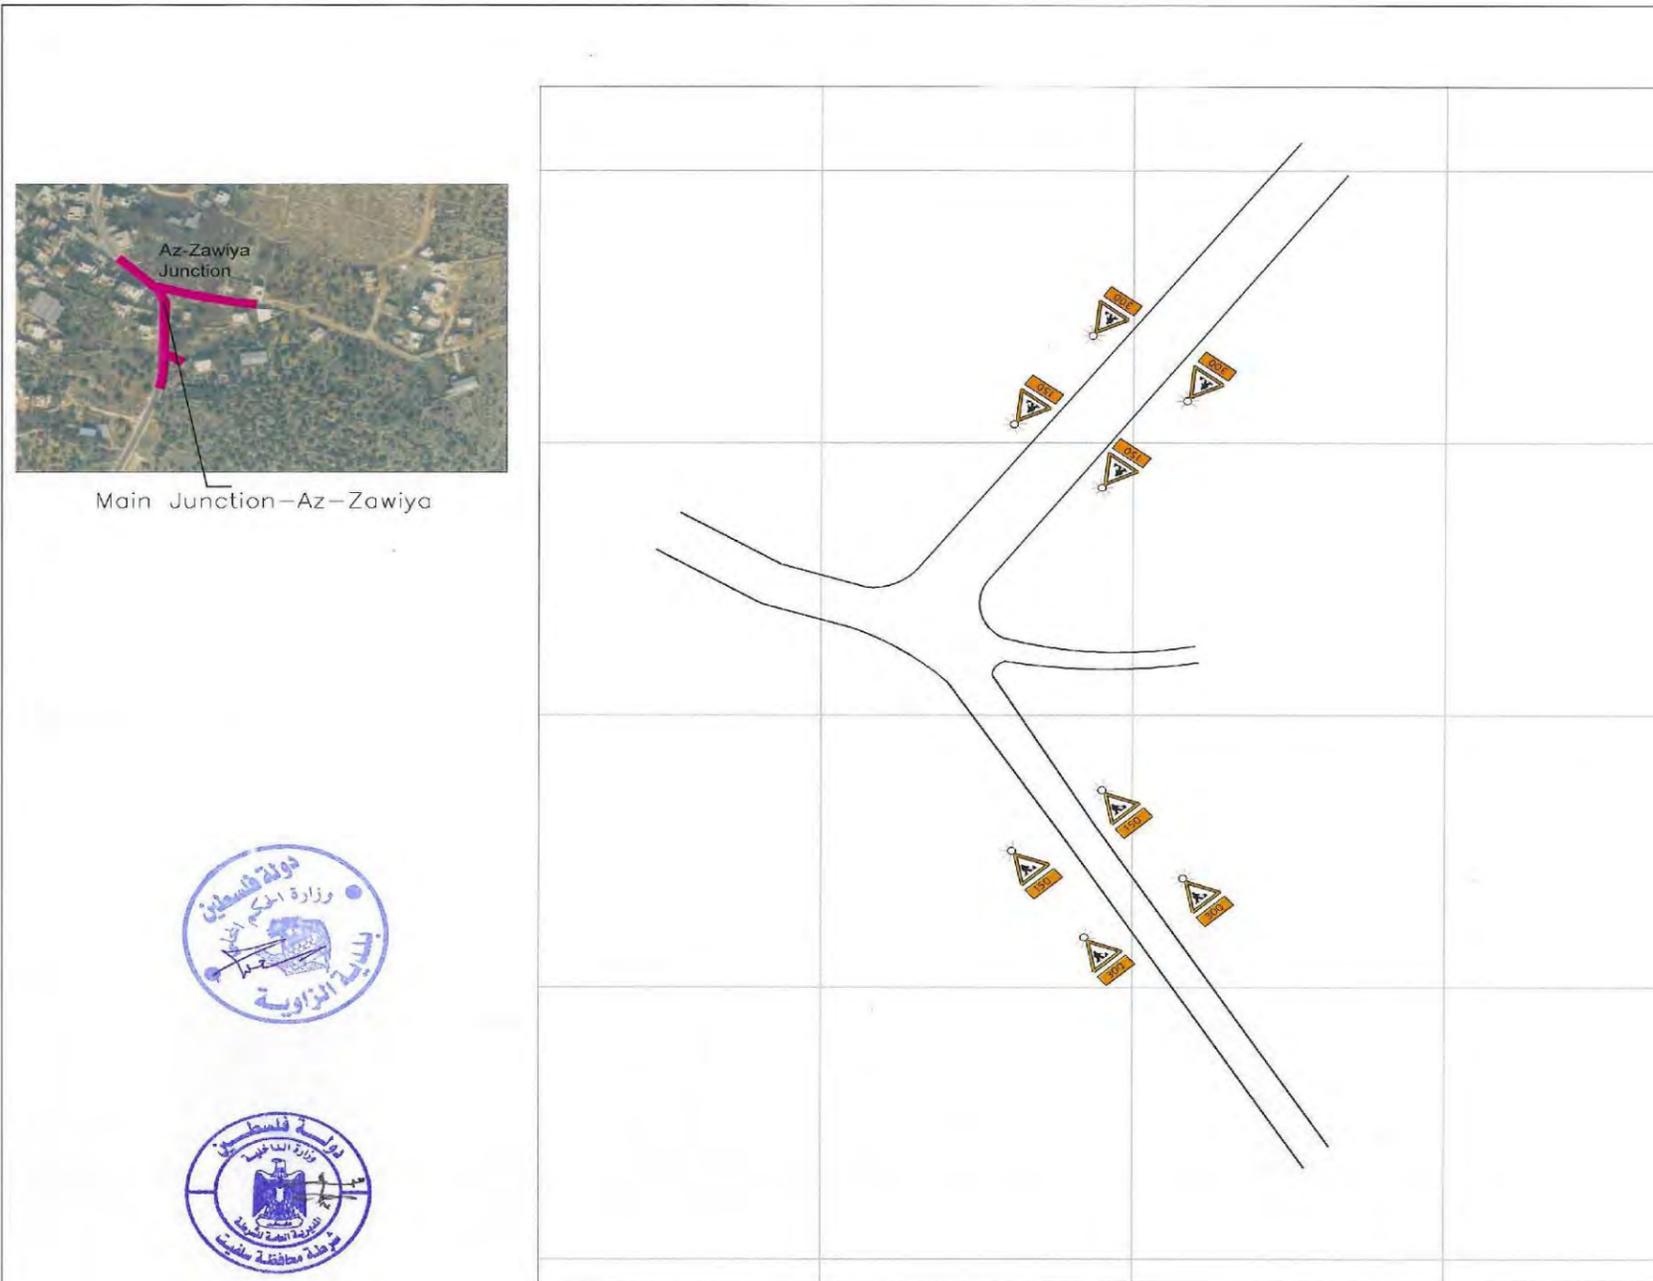
Az-Zawiya Main Junction

NOTES.
All Signs Are Reflective with Orange Background & Black Text (20 cm Hight)

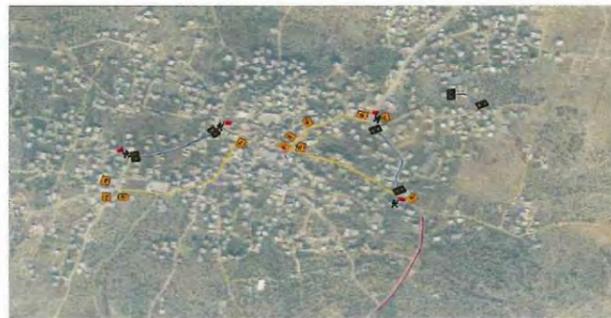
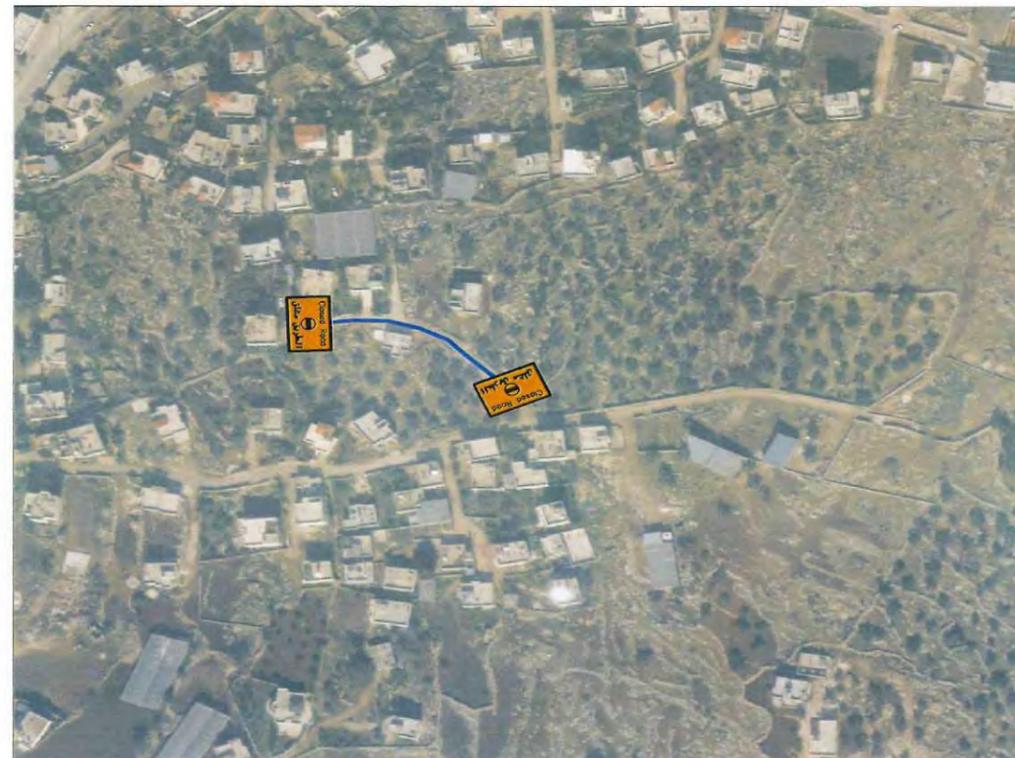
Key Map

Working Area

Az-Zawiya Dead End Road
Road Totaly Closed, Only for Pedestrian Walk

NOTES.
All Signs Are Reflective with Orange Background & Black Text (20 cm Hight)

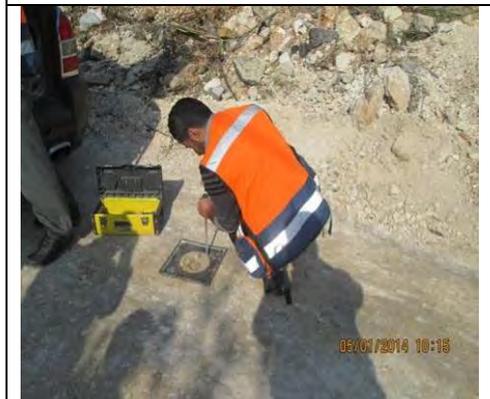
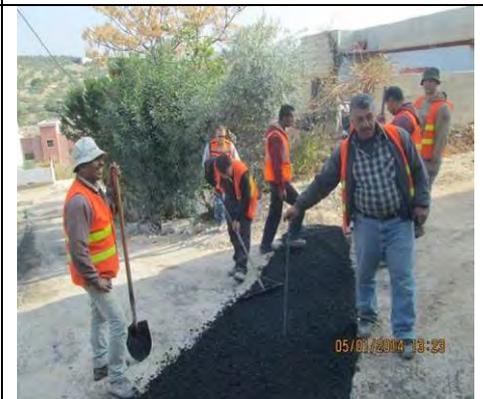
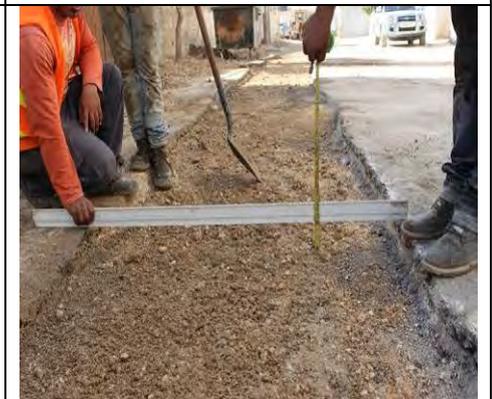
<p>Photo #1: ZWN- Holiday test. October 08 2013</p>	<p>Photo #2: ZWN- Holiday test. December 03 2013</p>	<p>Photo #3: ZWN- BC Technicians taking a sample from the compacted base course layer for field compaction test. December 28 2013</p>

The photographs below show examples of lab tests taken on site.

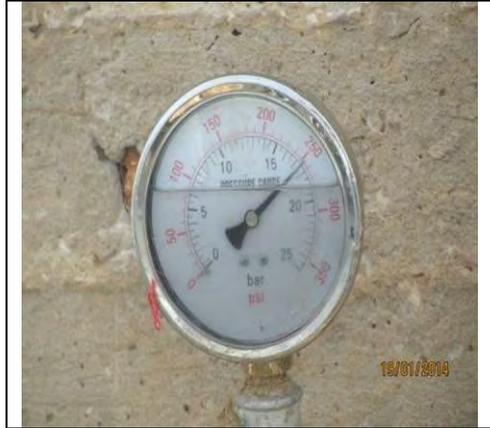
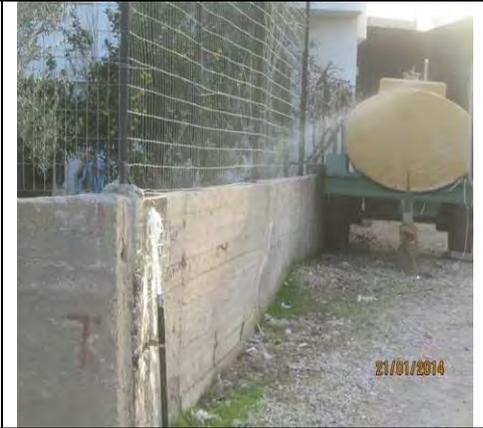
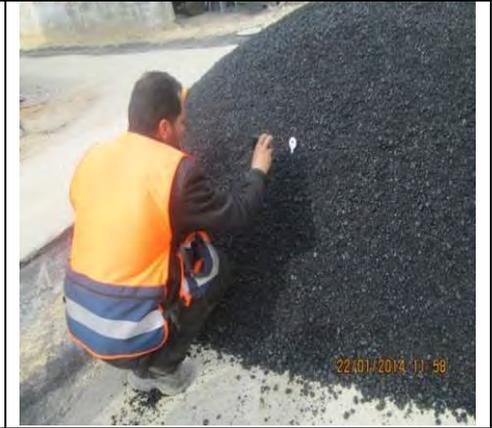
<p>Photo #7: ZWN- Hydrostatic pressure test. January 19 2014</p>	<p>Photo #8: ZWN- Flushing test. January 21 2014</p>	<p>Photo #9: ZWN- B&V QM checking the temperature of the hot asphalt mix. January 22 2014</p>

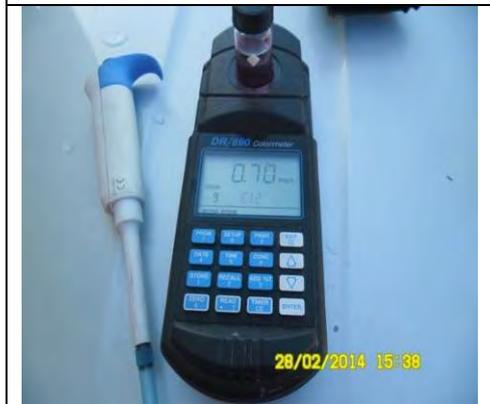
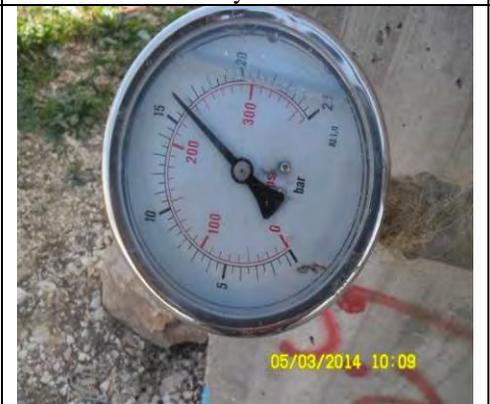
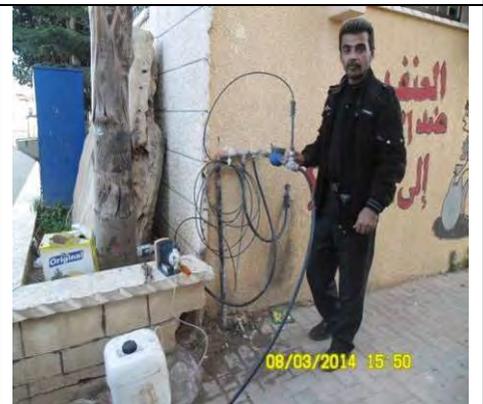
<p>Photo #13: ZWN-Chlorine concentration. February 28 2014</p>	<p>Photo #14: ZWN-Hydrostatic pressure test. March 05 2014</p>	<p>Photo #15: ZWN-Disinfection work. March 08 2014</p>

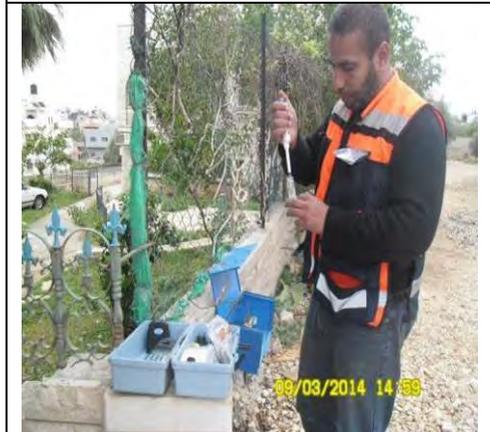
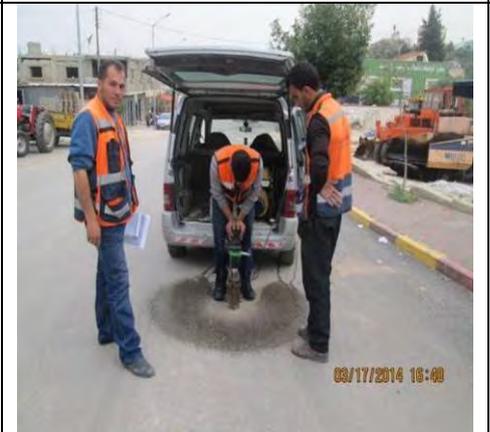
<p>Photo #16: ZWN-Disinfection work. March 09 2014</p>	<p>Photo #17: ZWN-BC technician taking asphalt core test. March 17 2014</p>

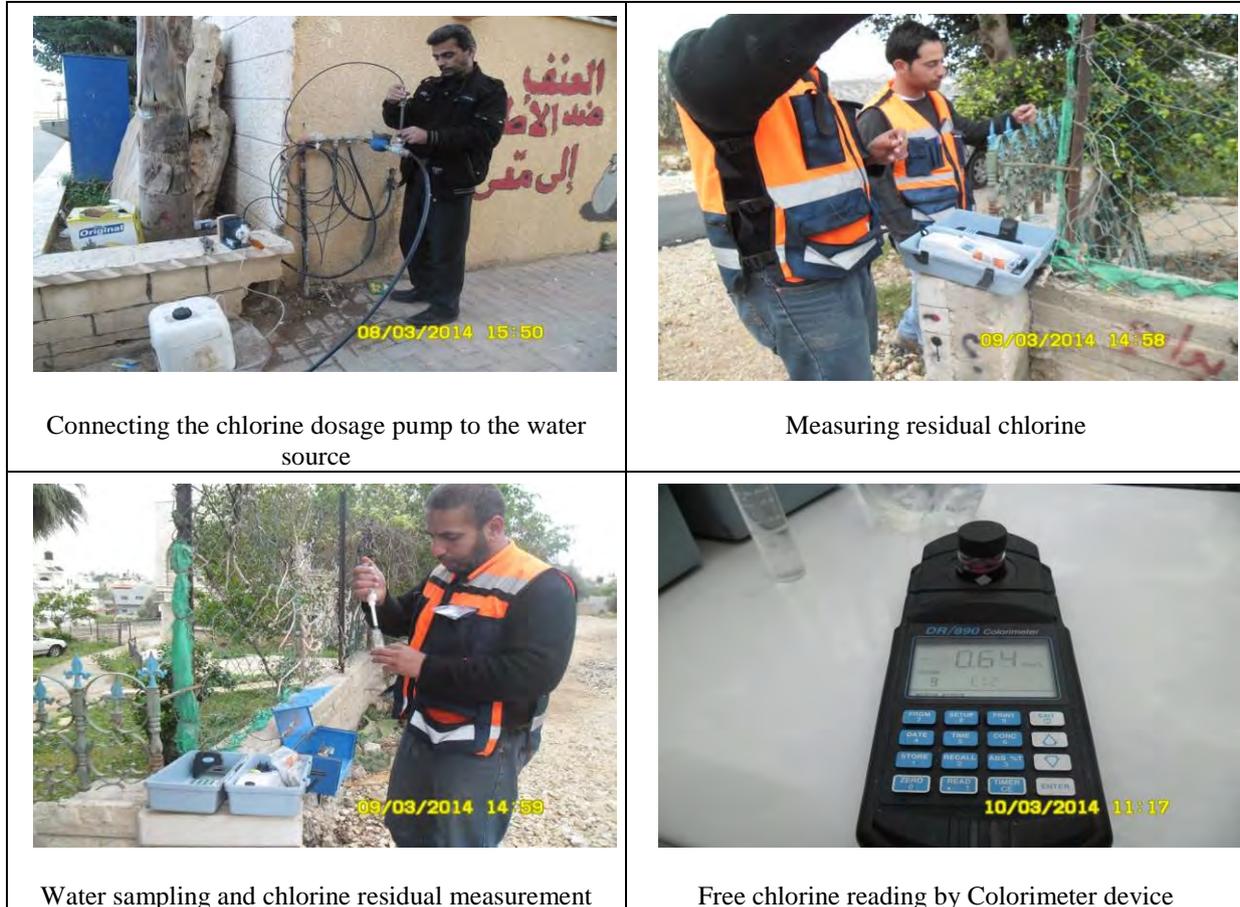
Disinfection Process Photos

- The following Photos show part of the disinfection works implemented by Mr. Hdidoun at Zawieh water network project during the disinfection period.
