A Rapid Ecohydrological Assessment of the Ruvu River Estuary, Tanzania

Tanzania Integrated Water, Sanitation and Hygiene (iWASH) Program

GLOWS 2015. A Rapid Ecohydrological Assessment of the Ruvu River Estuary, Tanzania. Global Water for Sustainability Program, Florida International University. 76 p.

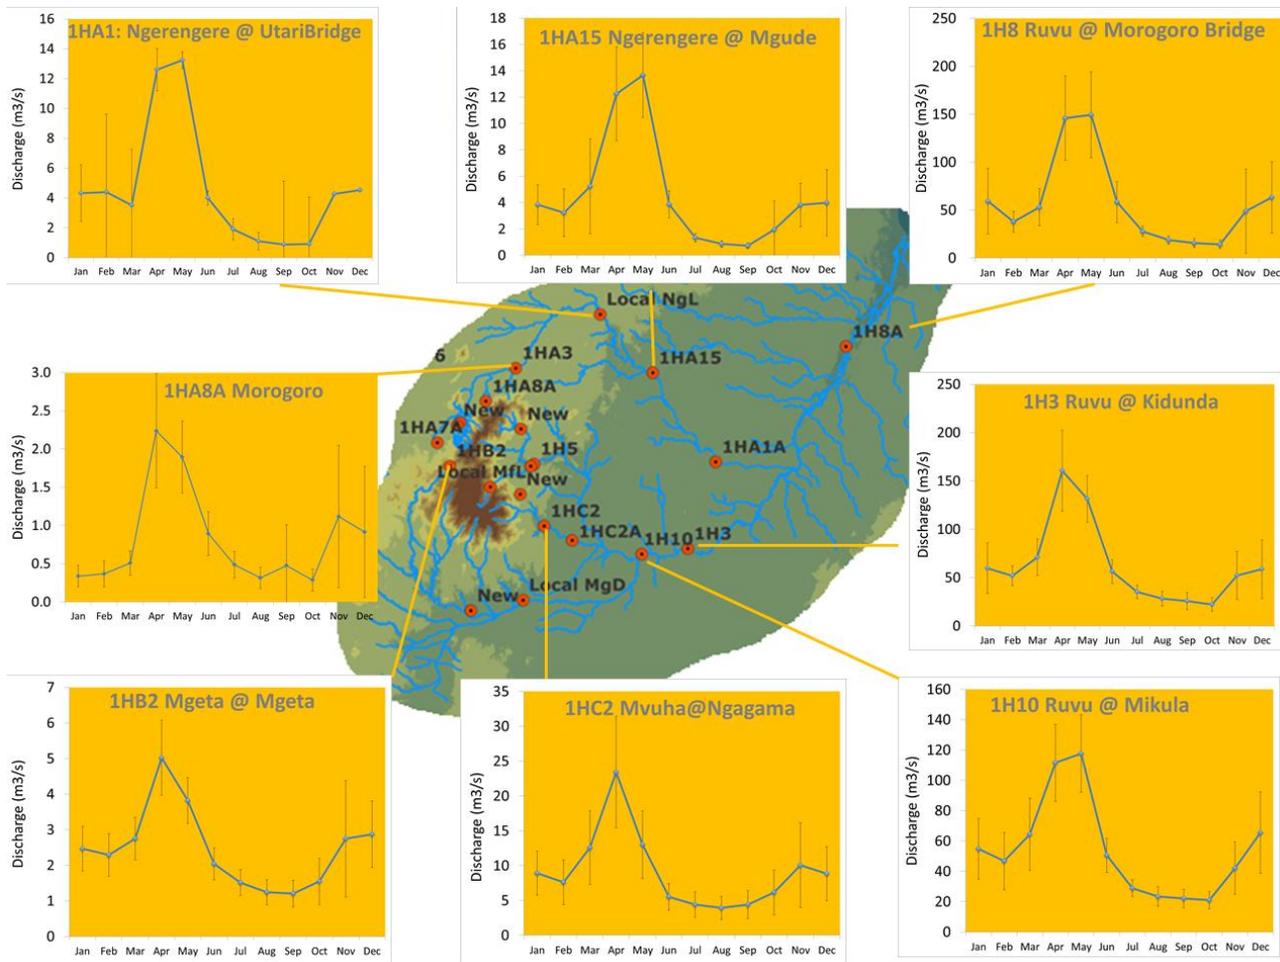
Figure 2-2: Monthly discharge (m³/s) in select tributaries and sections of the Ruvu river, averaged over 1950-2010. Error bars depict 0.5 standard deviation on either side of plot. Data source: WRBWO.

Lower Ruvu catchment has a relatively stable flow regime. The period of high discharge in all tributaries of the Ruvu drainage, April and May, coincides with the main rainy season (March- May) as seen in Figure 2-2.

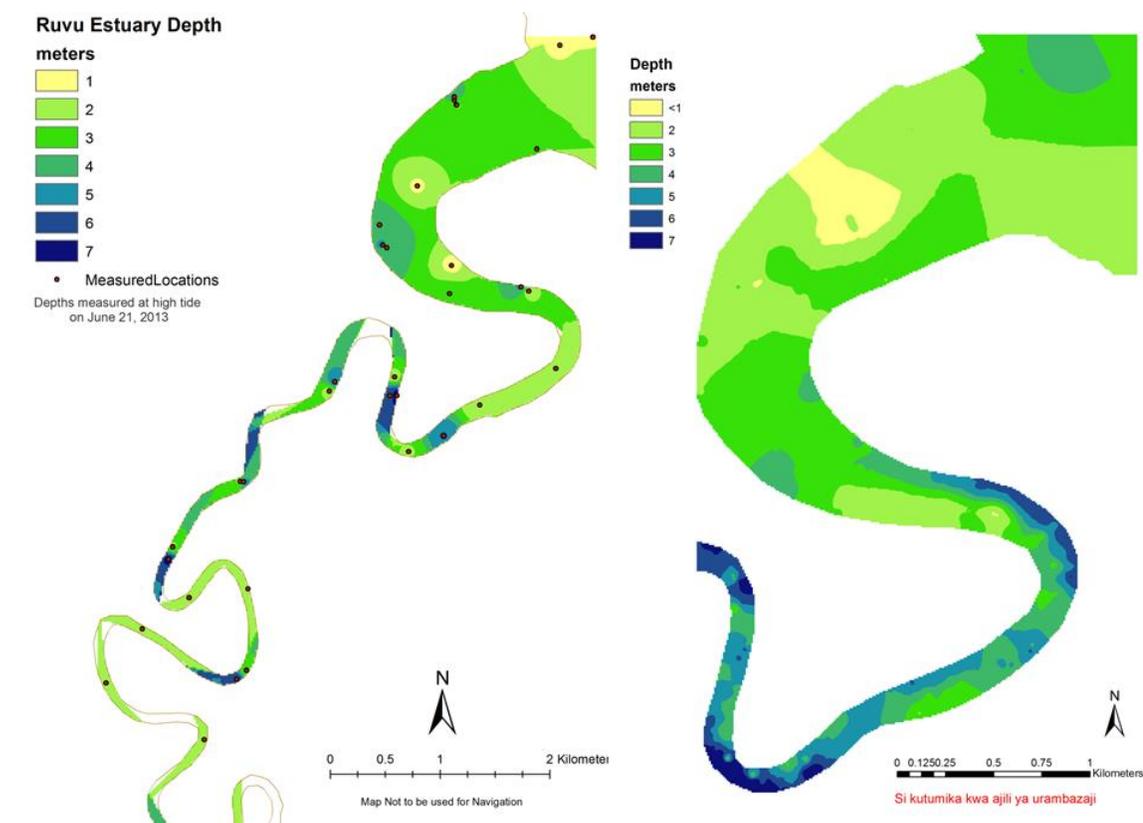
Figure 2-4: (Left) Water depth of the Ruvu Estuary and adjacent upstream river under flood tide conditions on June 21, 2013. Measurement locations are shown by tiny circles. (Right) Continuous water depth profile of a close-up of the Ruvu estuary taken on August 24, 2013. Data Courtesy Chris Dutton (right plot).

In general the estuary mouth ranges from 1-4 meters in depth depending on location and tide, and gets deeper upriver, especially on the scouring banks at channel bends (evident in Fig.2-4 right). The next section on channel profiles depicts these trends in the data. There are sandbanks deposited at the mouth of the estuary, one of which also supports a monospecific stand of the mangrove *Sonneratia alba*.

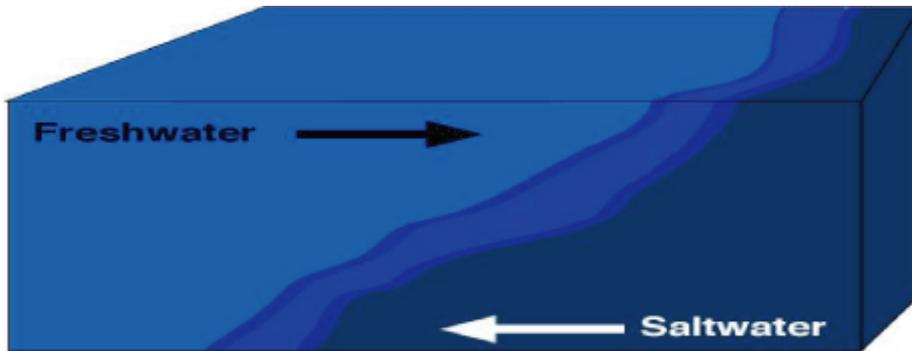
Figure 2-5: Seawater typically advances into a river as a wedge under inflowing freshwater. Source: <http://www.ldeo.columbia.edu/edu/k12/snapshotday/Parameters.html>.

From the estuary mouth to about 2 km upriver, flow velocities measured at numerous locations were nearly zero on both the surface and at 1 m depth during high tide. This was probably on account of the opposing fresh water and seawater flows. Wind blowing in from the Indian Ocean also pushed surface water in small waves upstream. At about 2 m depth flow was still often zero (no propeller turns); however at times eddies were detected by the flow meter propeller slowly turning upon altering flow meter orientation to catch the current. The current was transient in most cases, as inferred from the propeller turning for a while then stopping. These eddies likely arise from turbulence caused by the shearing action of a wedge of seawater moving upriver against the downriver freshwater flow (tidal mixing) as illustrated in Fig.2-5.

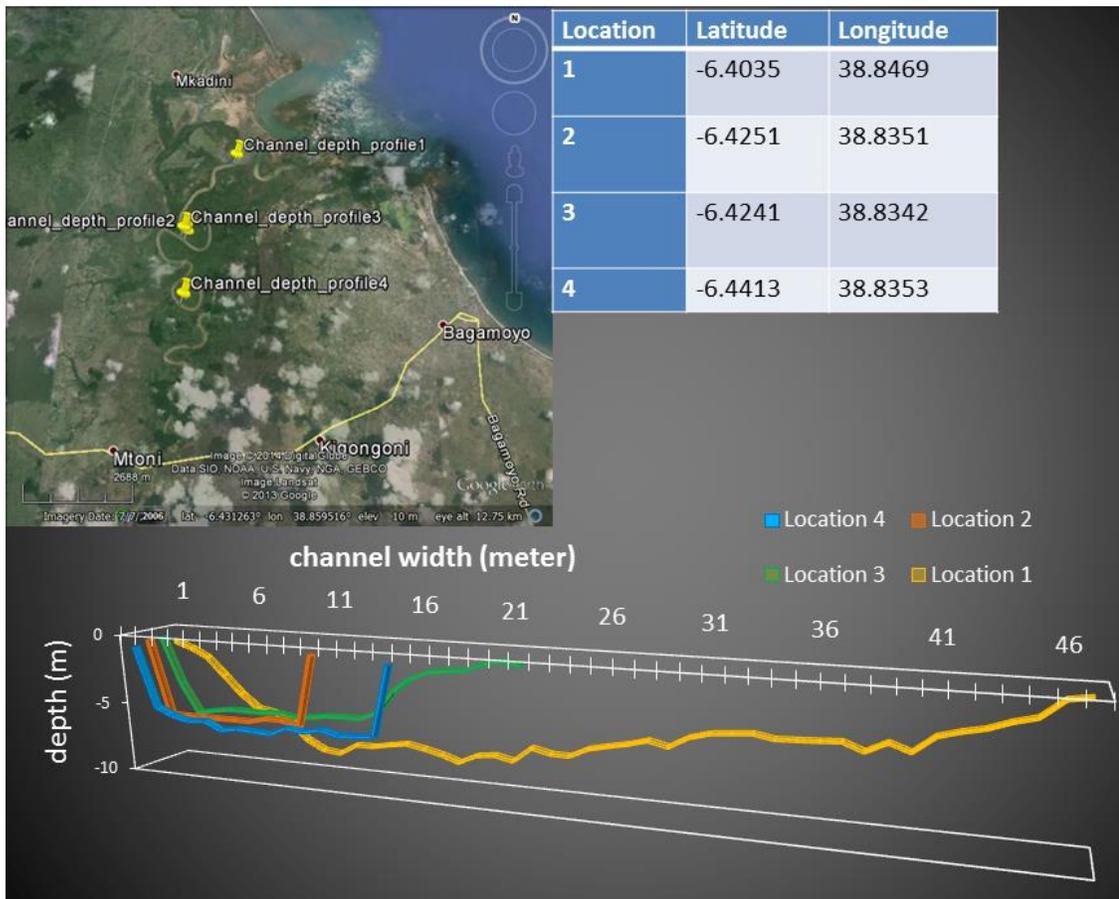
Figure 2-6: Top: Map of channel depth profile locations. Bottom: Channel depth profiles of the four locations on the Ruvu river shown along the river width (x axis) and depth (y axis).

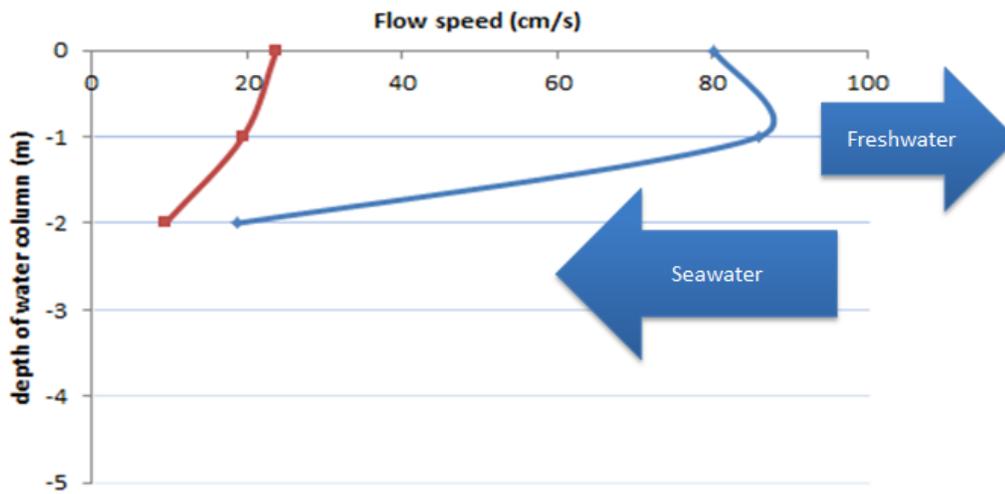
Figure 2-7: velocity profile with depth at locations 1 (6.4035 S and 38.8469 E, red, LEFT plot) and 3 (6.4241 S and 38.8342 E, blue, RIGHT plot).

Location 3 (Fig.2-9, right plot) is located 13 km from the estuary mouth showed faster flow than the downriver location 1 at all 3 depths. However, the velocity was higher at 1 m depth than the surface (0.86 m/s vs 0.81 m/s); this could be caused by opposing wind drag slowing down the surface water layer. An abrupt decrease in velocity was recorded from 1 m to 2 m depth (from 0.86 m/s to 0.19 m/s – Fig.2-9, blue plot). This abrupt decrease could be caused by a wedge of seawater flowing in underneath at high tide, that can change the typical parabolic velocity profile by further lowering the observed velocity because the seawater wedge opposes the freshwater flow.

With the assumption that an inflowing seawater layer causes this abrupt decrease in flow speed from 1 m depth to 2 m depth (Fig 2-10), the depth of the freshwater layer at location 3 is assumed to be 2 m. The mean velocity of this overlying freshwater layer is then computed by averaging the velocities at the surface, 1m and 2m that works out to around 0.60 m/s.

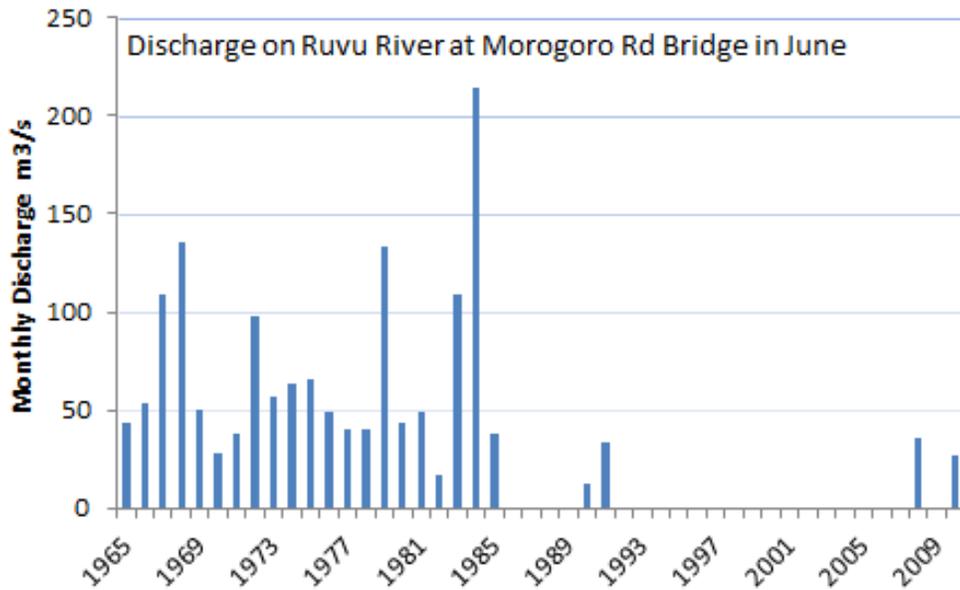
Figure 2-9: Monthly Discharge for the month of June, measured on the Ruvu River at Morogoro Rd Bridge. Data: WRWBO. Data is unavailable for years between 1986-1989, 1992-2007 and 2009.

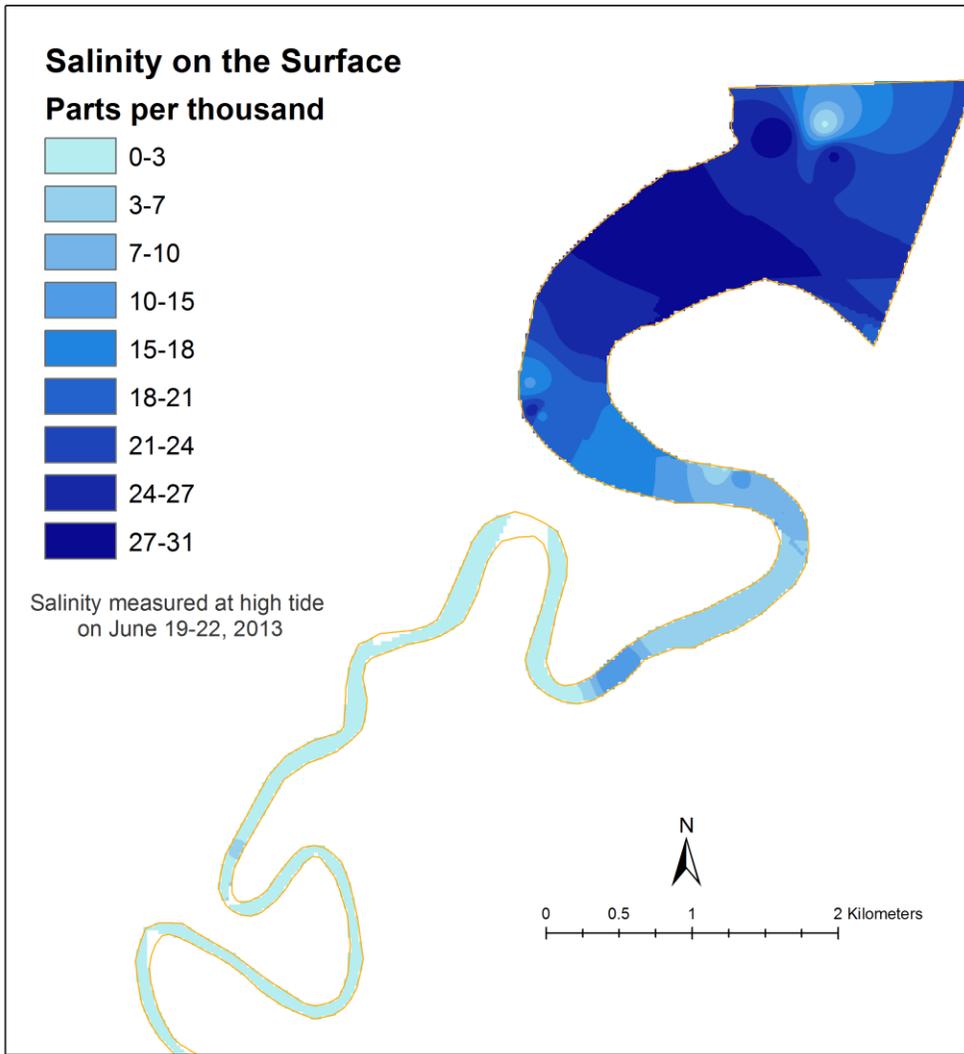
Figure 2-10: Surface Salinity gradient in the Ruvu estuary between June 18-26, 2013 corresponding to the wet-dry season transition.

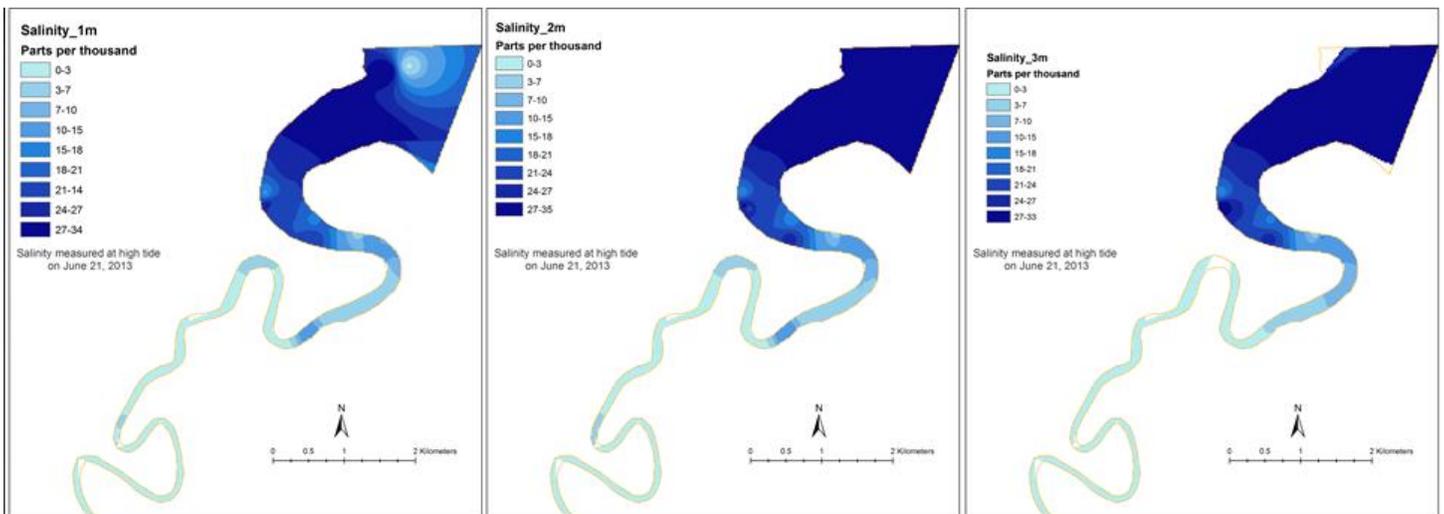
Figure 2-11: Salinity profiles of the Ruvu estuary at 1m, 2m and 3m depths under high tide conditions over June 19-22, 2013.

A conductivity probe (YSI EC 300A, YSI, USA) with a 10 m cable was used to measure salinity and temperature along the marine-freshwater transect. Salinity and temperature were measured at different depths (surface, 1, 2 and 3 meters) under different tidal conditions, i.e. flood and ebb tides. In places with strong flow, the cable at 3 m moved off at an angle and hence 3 m readings under these conditions are not included. The bridge (Fig.2-3) was chosen as the starting point to serve as a fixed geographical reference for future salinity measurements which change with season. At high tide, seawater was found to extend almost 11 km upstream from the mouth of the river (5.5 km as the crow flies), with the furthest inland salinity being noticed at (-6.417 S, 38.8344 E) under high tide conditions, measuring about 5 ppt. Salinity values in the freshwater-seawater mixing zone at the surface (Fig 2-10) were lower than at values at 1m, 2 m and 3 m depth (Fig 2-11). Data has been included in Annex 1.

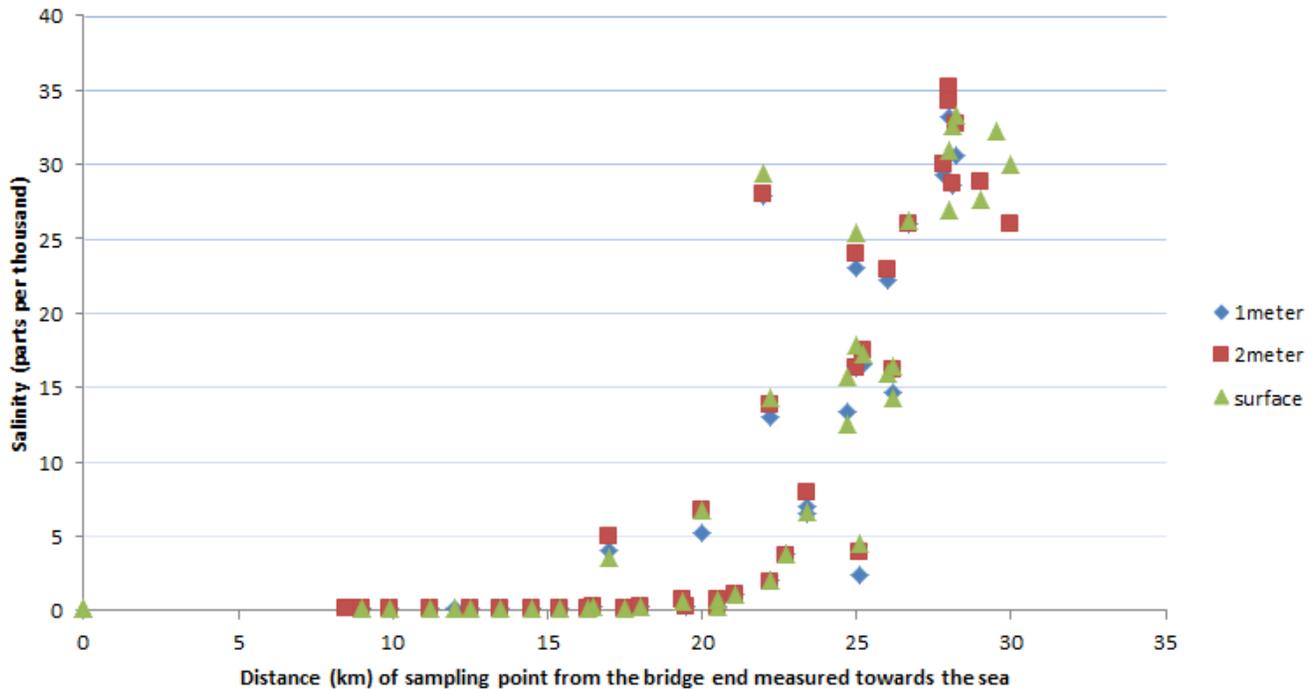
Figure 2-12: Salinity measurements at surface, 1 and 2 m depth carried out over both low and high tide conditions from the freshwater to the marine end of the Ruvu.

This survey noted that the Ruvu River estuary mouth up to 2 km inland had full marine salinity at high tide and lower salinity values at low tide. Figure 2-12 shows the salinity values plotted with distance (in km) from the bridge to the river mouth. The bridge was chosen as the origin as it represents a fixed spot for future sampling, unlike the mouth which has no clear landmark. The water at the bridge was entirely fresh even at peak high tide. It remained fresh 15 km downstream when the first slightly brackish water was observed (~5 ppt) at high tide at 2m depth. Similar salinity values were observed until about 22 km downstream from the bridge when the salinity began to increase until by 25 km downstream, values reached 25 ppt at high tide. The mouth lay at 28 km downstream.

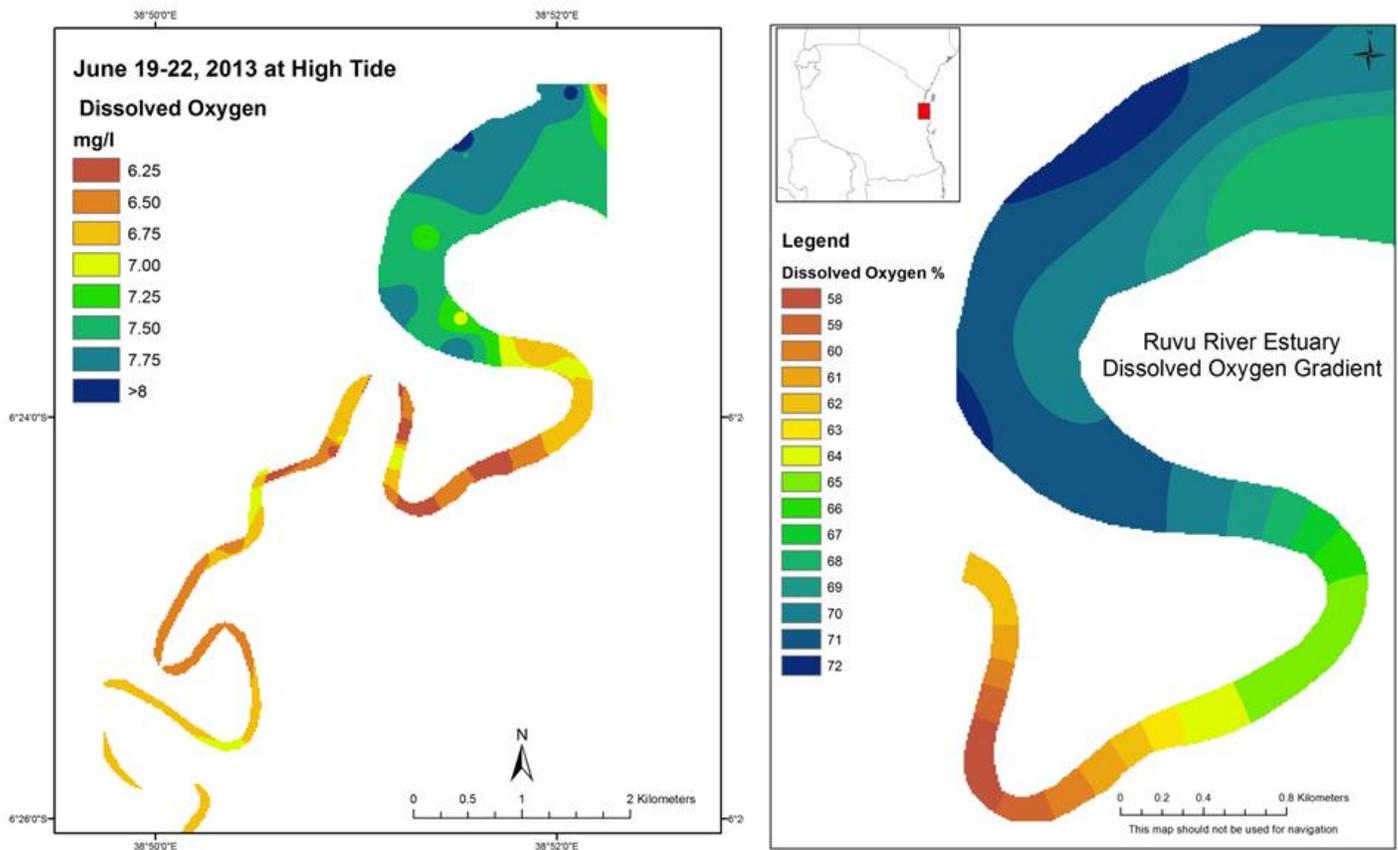
Figure 2-13: (Left) Dissolved Oxygen gradient in the Ruvu River Estuary as of June 19, 2013 (daytime). (Right) DO profile (in %) of the Ruvu Estuary obtained in August 27, 2013 (daytime). Courtesy: Chris Dutton for the plot on the right.

A Dissolved Oxygen (DO) probe (YSI DO 300, YSI, USA) with a 10 m cable was used to measure DO (in mg/l and %) as well as the temperature (°C) at the same depths as the salinity measurements. The dissolved oxygen profile of the estuary is shown in Figures 2-13 (left and right) taken in June and August respectively, the latter by the team studying sediment sources in the Ruvu. The same spatial pattern was present in both surveys. In general, the DO level decreases upriver from the mouth of the estuary, from turbulent well-mixed conditions at the mouth (ocean wave action) to lesser turbulence upstream. There also may be a higher biochemical oxygen demand upstream owing to organic matter inputs in runoff from farms and decaying leaf litter. Within the estuary mouth, the southeastern bank has a lower DO than the northwestern bank. There was no clear relationship between DO and depth in the first 2 meters of water.

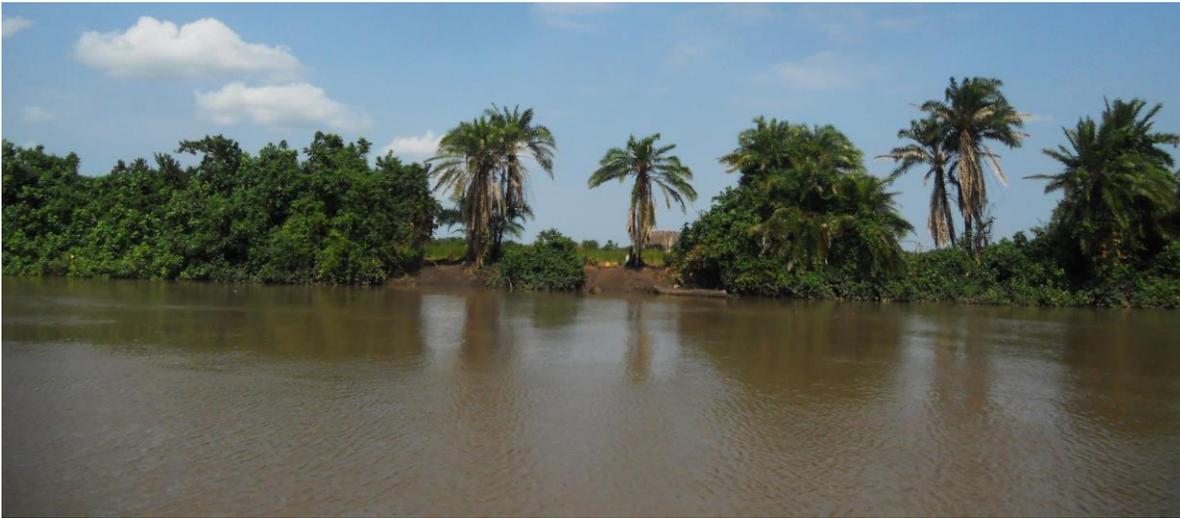
Figure 2-14: Turbid water in the freshwater section of Ruvu river, 20 km upriver from estuary mouth.

The survey over June 19-22 noted highly turbid water in the Ruvu river from the Mtoni bridge that decreased only at the estuary mouth. This is illustrated by the series of photographs (Figs 2-14 to 2-18) showing muddy brown water. Turbidity was visually examined by filling an 8 cm diameter transparent bottle with river water, looking along the diameter cross-section from one side of the bottle and by noting if letters on the other side were legible. Turbidity measurements were qualitative, but in no case visibility extended beyond 8 centimeters except at the estuary mouth where the water was clearer at high tide on account of mixing with clear seawater. Water in the Indian Ocean 1 km away from the mouth was very clear, with a blue surface appearance as was seawater off the coastline south of the estuary (Fig.2-22), away from the direct outflow from the Ruvu.

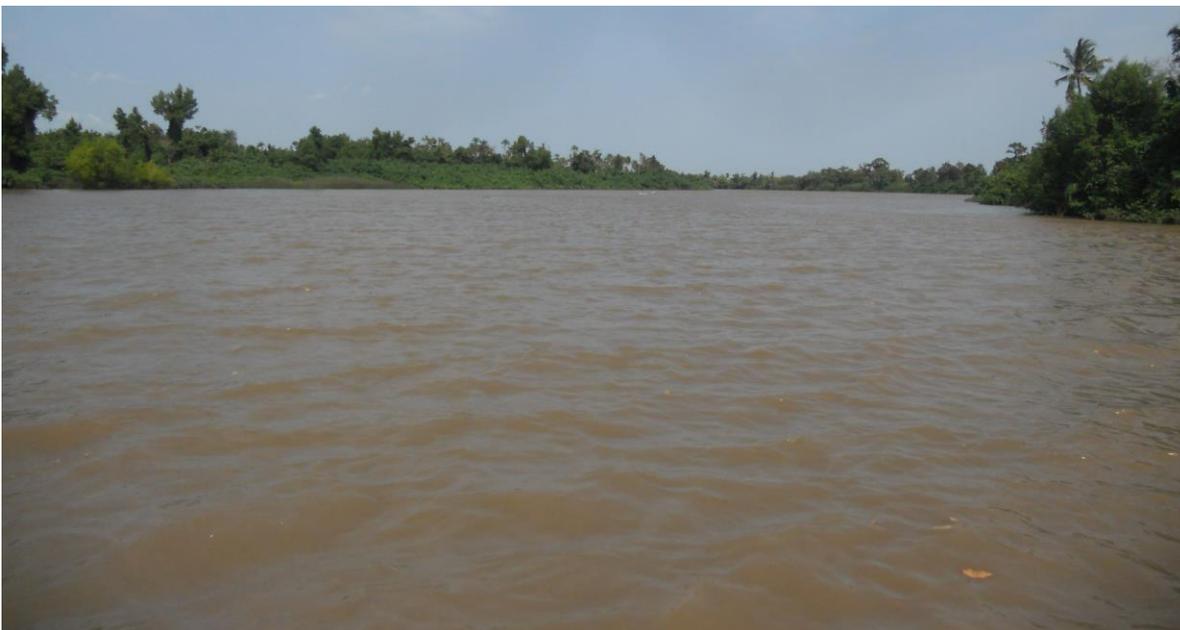
Figure 2-15: High turbidity in mangrove-palm transition zone, 14 km upriver from estuary mouth.

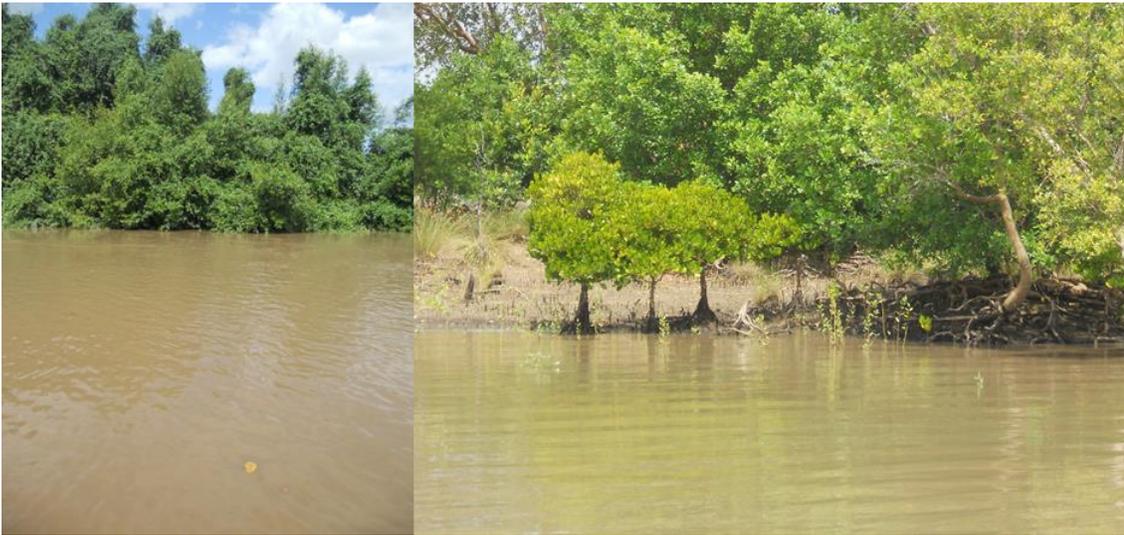
Figure 2-16: (Left) (Right) Turbidity from inflowing sediment-laden freshwater in the mangrove-forested section 4 km upstream from the mouth.

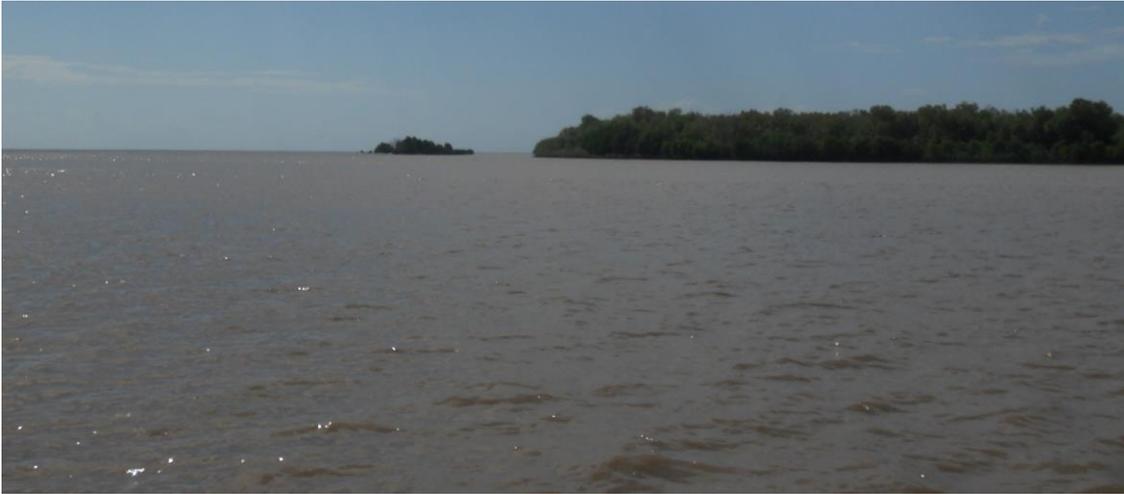
Figure 2-17: Turbidity persisting in Ruvu estuary mouth, June 21, 2013

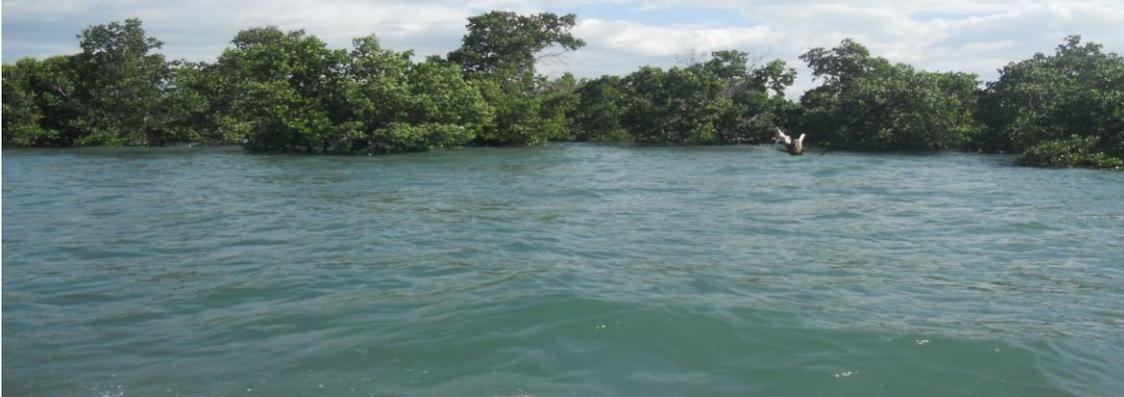
Figure 2-18: Clear seawater off the coast south of the estuary

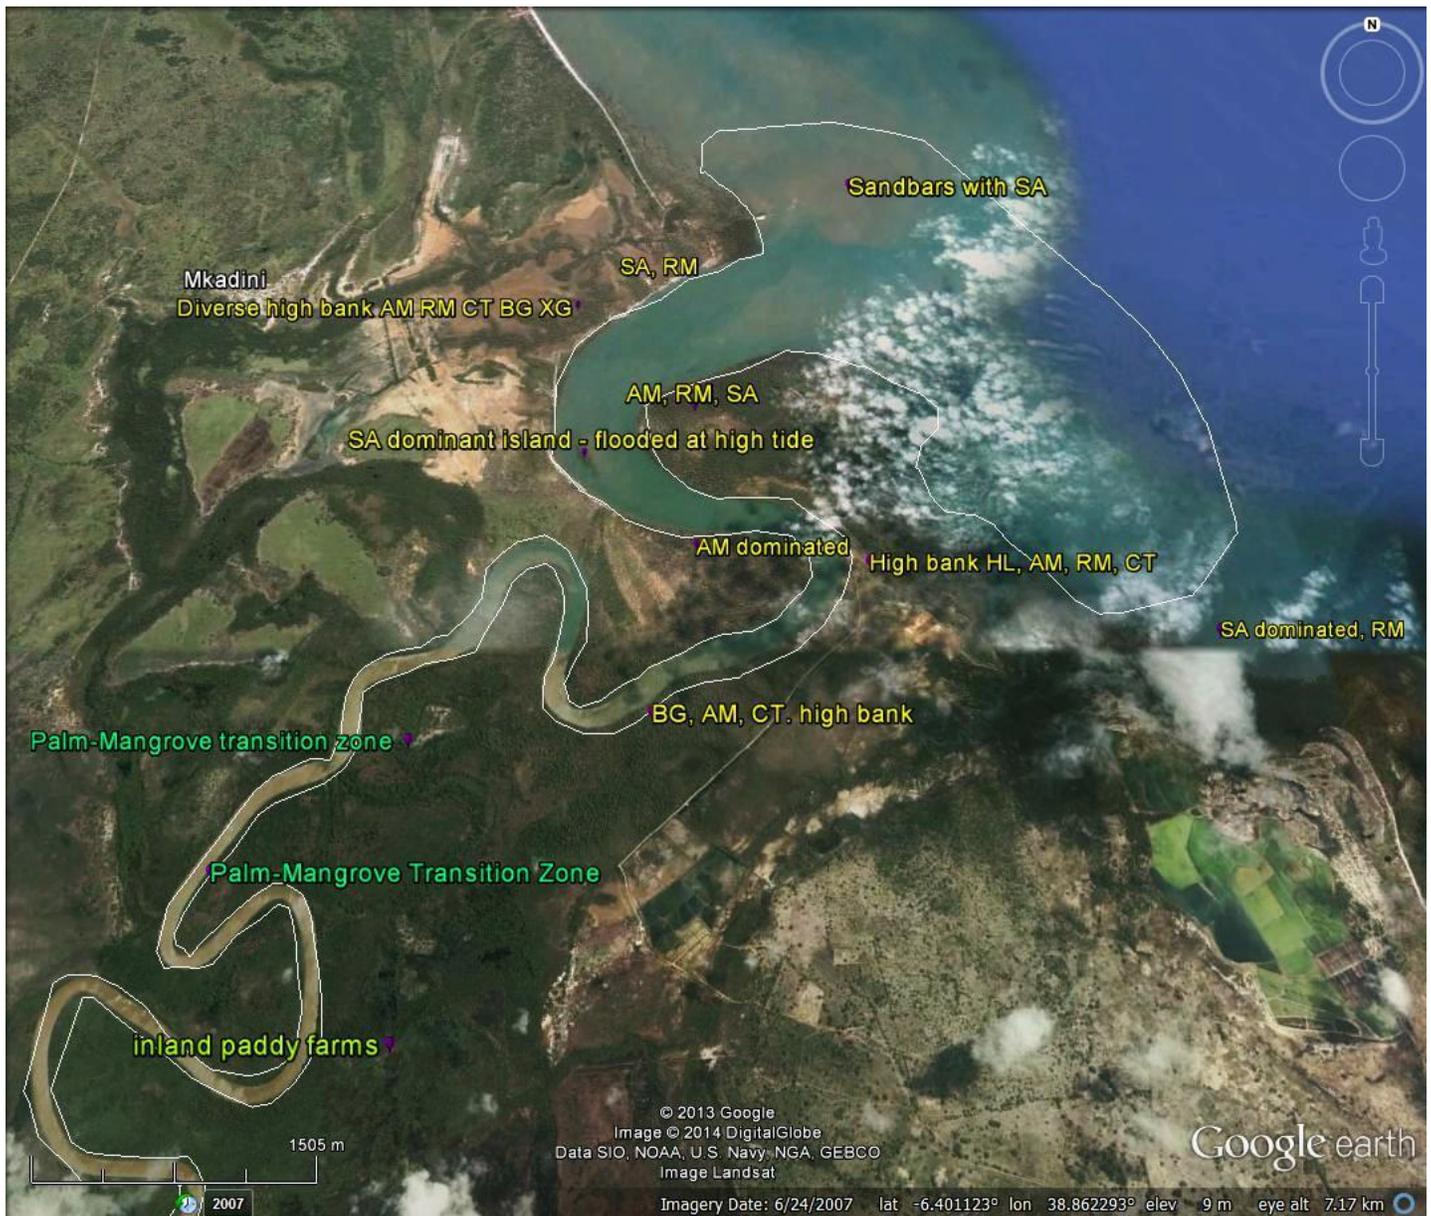
Figure 3-1: Woody vegetation composition in the Ruvo estuary, June 2013. Mangrove species abbreviations: SA: *Sonneratia alba*; RM: *Rhizophora mucronata*; AM: *Avicennia marina*; BG: *Brugeria gymnorrosa*; CT: *Ceriops Tagal*; HL: *Hereteria littoralis*.

The zone within 9 km upstream from the river mouth has different mangrove communities (Fig.3-1, 3-2), followed by the mangrove – palm transition zone for about 2 km and thereafter paddy farms and freshwater-source using trees (such as *Acacia senna*) on the bank. The distribution of species into these distinct communities is likely a direct outcome of the duration of flooding and the salinity of the water in the root zone. To sample water from the root zone, wells would be required to be installed; however, in the absence of wells, we relate vegetation distribution with adjacent river salinity.

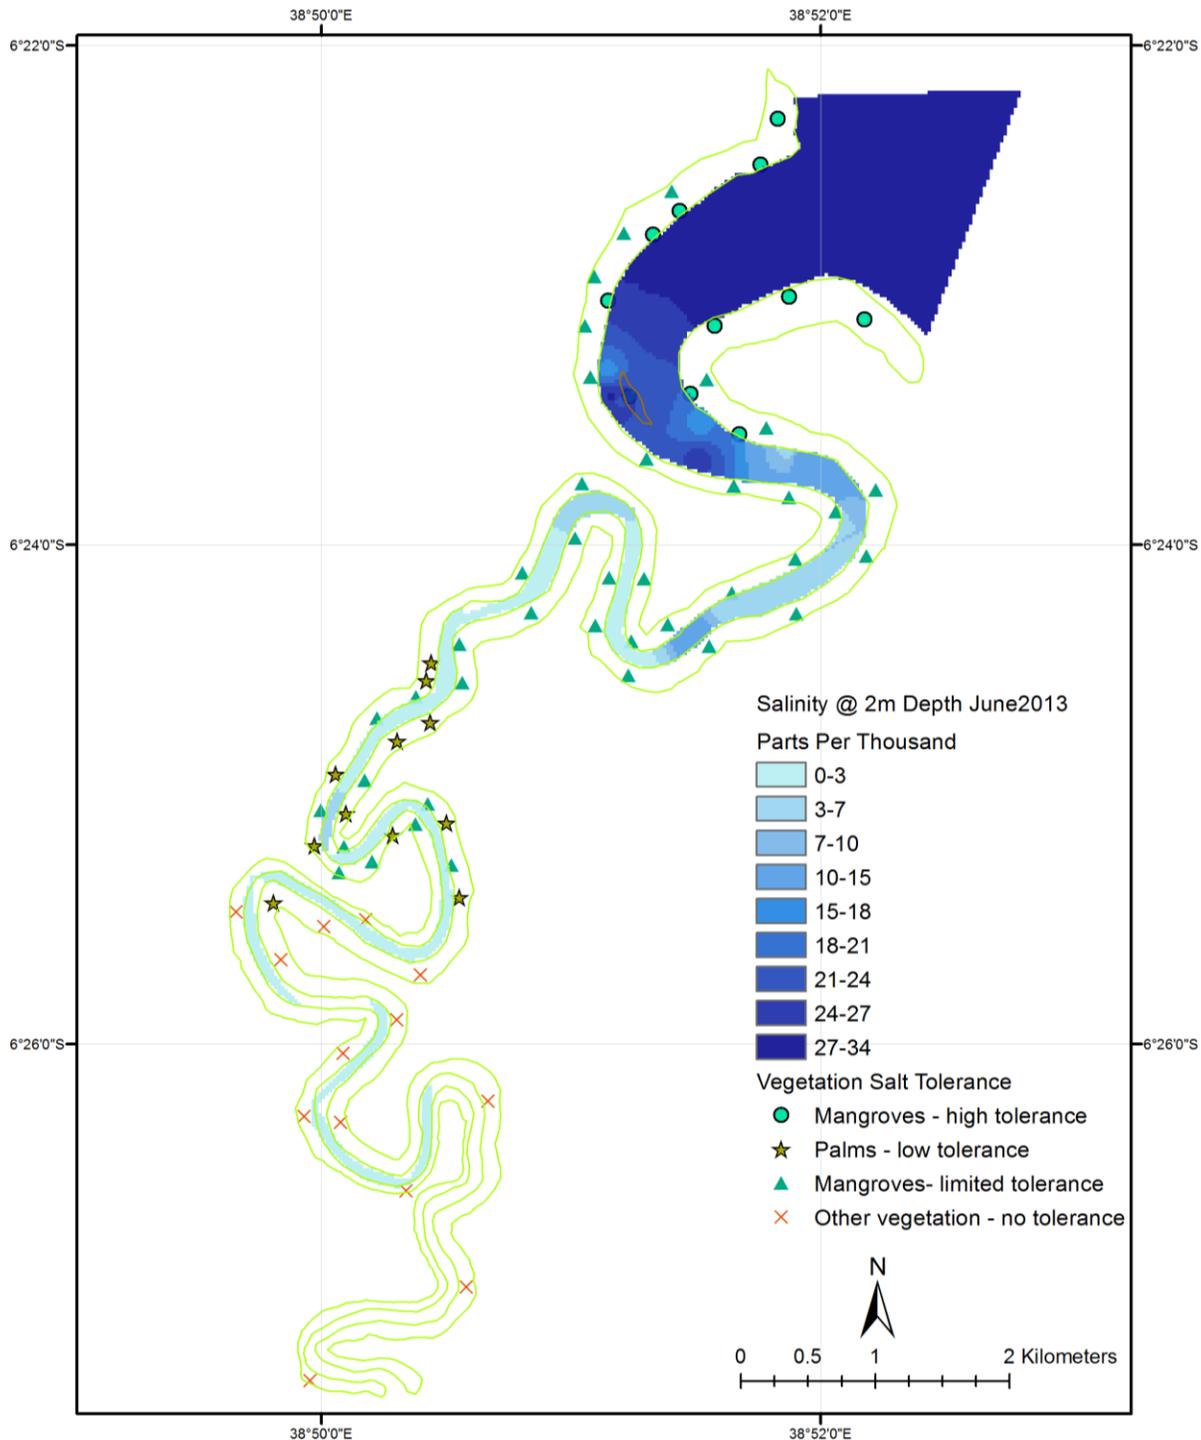
Figure 3-2: Riparian vegetation in the Ruvu estuary (freshwater to marine end) classified by salinity tolerance and shown along with salinity measurements in the Ruvu river (high tide phase at 2 m depth over June 19-22, 2013).

About 9 km inland the first palms appear (Figs. 3-2, 3-11), and then get more numerous. Unlike *Cocos nucifera* (coconut palm found on coasts) or *Nypa fruticans* (toddy or mangrove palm not found in East Africa, but that may have been introduced), the palms in these forests, such as *Phoenix reclinata* are not known to be tolerant of salinity, although they can withstand some degree of soil anoxia from flooding. Hence the presence of palms on riverbanks indicates water conditions that are largely fresh throughout the year. This is corroborated by this study's salinity measurements which at low tide were 0 ppt while at high tide were 0, 0.3 and 0.6 ppt at the surface, 1 and 2 m depths. The mangrove-palm transition thus can be reasonably assumed to indicate the average extent of seawater intrusion into the Ruvu. A similar transition zone has been observed in the Wami estuary (Anderson et al. 2007). Note that the palms have to be on the riverbank in order to be considered as indicators; inland palms may be located on higher ground that may have a layer of entrapped rainwater (freshwater lens, Saha et al. 2009) serving as the water source.

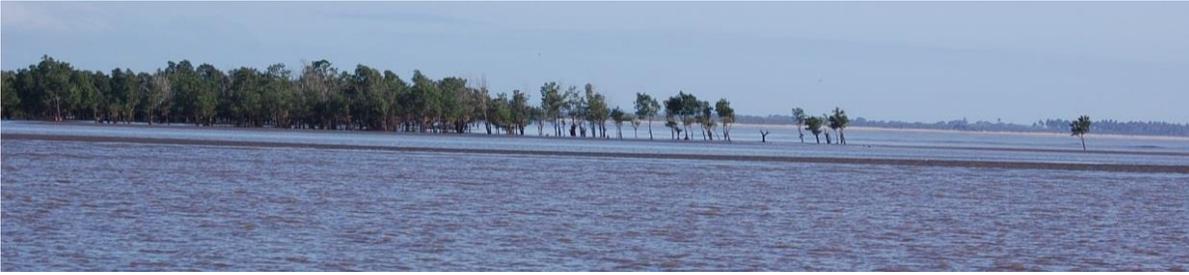
Figure 3-3: *Sonneratia alba* on a sandbank at low tide at the mouth of the Ruvu; the Indian Ocean is to the right.

The mouth of the river has sandbanks extending > 100 m from the coastline into the Indian Ocean (Fig.3-3, 3-4). The landward portions of these sandbanks have stunted *Rhizophora mucronata* and *Sonneratia alba* on account of being entirely submerged during high tide (Fig.3-3, 3-4, 3-5). The almost monospecific stands would indicate that these are the only mangrove species able to tolerate prolonged flooding by seawater on a diurnal basis.

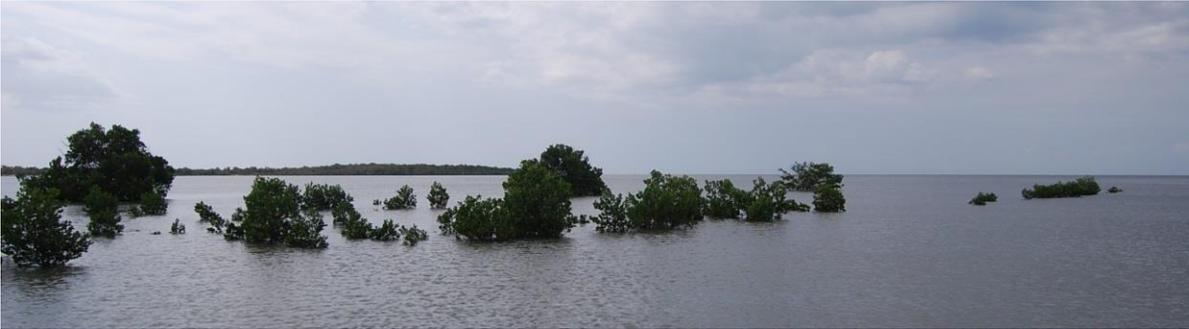
Figure 3-4: *Sonneratia alba* on sandbanks in the mouth immersed at high tide

Entering the river, low lying banks and islands have monospecific stands of *Sonneratia* with a few individuals of *Avicennia*. These banks were observed to be totally inundated by the high tide (Fig.3-4, 3-5). *Sonneratia* has been reported as being the most flood-tolerant of the mangroves along the East African coast (Semesi 1991). Both *Sonneratia* and *Avicennia* have pneumatophores as root respiratory adaptations to flooded conditions, while *Rhizophora* has stilt or prop roots (refer Appendix 2). A physiological description of mangrove function in flooding and saline environments is

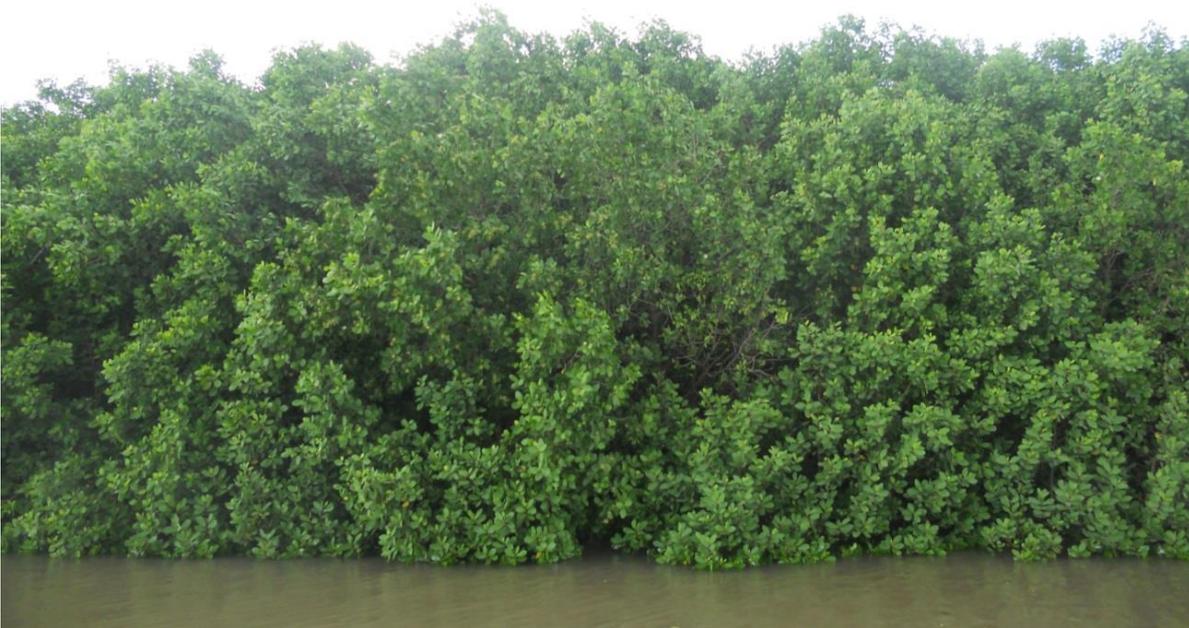
Figure 3-5: Pure stand of *Sonneratia alba* on island that gets inundated at high tide

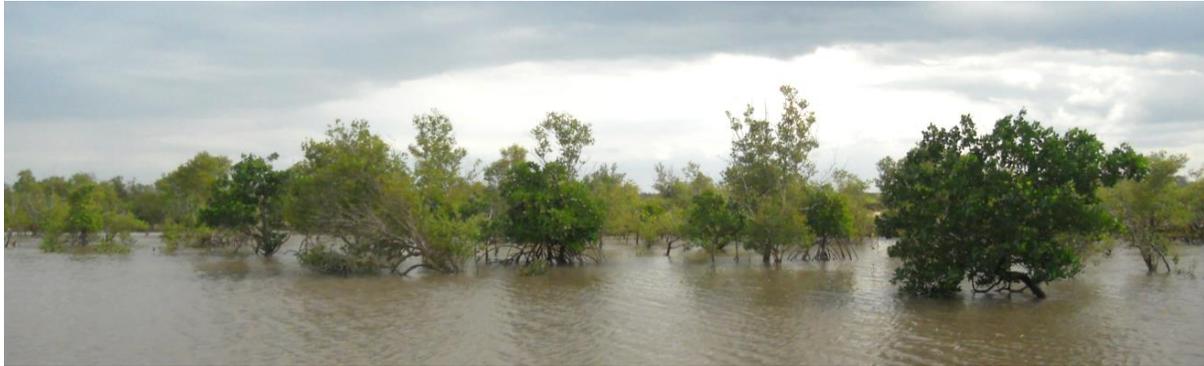
Figure 3-6: *Rhizophora* (stilt roots), *Sonneratia* (right) in the foreground, inundated at high tide, with *Avicennia* in the back, inundated to a lesser extent.

found in the literature (Semesi 2001, Richmond 2011). The coastlines have *Rhizophora* and *Sonneratia* along the banks, with stands of *Avicennia marina* inland (Fig.3-6).

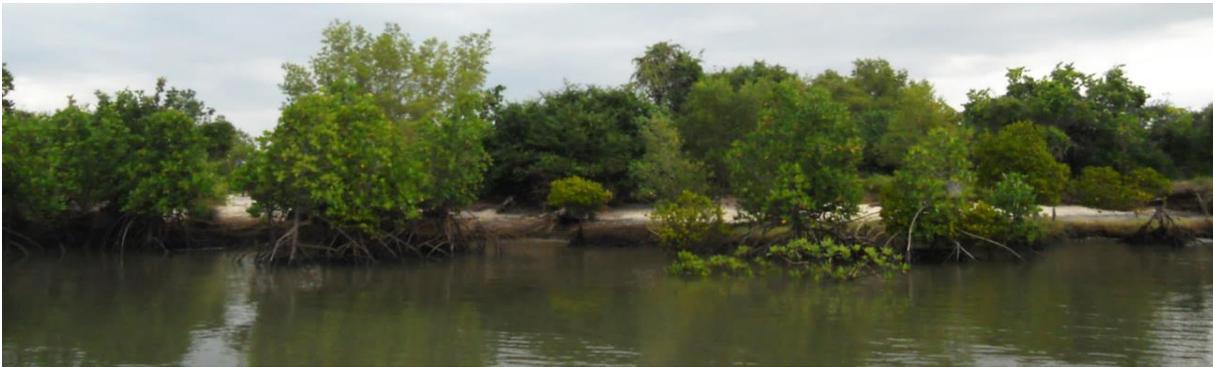
Figure 3-7: *Rhizophora* (left), *Ceriops* on sandbank (centre) with *Avicennia* on higher ground. Salinity varies between brackish and marine.

The western river bank gets noticeably higher upriver from the mouth with an accompanying increase in mangrove species present. *Ceriops tagal* is noticed with its characteristic bunched roots at the base of the trunk, along with *Rhizophora* and *Avicennia*, while *Sonneratia* is absent (Fig.3-7), probably outcompeted by other mangrove species.

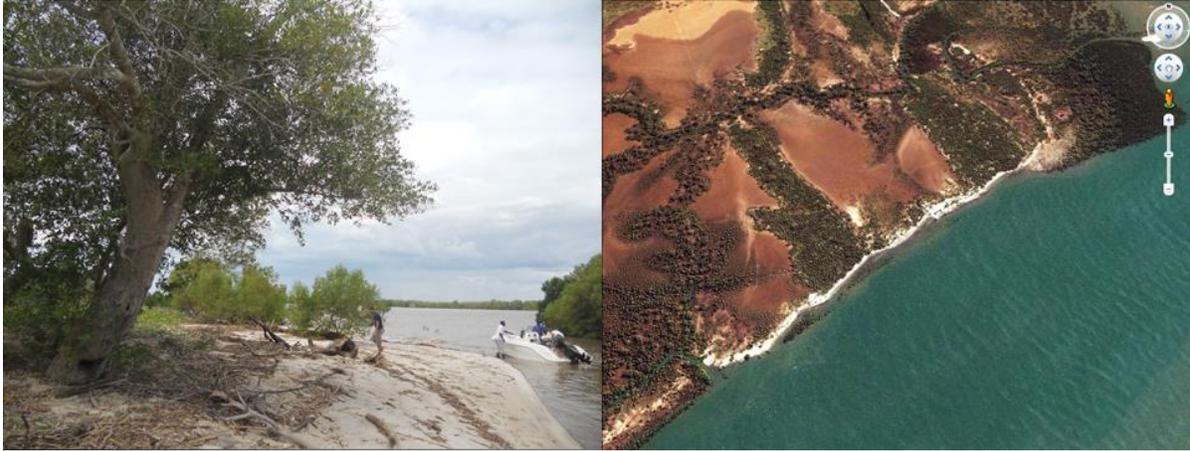
Figure 3-8: (Left) High sandy bank on an incoming tide with an *Avicennia marina* tree on left and smaller *Avicennia* on the bank. (Right) Google Earth satellite image taken at high tide, showing *Rhizophora* and *Sonneratia* trees inundated at the edge of the bank as well as presence of channels that flood at high tide.

In order to observe what species exist inland away from the riverbank and to examine how community composition is related to distance from the bank, local topography and soil type, shore-based investigations were undertaken. Banks that were up to 0.5 m higher than the high tide level (such as in Figure 3-8 left) showed a diverse assemblage of mangroves, including *Ceriops tagal*, *Brugeria gymnorhiza*, *Heretaria littoralis* and *Xylocarpus granatum* apart from *Avicennia marina* and *Rhizophora mucronata* (Fig.3-9). Soils under these diverse mangrove communities were sandy thereby allowing free drainage at low tide; the availability of well-aerated conditions is an important factor in permitting these other mangrove species to exist that are not as tolerant of prolonged flooding as *Sonneratia* and *Rhizophora* are.

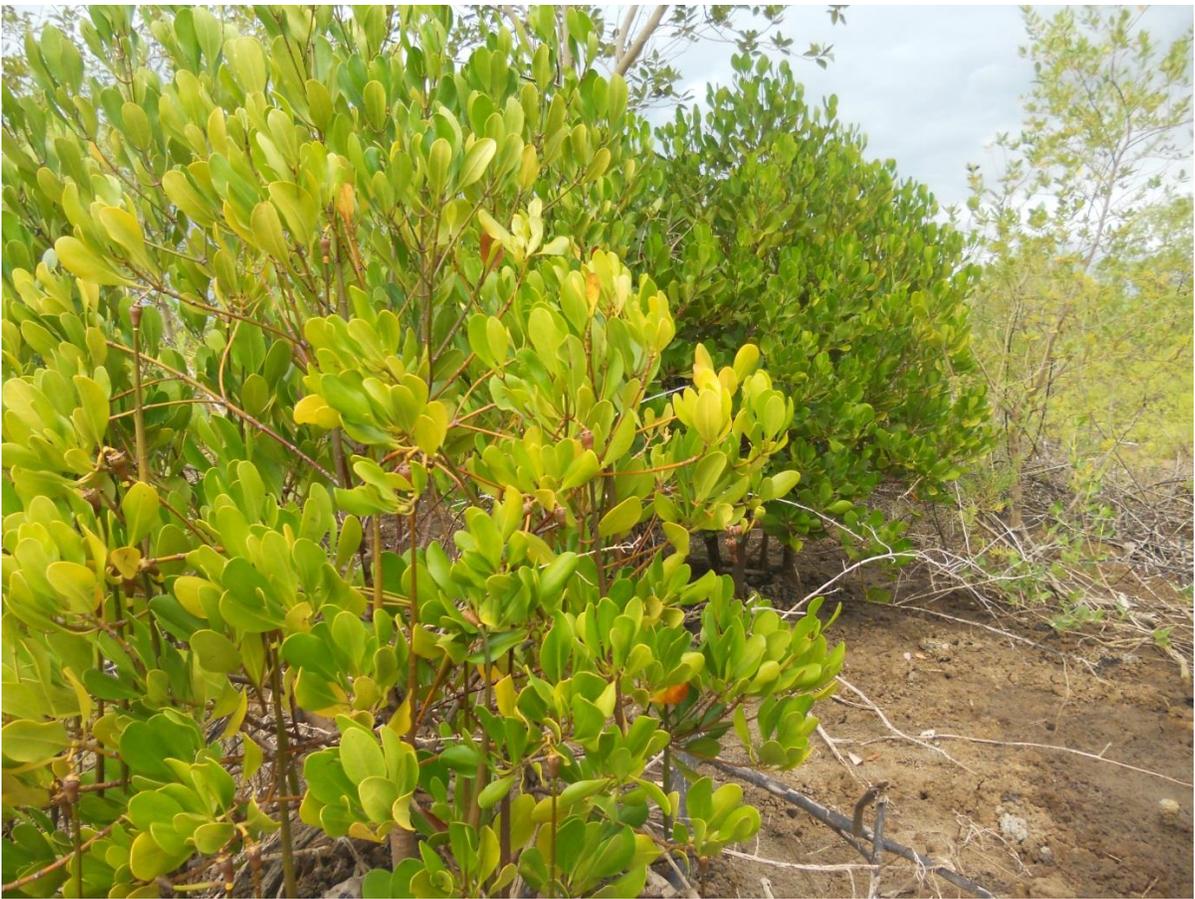
Figure 3-9: Diversity of mangroves on high bank. *Ceriops* (left), *Xylocarpus* (centre), and *Avicennia* (right) in the back, with a relatively low-lying area (darker soil on the right).
