A Rapid Ecohydrological Assessment of the Ruvu River Estuary, Tanzania

Tanzania Integrated Water, Sanitation and Hygiene (iWASH) Program

GLOWS 2015. A Rapid Ecohydrological Assessment of the Ruvu River Estuary, Tanzania. Global Water for Sustainability Program, Florida International University. 76 p.

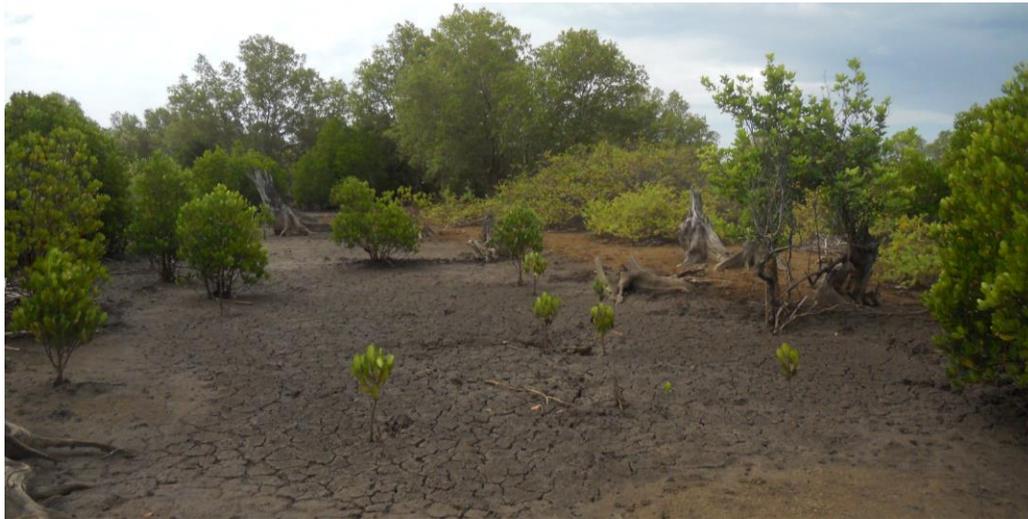
Figure 3-10: Low-lying area with cracked soil indicating periodic wetting and drying

On the bank there were also relatively-low lying areas with little vegetation and with cracked soil indicating periodic flooding and drying (Fig.3-10). During the survey, the tide began entering inland along these low-lying areas, not from the riverbank which was still higher than the river level but from other small channels that came in from the coastline. These stream flow channels are visible on the Google Earth map (Fig. 3-8 right). This map shows this bank at high tide with clusters of mangroves flooded off the bank shore that are mainly *Rhizophora*. Salinity in the river varied between

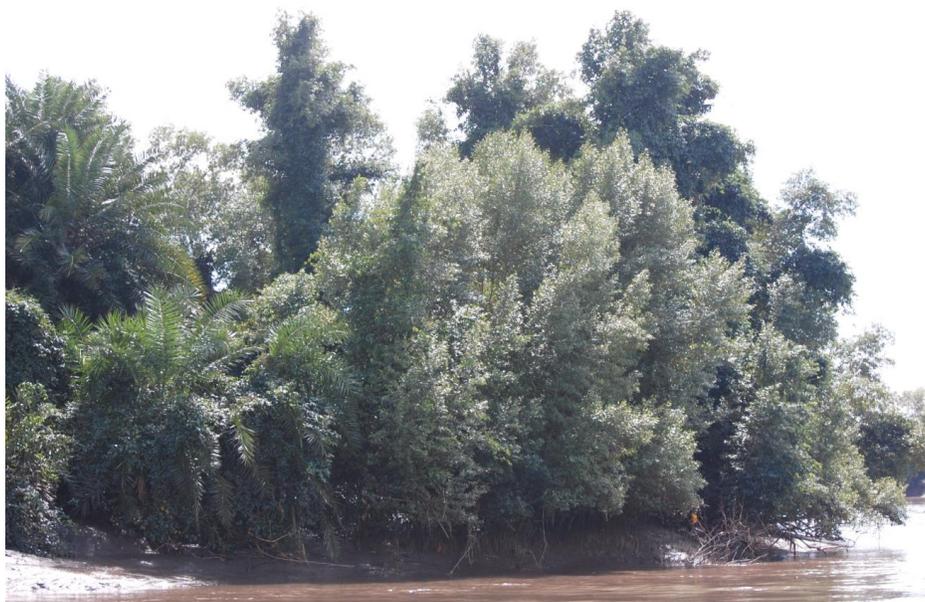
Figure 3-11: *Phoenix reclinata* palms (left) coexisting with *Avicennia marina* (center) in the mangrove-palm transition zone

About 9 km inland the first palms appear (Figs. 3-2, 3-11), and then get more numerous. Unlike *Cocos nucifera* (coconut palm found on coasts) or *Nypa fruticans* (toddy or mangrove palm not found in East Africa, but that may have been introduced), the palms in these forests, such as *Phoenix reclinata* are not known to be tolerant of salinity, although they can withstand some degree of soil anoxia from flooding. Hence the presence of palms on riverbanks indicates water conditions that are largely fresh throughout the year. This is corroborated by this study's salinity measurements which at low tide were 0 ppt while at high tide were 0, 0.3 and 0.6 ppt at the surface, 1 and 2 m depths. The mangrove-palm transition thus can be reasonably assumed to indicate the average extent of seawater intrusion into the Ruvu. A similar transition zone has been observed in the Wami estuary (Anderson et al. 2007). Note that the palms have to be on the riverbank in order to be considered as indicators; inland palms may be located on higher ground that may have a layer of entrapped rainwater (freshwater lens, Saha et al. 2009) serving as the water source.

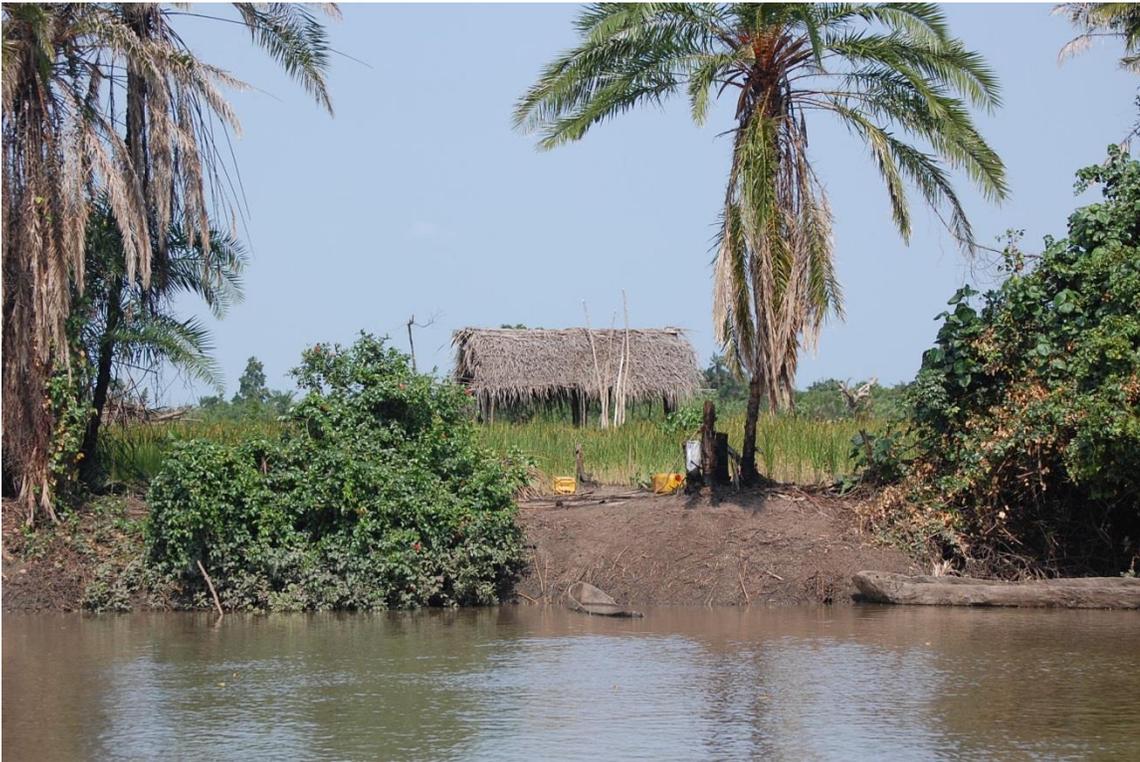
Figure 3-12: Palms get more numerous, and paddy farms appear up to the bank

Palms (primarily *Phoenix reclinata*) become more dominant, until acacias and other terrestrial evergreen and deciduous trees appear, interspersed in today's landscape with rice fields (Fig.3-12). The water is completely fresh in these regions. Hydrologists from the Wami Ruvu Basin Water Office have observed saline water past the bridge that is 5 km further upstream from the mangrove-palm transition zone. It is possible that seawater extends further upriver when spring tides coincide with the lowest freshwater flow in the dry season. However, the vegetation is dominated by freshwater-dependent plants, and also paddy farms. This is because the banks are high enough to avoid prolonged flooding by the river, the top water layer is fresh and, eventually upon wet season flows, the freshwater pulse can flush saline water in river bed soil interstices. Also the high banks collect rainwater that constitutes the main water source for plants.

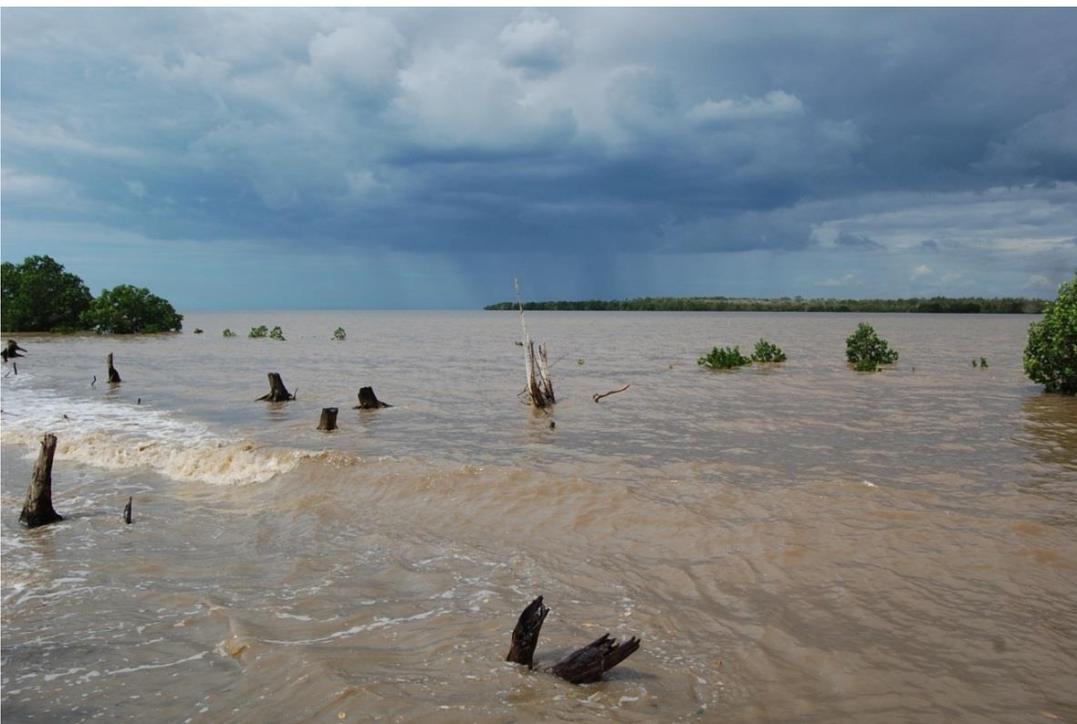
Figure 4-3: Mangrove stumps poke out over the high tide waves on a clear-cut bank

from these forests for the Indian Ocean trade (Martin & Martin 1978, Stedman-Edwards *et al.* 2013). However, increasing pressures are threatening mangrove forests through indiscriminate cutting of mangroves for timber (Stedman-Edwards *et al.* 2013). This survey noticed areas on higher banks that were clear-cut (Fig. 4-3). Clear-cutting sections decreases habitat for bird communities that roost and breed in these trees. Another environmental issue involves plastic bags and garbage that are washed up with the tides in increasing amounts, covering mangrove propagules, roots and pneumatophores. Plastic bags also pose a serious danger to turtles, fish and birds by choking them. Efforts are required to increase protection for these forests, as well as to work with communities for mangrove restoration programs while simultaneously exploring other avenues for sustainable income generation for local communities.

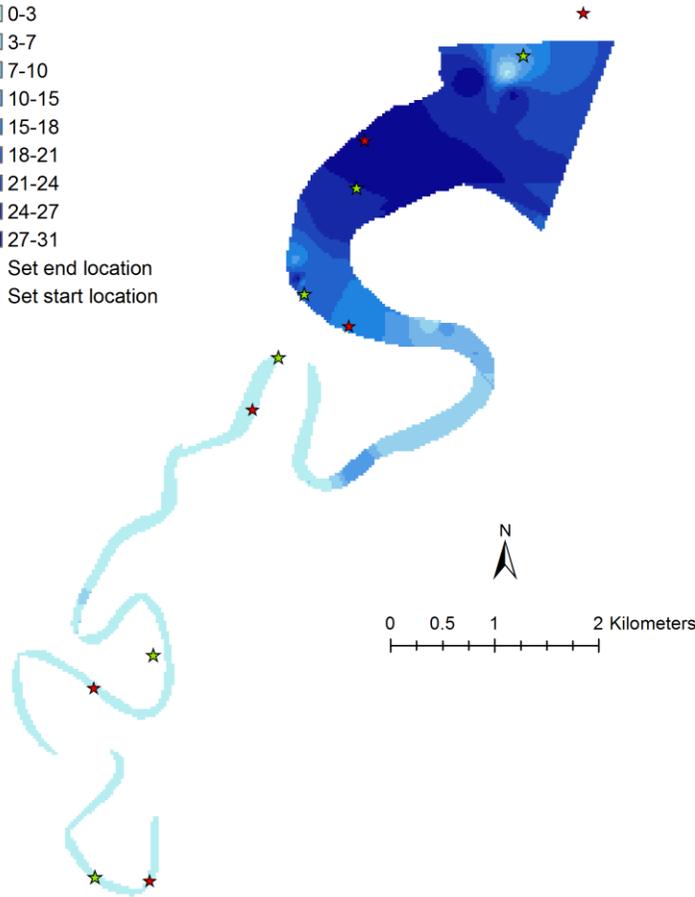
Figure 4-4: Longline fishing locations with start (green star) and end (red star) for each longline set, corresponding to the anchor and buoy locations. Also shown are surface salinity as of June 2013 (shades of green) and salinity values measured at the time of fishing.

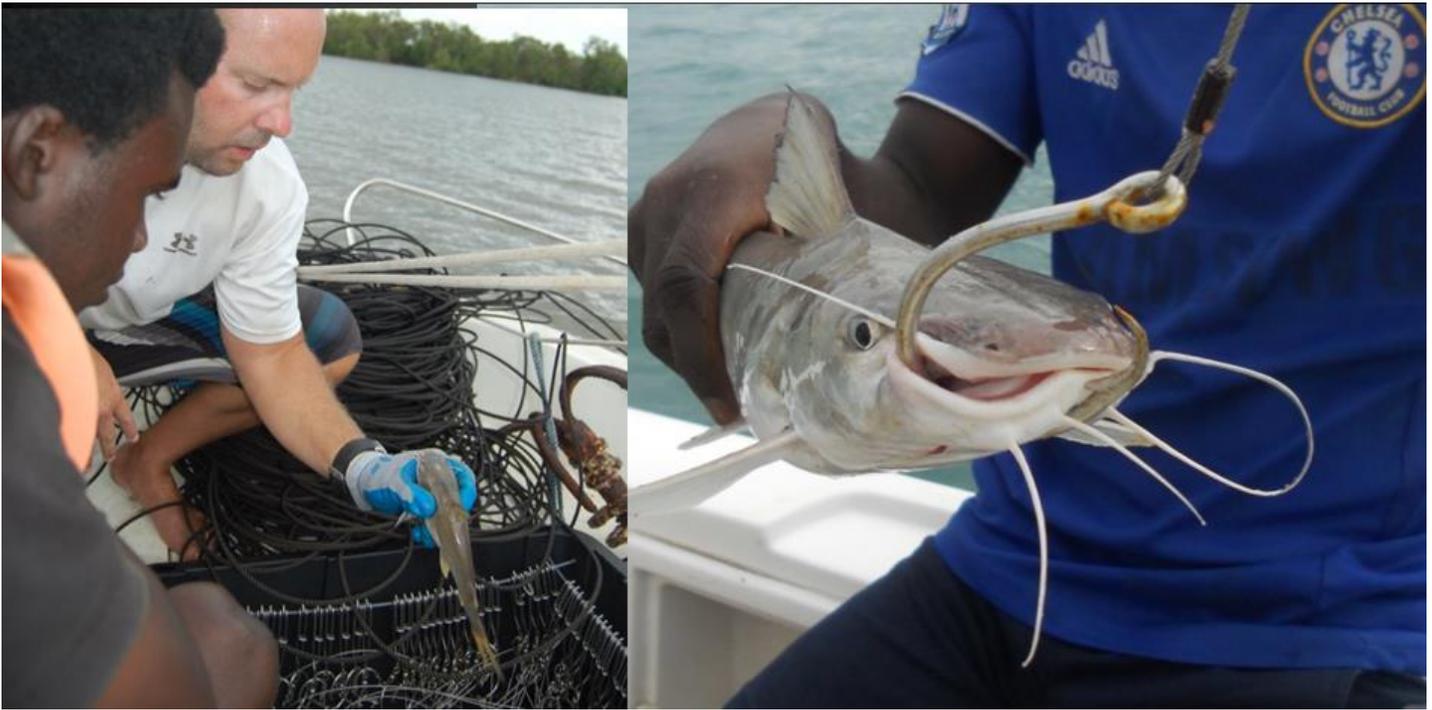
Figure 4-5: (Left) (Right) Longline nylon rope, hooks and anchor. Two sea catfishes (*Arius africanus*) caught on the longline.

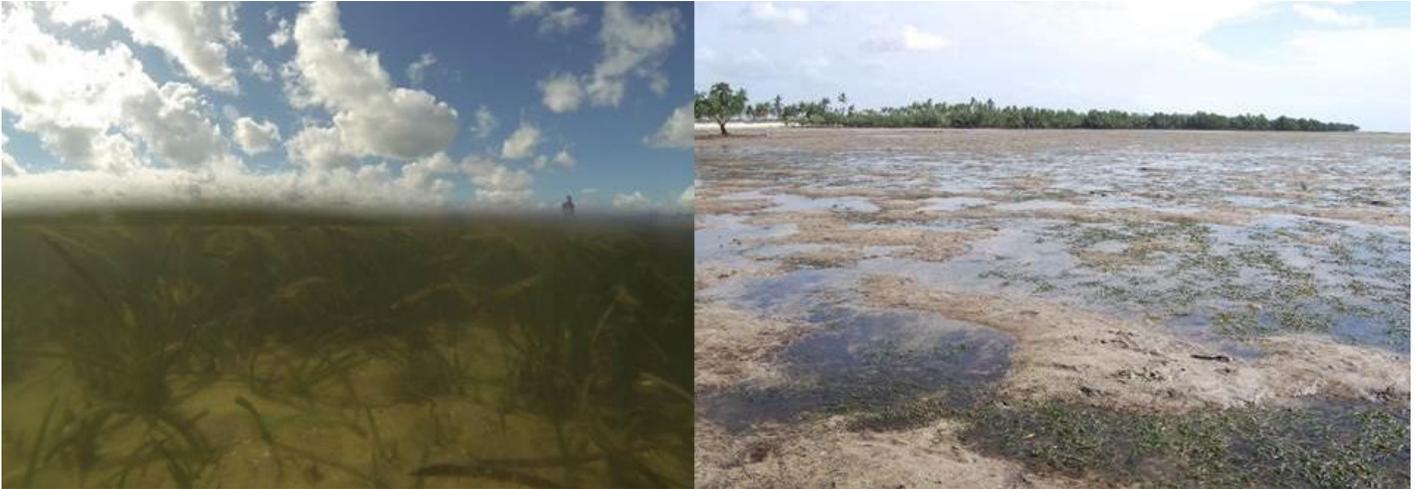
Figure 4-6: Seagrass beds along the coast at high tide (left) and low tide (right) with some degree of sedimentation.

A total of 7 seagrass species and 5 macroalgae species were sampled north of Bagamoyo village from the coastal flats at low tide (Fig 4-6). The seagrass species identified were *Thalassodendron ciliatum*, *Halodule wrightii*, *Halodule uninervis*, *Halophila ovalis*, *Syringodium isoetifolium* and *Cymodocea* species

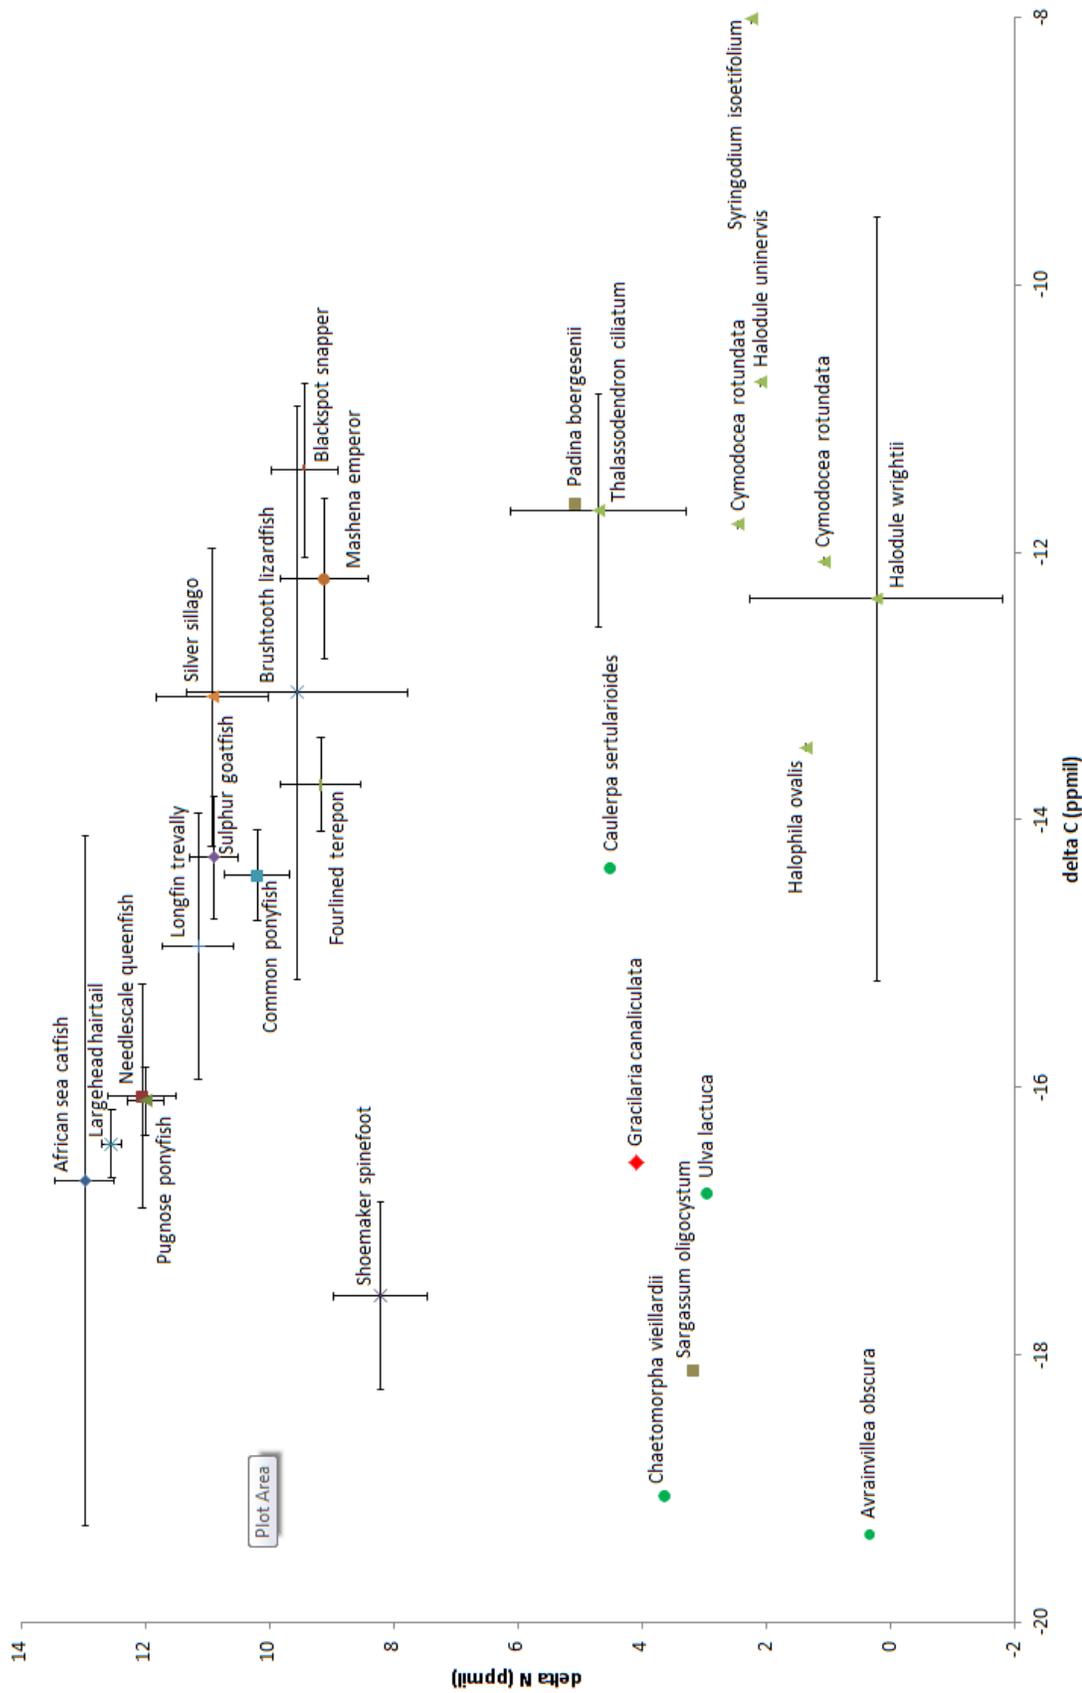
Figure 4-7: Trophic levels of secondary consumers (fish - above) and primary producers (seagrasses and macrolagae- bottom) obtained from a plot of Carbon and Nitrogen stable isotopes for the Ruvu Estuary

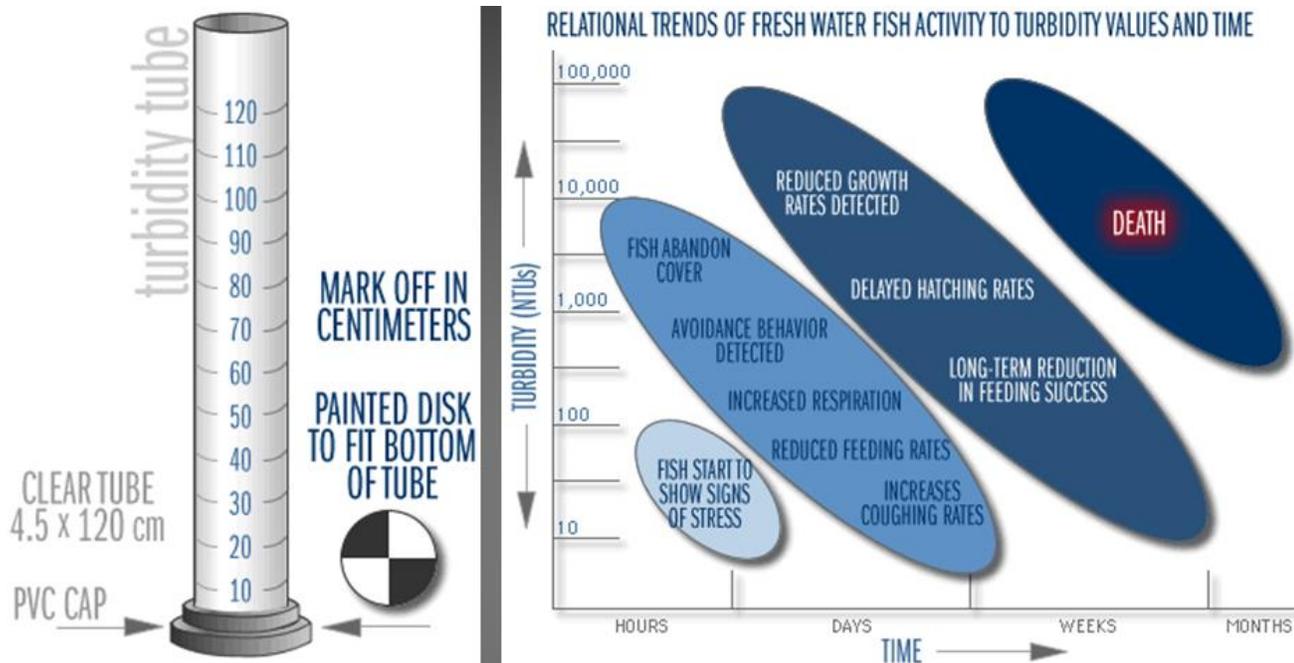
Figure 5-1: (Left) Turbidity tube and (Right) a schematic showing relationship between turbidity and fish. Source: http://steinhardtapps.es.its.nyu.edu/nyuhudson/?page_id=168

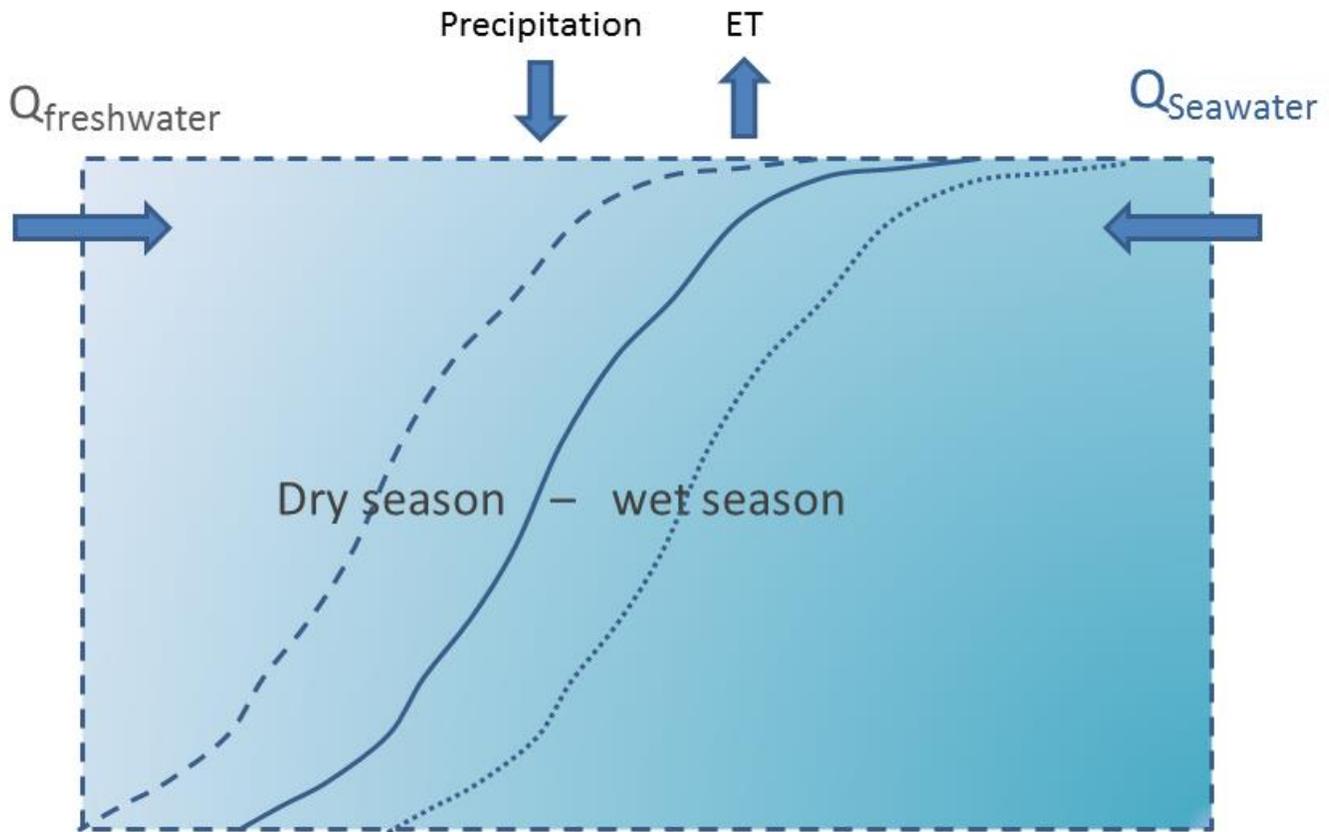
Figure 5-2: Water inputs and outputs in an estuary. $Q_{\text{freshwater}}$ (representing freshwater inflows, both surface and groundwater), rainfall, evapotranspiration and Q_{seawater} , i.e. seawater inflows. The set of S-shaped curved lines indicate the diffuse boundary between freshwater and seawater pools.
