Water Quality Survey, Ruvu River Basin, Tanzania

Tanzania Integrated Water, Sanitation and Hygiene (iWASH) Program

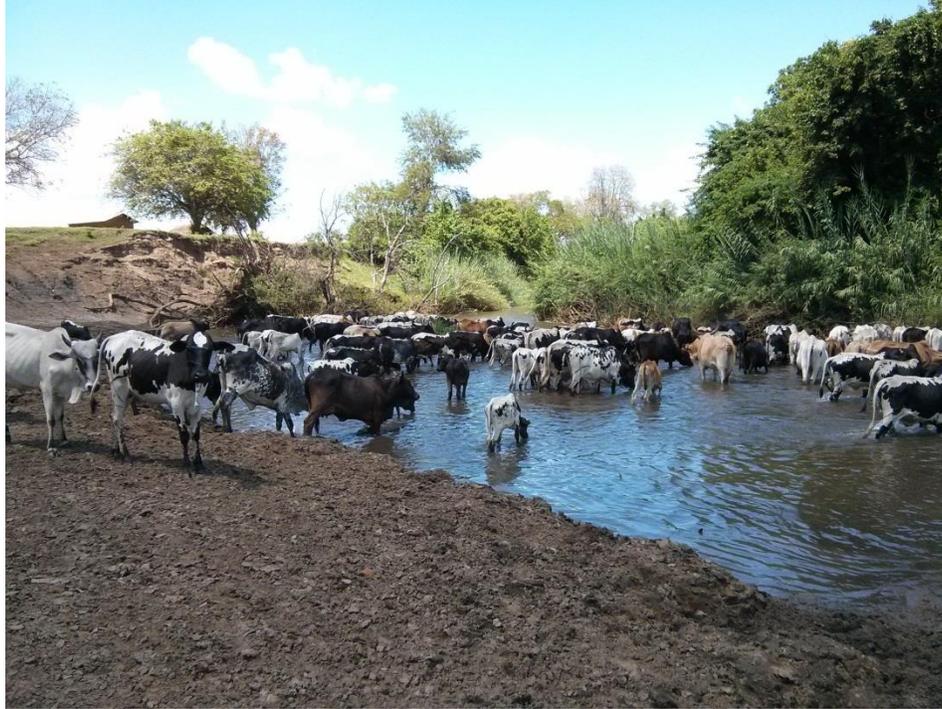
Figure 33: EFA Site 2 - Mgeta at Dutumi

EFA Site 2, Mgeta at Dutumi, is in the upper catchment yet it has some of the worst water quality in the basin. This is unsurprising given the pastoralists reliance on the Mgeta for their domestic and livestock needs (Figure 33).
