High Mountain Glacial Watershed Program

Ground Penetrating Radar Survey for Risk Reduction at Imja Lake, Nepal

IQC Contract No. AID-EPP-I-00-04-00024
Task Order No. AID-OAA-TO-11-00040
October 2012

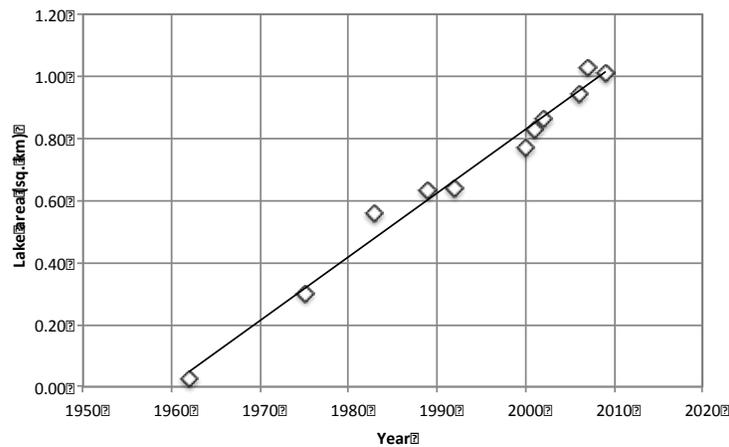
Figure 4. Imja Lake Expansion 1962-2009.

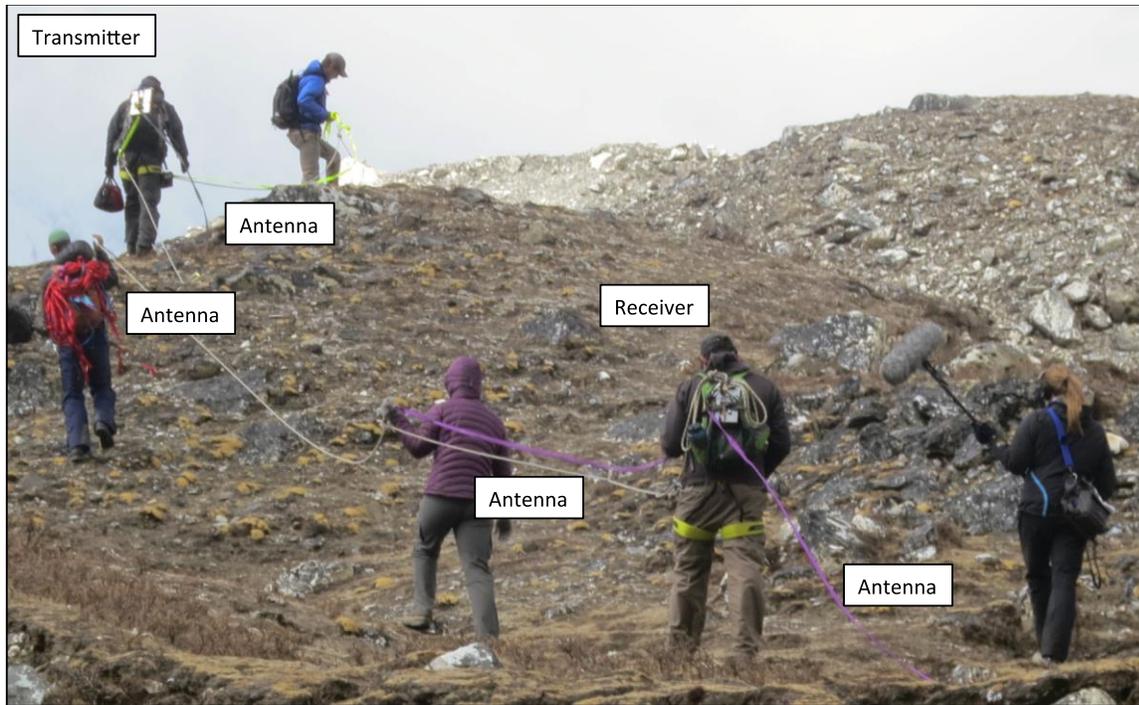
Figure 5. Backpack mounted GPR system deployed in the field at Imja Lake. (Photograph: Alton Byers)

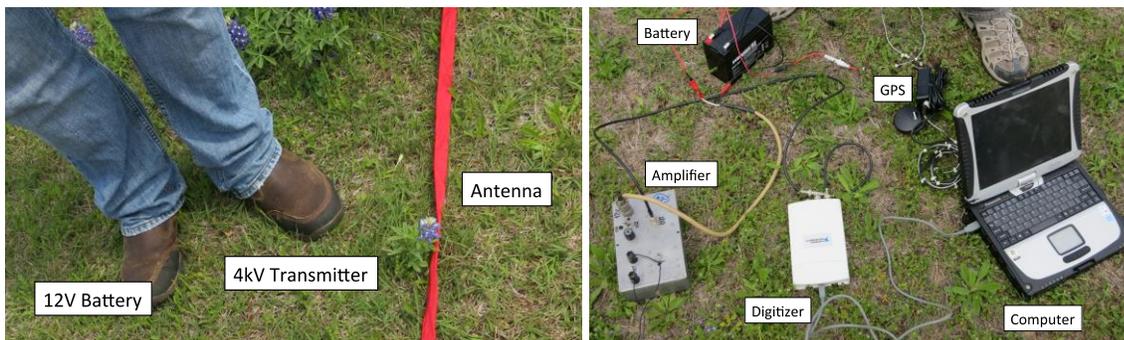
Figure 6. GPR transmitter (left) and GPR receiver (right) (*Photographs: Daene McKinney*)

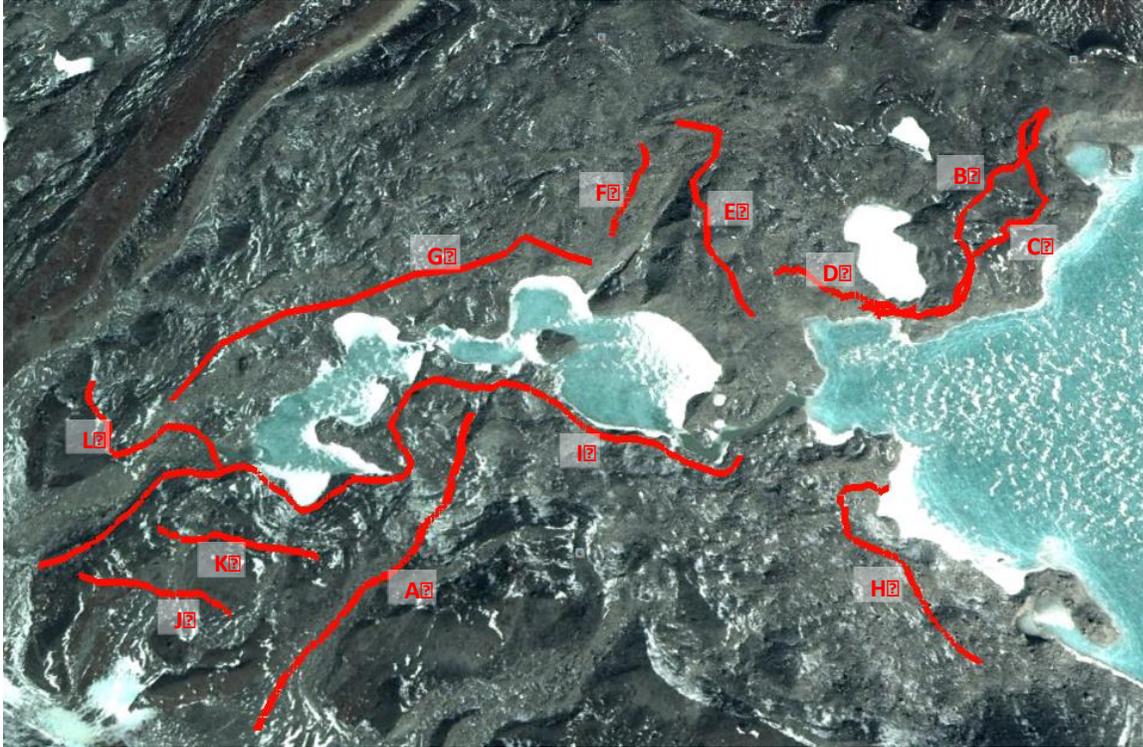
Figure 7. Mapping of GPR transects at the terminal moraine of Imja Lake taken in May 2012.
 (Source: Google Earth, 2010)

Table 4 lists the GPR transects conducted at the terminal moraine of Imja Lake and one on the Imja glacier 22-26 May and 21-25 September 2012. Figure 7 shows the layout of GPR transects on an image of the lake.

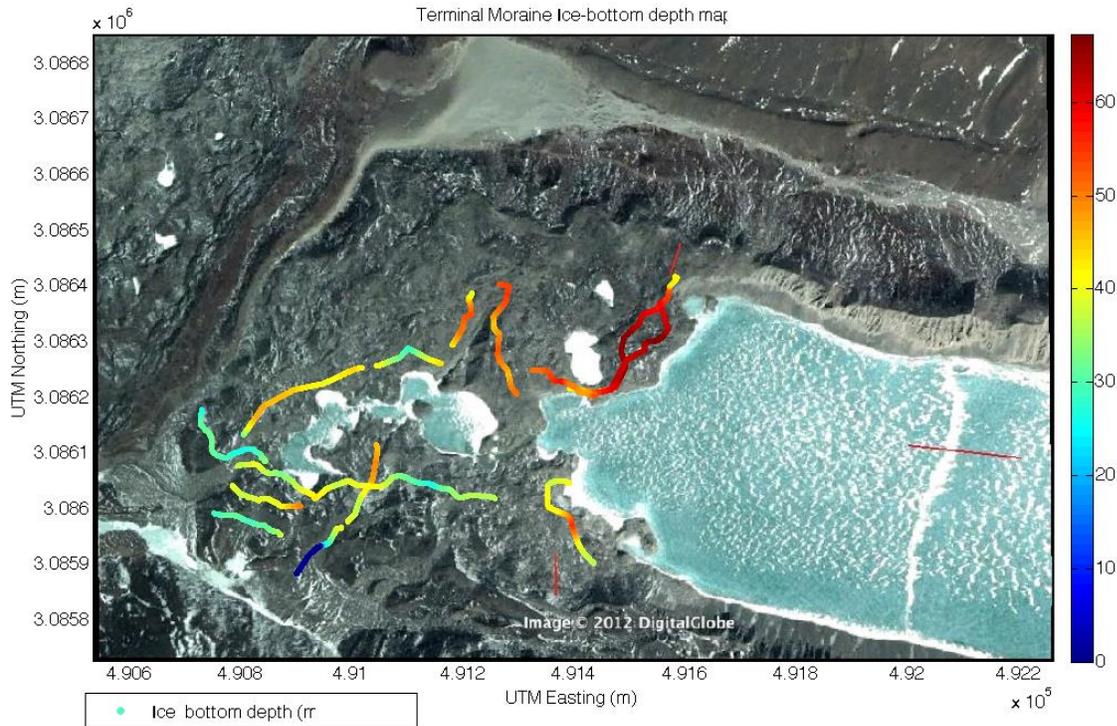
Figure 8. Imja lake ice-bottom depth (m) within the terminal moraine area.

The results of the GPR survey show that there is extensive ice present in the core of the terminal moraine complex at Imja Lake (see Figure 8). The thickest areas of ice are in the moraine near the western end of the lake on the northern side of the lake outlet. The ice in this region is several tens of meters thick and up to fifty meters thick in some places. Along the northern and southern sides of the lake outlet, the ice is between ten and twenty-five meters thick. In some portions of the moraine on the southern side of the outlet the ice thickness is up to forty meters.

Surface elevations were measured by GPS during the GPR transects. The GPS data were collected using both a Garmin BU-353 and a handheld Garmin Etrex Vista HCx unit. Figure 8 shows the depth of the bottom of the ice (m) in the Imja Lake terminal moraine interpreted from the GPR transects assuming a velocity of propagation in the subsurface material of 110×10^6 m/s.

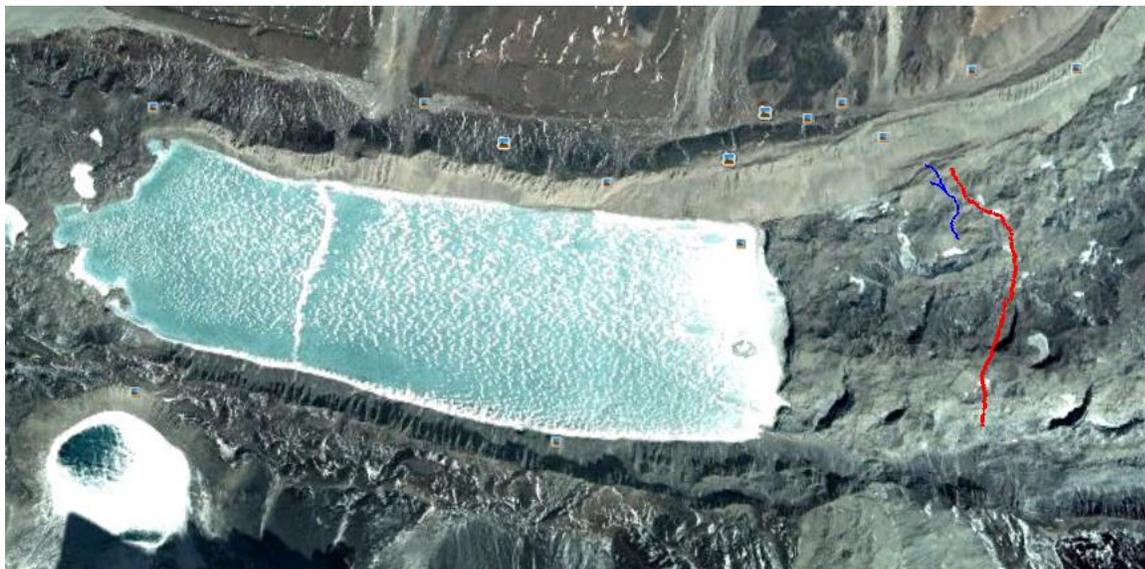
Figure 9. Mapping of GPR transects at Imja glacier taken May 25, 2012 (Blue) and September 25, 2012 (Red). (Source: Google Earth, 2010)

Figure 9 shows the location of the GPR transect taken on the Imja glacier. Figure 10 shows the resulting GPR data from the transect, clearly illustrating the transition from layered ice (upper left) to bedrock (lower right). The GPR data were processed assuming a velocity of propagation through the ice of 167×10^6 m/s, typical of a debris containing ice. Figure 11 illustrates the nature of the glacier with its thin layer of debris overlying the thick ice formation. The thin layer of debris has contributed to the rapid melting of the Imja glacier since the 1960s.

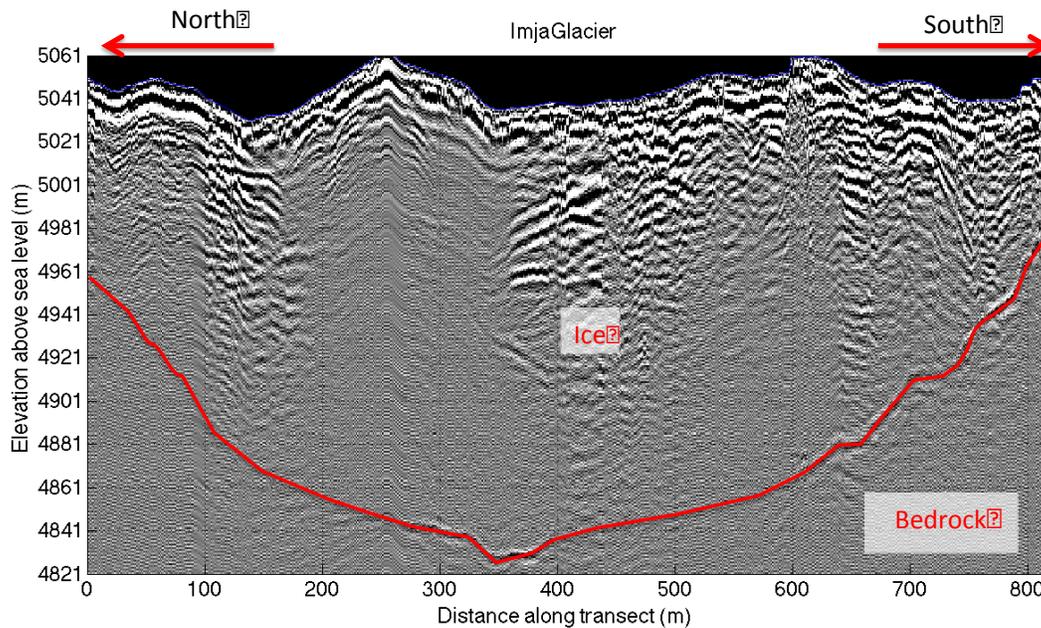
Figure 10. GPR transect at Imja glacier at Imja Lake crossing from north to south on September 25, 2012 using a 10 MHz antenna assuming a velocity in ice of 167×10^6 m/s.

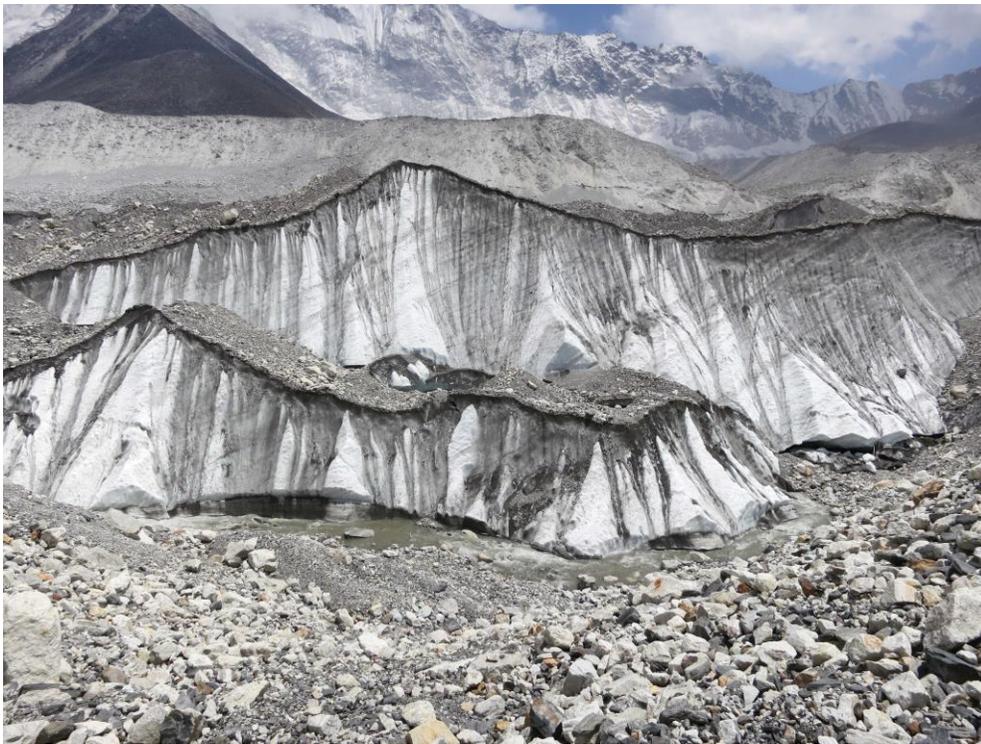
Figure 11. Photo of the Imja glacier showing the thin debris cover and ice structure beneath. (Photograph: Daene McKinney)

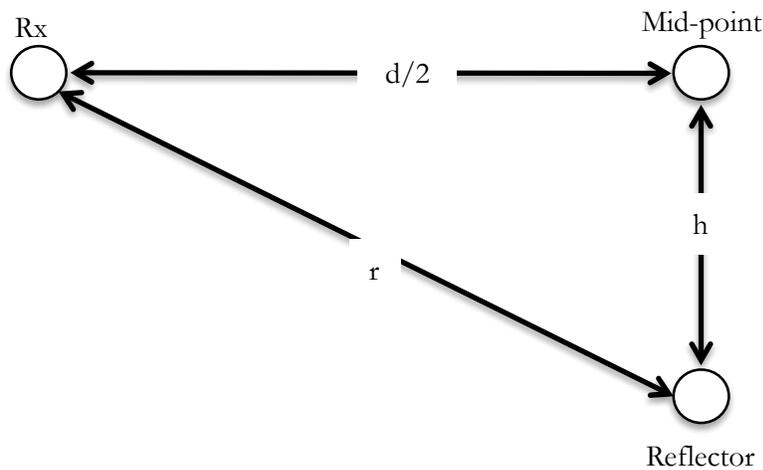
Figure 12. Common Mid-Point (CMP) method setting.

The common mid point (CMP) method (Annan 2001) was used to estimate the propagation velocity of the GPR signal in the terminal moraine at Imja Lake. In order to achieve that we took a set of five static GPR measurements on September 25, 2012 at the location of Transect B (see Fig. 7) on the terminal moraine on the north side of the outlet of the lake. The 5 sets of measurements have different distances (20, 25, 30, 35 and 40 m) from the transmitter (Tx) to the receiver (Rx) with a constant (common) midpoint location. From now on the transects are going to be identified by their distance from the Rx to Tx. Figure 12 shows an idealized sketch of the field setting. We have three important variables, the distance from Rx to Tx which is known, the depth of the reflector point (h) which needs to be calculated and the distance traveled by the signal from the reflector to the receiver (r) which also needs to be calculated.

$$r^2 = (h)^2 + \left(\frac{d}{2}\right)^2 \quad (1)$$

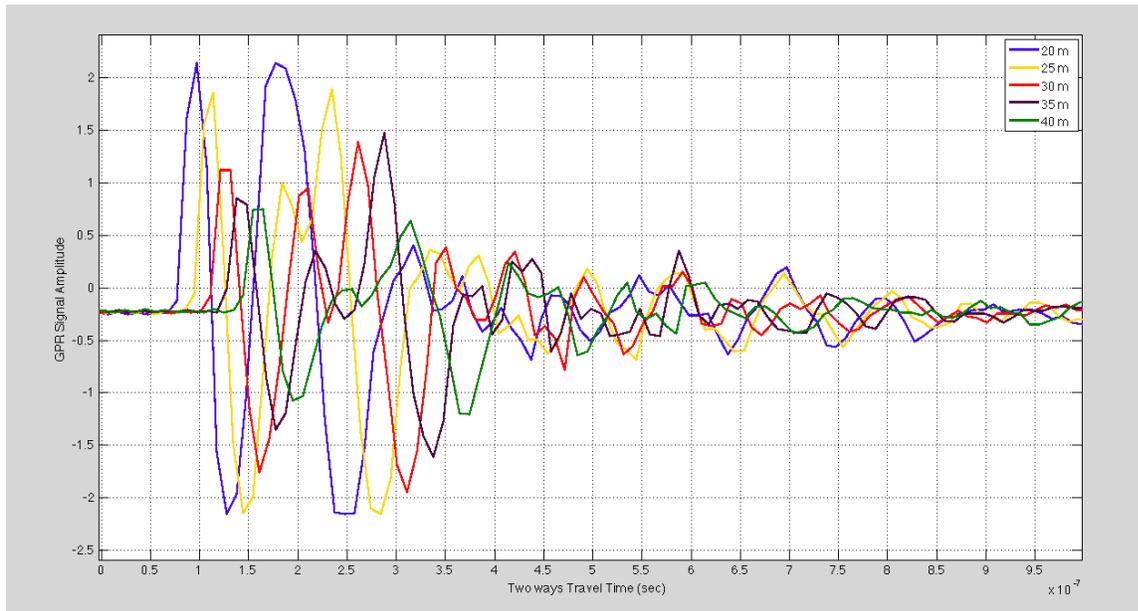
Figure 13. Static data collected at the Imja Lake moraine using a common mid point (CMP) for different distances from the transmitter to the receiver.

The data collected at Imja Lake terminal moraine for the CMP calculation is shown in Figure 13 and the results are shown in Table 5. The average earth wave velocity is estimated in 118×10^6 m/s. The average velocity from the reflector is 124×10^6 m/s $\pm 8.1 \times 10^6$ m/s. The vertical distance from the surface to the reflecting point is 16.3 m ± 0.2 m.

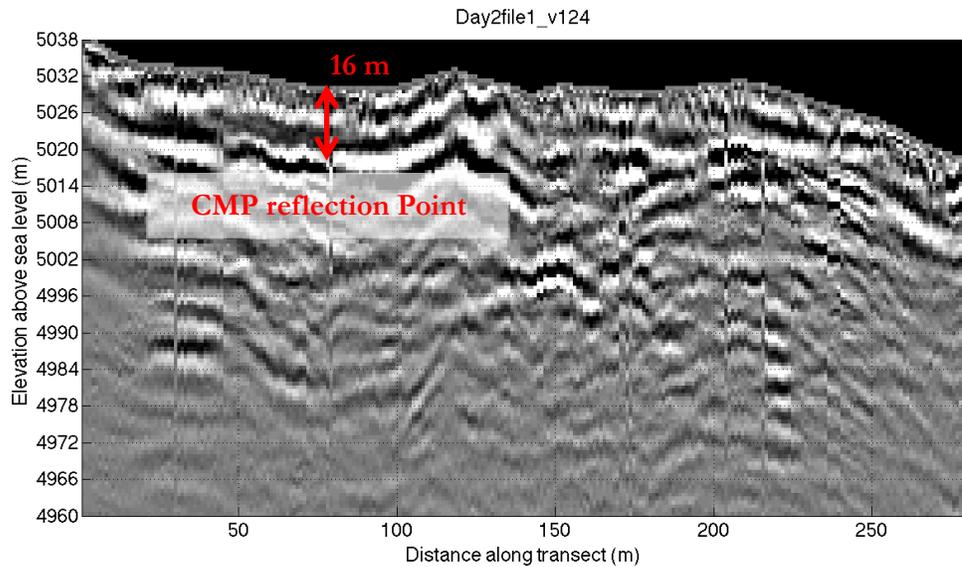
Figure 14. Location of the CMP measurement in Transect B (see Fig. 7). The velocity used in this echogram is 124×10^6 m/s.

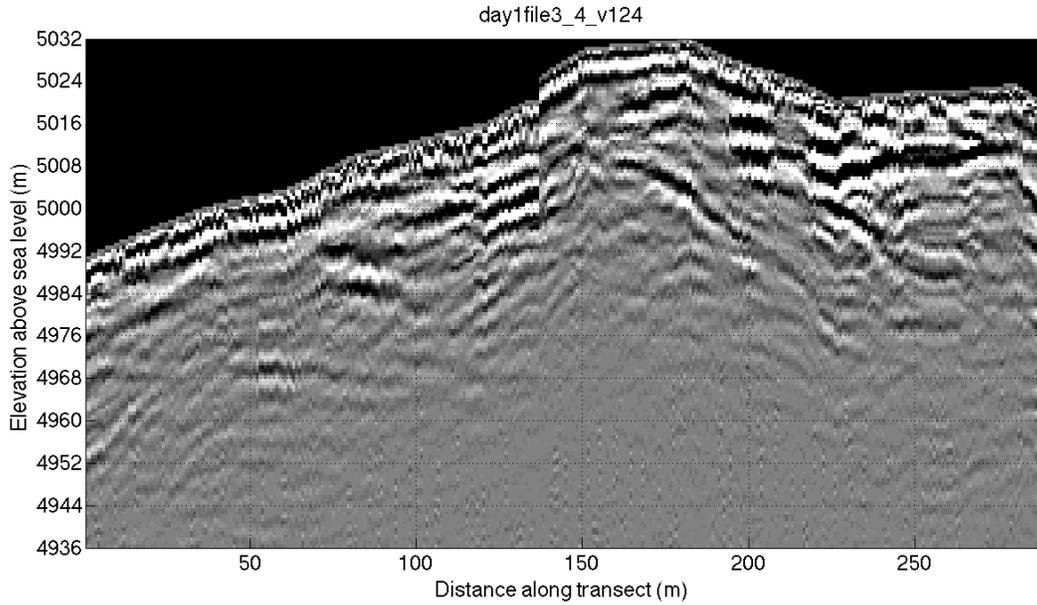
Figure 15. GPR transect A (Day1file3_4) at Imja Lake on the south lateral moraine crossing from south to north using a 10 MHz antenna and assuming a velocity of 124×10^6 m/s.

Figure 15 shows the GPR transect at the south lateral moraine crossing from south to north using a 10 MHz antenna (see Fig. 7 for location of Transect A). After 50 m along the transect high reflections indicate ice underneath. Around 75 m, more areas with high reflections are visible with ice thickness from 30 m at the outer side of the moraine to 70-80 m in the inside of the moraine.

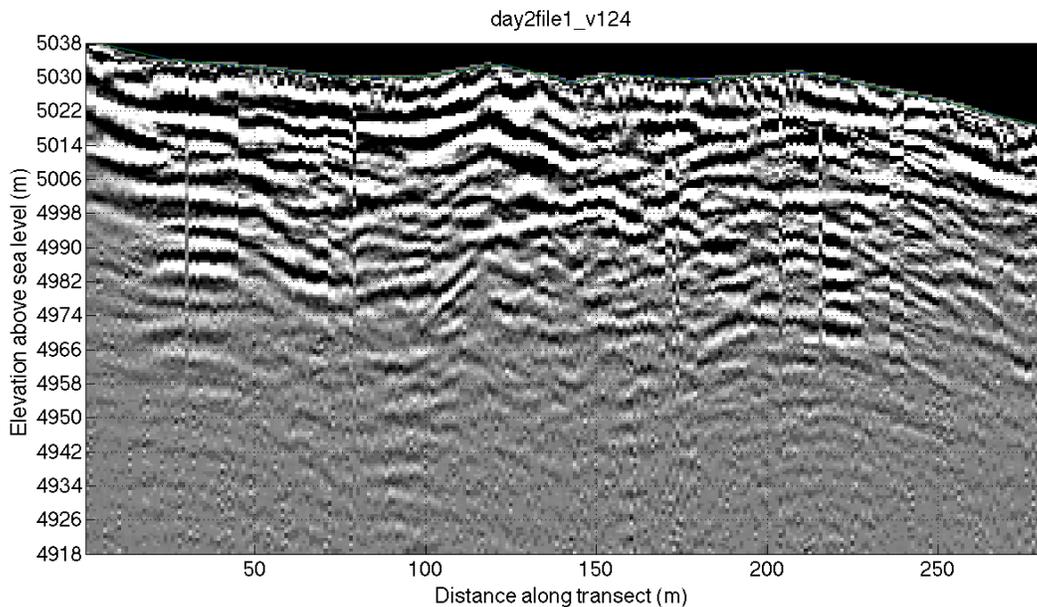
Figure 16. GPR Transect B (Day2file1) at Imja Lake from north to south on the terminal moraine above the north-west shore using a 5 MHz antenna and assuming a velocity of 124×10^6 m/s.

Figure 16 shows GPR Transect B (Day2file1) moving from north to south on the terminal moraine above the north-west shore of Imja Lake using a 5 MHz antenna. In the center of the transect (after about 150 m) the depth of the ice is about 60 m. On the face of the moraine, this ice is collapsing into the lake according to observations in the field (see Figure 17).

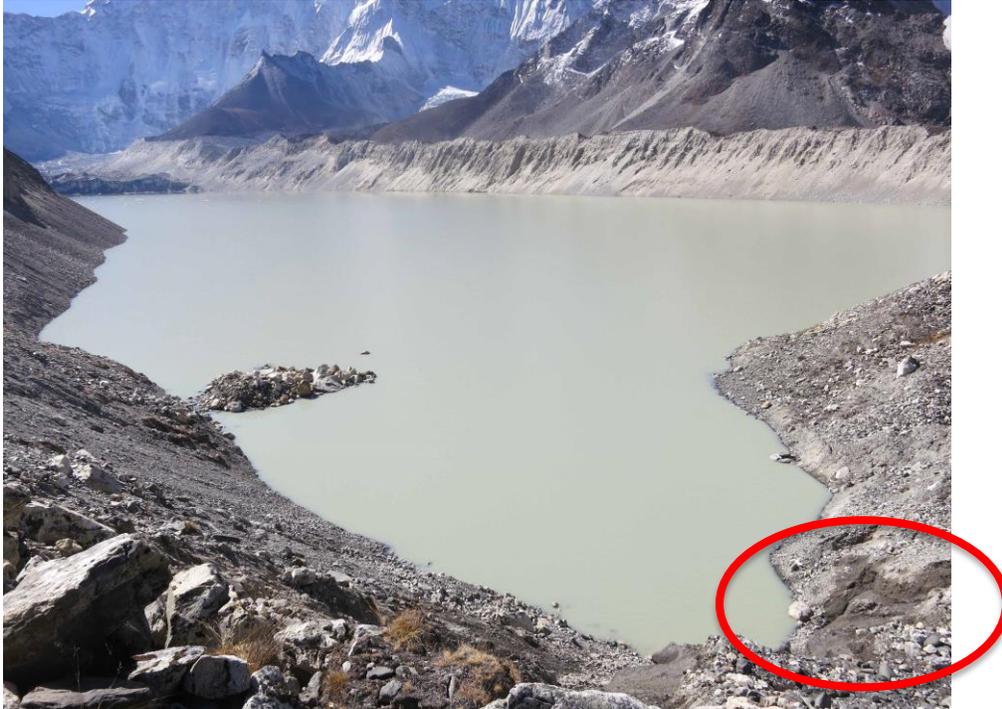
Figure 17. Ice on the face of moraine on Transect B, May 23, 2012. (Photograph: Daene McKinney)

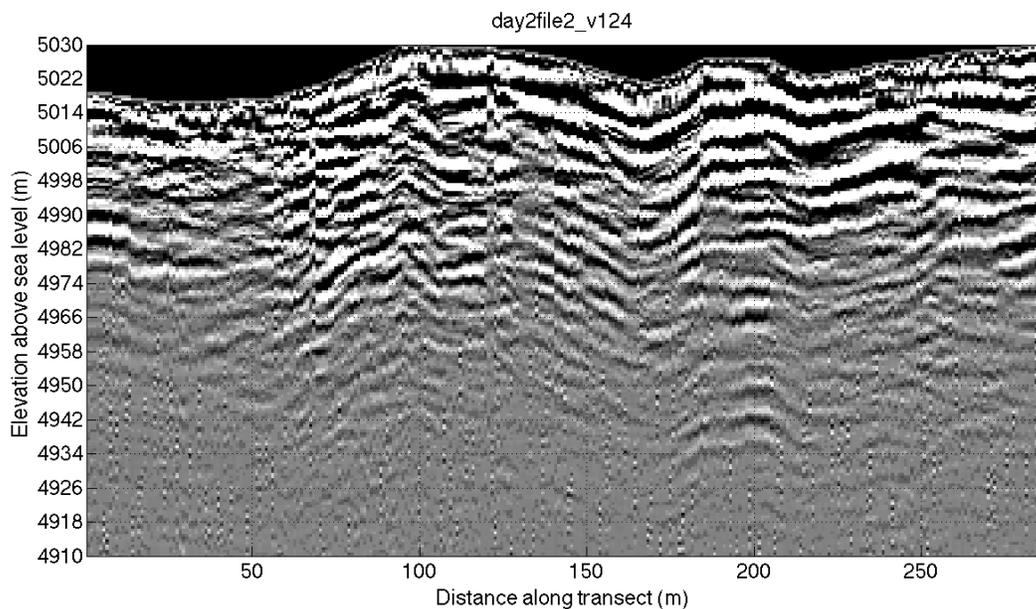
Figure 18. GPR Transect C (Day2file2) at Imja Lake moving from south to north on the terminal moraine above the north-west shore with a 5 MHz antenna and assuming a velocity of 124×10^6 m/s.

Figure 18 shows GPR Transect C (Day2file2) moving from south to north on the terminal moraine above the north-west shore of Imja Lake with a 5 MHz antenna. In the center of the transect the depth of the ice is about 60 m.

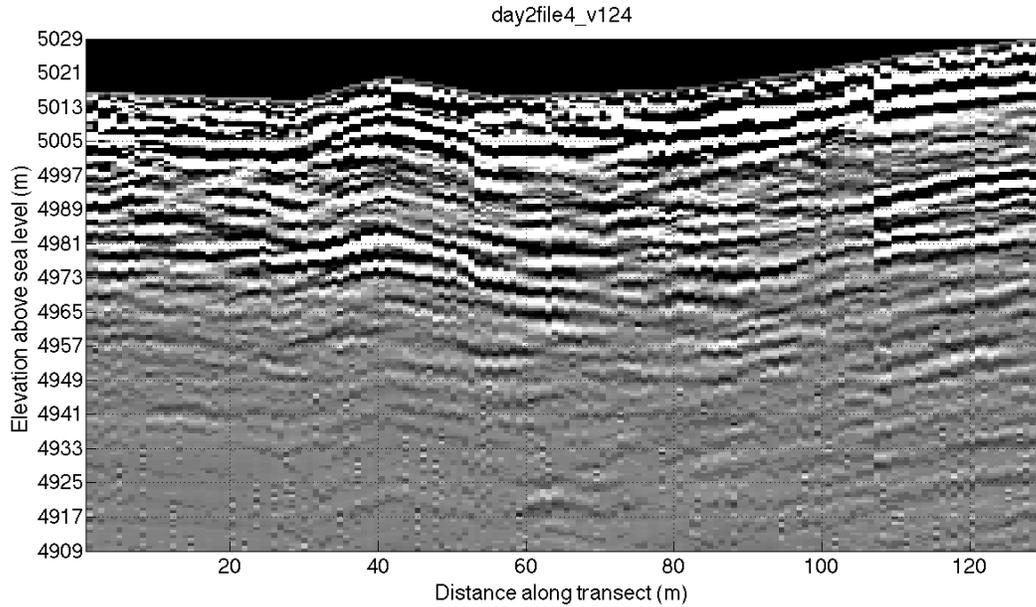
Figure 19. GPR Transect D (Day2file4) at Imja Lake crossing between the blue pond at the north side of the outlet using a 10 MHz antenna and assuming a velocity of 124×10^6 m/s.

Figure 19 shows GPR Transect D crossing between the blue pond at the north side of the outlet using a 10 MHz antenna. Figure 20 shows the exposed ice face on the side of the moraine above the blue pond.

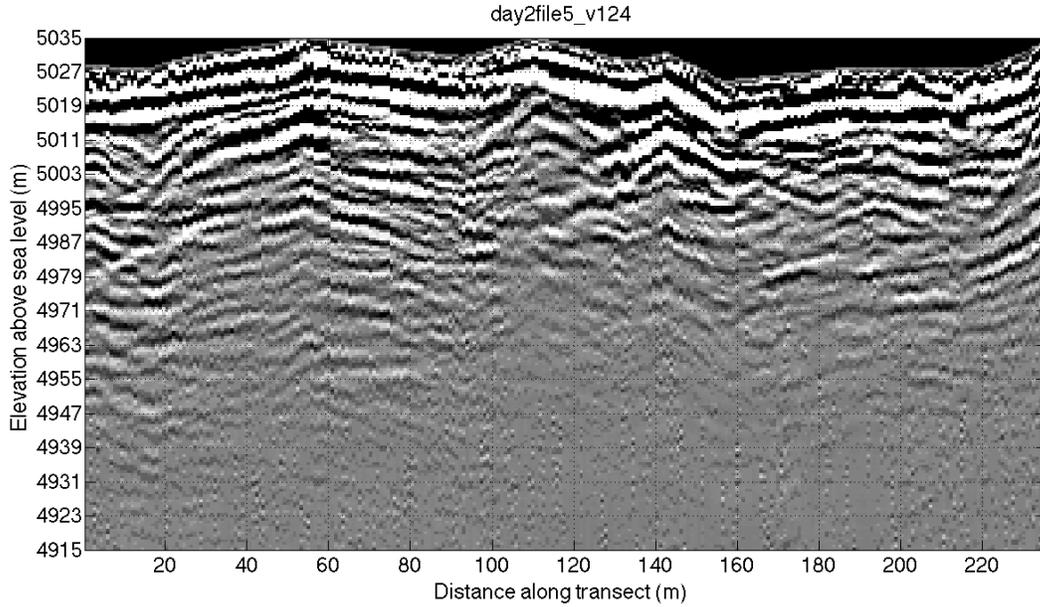
Figure 20. Transect E (Day2file5) at Imja Lake moving in the direction of the northern lateral moraine with a 10 MHz antenna and assuming a velocity of 124×10^6 m/s.

Figure 20 shows GPR Transect E near the middle of the terminal moraine, starting from the outlet and moving in the direction of the northern lateral moraine with a 10 MHz antenna. This transect corresponds to the highest surface elevation points of the moraine. Reynolds Geoscience Ltd. (RGS 2003; Reynolds 2006; Hambrey et al. 2008) deployed a Sensors and Software PulseEKKO 100 system with an antenna center-frequency of 100 MHz at Imja Lake in 2001 along two profiles across the terminal moraine complex (one transverse from the north lateral moraine to the lake outlet (similar to Transect E reported here) and one longitudinal along the north side of the outlet (similar to Transect G reported below) to determine depths of the debris cover over ice within the moraine complex, and to estimate ice thickness (Hambrey et al. (2008)). The results from one transect (near Transect E) show an ice-cored inner zone at the western end of Imja Lake comprised of debris-covered ice tens of meters thick. They note that the presence of ice is clearly indicated, especially by ERT and that the morainic debris is layered. The electrical resistivity measurements reported by Hambrey et al. (2008) are interpreted to show a debris cover about 5 – 20 m thick with 20 – 30 m of ice below that. Their GPR measurements are only reported in terms of two-way-travel time and not converted to depth since the velocity of GPR wave propagation in the subsurface was unknown.

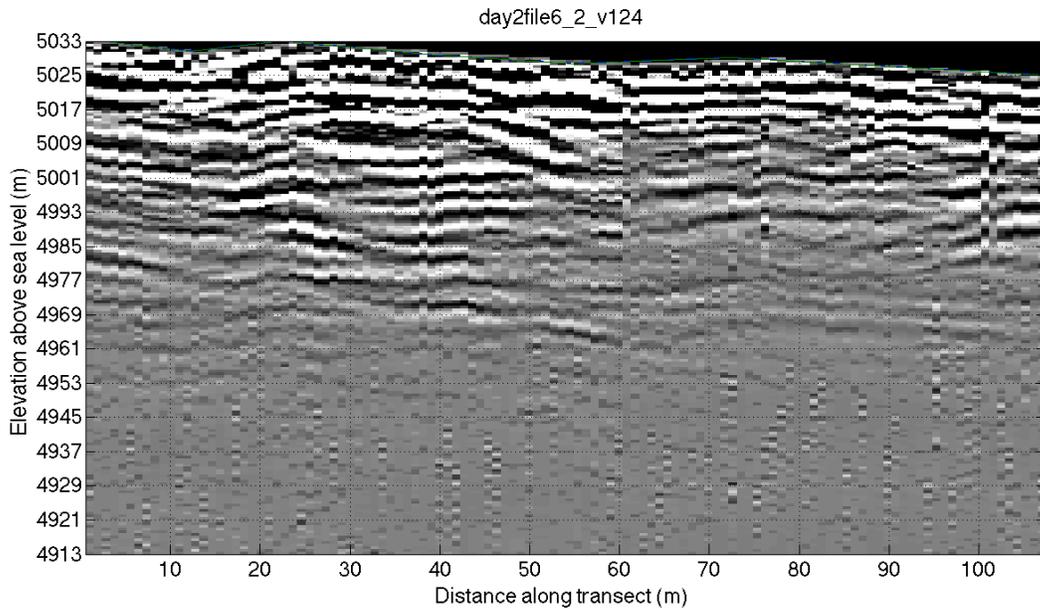
Figure 21. GPR Transect F (Day2file6) at Imja Lake moving in the direction of the northern lateral moraine with a 10 MHz antenna and assuming a velocity of 124×10^6 m/s.

Figure 21 shows GPR Transect F on the north side of the outlet near the middle of the terminal moraine, starting north of the outlet and moving in the direction of the northern lateral moraine with a 10 MHz antenna. This transect reflects a shallow thickness of ice, especially at the end of the transect.

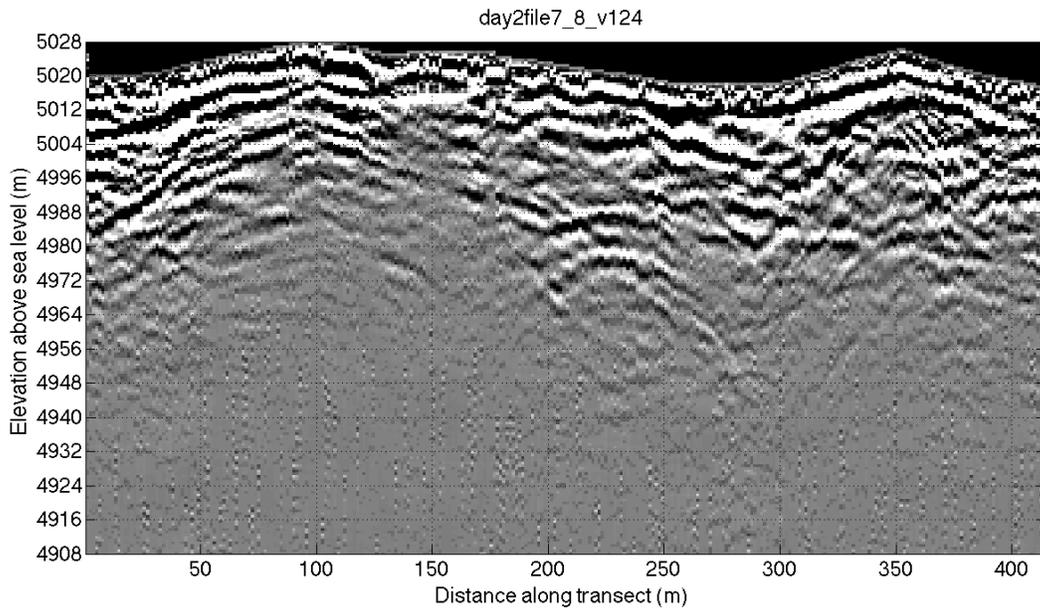
Figure 22. GPR transect G (Day2file7_8) at Imja Lake on the north side of the outlet using a 10 MHz antenna and assuming a velocity of 124×10^6 m/s.

Figure 22 shows GPR Transect G which is a longitudinal transect on the north side of the outlet using a 10 MHz antenna. This profile illustrates the presence of a debris cover up to 10 m and then ice of 20-30m thick over most of the transect. In the middle of the transect (from 120 to 160 m) the data was lost which explains the vertical fringe without changes in that range. After that it is possible to see some ice

with a thickness of 20-30 m. The results from the second transect of Reynolds (Hambrey et al., 2008) (near Transect G) show a relatively ice-free zone several hundred meters wide forming the outer part of the moraine complex. They report surface debris from 5 to 10m thick overlying an intermediate layer, believed to be water-saturated moraine. This layer, in turn, overlies a basal zone, the top of which is about the same elevation as the outlying floor of the valley. This report shows considerably more ice in this area than Hambrey et al. (2008) show. However, they used a 100 MHz antenna, so the penetration was limited to a few meters and we used a 10 Mhz antenna resulting in much deeper penetration. The depth of penetration for the 100 MHz GPR system used by Hambrey et al. (2008) is unlikely to be greater than 15 – 20 m (Jol, 1995). Hambrey et al. (2008) do not consider the lake to pose a threat in the short term, contrary to Yamada (1998) and Bajracharya et al. (2007).

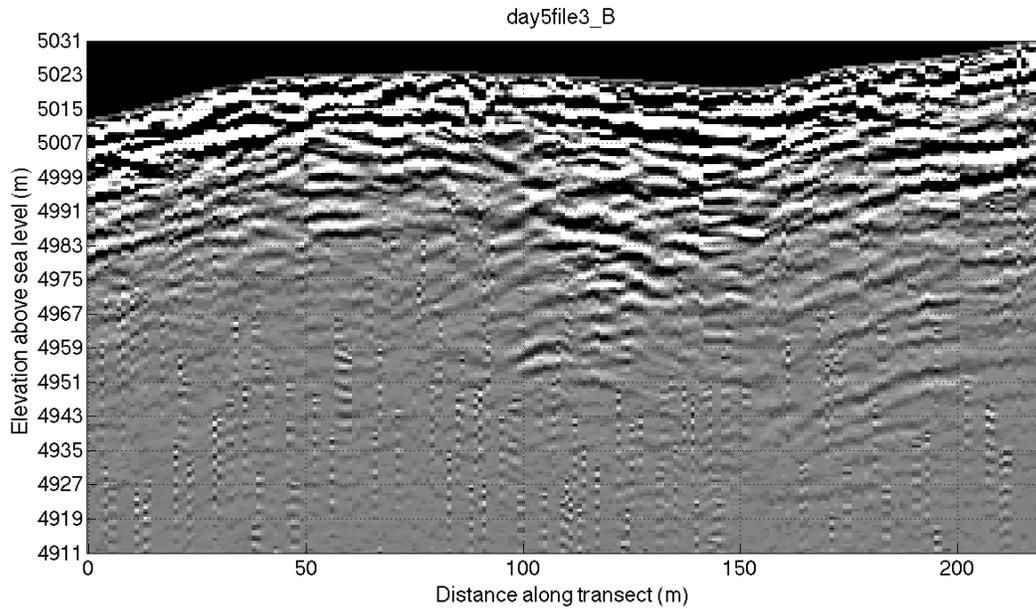
Figure 23. GPR transect H (Day5file3_B) at Imja Lake on the south side of the outlet using a 10 MHz antenna and assuming a velocity of 124×10^6 m/s.

Figure 23 shows GPR Transect H along the shore of the lake at the south lateral moraine in an area where ice is visible from a small peninsula in the lake (see Figure 24) using a 10 MHz antenna. Since we were able to see the first 20 m depth of this profile from the lake, this transect helped us to interpret the data from other areas. The debris in this area appears to be about 10 m thick with about 20 - 30 m of ice below that.

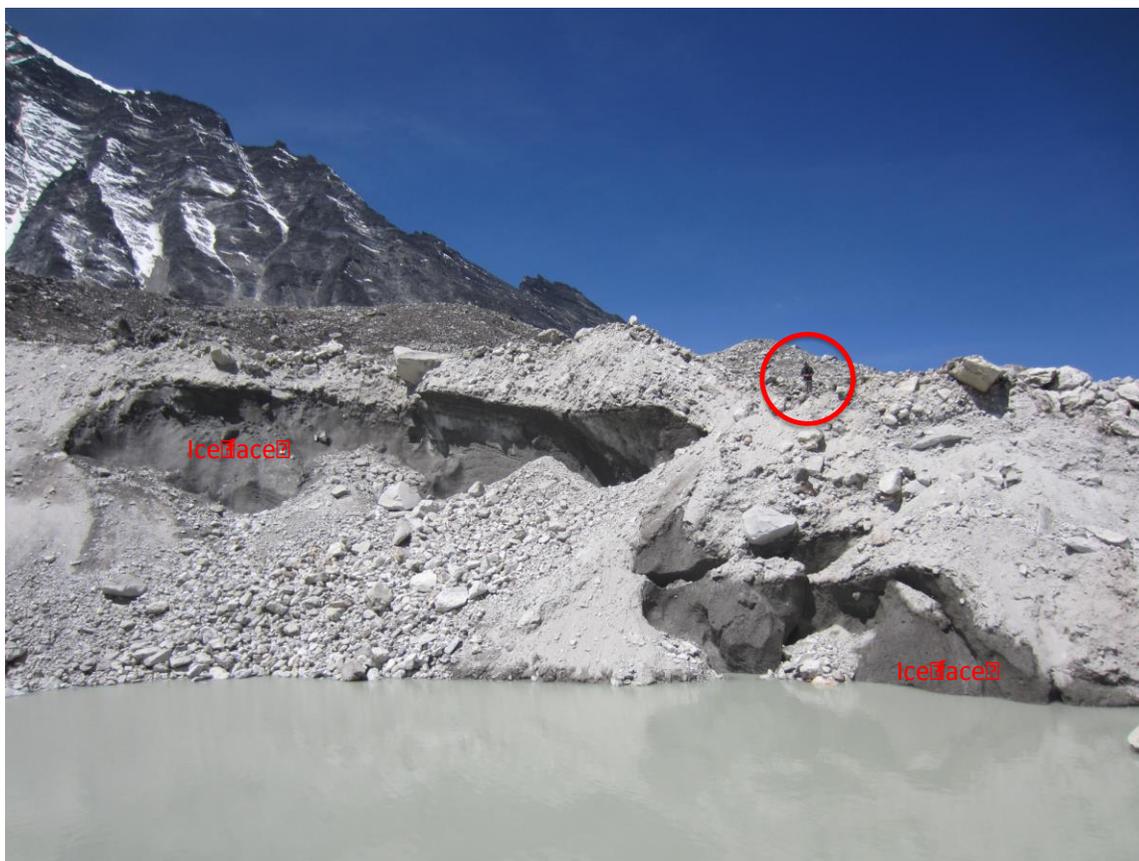
Figure 24. Ice visible below GPR transect H seen from a small peninsula near the shore of the lake. (Photograph: Marcelo Somos-Valenzuela)

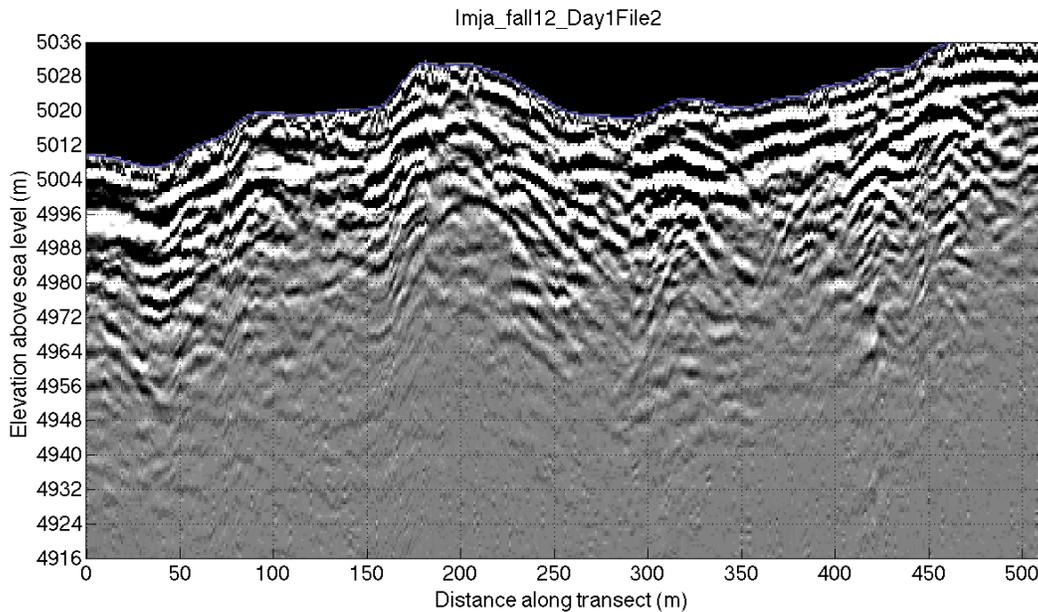
Figure 25. GPR transect I (Fall12_Day1File2) along the south side of the outlet from the lake to the bottom of the outer side of the terminal moraine using a 10 MHz antenna and assuming a velocity of 124×10^6 m/s.

Figure 25 shows the long GPR Transect I (from September 21, 2012) along the south side of the outlet from the lake to the bottom of the outer side of the terminal moraine using a 10 MHz antenna. The image shows a debris layer about 10 m thick with ice present under the debris in the first 300 m of the transect and some ice present near the lake outlet.

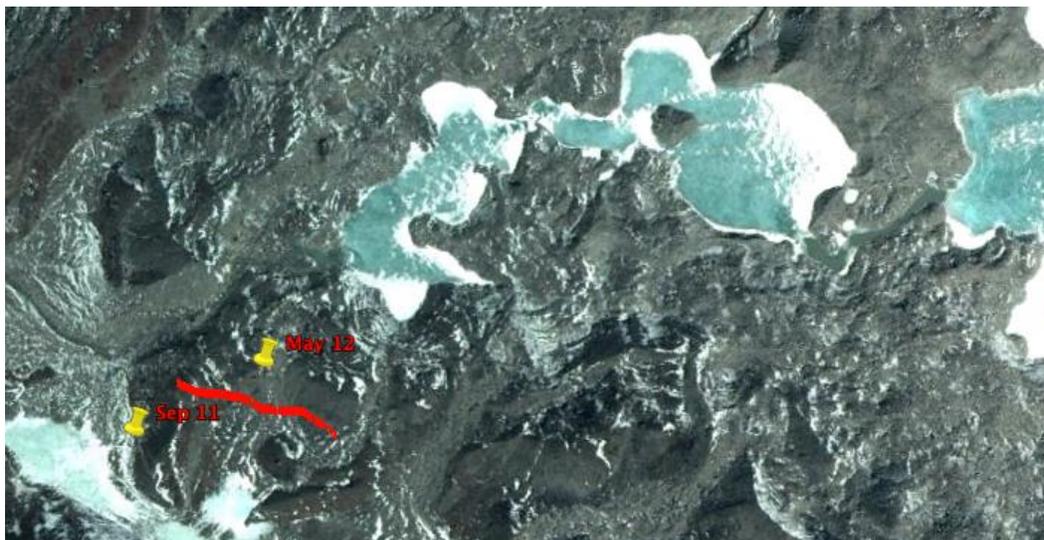
Figure 26. Location of seepage observations at the terminal moraine of Imja Lake in September 2011 and May 2012. (Source: Google Earth, 2010)

Extensive seepage from the base of the southern portion of the terminal moraine was observed in September 2011 and May 2012. The location of the seepage was different during these two times (see Figure 26) with the September 2011 observation (see Figure 27, left) being on the western side of the terminal moraine and the May 2012 observation being farther east and on the other side of a small ridge (see Figure 27, right).

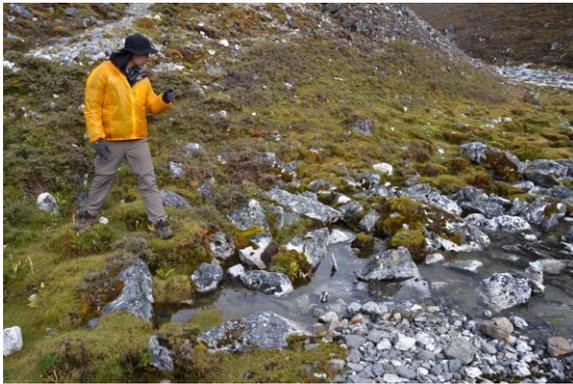
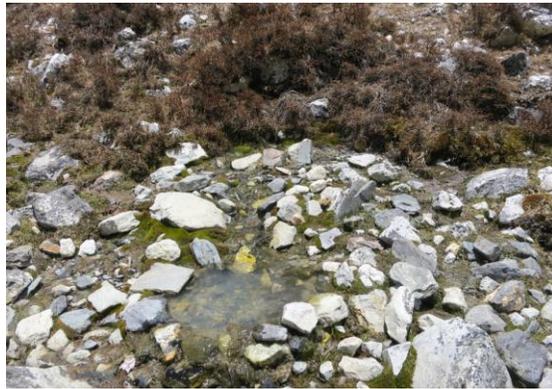
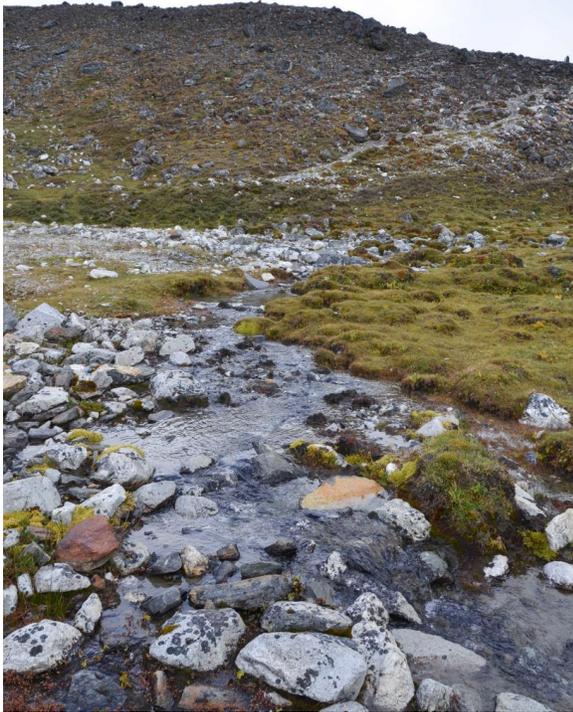
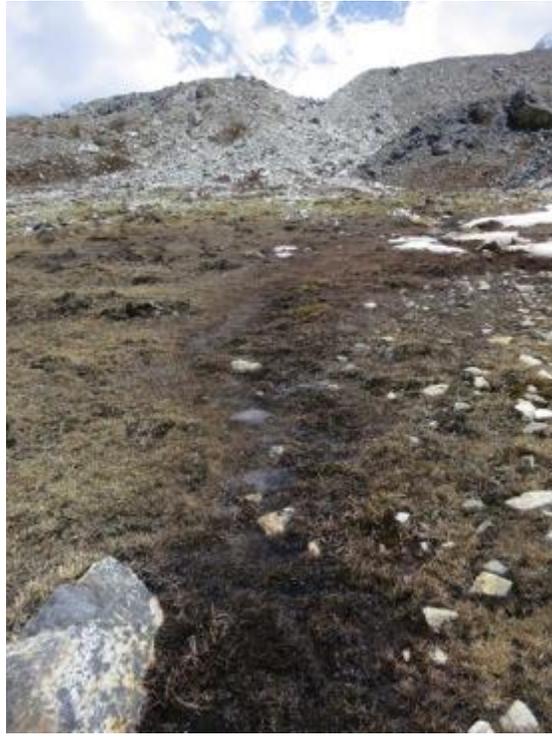
Figure 27. Seepage from the base of the terminal moraine at Imja Lake observed in September 2011 (left) and May 2012 (right). (*Photograph: Daene McKinney*)

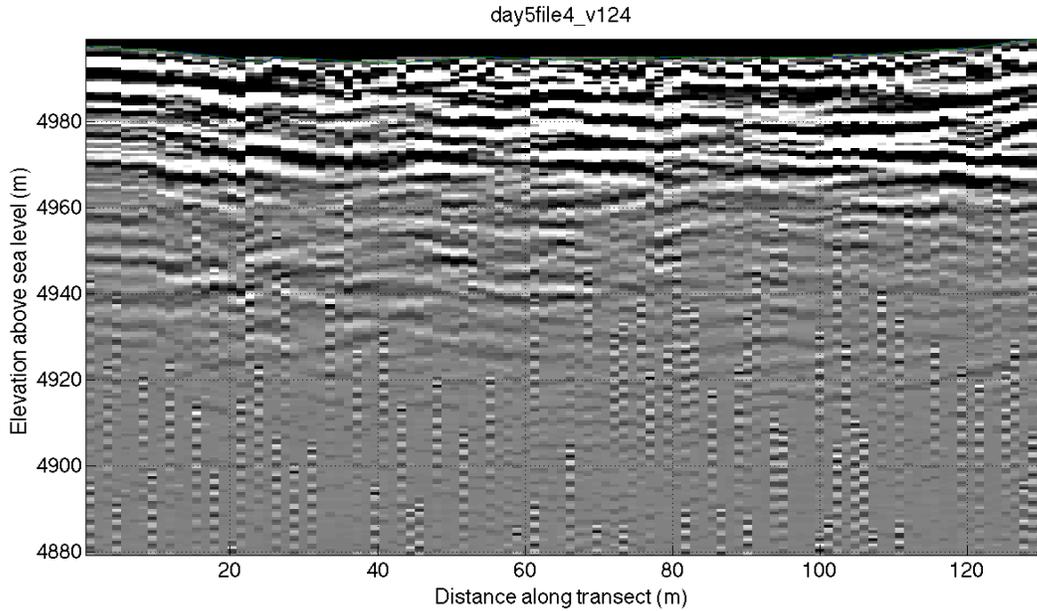
Figure 28. GPR Transect J (Day5file4) at the middle of the outer face of the south lateral moraine below a major seepage point using a 10 MHz antenna and assuming a velocity of 124×10^6 m/s.

Figure 28 shows GPR Transect J at the middle of the outer face of the south lateral moraine above a seepage point using 10 MHz antenna. We observed water running 15 meters below the ridge of the moraine. This transect has the same pattern as an area in which there is ice. The image indicates about 10 m of debris cover with about 10 m of ice below that. We observed water running just above this transect, about 15 meters below the ridge of the moraine (see Fig 27, right). Figure 29 shows GPR Transect K at the middle of the outer face of the south lateral moraine above Transect J and above a major seepage point using a 10 MHz antenna. This transect has the same pattern as Transect J (see Figure 28) except that the ice layer is much thicker, about 20-30 m.

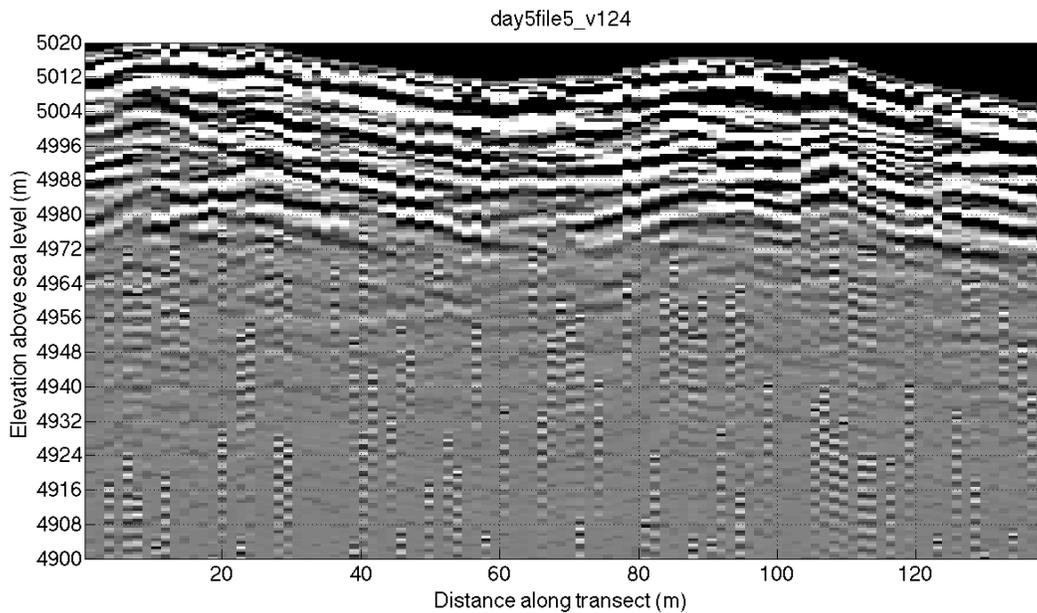
Figure 29. GPR Transect K (Day5file5) at the middle of the outer face of the south lateral moraine above transect J and above a major seepage point using a 10 MHz antenna and assuming a velocity of 124×10^6 m/s.

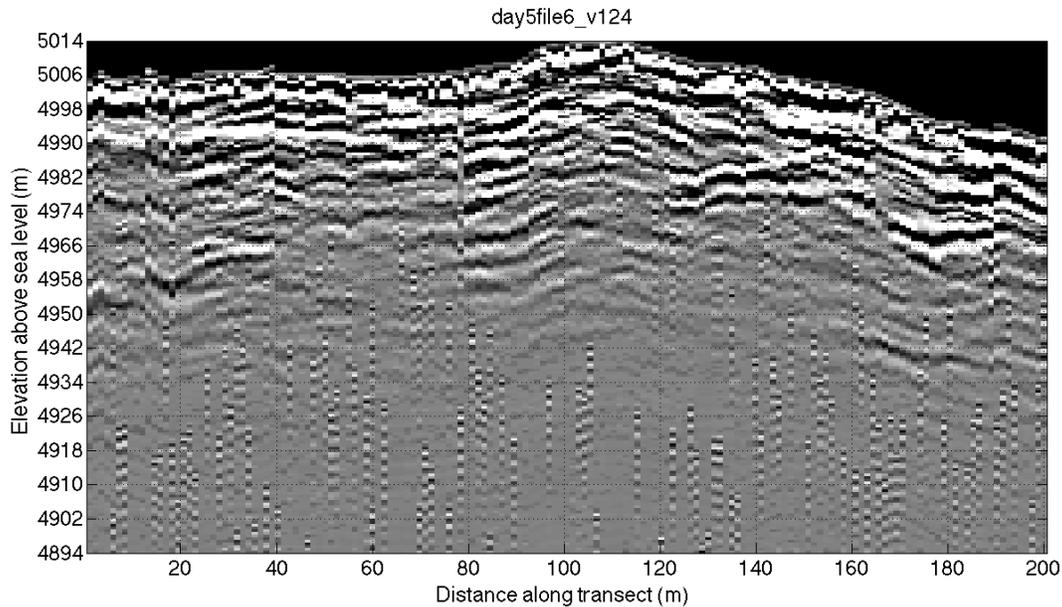
Figure 30. GPR Transect L (Day5file6) crossing the outlet from south to north heading down to the outer face of the terminal moraine using a 10 Mhz antenna and assuming a velocity of 124×10^6 m/s.

Figure 30 shows GPR Transect L crossing the outlet from south to north heading down to the outer face of the terminal moraine using a 10 Mhz antenna. This transect indicates that some ice is present in the end of the terminal moraine at the north side of the outlet, perhaps as much as 20-30 m thickness.
