TECHNICAL REPORT

POST-EARTHQUAKE ASSESSMENT

IMJA, TSHO ROLPA, AND THULAGI GLACIAL LAKES IN NEPAL

AUGUST 2015

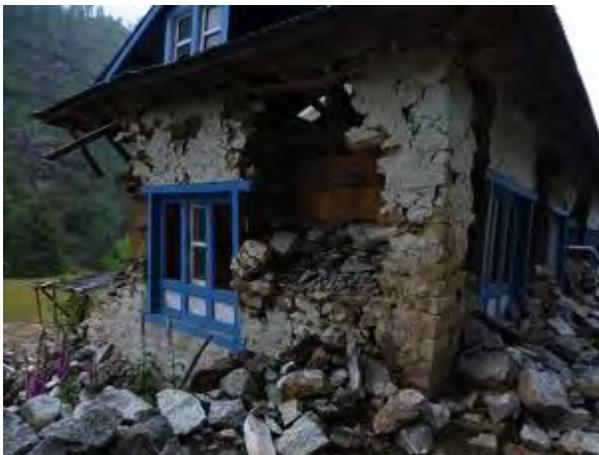
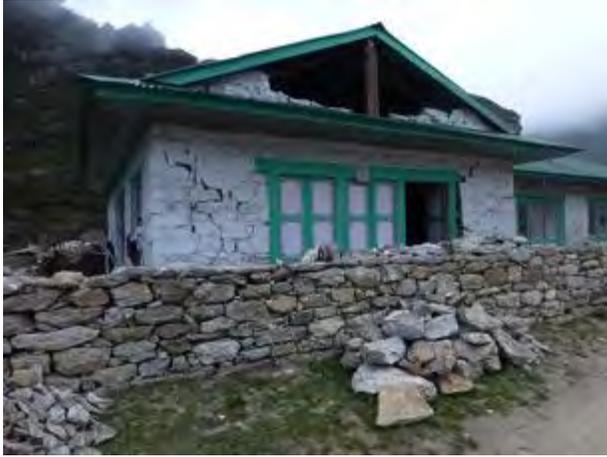
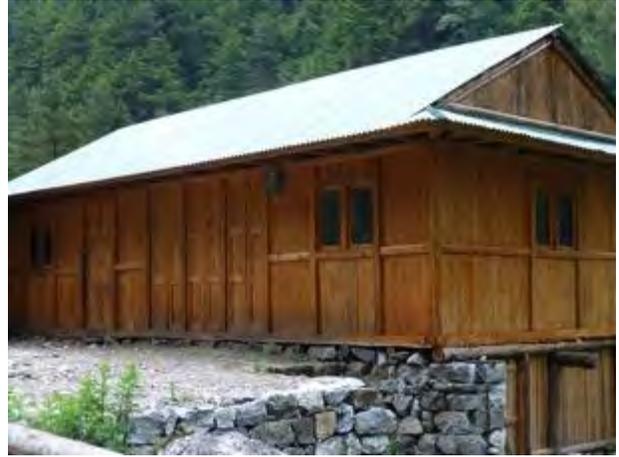
a. Mostly rough-hewn rock without mortar (highly susceptible)

b. Mostly rough-hewn rock with mortar (less susceptible)

c. Rough-hewn rock with plaster, but weak gable
(highly susceptible)

d. Wood with rock foundation (highly resilient)

Figure 1 (a., b., c., and d., above). Different construction methods used in the Khumbu region and their condition about 1 month after the earthquake.

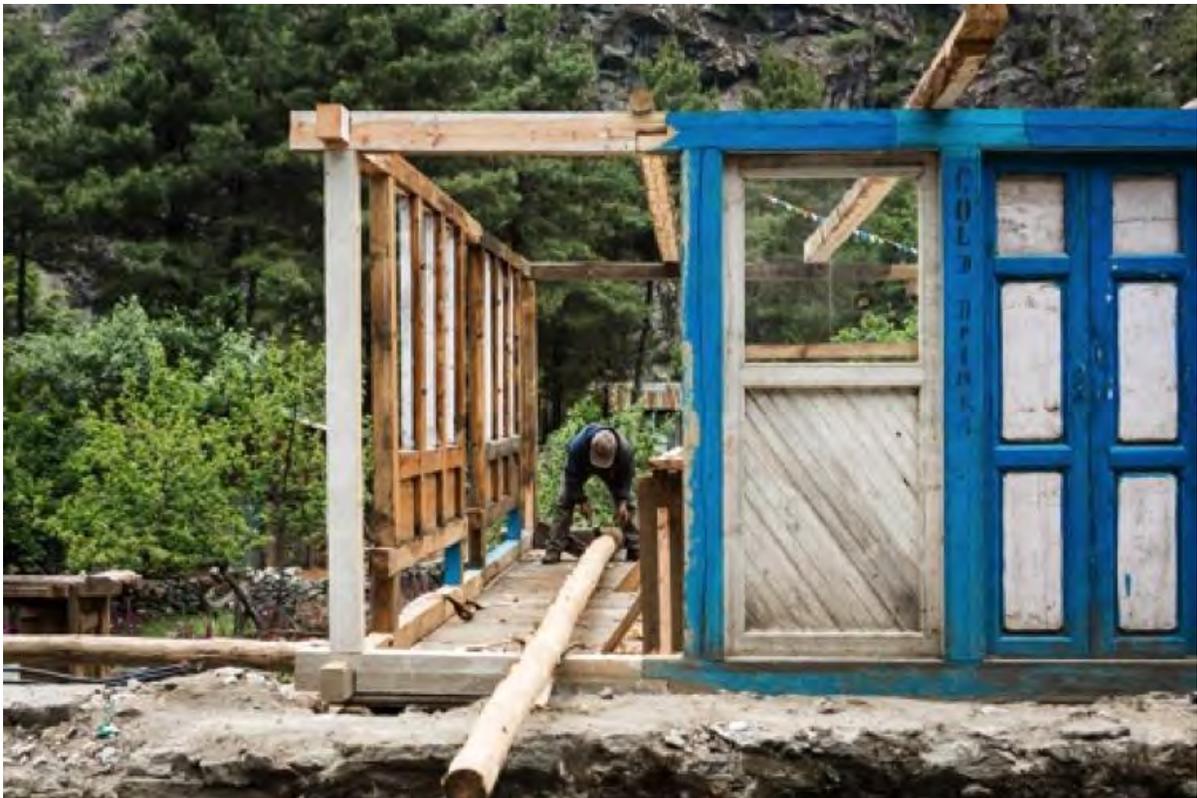
Figure 2. Example of reconstruction in the Khumbu region approximately 2 months after the earthquake. Note the extensive use of wood. In other buildings a higher usage of rebar, concrete, mortar, and wood-framed paneling was also observed.

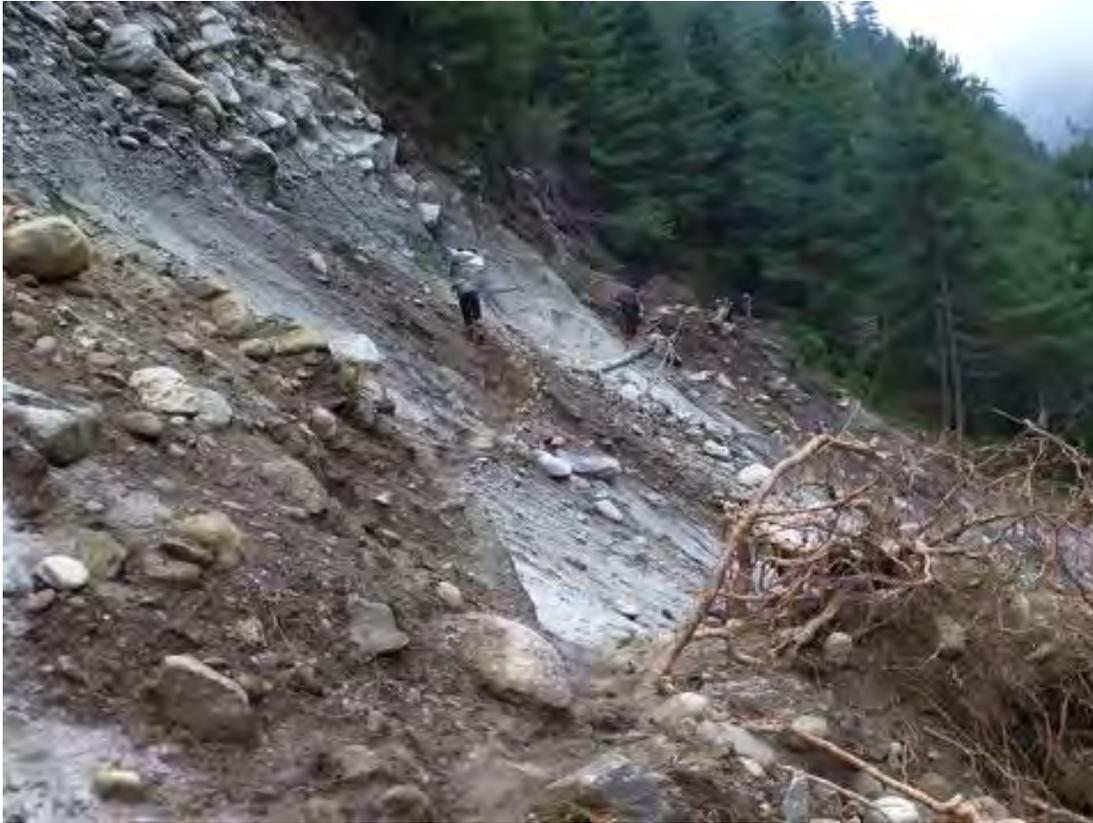
Figure 3. Re-activated landslide damaged trail at Phakding with boulders perched above.

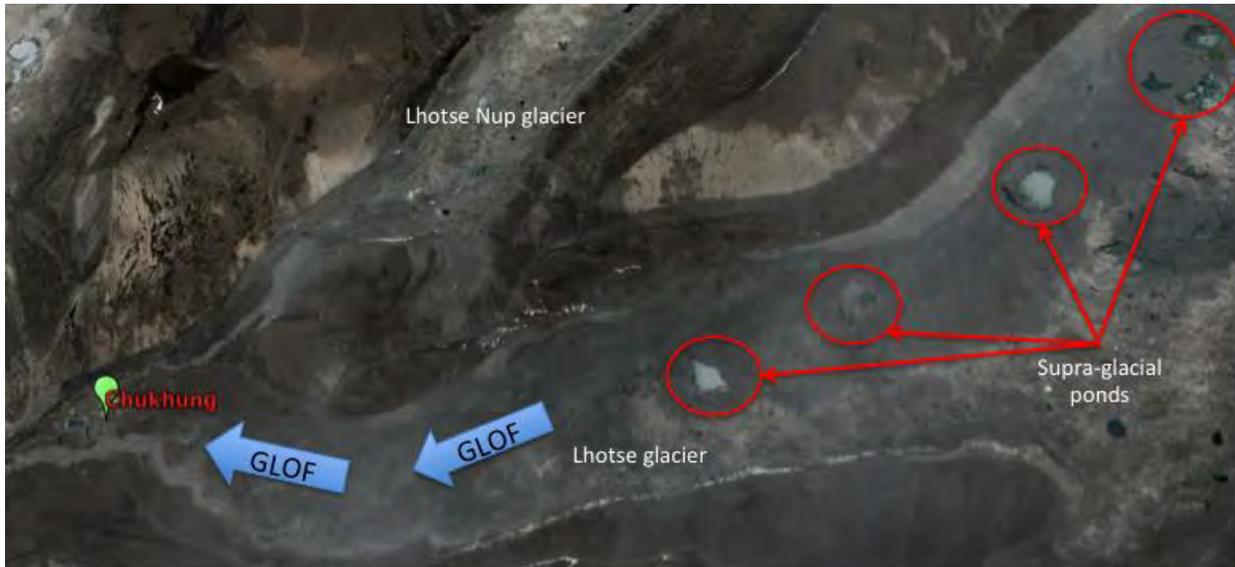
Figure 4. Lhotse glacier and Chukung illustrating the numerous supra-glacial lakes on the glacier and the approximate path of the May 25, 2015 Chukung GLOF.

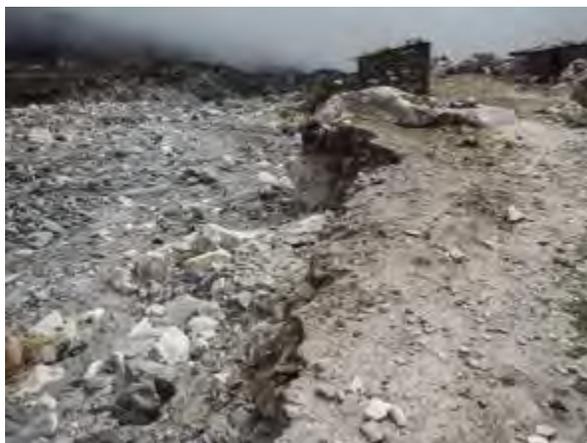
a. Undercutting damage at Chukung resort.

Figure 5 (a. and b.). GLOF damage and emergency diversion dam at Chukung resort

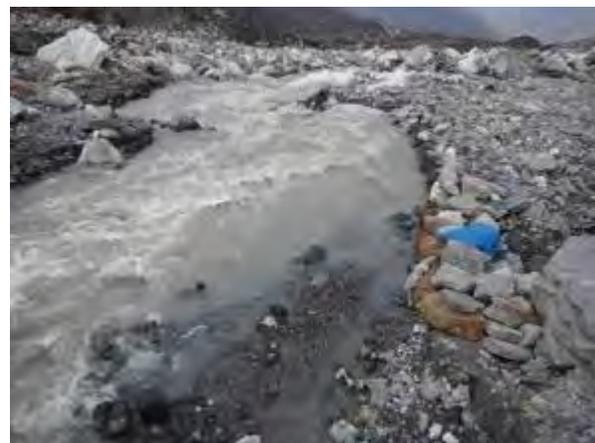
b. Temporary emergency diversion dam.

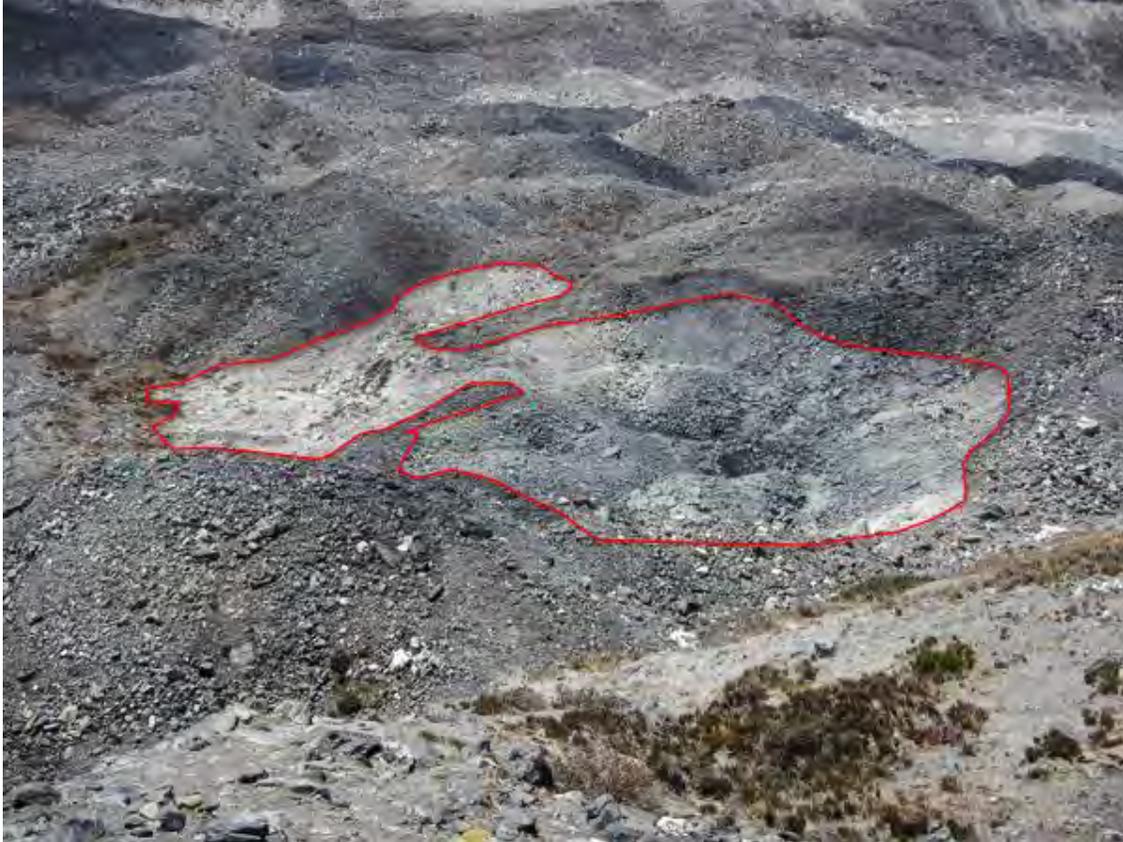
Figure 6. Drained lake with former volume of about 27,000 m³ above Chukhung that contributed a portion of the GLOF flow.

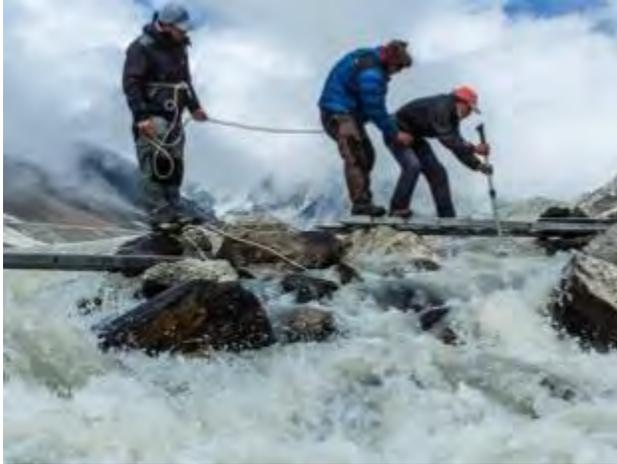
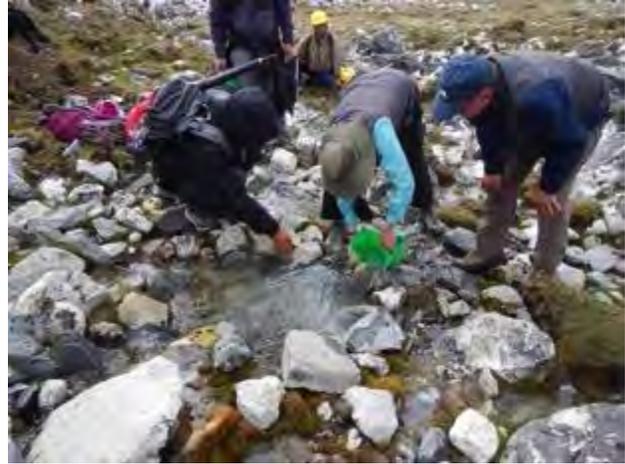
Figure 8. Measuring discharge at the Imja Lake outlet (left) and seepage (right).

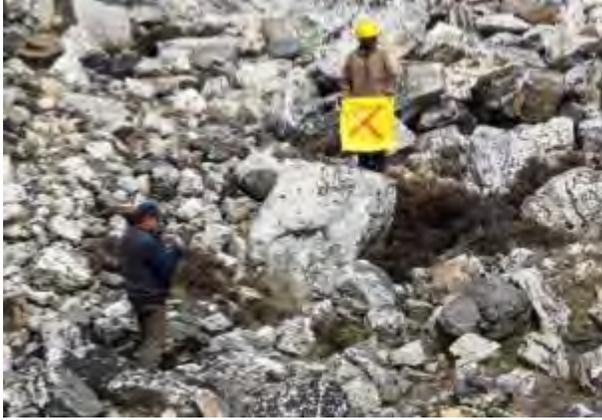
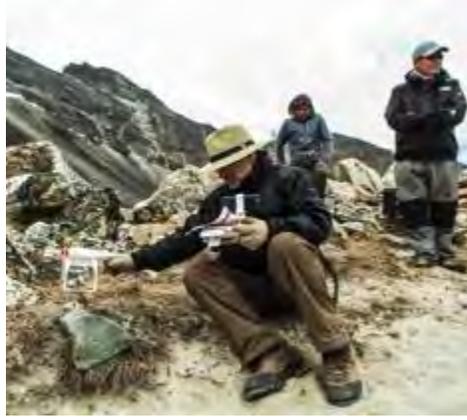
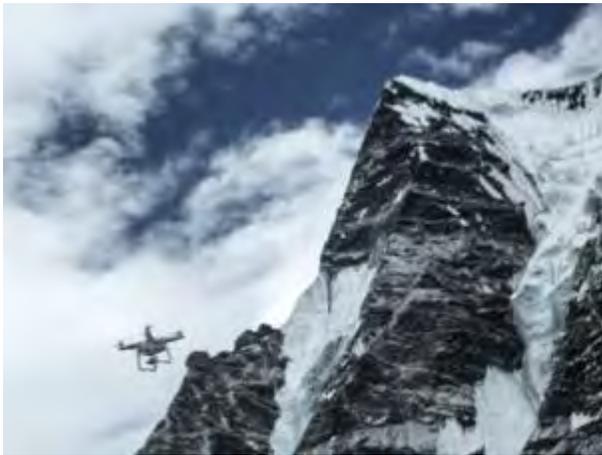
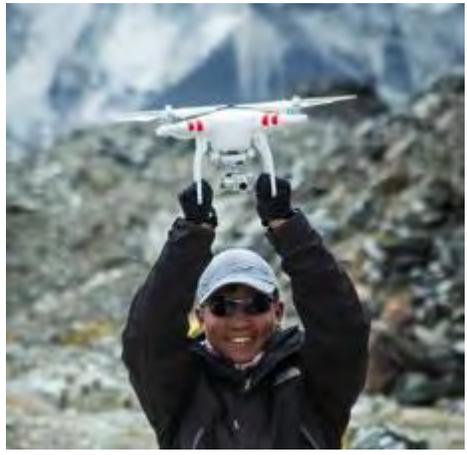
a. Setting the targets for the SfM photos

b. Preparing the drone for flight

c. The drone in flight

d. Catching the drone for landing

Figure 9 (a., b., c., and d., above). Using a drone at Imja Lake to take Structure for Motion (SfM) images to construct a digital elevation model (DEM) of the preconstruction condition of site.

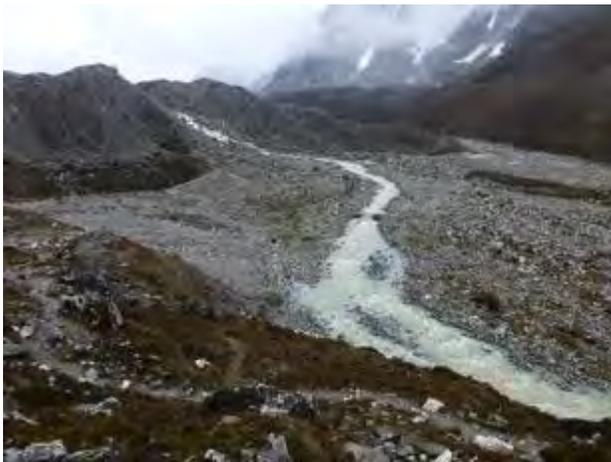
a. Extensive new braiding of river downstream of outlet

Figure 10 (a. through f. above). Changes in the terminal moraine and outlet lake complex at Imja Lake.

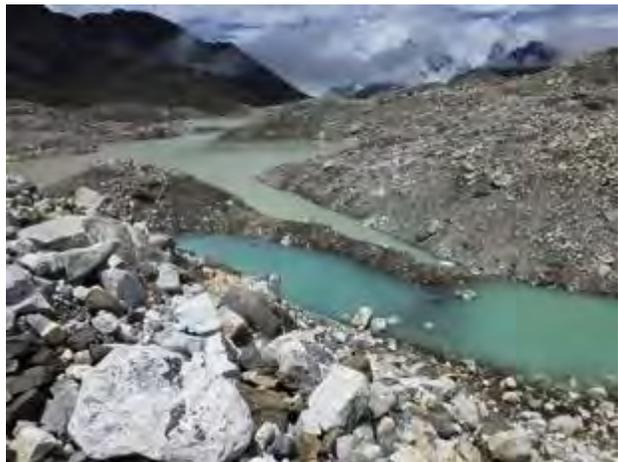
b. Lateral Pond Extensions

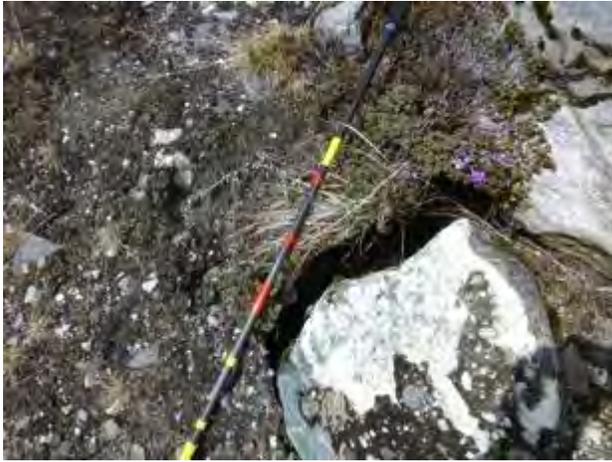
c. Boulder in Terminal Moraine Shifted by Earthquake

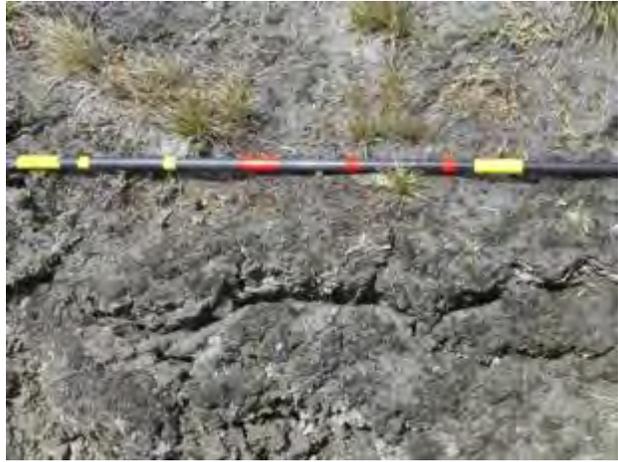
d. Abundant New Cracks Parallel to Lake Shore

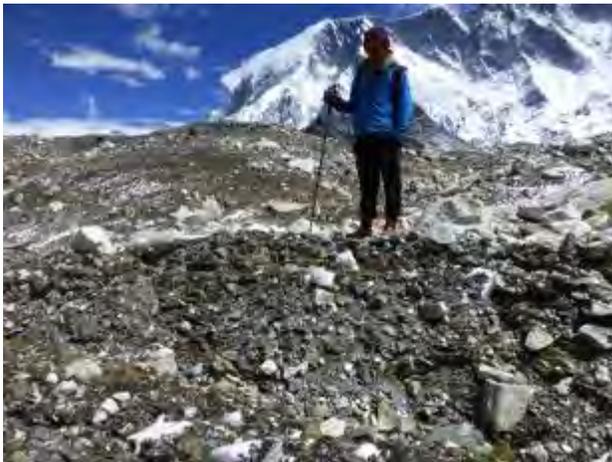
e. Slump Benches at Isthmus

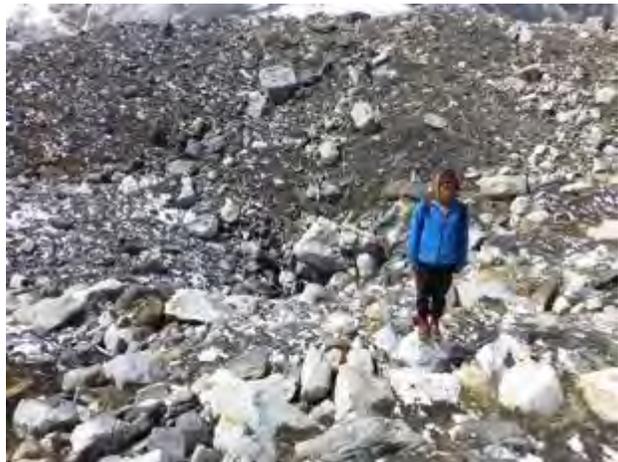
f. Thermokarst Collapse in Terminal Moraine

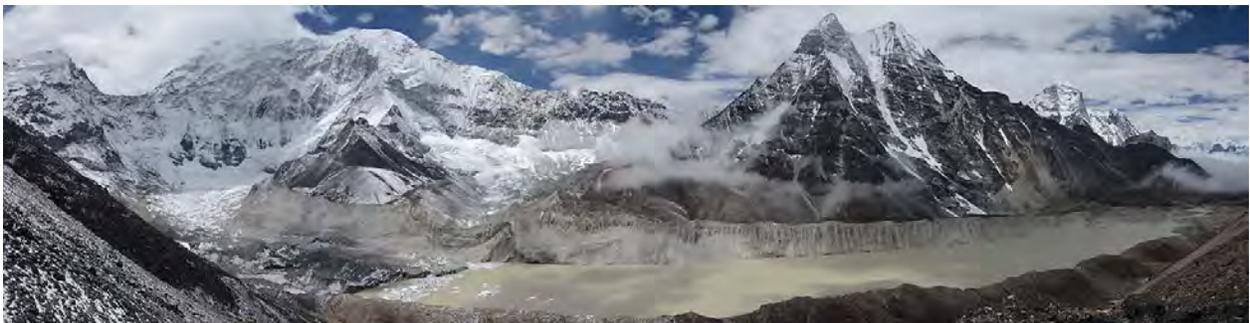
Figure 11. Imja glacial lake, June 2015. Careful comparisons with panoramas taken exactly one year ago revealed significant changes in glacier debris cover, new earthquake-induced landslides, and outlet channel form that are related to both climate change as well as the 25 April earthquake. A complete circum-navigation of the lake (excluding the glacier terminus), and thorough examination of the entire terminal moraine, was also conducted.

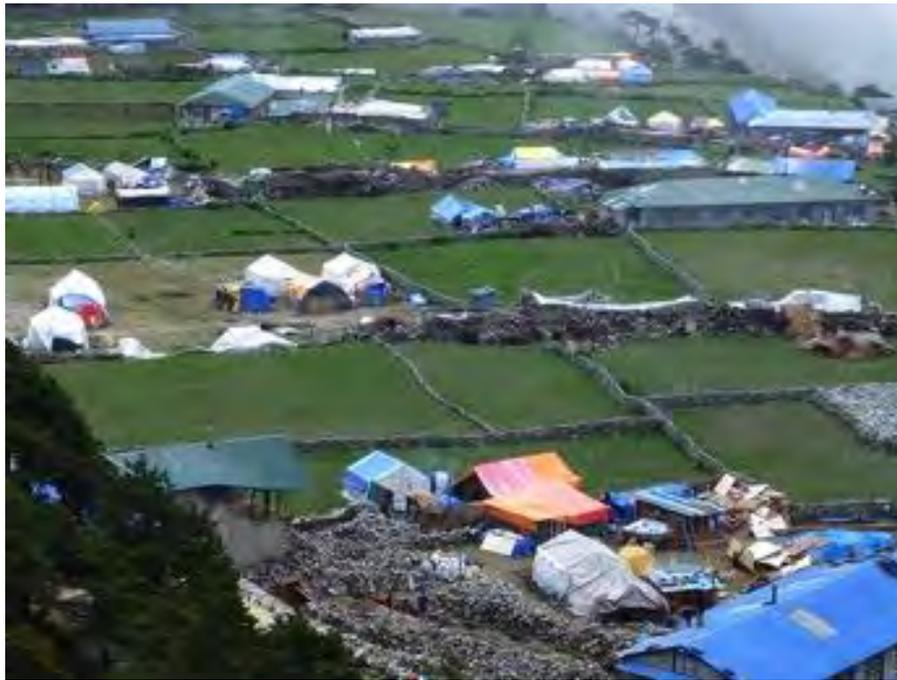
Upon completing the assessment at Imja Lake and Chukhung, we returned to Namche Bazar and proceeded up the Bhoti Koshi valley to the village of Thame (27° 49.905'N, 86° 39.039'E) and the glacial lake Dig Tsho. The village of Thame was one of the hardest hit in the Khumbu region by the April and May earthquakes. Every building in Thame and surrounding villages has been severely damaged or destroyed.

Figure 13. Village of Thame, where every building was severely damaged or destroyed by the earthquake.

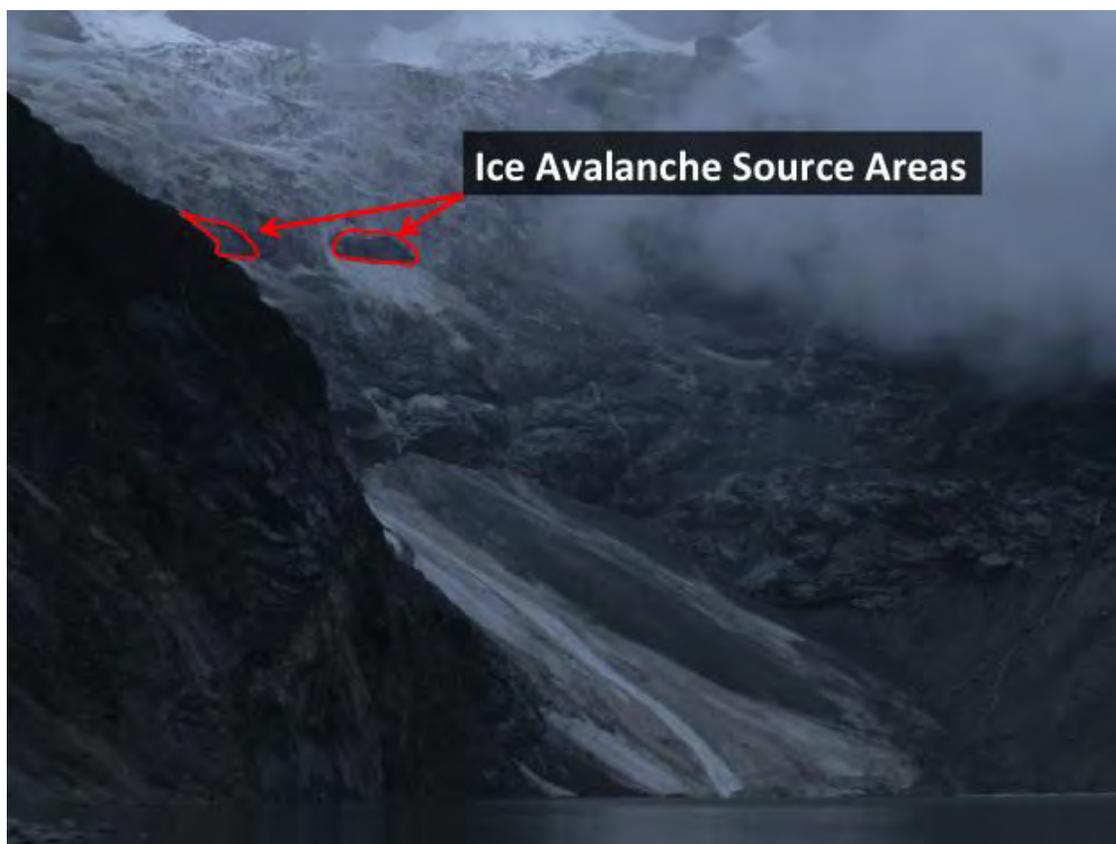
On April 25, 2015, the day of the earthquake, an avalanche of ice and rock was dislodged from the mountain Tengri Ragi Tau (6650 m) that fell into Dig Tsho, creating an 8 m surge wave that passed through the lake outlet with a very brief peak discharge of about 3000 m³/s (estimated from high water marks, channel cross-section and slope) and flooded the Bhote Kosi downstream. The flood destroyed 2 small bridges and damaged a third larger bridge at Thametang, where the flood height peaked at about 1.5 meters. Dig Tsho had experienced a major GLOF in 1985 that caused considerable loss of homes, property and infrastructure downstream. Fortunately the flood was contained in the river channel, and downstream witnesses report that half of the Bhote Khosi river was white and half black from the outburst. Villagers in Langmoche, the first downstream village, were terrified, as on one side of the village there was a flood and on the other massive rock falls from the earthquake. This event indicates that even lakes that have already experienced outburst floods are potentially dangerous, and need to be monitored along with the large glacial lakes as part of an effective risk reduction strategy.

Figure 14. Ice avalanche source areas above Dig Tsho.

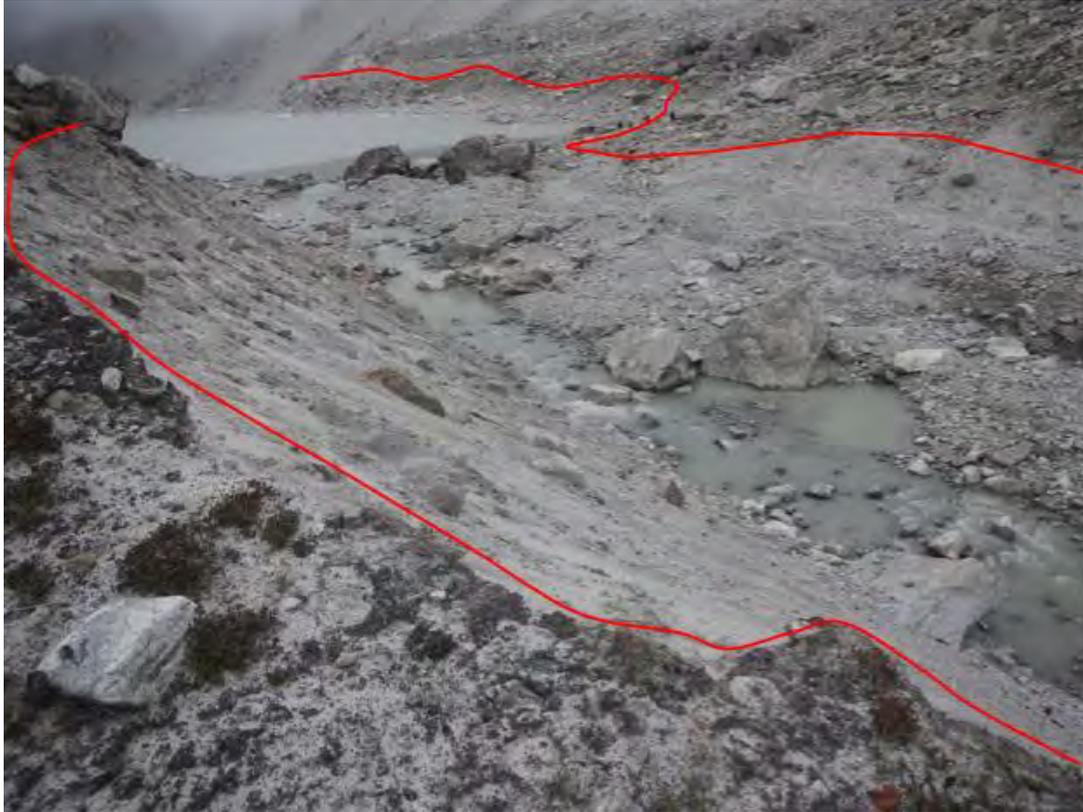
Figure 15. Eight-meter high surge wave height at Dig Tsho outlet. There was no significant lowering of the outlet and no subsequent reduction in future flood hazard.

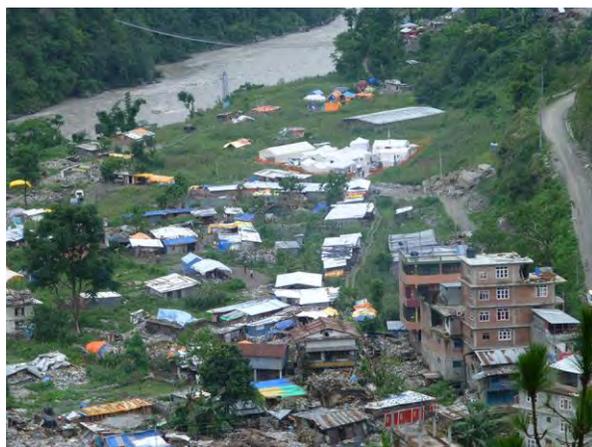
Figure 18. Singati bazaar.

Along the way we observed a great deal of earthquake damage. We estimate that about 100% of the buildings in Singati Bazaar were damaged beyond repair and most of them were destroyed completely. This commercial village was one of the most heavily damaged by the earthquake with estimates of more than 150 people perishing in nearby landslides and collapsed buildings. Damage reached a similar level in the remote and rural areas traveled through, and when viewed from afar the typical village of some hundred structures or more took on the appearance of candy-colored mosaics against a background of green, from the different tarps covering the roofs donated by different international governments. Life appeared to be continuing as usual in the rural areas because of the need to plant this season's rice and millet, which keep people fully occupied as they began to slowly repair their temporary or permanent residences. People living in bazaar and road head towns such as Singati, however, seemed to be particularly stunned by the loss of their businesses, friends, and trauma of the recent earthquake, and appeared incapable of moving forward, at least for the time being. Several people interviewed in the

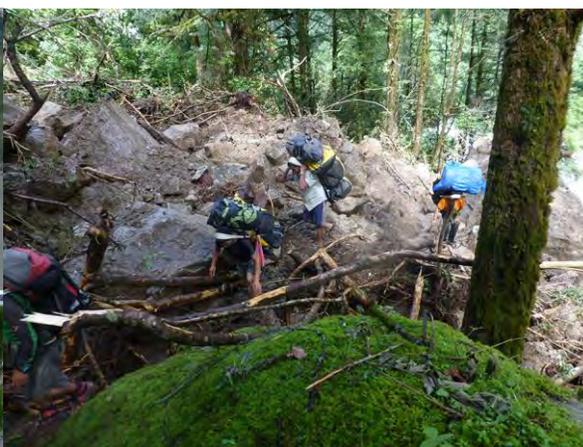
Figure 19. Landslide along trail.

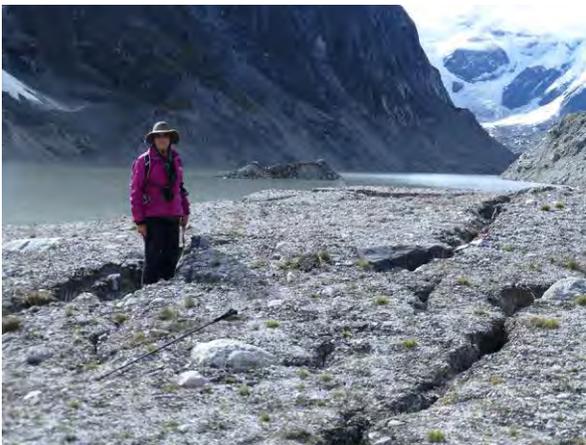
We observed cracks in the fill zone east of the outlet (earthquake). At the inlet of the canal structure there is definite slumping and cracking of the surface in the direction of the lake on both sides of the inlet (see Figure 22). This damage was caused by the April/May 2015 earthquake and aftershock. These cracks are some 10-15 m in length, 40-60 cm in width and 40-50 cm deep. These areas need to be repaired in order to slow and stop the deterioration of the inlet to the canal.

Figure 22. Cracking at the inlet from the lake to the outlet structure.

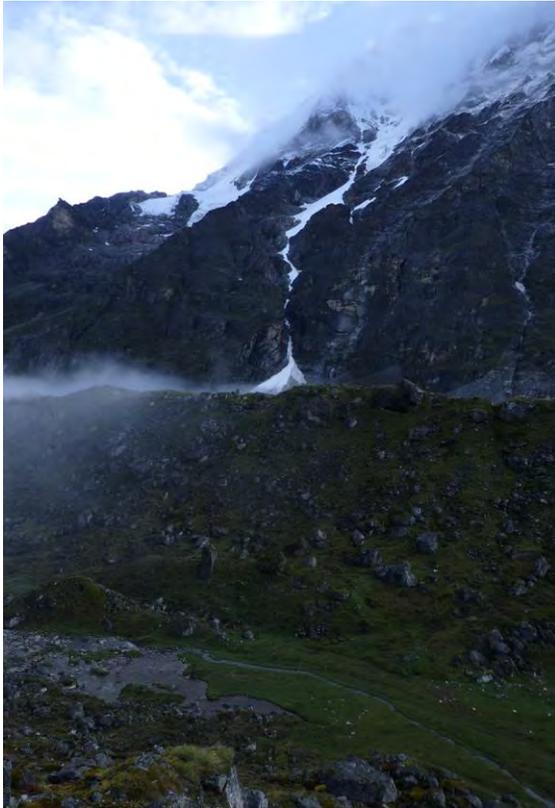
We observed and documented hanging ice, which now has a distinct avalanche path into the lake based on Swiss models and verified by direct observation of meltwater and debris on the avalanche path entering the lake (climate change, further destabilized by the earthquakes).

Figure 23. Hanging glacier and avalanche track.

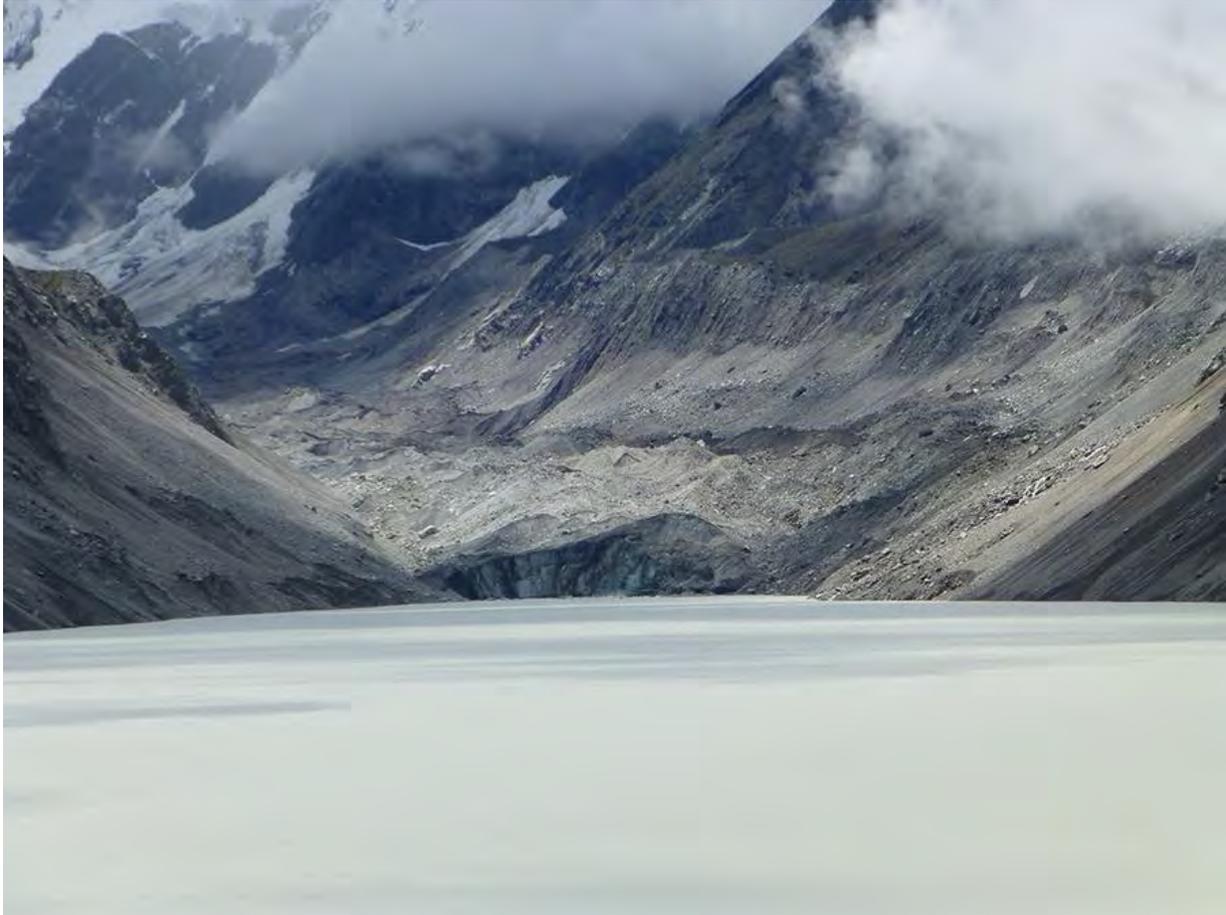
Figure 25. Glacial terminus and overhanging ice.

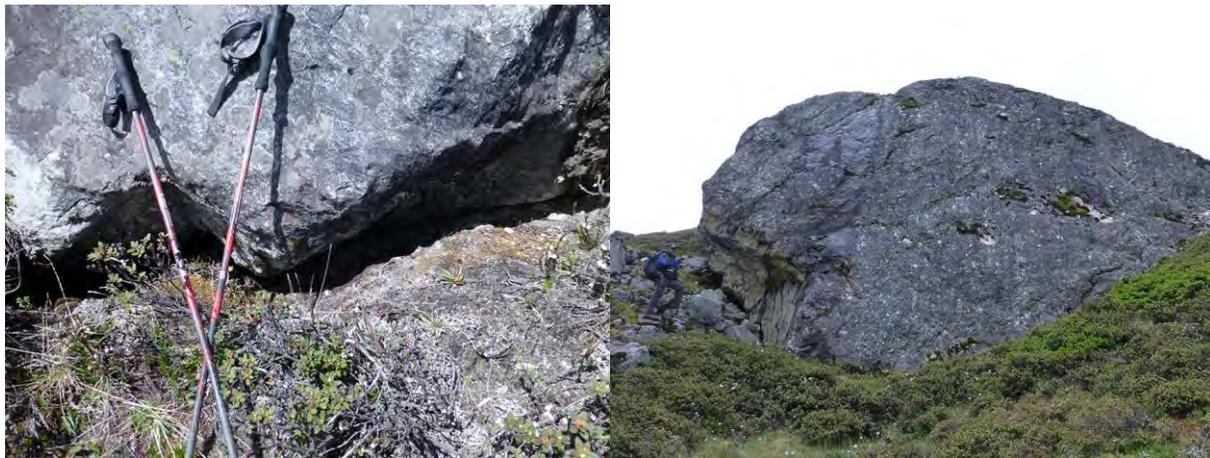
We observed shifted boulders in the terminal and lateral moraines, leaving 20 cm+ cracks vulnerable to monsoon precipitation penetration caused by the earthquake.

Figure 26, left. Shifting of boulders on the terminal moraine.

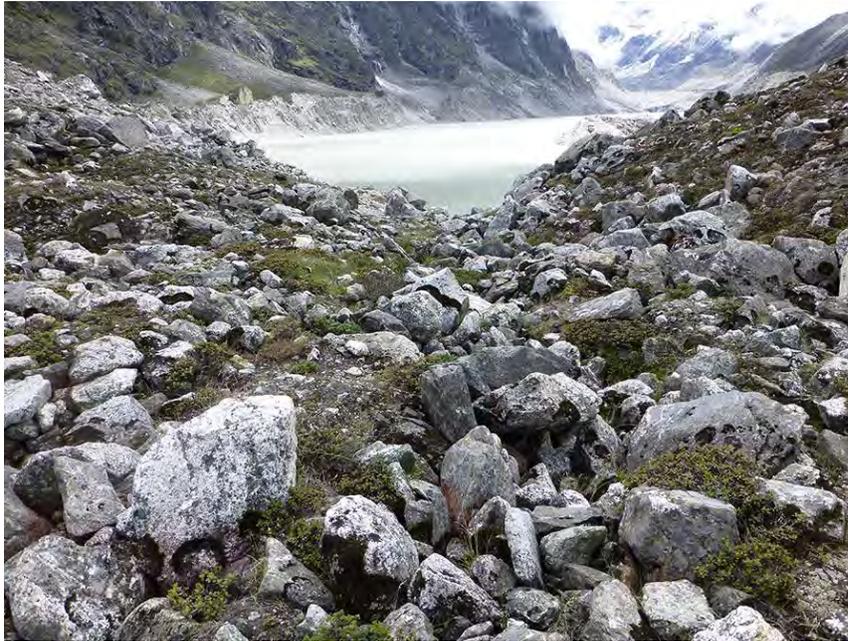
We also observed linear collapses, such as troughs and canals in the terminal moraine caused by climate changes.

Figure 28. Six linear collapses were counted and measured on the terminal moraine, and two on the right lateral moraine.

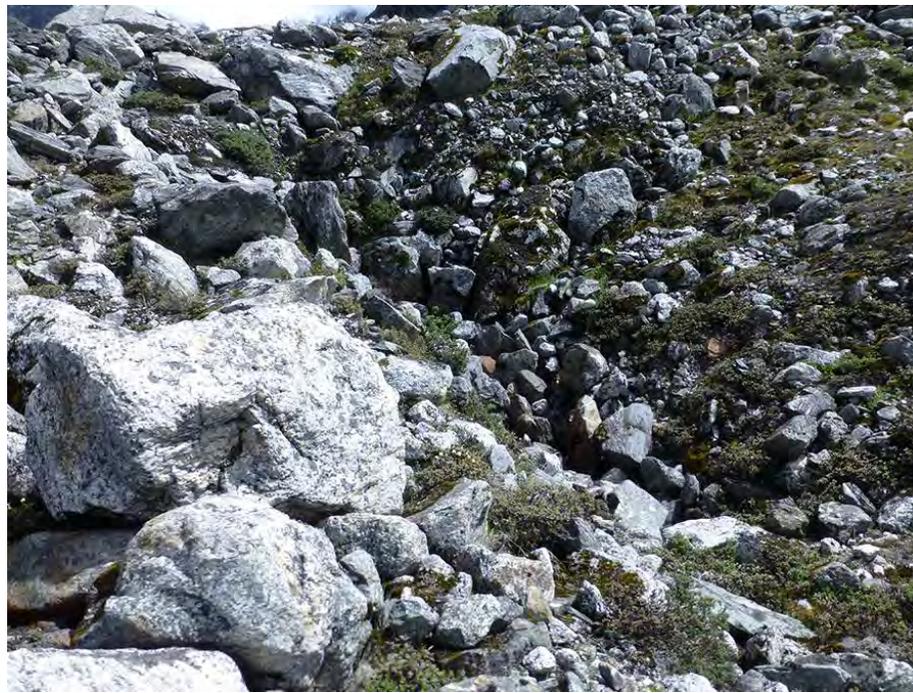
Sinkholes were observed and documented in the terminal and lateral moraines likely due to climate change.

Figure 29. Large sinkhole on the terminal moraine.

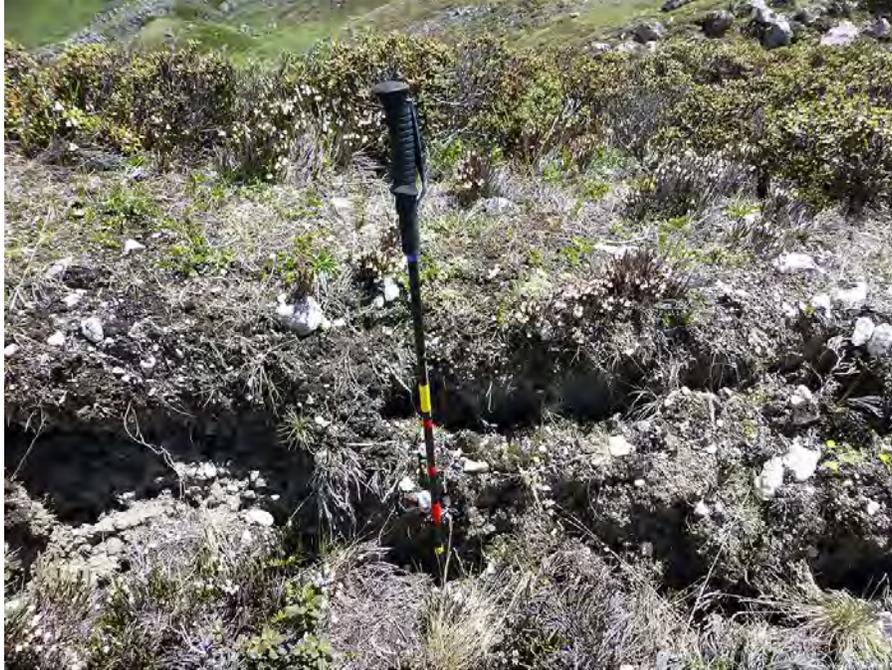
100 m+ long crack in the crest of the right lateral moraine caused by the earthquake.

Figure 30. 100 m+ long crack in the right lateral moraine.

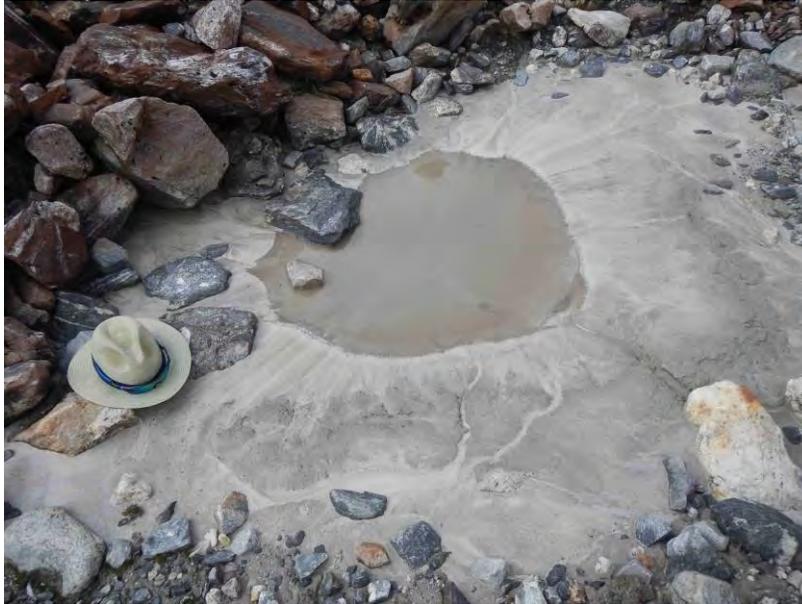
Soil liquefaction in the top of the terminal moraine at Tsho Rolpa from the earthquake.

Figure 31. Soil liquefaction in the top of the terminal moraine at Tsho Rolpa.

Several square meters of silt deposits within one of the linear collapses were noted which appear to have been produced as a result of soil liquefaction, a phenomenon common to earthquakes where soil loses its stiffness and strength and behaves like a liquid.

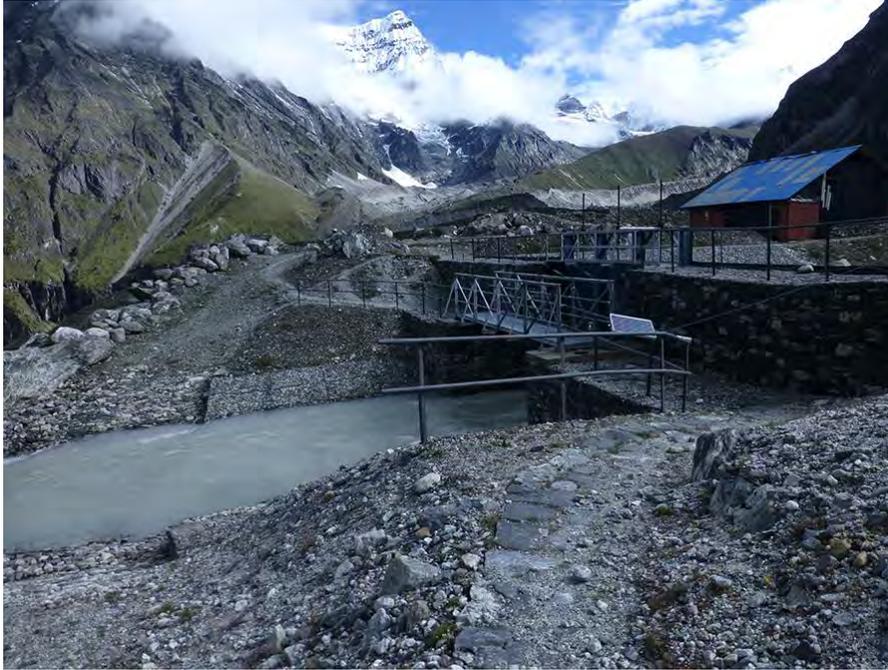
Figure 32. Tsho Rolpa outlet structure.

To lower the water level of Tsho Rolpa by approximately 3 m, a gated structure (Figure 32. Tsho Rolpa outlet structure.) of 4.2m wide, 3m deep and a 70m long canal were constructed across the end moraine in 2000 (Mool et al., 2001). It was recognized at that time that to fully reduce the risk of a GLOF from Tsho Rolpa the lake needed to be lowered a full 20 m to reduce the volume of the lake by 35 million m³.

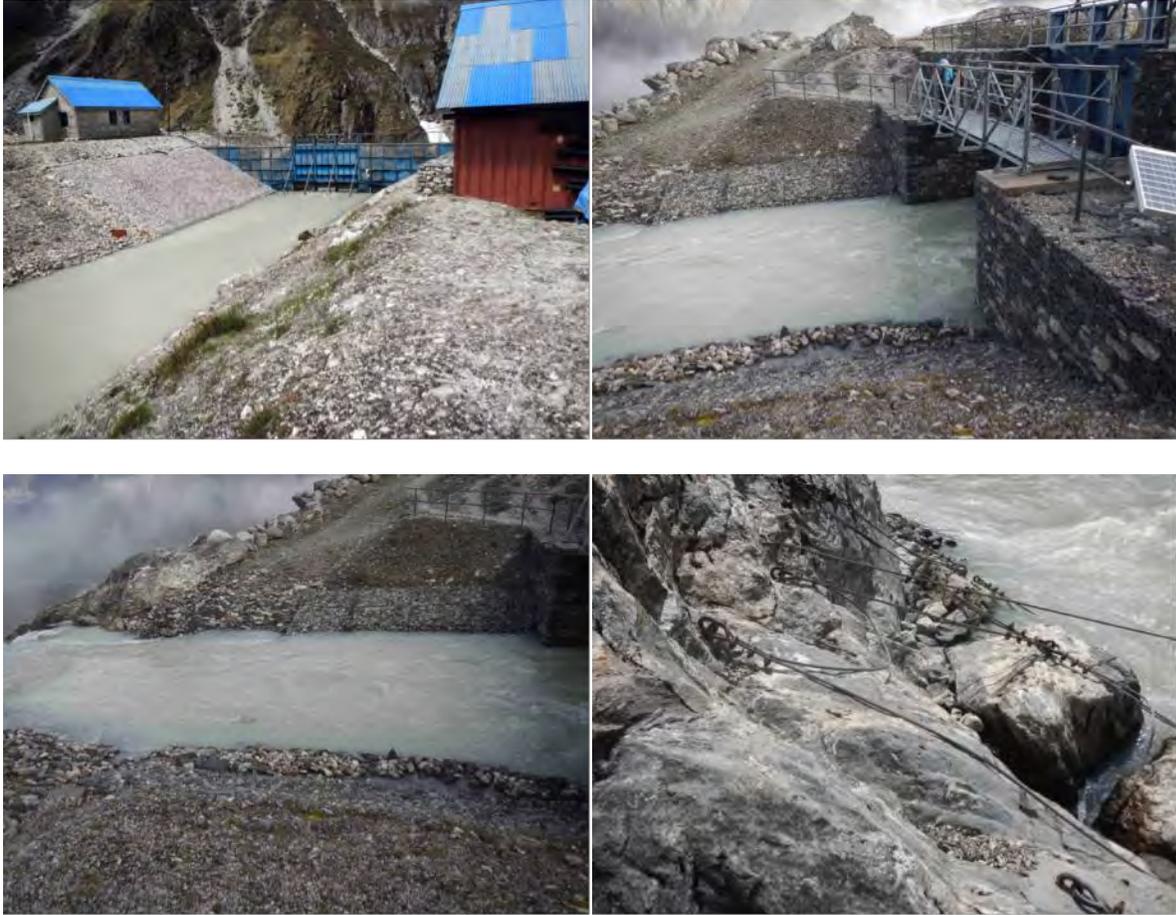
Figure 33. The gated outlet structure at Tsho Rolpa (top left); structure from lake side, (top right); structure from downstream side (bottom left); and spillway on downstream side (bottom right) with cables holding spillway boulders in place.

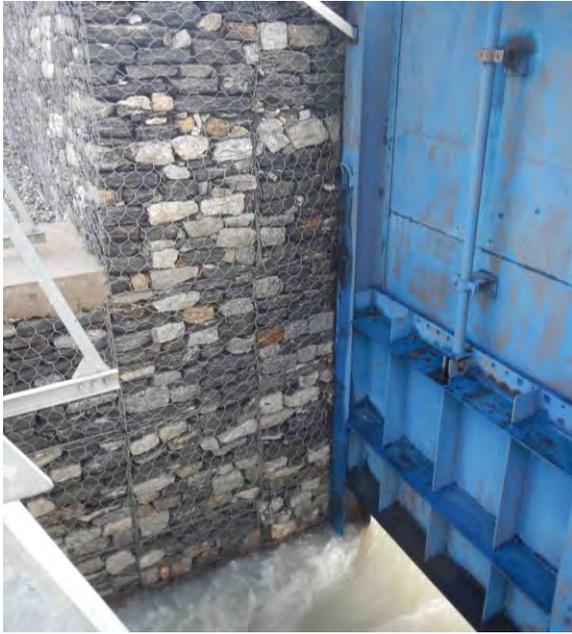
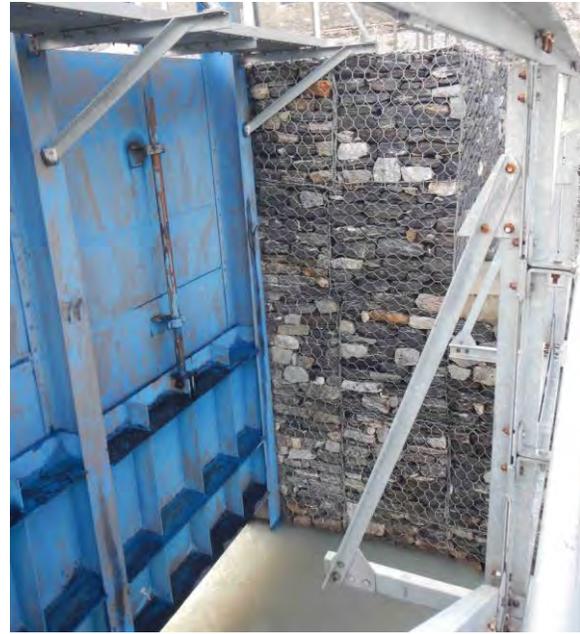
The main outlet gates and gabion support structures, shown on the downstream side in Figure 33 right hand side (a), and left hand side (b), appear to be in good operating condition with the wires of the gabion cages remaining properly stacked and aligned. Some damage to the lower gabion on the lower left outlet wall (photo c above) was observed that is in need of repair.

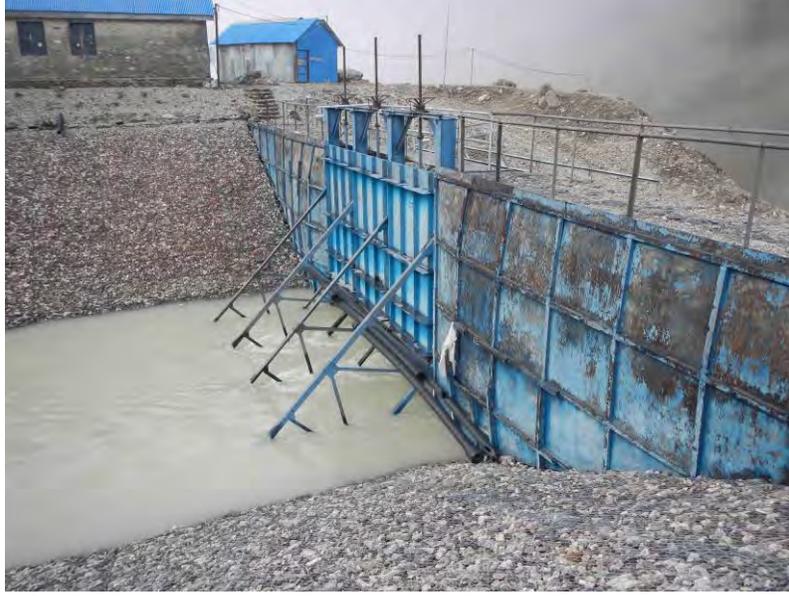
One of the things that is very noticeable at the outlet structure gates is the bulging of the wood facing on the upstream (lake side) of the supporting gabions on both sides of the gates (see Figure 35). Our team was unable to verify if this has developed over the 15 years since construction was complete or if it is a result of the earthquake and aftershock. However, the blue paint covering the wood has obviously deteriorated over time and the bulging might be an accompanying warping of the wood due to weathering. However, there could also be a failure of the gabion cage wire next to the wood. In any case, this needs to be investigated and proper repair and maintenance performed on these structures.

Figure 35. Bulges in the supports to the gates at the outlet structure.

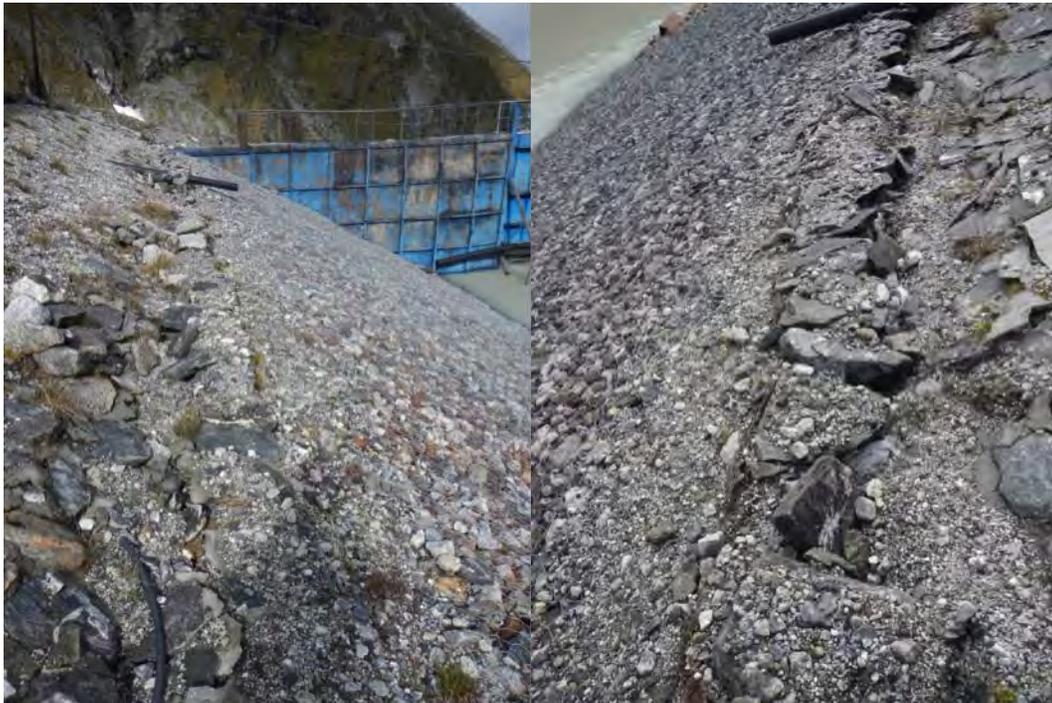
Another slight damage to the outlet structure is separation of the sloping gabions from the adjacent material on the left side of the inlet leading to the outlet structure. Figure 35 shows this looking west toward the gates (a), and east toward the lake (b), respectively. We were unable to verify if this is a new development or if it is long-term deterioration of the structure. In any case, it needs to be repaired before it deteriorates further.

Figure 36. Separations in the sloping gabions on the left side of the inlet leading to the outlet structure: (left photo) looking west, and (right photo) looking east.
