TECHNICAL REPORT

POST-EARTHQUAKE ASSESSMENT

IMJA, TSHO ROLPA, AND THULAGI GLACIAL LAKES IN NEPAL

AUGUST 2015

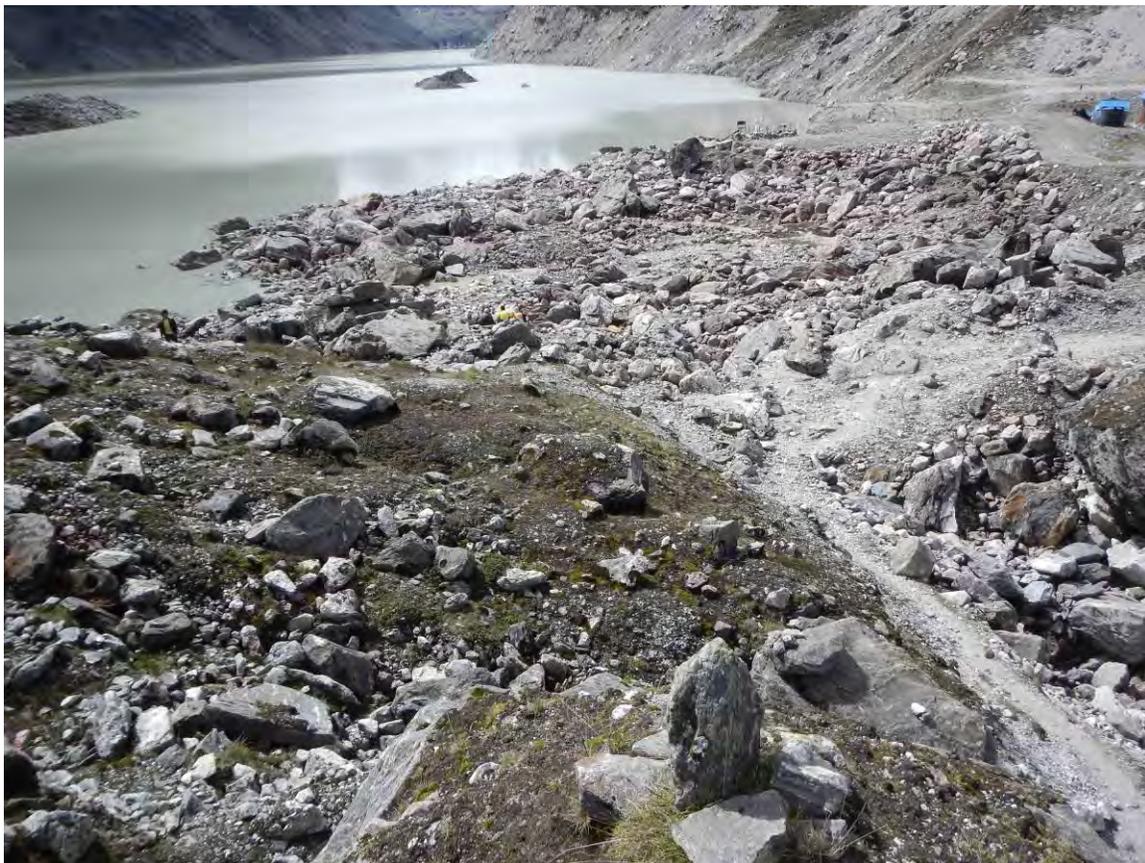
Figure 37. Old outlet (before 2000 construction of outlet structure) at Tsho Rolpa.

One way to lower Tsho Rolpa by 20 m would be to use the old outlet of the lake (pre-2000) as a channel, build a coffer dam to isolate the lake from this channel, and begin excavating that channel. Once a depth of 20 m below the original water level of the lake had been reached, then a drainage tunnel could be placed in the cut in the moraine. After that, the cut would be refilled with sturdy material and covered with a facing of stone and concrete in the manner of the Peruvian lake safety dams (Portocarrero, 2014). Figure 37 shows the old outlet (before 2000 construction of outlet structure) at Tsho Rolpa, and Figure 38 shows the concept of the excavation process to lower the water level of glacial lakes held by moraine dams or other loose sediments (a), and (b) a cross-section showing the characteristics of the spillway (left) and a lateral view of the canal showing the restored security dam that will contain surges resulting from falling ice (right).

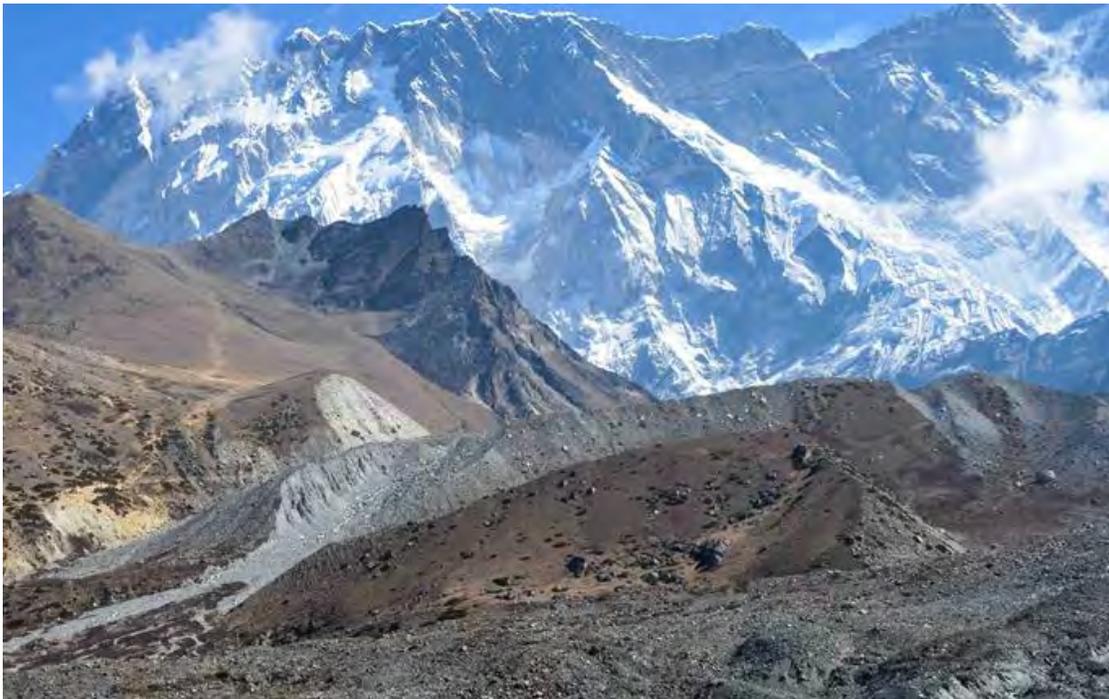
Figure 43. Glacial lakes throughout Nepal are following a natural flood cycle already demonstrated by Pleistocene glaciers some 20,000 years ago, all of which eventually drained through their temporary moraine dams following the commencement of warming trends. Increases in the number and frequency of GLOFs in Nepal can be expected with confidence.

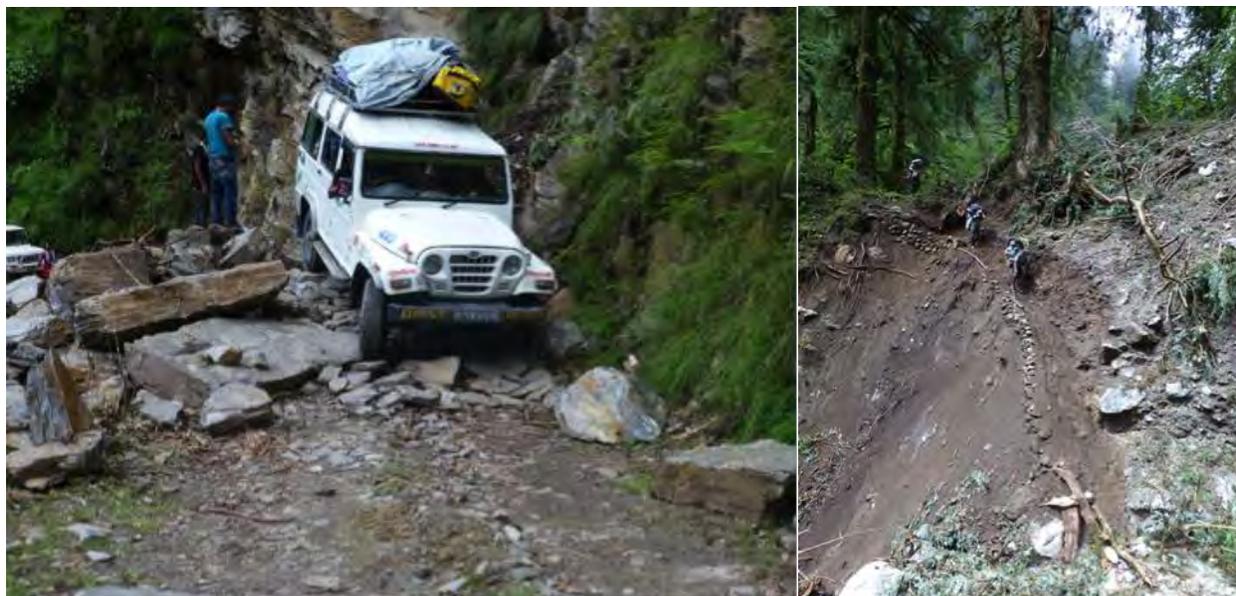
Figure 50. Crossing a landslide enroute to Chamje.

Figure 51. Landslides in the Dona valley.

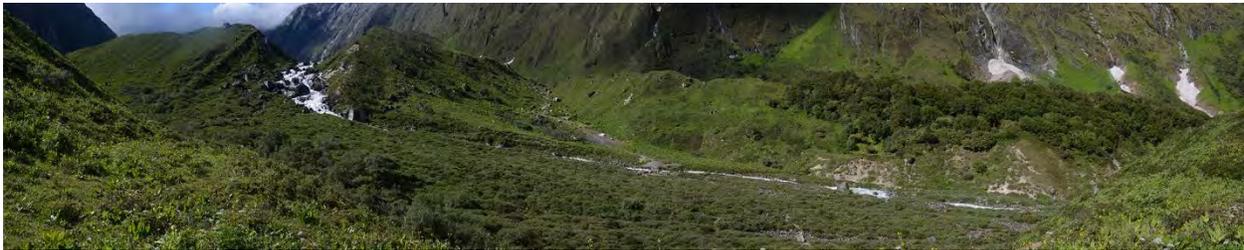
Figure 52. Older lateral and terminal moraines in front of the present day outlet.

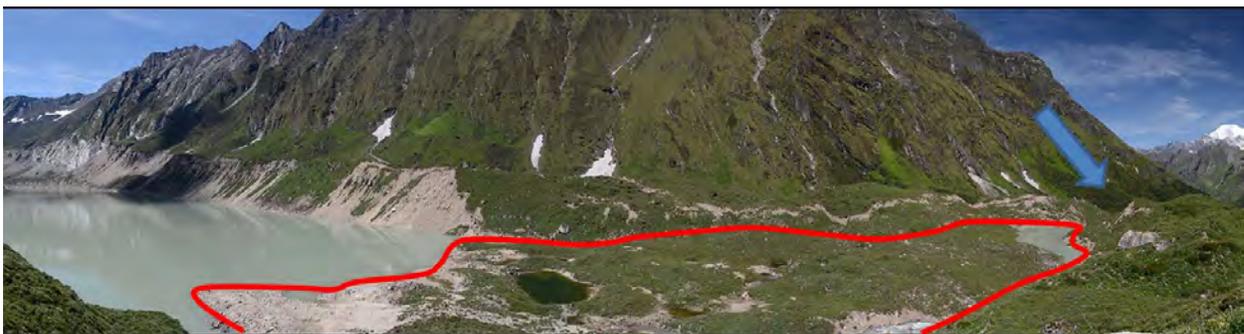
Figure 53. Terminal complex.

A second feature of note is the terminal complex (red line, Figure 53) which acts as a buffer to surge waves as well as bearing the brunt of most of the lake's hydrostatic pressure which otherwise would be directly against the thin, unconsolidated, and increasingly fragile terminal moraine (blue arrow, Figure 54). A third feature of note are the steep right and left lateral moraines, which continue to erode slowly into the lake (Figure 54).

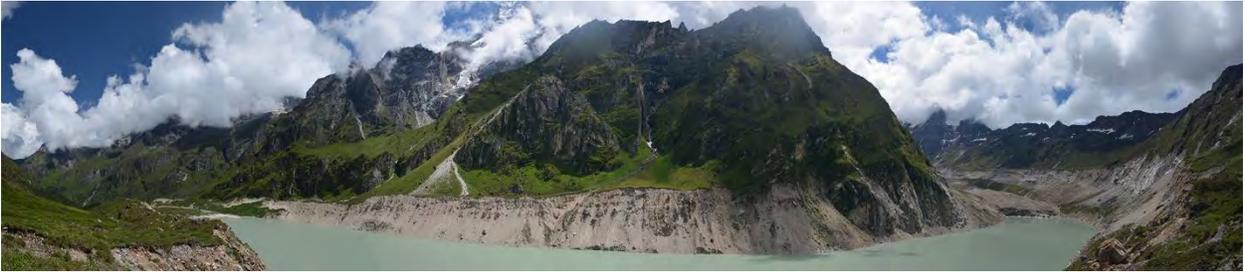
Figure 54. Steep lateral moraines. The glacier terminus is to the far right.

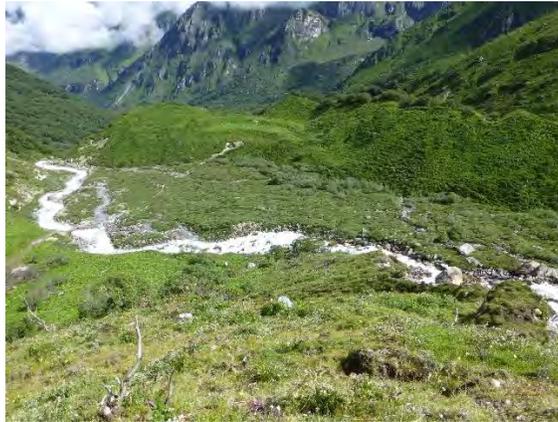
Figure 55. Outlet channel, looking downstream.

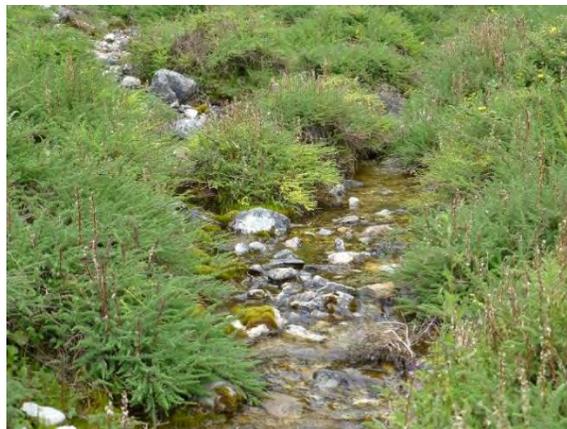
Figure 56. Seepage below the outlet channel.

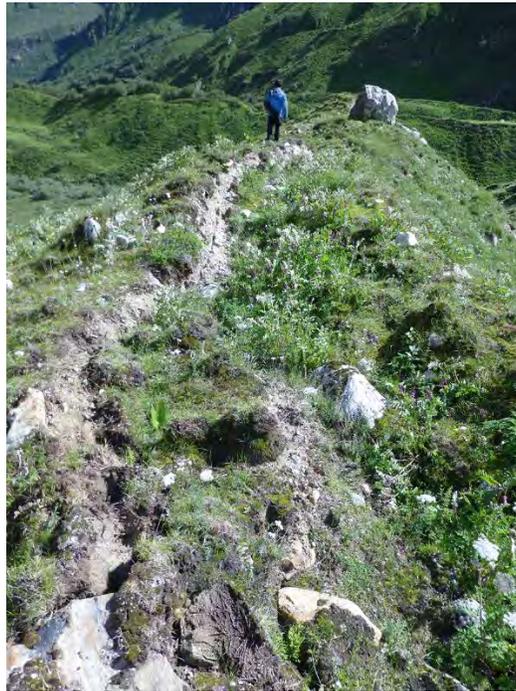
Figure 57. Massive cracks along the crest of the terminal moraine as a result of the earthquake.

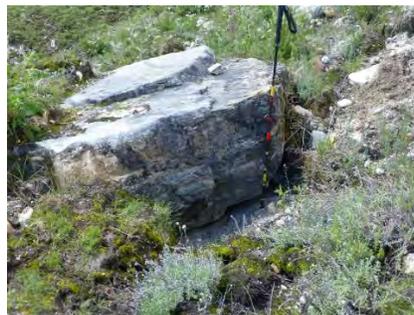
Figure 58. Displaced benchmark boulder on the terminal moraine.

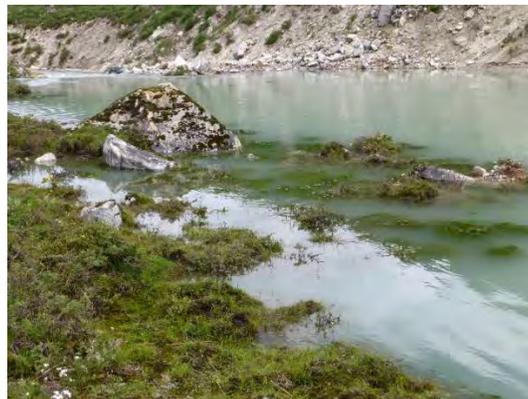
Figure 60. Fresh slumping along the shoreline of the outlet pond.

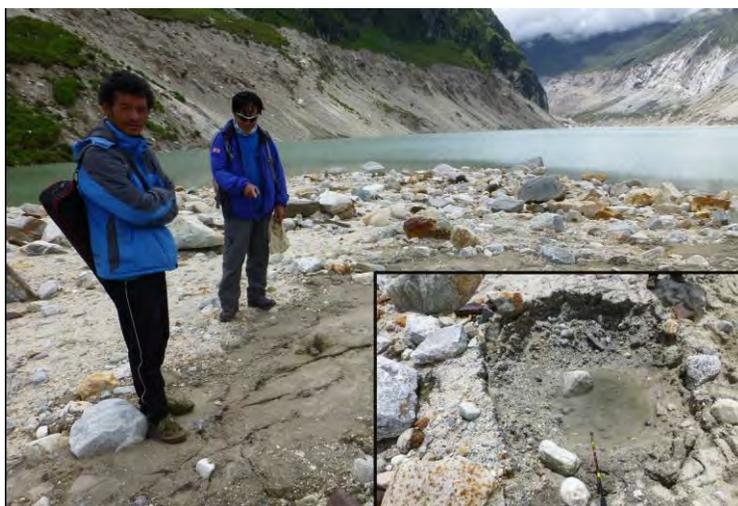
Figure 61. Silt boils on the terminal complex.

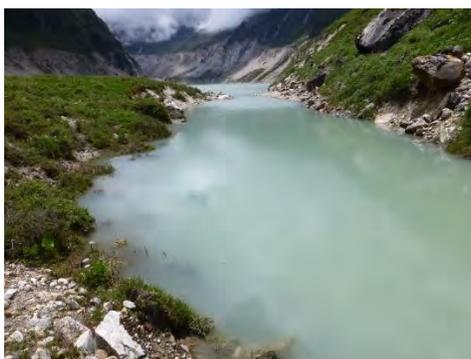
Figure 62. A recently formed finger lake on the south side of the terminal complex grew by 35 m as a result of the earthquake.

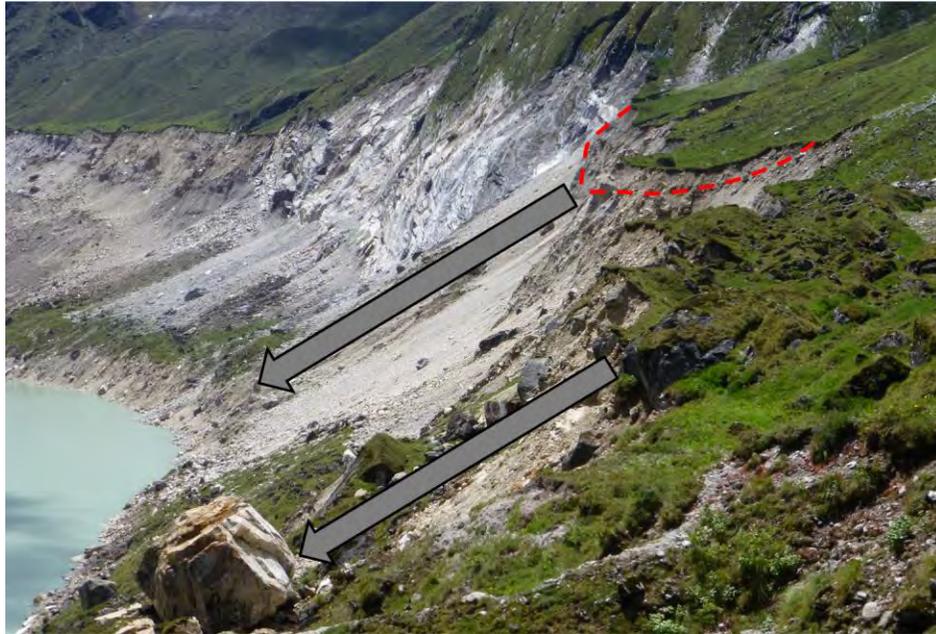
Figure 63. Grazing land was lost (upper right) and the huge boulder to the lower left displaced on the day of the earthquake.

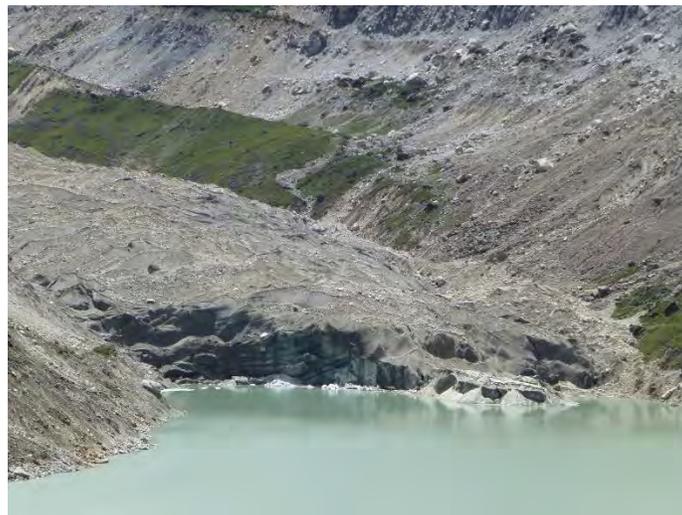
Figure 65. The glacier terminus.
