Juba Public Toilets Survey

January 2015

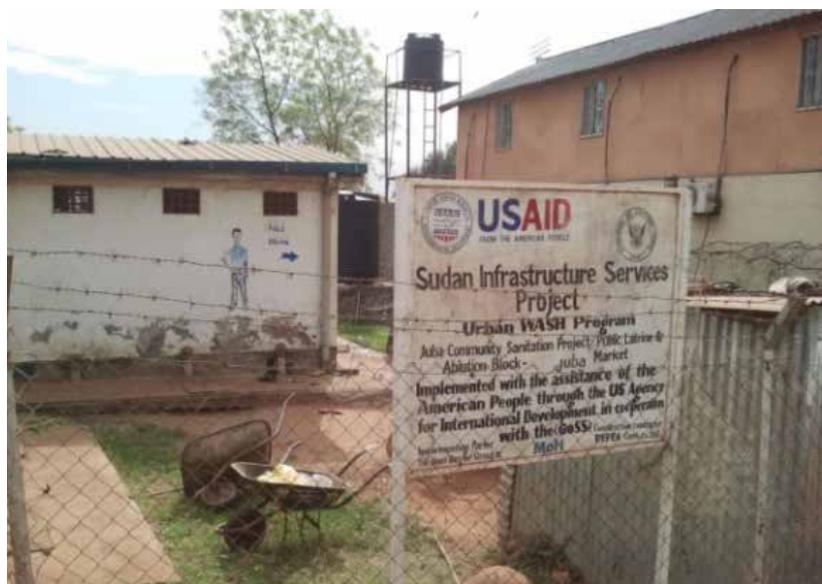
Figure 1: Public Toilet Block in Juba

Additionally, Juba has a significant number of public toilets although it is not clear what the exact number is (Figure 1). The first five public toilets were constructed with funding from USAID through the Sudan Infrastructure Services Project and another three were funded through the Multi-Donor Trust Fund managed by the World Bank.

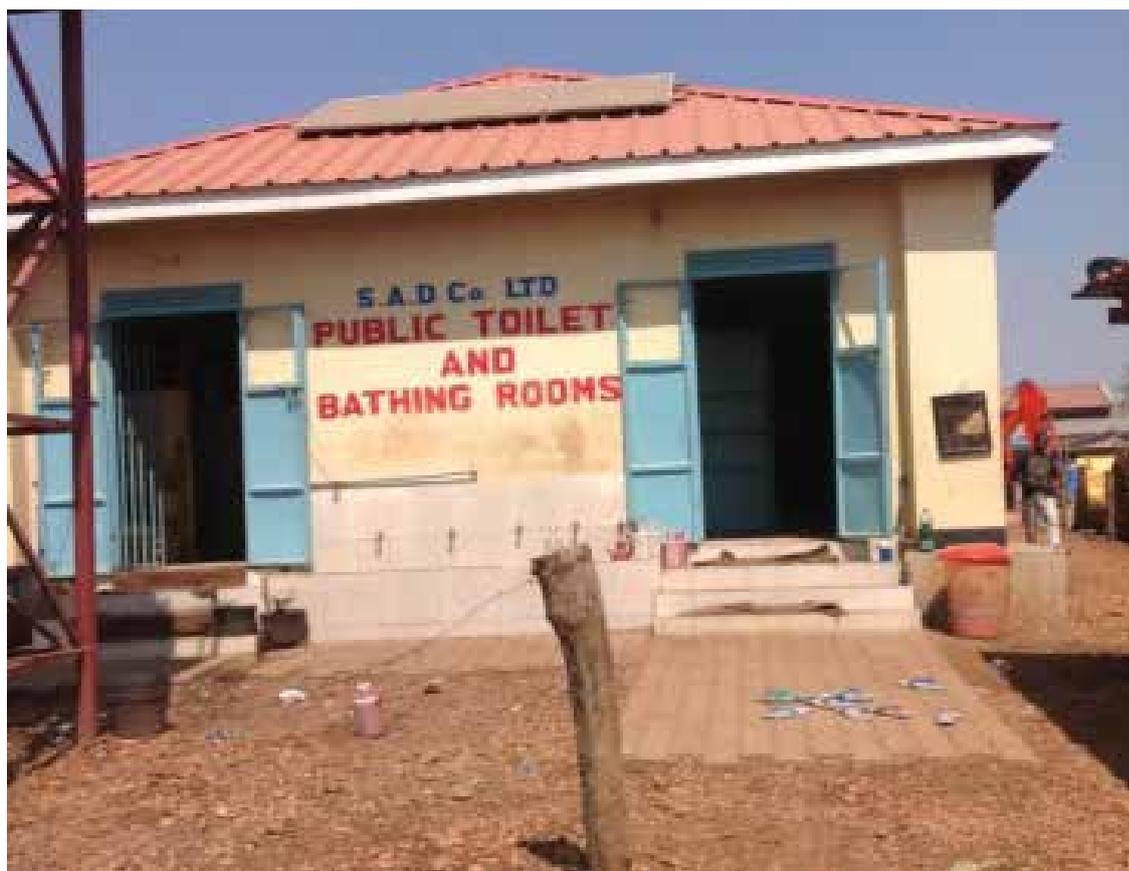
Figure 7: Registered Toilet Run by Private Sector

The majority of the public toilets are financed by private individuals and companies, although the biggest toilets are financed by donors and government (Figure 6 and Figure 7).

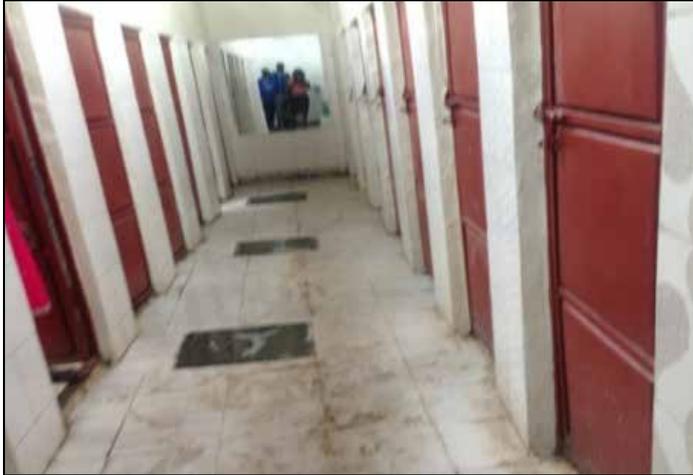
Figure 10: Manholes inside Public Toilet Building

Most of the pour flush toilets reported having a septic tank and substructures that are lined with concrete. It is however worth noting that this technology is generally poorly designed as shown in Figure 10.

The location of the manholes inside the toilet increases odor within the building and also means that in the event of a blockage, the place would be very unhygienic.

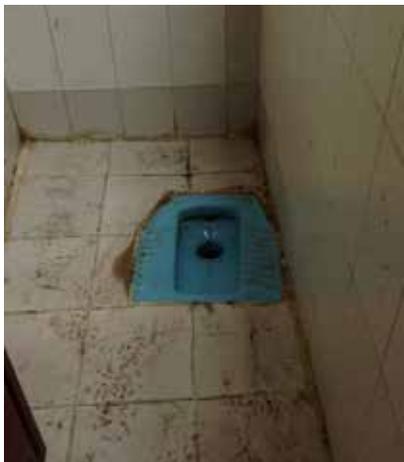
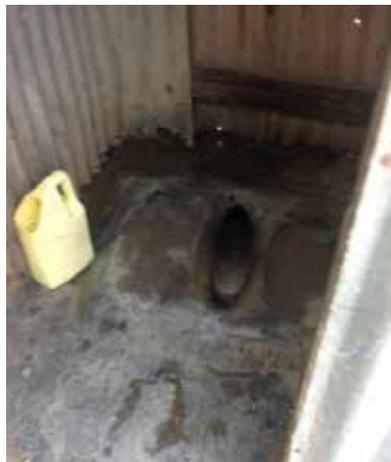
Figure 11: Typical Ceramic and Concrete Screed Floors with Squat Pan

Almost all public toilets in Juba use squat pans to allow for anal cleansing with water (Figure 11).

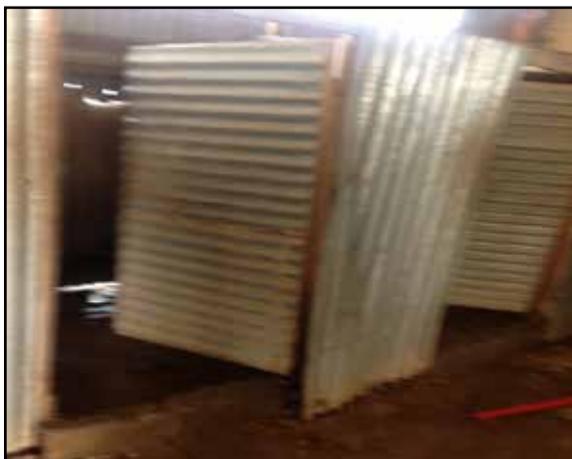
Figure 12: Public Toilet Constructed of Iron Sheets

Most toilets are built of concrete walls although some of the private ones are made from iron sheets (Figure 12). Almost all roofs are iron roofing sheets. The floors of the toilets are either ceramic tiles or cement screed whilst ventilation is largely by airbricks/ air vents although some of the larger toilets have windows (Figure 13 and Figure 14).

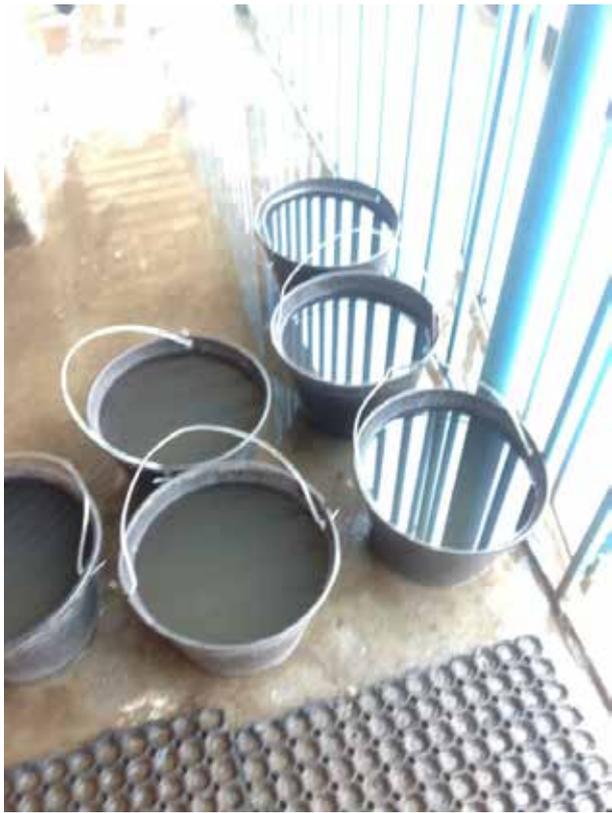
Figure 15: Buckets for Showering

Bathing facilities are provided in almost all the toilets, but mainly in the form of buckets (Figure 15).

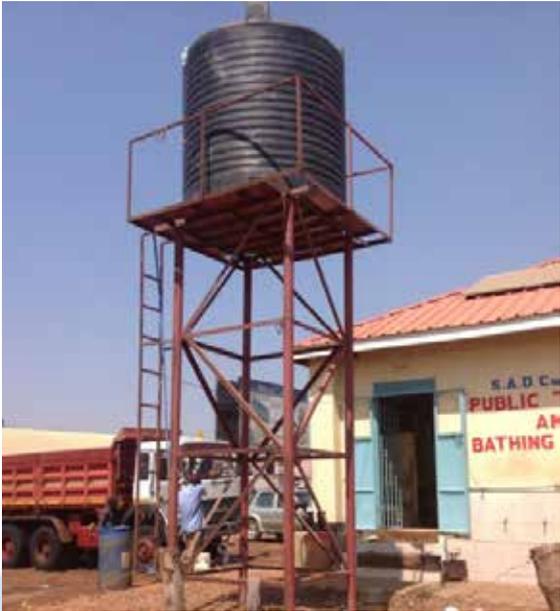
Figure 18: Typical Water Tank at Public Toilet

Almost all the toilets have a water storage tank as they all obtain water from private tankers (Figure 18). The average size of the storage tanks is 3,488 liters, the minimum 400 litres and the maximum 25000 litres.
