SITE VISIT REPORT SATPARA MULTIPURPOSE DAM PROJECT

November 2013

SATPARA MULTIPURPOSE DAM PROJECT

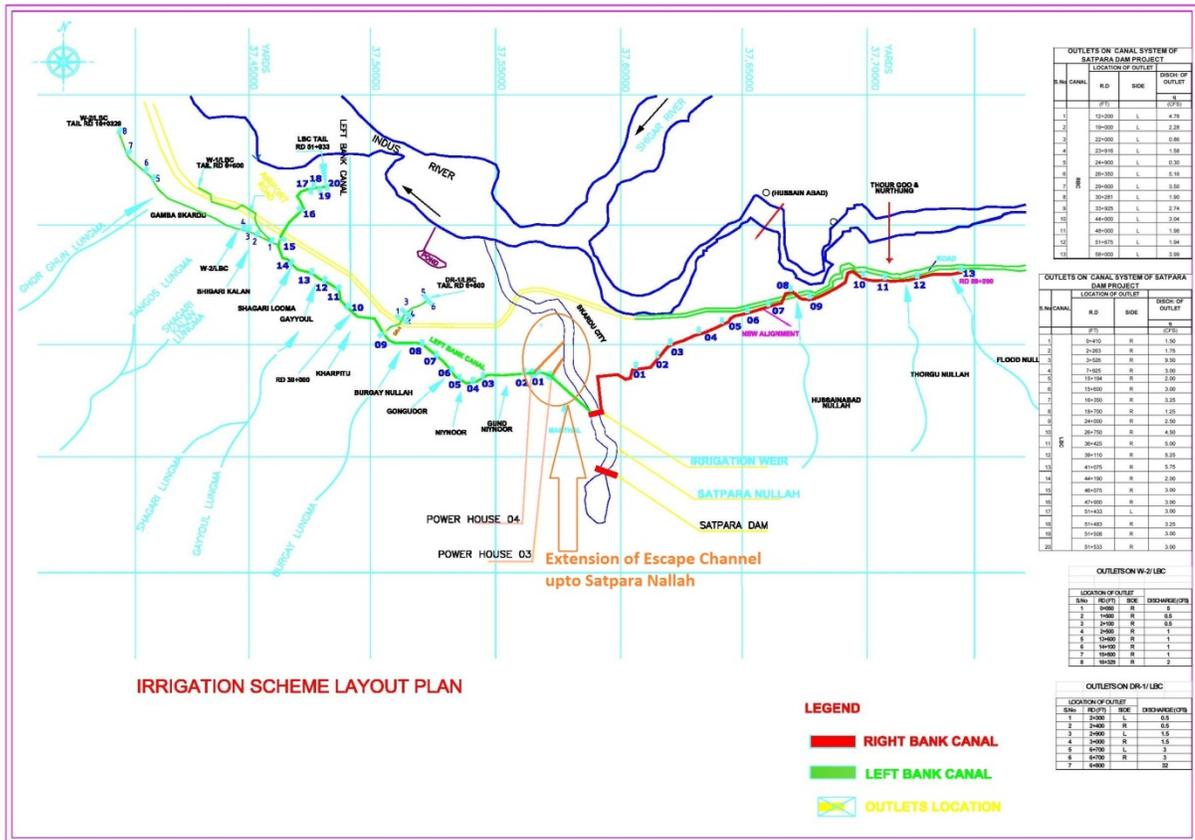
- B. As a long term solution, it is also recommended that following additional works may be carried out to achieve independent operation of powerhouses 3 & 4; (see attached layout showing extension of escape channel and new channel from powerhouse # 3 & 4)

1. Construct tailrace channel from powerhouse #3 to Satpara Nallah – about 1000 ft. to release powerhouse discharge in the Satpara Nallah.
 2. Extend escape channel to Satpara Nallah – about 10,000 ft. to release power house discharge direct to the Satpara Nallah.

Figure 1: Extension of Escape Channel up to Satpara Nallah

3. Estimated time required to complete both tailrace channels is 18 – 20 months.
 4. Estimated cost of the additional works will be about \$ 1.8 million.

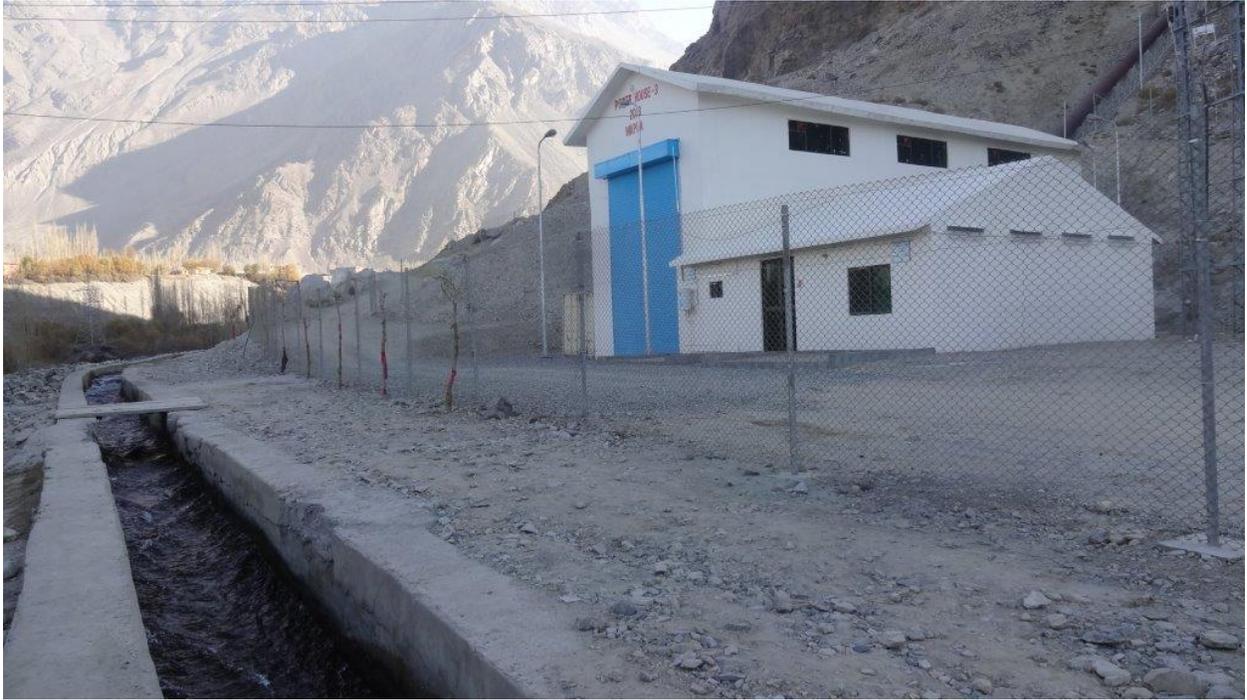
Figure 2: Irrigation Channel in front of Power house 3

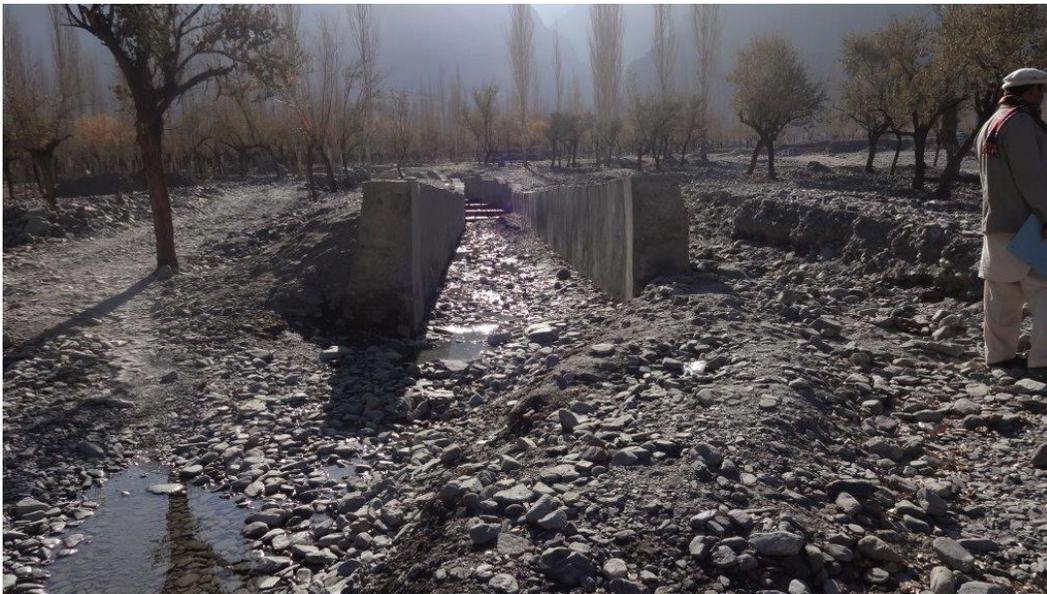
Figure 3: Escape Channel of the Irrigation System

- A. The civil administration at Skardu shall take immediate steps to remove encroachments downstream of the escape channel. This will allow powerhouses # 3 & 4 water discharge to the existing Satpara/ Harisha nallah. With the removal of encroachments, powerhouses # 3 & 4 will generate 3.8 MW and provide relief to the local residents by reducing load-shedding at Skardu.

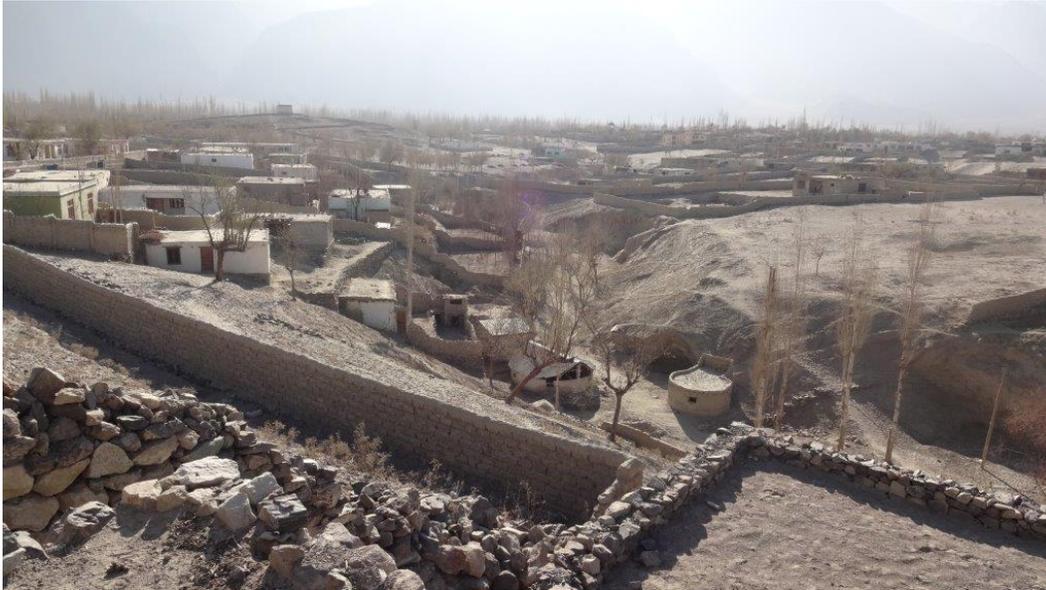
Figure 4: Land Encroachments

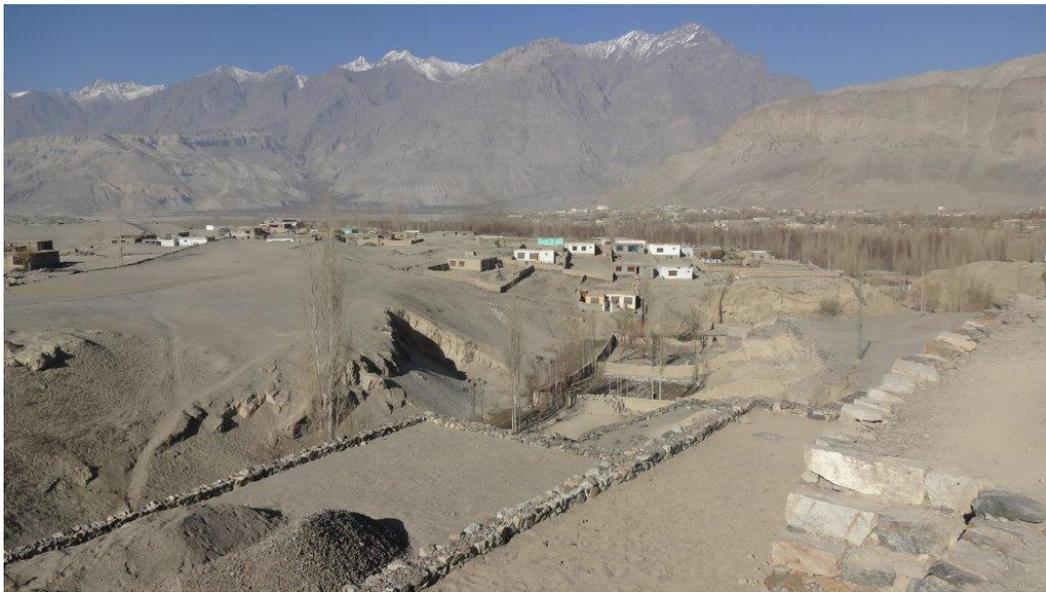
Figure 5: Land Encroachments

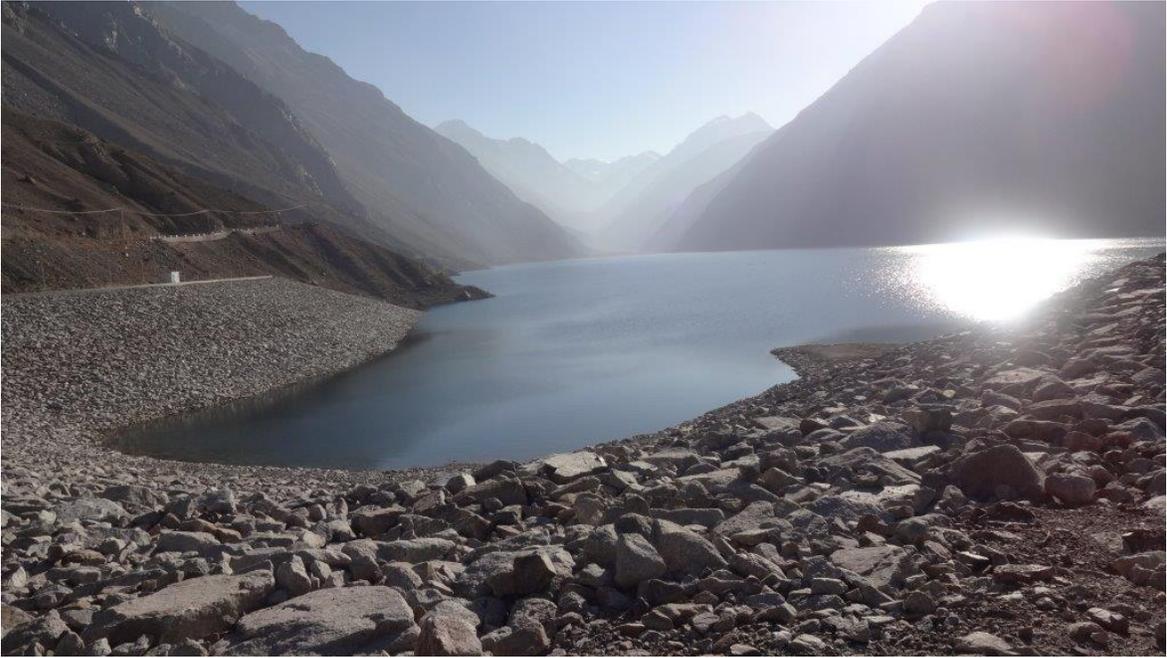
It was observed during the visit that the reservoir level was decreasing due to less inflow and increased releases from the Satpara reservoir to meet power generation requirements. On July 15, 2013 the reservoir level was 8,697 ft. (25 ft. below spillway level). And total seepage recorded downstream of the dam was 40 cusecs.

Figure 6: Satpara Dam Reservoir
