## ENVIRONMENTAL AUDIT REPORT ENVIRONMENTAL COMPLIANCE MONITORING OF MUZAFFARGARH THERMAL POWER STATION

VISIT 04

April 2013

### ENVIRONMENTAL COMPLIANCE MONITORING OF MUZAFFARGARH THERMAL POWER STATION

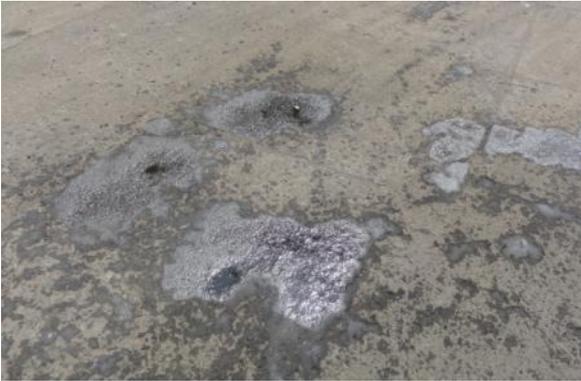
**Photograph 01:** Oil spill/leakage observed near Unit 5 and 6

Serial Number	Issue ID	Visit No.	Issue	Photographic ID	Date Raised	Proposed Corrective Action	Responsibility	Target/ Revised Target Date	Status	Verification	Comments	Addressed Date	Days taken to Address/ Reason of Delay
<b>New Issues from Recent Visit</b>													
10	4-01	04	Oil spills/ leakages were observed near Unit 5 and 6	01	April 15, 2012	Oil shall be stored in designated and clearly marked areas and shall be lined with impervious flooring. The oil storage area shall have dykes constructed around it to control accidental leakages and spills ( <b>EMMP Ref: 3.2</b> )	ET of Unit 5 and 6	Immediate	Open	-	All oil spill/leakage should be collected and need to disposed off at earliest	-	-
11	4-02	04	Solid waste and plastic papers observed at unit 5 and 6	02	April 15, 2012	All type of waste shall be collected and stored in separate bins marked for this purpose ( <b>EMMP Ref: 3.2</b> )	ET of Unit 5 and 6	Immediate	Open	-	All waste should be collected and disposed off properly	-	-

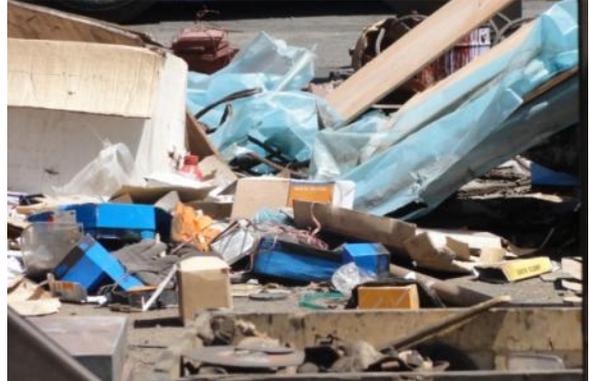
**Photograph 02:** Solid waste and plastic waste observed at unit 5 and 6

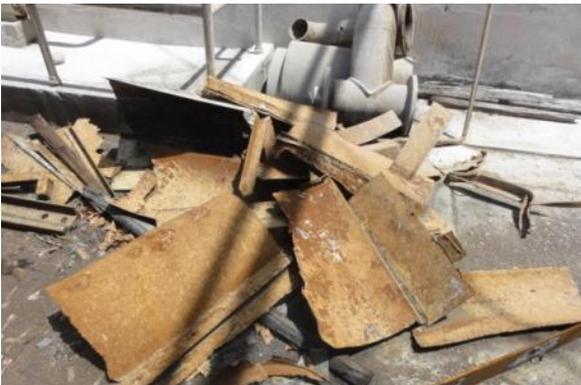
**Photograph 03:** Sharp edged metal observed at unit 5 and 6

Serial Number	Issue ID	Visit No.	Issue	Photographic ID	Date Raised	Proposed Corrective Action	Responsibility	Target/ Revised Target Date	Status	Verification	Comments	Addressed Date	Days taken to Address/ Reason of Delay
12	4-03	04	Sharp edged metal were observed left behind after completion of work at unit 5 and 6	03 and 04	April 15, 2012	Sharp edged metal shall not be left unattended at any time. It shall be moved to storage yard immediately after removal. In the storage yard, the storage area for such metal shall be cordoned off using clearly visible tapes. (EMMP Ref: 3.2)	ET of Unit 5 and 6	Immediate	Open	-	All waste need to collected and disposed-off appropriately	-	-
<b>Issues Closed</b>													
13	1-02	01	MTPS has not formulated any environmental team to implement EMMP	-	April 18, 2012	Environmental team will be designated at each unit and their job description will be documented (EMMP Ref: section 4.5).	CEO and HSE officer	September 27, 2012	Closed	Yes	An environmental team has formed for each unit for implementation of EMMP	September 25, 2012	160

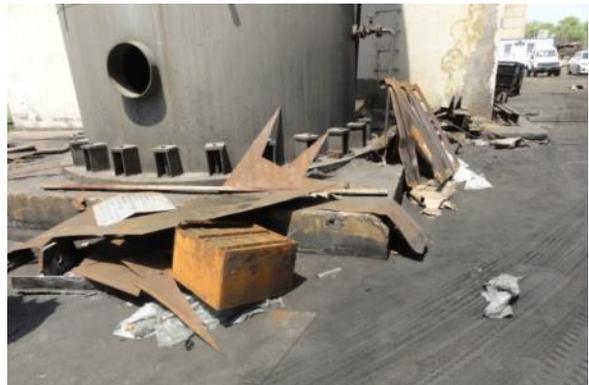
**Photograph 04:** Sharp edged metal observed at unit 5 and 6
