ENHANCING CAPACITY FOR LOW EMISSION DEVELOPMENT
STRATEGIES (EC-LEDS) CLEAN ENERGY PROGRAM
COOPERATIVE AGREEMENT NO. 114-A-13-00008

Project Proposal

The Project Proposal for the Full and Energy Efficient Restoration Programme of Municipal Buildings in Tbilisi City

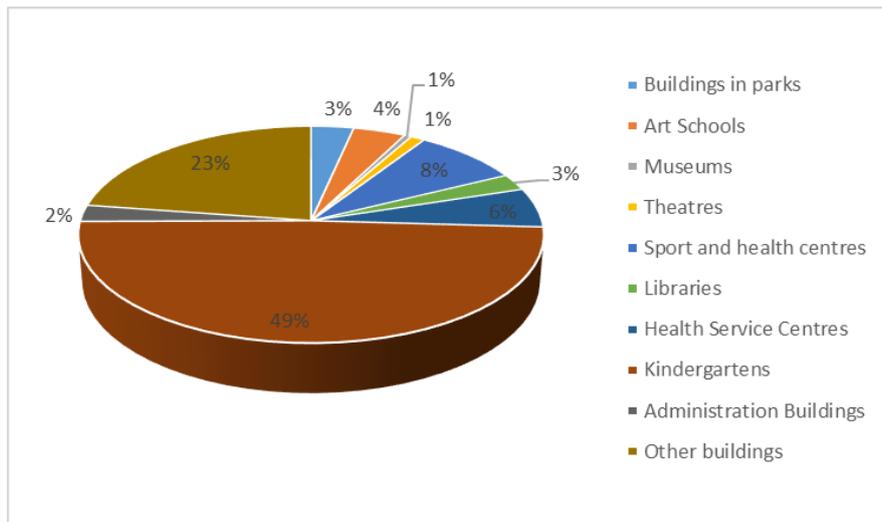
Fig. 1 Division of total areas of municipal buildings according to their function

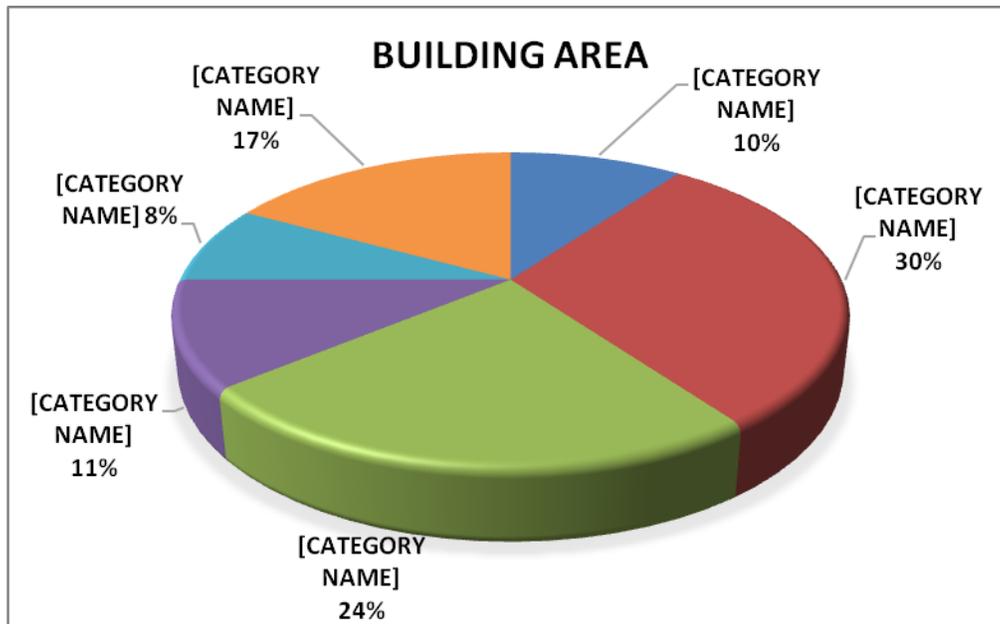
Figure 1. According to the area, majority of kindergarten buildings (55%) fall within the range of 500-1500 m². Also, considerably large group (17%) comprises of buildings with an area of 2500 m². The share 500 and 2000-2500 m² buildings is relatively insignificant.

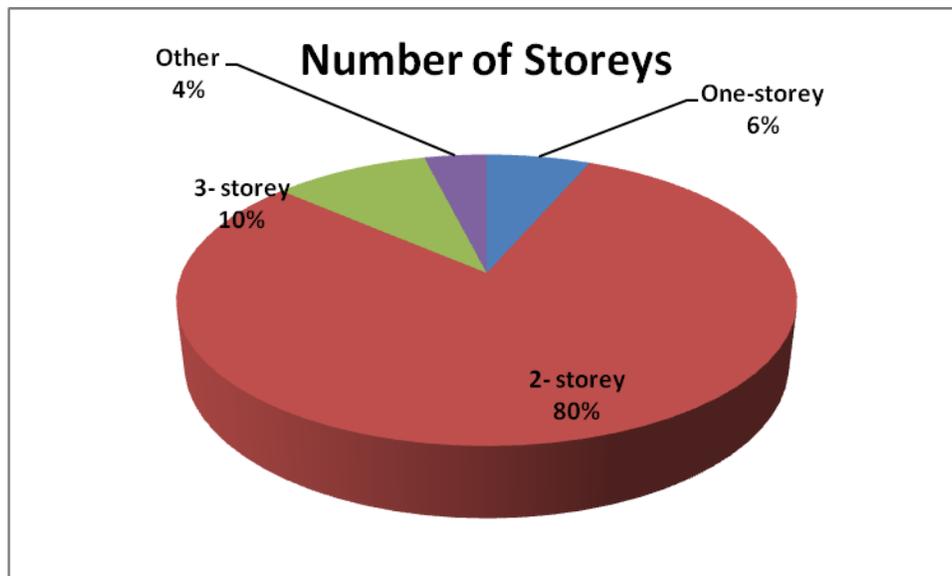
Figure 2. Number of storeys of kindergarten buildings (80% are two-storey and 6% are one-storey buildings)

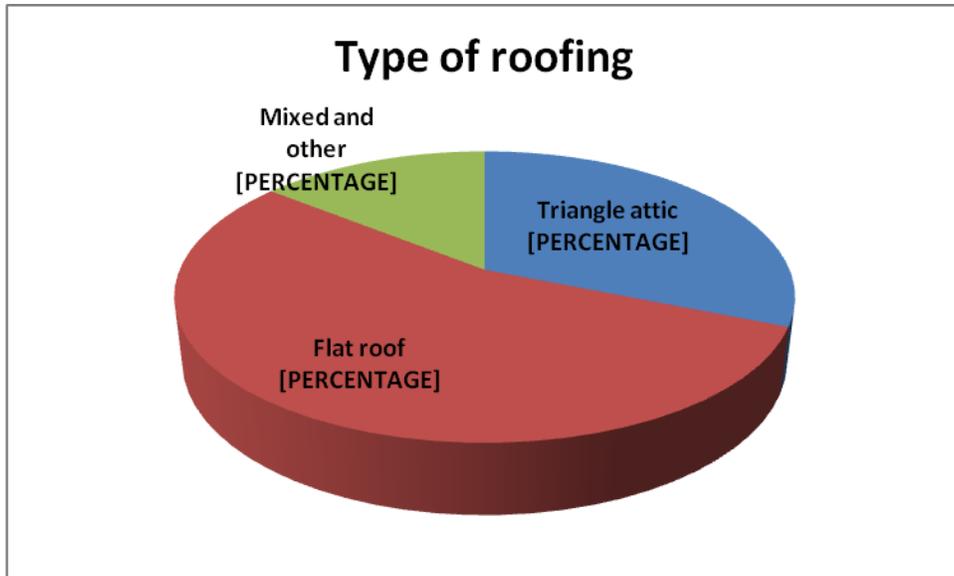
Figure 3. Majority of kindergarten buildings (55%) have flat roof, 31% triangle attic. Remaining roofs are of standard types (mixed, differing shapes)

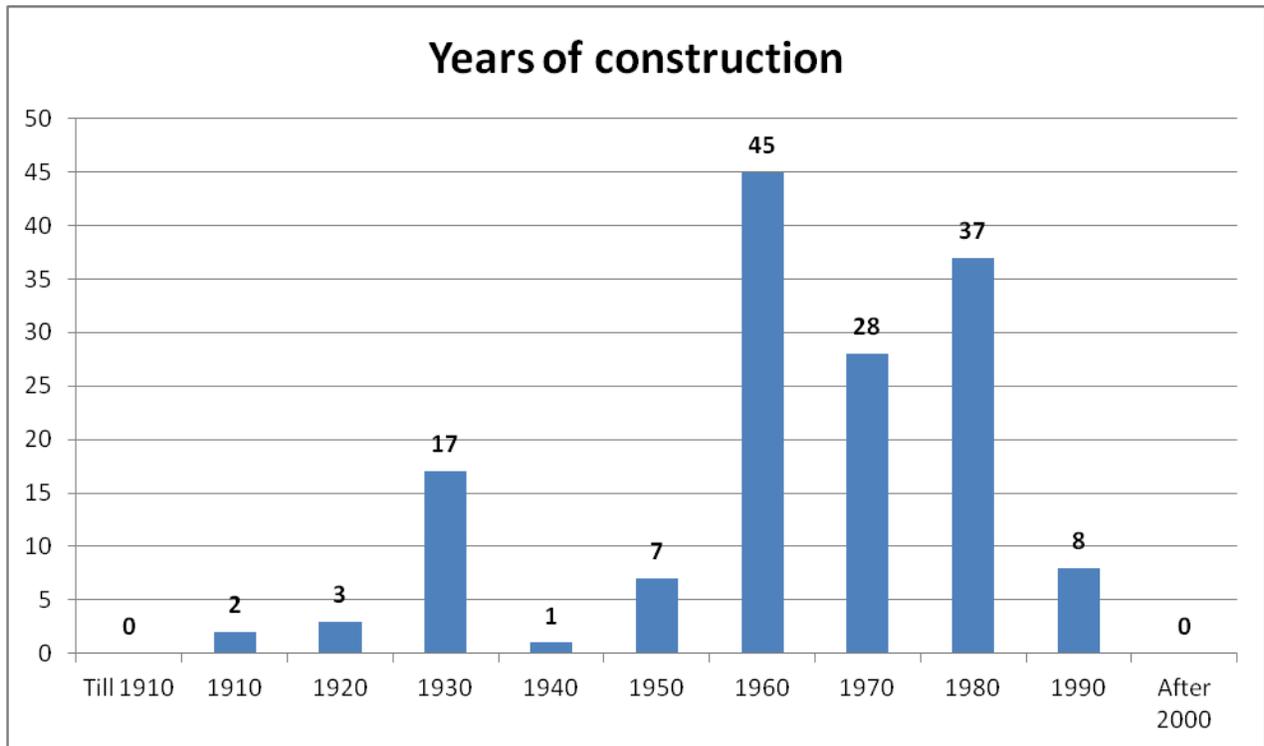
Figure 4. Vast majority of buildings (72%) is constructed in the time period of 1960-1980

Vast majority of kindergarten buildings were constructed in 60-es and 70-es of XIX century. One out of these buildings represents the sight of cultural heritage; in case of the second building general renovation was conducted (building casing). Due to this reason, building represents an outlier and does not enable generalization of research findings.

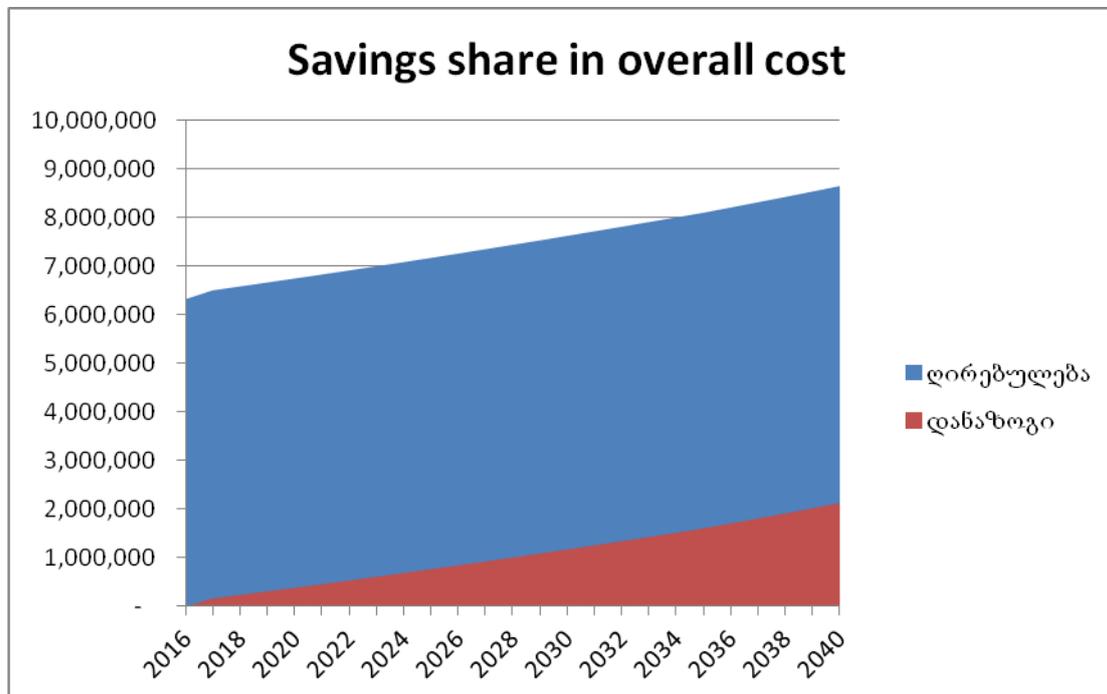
Figure 5. Savings share in overall annual investment (blue colour-investment, red colour - savings)

Drawings 1-4 demonstrate the total share of savings in overall annual investment and rate of changing of this share.

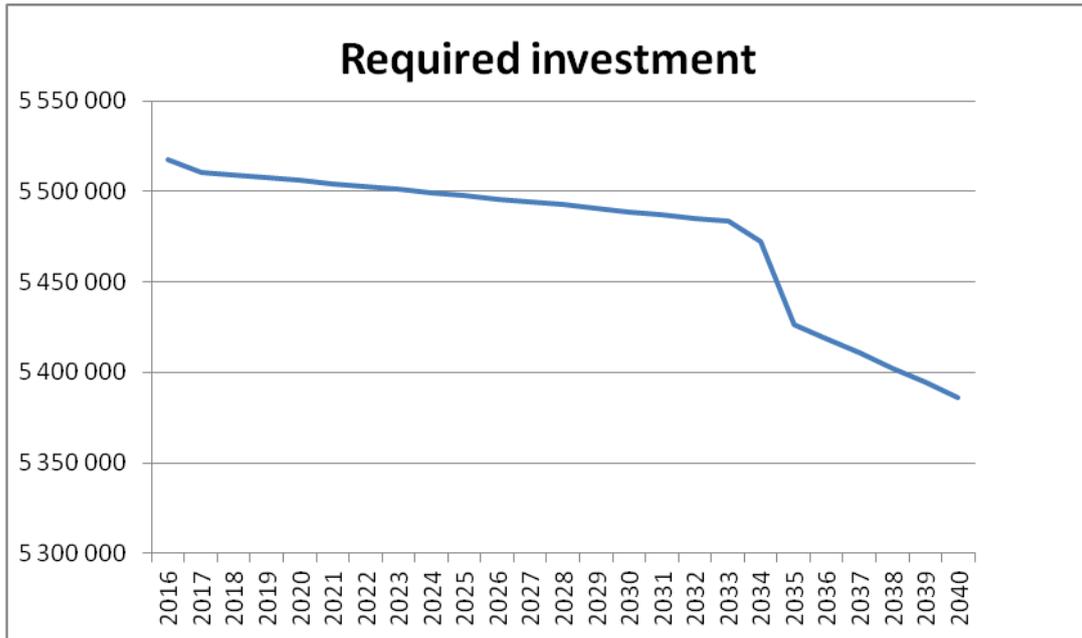
Figure 6. The growth rate of annually required investment

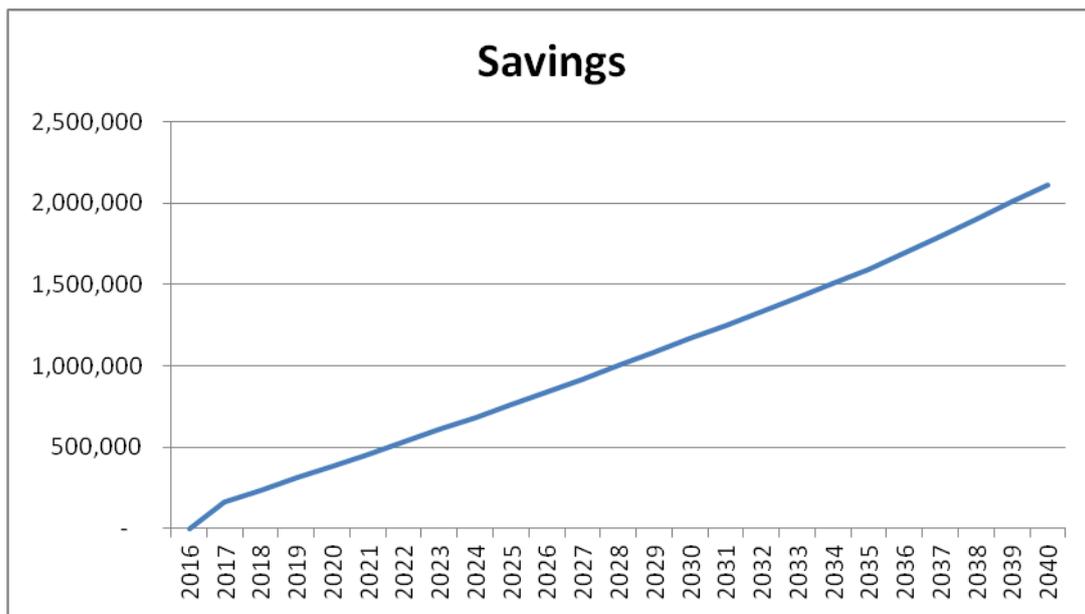
Figure 7. The annual growth of financial savings

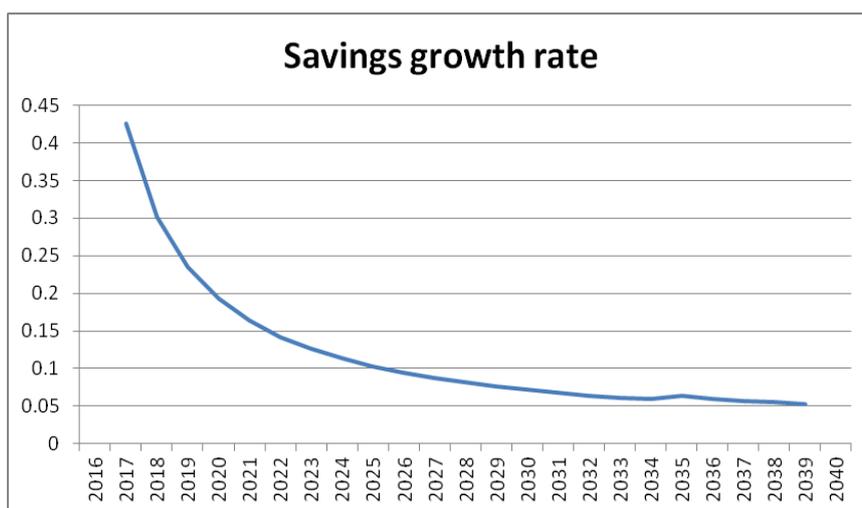
Figure 8. The growth rate of annual financial savings

It should be mentioned herewith that annual financial savings caused by reduction of incidental expenditure as a result of full renovation of buildings are not considered in these calculations.

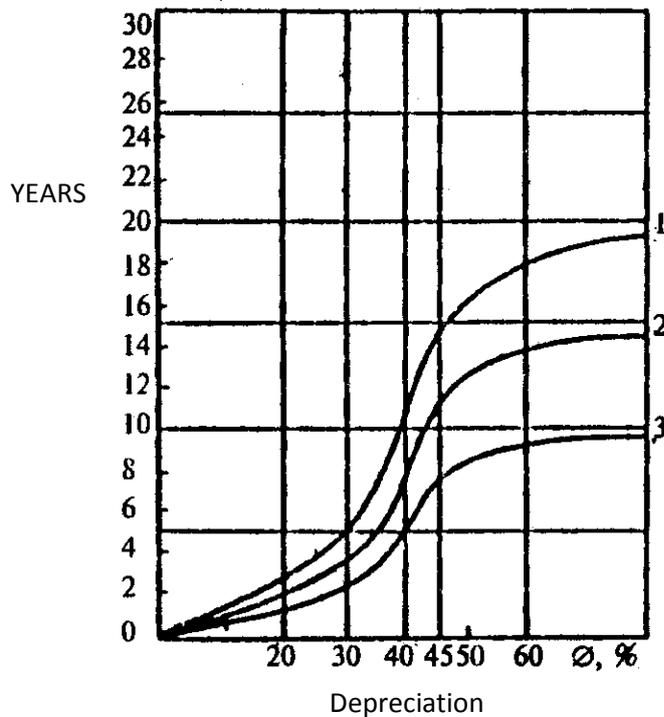
Physical depreciation of internal water supply systems.

- 1 - Stand-pipe from galvanised pipes
- 2 - Galvanised distributing pipes, all kinds of mixers, locking devices
- 3 - Ferrous material and pressure pipes and distributing pipes, cast iron locks.

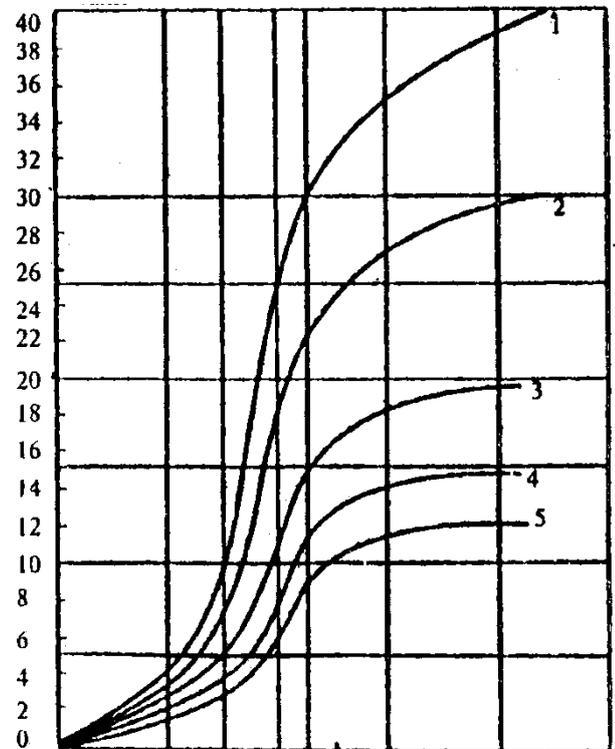
Internal water network physical depreciation

- 1 - Ungalvanised piping
- 2 - Ceramic and cast iron dipping tanks
- 3 - Ferrous metal pipes, PVC pipes, bronze taps and loc
- 4 - Cast iron taps and locking fittings

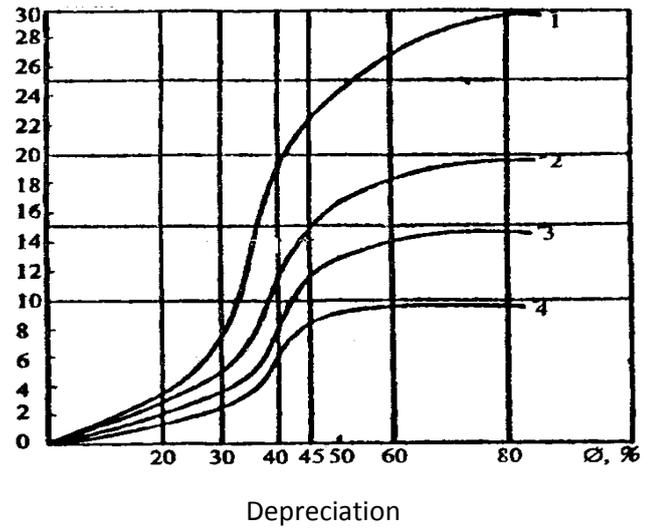
Physical depreciation of internal sewage systems

- 1 - Cast iron pipes, cast iron bath
- 2 - Cast iron and stainless steel basins
- 3 - Steel pipes and baths, ceramic toilets and basins, asbestos cement pipes
- 4 - Enamelled steel washing basins
- 5 - PVC pipes

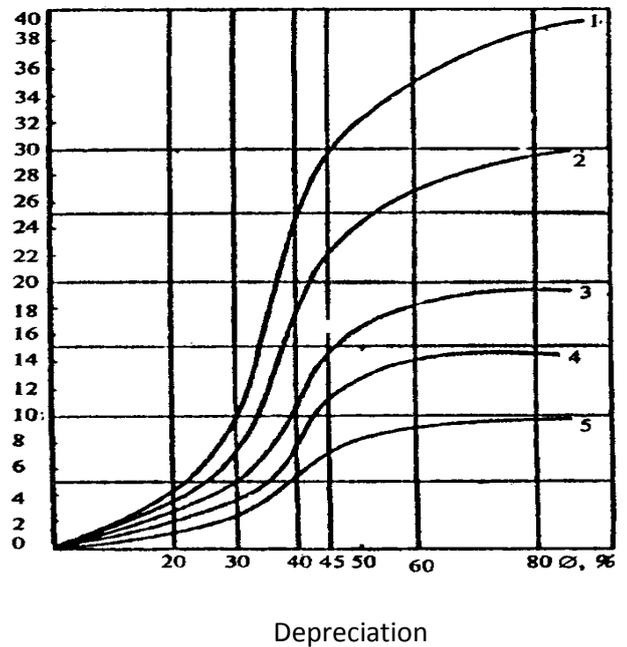
Physical depreciation of internal electricity network

- 1 - Hidden internal network;
- 2 - Open internal network;
- 3 - Distributing nodes
- 4 - Electric tools

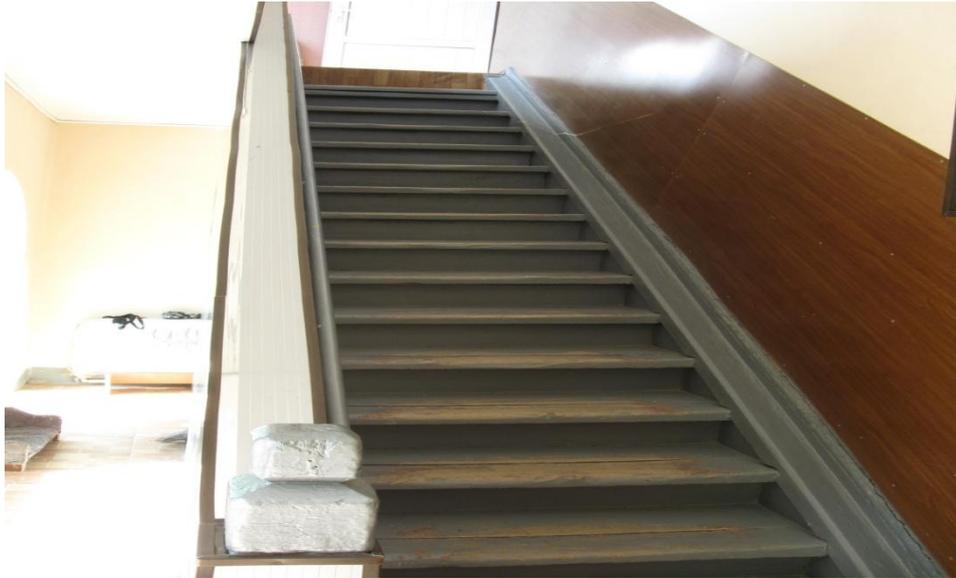
3. Floor trusses are made from the timber and partial monolithic steel and concrete tiles in washroom areas. Timber beams are partially broken and need to be replaced, alongside with floors decks. Stairwell to the second floor is not designed for children usage and is outdated, the height adjustment of individual stairs is necessary.

4. The building is constructed reliably and fundamentally, in compliance with building norms and regulations of that time period.
5. The building has a utility space without designated entrance, underneath the floor on first storey.
6. Building has a hipped roof, partially made from tin and partially from corrugated asbestos board. The roof needs to be replaced alongside with rainwater harvesting systems. It must be noted that, according to current building regulations, use of asbestos is forbidden.

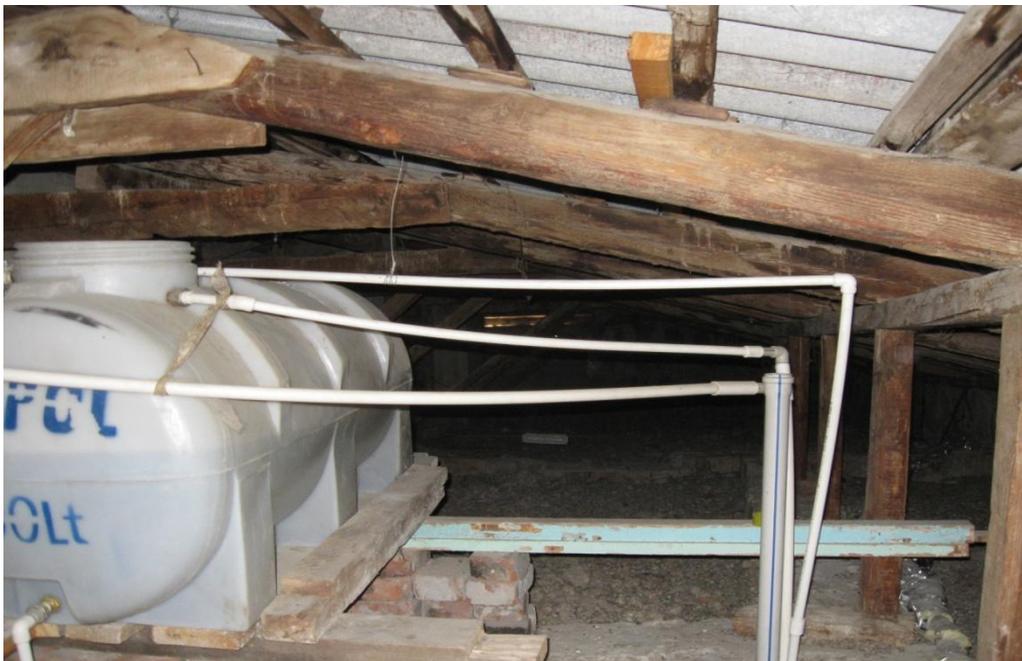
7. Out of dated electricity network has to be replaced
8. New central heating system that operates quite reliable is available in the building. However, due to frequent energy outages during the winter period, automated system disable mechanism and additional gas heaters become necessary
9. Windows and doors are made of steel-metal profiles; the state of heat bridges is unsatisfactory

10. Façade walls require plastering, especially socle block and silicate brick parts of the building, as nearly 70% of external walls are severely worn out due to the aggressive climate conditions, plastering must be done over the steel web.

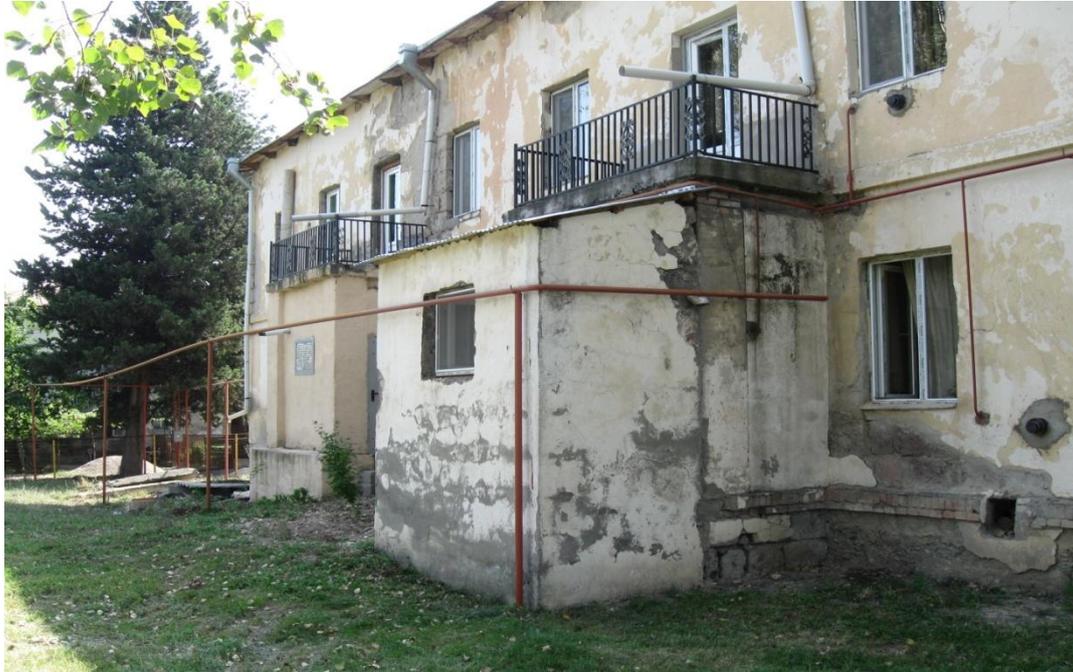
11. Extension wing walls, alongside with the foundation are damaged, engineering-geological research of this component and construction reinforcement project preparation are necessary.

12. Sewerage system of the next door neighbour must be replaced and moved away, as it often is blocked and causes serious problems to children's playground. Weeper system needs sorting out. It must be noted that sanitary sewer manholes do not have covers, something that is completely unacceptable.

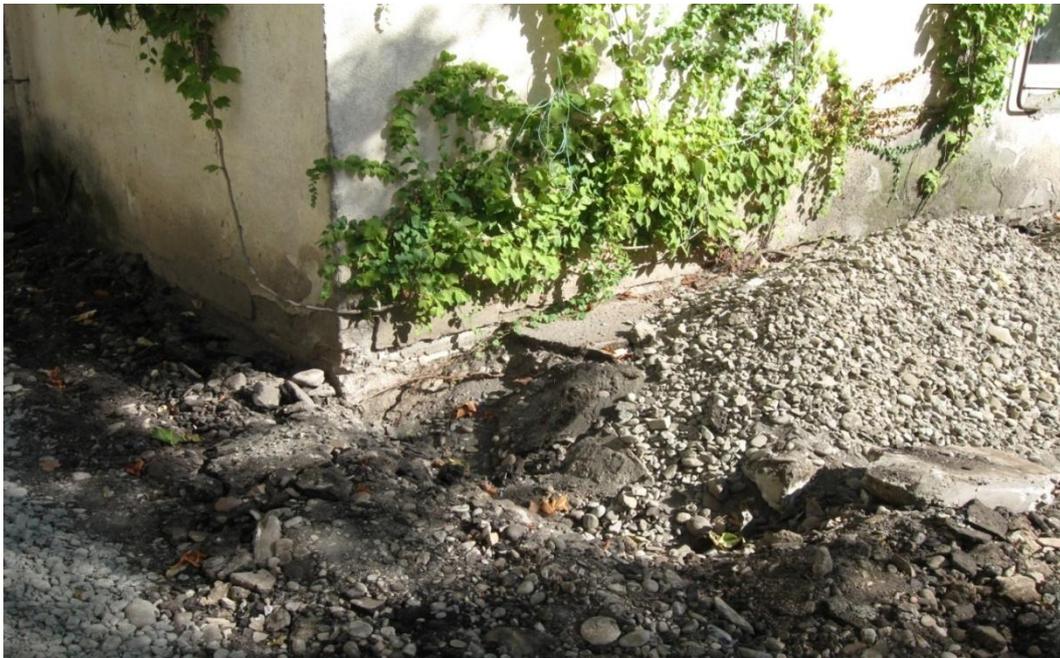
1. Foundation ribbon construction is made from continuous monolithic concrete, concrete is produced from rough river filling material,.
2. Load bearing wall constructions of the building is mainly made of silex bricks on the mortar of cement/sand; however small sized holystone and construction block walls are present as well.

3. Floor trusses are done with set of hollow steel and concrete tiles and partially monolithic steel and concrete tiles in washroom facilities.
4. The building is constructed reliably and fundamentally, in compliance with building norms and regulations of that time period.
5. The building has a basement level, in relatively dry and acceptable condition, requiring cosmetic renovation and cleaning. Afterwards, it can be utilised as the supplementary storage space.
6. Building has a hipped roof, partially made from tin and partially from corrugated asbestos board. The roof needs to be replaced alongside with rainwater harvesting systems. It must be noted that, according to current building regulations, use of asbestos is forbidden.

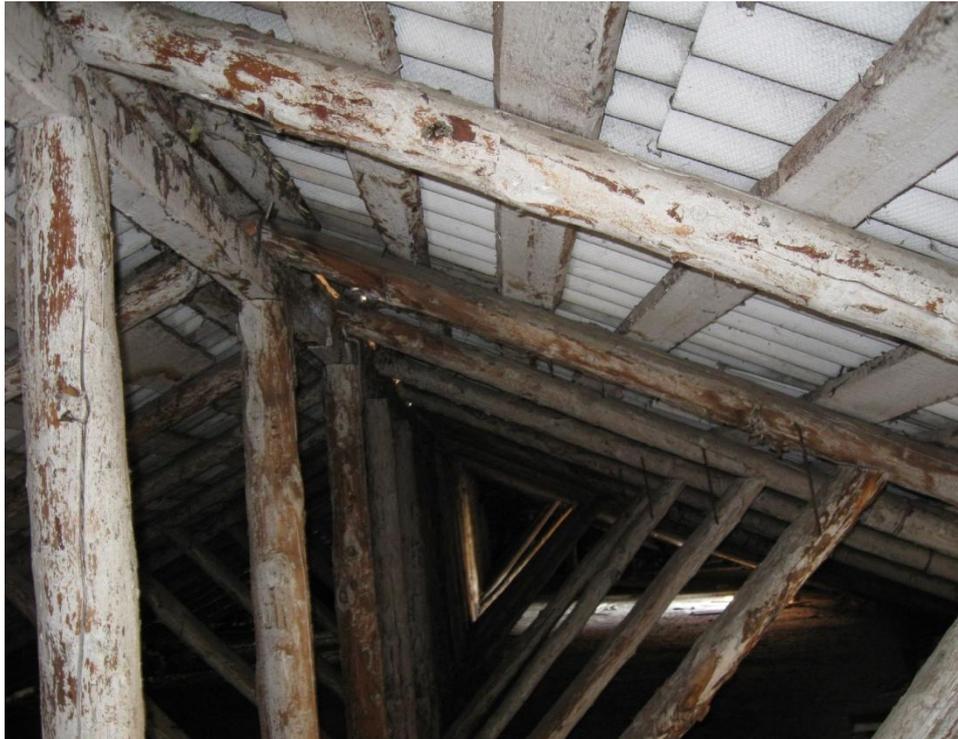
7. Out of dated electricity network has to be replaced

8. Existing central heating system is brand new and functions properly. As the old boiler does not ensure full hot water supply of the building, additional boilers are being installed currently.

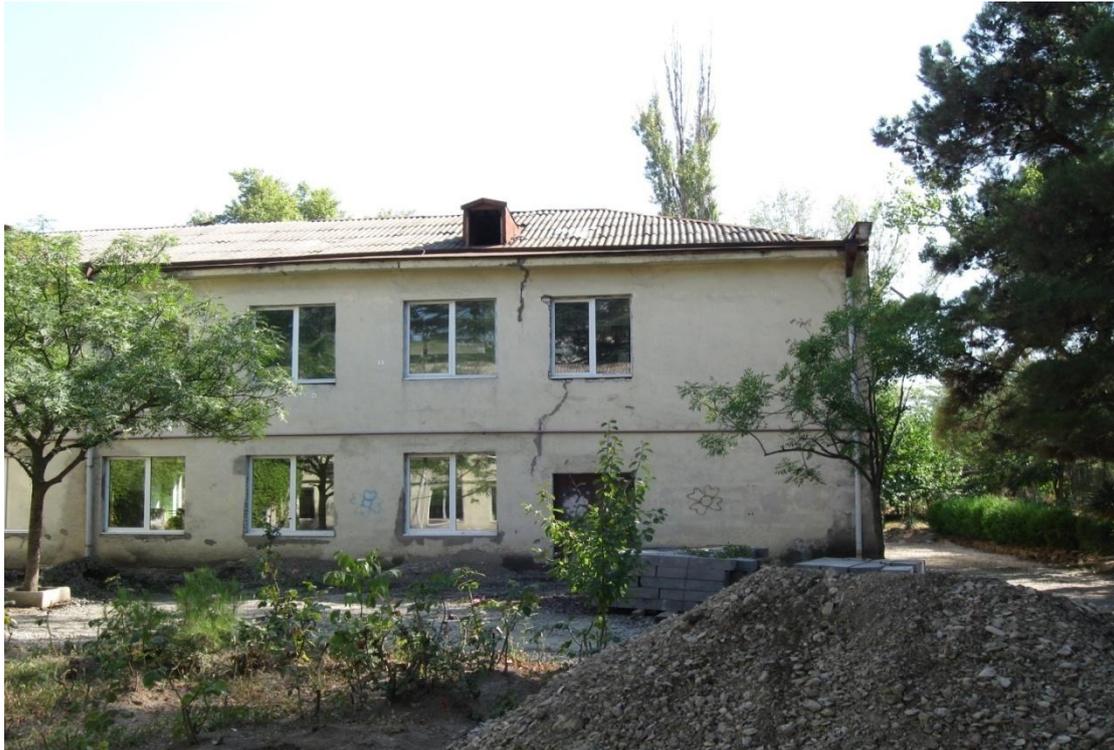
11. Extension wing walls, alongside with the foundation are damaged, engineering-geological research of this component and construction reinforcement project preparation are necessary.

12. External sewage and rain water harvesting systems must be replaced inside the territory belonging to the kindergarten.

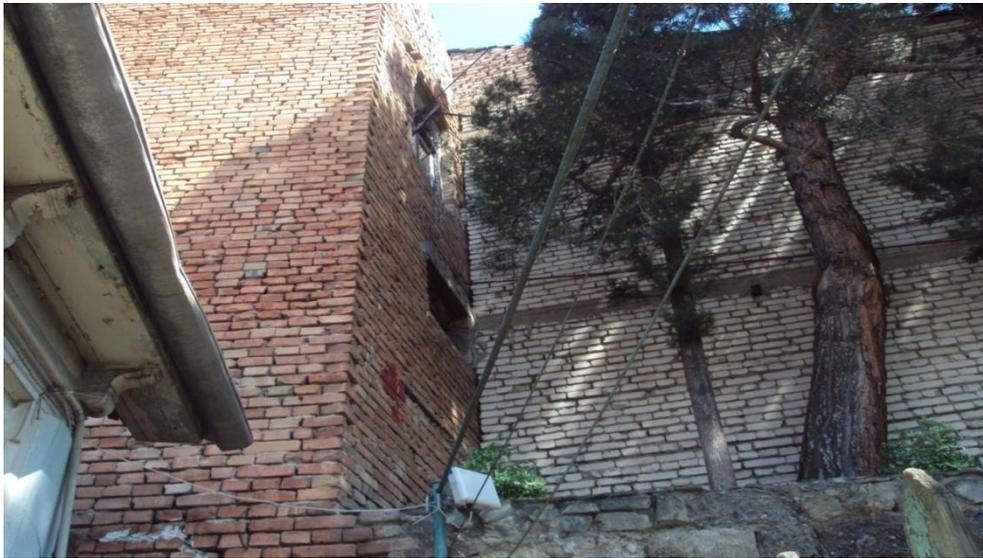
1. Foundation ribbon construction is made from continuous monolithic concrete; concrete is produced from rough, river filling material.
2. Loadbearing wall constructions are made of red bricks on lime mortar mix and match.
3. Extension wing foundation is made from monolithic concrete on rough concrete river filling material.
4. Extension wing wall is made of sile brick on mortal of cement/sad, that leads us to the conclusion that extension was built in 70ies of the last century.

5. Floor trusses are made from timber and partially from monolithic steel and concrete tiles in sanitary points. Timber beams are partially broken and need to be replaced alongside with floors decks. Steel stairwell to the second floor is not designed of children and is outdated, installation of new stairwell with appropriate stair heights is necessary.

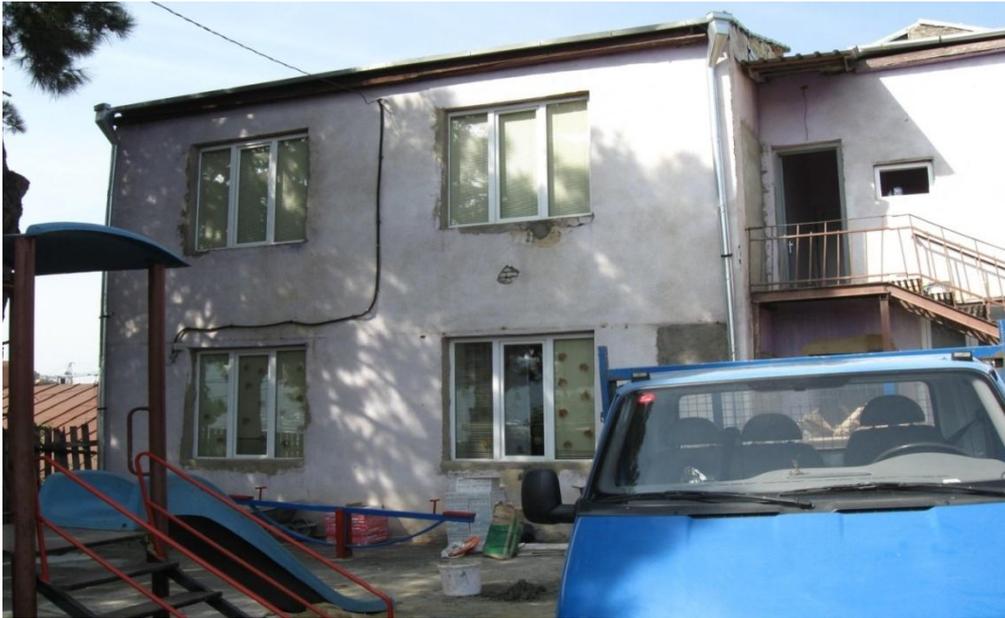
6. The building is constructed robustly and reliably in compliance with building norms and regulations of that time, however without any seismic resistance measures: the building does not have a common belt, that would have bonded together main and extension parts of the building, as a monolithic spatial system.

7. Building has a hipped roof, partially made from tin and partially from corrugated asbestos board. The roof needs to be replaced alongside with rainwater harvesting systems. It must be noted that, according to current building regulations, use of asbestos is forbidden.

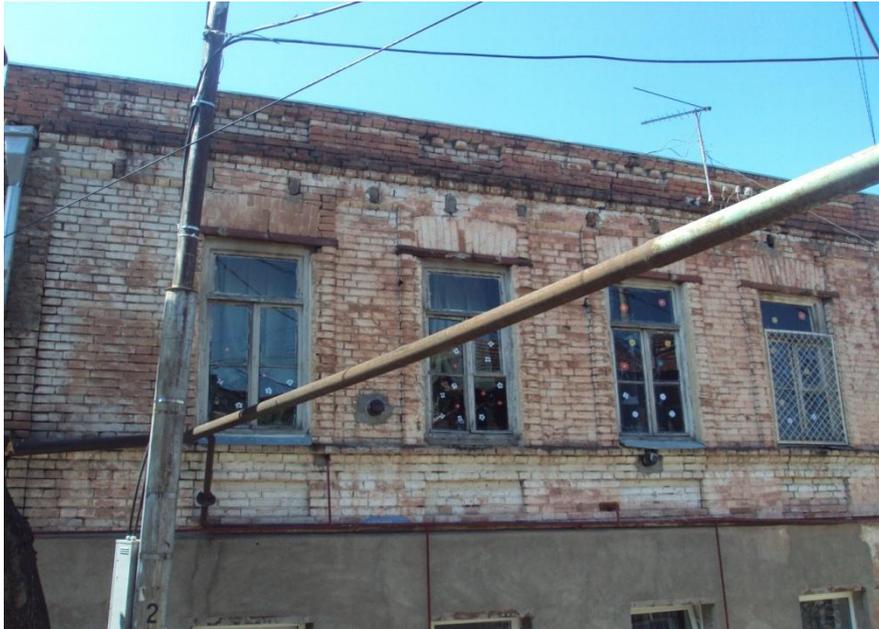
11. Façade wall require plastering works, especially silex brick part of the building. Plastering must be done on a steel grid.

12. It must be noted, that on the first level of the building neighbour is intruded illegally and has set up storage space. Engineering-geological research of this component and construction reinforcement project preparation is necessary.

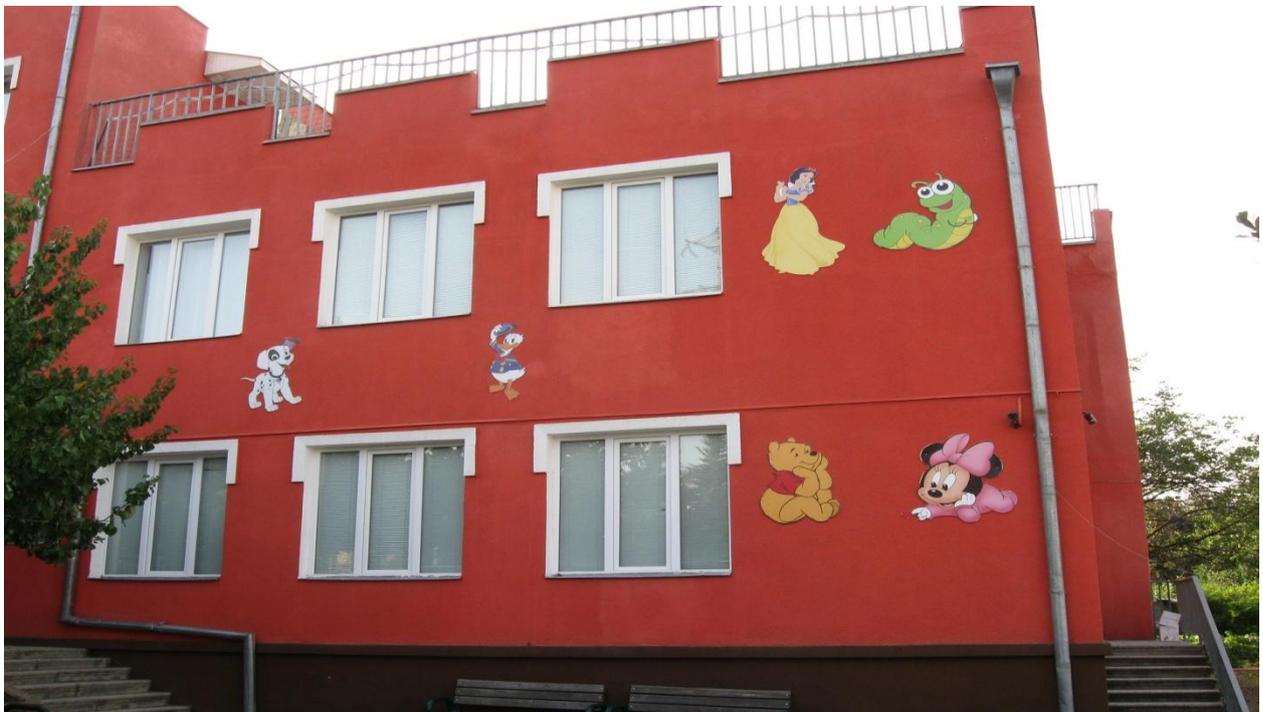
1. Foundation ribbon construction is probably made from continuous monolithic concrete
2. Loadbearing construction of wall is monolithic steel and concrete frame, consisting from columns and rafters.
3. Floor trusses are made of monolithic steel and concrete tiles
4. The building is constructed robustly and reliably in compliance with building norms and regulations of that time
5. Building roof is of a soft construction. Roof cover has been recently replaced and its condition is satisfactory.
6. Central heating system is brand new, functioning properly.
7. External windows and doors are made of PVC material; brand new, in good condition. As for internal doors-they made of timber, in quite good condition.
8. Inner courtyard and whole territory is wellorganized.

It must be noted that any damages or defotmations are not observed onto existing building.

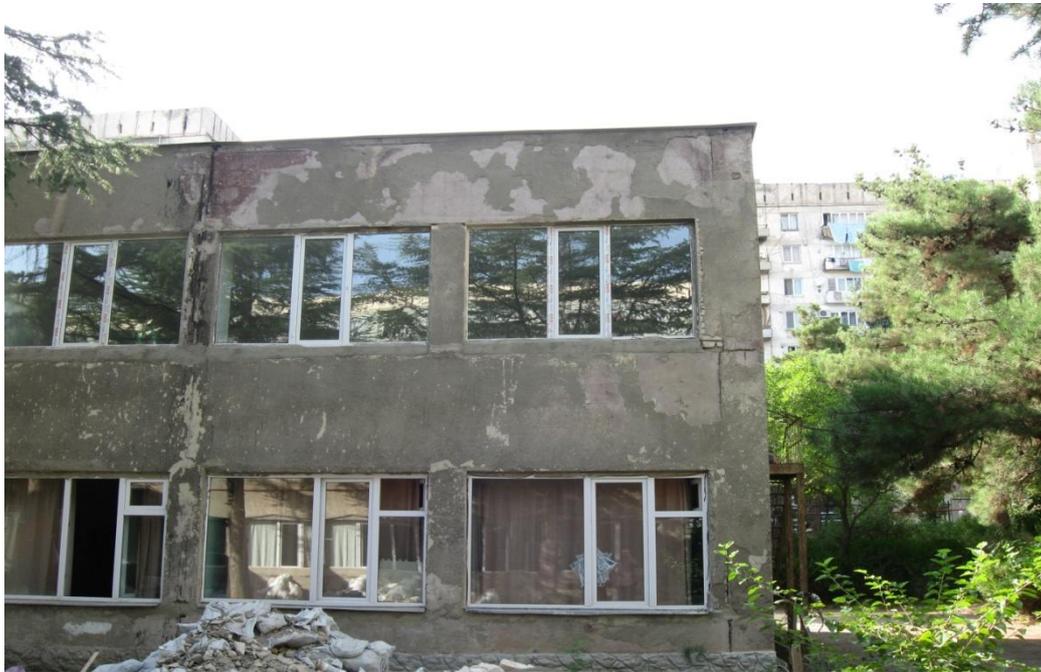
1. Foundation ribbon construction is made from continuous monolithic concrete; concrete is produced from rough river filling material
2. Loadbearing construction of the building is mostly made from assembly of wall blocks and bridge walls (mid walls) done using silicate brick.

3. Floor trusses are assembled steel and concrete construction hollow tiles and partially monolithic steel concrete tiles in washroom facilities.
4. The building is constructed reliably and fundamentally, in compliance with building norms and regulations of that time period
5. East wing rooms of the building require heat insulation, wall thickness is not sufficient from the viewpoint of heat resistance.

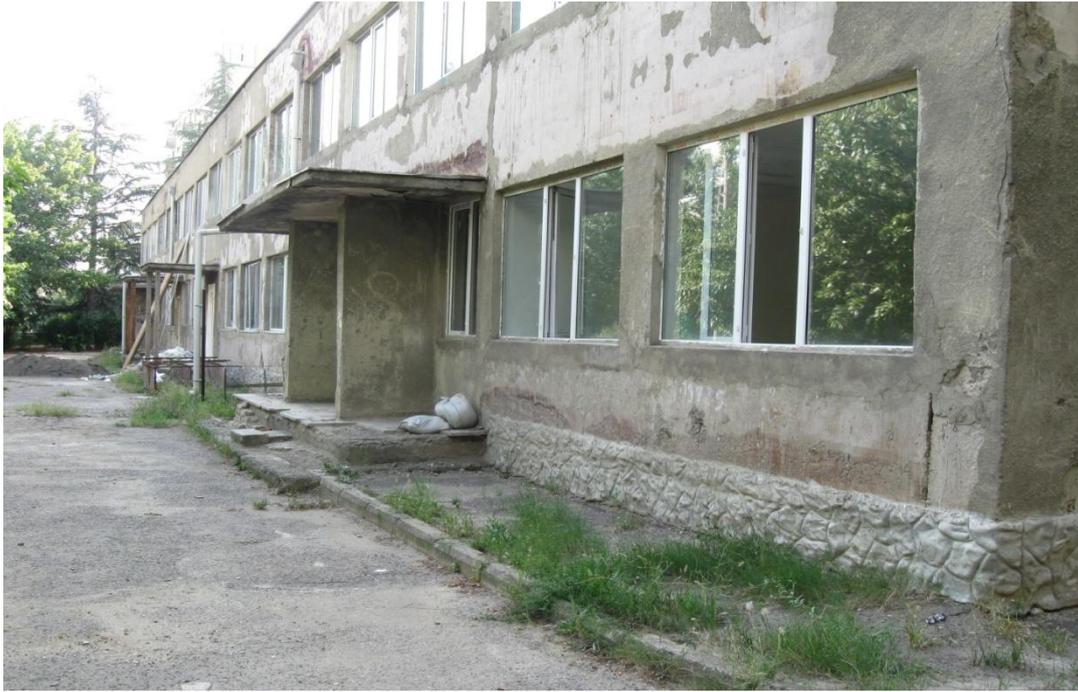
6. Building roof is of a soft construction. Roof requires refurbishment, together with the rain collecting system. Roof cover is damaged and leaks the water.
7. Out of dated electricity network needs to be replaced.
8. Central heating system is brand new, functioning properly.
9. Building windows and doors are brand new, made of PVC materials, however the quality is unsatisfactory, they are not sufficiently thermally stable.

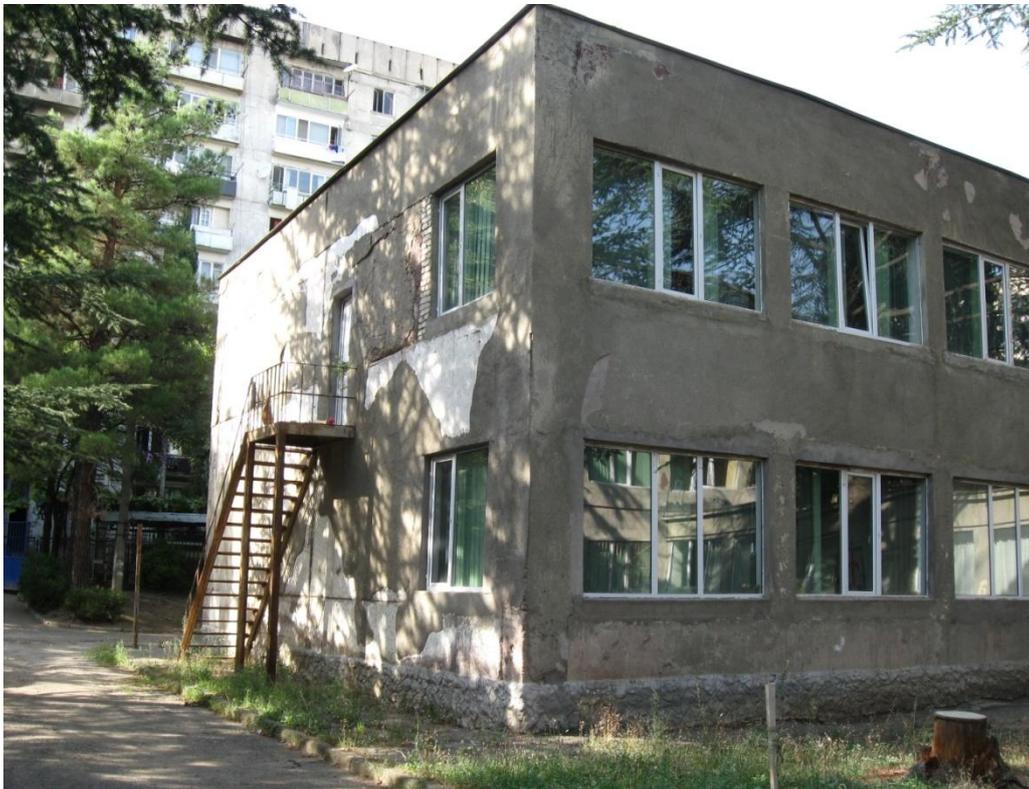
10. Façade wall require plastering works. Plastering must be done on steel grid.
11. It must be noted that basement is in a satisfactory condition, requiring just a minor

refurbishment work.

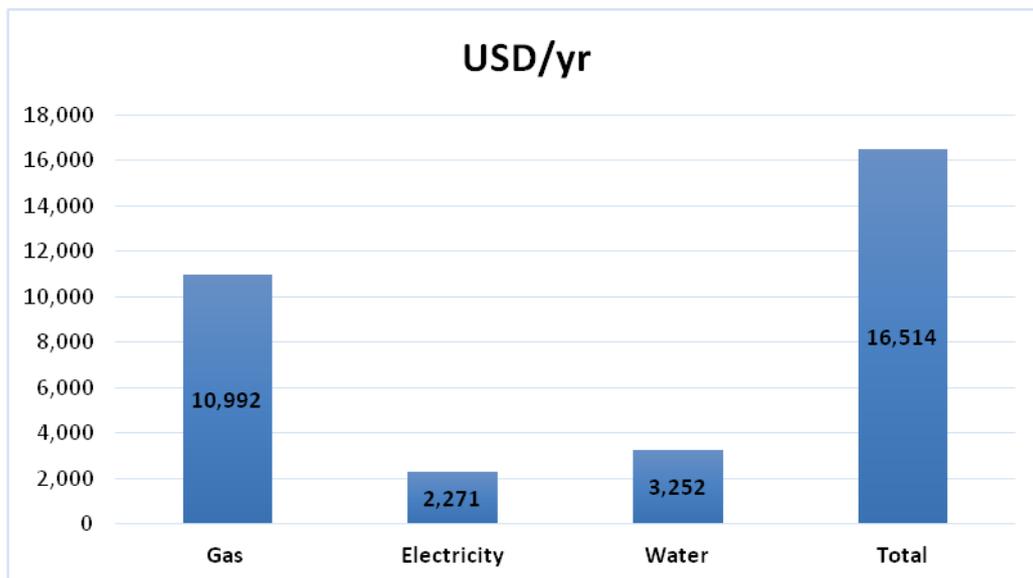
Figure 9. Annual spending for NG, electricity and water consumption in the kindergarten # 95 (For the period 11.06.2014-16.06.2015)

Electricity expenditure includes energy consumed by an artificial lightning and 7 units of water heating equipment Thermex: energy consumed by water heating Thermex equipment is evaluated as $E_T = 7 \text{ units} * 1.2 \text{ kWh} * 8 \text{ hours} * 22 \text{ days} * 10 \text{ months} = 14\,784 \text{ kWh}$. In the scenario of gas heating boiler existence, it is advantageous to provide hot water supply via a boiler instead of electric heaters based on economic motivation, from energy saving standpoint, it is more beneficial to provide hot water supply using solar collectors.

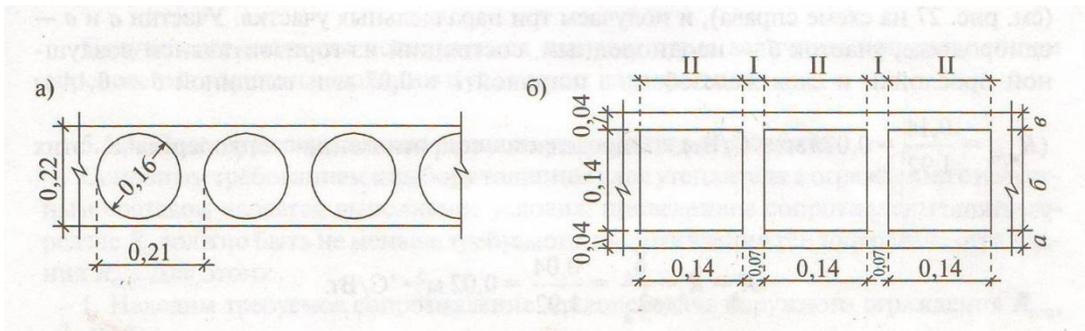
Figure 10.

2. Regular component is divided into flatnesses rectangular to heat stream (isothermal flatness).

a) Let us isolate regular component and divide in parallel to the heat stream (adiabatic flatness), we shall come up with two sections. Section I is homogenous and section II is heterogeneous, consisting from two air layers a and b, with equal thickness. Thermal resistance of given layers $R_I \propto R_{II}$ accordingly, equal to:
