REPORT OF ACTIVITIES IN ECUADOR
OF DR. JUDSON HARPER AUGUST 7 THROUGH AUGUST 20
AND
CHARLES WOMMACK AUGUST 7 THROUGH AUGUST 27

Industrial Development Division
ENGINEERING EXPERIMENT STATION
Georgia Institute of Technology
November 1975

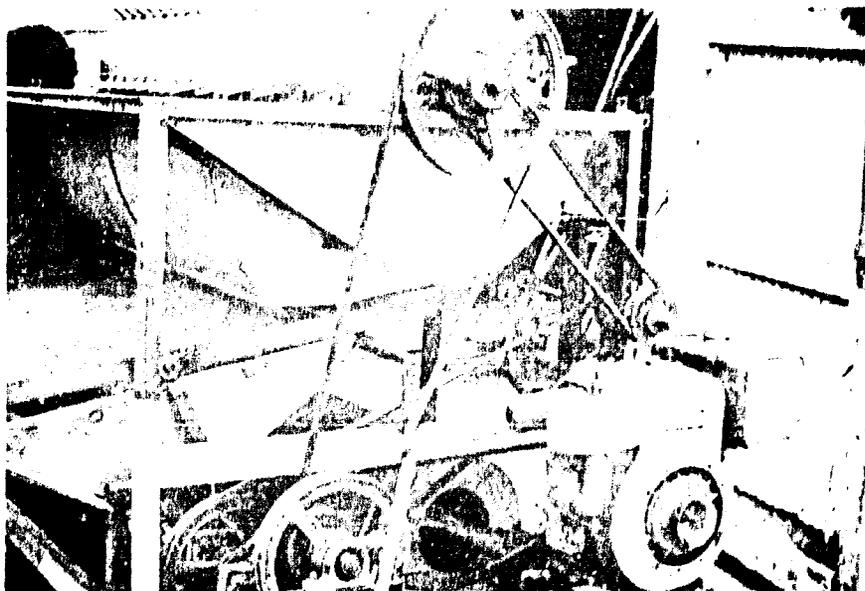
Illustration #2

1. Increasing the height of the machine by 6" to allow placement of the inclined oscillating cleaning screen. (See Illustration #2, page 10.)
2. Making an oscillating cleaning screen and placing it below the lower concave.

3. Lowering and relocating the blowers and grain auger. (See Illustration #4, page 11.)
4. Reworking the belt drive for drives and modifications. (See Illustrations #1 and #2, page 10.)
5. Adding leaf springs and pneumatic tires.
6. Using perforated (slotted) metal for the lower concave and punched plate for the oscillating shaker screen.
7. Redesigning the threshing pin holders on the lower concave. Angle iron threshing pin holders were used to greatly strengthen pin mounts and to assure a positive pin positioning.

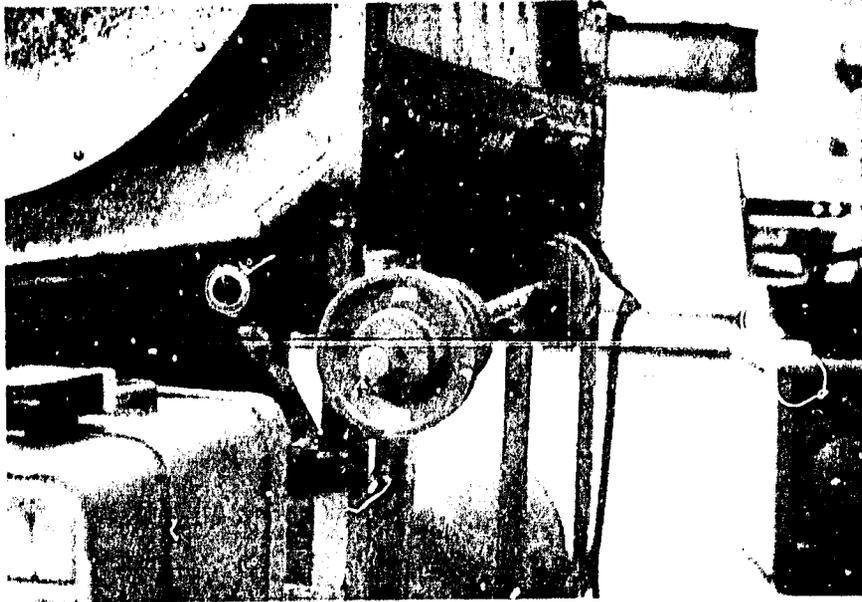
Illustration #3

The modified thresher was given a trial run on the last day of Charles Wommack's stay in Ecuador. Many small additional modifications were needed, as noted in the following section of this report, but the major modifications had been completed. The illustrations on page 10 through page 13 of this report were taken during the first trial run of the modified machine.
