*FINAL REPORT ON THE
UTILIZATION/EVALUATION OF AN
AID HAND-OPERATED WATER PUMP*

FINAL REPORT ON THE UTILIZATION/
EVALUATION OF AN AID HAND-OPERATED
WATER PUMP

The U.S. Agency for International Development
under Contract No. AID/ta-C-1354

Office of International Programs
Engineering Experiment Station
GEORGIA INSTITUTE OF TECHNOLOGY
Atlanta, Georgia
January 1979

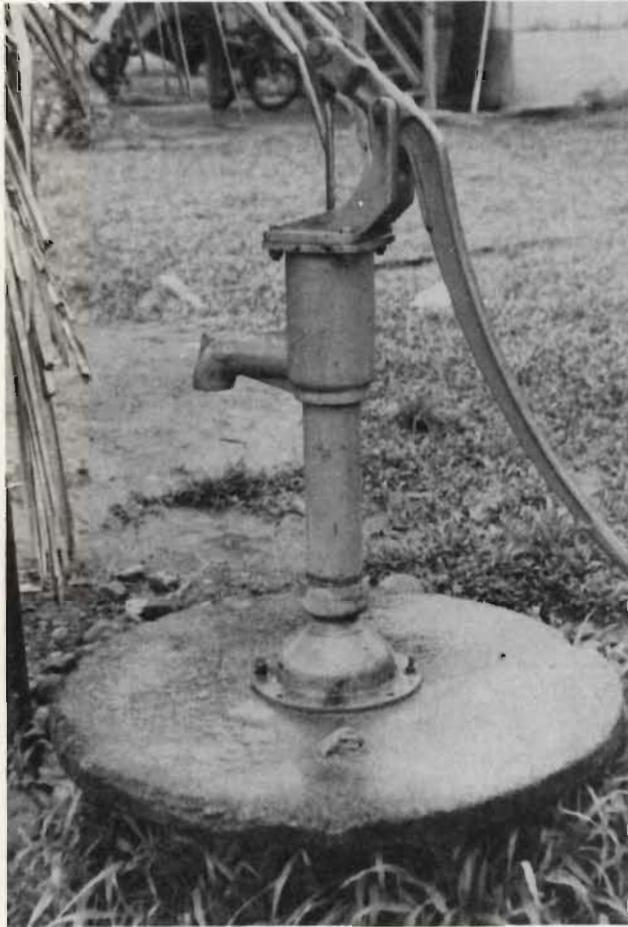
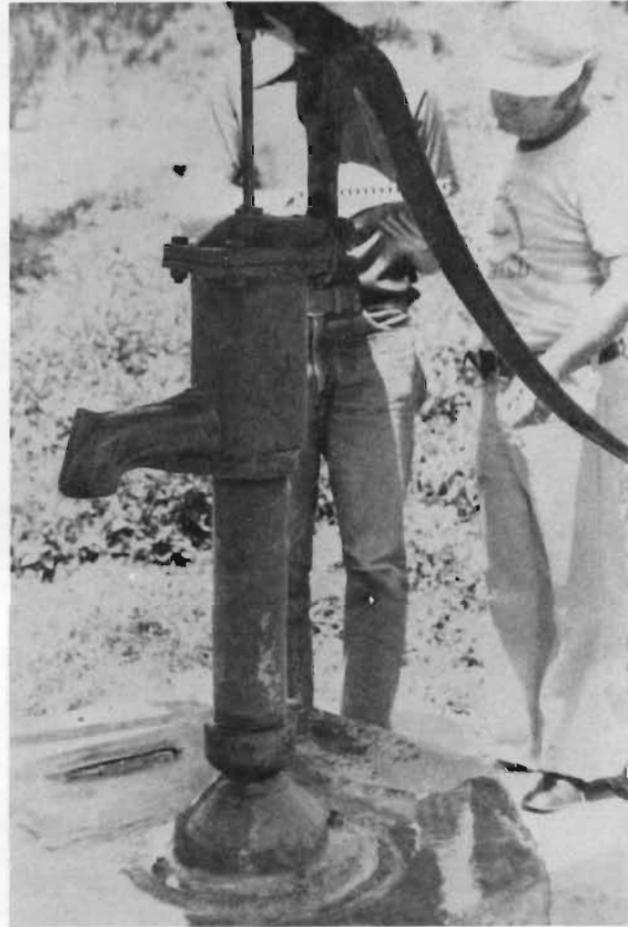
The AID shallow-well pump, left photo, and the AID deep-well pump, right photo, both manufactured in Costa Rica.

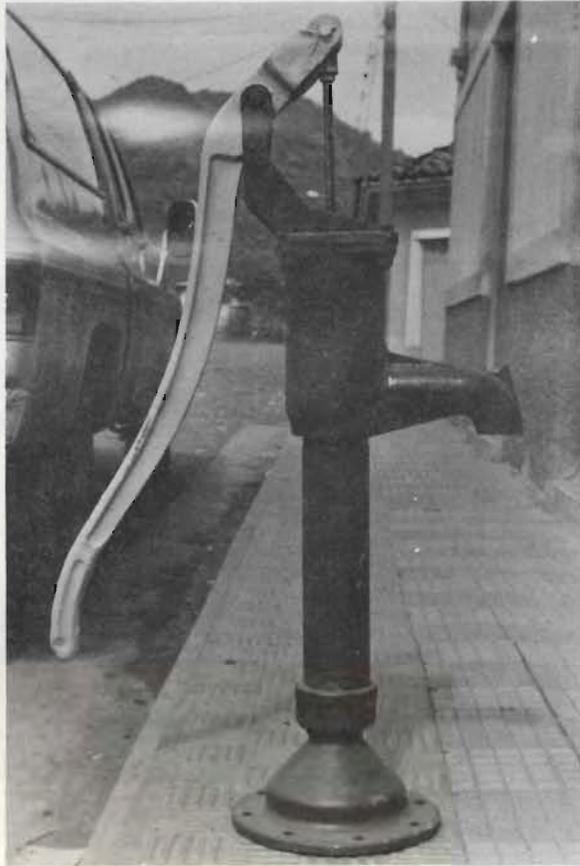
The AID shallow-well pump, manufactured in Nicaragua

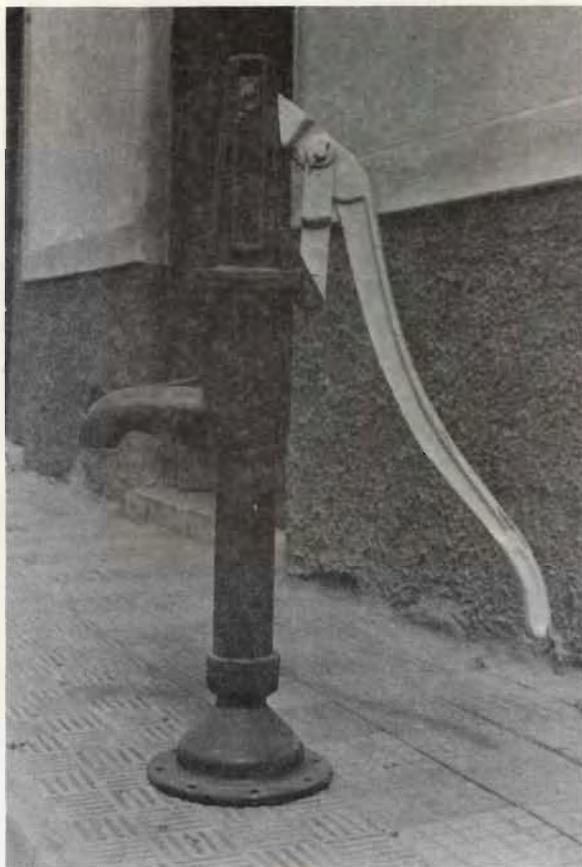
The AID deep-well pump, manufactured in Nicaragua

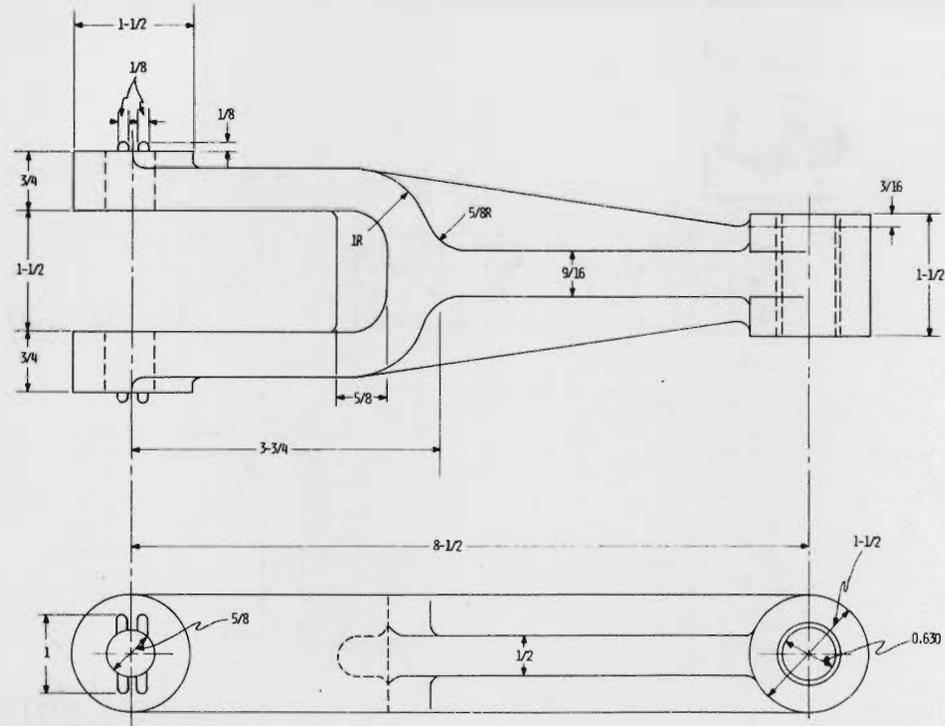
FULCRUM HANDLE FOR MODIFIED DEEP-WELL
PUMP CAP IN COSTA RICA

2. The handle pivot pins were hardened to 40 Rc and steel bushings (60-64 Rc) were inserted in the pump handle holes. By taking this approach, the pins are expected to wear out before the handles, allowing easier repairs at the least cost.

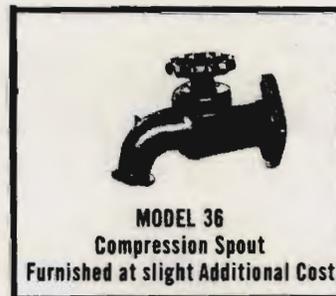
MODEL 210F

Dempster hand and windmill pumps are adapted for wells of any depth. Neat in design and substantially built, equipped with a 4-bolt adjustable flanged top, extra long handles and heavy steel bearer pins. Tops fitted with stuffing box and packing for tight seal on the piston rod. 4-position handle adjustment for up to 10' inch stroke. Large capacity air chamber for smooth force pumping. Furnished with syphon or compression spout. Syphon spout furnished unless otherwise ordered. 2 x 1-1/4-inch suction bushing furnished with each pump.

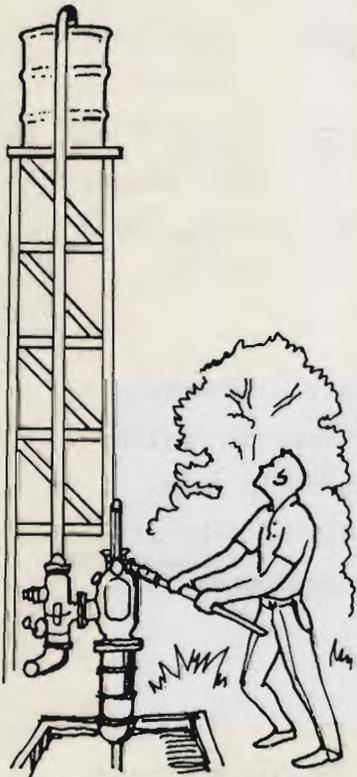
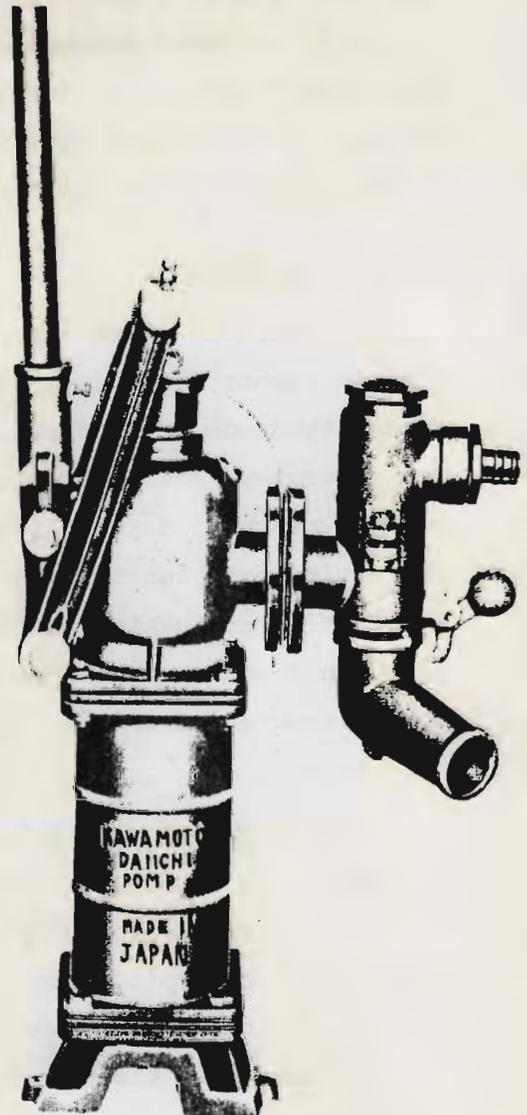
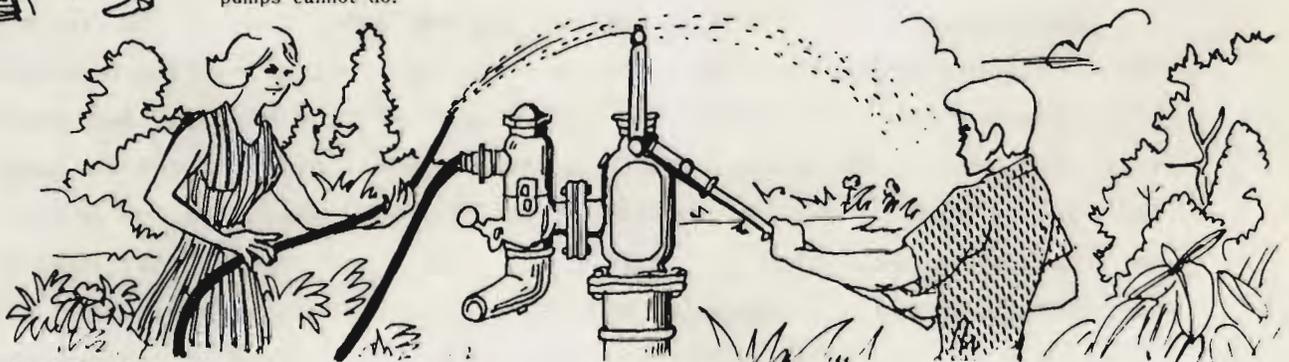
Figure 6(continued)

- ① DRIVEN SUCTION VALVE BOX
- ② DUG SUCTION VALVE BOX
- ③ VALVE
- ④ VALVE GUIDE
- ⑤ RUBBER PACKING
- ⑥ LOWER PISTON
- ⑦ CYLINDER
- ⑧ BOWL RUBBER
- ⑨ PISTON VALVE
- ⑩ UPPER PISTON
- ⑪ SLEEVE PORCELAIN ENAMELED
- ⑫ CHAMBER
- ⑬ HANDLE PIN
- ⑭ DOUBLE ROD
- ⑮ STEEL-PIPE HANDLE
- ⑯ LEVER
- ⑰ UNIVERSAL SPOUT
- ⑱ FAUCET BOX
- ⑲ FAUCET VALVE
- ⑳ VALVE SPINDLE
- ㉑ PISTON ROD
- ㉒ STOP WATER WEIGHT
- ㉓ FACET COVER
- ㉔ UPPER FAUCET
- ㉕ HOSE COUPLING
- ㉖ INNER GLAND BOX
- ㉗ GLAND BOX
- ㉘ LEAKAGE SPOUT
- ㉙ INNER GLAND
- ㉚ GLAND
- ㉛ ROD HEAD
- ㉜ GUIDE PIN

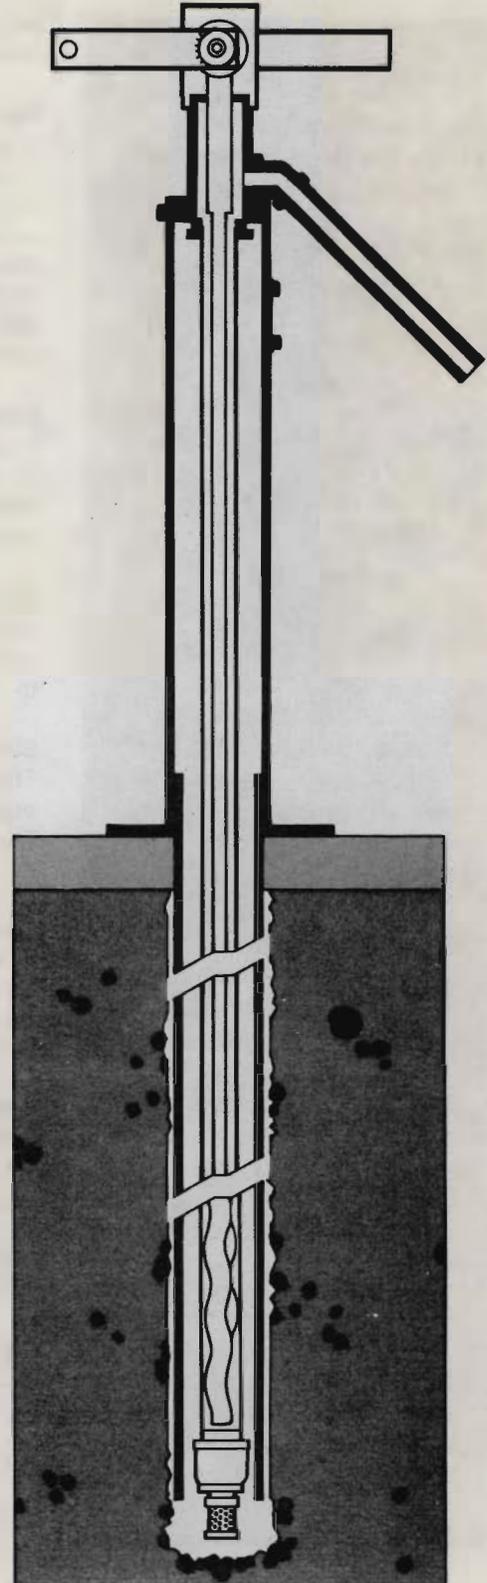
Pumping elements designed to provide years of trouble free operation. The rotor is machined from alloy steel and plated for additional abrasion resistance and longer life; the stator utilizes a special low water swell elastomer, permanently bonded to a steel tube.

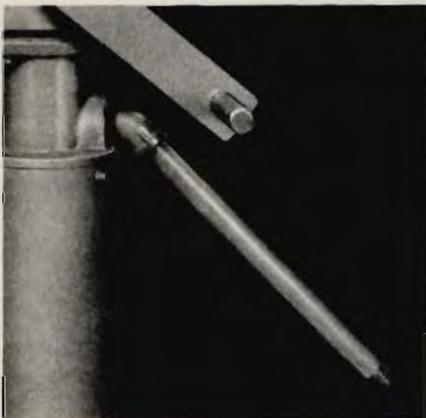
Pump stand completely sealed to prevent external contamination of the well.

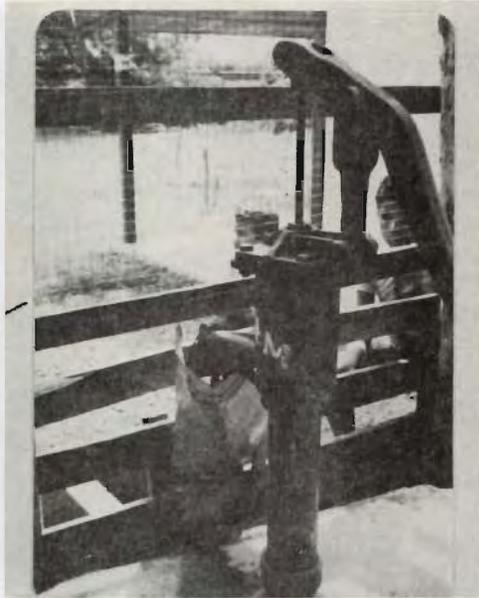
Site No. 1, located at La Palma de Abangares (AID deep-well pump).

<u>Site No.</u>	<u>Location</u>	<u>Corrective Maintenance During Test Period</u>
A. AID DEEP-WELL PUMP WITH PVC CYLINDER		
1	La Palma de Abangares	Replaced handle (broken - casting defect)
2	San Joaquin de Abangares	NONE
19	Caimitalito de Nicoye	NONE
26	San Juan Grande	Replaced handle fulcrum (broken - casting defect)
27	Sabana Grande	NONE
28	Coyolito de Santa Cruz	NONE
30	Lajas de Canas	NONE

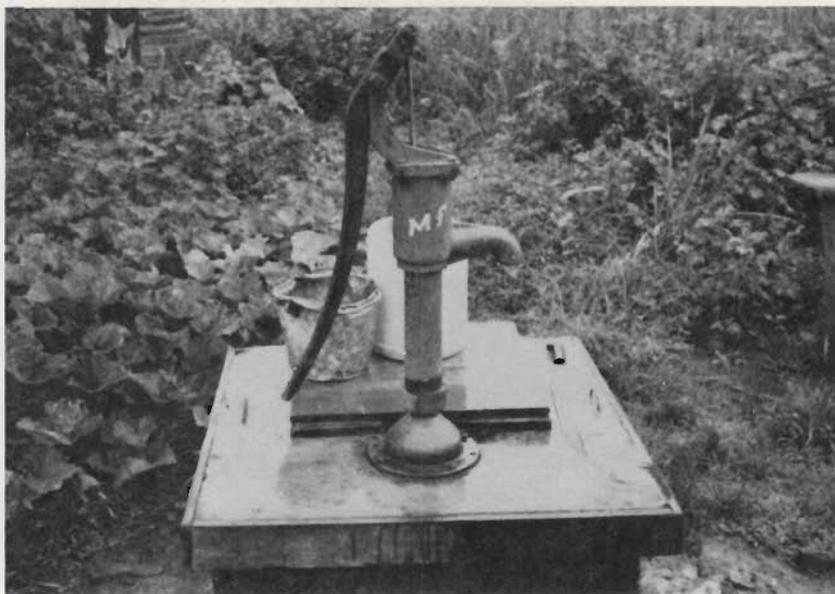
Site No. 3, located at IMAS, El Torito, Samara (AID shallow-well pump).

C. AID SHALLOW-WELL PUMP WITH STEEL CYLINDER		
3	IMAS, El Torito, Samara	Replaced handle (broken - casting defect) 2 cup changes (excessive wear)
7	La Javilla de Cañas	Replaced handle (broken - casting defect) 6 cup changes (excessive wear)
8	Zent #1, Matina (school)	Replaced pump cap (broken - casting defect) Replaced handle (broken - casting defect) 1 cup change (excessive wear)
9	Corina, Matina	2 cup changes (excessive wear)
10	Bristol, Matina	3 cup changes (excessive wear)
13	Zent #2, Matina	1 cup change (excessive wear)
16	Pueblo Nuevo de Colorado	Replaced pump cap (broken - casting defect)
18	Terciopelo de Nicoya	1 cup change (excessive wear)

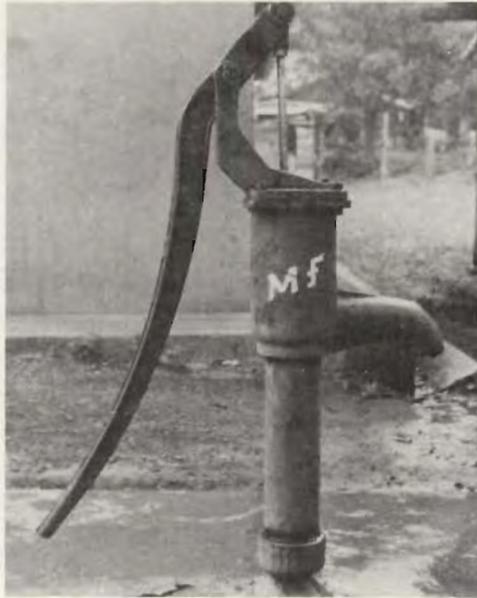
Site No. 7, located at La Javilla de Canas (AID shallow-well pump).

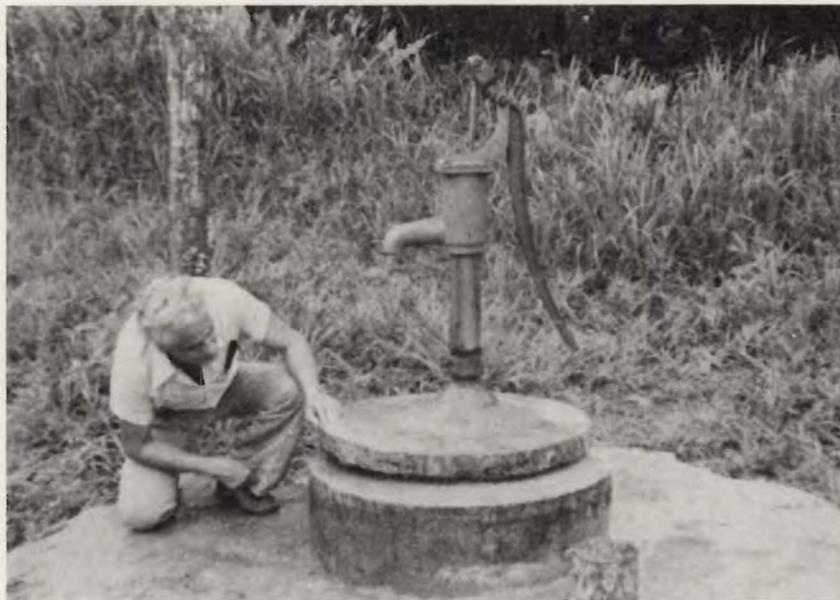
Site No. 31, located at Indiana Tres-Siquirres (AID shallow-well pump).

<u>Site No.</u>	<u>Location</u>	<u>Corrective Maintenance During Test Period</u>
31	Indiana Tres, Siquirres	Replaced handle (broken - casting defect) 2 cup changes (excessive wear)

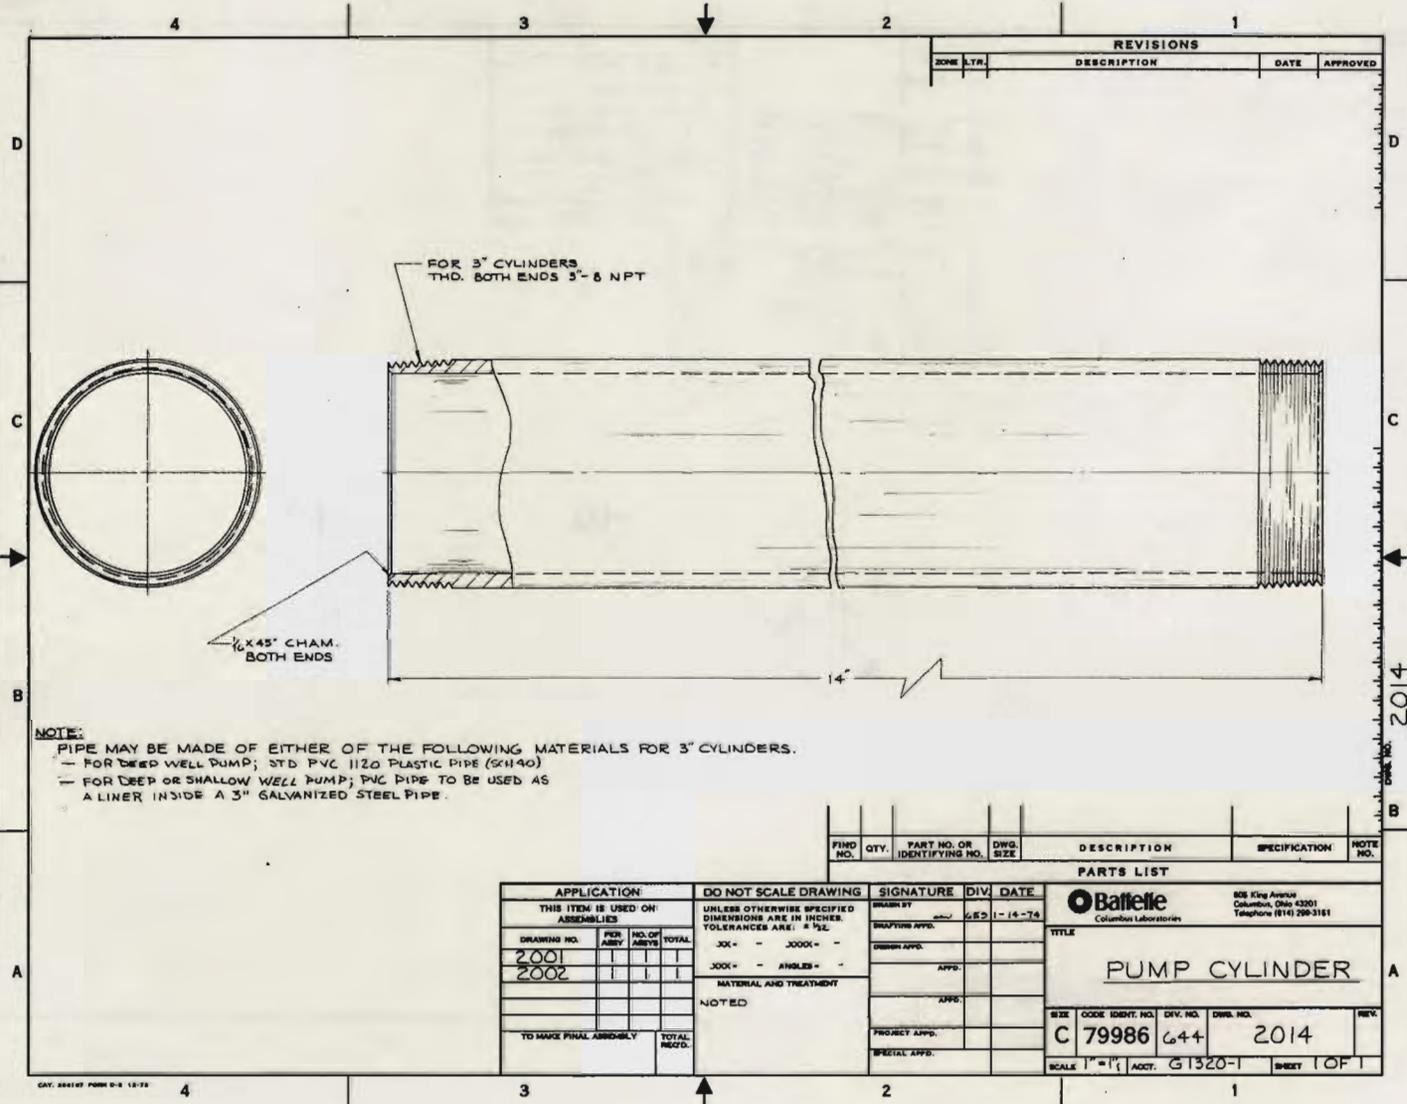
NOTE:
 PIPE MAY BE MADE OF EITHER OF THE FOLLOWING MATERIALS FOR 3" CYLINDERS.
 - FOR DEEP WELL PUMP; STD PVC 1120 PLASTIC PIPE (SCH40)
 - FOR DEEP OR SHALLOW WELL PUMP; PVC PIPE TO BE USED AS A LINER INSIDE A 3" GALVANIZED STEEL PIPE.
