Watercourse improvement research in Pakistan

Water Management Research Project
Colorado State University
Fort Collins, Colorado
January 1980

WATERCOURSE IMPROVEMENT RESEARCH IN PAKISTAN

WATER MANAGEMENT TECHNICAL REPORT 56

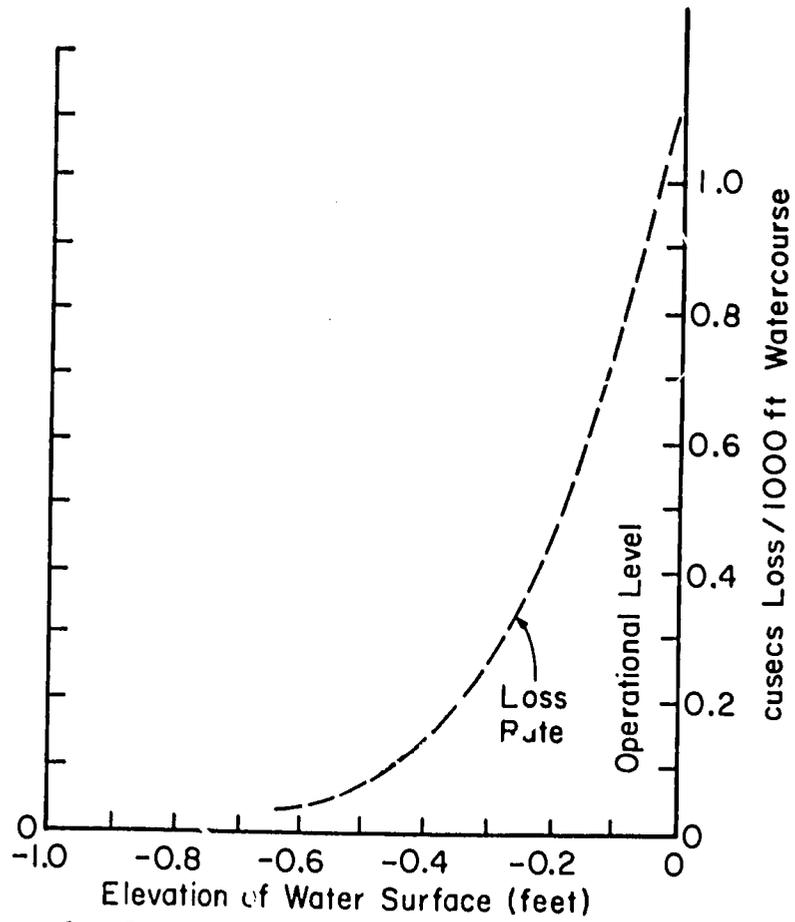
Figure 1. Loss rate as a function of surface elevation.

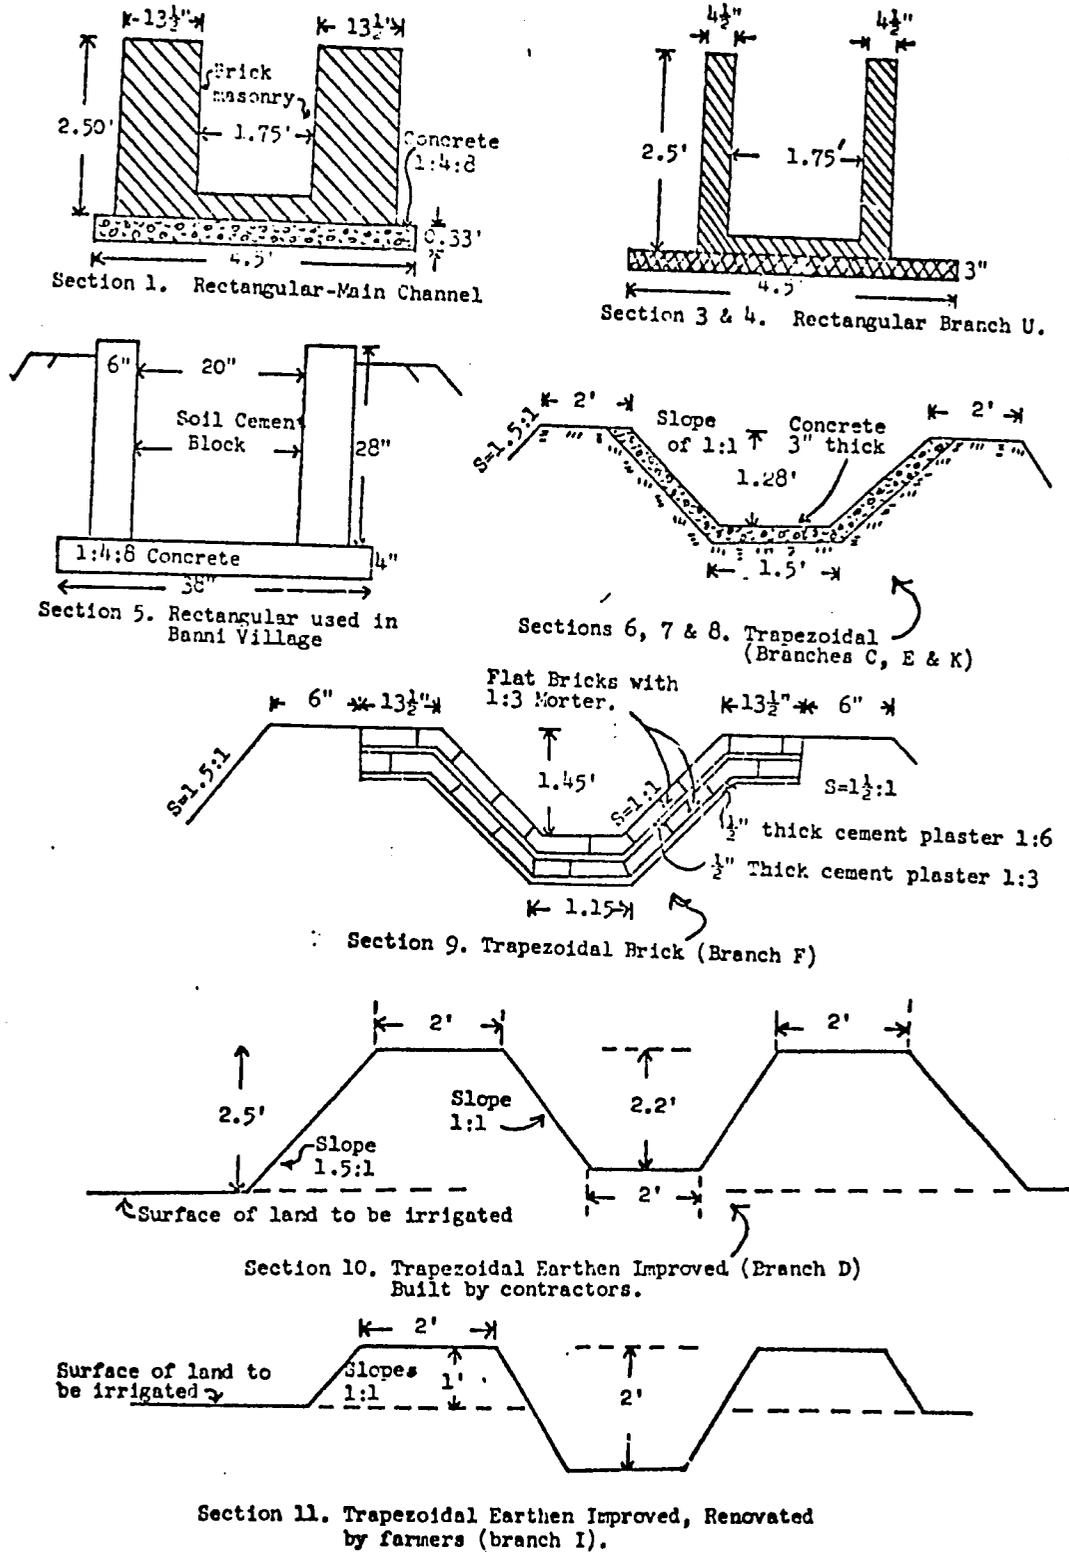
Figure 4. Cross-sectional designs of watercourses tested at Tubewell 78.

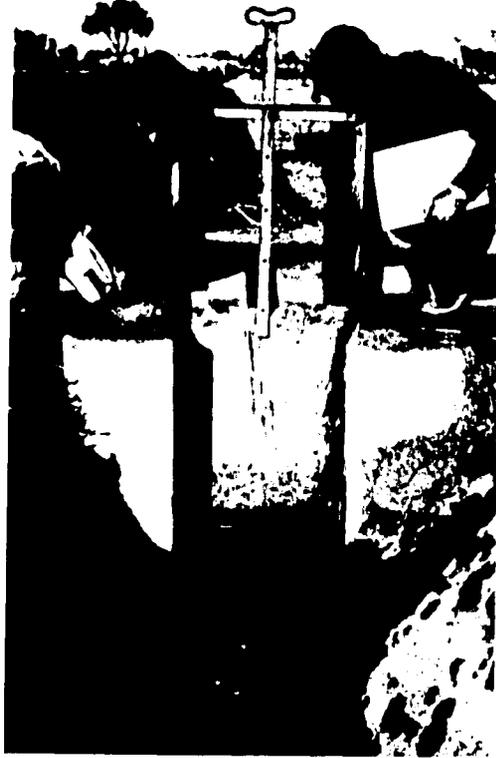
Figure 5. Steel check gate on a watercourse.

The major point of dissatisfaction centered around the outlet and check structures which were constructed of steel as shown in Figure 5. When these steel check structures are properly manufactured and properly installed they work very well. However, in many cases the control structures had not been manufactured to the required specifications or had been

installed in such a manner that the plates did not slide freely in the frame. This tendency increased as the frame and the plates developed the normal rust and scale. The plates became almost impossible to move in several cases. With their vital water supply at stake, and no apparent alternative available that could be initiated before their irrigation turn was over, the farmers resorted to beating on the plates and their handles with various instruments to try and move them up and down. The normal result was further and sudden deterioration of the structure to the point where it was completely inoperative.

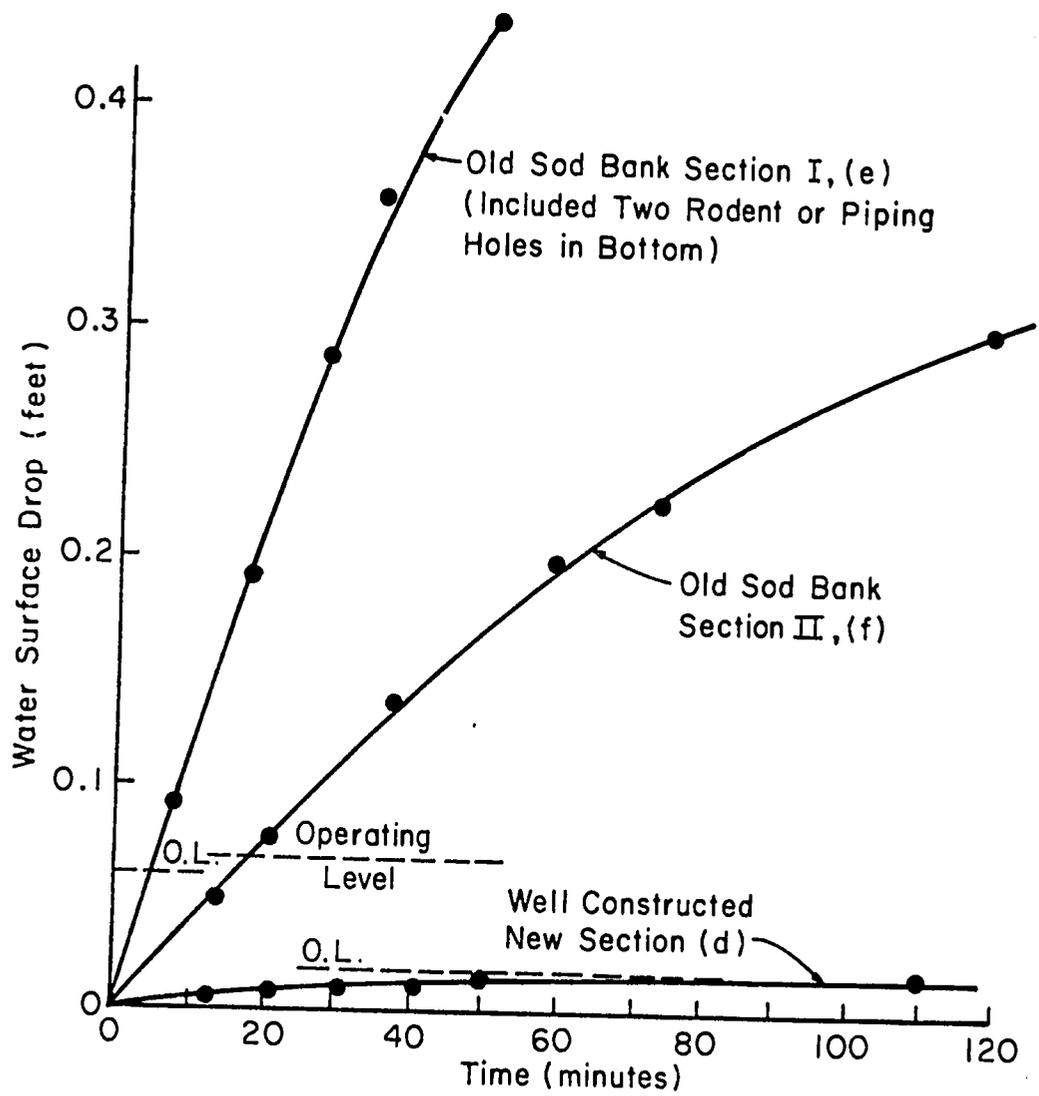
Figure 6. Water loss from ponded channel sections on and below the Rauf plots of the Mohlenwal Khurd watercourse (loam soil).

Ponding measurements on the reconstructed sections indicated that loss rates could be significantly reduced, sometimes to less than 30 percent of the previous rate, especially in sections where the previous loss rates were high. Careful bank reconstruction utilizing clean (no vegetation) soils and good compaction resulted in loss rates which were as low as the average loss rates measured in some of the lined channels (Figure 6). Although the initial potential for water savings from earthen improvements was dramatic, the effective life of such improvements could only be determined in long term studies.

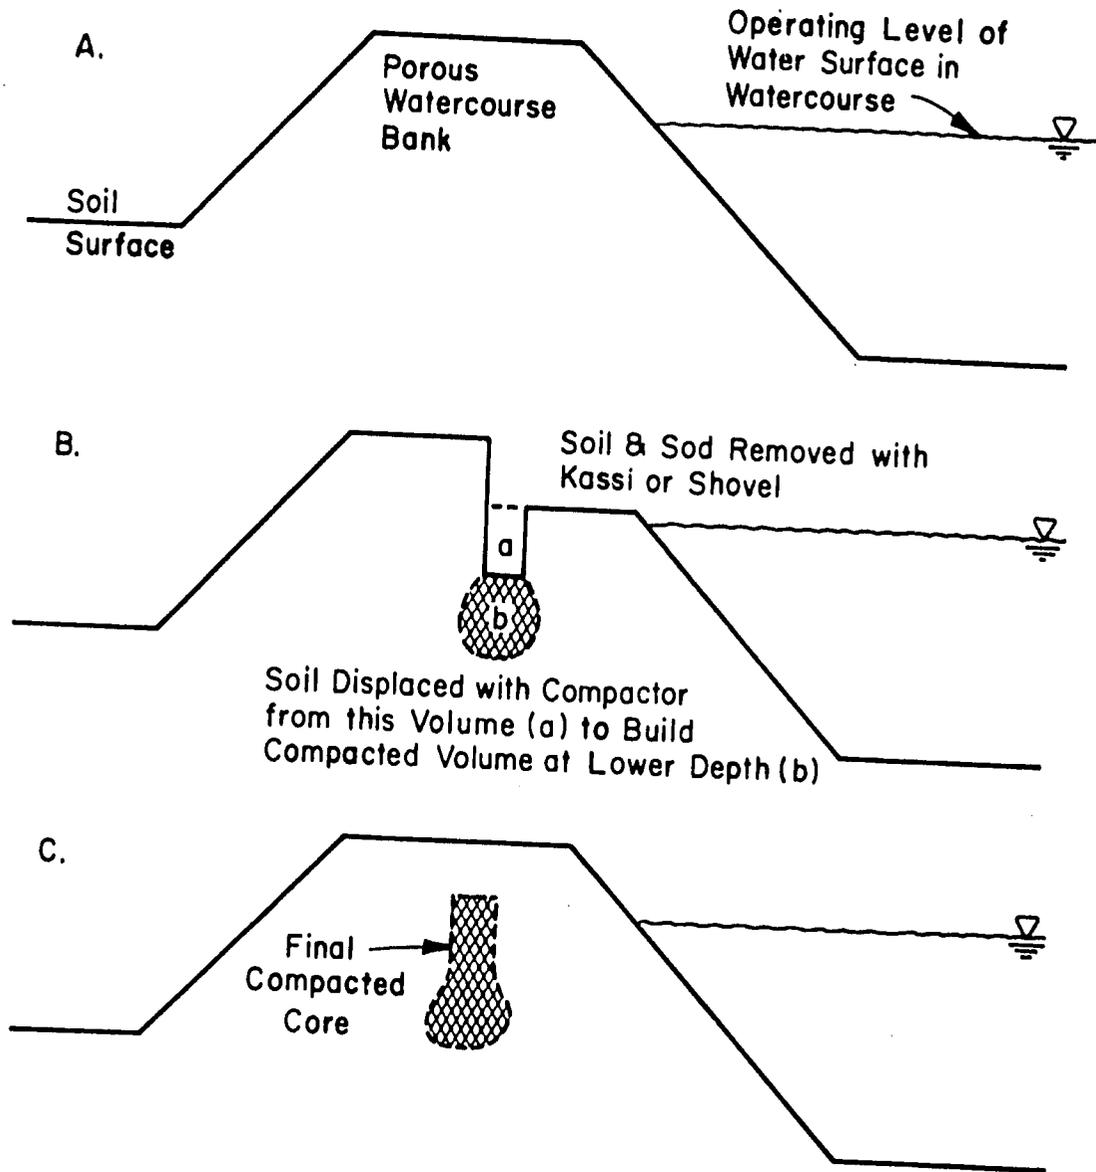
Figure 7. Steps used in forming compacted cores in watercourse banks.

compacted soil core. The soil and sod excavated from the top of the bank was then replaced as indicated in Figure 7 and pressed into place by foot. The results of this operation was a compacted core of soil about 8 cm wide and 15 to 30 cm deep with the top of this soil being an inch or so above the operating level of the water. One man could easily install six meters of this type of core in a watercourse bank per hour, or in other words, could install this type of core in both banks of a watercourse to improve three meters per hour.

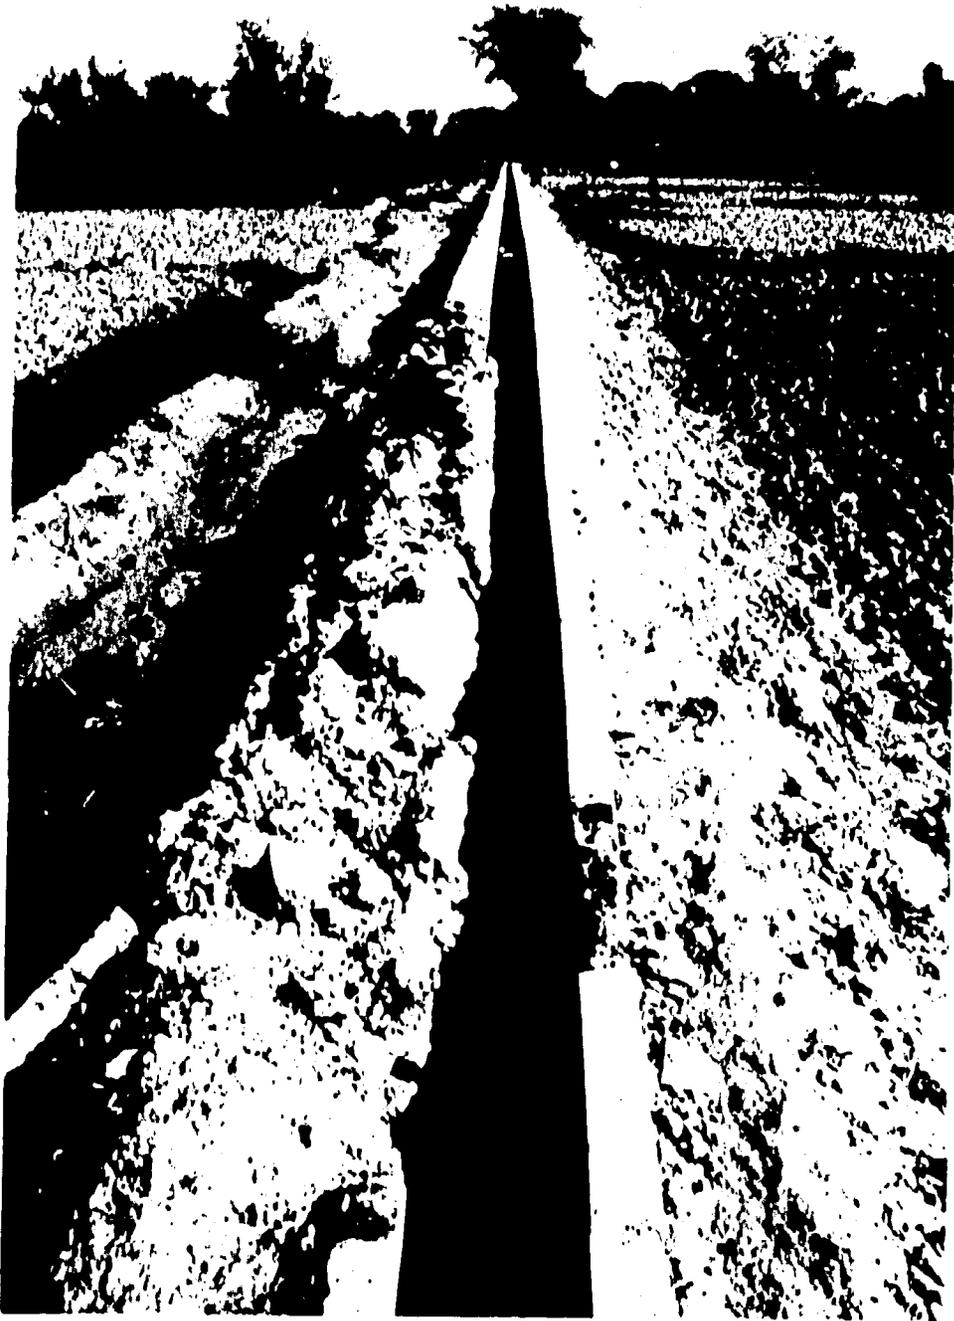
Figure 8. Masonry walls 4.5" thick which have collapsed due to soil and water pressure.

Masonry lining involving vertical walls allows development of considerable side pressure on these walls. If there is no earth on the outside of the lined channel, when the watercourse is full of water, the pressure of the water from the inside is not balanced by an equivalent force from outside, and consequently, the walls must be strong and have a solid base or they will collapse outward. Conversely, if there is a good bank of supporting soil on the outside which supports this wall, but a small amount of leakage occurs through the wall from the watercourse, the soil on the outside of the wall becomes saturated with time if the conductivity of the wall for water is greater than that of the undisturbed surrounding soil. Since the water is often in the sections for several days, the soil can become saturated almost to the surface of the ground. When the water is suddenly taken out of the watercourse, the saturated soil on the outside of the watercourse creates a substantial pressure on the wall and often causes failure towards the inside as is indicated in Figure 8. Experience with this type of failure has led most long-term practitioners in this field to recommend that there be a very solid and thick base in the watercourses which are to have vertical walls. The common recommendation in Pakistan is a four-inch concrete base covered by three inches of brick base. They also generally recommend walls that are at least 9 inches thick and are often 13 1/2 inches thick as indicated in Figure 4. The large amounts of brick, cement and other materials involved in this type of construction make them costly (Table 1). Alternative structures of trapezoidal design were discussed above and trapezoidal watercourses with the cross sections indicated in Figure 4 are in place for testing. A strong and solid base is not necessary for these structures because the force of the water and of the masonry is always born by the supporting earth. When this earth is sufficiently compacted (and there is no frost action, which is the case in most of Pakistan) this is a stable configuration and there have been no failures for this kind of structure other than erosion of the mortar where this was not mixed properly or had inadequate amounts of cement. However, the long perimeter of this type of design, including a bottom on the watercourse and often a few layers of brick on the top of the bank also consumes a large amount of material and construction time, so that these watercourses were not appreciably less costly than those with the vertical walls.

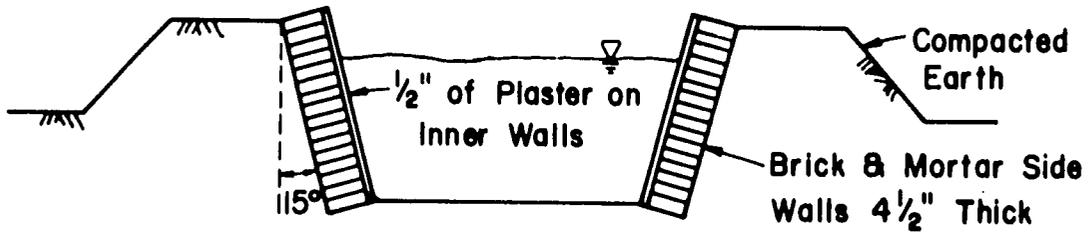
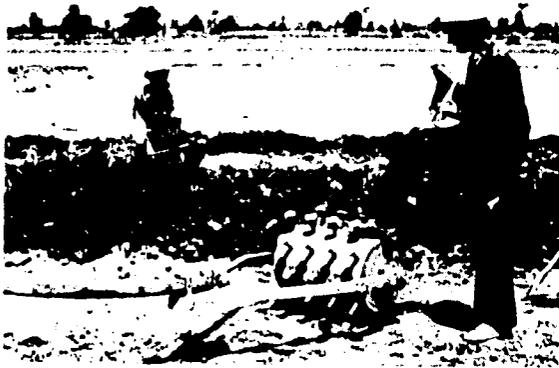
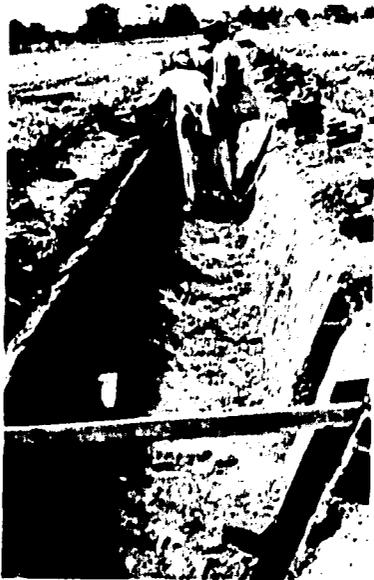
A. Cross section diagram.

B. Bullock drawn packer used to compact pad

C. Excavating the channel in the compacted pad.

D. Laying the bricks.

E. Finished, plastered walls containing water in the watercourse 3 days after filling.

Figure 9. Side linings to reduce water losses and costs thereof, from watercourses.

On the basis of the findings that very little water was lost through the bottoms of watercourses, and desiring to minimize the amount of materials used in lining a watercourse, designs indicated in Figure 9 were developed and installed in test sections at the Phularwan Research farm in the Mona

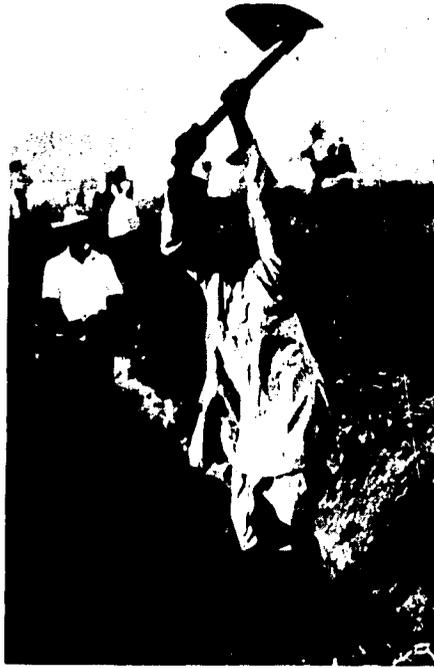
Figure 10. Farmer digging a watercourse with a kassi.

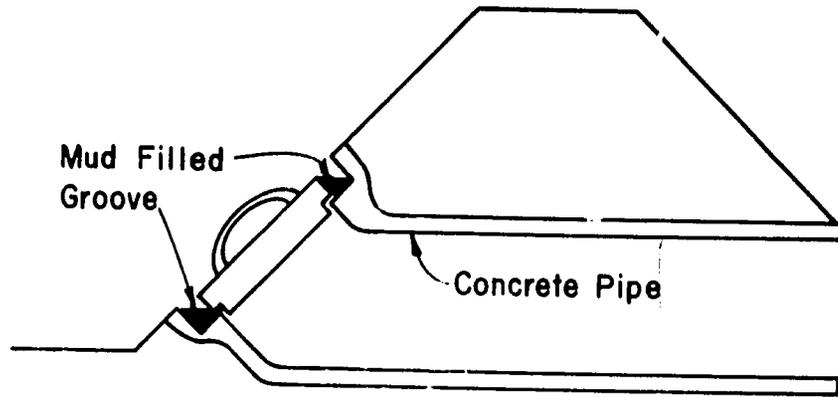
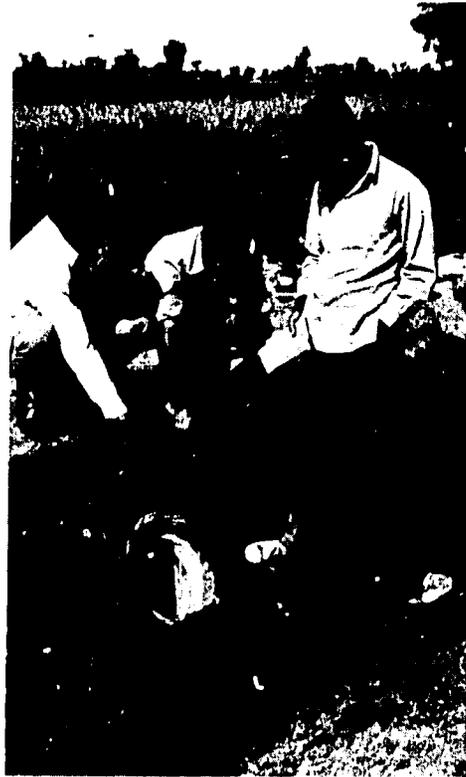
A. Design.

B. Installation.

Figure 12. Pipe outlet used at junctions into branch watercourses.

Pipe outlets were designed as indicated in Figure 12 to fit into the 45° angle wall that is common to watercourses which have a 1:1 side slope. The manufacturer constructs

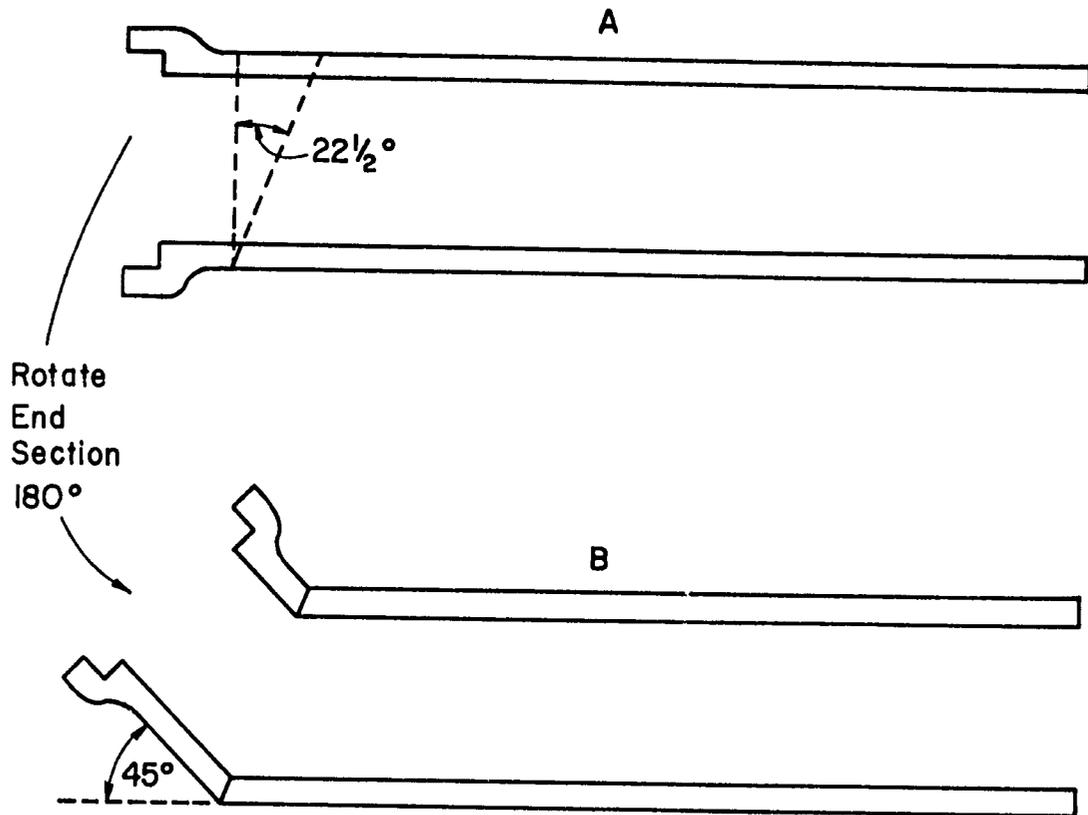
Figure 13. Steps in manufacture of 45° angle concrete pipe.

them by making a regular piece of concrete pipe, but placing an elliptical ring near the end of the pipe at a $22\text{-}1/2^\circ$ angle as indicated in Figure 13A. This ring allows the manufacturer to pull the end section loose from the pipe while the concrete is still green and to then rotate the end section 180° and cement it back onto the rest of the pipe, thus forming a 45° angle as indicated in Figure 13B. Small pieces of wire mesh mortared onto the outside edges of these junctions as indicated in Figure 14 increased the strength of the joint, however, several of these outlets were constructed and installed successfully without such reinforcement. The main problem encountered with these outlets was the tendency for water to leak through the area under the pipe, where firm contact between the pipe and the underlying soil was difficult to obtain. Washouts under the pipe were common during the first filling of the watercourse following installation. This tendency was eliminated by two approaches. The first was to build a cutoff wall at the ditch bank as indicated in Figure 15A. The second approach was to build a small cutoff wall in the middle of the bank along the bottom edge of the pipe by digging a trench, about 50% longer than the diameter of the pipe, parallel to the bank as indicated in Figure 15B. This trench should be dug into solid earth that has been thoroughly compacted, but it only needs to be about 6 inches wide and 4-6 inches deep. The trench is then over-filled with 1:3 cement-sand mortar mix, so that when the pipe is laid in position, the mortar forms a cradle on the bottom side making good contact with the pipe and forming a cutoff wall on the bottom side of the pipe midway through the bank. A reasonable amount of care in compacting the soil on the sides and top of the pipe is sufficient to prevent water from beginning to leak along these portions of the pipe.

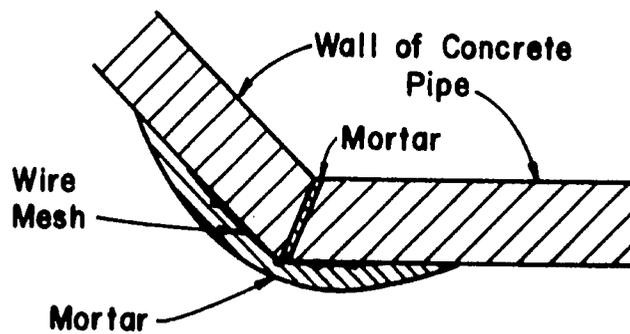
Figure 14. Detail of joining and reinforcing concrete pipe.

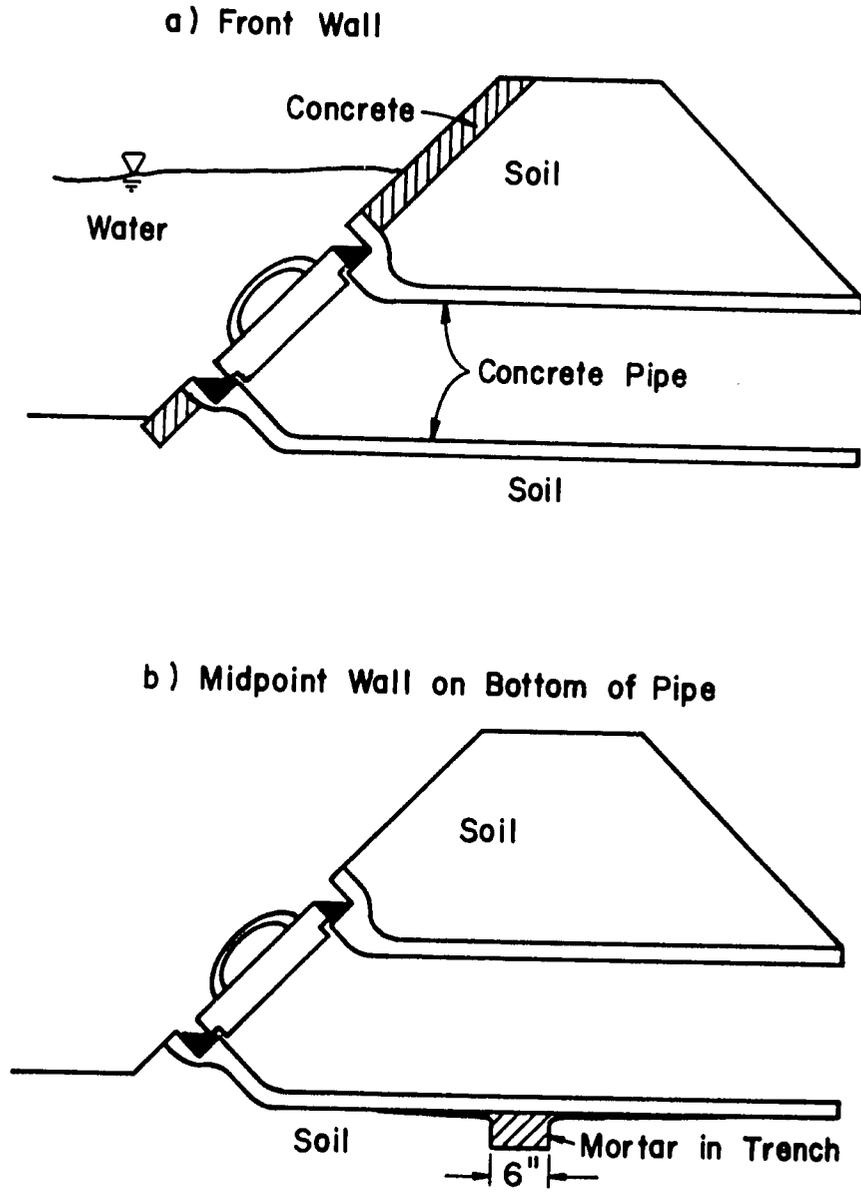
Figure 15. Cutoff walls to avoid washouts around pipe outlets.

The latter alternative, using a trench and placing concrete in the center of the banks, was generally much less costly than the larger cutoff wall which was necessary on the face of the bank. This type of outlet was one of the least expensive when the cost of installation was included. An outlet of this type with an internal diameter of 12 inches long and a pipe section 6 feet long would cost about \$12 (Rs. 120). The head losses for large flows (4 or 5 cusecs) in pipes of 1 foot diameter are significant and consequently, if there is little head available, larger pipes must be used. This not only increases the cost of manufacture at a rate more than proportional to the size of the pipes, but also increases the cost of transport and the effort involved in installation by a factor approximately proportional to the square of the diameter of the pipe. Another disadvantage of small diameter pipes is that the velocity of the water coming out of these pipes, when the flow is 4 or 5 cusecs, is sufficiently fast to cause erosion at the outlet end if the banks are not protected. When this outlet goes to watercourses which are only used one day per week, sod placed on the

bank near the outlet grew well and prevented such erosion. The pipe outlet has the advantage that the continuity of the top of the bank over the outlet is not broken and it can continue to serve as a foot path for human and animal traffic, which is a significant advantage in cases where this path is used as the primary access to the farmers' fields.

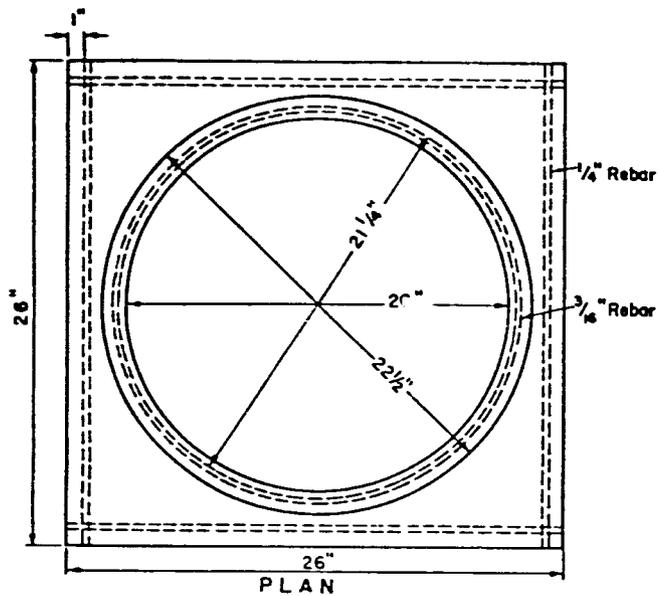
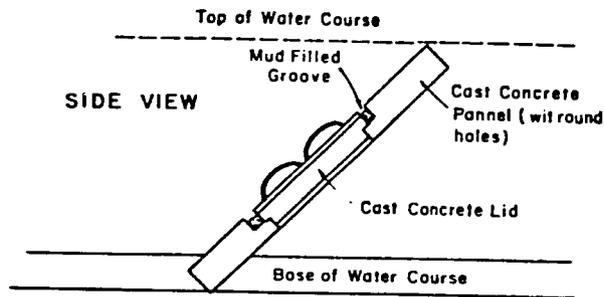
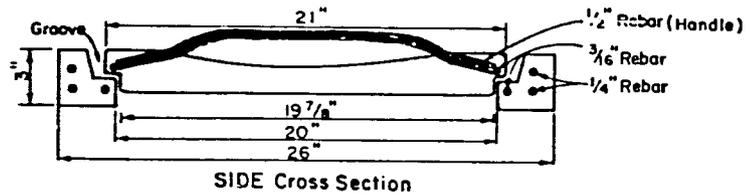
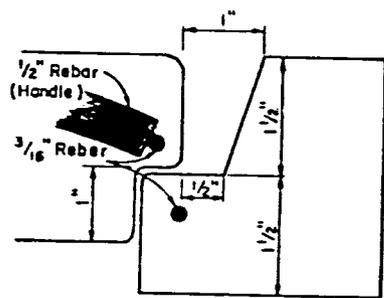
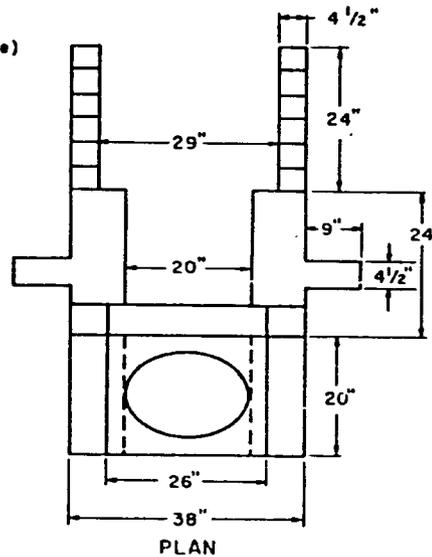
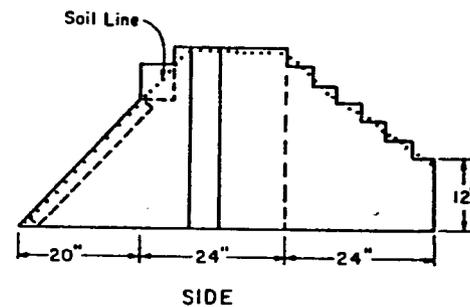
A. Details of the panels and lids.

R. Mode of installation.

Figure 16. Concrete panels with orifice and lids and supports for their installation as check structures in watercourses.

When the flow in the watercourse is large and appreciable head loss at the outlet is undesirable, large pipes necessary to avoid the loss are difficult to install and costly. Consequently, an alternative was developed in the panel outlets indicated in Figure 16. The concrete panel with its round opening and lid were precast with the reinforcement indicated and using machined steel forms which achieved a reasonably close fit between the seal and the lid. When properly manufactured and new, these panels could reduce leakage of water through the joint between the panels and the lid to less than 1/1000 of a cusec (Trout and Akram, 1975). However, as concrete chips away during usage, some leakage develops. To help farmers prevent this leakage, a small groove was formed around the edges of the lid, which when filled with mud completely prevents the leakage.

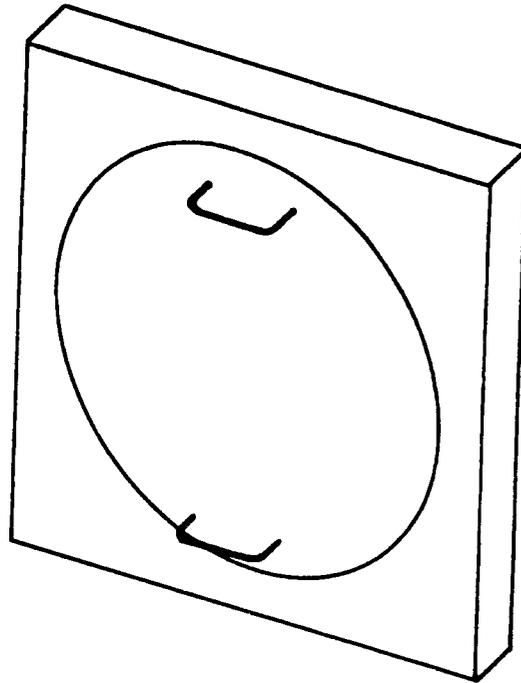
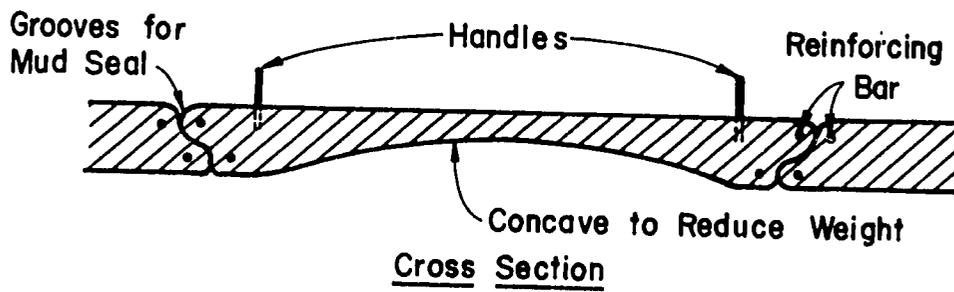
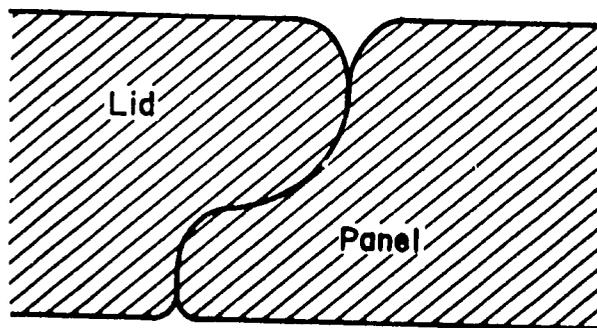
Enlarged Cross Section of the Sealing Surface

Figure 17. Improved circular panel outlet (20" and 15" diameter).

One of the biggest improvements in the panel outlets was developed by the manufacturer. He found that he could cast the outlet panel shown in Figure 17 using a precise metal form, and then the following day, after greasing the surface, cast the lid directly into the panel. In this way he not only got a precise fit, but also could greatly streamline his

production. After curing the two pieces together in a water bath, the lid was broken loose from the panel, and then was rotated for several minutes in the panel while adding water. In this way the lids precisely fit into the panels and the sealing surface was very smooth. Water leakage through these improved outlet panels was minimal, and breakage and chipping was reduced. Further work in improving the production techniques and quality control of the concrete is being done.

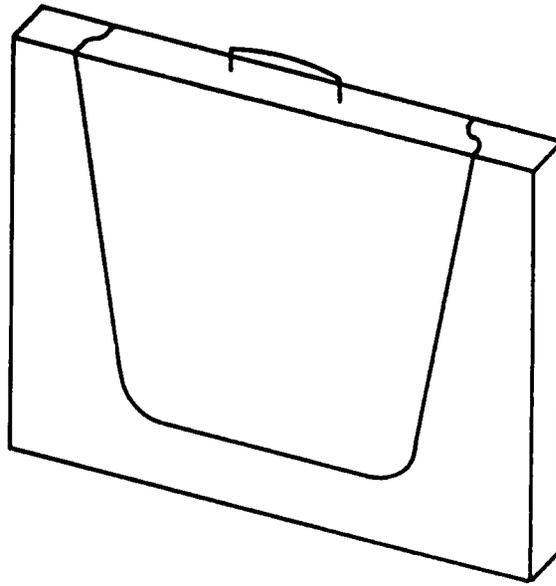
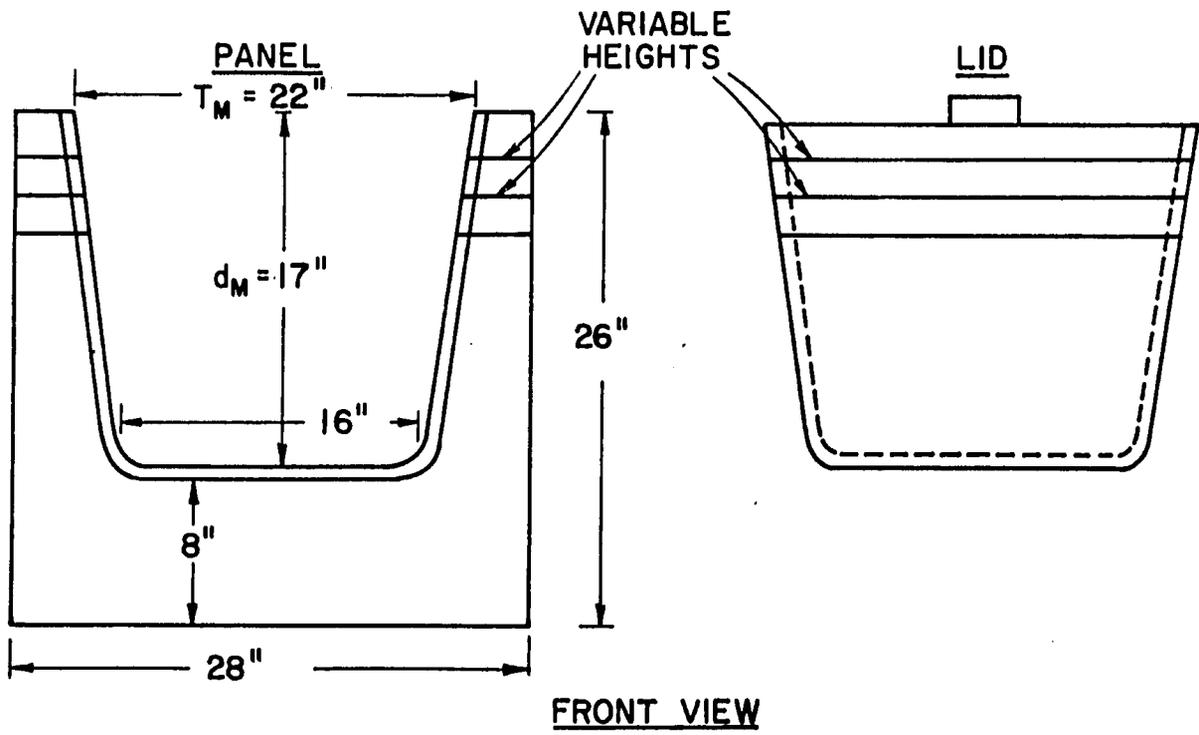
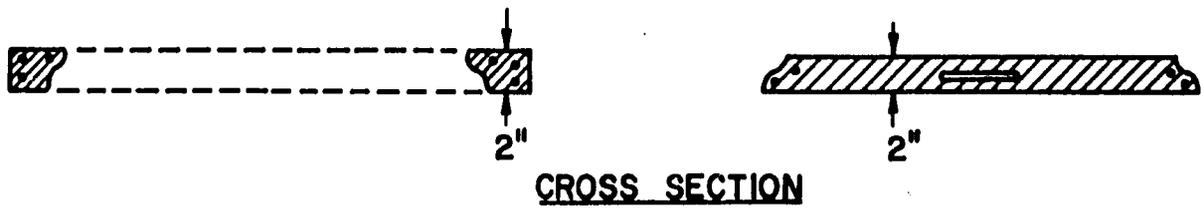
Figure 18. Trapezoidal panel outlet.

Circular outlets could not easily be opened or closed, especially on larger watercourses, without the farmer entering the watercourse in front of the structure. To alleviate this need, a trapezoidal opening was developed, as shown in Figure 18, from which the lid could be removed from above. The outlet was constructed into a panel by the same "cast-in-place" techniques used for the circular cutlets, and thus was quite leakproof. A problem with the design was that sediment would sometimes collect on the bottom seat which would prevent the lid from closing completely. This was not a problem with the circular shape since less sediment collected on the round seat and a twist of the lid would evenly distribute the sediment around the sealing surface.

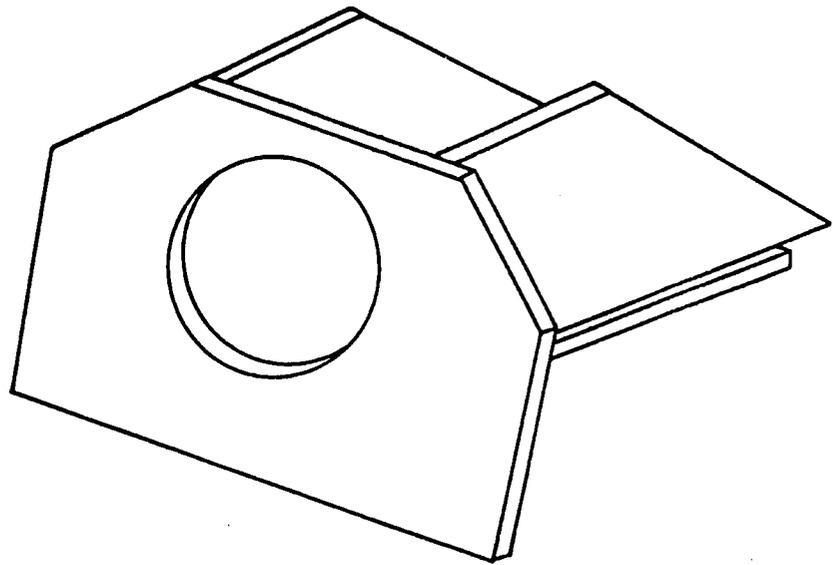
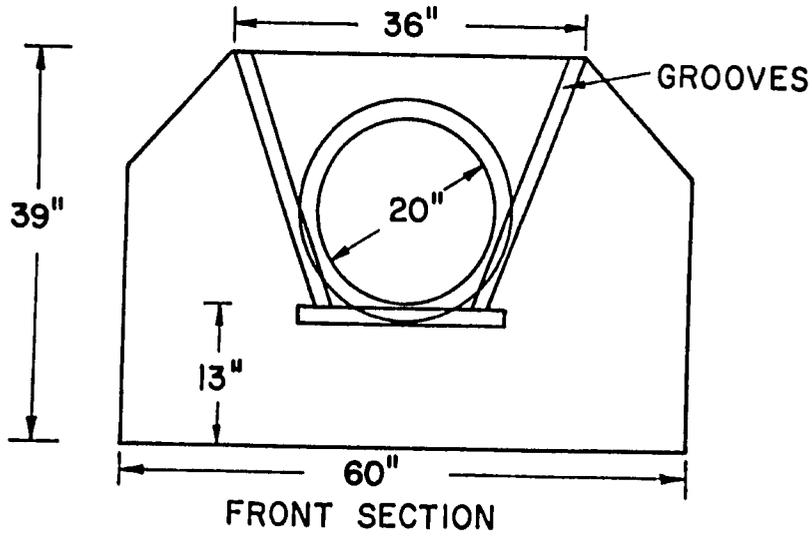
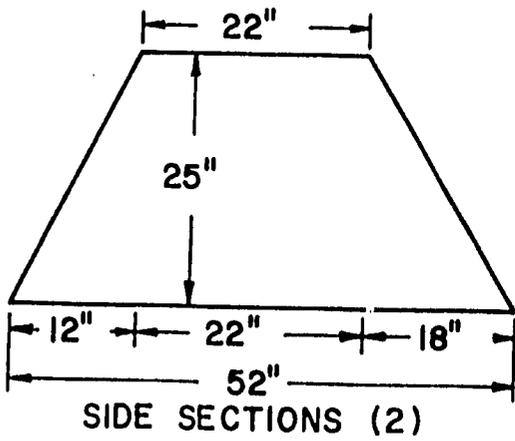
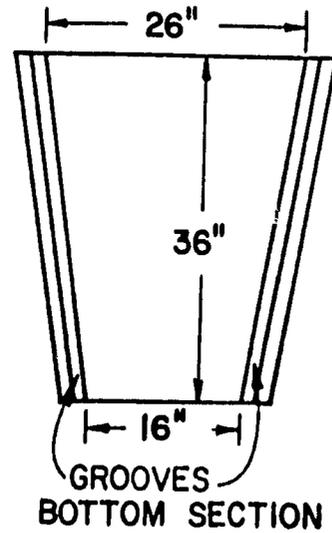
Figure 19. Precast concrete slab installation for panel outlets.

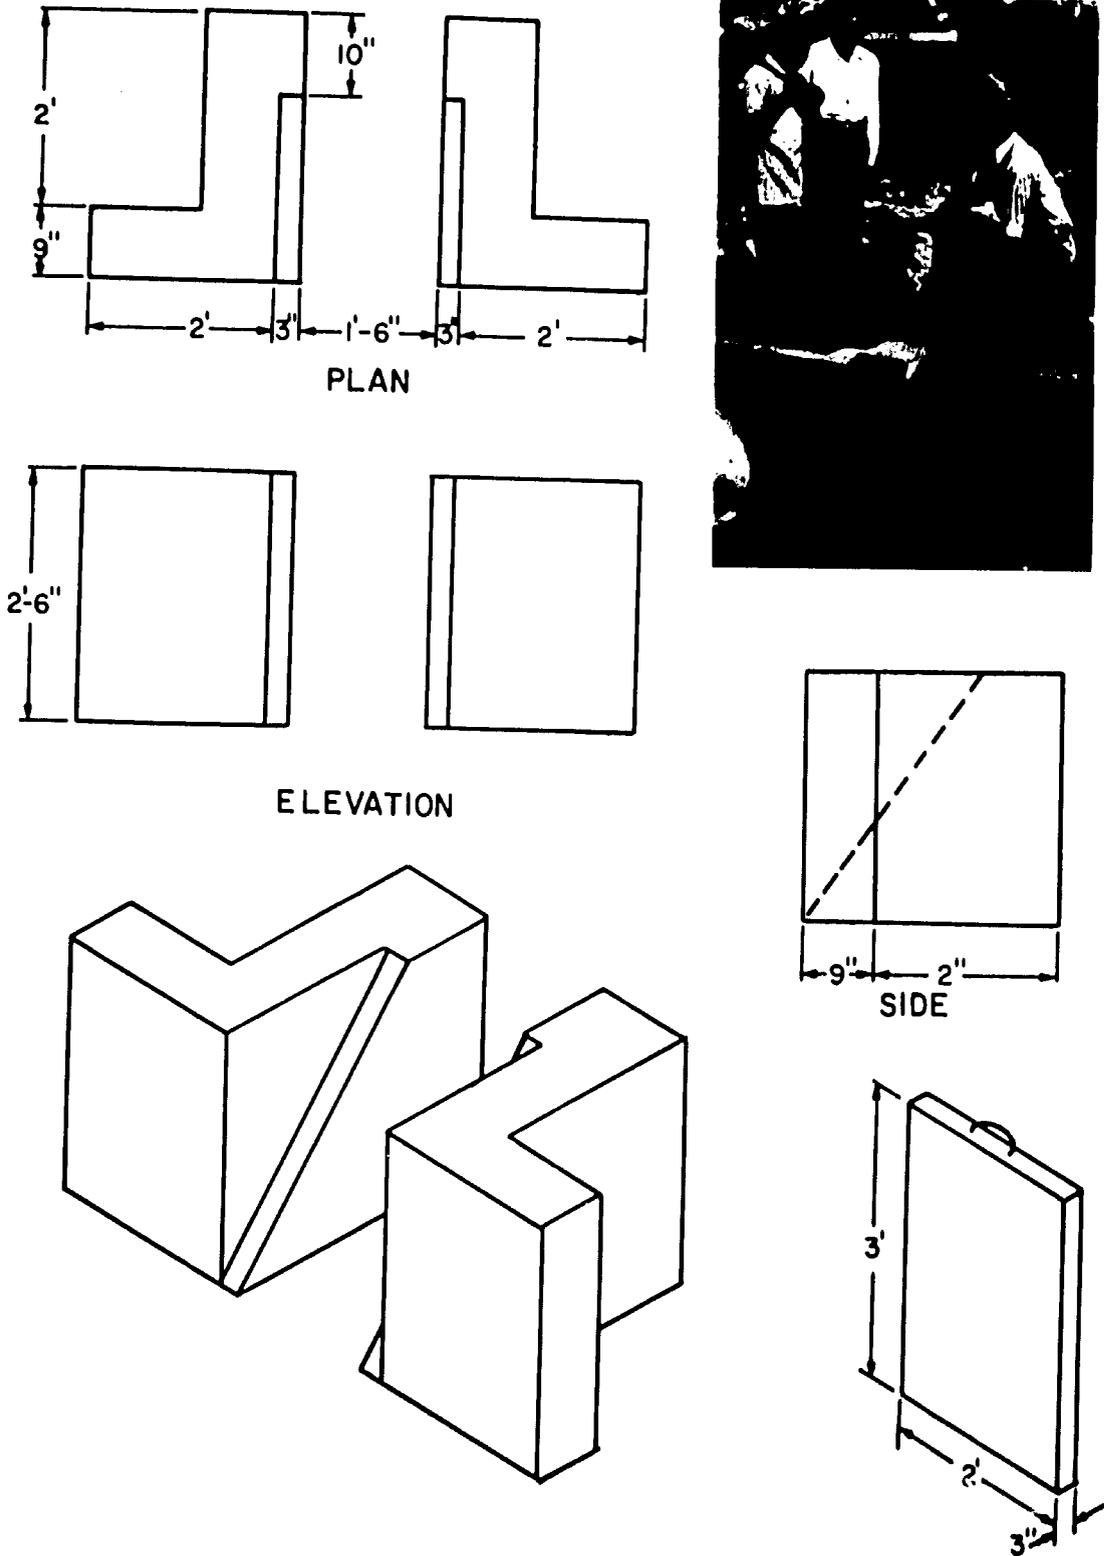
Figure 20. Slide check structure (Akram et al., 1976).

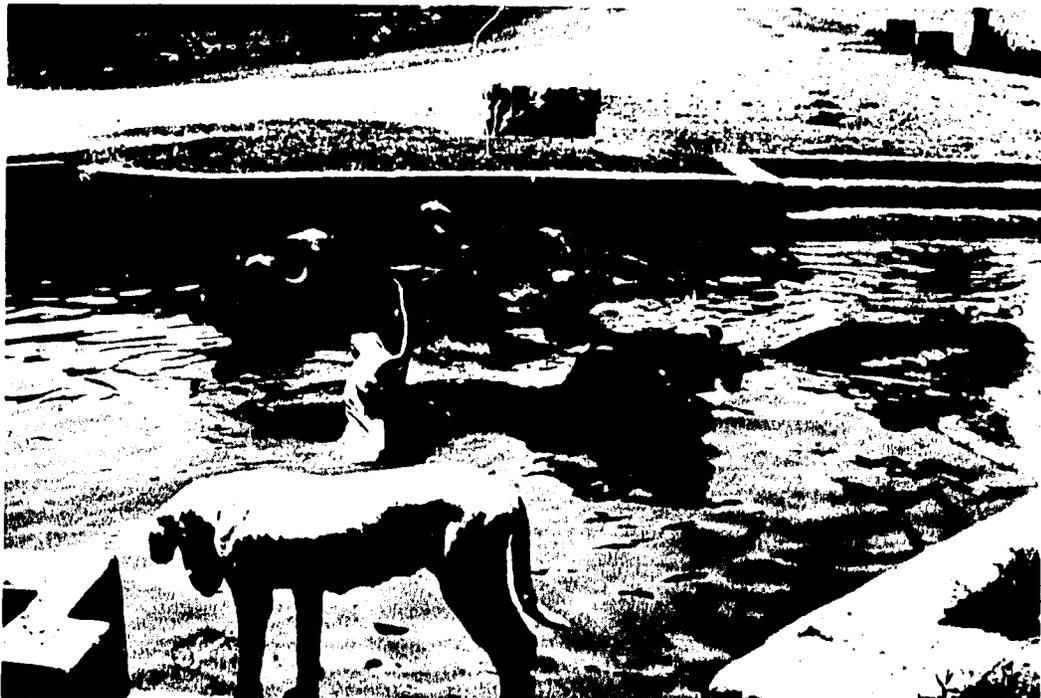
Figure 21B. Same section as shown in 21A where the banks and channel were built by farmers to the designed size.
