Watercourse improvement research in Pakistan

Water Management Research Project
Colorado State University
Fort Collins, Colorado
January 1980

WATERCOURSE IMPROVEMENT RESEARCH IN PAKISTAN

WATER MANAGEMENT TECHNICAL REPORT 56

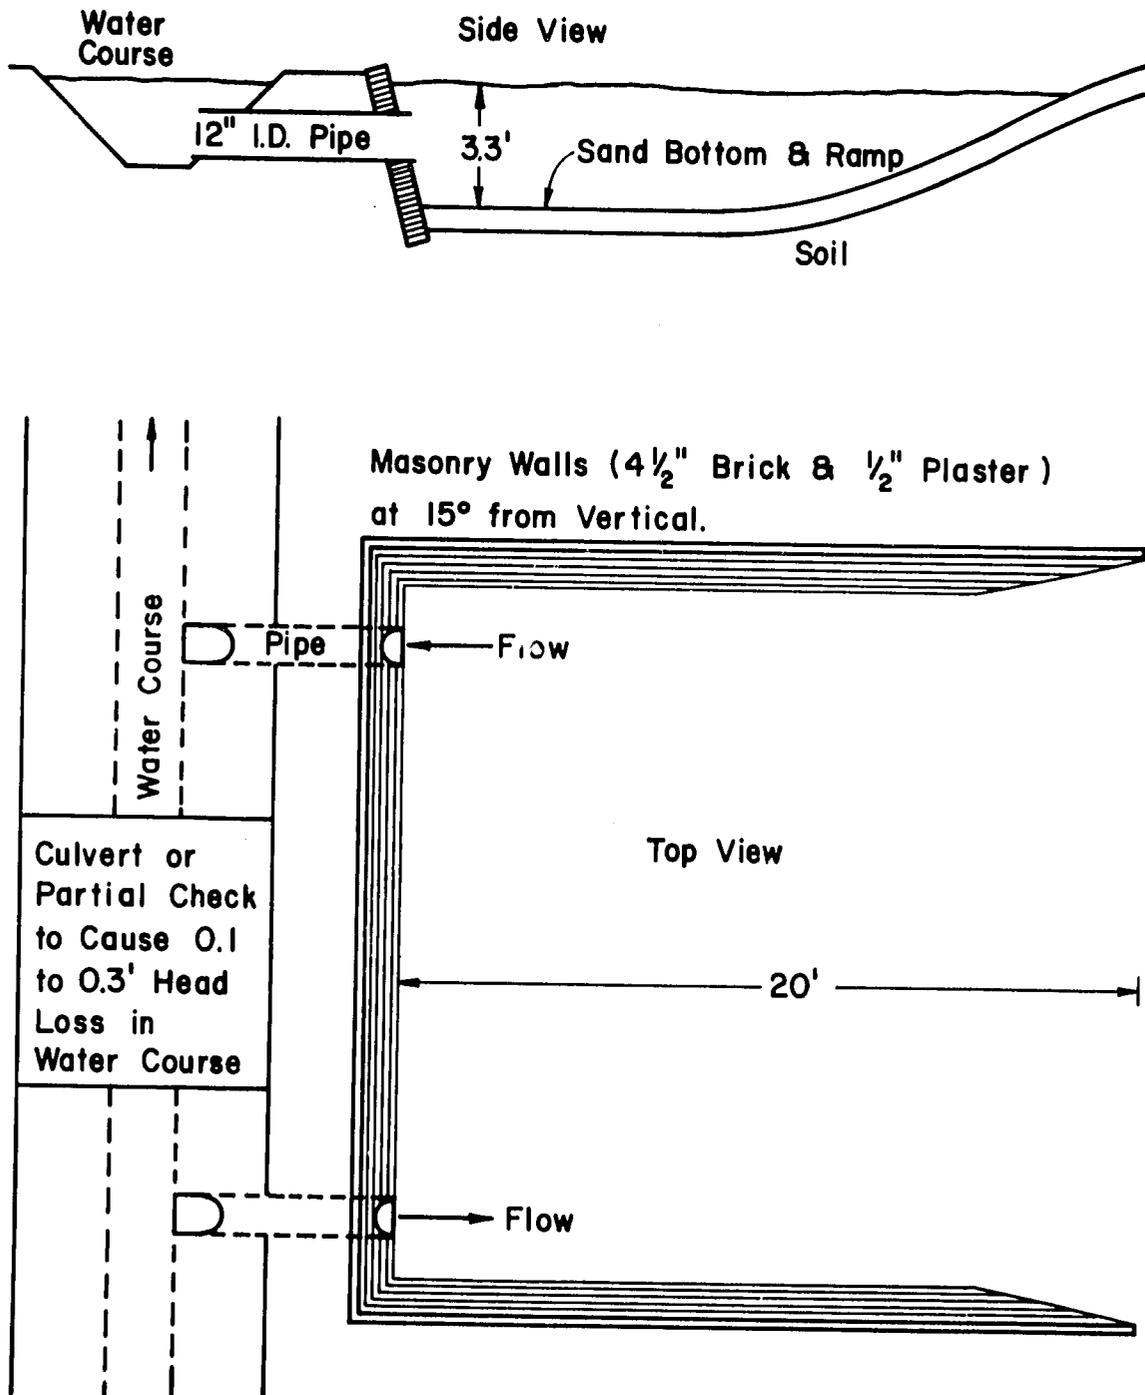
Figure 22. Reasonable cost structure for animal bathing.

One of the least costly and most used buffalo baths was constructed adjacent to the watercourse serving Tubewell 51 with the design indicated in Figure 22. The sandy soil at this location allowed the buffalo to enter the bath without miring into the mud and consequently a masonry or concrete ramp was not necessary. Ramps were the primary cost of many of the constructed buffalo baths because the soil underneath these ramps was commonly saturated and the force exerted by the foot of the

buffalo as it comes down this ramp can often exceed 500 pounds. This resulted in a rapid deterioration of the ramps which were first constructed. It was found to be necessary to install a base of gravel or broken brick which was about a foot thick if the concrete or masonry surface of the ramp was to remain intact. For reasons of economy, safety and preference by the animal, it is generally recommended that the ramps to such baths be formed of unconsolidated sand with a slope of about 1:4 or less. Where the soil is not sandy, this sand can be hauled in. Their sand ramp will require some maintenance schedule for the watercourse. These buffalo baths frequently become a social center for the young boys of the area who are commonly the escorts and bathing companions of the buffalo!

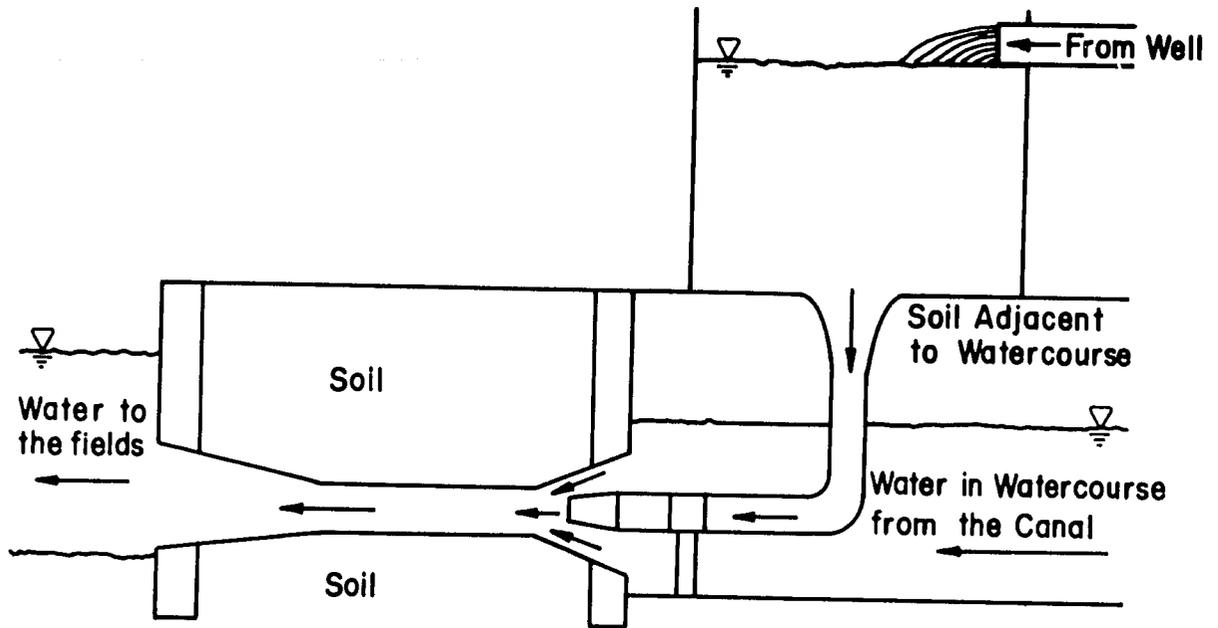
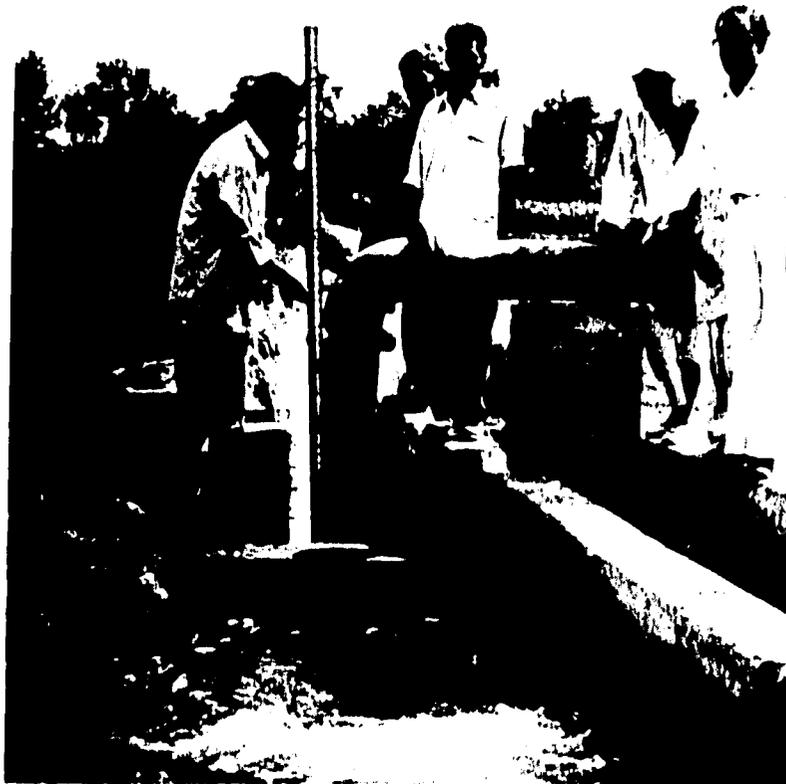
A. Side view.

B. Operating (direct hookup to pump) in Pakistan 3 months later.

Figure 23. Basic components of "jet junctions" for lifting canal water to desired levels using energy normally dissipated in the fall boxes of wells in Pakistan.

To solve this problem, jet junctions of the type indicated in Figure 23 have been designed (Aust, 1978). These junctions make use of the elevation energy (3 to 6 feet of head) commonly available in the fall boxes from tubewells in Pakistan. This energy of the tubewell water is used to lift the canal water to an elevation a foot or so higher than the elevation of the water in the watercourse just below the outlet from the canal. This extension of the jet pump to high volume-low lift dimensions has no moving parts and the constricting jet, receiving funnel, mixed chamber and diffusing chamber can generally be manufactured at a cost of about \$100. The primary cost is generally the installation, including the concrete pipe or elevated watercourse needed to carry the water from the tubewell fall box to the junction with the watercourse that comes from the canal.

If greater lifts are needed and the pump on the tubewell has sufficient power, the outlet pipe of the tubewell can be connected directly by a pipe to the constricting jet and the size of this jet can be designed to achieve the desired lift. In such direct connections, a one-way valve or standpipe should be incorporated into the highest point of the piping system between the tubewell and the constricting jet, which will allow the air to enter the pipe when the tubewell is turned off and thereby prevent siphoning of the sediment loaded canal water back into the well. Further details of these jet junctions are available in the report prepared by Aust (1978).

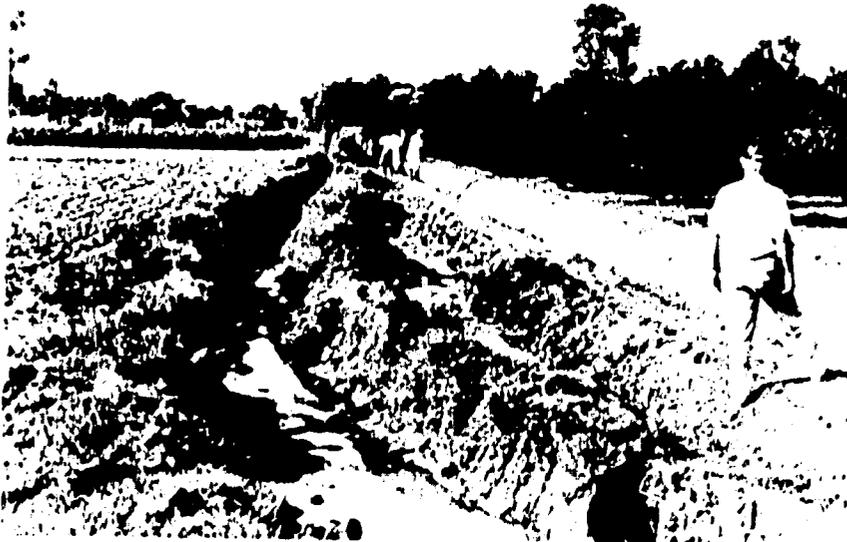
Figure 24. An improved earthen channel section beside the original channel it replaced.

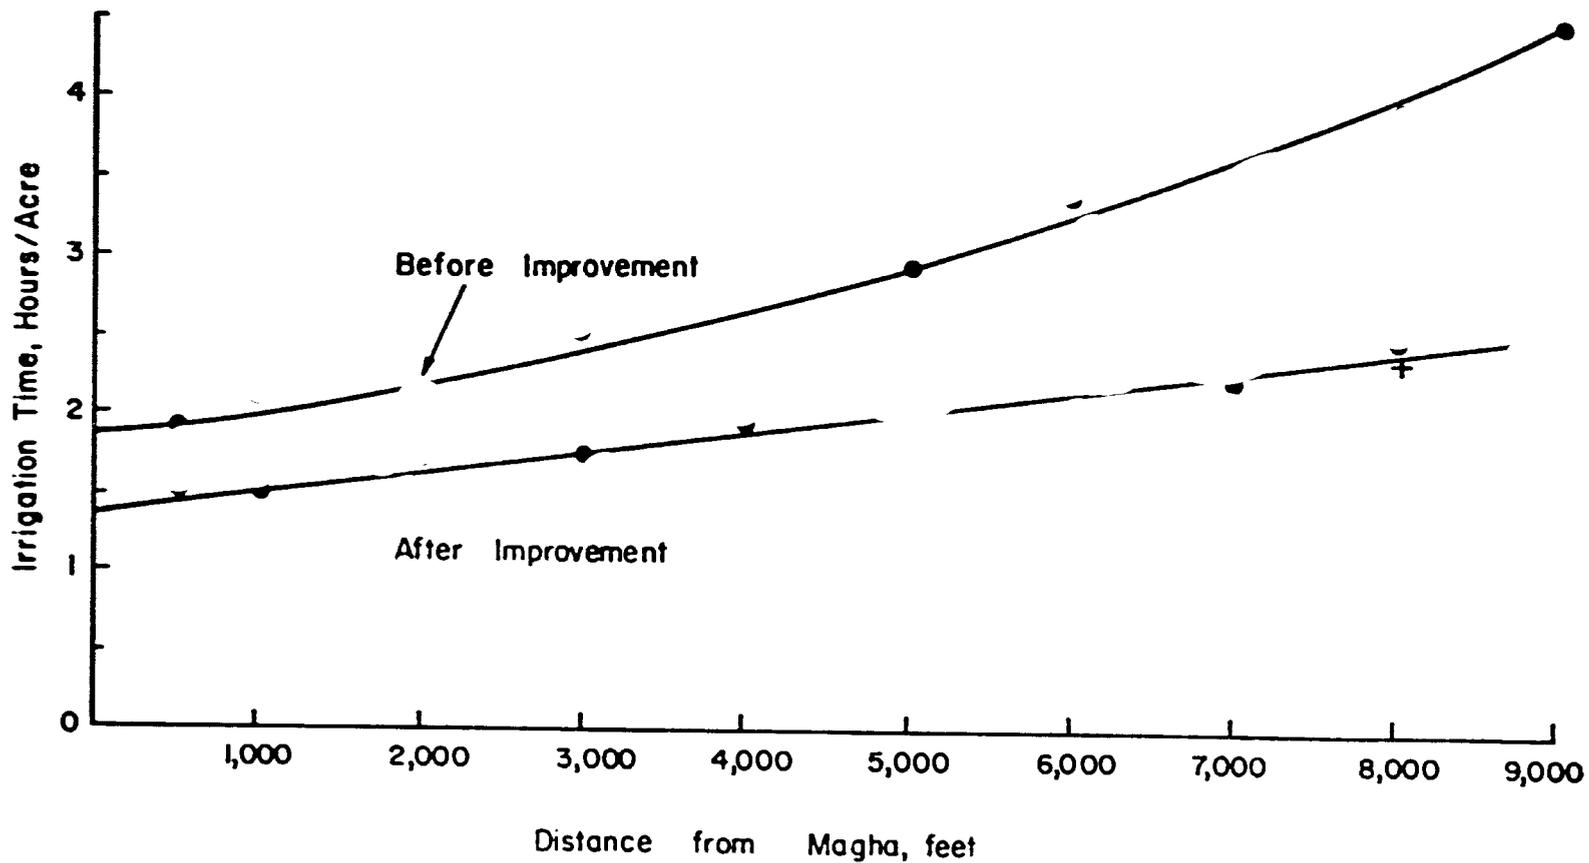
Figure 25. Farmer estimates of time to irrigate fields when tubewells and mogha were all providing water (before and after improvement).

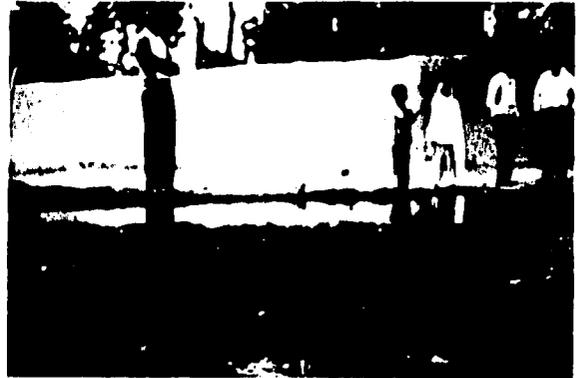
Figure 26b. Leakage from an elevated section before improvement.

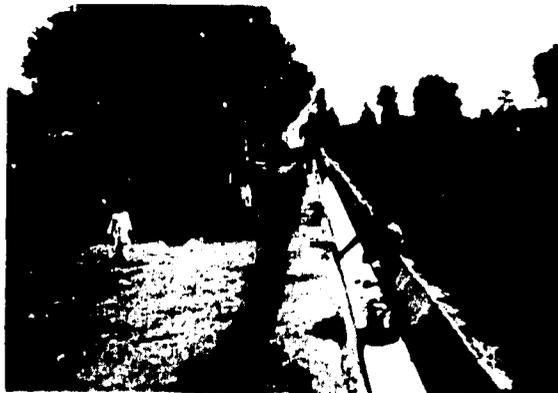
Figure 27. Side lining of the watercourse serving Tubewell XX where it passes by the village.

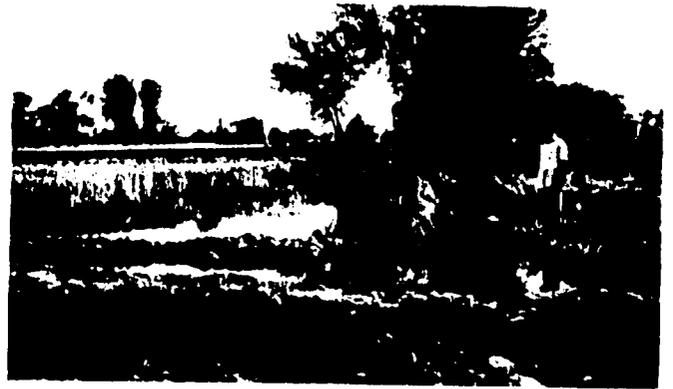
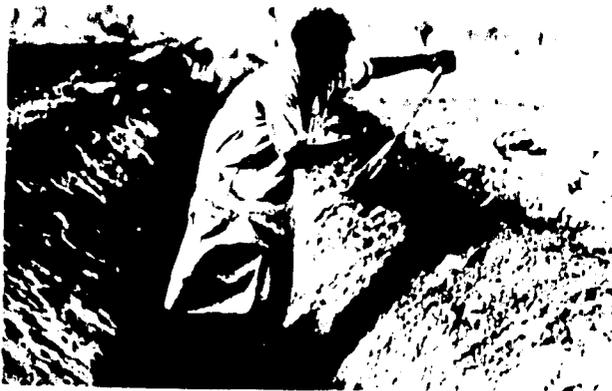
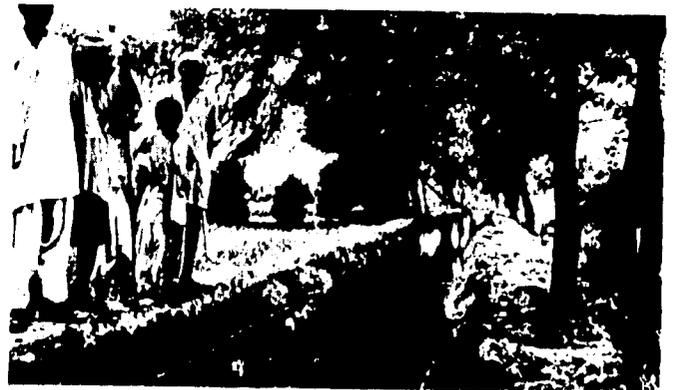
A. Grassy section before improvement.

B. A degraded junction with borrow pits full of water and leaking banks before improvement.

C. Improvement in progress.

D. Farmers watching smooth unhindered flow of their water following watercourse improvement.

Figure 28. Sections before and after essential improvement.
