Commercial Fish Farming Project in Nigeria

Research and Development Series No. 30

May 1983

International Center for Aquaculture

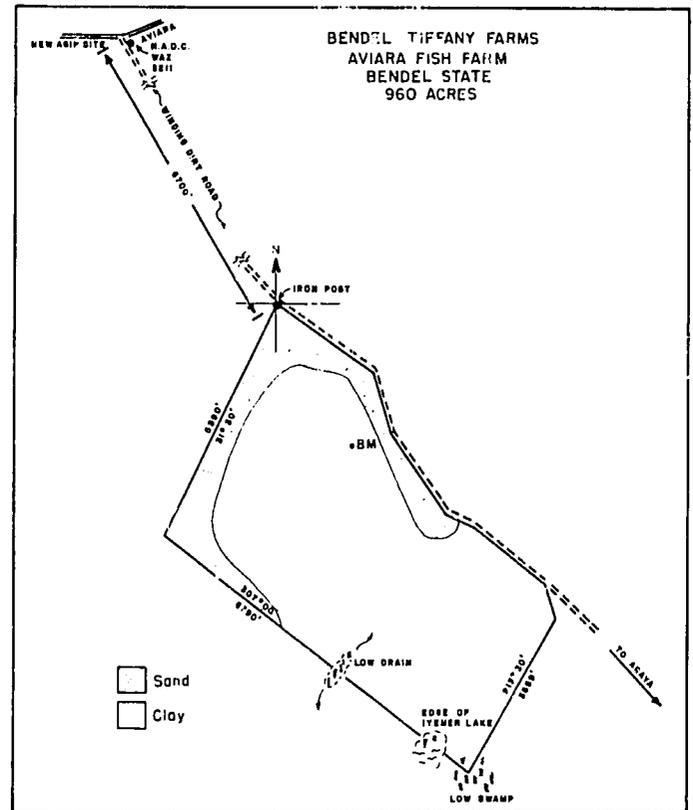
FIG. 3. Sketch of 960-acre site to be developed into commercial fish farm.

The site chosen, figures 2 and 3, was vegetated with tropical rain forest, except for a few small family plots of cassava, yam, bananas, and cola nut trees. The dimensions of the site are 1 mile wide by 1.7 miles in length. The total area is 960 acres, with approximately 500 acres targeted for development into fish ponds.

At the highest elevation the soils are a relatively coarse sand overlain by a thinner layer of sandy loam. The extent of this soil type is approximately 80 acres. Due to favorable topography and well drained soils, this area was readily adaptable as a headquarters site for shops, warehouses, fuel dump, fish holding shed, and housing. It will also accommodate an airstrip for executive type aircraft.

This sandy ridge slopes to the southeast into a low swamp of alluvial clays. The topography is rough, but it is suitable for the construction of commercial fish ponds of the type found in the Mississippi River delta of the United States.

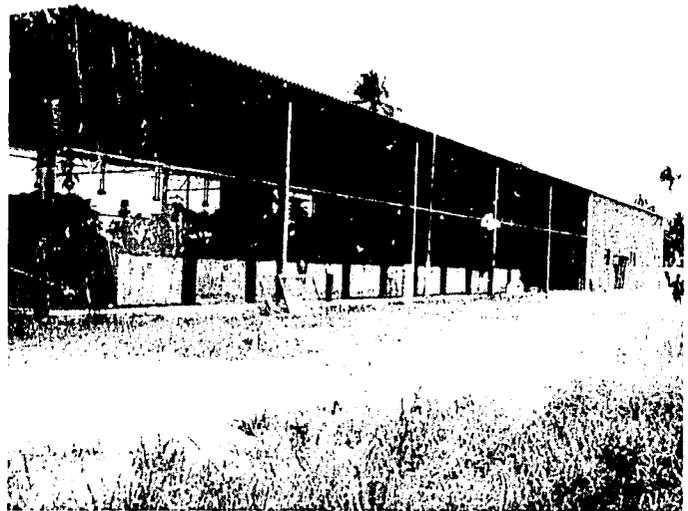
FIG. 4. TOP—fish holding and hatchery building; BOTTOM—close-up showing fish holding tanks in foreground and office in background.

The headquarters facilities consist of a large (50 x 160 feet) fish-holding and hatchery building, figure 4. The building is enclosed at one end with aluminum siding. This enclosure houses the office, the wet-lab, and storage for small hardware and supplies that require shelter. It also houses four concrete tanks (3 x 3 x 25 feet) that are to be used for indoor breeding and fry-rearing purposes and other specialized hatching and incubation facilities.

The rest of this structure is an open shed in which there are 11 fish holding tanks measuring 4 x 3 x 45 feet. Each tank has an independent water supply and drain, and a walkway along each side to facilitate fish seining, treatment, size grading, and other procedures.

The entire building is supplied water by steel lines embedded in the concrete slab. Water of low hardness is supplied from a bore-hole or well at a rate of 800 g.p.m. The submersible well pump is powered by a 240-volt generator rated at 162 KVA (129 KW) power output. Water is discharged into a 5,000-gallon elevated surge tank, from where it flows by gravity to the facility. Water level in the tank is controlled by an automatic mercury switch. This system will also furnish water to the housing, shops, and work area.

The construction of the fish holding hatchery building is that of conventional pre-fabricated metal buildings, with a 6-inch concrete slab floor. A 6,000-square-foot slab could be poured in one piece in one day by conventional equipment and methods in the United States. With only one 14-cubic-yard concrete mixer available at the project site, it was possible to pour only one strip 10 feet wide across the 50-foot dimension of the building per day. This required 15 "cold-joints" in the overall length of the slab. In order to strengthen and enhance the integrity of the slab, the normal procedure of joining individual slabs by smooth butts was modified.

Concrete holding tanks were constructed on the finished slab. Holes 5/8 inch in diameter were drilled into the slab at the center-line of the tank walls at 18-inch intervals. Steel reinforcing bars long enough to reach just short of the 3-foot high walls were inserted vertically into the holes and cemented in place. The tank walls were formed with prefabricated steel forms into which concrete was poured.

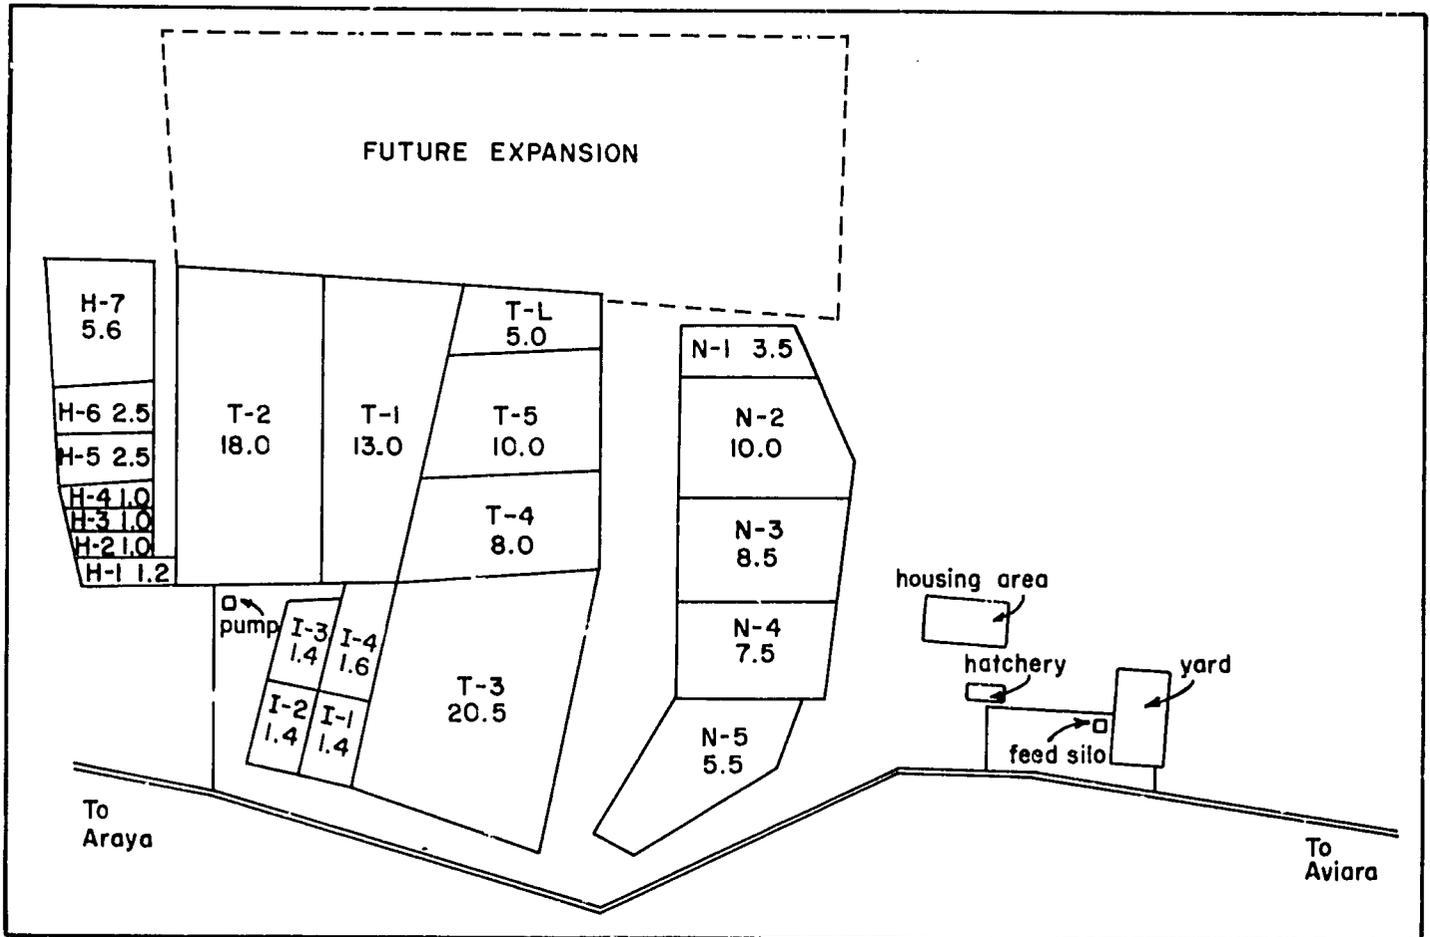
FIG. 5. Aviara fish farm showing individual ponds and acreages with related facilities.

Seven hatchery and nursery ponds were constructed (ponds H-1 to H-7). Four of these ponds were approximately 1 acre each, two ponds were 2.5 acres each, and one was 6 acres (measurements from levee center line to levee center line). Due to the higher cost of building small ponds, a conservative estimate of the costs per acre for hatchery ponds is N5,000.00 (U.S. \$7,500.00) in the Nigerian situation.

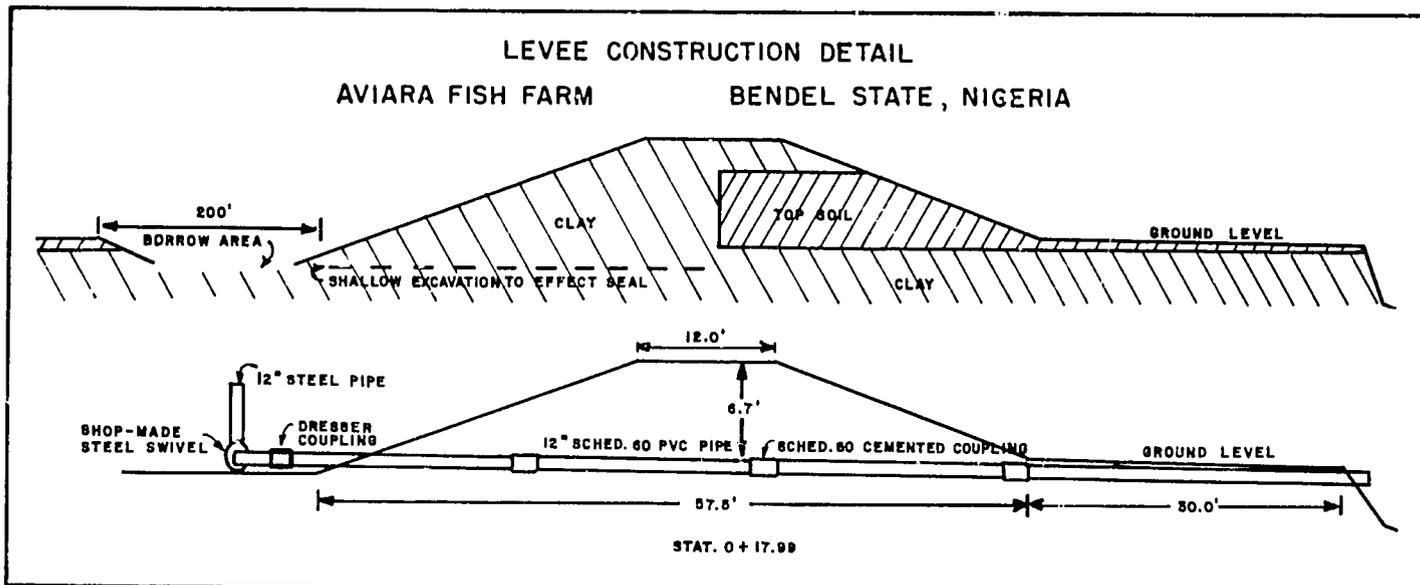
FIG. 6. TOP—upper-cross-section of dam depicting cut (borrow area) and fill area; BOTTOM—lower-cross-section of dam showing detail of drain pipe design.

pit exposed. Next, a cut penetrating the exposed clay soil to a depth of about 1 foot was made between the opposite toe and the center line forming a shallow core trench. This soil was deposited with the previously deposited topsoil. The core trench was necessary to break up soil stratification and secure a seal of clay to clay. Next, clay soils in borrow areas on both sides of the levee were used to complete the levee. At least one-half of each levee was of good clay. Additional topsoil was mixed with clay in the portion of the levee above the water line to help stabilize the roadways.

A harvest pit about 1/2 acre in size was excavated at the lowest point of each pond. Pond bottoms and borrow pits were formed to slope evenly to the harvest pits. The drainpipe used was schedule 80 (5/8-inch wall), 12-inch PVC pipe with cemented joints. The drain mechanism was a fabricated steel swivel to which was welded a 12-inch steel stand-pipe of the exact length to establish the pond water level when upright. This device was fastened to the PVC horizontal drain pipe by means of a 12-inch Dresser coupling. Each pond drains as an independent unit directly into a central drainage ditch that was constructed to approximate the course of the natural drainage for the site. This ditch runs east and west thus bisecting the site. It will drain all of the ponds as well as taking care of drainage runoff of the headquarters site.

Details of levee construction and drain-pipe installation are shown in figure 6. It was not necessary to alter this basic design and all ponds were thus similarly built.

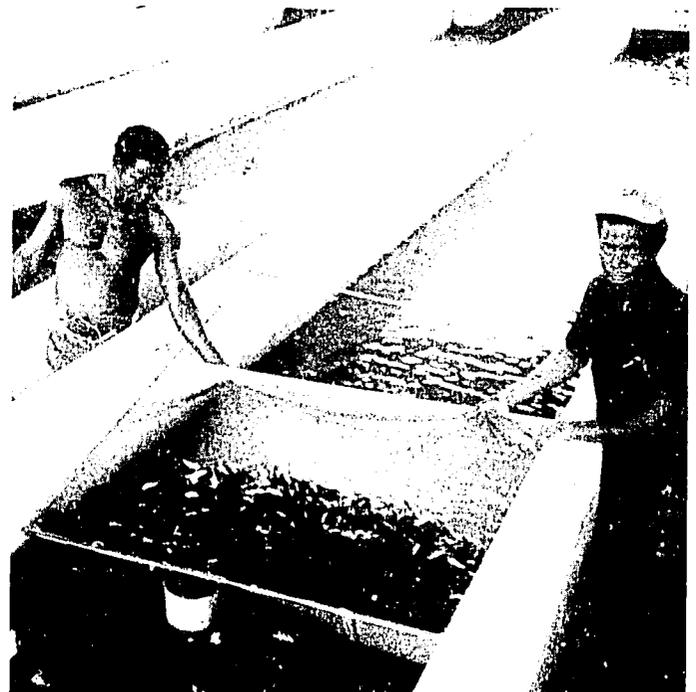
FIG. 7. LEFT—harvesting fish fingerlings from "fish seed" pond; RIGHT—selecting fingerling fish from concrete holding tanks prior to stocking grow out ponds.

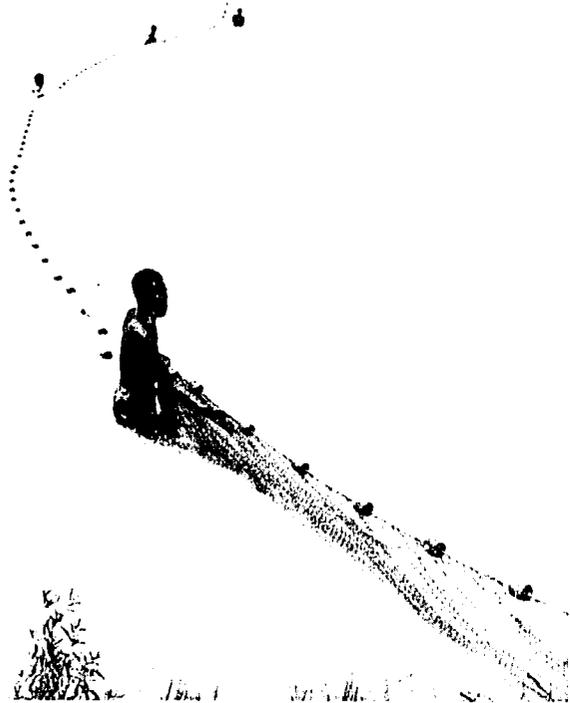
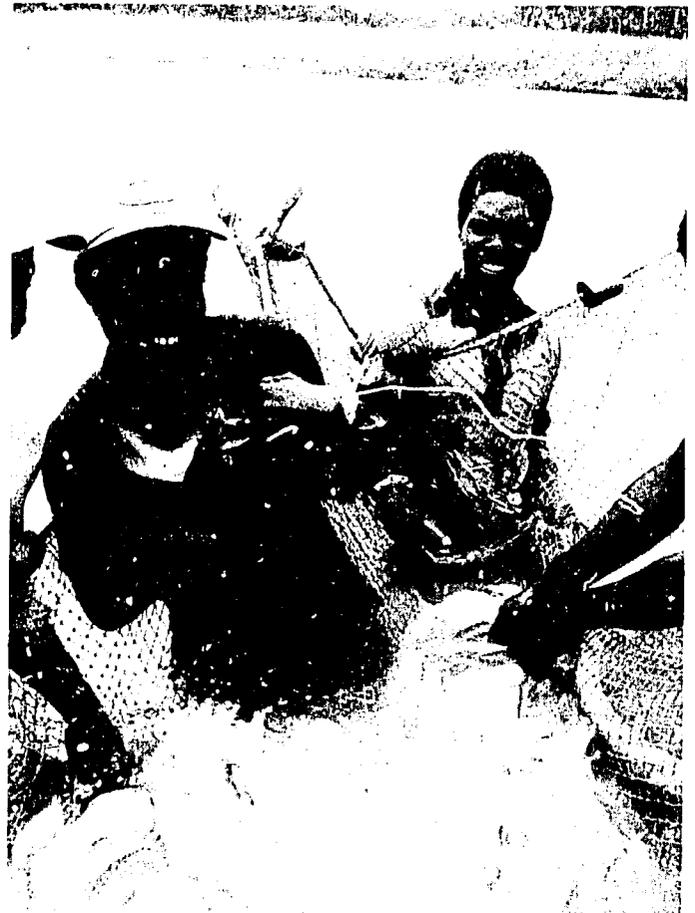
FIG. 8. LEFT—seining operation in production fishpond to obtain fish for market; RIGHT—net of harvestable size fish being prepared for market.

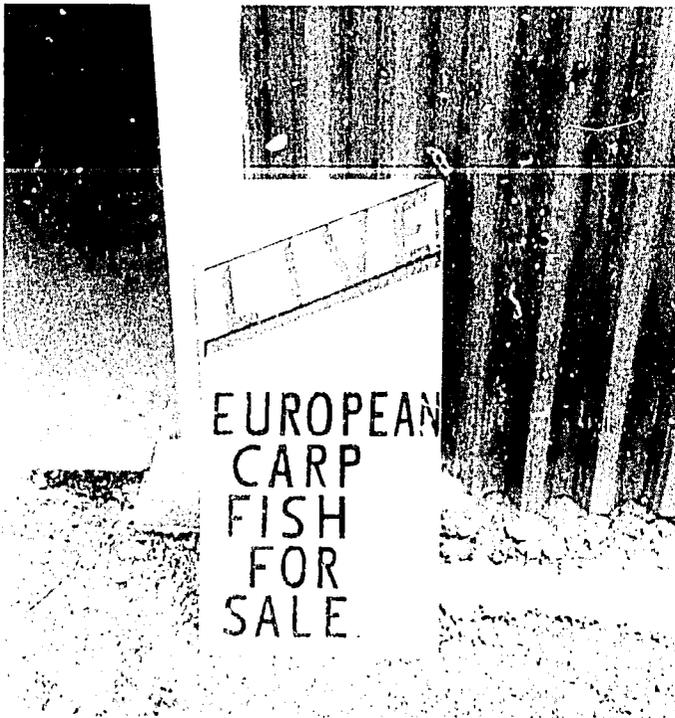
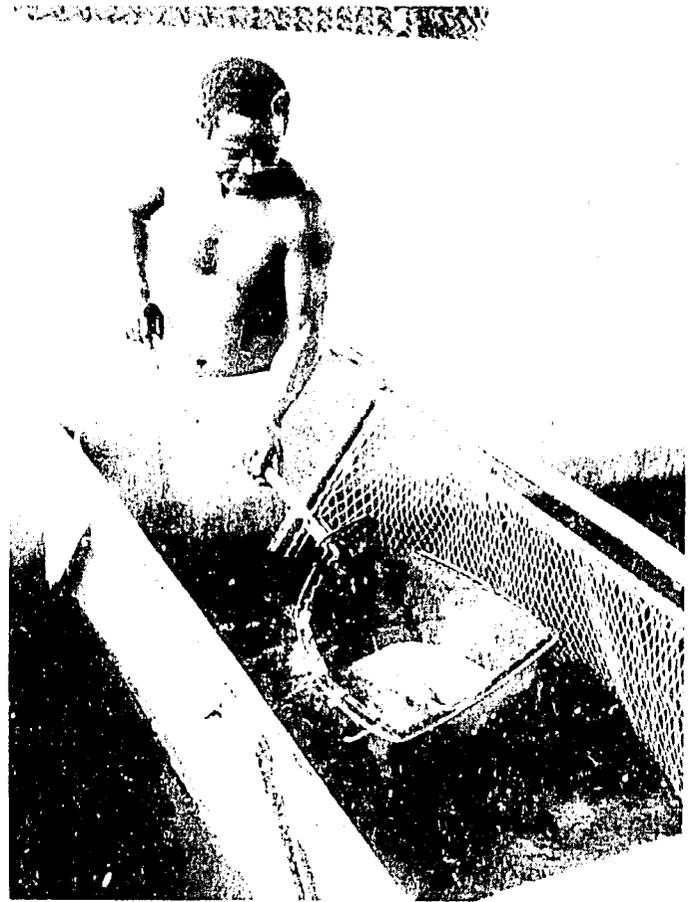
FIG. 9. LEFT—fish are sold live in Nigeria because of higher price and greater demand; RIGHT—fish are maintained in live-holding facilities for retail sales at the fish farm.

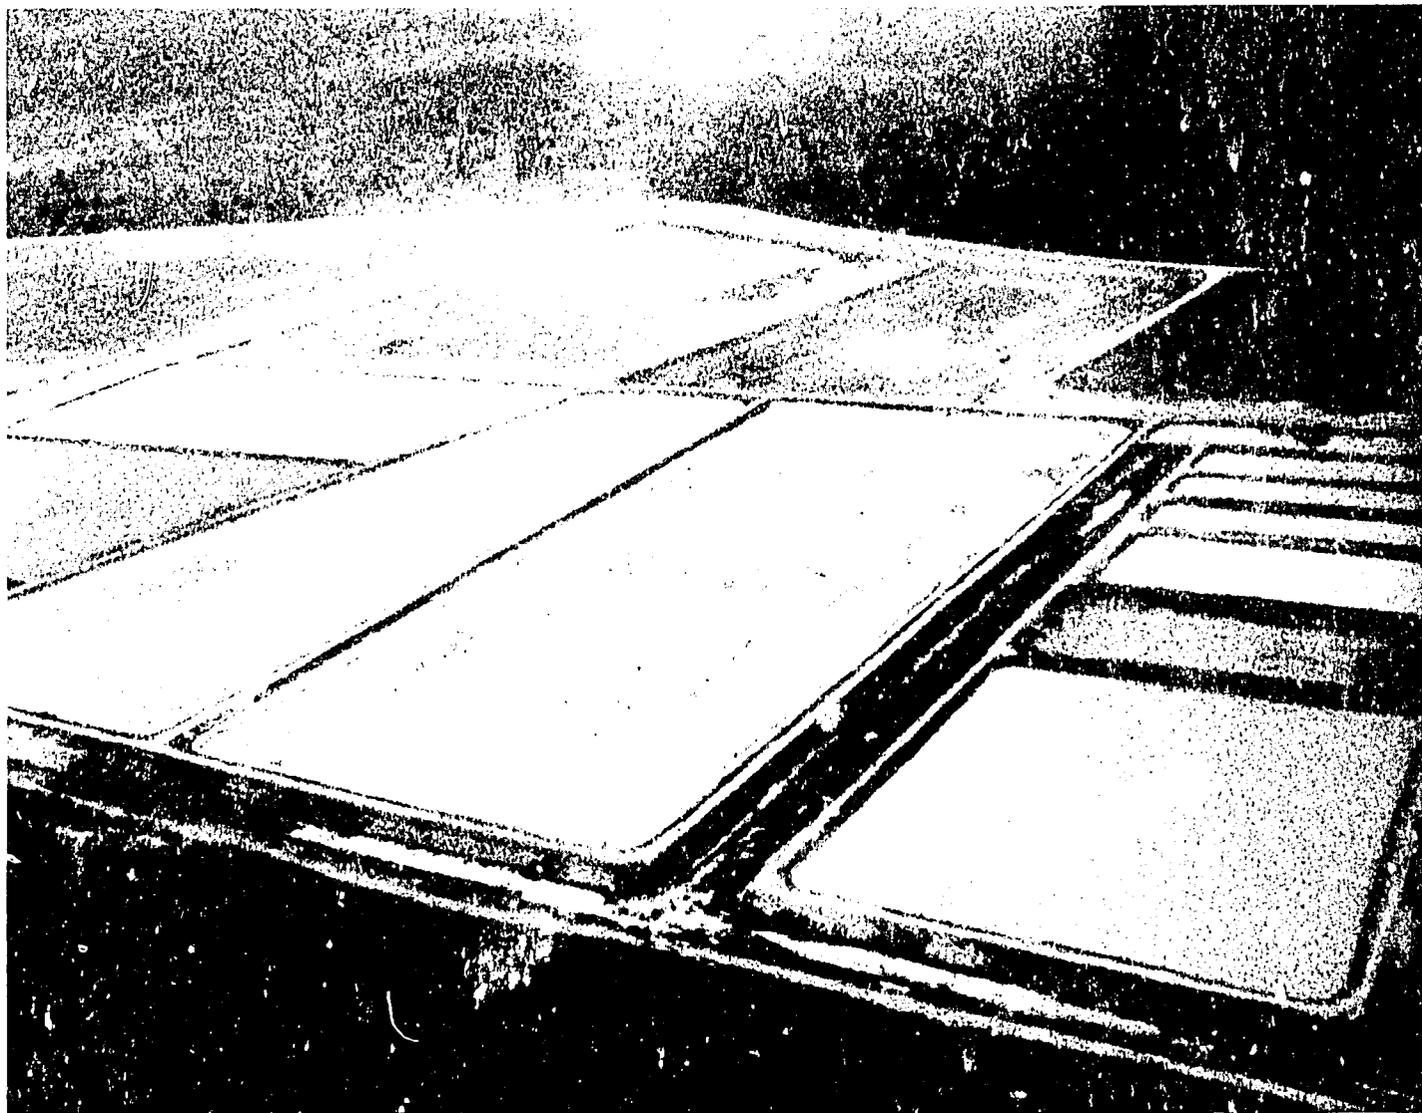
FIG. 10. Photograph of Aviara Fish Farm showing smaller hatchery ponds on right with adjacent, larger production ponds on left.
