**HELMAND-ARGHANDAB VALLEY
IRRIGATION SYSTEM**

A CHANGE ASSESSMENT: 1973 - 1990

**DEVELOPMENT ALTERNATIVES, INC.
and
EARTH SATELLITE CORPORATION**

February 1993

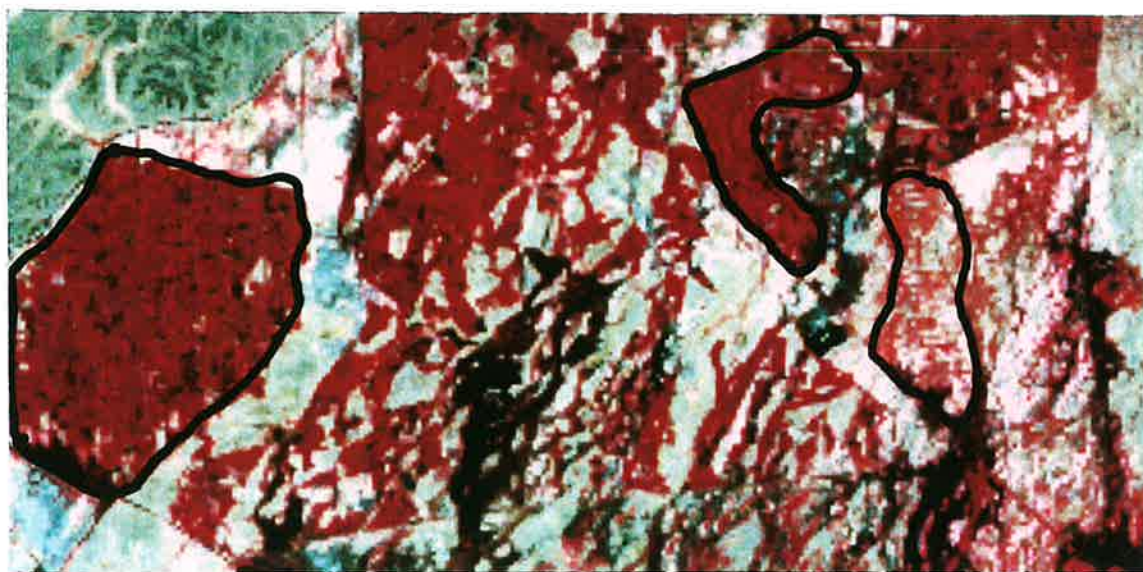
Figure 8 Study Sites 2, 3 and 4 - Northern Marja and Southeastern Nad-i-Ali

Site 3 (the northeast portion of the image) is an area of 400 hectares located in the southeastern portion of Nad-i-Ali, which has shown an increase in irrigated cropping. At one time this area was government-owned forest that was later cut down and the land distributed amongst settlers. Land is heavily farmed although there are some pockets of salinity.

Site 4 (the east-central portion of the image) is adjacent to, but outside of, Nad-i-Ali. The area was not farmed in 1973. In the 1990 image, a rectilinear pattern of irrigation infrastructure has been established but appears abandoned. This area lies between government posts and Mujahiddin positions and saw much fighting. The land has been mined and irrigation facilities are damaged. The few areas cultivated in 1990 are watered from drainage canals. The area covers approximately 350 hectares.

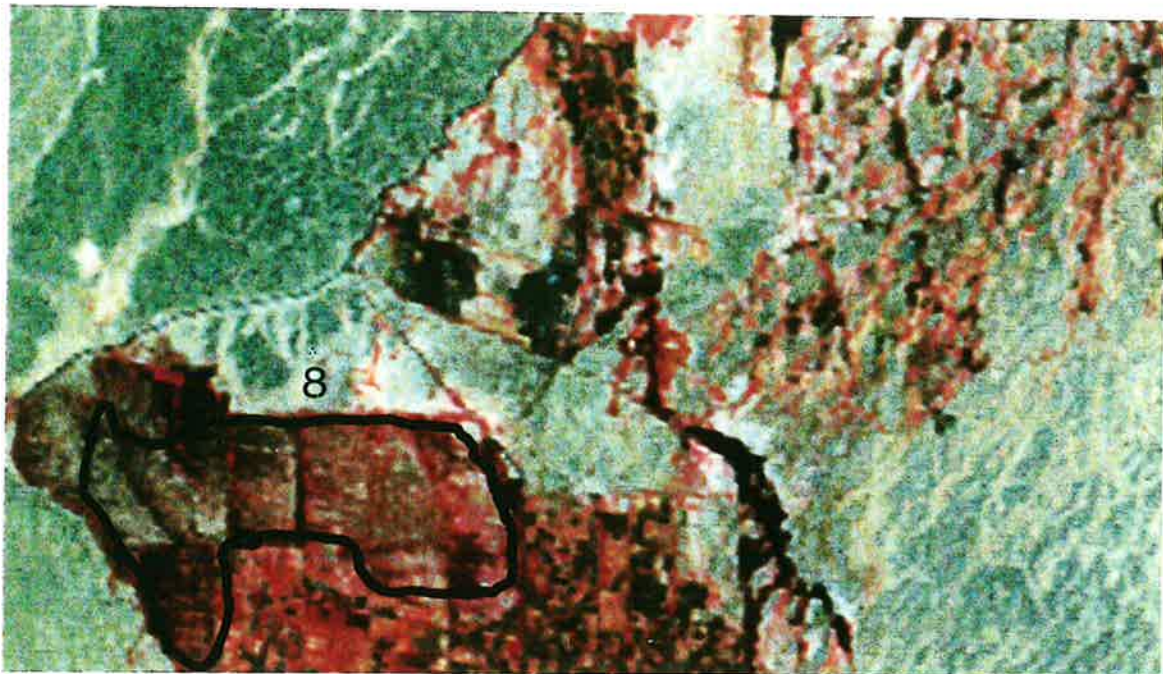
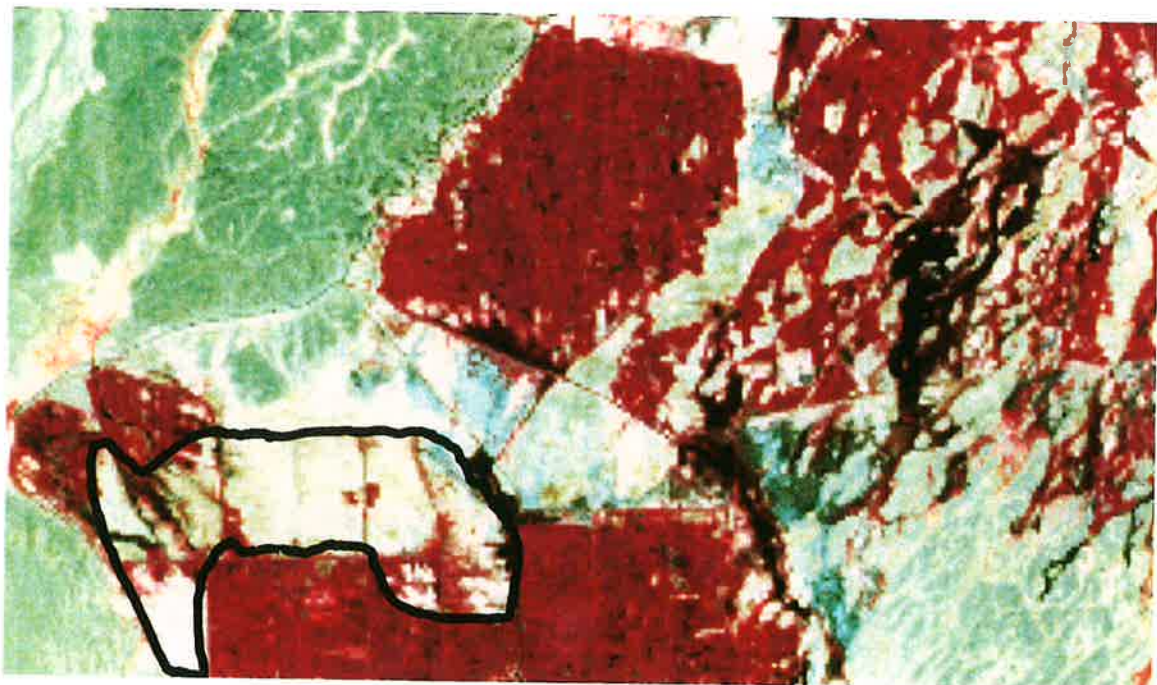
Figure 10 Study Site 8 - Northwest Marja

¹⁰ Sodium salts are particularly harmful. Sodium concentrations can lead to soil impermeability and an inability to remove salts through leaching.

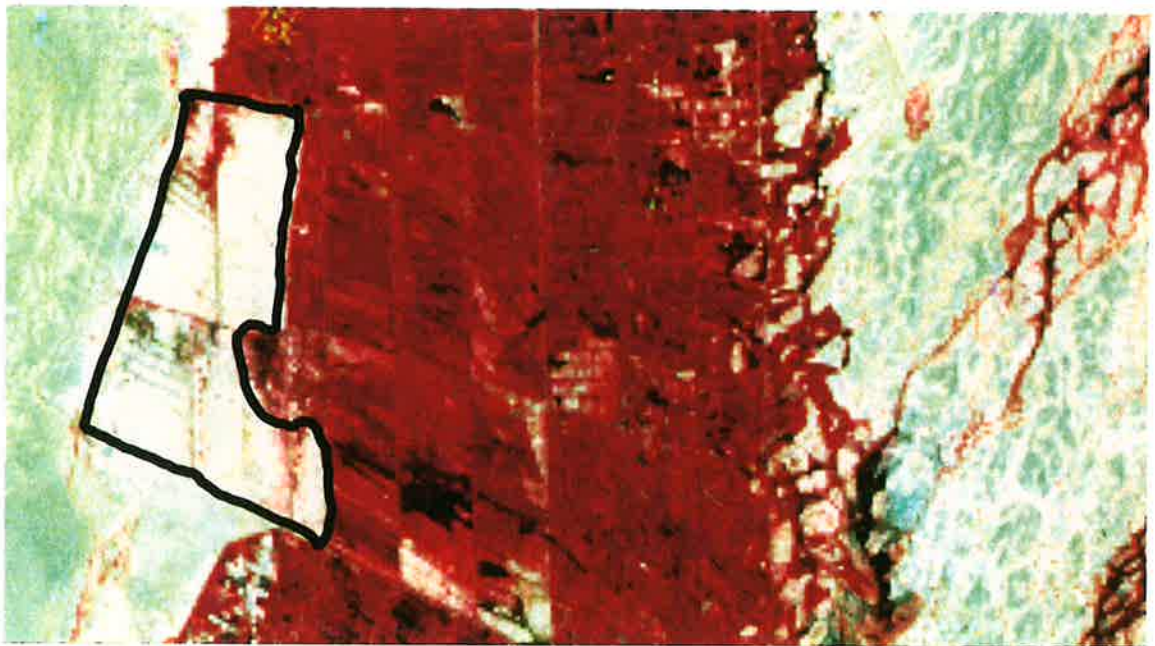
Figure 11 Study Site 9 - Western Marja

Patterns in Site 9, the west portion of Marja, appear similar to those in Site 8. In the 1973 image, evidence of recent cultivation and waterlogging can be seen. In the 1990 image, the land is abandoned and appears salinized. This can be due to blocked drainage outlets. Approximately 1,000 hectares are affected. Parallel lines visible in the imagery may be abandoned canals.

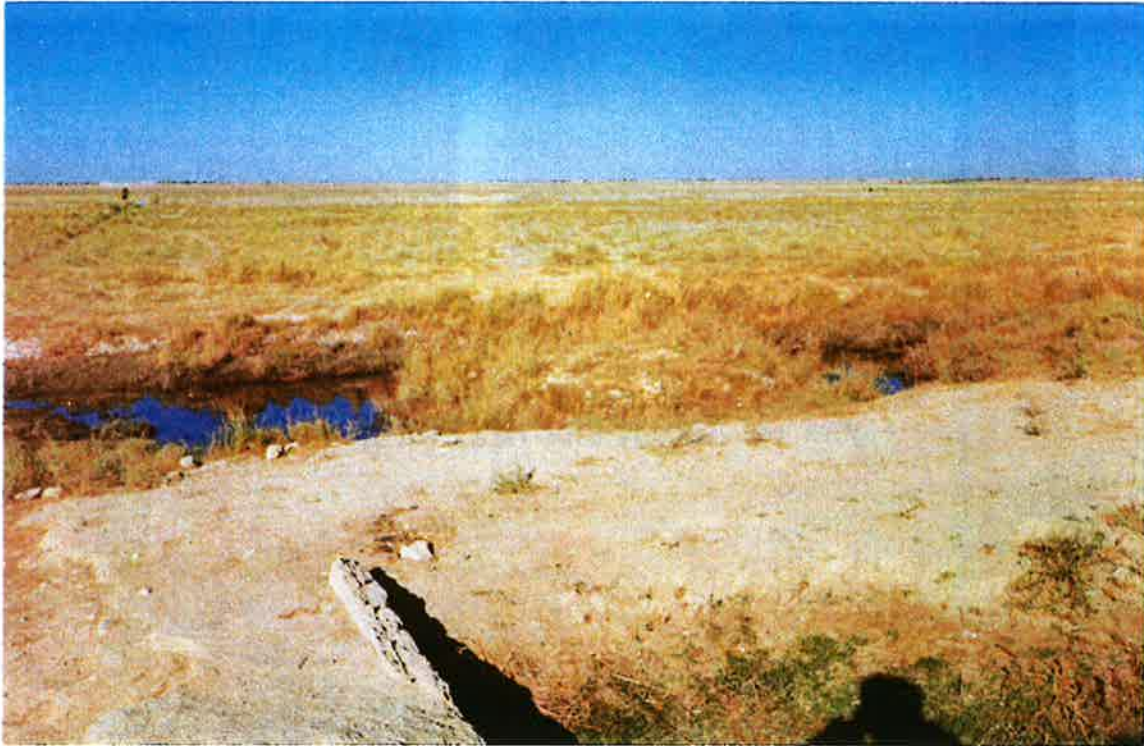
Site 14 (portions of which are shown on both Figures 15 and 17) is the largest area of change in the Helmand system. The area is located in the downstream/southwestern portion of Shamalan. Abandonment of irrigated agriculture between 1973 and 1990 encompasses more than 5,000 hectares. Most inhabitants have left the area. Rectilinear patterns of irrigated agriculture which are seen in the 1973 image have been replaced in the 1990 image by a background mosaic which appears strongly salinized. Only scattered/limited agriculture can be seen, particularly along canals and drains. Prior to the war, the area had been irrigated by the Shamalan Canal which was damaged by military activity and by floods. Inadequate canal maintenance led to constraints in water supply. Lack of maintenance of drains helped give rise to pockets of salinity. The field team that visited the area in December 1992 brought back photos which showed patches of salinity and adjacent standing water (groundwater) that was nearly at the level of the soil surface. (See Figure 16.)

Figure 16. Photograph taken near Site 14 which shows standing water and adjacent patches of salinity.

Better-drained land is currently being distributed in 2.4 hectares blocks to new settlers. Some farmers are irrigating their land with water from drains. The United Nations Development Programme (UNDP) and Mercy Corps International presently have a canal repair and cleaning project in the area.
