# THE COASTAL ENVIRONMENTAL PROFILE OF HIKKADUWA, SRI LANKA

To support Special Area Management Planning  
for the Hikkaduwa Coast and Marine Sanctuary

CRC Technical Report No. 2080

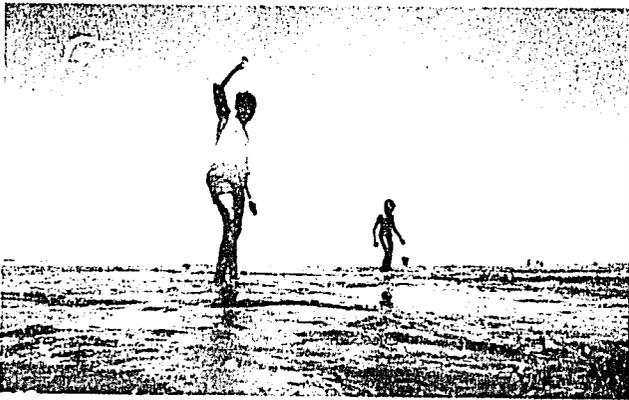
*People walking on the reef and breaking the corals*

foreign as well as local, stand and walk on the corals. Anchoring and dumping of oil by fishing boats is also a major problem. In addition, polluted water from fish holds and waste oil are dumped directly into the Sanctuary. The reef has been completely destroyed where the fishing boats are anchored. Further, fishermen continue to widen the gap in the reef in front of the Cooperative Beer Garden Restaurant to bring larger boats into the Sanctuary. Sedimentation of the coral reef is another cause of degradation. Much of this sediment is stirred up and deposited on coral as a result of boat movement within the Sanctuary.

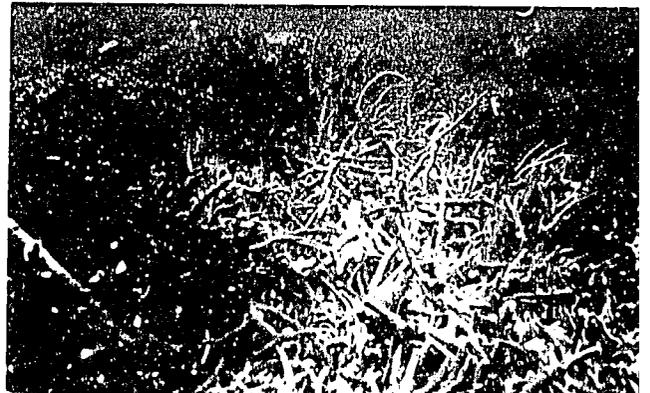
*Corals broken by glass-bottom boats in Sanctuary*

Coral reefs are a primary tourist attraction at Hikkaduwa, but as in other locations in Sri Lanka have suffered extensive degradation. Long-time residents of Hikkaduwa have stated that "entire sections" of reef have been destroyed. In recent years, the prevalence of coral mining has decreased in the immediate Hikkaduwa area. The large number of glass bottom boats operating without regulations, are now the main cause of coral reef destruction within the Sanctuary. The boats hit the corals, anchors are dropped, tourists,

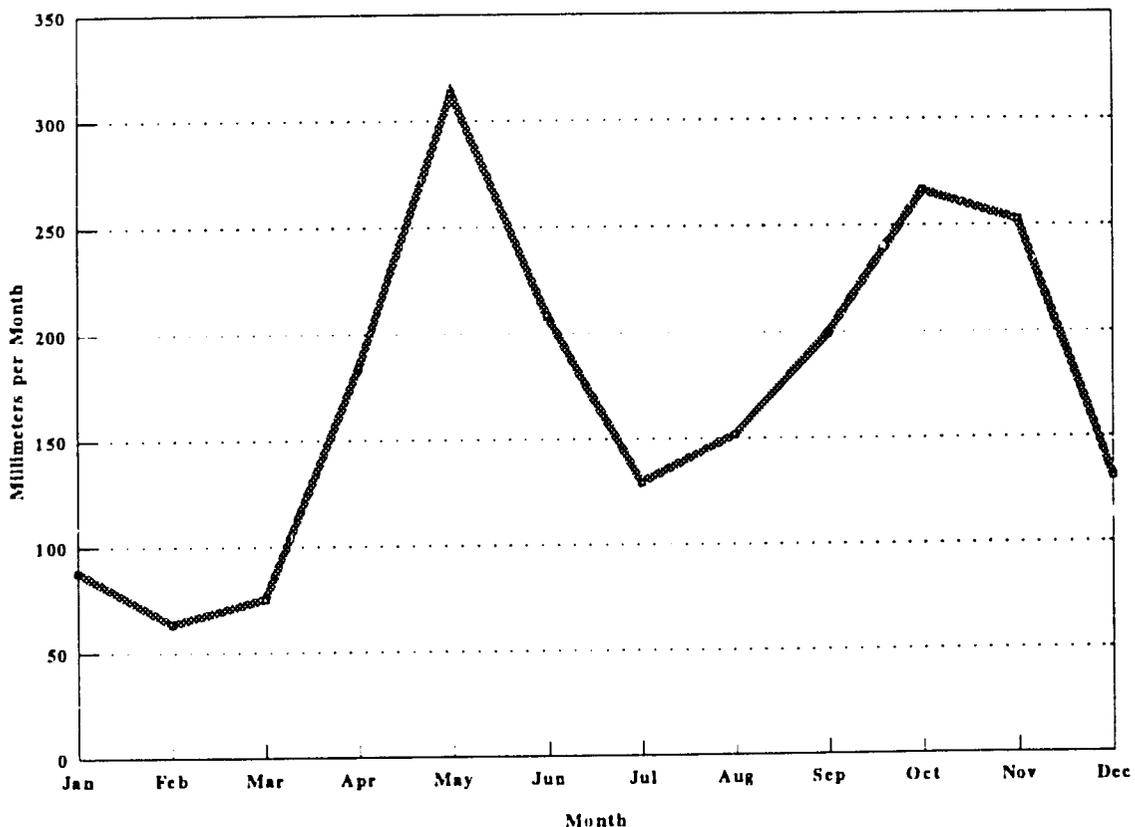
Figure 2.1 Mean monthly rainfall for Hikkaduwa area, 1983-1992 (Meteorology Department)

Hikkaduwa is located in Sri Lanka's wet zone on the south coast as shown in Figure 1.1. Annual rainfall in the area has averaged 2,073 mm for the last 10 years (Figure 2.1). There are two distinct rainy seasons, the southwest monsoon from mid-April to mid-June, averaging about 280 mm/month, and the northeast monsoon from mid-September through November, averaging about 255 mm/month. The driest part of the year is January through March, averaging 75 mm/month. The windiest time of year generally coincides with the southwest monsoon. Data collected for the last 10 years for Galle, which is representative of Hikkaduwa, shows that from May to October the average wind speed is 10.9 km/h, whereas from November to April it averages 6.5 km/h (Figure 2.2). There is little variation in the mean monthly temperature. Temperature data for Galle, which again is representative of Hikkaduwa, shows that the average range is from a low of 26.2°C in January to a high of 28.1°C in April (Figure 2.3).

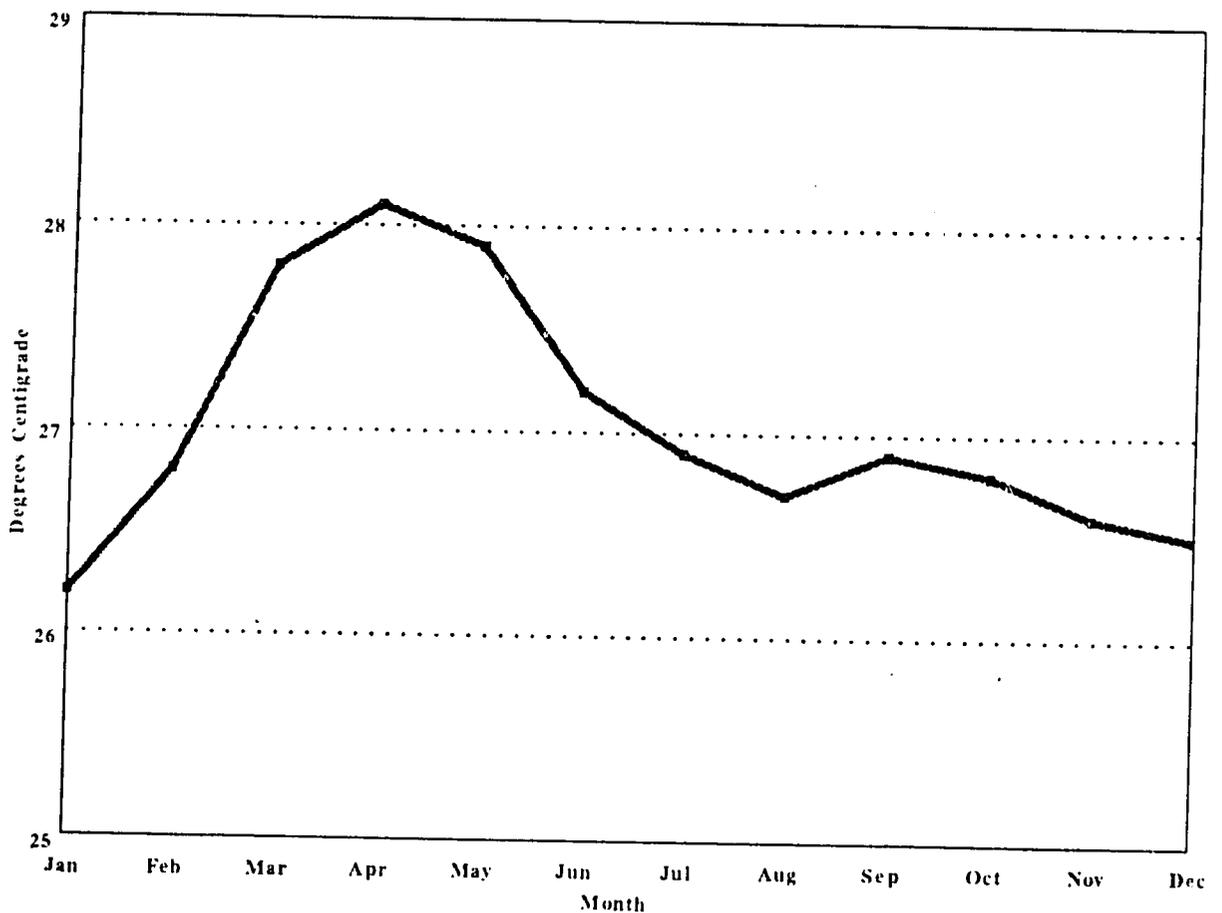
Figure 2.3 Mean monthly temperature in Galle, 1983-1992 (Meteorology Department)

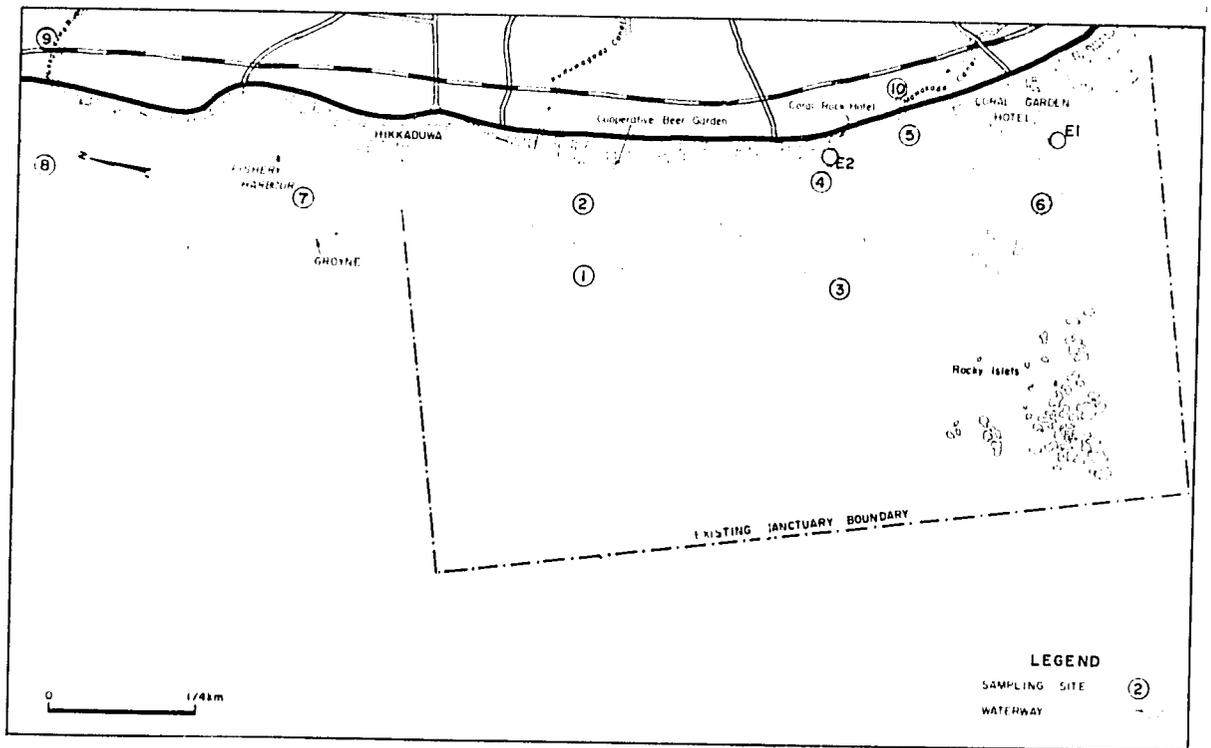
Figure 3.1 Water quality sampling stations for survey of June 1993 - May 1994 (De Alwis et al, 1994)

In the sanctuary sampling sites (Stations 1-4), the physical parameters did not vary much during the year and do not display extreme or unexpected values. The nutrient values were higher during the months of July through November but not significantly.

BOD in the sanctuary varied between 1 and 8 mg/liter indicating the buffering capacity of marine waters. BOD exceeded the tolerance limit set by the Sri Lanka Standard Institution and the Environmental Quality Standards of the Central Environmental Authority (CEA) on one occasion at Stations 1 and 3 and twice at 2. Faecal coliform

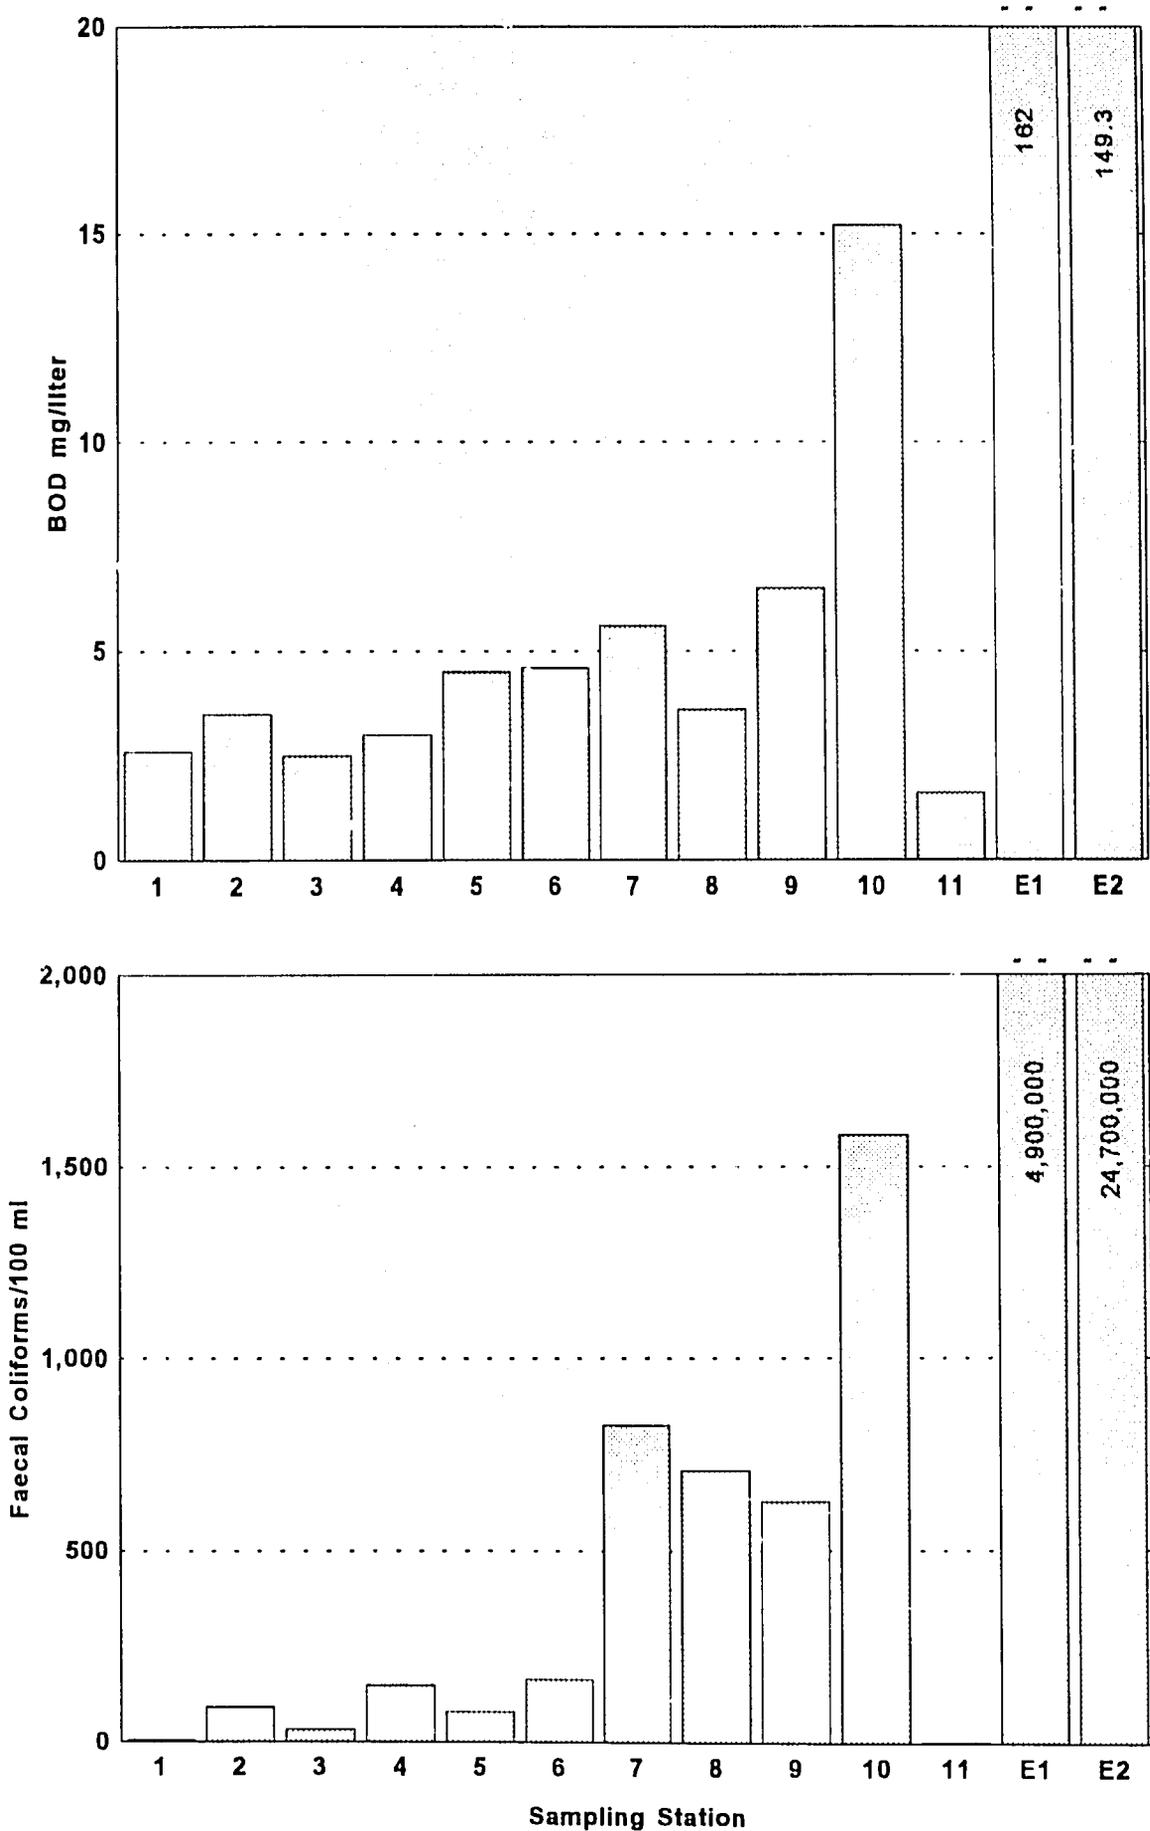
Figure 3.2 Relative mean variation in pollution indicators (BOD and Faecal Coliforms/100 ml) from 11 sampling stations in Hikkaduwa (De Alwis et al, 1994)

The Hikkaduwa River had good levels of dissolved oxygen whereas the Mawakada canal showed low DO levels with anoxic conditions noted on one occasion. BOD was also high in the Mawakada canal. Faecal coliform counts obtained from the Hikkaduwa River varied from 10 to 3600 cells/100ml and counts in the Mawakada canal went as high as 7200/100 ml indicating contamination of the water in both sources (Figure 3.2).

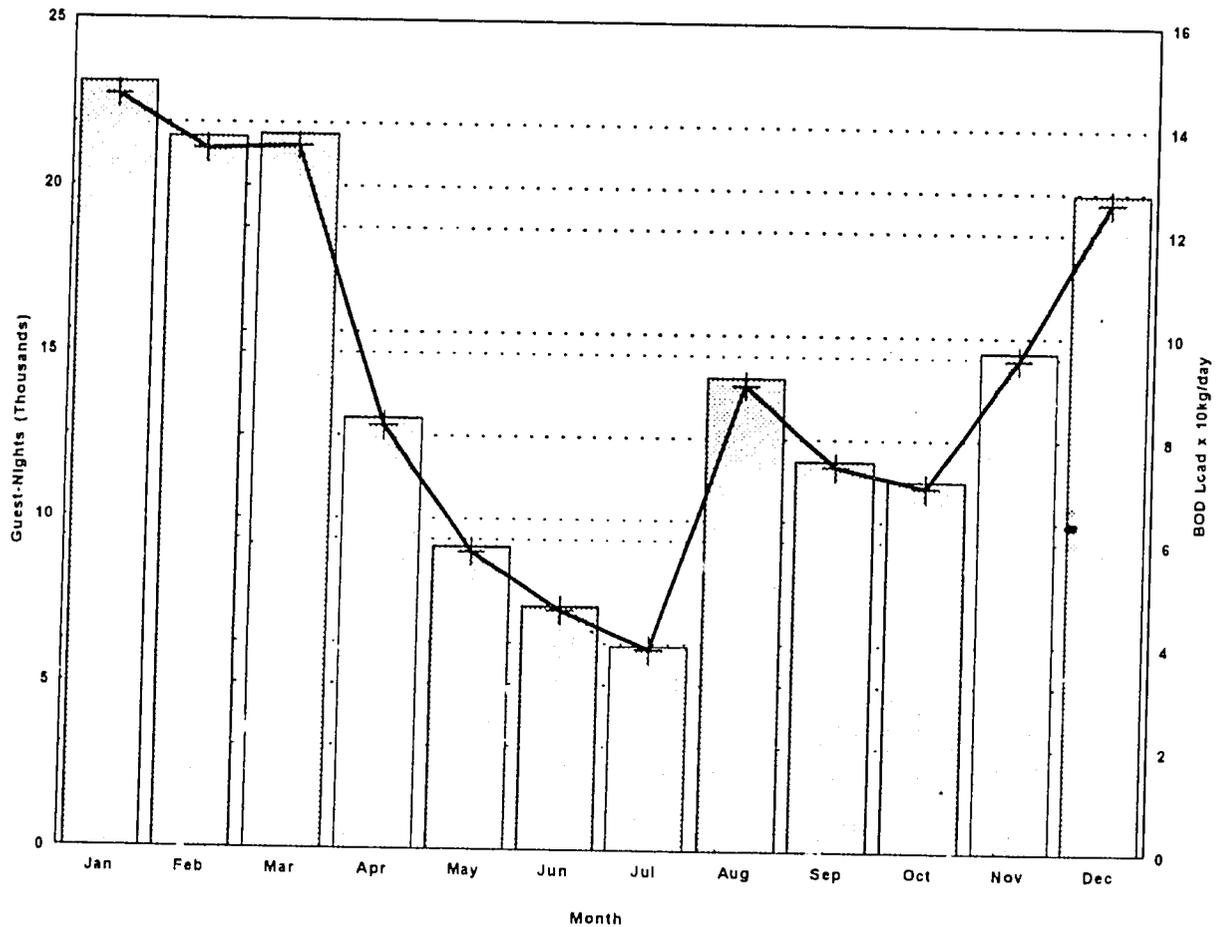
Figure 3.3 Potential BOD loads per month from a sample of 34 hotels (De Alwis et al, 1994)

It is noted by De Alwis et al (1994) that all the hotels, except one, released their effluent on land. Only the Coral Garden Hotel has a treatment plant for liquid wastes. All the other hotels have soakage pits and septic tanks. Although soakage pits and septic systems are generally effective if their design capacity is not surpassed, ground water as well as beaches are gradually polluted by seepage during rainy periods. Further, overflowing of concrete tanks, cracked septic tanks and deliberate pumping of sewage effluents into the sanctuary were noted during the study period.

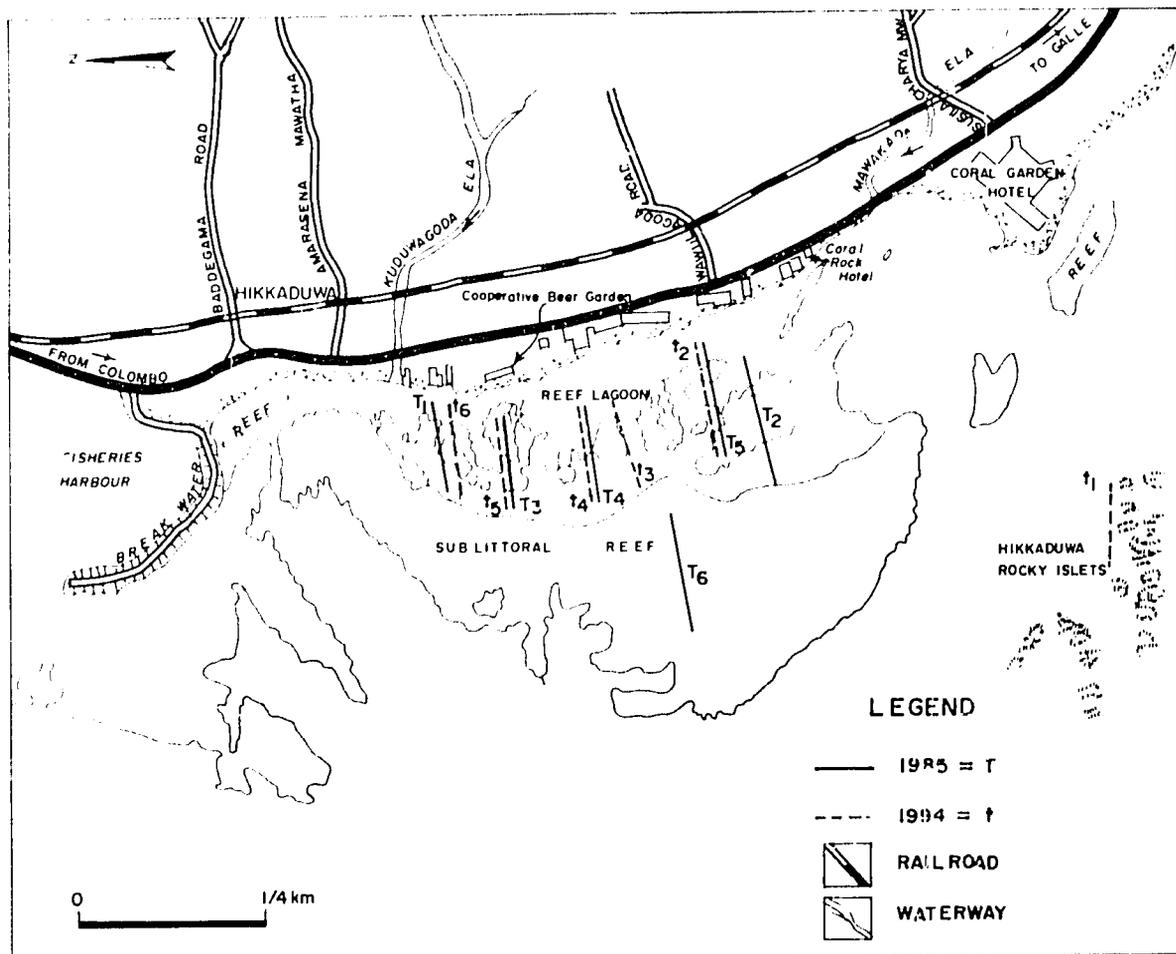
Figure 3.4 Location of coral reef and line transects for NARA surveys in 1985 and 1994

The remaining coral reefs occur primarily as fringing reefs in the Sanctuary between the Coral Gardens Hotel to the south and the Fisheries Harbor groyne to the north (Figure 3.4). The reef extends for about 130 m seawards before dropping to soft substrate at 7-10 m. The reef is separated from the shore by a 2-3 m deep channel parallel to shore. In the south, it abuts directly onto the shore. Spur and groove formations are found on the seaward face of the reef, particularly in the southern section. There is generally no marked coral zonation. A series of sandstone and rocky substrate reefs are also found just beyond the Rocky Islets at about 20 m. These are scattered with occasional coral colonies and gorgonians.

Surveys were conducted by NARA in 1985, 1992 and 1994 to assess the condition of the coral reef within the Sanctuary. Information collected during the surveys included the status of the coral reef, extent of live hard coral cover, dead coral, live soft coral, reef

\* See figure 3.4 for locations

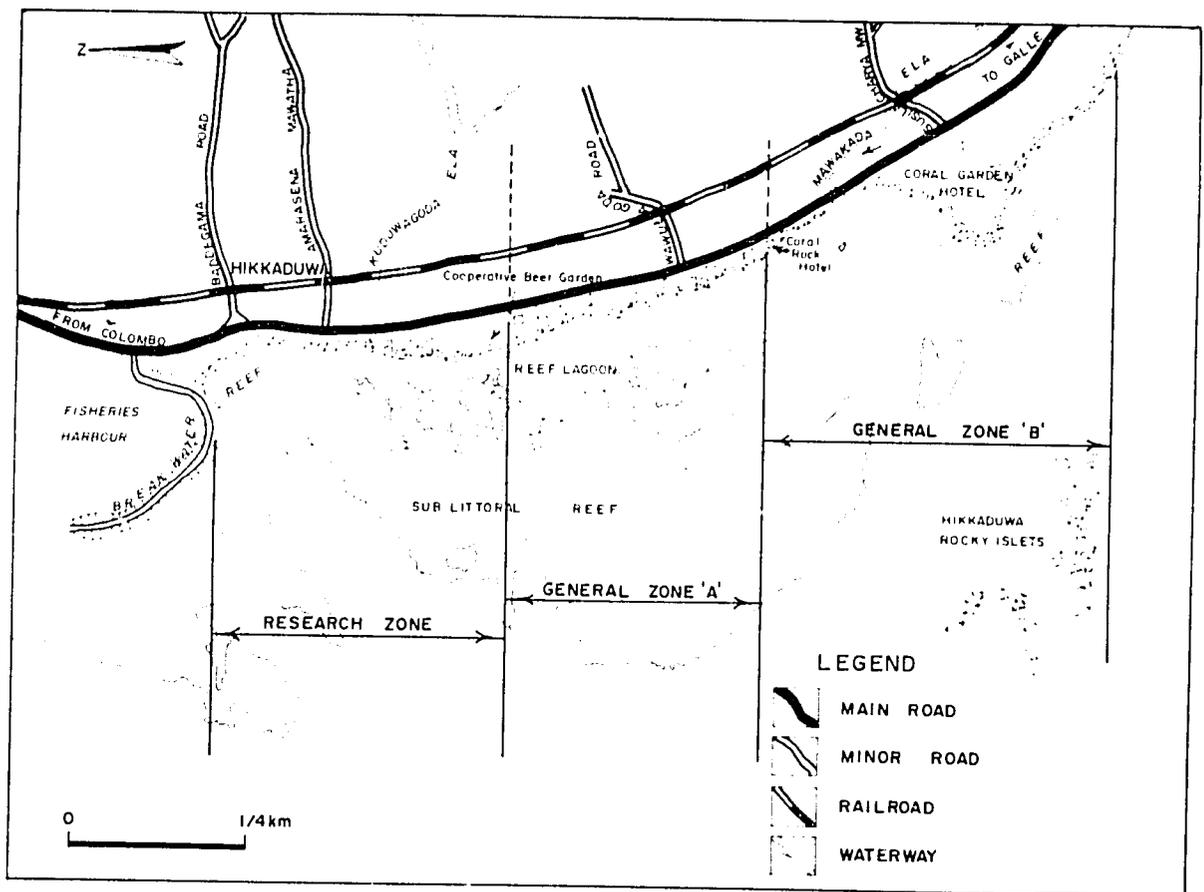
Figure 3.5 Zonation of Hikkaduwa Marine Sanctuary proposed by De Silva and Rajasuriya, 1985

De Silva and Rajasuriya in 1985 recommended zoning the Sanctuary for different uses (Figure 3.5). Although the proposed zonation was not implemented, it is useful to refer to it because they demarcated the zones according to user patterns within the sanctuary. The following was their analysis in 1985:

**Zone B (general use):** Live coral patches in reasonably good health grow around the Rocky Islets, which are located in this zone. Due to heavy visitor pressure, however, some have been damaged. Most glass bottom boats operate within this zone. Although this zone contains the highest amount of live coral the abundance of reef fish was relatively low.

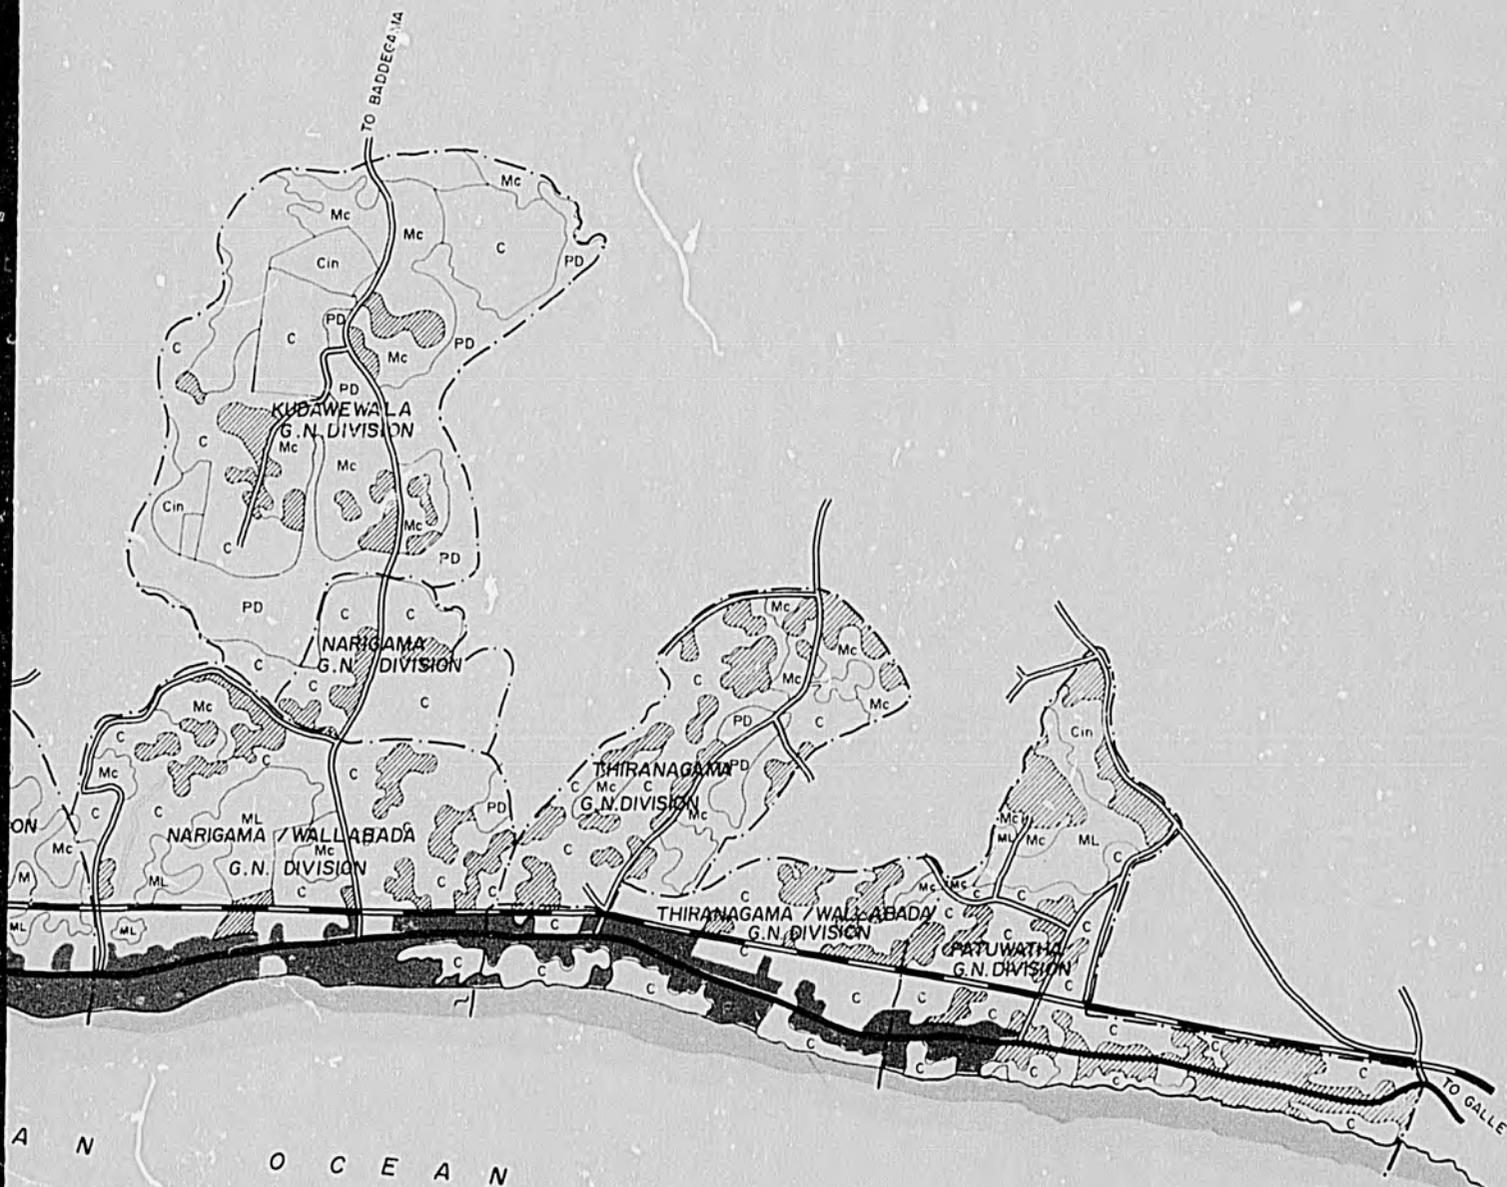
Figure 5.7 Overall land use and resource distribution in Hikkaduwa SAM area

highlighting beaches, water bodies, urban centers, tourism and agricultural uses

The most common use of land in the SAM area is for urban purposes, which includes land used for residential, public, tourist, commercial, industrial and religious purposes. This accounts for 39.8 percent of the SAM area. This is closely followed by land used for coconut cultivation, 35.3 percent. Following that is land used for mixed crops, 9.3 percent, vacant land, 6.2 percent and paddy 4.8 percent (Figure 5.6). The amount of land used for paddy has been decreasing due to salinization of soil close to the coast. A schematic representation of land use in the SAM area is shown in Figure 5.7. For the Hikkaduwa AGA Division as a whole, 42 percent of land is used for the cultivation of coconuts, 32 percent for paddy, 9 percent for home gardens and 8 percent for cinnamon (MPPI, 1990; GSI., 1989).
