**INITIAL ENVIRONMENTAL EXAMINATION**

**PROPOSED INDUSTRIAL ESTATE**

**TAMMANAKELE**

**December 1995**

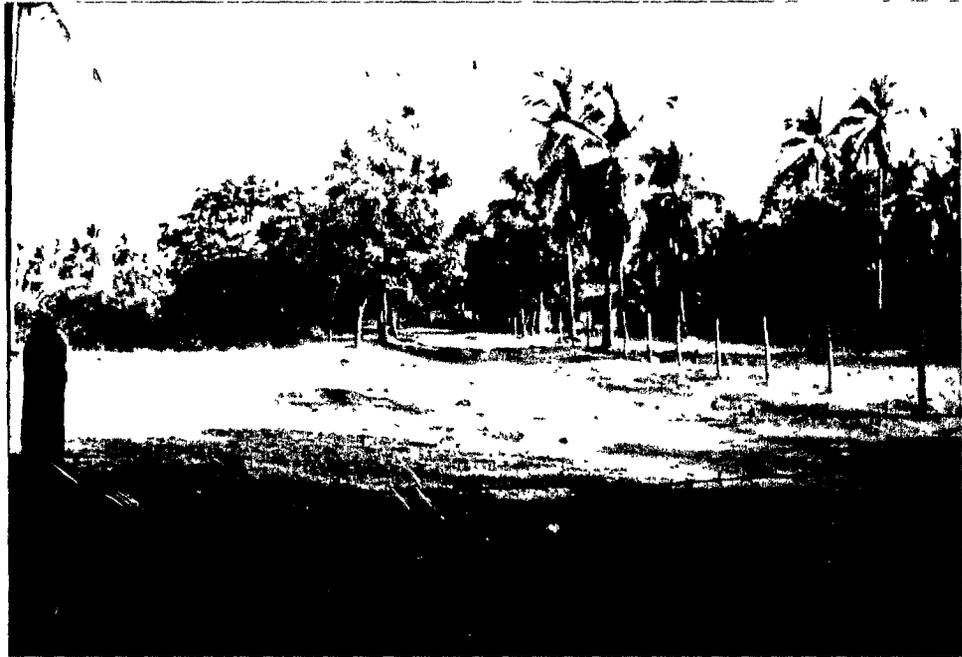
A. Proposed Industrial Estate Site at Tammanakele in Archchikattuwa.
