## Zambezi Survey -

A report to  
**USAID**

River depths in the Rio Zambeze  
during the dry season of 1993.

Project # 656-0237 & 656-0270.56

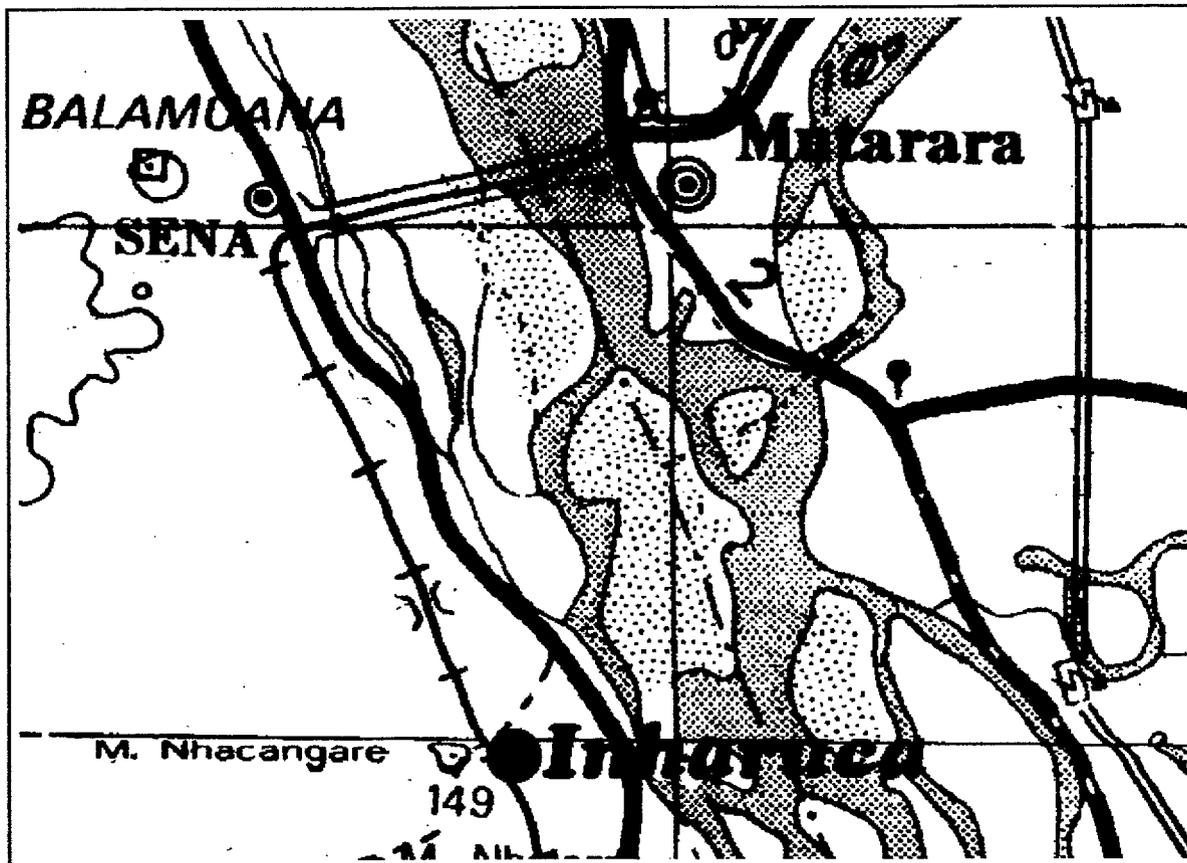
## A. Mutarara to Inharuca

Depth of water in the main channel between these two locations varies between 1.5 and 4 metres. The deeper water is on the NE bank, due to the influence of the Rio Ziu Ziu which enters the Zambezi to the south of Mutarara after rains. This river appears to receive some water from the Chire when that river is high. Crossing to the Inharuca bank is made difficult by the presence of a large island which is difficult to navigate around.

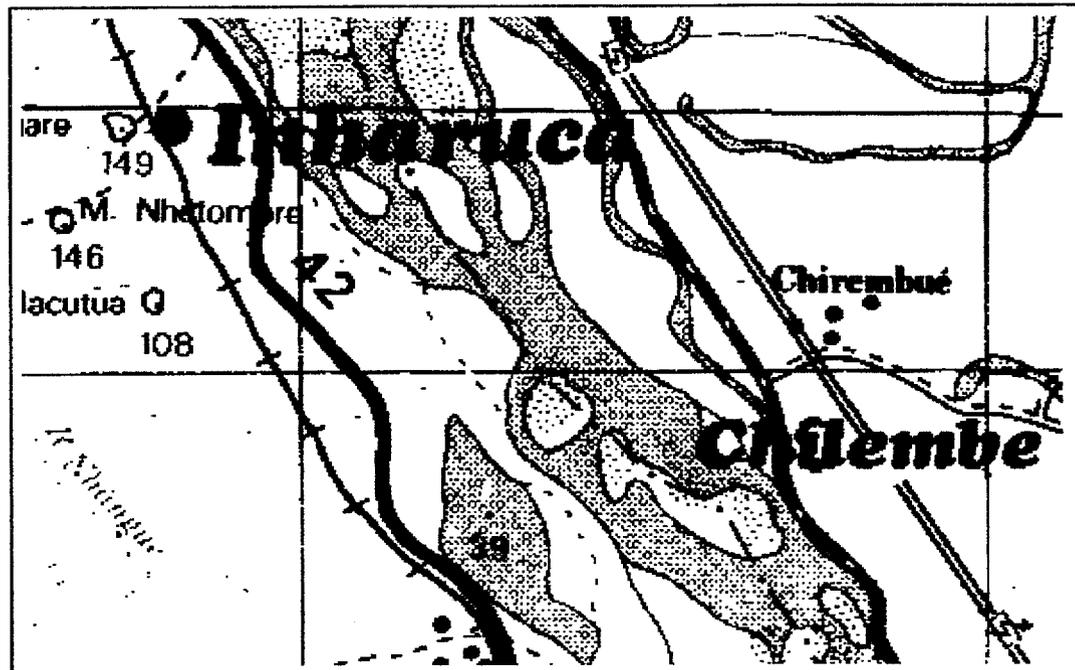
### B. Inharuca to Chilembe:

Depths between 1.5 mtrs. and 3 mtrs. The principal channel on this stretch of the river is on the SW bank. This region is almost completely uninhabited.

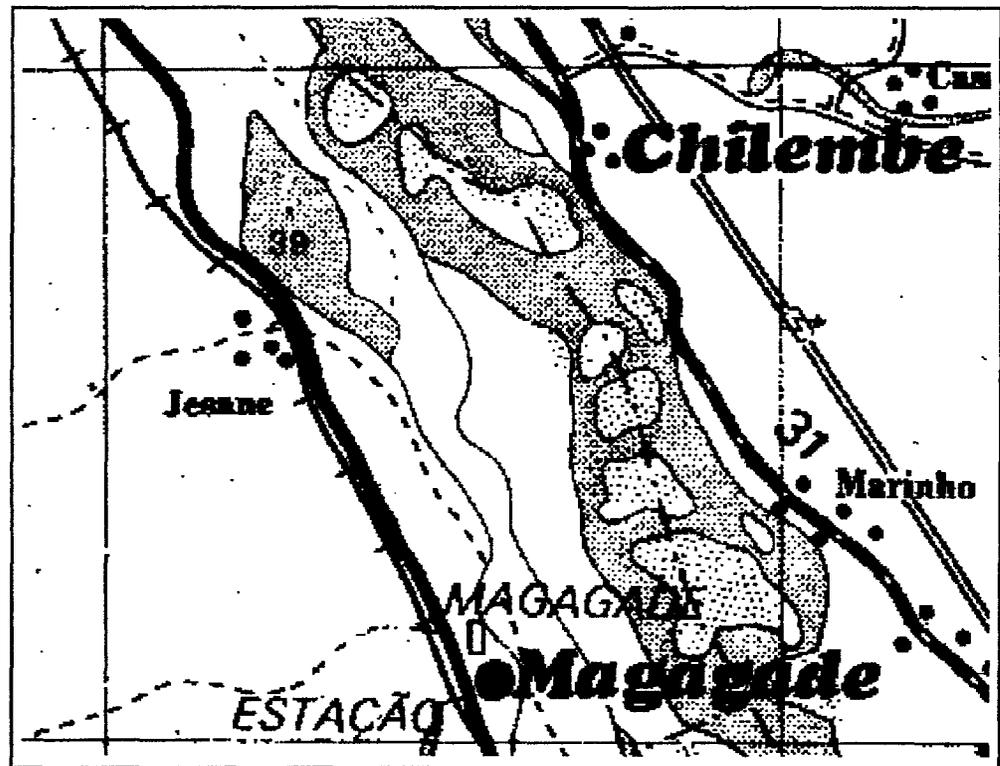
### C. Chilembe to Magagade:

Depths between Chilembe and Magagade fall to between 1mtr. and 3 mtrs, with the channel running parallel to the Magagade shore.

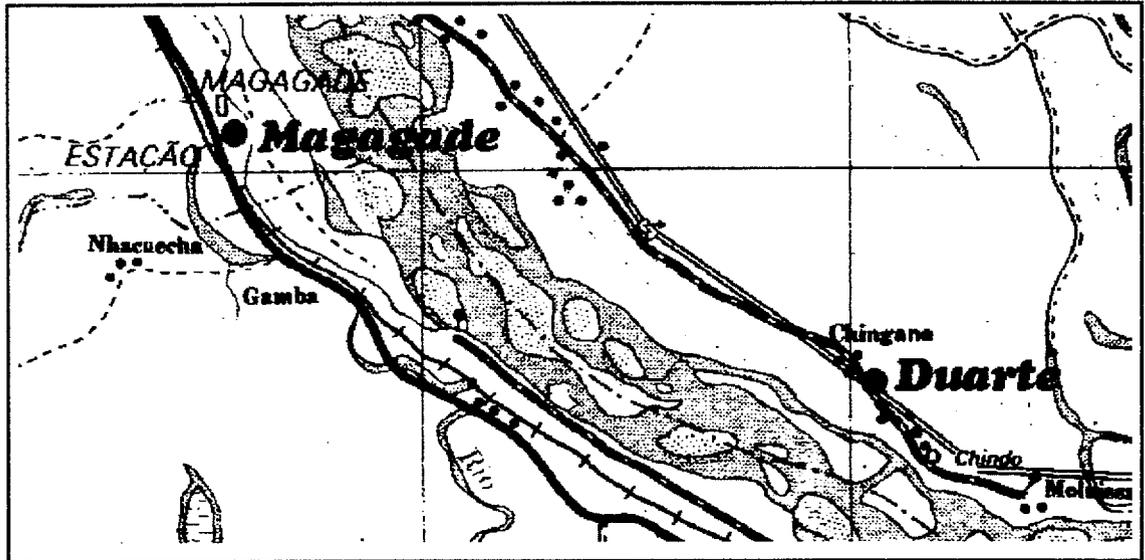
### D. Magagade to Duarte:

Depths in this area increase to between 6 and 8 mtrs. It is possible that the increase in depth is caused by a backing up effect of the confluence with the Rio Chire.

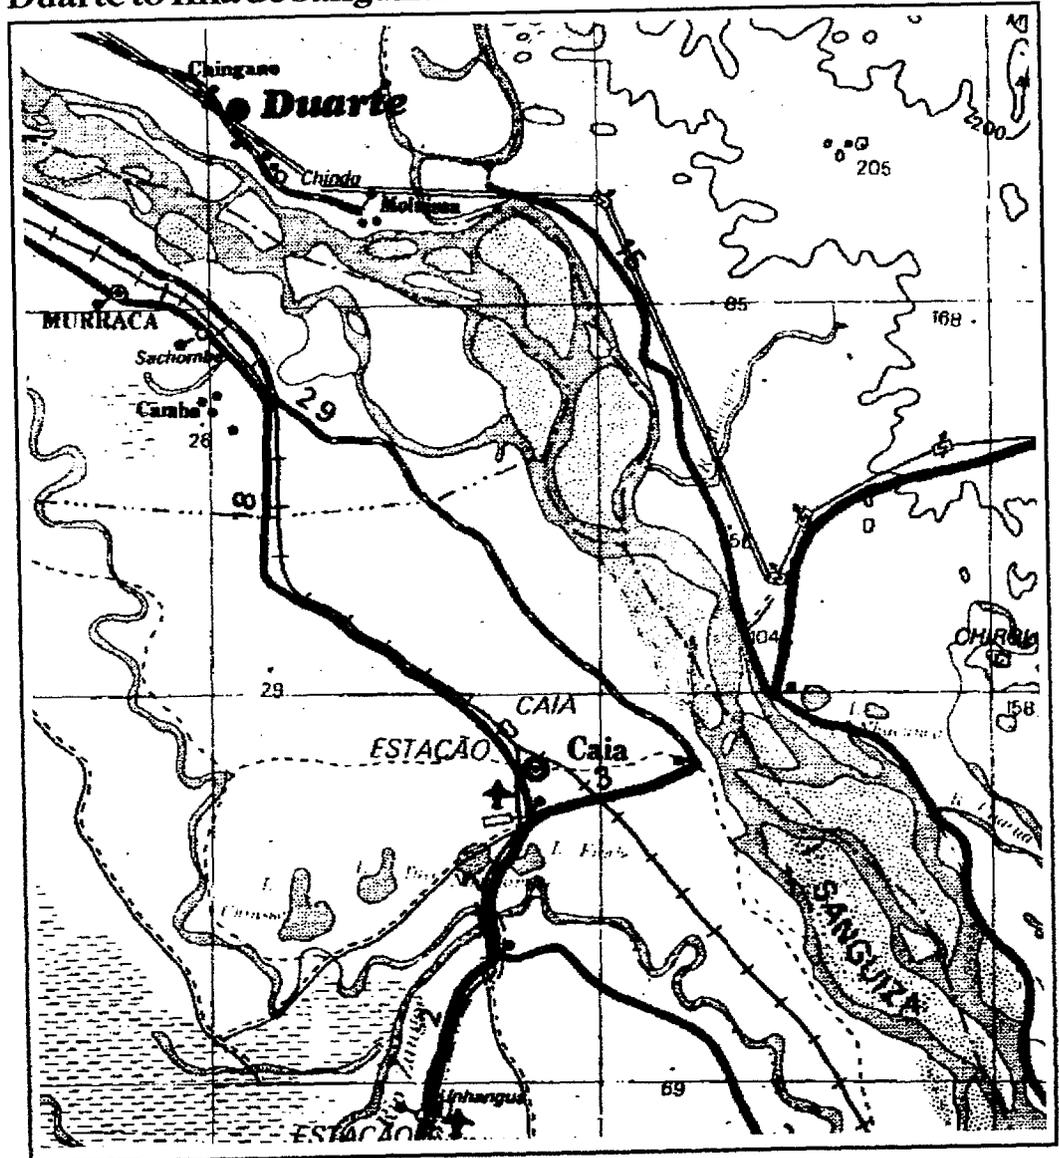
### E. Duarte to Ilha de Sanguiza:

The deep water caused by the confluence of the Chire of between 6 and 8 metres continues to a place called Chinuara, from whence it shallows to a depth of 3 metres, with the channel mainly on the NE bank of the river.

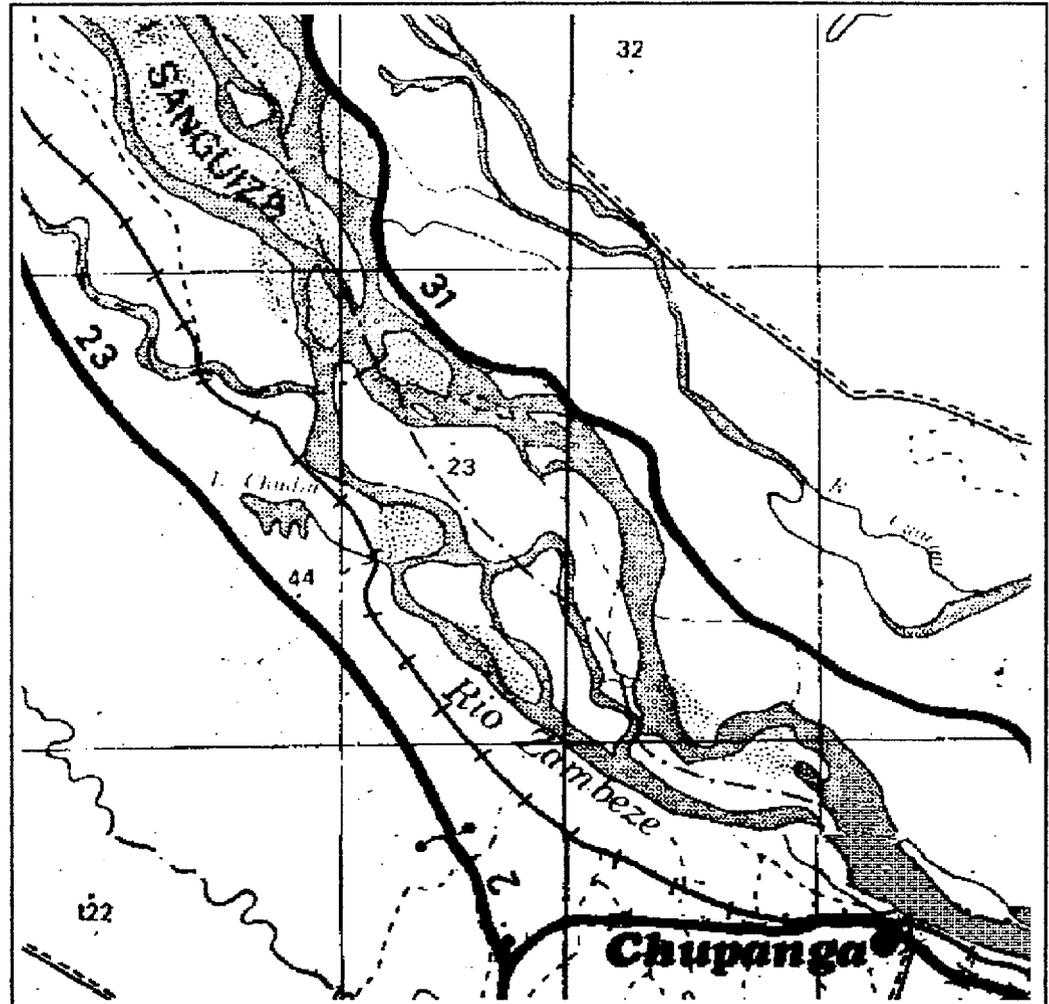
### F. Ilha de Sanguiza to Chupanga:

This is another deeper section with depths varying between 5 and 8 Metres. The 8 metre part is by Chupanga itself and was the site of the earlier ferry service. (See Para. XIII B.)

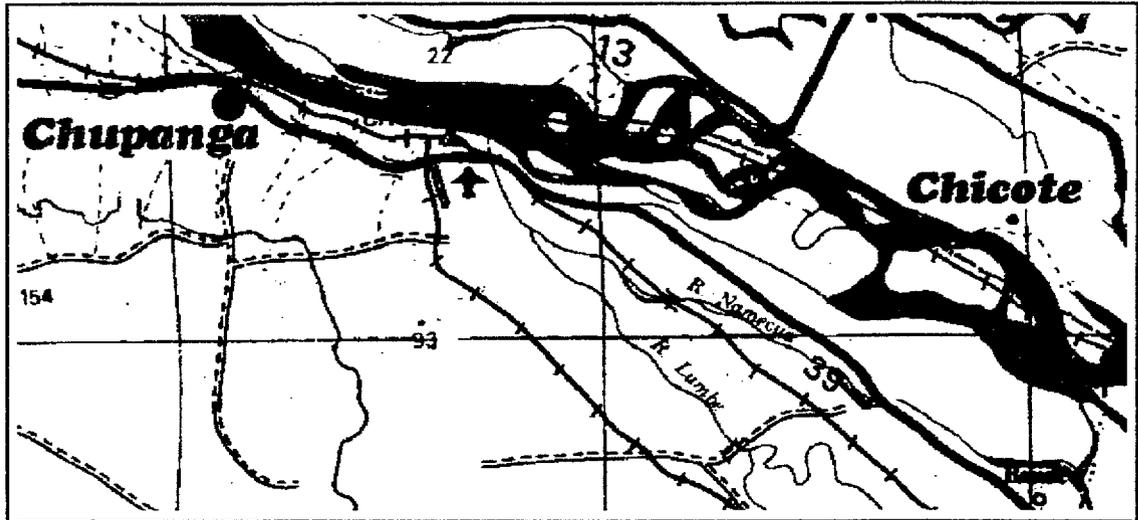
### G. Chupanga to Chicote:

This remains a deep area in general, with depths of up to 7 mtrs. However, some shallower zones with as little as 1 metre were also found.

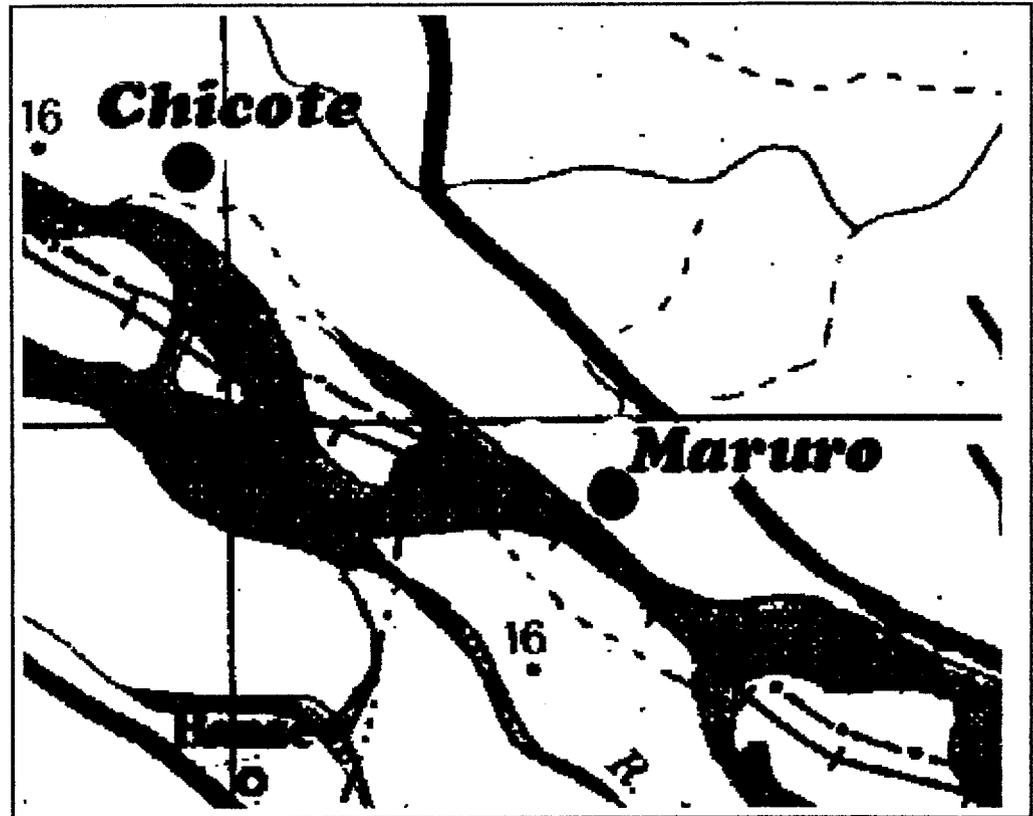
### II. Chicote to Maruro:

The main channel is on the NE bank of the river and is narrow and normally deep - up to 7 metres once more, but with short shallower sections down to 1 metre.

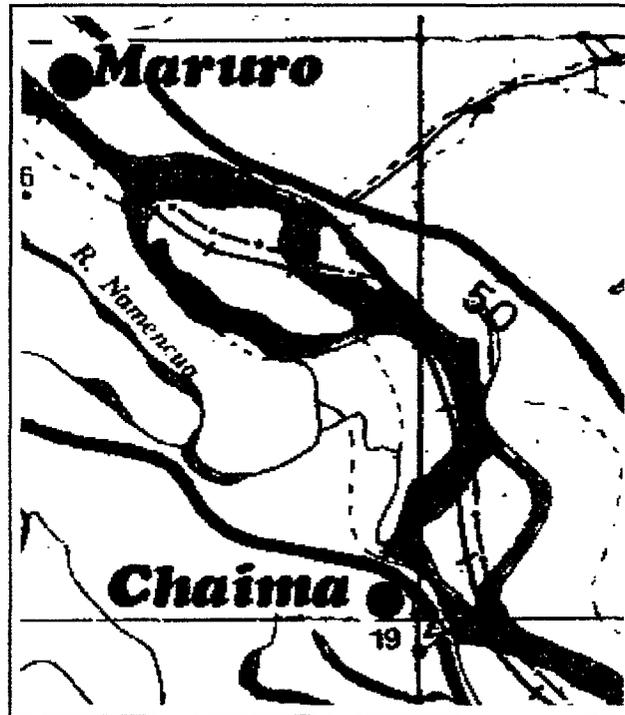
### I. Maruro to Chaima:

The main channel remains narrow, but deep, still on the NE side of the river. Depths vary between 2.5 and 5.5 mtrs.

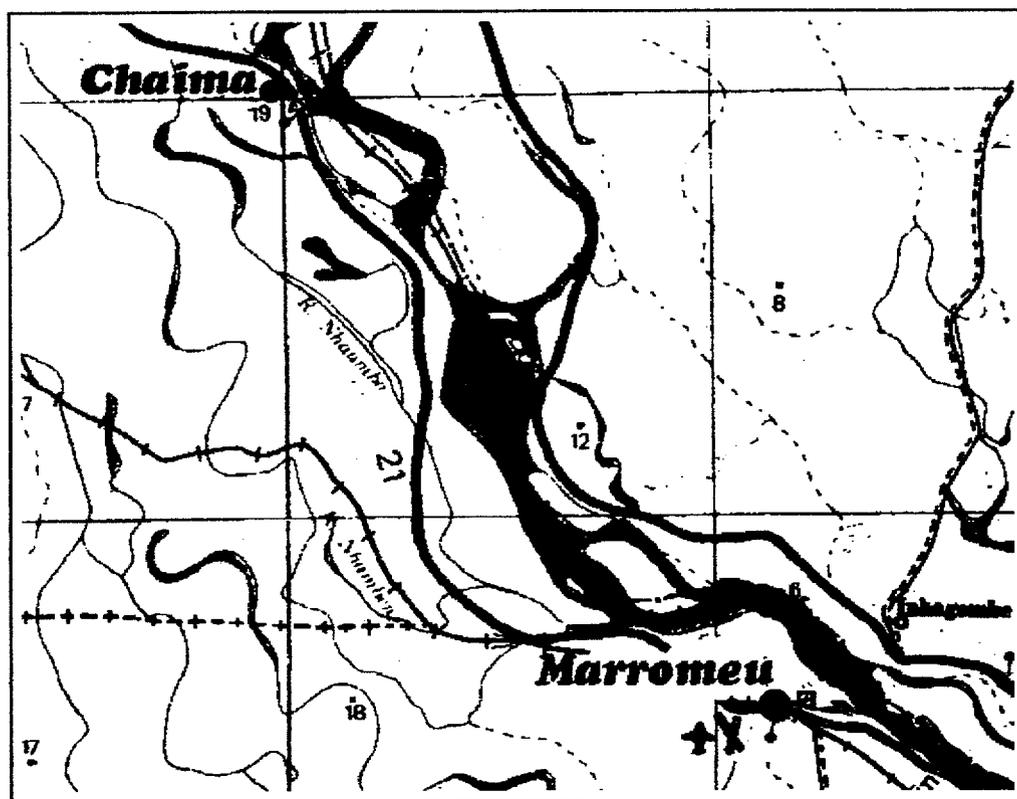
### J. Caimo to Marromeu:

Depths between 1 mtr. and 6 metres. The channel is wider in this zone.

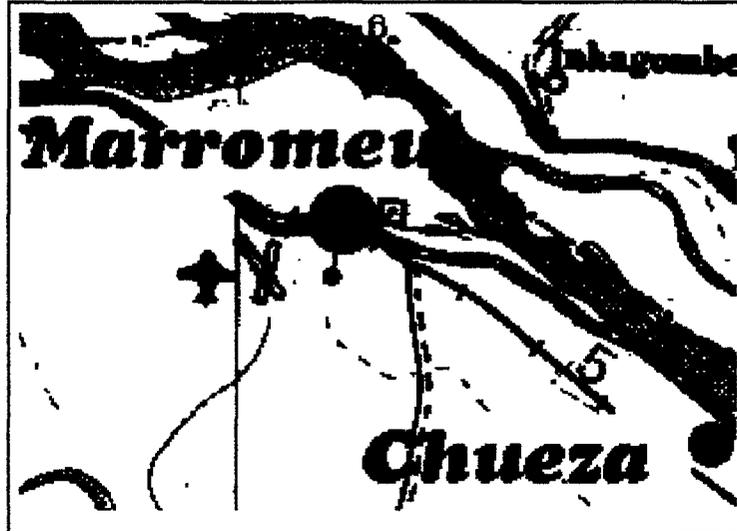
### K. Marromeu to Chueza:

- L. In the short distance between Marromeu and Chueza the depth is mainly between 5 and 5.5 mtrs. However, there is one area where depths only reach 1 mtr. This shallower patch is a limiting factor because it prevents barges from reaching Marromeu during the dry season. Instead, discharge is effected at Chueza and merchandise for Marromeu is taken by tractor from this point.

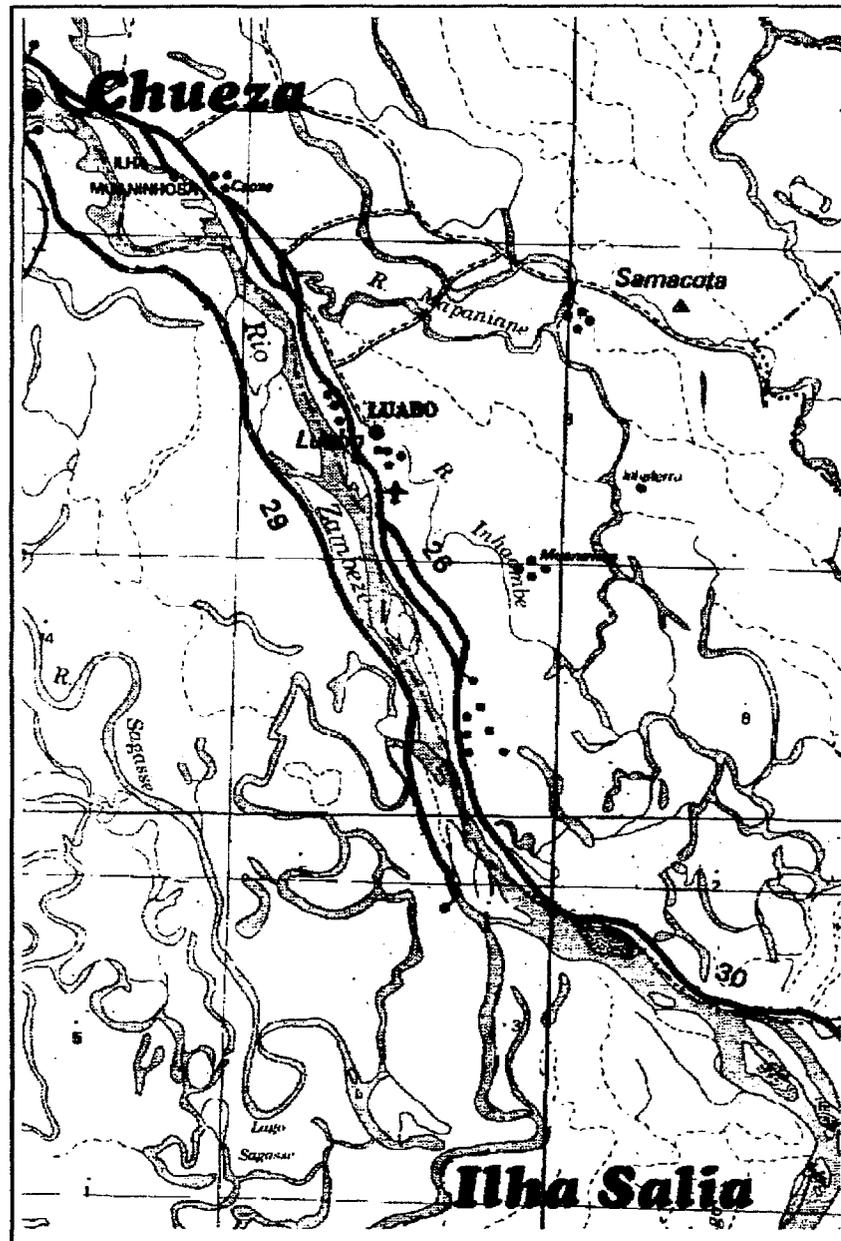
### M. Chueza to Ilha Salia:

From Chueza to the coast the river is navigated regularly by 60 ton capacity barge at all times of the year and regardless of the river level. This indicates that there is a minimum depth of 1.5 metres, and in most places the depth will be considerably greater. There is, however, a patch just to the south of Luabo where there is a minimum depth of only a little over 1.5 metres when the river is at its lowest.

The Rio Micelo, on the other hand, seems to be a much deeper channel and has at times been navigable as far as the main Zambezi. H.M.S. "Mosquito" succeeded in navigating through to the Zambezi, albeit with a great deal of difficulty. It is interesting to note that it was by this channel that the explorer David Livingstone first entered the river. However, the islands at the delta mouth are largely uninhabited other than for a few fishing families. Ilha Salia is the first zone to have any substantial habitation.

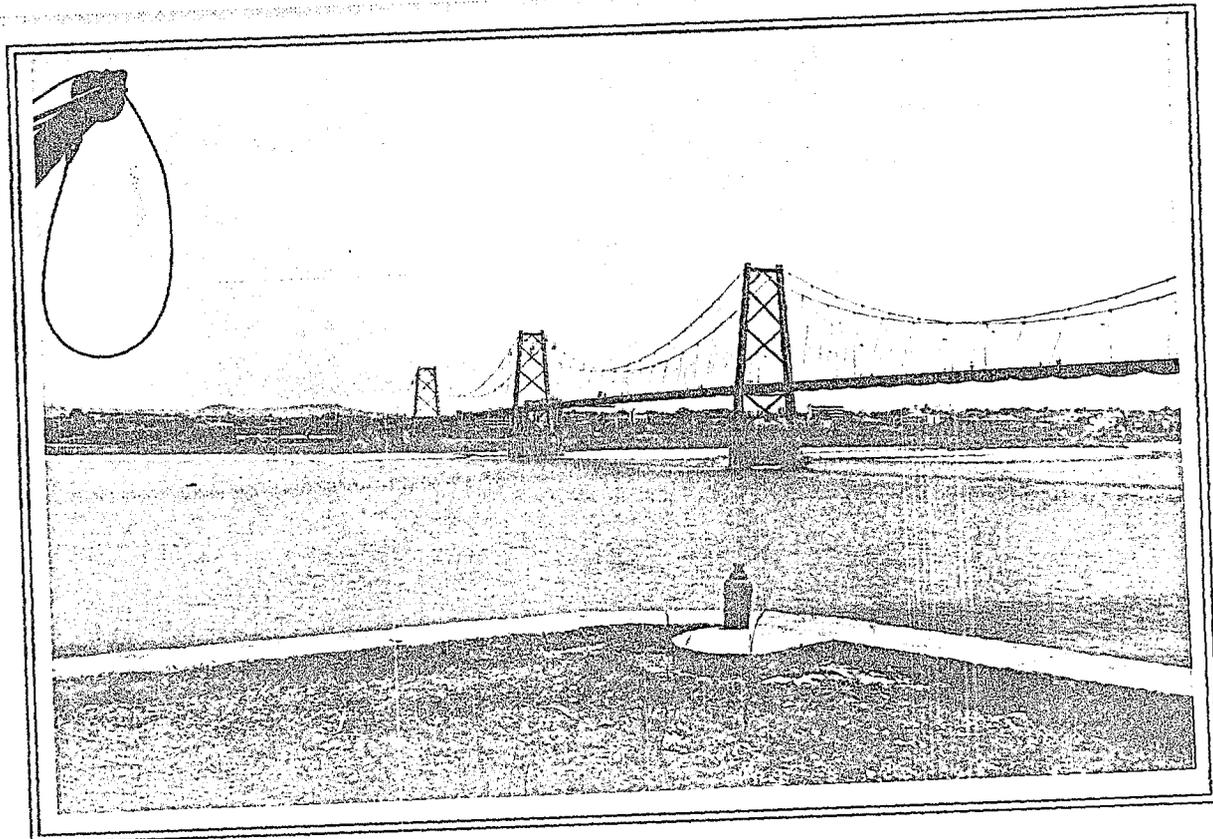
*Top. Bridge at Tete. Water Low! Bottom. Zambezi river 4km SW Tete.  
Date: 12/10/93*

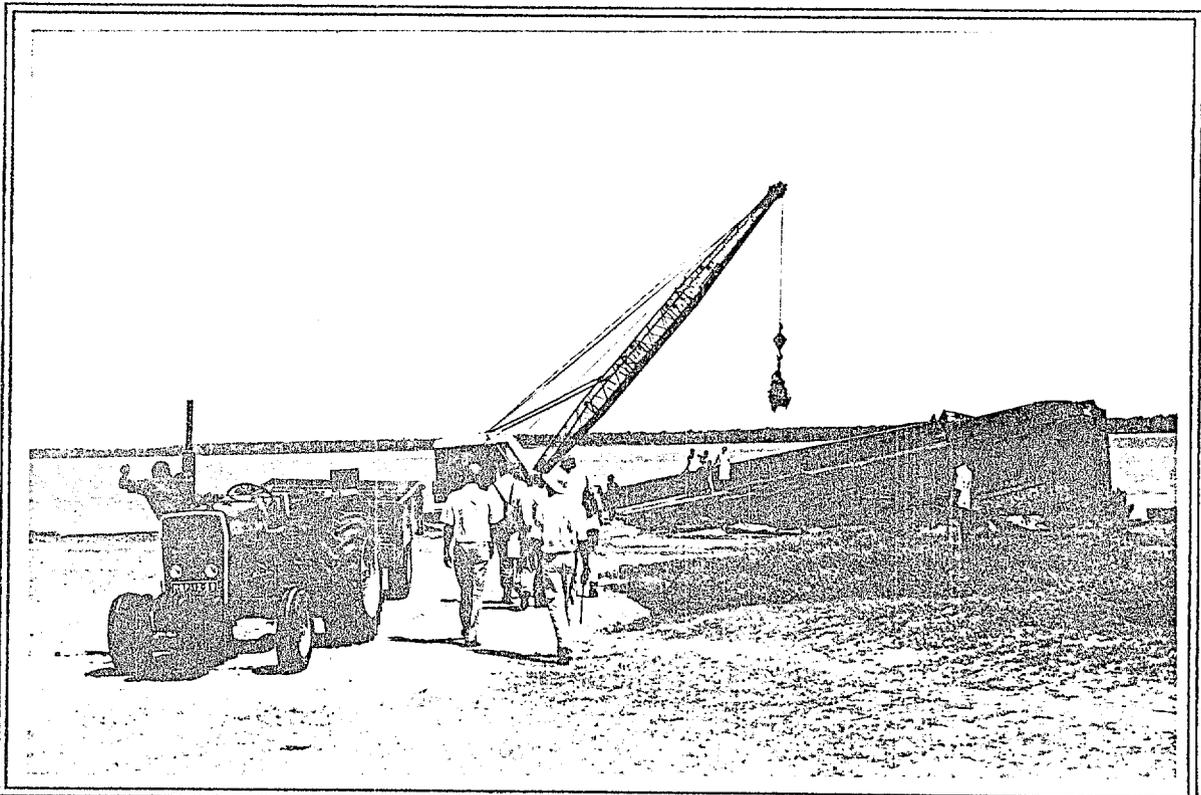
*Top.* Chinde ship wreck. Zambezi joining the Indian Ocean.  
& *Bottom.* Sunken ship used to discharge and load vessels. Date: 12/10/93
