**MOZAMBIQUE**  
**DEMINE REPORT**  
**(OPERATIONAL PHASE)**

**MOZAMBIQUE DEMINE PROJECT**  
**(USAID CONTRACT 656-0247-C-00-3036-00)**  
**(PROJECT 656-0235-3-30007)**

**JANUARY 1996**

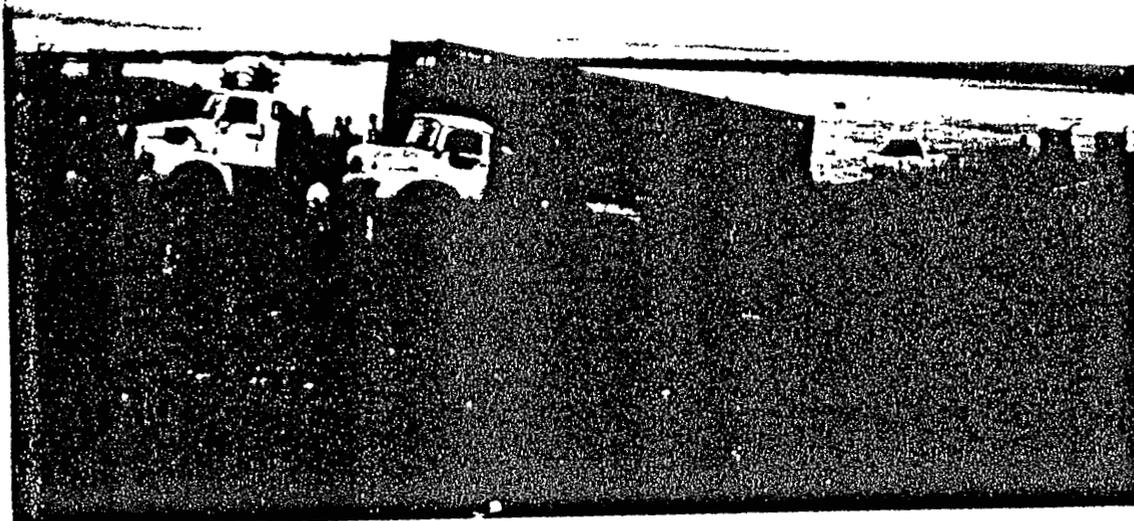
Cala Ferry

An example of the effects of weather was the erratic functioning of the Caia ferry. At that time, the Caia ferry, so crucial for the operation, was still going through teething problems with engine failures, bad navigation, etc. Coupled with this was the fact that the river water level was constantly changing due to the opening and closing of an upstream dam and flash flooding inland. This meant that the ferry crossing was closed for days at a time, and when it would happen could not be predicted. Even the river banks at Caia used to load and off-load vehicles onto the ferry were affected by bad weather, and delays of up to hours at a time were normal (see photos). To try to alleviate this problem, RONCO supplied some equipment (generators) and using its own vehicle winches, helped to off-load vehicles from the ferry to enable RONCO vehicles to proceed. One expatriate was stuck at the ferry crossing for 4 days and eventually drove an extra 1,000 kilometers via Malawi to get to his destination.

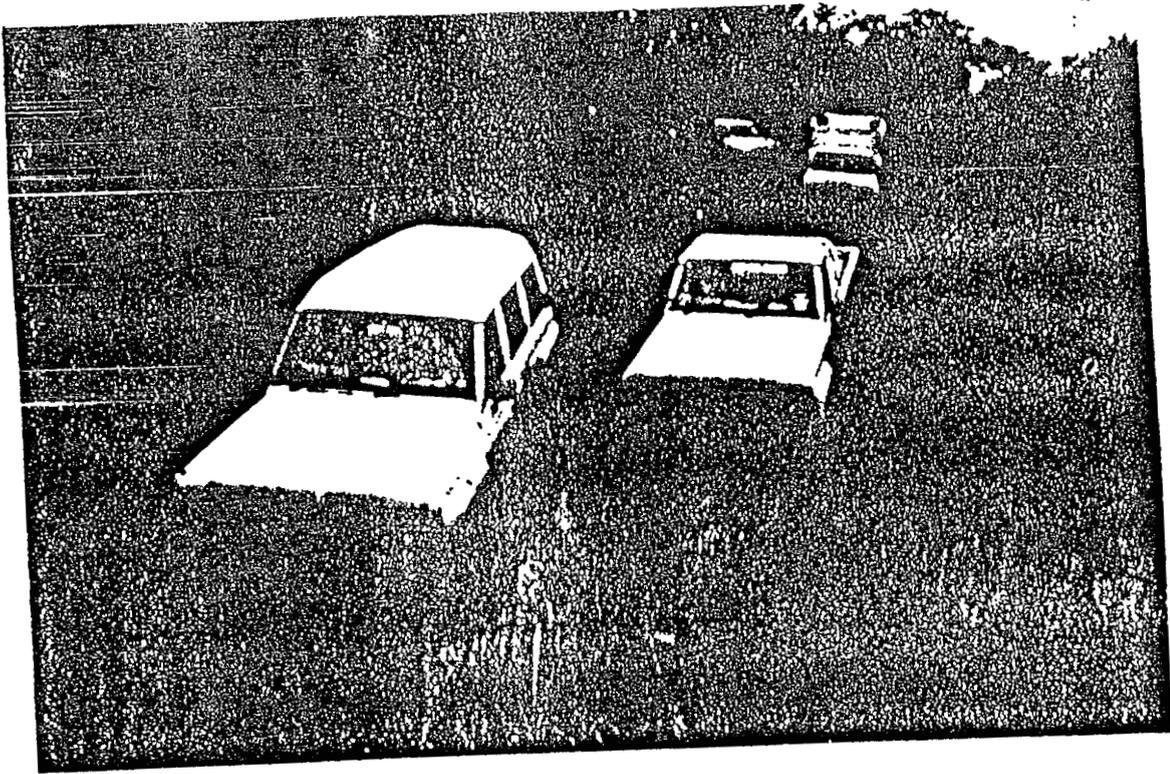
Zambezia Rainy Season Roads

During periods of low productivity, more than 50 percent of "demining time" was often consumed cutting through vegetation, repairing bridges, and upgrading the road surface so that project vehicles could safely navigate them. These road conditions were exacerbated during the end of 1994 and beginning of 1995 by an extraordinary rainy season in Zambezia Province that lasted six months, turning roads into quagmires and causing severe erosion (see photos).
