# Environmental Impact Assessment: Gros Islet and Soufriere

## Hurricane Lenny Recovery in the Caribbean

Contract Number 532-C-00-01-00006-00

August 28, 2001

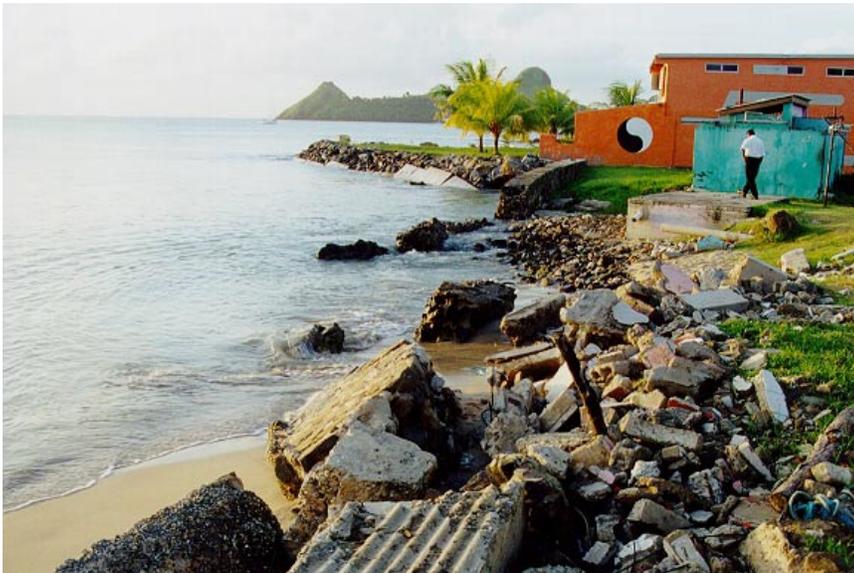
**Photo 2 Existing shore protection at headland of Bay Guesthouse**

The shoreline comprises a narrow sandy beach with three small headlands. Two of these headlands are occupied by guesthouses; Bay Guest House on the northern headland and Alexander's Guest House on the central headland. The southernmost headland supports the entrance to the Rodney Bay Marina. All three headlands are reinforced with rubble protection. In the case of the Bay Guest House headland, the owner has further protected his property by placing reinforced concrete slabs in front of the rubble stones (Photo 2).

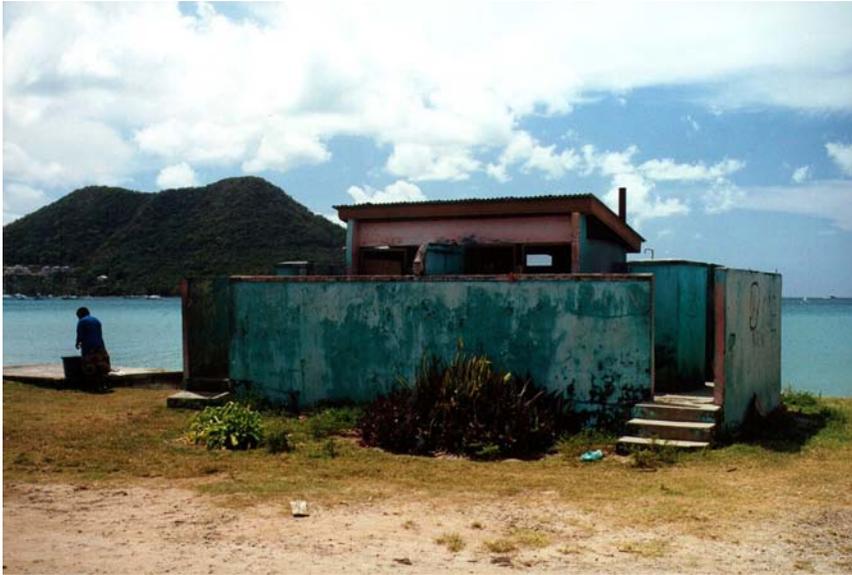
**Photo 3 Public convenience in poor state of repair**

Close to this headland are the remains of a collapsed sea wall, at the back of which is a small, disused public convenience with shower and toilet facilities (Photo 3).

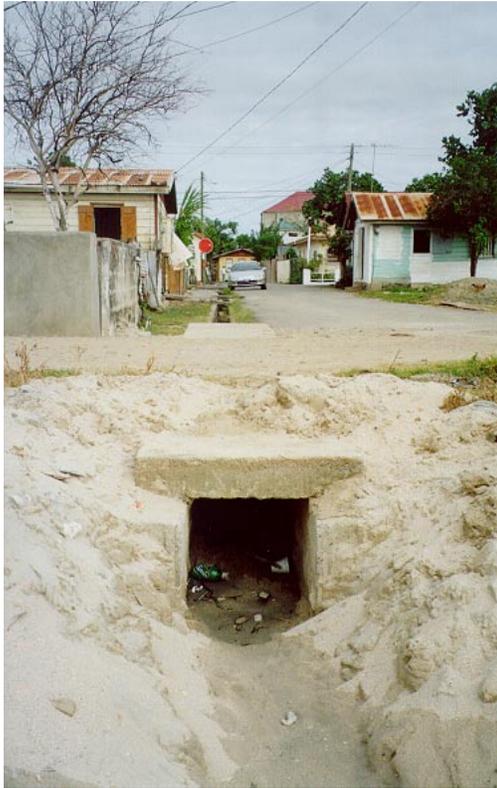
**Photo 4** Drain outfall directly onto beach

To the south of Dauphin Street, there is one drain that discharges directly onto the beach. This will be extended along the headland at the entrance to the Rodney Bay Marina and discharge into the sea at this point. It is intended that this discharge pipe would be placed within the existing armour stones of the north Rodney Bay channel entrance.

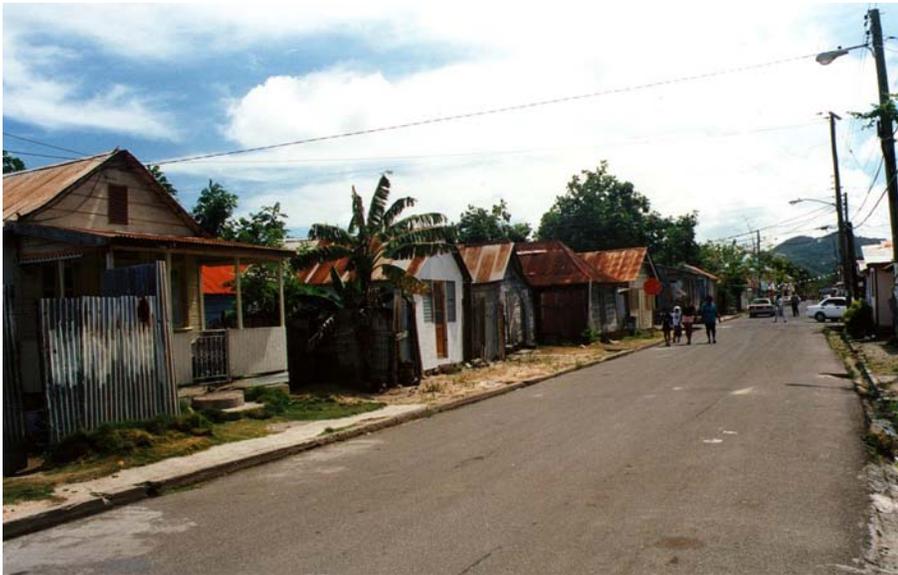
**Photo 6 Typical housing at north end of Gros Islet**

The houses in the study area have been constructed of timber, concrete walls or a combination of both (Photo 6). From the sample, it was recorded that 64.4% of the homes were constructed of timber, 20% of concrete wall and 13.3% of a combination. Of these, less than half (46.7%) are reported to be in good condition, 28.9% are in fair condition and 20% are in poor condition.

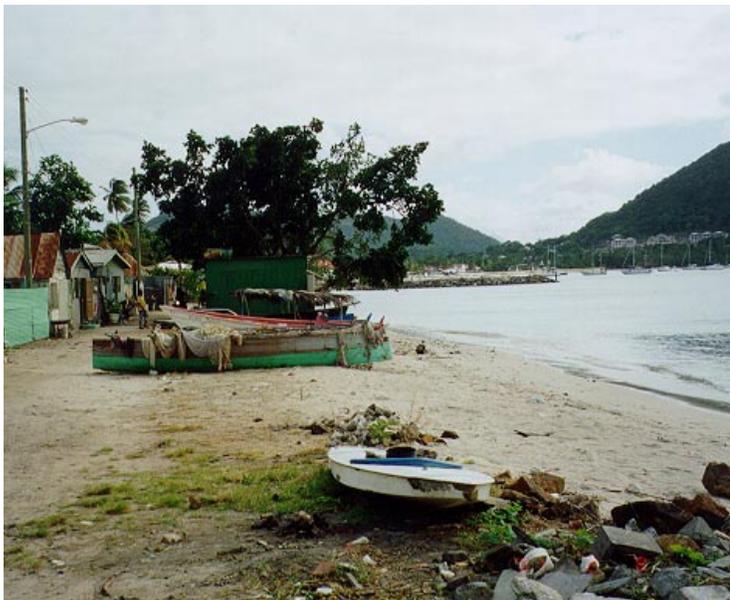
**Photo 7 Canoes hauled onto beach at Gros Islet**

At least 14 of the boats in the town moor alongside the fisheries facility, with four canoes hauled onto the beach and one located inside the marina itself (Photo 7). Fishers are apparently quite happy with the location of the facility and the greater convenience it affords the landing and marketing of fish.

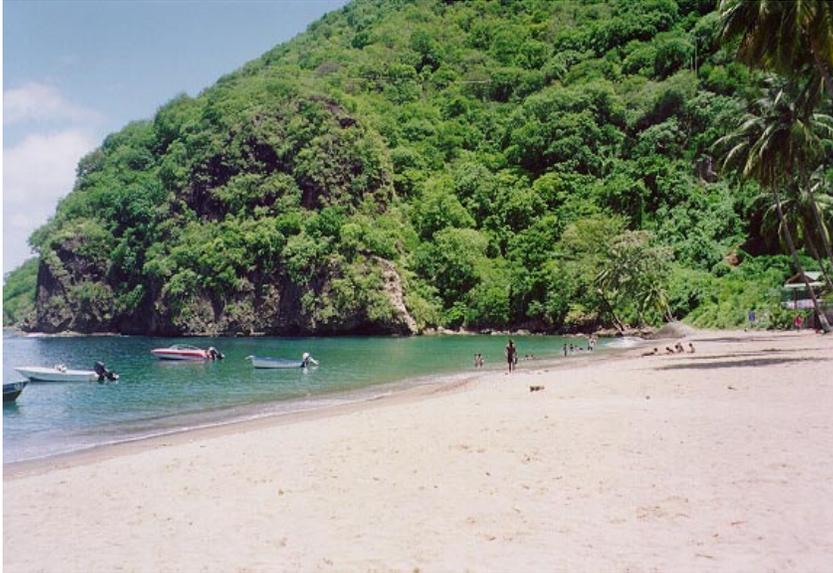
**Photo 1 Hummingbird Beach**

Southeast of the cliff area is Hummingbird Beach (Photo 1), which stretches for a distance of approximately 490 m until it reaches the town's waterfront area. This beach is mainly used for recreational and fishing activities and its waters designated a Fishing Priority Area by the SMMA. Although the beach itself has been designated as a recreational area by the SMMA, the main users are from the immediate surrounding community.

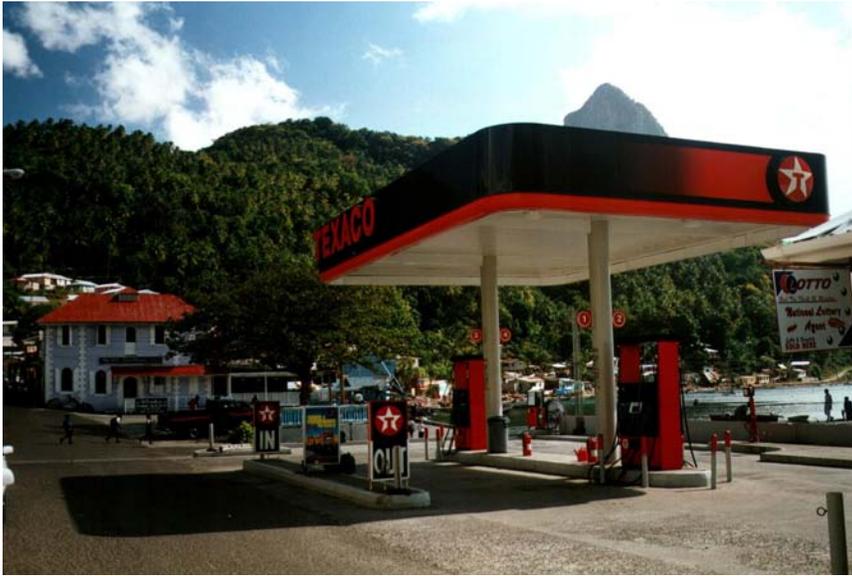
**Photo 3 Fuel station near the Soufriere waterfront**

South of Hummingbird Beach is the town's developed waterfront area. This area stretches for approximately 290 m ending at a fish market and storage building. Along the waterfront area are two yachting jetties that are used by both individual yacht owners and tour operators. A short concrete wall with pebble stone laid at the base protects the shoreline in this area. There is a very small sandy area in front of this protection. A portion of the waterfront just behind this wall has been recently landscaped. A fuel station also lies very close to the waterfront, just behind this wall (Photo 3).

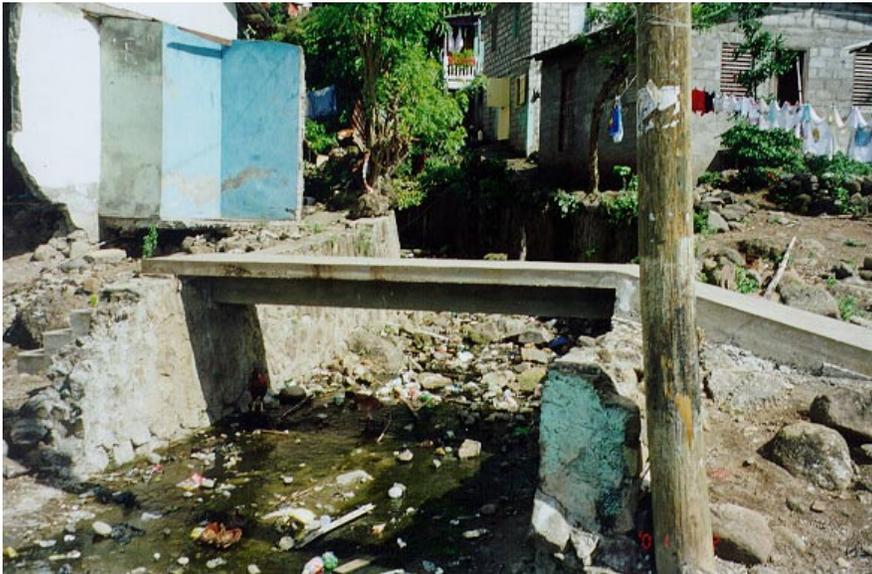
**Photo 4 Drain empties onto beach**

Further southeast of the fish market/storage building to the end of the Baron's Drive housing settlement, a narrow cobble beach continues for a distance of approximately 390 m. A large fishing community has developed in this area. The beach is mainly used by this community for fishing, bathing, washing and other domestic purposes. Several drains outfall directly onto the beach (Photo 4).

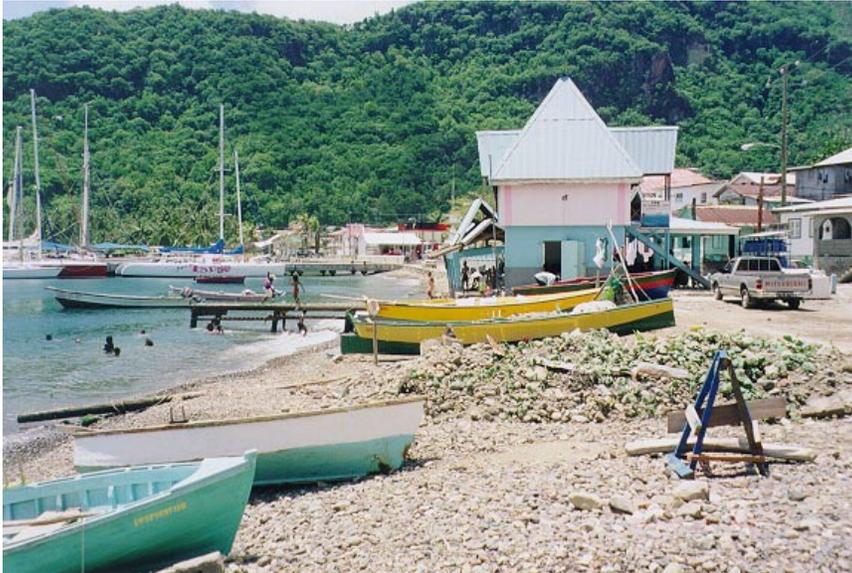
**Photo 5** Fishermen haul boats up onto beach along Baron's Drive

The Baron's Drive roadway separates the beach from the residents. This road was destroyed during the passage of Hurricane Lenny and is in poor condition, however it is still being used. Fishermen bring their boats straight up onto the beach in this area (Photo 5).

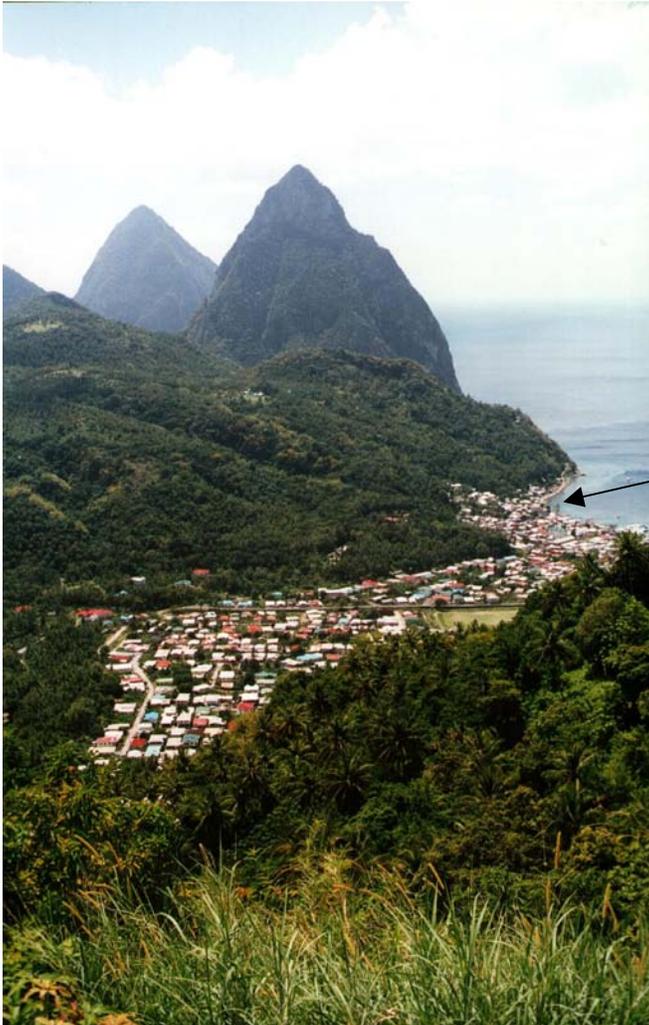
Photo 6 Looking south towards the town of Soufriere

Mountains ring the town of Soufriere, so that its flat land development potential is limited (Photo 6). This is particularly marked in the area landward of Baron’s Drive, where the ground elevation rises sharply from sea level.

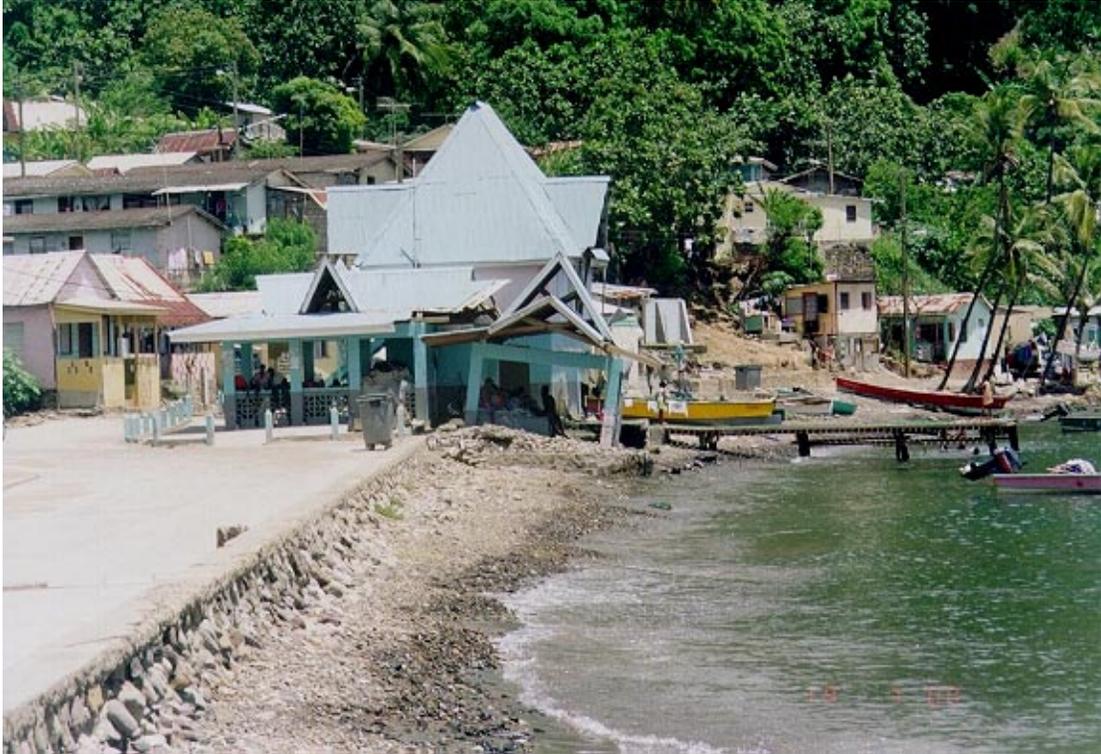
**Photo 7 Collapsed fish market**

With the passage of Hurricane Lenny in November 1999, the land on which the fish market stood was washed away by the storm surge, and the structure collapsed (Photo 7). The fuel station and the jetty alongside the fish market were also destroyed, as were the arts and craft market and the larger northern jetty. Six fishing boats were sunk and many more were damaged.

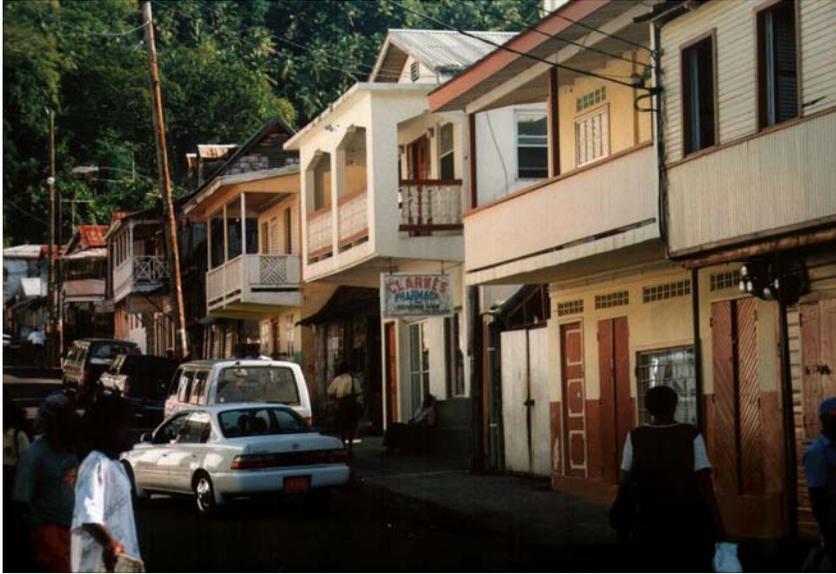
**Photo 8 Commercial section of Soufriere**

Building height in the commercial land use zone is primarily two-storey. Buildings in the residential zone are mainly one storey, with a few two-storey structures. Building density in the commercial zone is typical of urban centres in the region (Photo 8), while the very high housing density at Baron’s Drive is typical of regional urban slums.
