Landslides Induced by Hurricane Mitch in El Salvador— An Inventory and Descriptions of Selected Features

*By Anthony J. Crone, Rex L. Baum, David J. Lidke, Damon N.D. Sather,
Lee-Ann Bradley, and Arthur C. Tarr*

Open-File Report 01-444

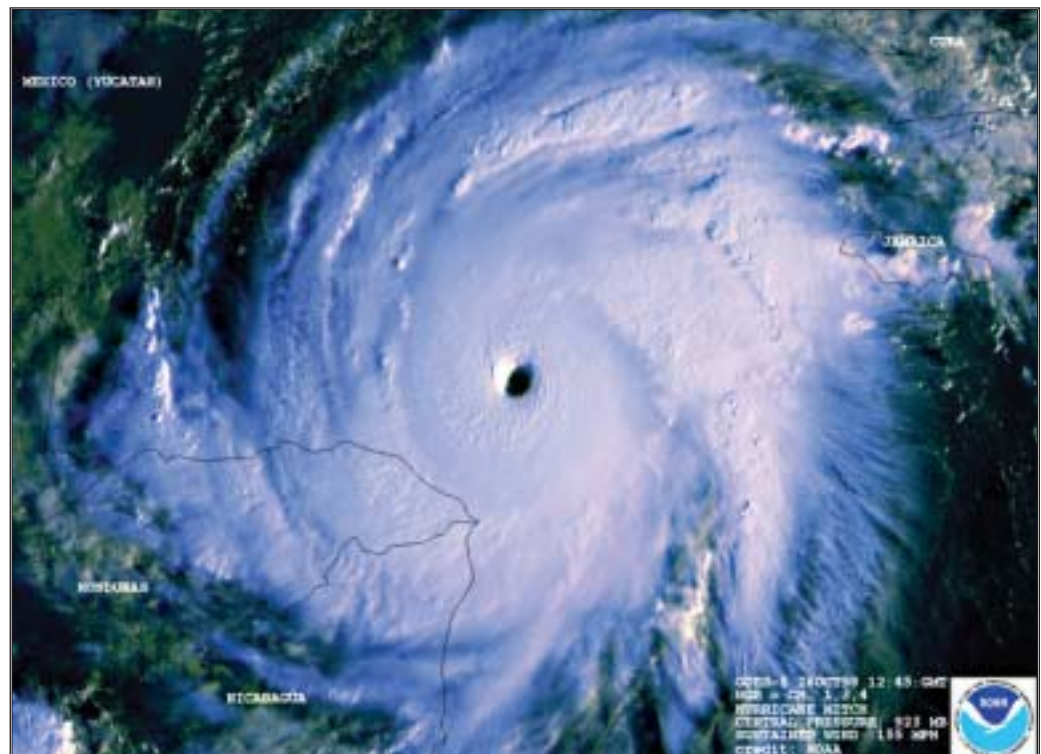
Figure 1. Satellite image of Hurricane Mitch on 26 October 1998 showing the well-defined eye of the storm. Image is from National Oceanic and Atmospheric Administration (NOAA) and is available on the web at: http://www.osei.noaa.gov/Events/Tropical/Atlantic/1998/Mitch_10/TRCmitc h299B_G8.jpg.

Hurricane Mitch began as a tropical depression on 21 October 1998 in the southern Caribbean Sea. As it moved westward, it strengthened into an intense storm (Figure 1) that by October 26th had sustained winds of 290 km per hour, gusts greater than 320 km per hour, and became the most deadly hurricane in the Atlantic Ocean in more than 200 years (Lott and others, 1999). The storm remained nearly stationary off the northeastern coast of Honduras for more than 24 hours and then moved slowly inland across Honduras and into western Nicaragua (Figure 2). The storm's slow movement produced heavy rain throughout Honduras and western Nicaragua, with less total precipitation in El Salvador and eastern Guatemala. As it moved onto land, it drew additional moisture from the Pacific Ocean, which supplemented the moisture already incorporated in the storm. The amounts of rain that fell during the storm are not

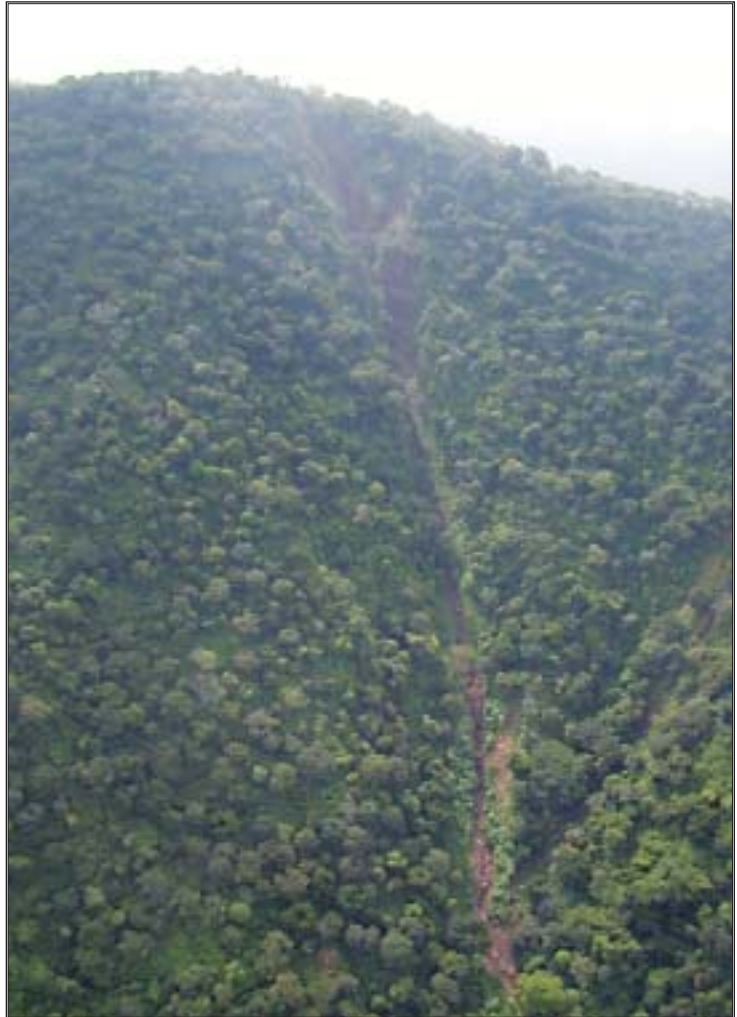
Figure 4. View of one of several recent landslides in the area south and west of Lago de Coatepeque. These recent landslides postdate January 1999 aerial photography and were probably triggered by the 13 January or 13 February earthquakes.

The largest concentration of landslides in this area is directly west and southwest of Lago de Coatepeque (Plate 2). Most of these slope failures are west of the lake along and near the eastern flank of Volcán Santa Ana O Ilamatepec. All of these landslides appear to be shallow failures, and only a few formed debris-flow channels with visible deposits at their bases. A few of the landslides damaged local roads, but none of the slides apparently damaged homes or infrastructure. The landslide closest to a population center is shown on the west flank of Cerro Pacho, directly east of the village of San Juan Las Minas El Chorizo (not shown on 1:50,00-scale map). Both aerial photographs and field reconnaissance of this landslide suggest that it is a very shallow slope failure that produces modest deposits at the base of the slope during most significant storm events; it does not appear to pose a significant threat to the nearby village. Aerial reconnaissance of the region south and west of Lago de Coatepeque revealed numerous post-Hurricane Mitch landslides that were probably caused by the 13 January or 13 February earthquakes (Figure 4).

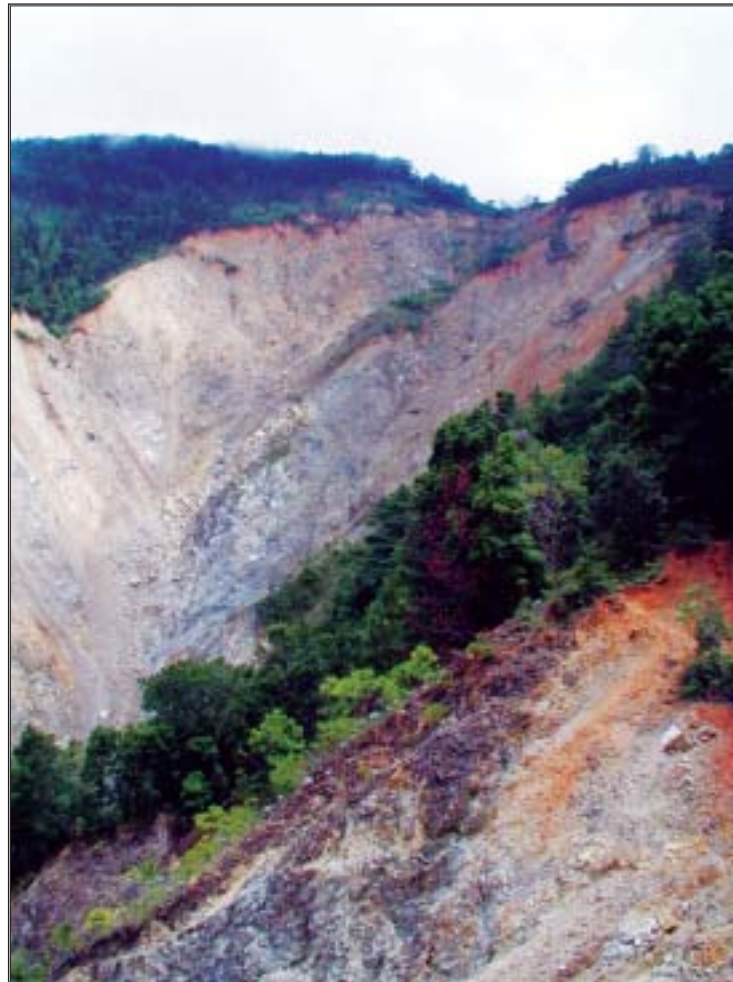
Figure 5. View to the northeast of the upper part of El Zompopera landslide. The collapse of unstable blocks in the upper part of the landslide destroyed a road at the crest of the ridge. Many unstable blocks remain in the upper part of the slide and a catastrophic collapse of those blocks could potentially dam the Río La Palma at the bottom of the valley.

El Zompopera landslide is the largest single landslide that we mapped in all of our study areas. The head of the landslide is about 300 m above the adjacent valley, and the denuded slopes drop steeply into the valley (Figure 5; Plate 4). Bedrock exposed by the land-

Although El Zompopera landslide was active prior to the hurricane, the storm caused unstable blocks in the upper part of the landslide to fail and add huge amounts of sediment to the adjacent valley of the Río La Palma o Los Pozos. This sediment initially moved into the valley as an earth slide and debris flow but, farther downstream, the landslide deposits were partially reworked into flu-

These continuing collapses are cause for concern. Many of the unstable blocks in the upper part of the landslide have volumes of several thousand cubic meters, and the simultaneous collapse of many of these blocks could potentially create a landslide dam in the Río La Palma o Los Pozos. If the dam were sufficiently large, a lake could form quickly behind the dam, and a catastrophic failure of the dam could release a major flood down the valley. A major flood could reach La Palma in a matter of minutes, and if large enough, could inundate

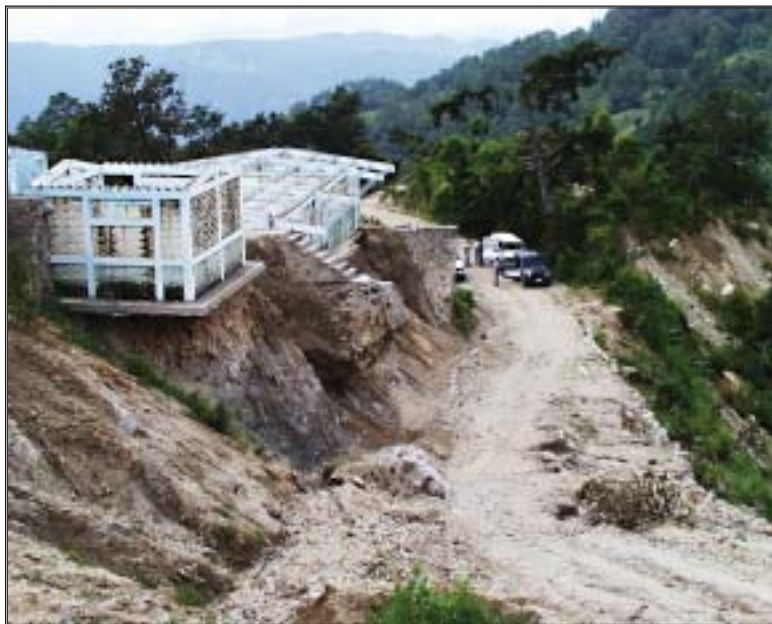
Figure 6. View of the El Pinar landslide and the abandoned school. A new road has been graded across the head of the landslide, which slid into the valley of the Río La Palma o Las Pozos on the right. Future movements on the landslide will likely disrupt the new road.

m of road and the only school in the area (Figure 6; Plate 4). El Pinar is located about 3 km east-northeast of La Palma, on the 15- to 25-m-wide crest of a steep-sided ridge. The landslide began at the crest of the ridge and traveled downslope about 150-200 m to the bottom of the Río La Palma o Los Pozos valley. The landslide undermined the foundation of the local school, which was not occupied when the failure occurred. A new road has been graded across the head of the landslide, but the slope of the landslide remains unstable and future movements will likely disrupt the road again and could threaten nearby homes.

The storm also caused significant retreat of the scarp at the head of the landslide, which destroyed a road that provided access to the surrounding countryside. The road has been temporarily reopened, but unstable blocks in the upper part of the slide will continue to collapse and eventually destroy the temporary road.

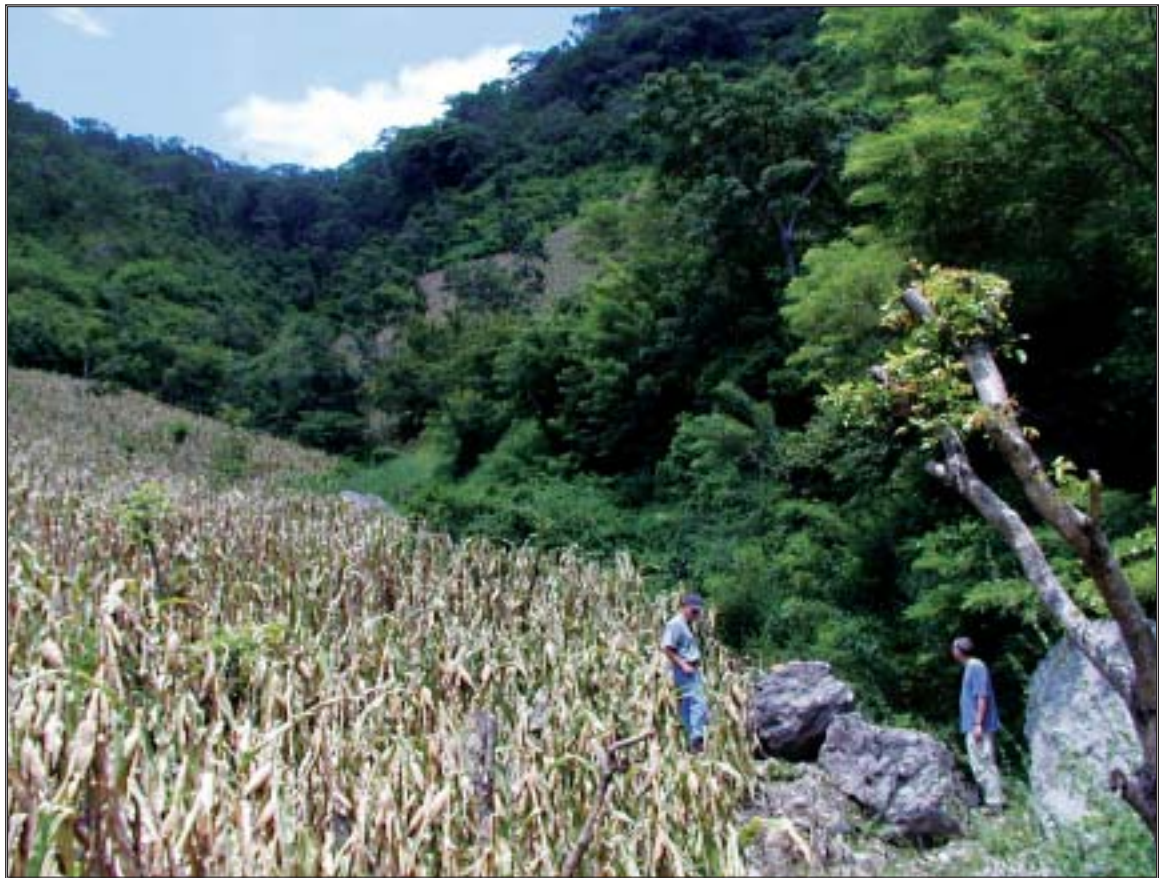
Figure 7. View of the western debris-flow channel and source area on Cerro El Coyote. The source area of the flow is at the ridge in the upper left of the photograph. Person on the left is standing on the debris-flow levee, which is about 3-4 m above the channel bottom. Note the 2-m-wide boulder (lower right) that was carried by this small but powerful debris flow.

Hurricane Mitch generated two debris flows on the south side of Cerro El Coyote, which is about 5.5 km north-northeast of El Paraiso and 3.5 km north-west of San Rafael (Plate 5). These debris flows had estimated volumes of a few thousand cubic meters, originated on steep, tree-covered slopes, and flowed 300-400 m down narrow channels. Levees along the western debris flow show that the flow filled the 5-m-wide channel to a depth of 3-4 m and transported 2-m-wide blocks more than half way down the channel (Figure 7). The source areas of the debris flows are now

completely overgrown, and even much of the coarse bouldery deposits is concealed by heavy vegetation. The catchment basins where the debris flows originated are very small relative to the volume of rock and water involved in the flow. During our field review, we observed several small flowing springs on the lower slopes of the Cerro El Coyote. We speculate that groundwater from springs scattered around Cerro El Coyote may have added to the surface runoff from the hurricane and may have been a factor in the development of these small, but highly fluid and powerful debris flows.

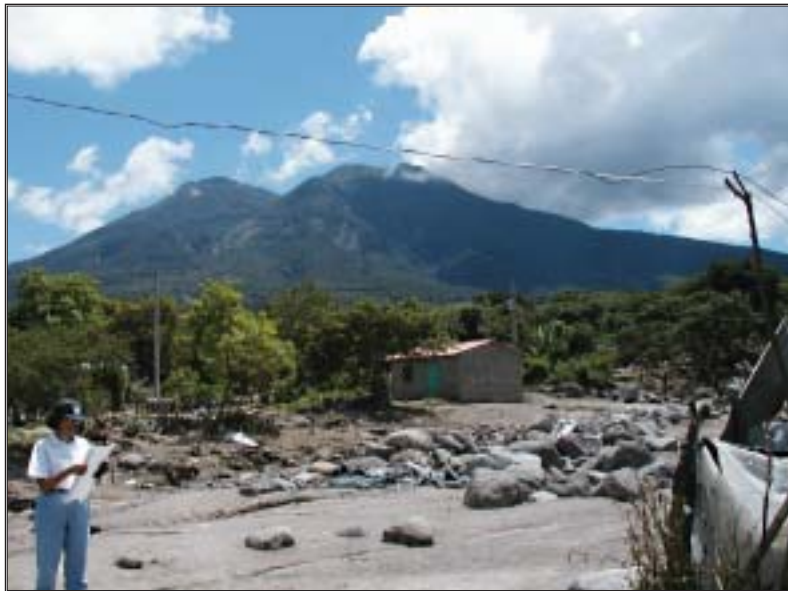
Figure 8. View of part of the town of Guadalupe that was struck by a debris flow on 15 September 2001. Temporary shelters in the right foreground were swept away by the debris flow, which originated on the western slopes of Volcán de San Vicente, shown in the background.

northeastern edge of the town of Guadalupe, destroyed several temporary shelters, and carried away a woman and a small child (Figures 8, 9, and 10). Other debris flows that swept across the highway between Guadalupe and Verapaz traveled several kilometers from their source areas on the east side of the volcano.

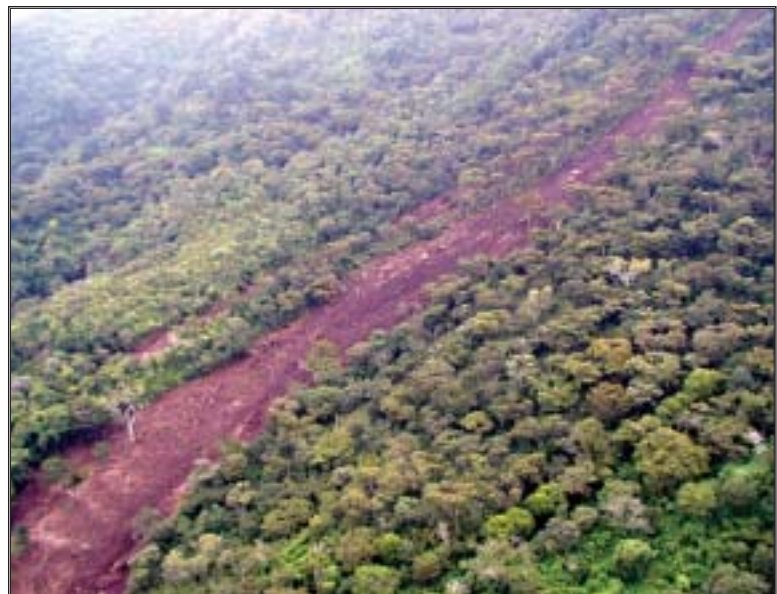
Figure 9. Oblique aerial view of the main source area for the debris flow that occurred on 15 September 2001 on Volcán de San Vicente. Smaller landslides along the banks of the channel, farther downslope also contributed sediment to the devastating debris flow that swept through Guadalupe.

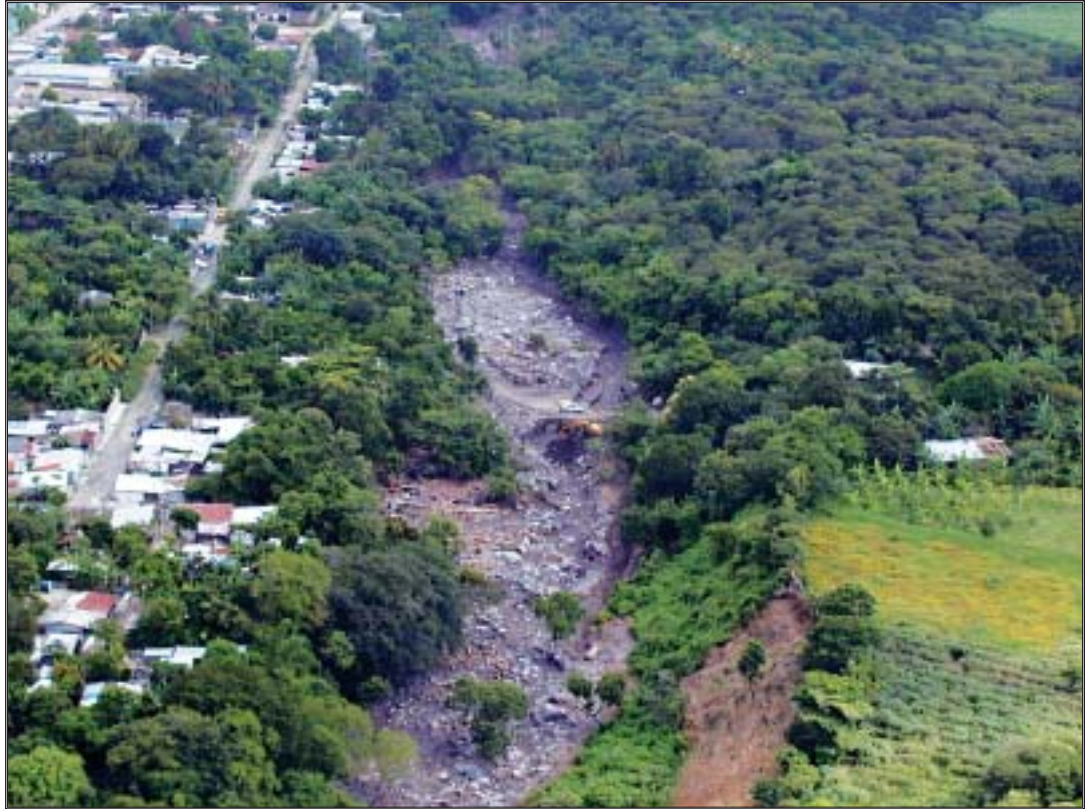
Figure 10. Oblique aerial view of the debris flow on the northeast side of the town of Guadalupe that occurred on 15 September 2001. Many of the large boulders in the channel were transported by the debris flow.

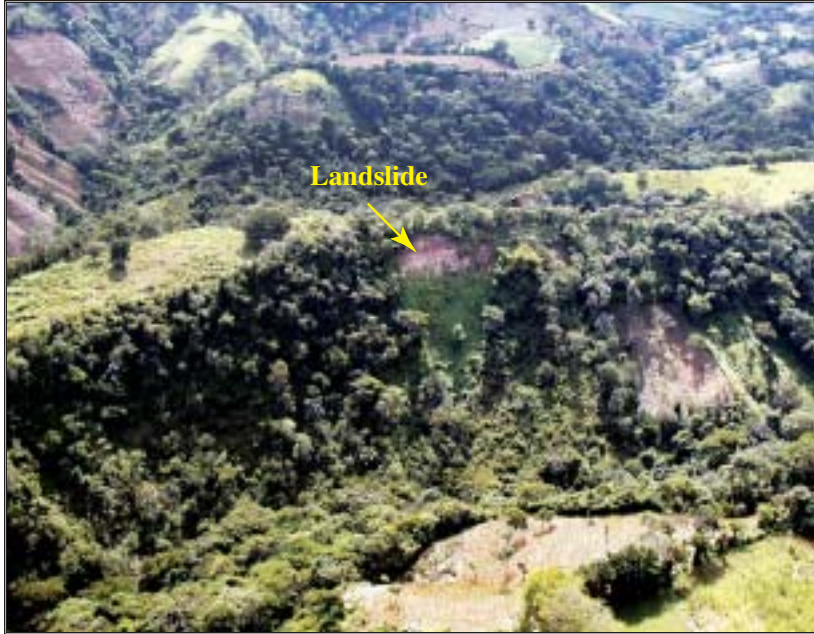
Figure 11. Partially overgrown scar of a shallow landslide in the area west of San Lorenzo. Dozens of small shallow landslides similar to this one occurred in this area as a result of Hurricane Mitch, but few caused significant damage.

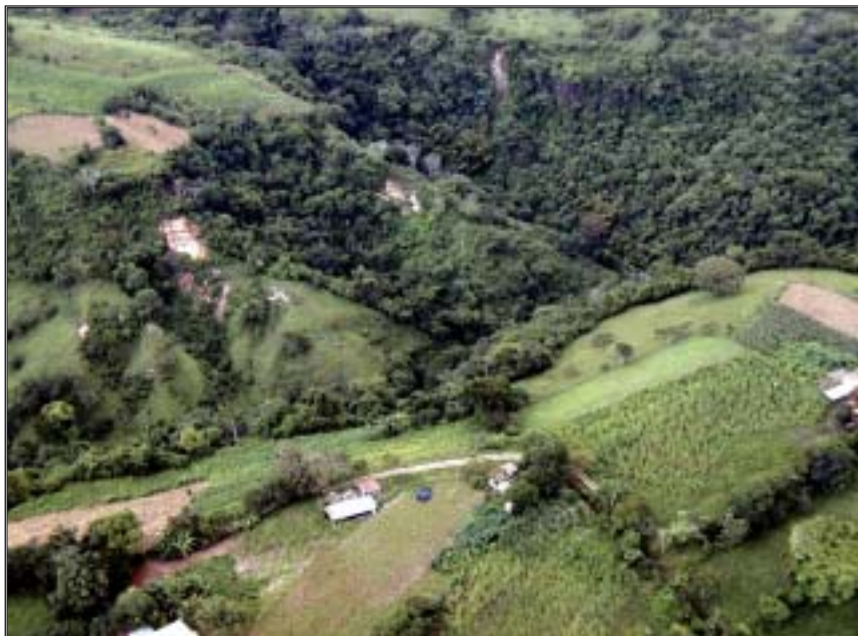
Figure 12. Scars of landslides caused by the 13 February 2001 earthquake west of San Lorenzo. Like the Hurricane Mitch landslides, these shallow landslides caused little serious damage, but repeated sliding here shows that these slopes are highly susceptible to landslides.

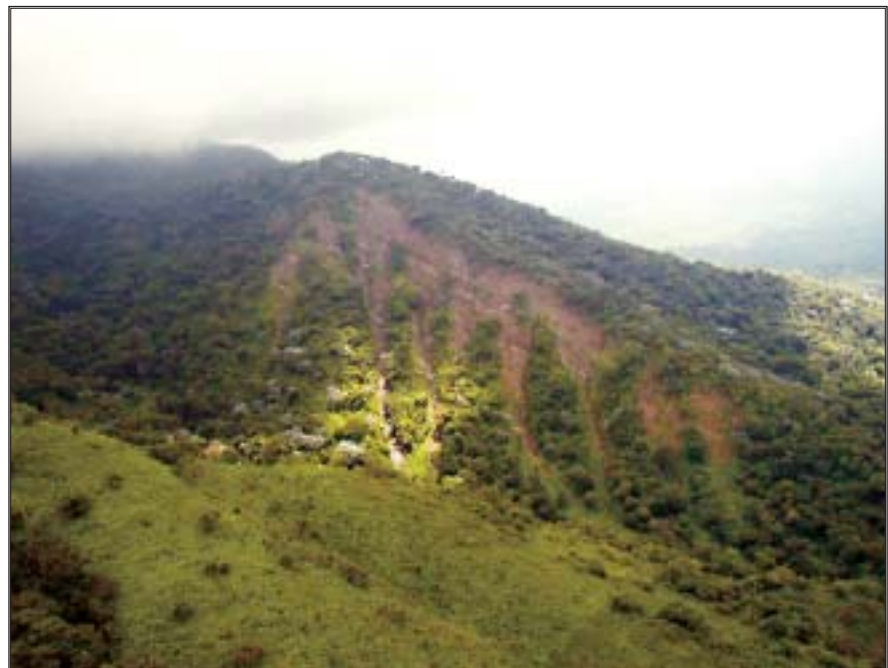
Figure 14. Scars of landslides on Volcán de Usulután triggered by the 13 February 2001 earthquake. Numerous landslides like these occurred on the volcano as a result of strong shaking, and produced large amounts of sediment that will be eroded from the volcano and deposited in surrounding areas during future years.

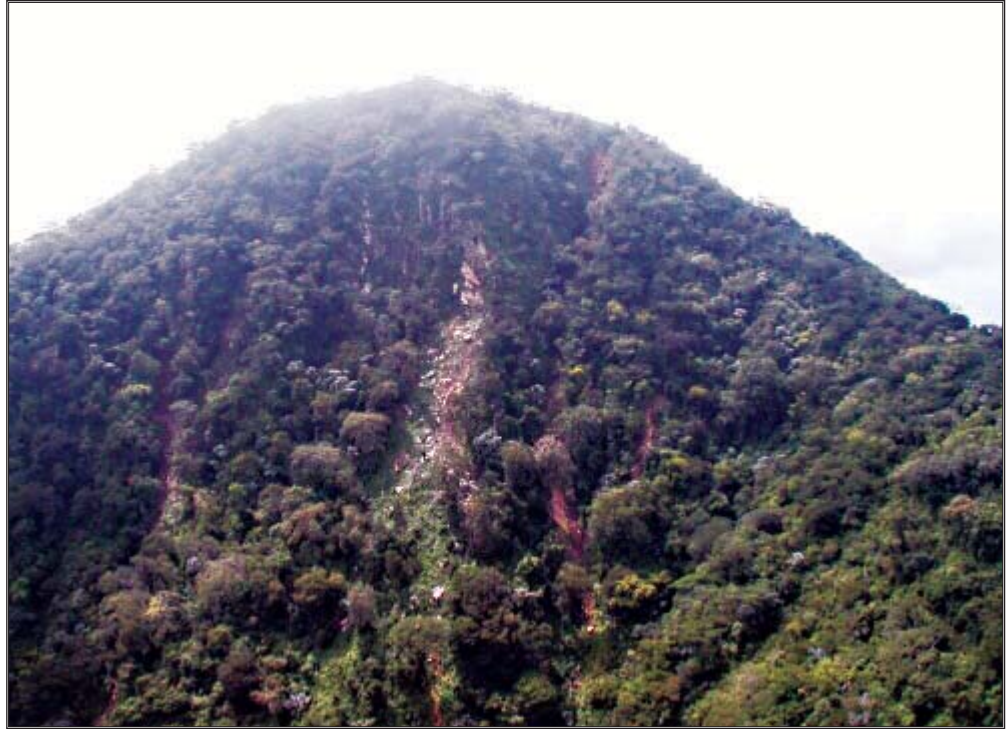
Figure 15. Landslides inside the crater of Cerro El Taburete that were probably caused by the 13 February 2001 earthquake. Many similar landslides occurred on this and nearby volcanoes as a result of the earthquake. Shallow landslides in this area that were caused by Hurricane Mitch were probably very similar.

Two landslides that occurred inside the crater rim of Cerro El Taburete appear to be shallow landslides in colluvium and weathered residuum derived from the volcanic rock (Plate 10). The larger of these slides is about 200 m long and started at the crater rim; the second is about 80 m long and initiated about midway up the crater wall. In the field, we observed new landslides inside the crater rim and on the outside of the volcano that were triggered by the 13 February 2001 earthquake (Figure 15).

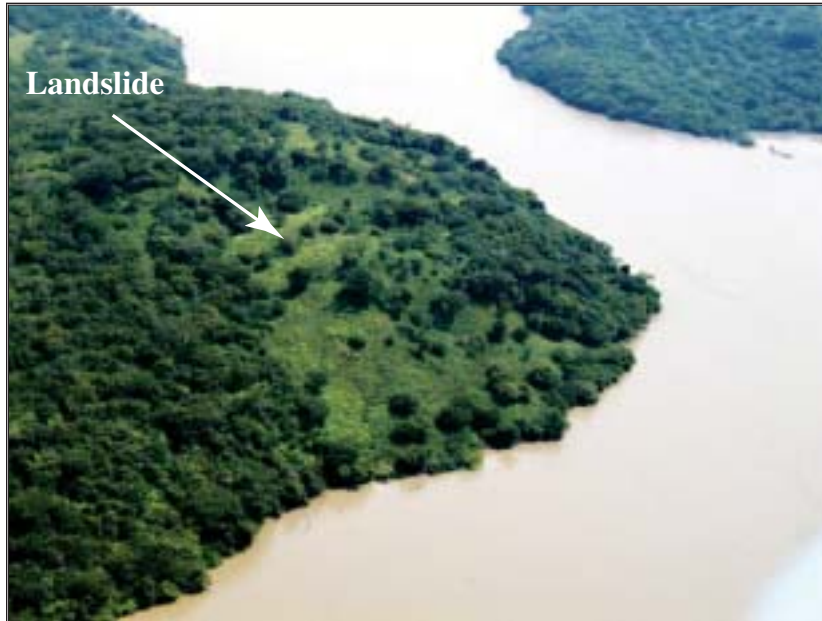
Figure 16. Large dormant pre-hurricane landslide on the shore of Embalse 15 de Septiembre. If reactivated, a large landslide such as this one might partially block the reservoir, however, it is far enough upstream from the dam that it probably would not interfere with operation of the dam or the hydroelectric facilities.

The few landslides observed along the shores of the Embalse 15 de Septiembre are unlikely to pose any serious threat to the dam or reservoir. These slides include a debris flow on the southwest shore (about 400 m upstream from the dam), a large pre-hurricane rotational slide on the northwest shore (Figure 16, 5 km upstream from the dam), and a shallow landslide on the west wall of the flooded Río Malancolo valley (Figure 17, 7 km upstream from the dam). Of these, only the pre-hurricane slide has a large enough volume to have a significant impact on the

reservoir. We observed no signs of recent activity of the slide during an overflight in September 2001 (Figure 16). Reactivation of the slide might partially block the reservoir, but such a blockage is unlikely to be large enough to interfere with operation of the dam.

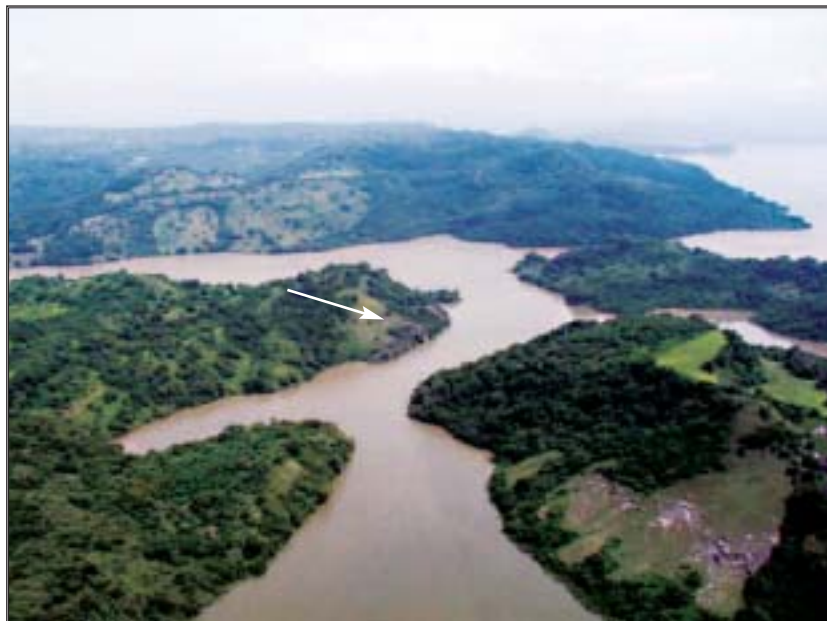
Figure 17. Shallow landslide on the shore of Embalse 15 de Septiembre. The scar was largely vegetated when this photograph was taken in September 2001.

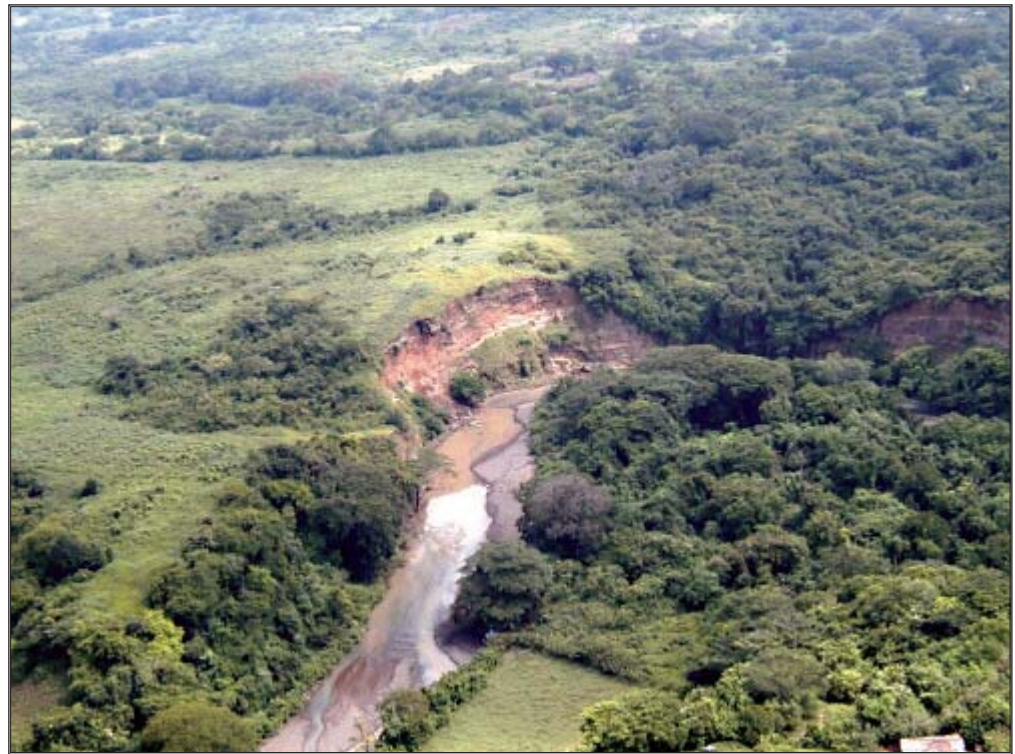
Figure 18. Bank failure on the Río Gualcho about 4 km upstream of Embalse 15 de Septiembre. This and similar failures along the Río Gualcho may have resulted from accelerated bank erosion cause by the high stream flows that occurred during Hurricane Mitch.

Banks of the deeply incised Río Gualcho are actively failing at several places downstream from Comunidad Nuevo Gualcho, about 4 km upstream from where the river enters the reservoir (Plate 9). Most of the bank failures are on the outside of meanders where undercutting has caused failure either by toppling or slumping (Figure 18). Bank failure at these locations likely was ongoing before Hurricane Mitch, but many scars or deposits are fairly recent. High flow in the Río Gualcho from Hurricane Mitch may have accelerated these bank failures.
