White River Rapid Assessment

Coastal Water Quality Improvement Project

July 31, 2000

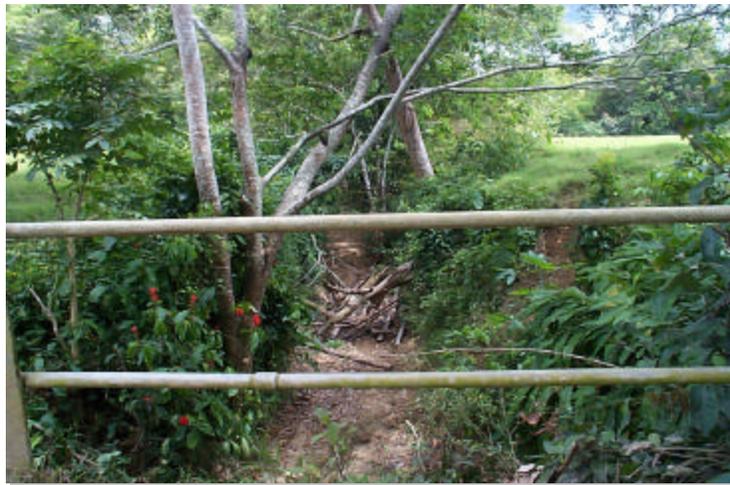
Channel of White River tributary nearby Wilderness Resorts

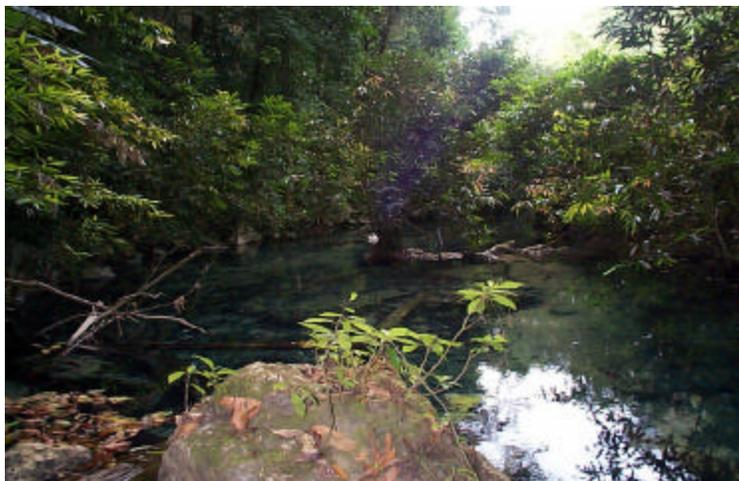
Genesis of White River on property belonging to Forevergreen Farms

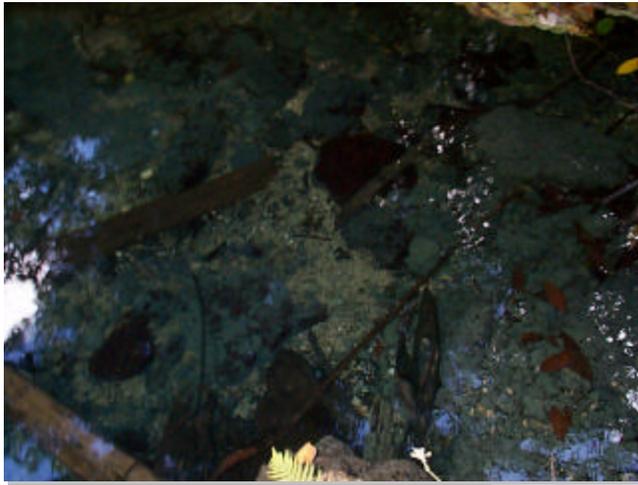
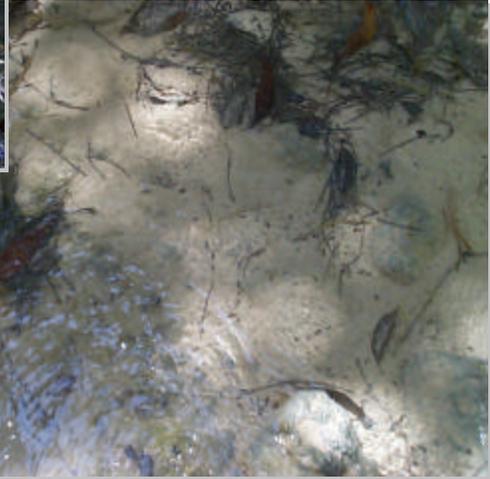
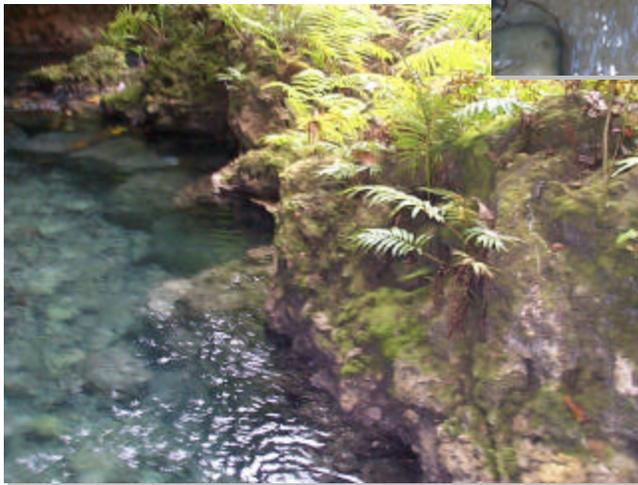
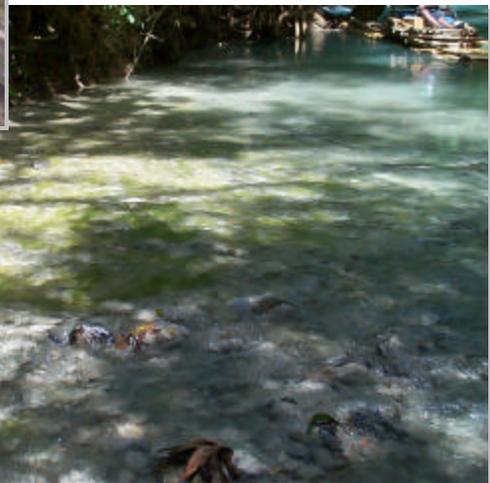
Appearance of river of river between sample points 1 and 8

Appearance of river between sample points 8 and 9

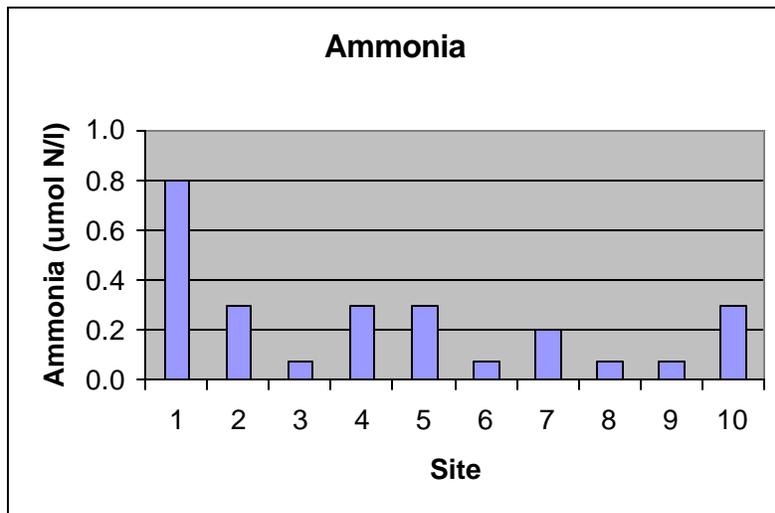
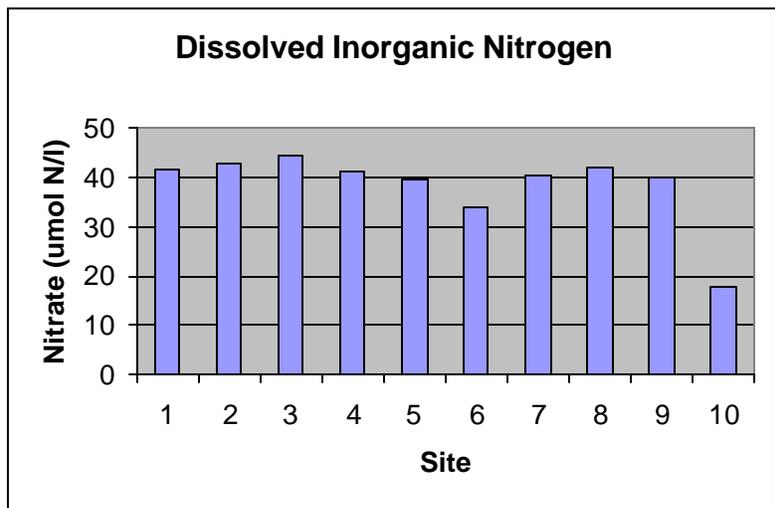
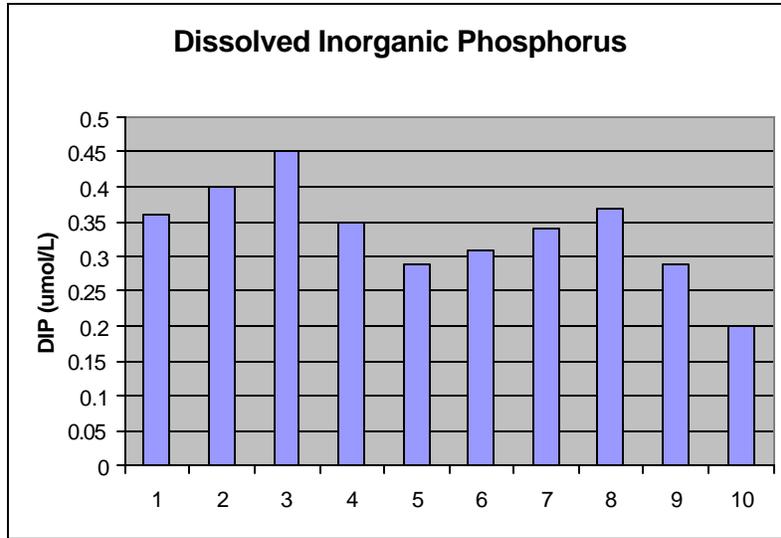
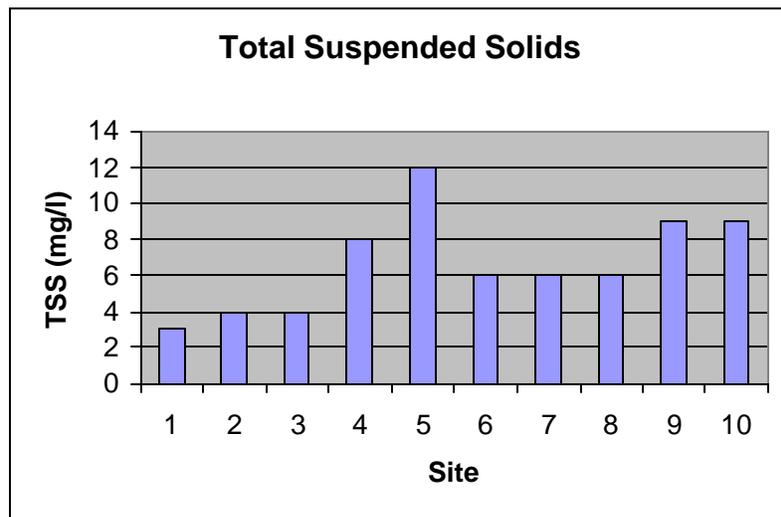
The data showed little variability in the concentrations of the constituents examined as a function of distance down the river, suggesting that the activities along the river were having minimal effects on the chemistry of the river. Concentrations for nitrates were a bit elevated, with similarities to concentrations in fresh water springs found in the hills behind Discovery Bay and the Turtle River in Ocho Rios.

There was a marginal drop in the nitrate and phosphate concentrations between sites 4 and 6. The beginning of algal growth on rocks along the riverbed was noted below site 6. There was also a drop in conductance at site 6 coincident with the presence of a coating of a white substance on the riverbed suggesting the precipitation of calcium carbonate.

Nutrients (nitrogen contained in the available forms of oxides of nitrogen, and phosphorus contained in the available forms of oxides of phosphorus), stimulate plant growth, and cause a proliferation of this growth under eutrophic conditions. These conditions can lead to a general deterioration in water quality with depletion in dissolved oxygen and the creation of anoxic conditions under certain conditions. The nutrient status (forms and concentrations) within the aquatic environment over a period influence the types and numbers of plant and animal species found in the aquatic environment.

Nutrients are derived from the decomposition of organic matter such as sewage, kitchen waste, decaying flesh, and inorganic fertilizers used on farms. Presently there are no concrete or definitive nutrient standards for recreational waters.

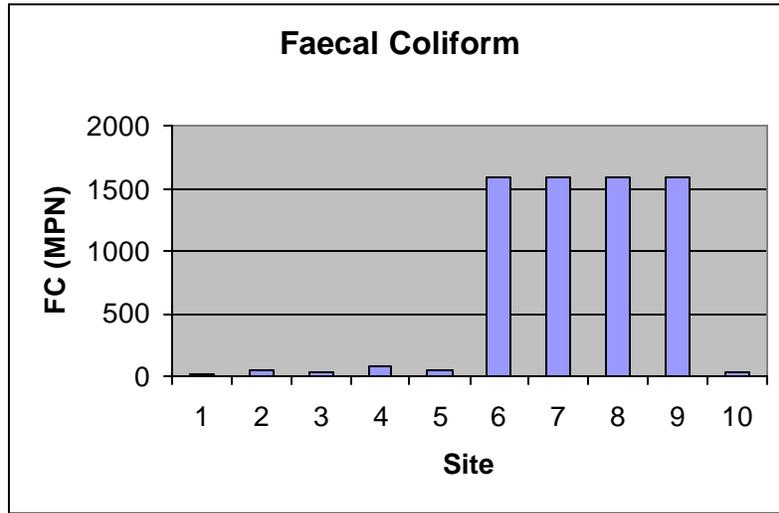
Examination for the presence of fecal coliform organisms showed moderate concentrations between sites 1 to 5, and very high concentrations between sites 6 to 9. Concentrations returned to moderate at site number 10, which were exposed to the dilution effects of the sea.

Fecal coliforms are bacteria associated with the alimentary canal of warm blooded animals and as such indicates the possible presence of fecal contamination. The NEPA/NRCA guideline for the occurrence of these organisms in recreational waters is no more than 200 MPN/100 ml of water.

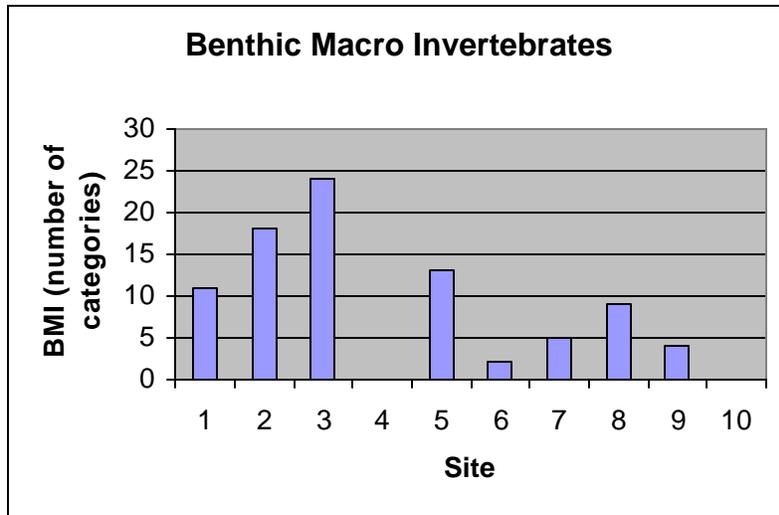
Data describing the types and distribution of benthic macro invertebrates (BMIs) categorizes the river as being healthy when considered as a whole. A different picture is presented, however, when the data is examined on a site by site basis. Here sites 1 to 4 show relatively unpolluted waters, while some deterioration is evidenced at site 6. The beginning of algal growth on rocks along the substrate was evidenced. Sites downstream of site 6 show some degree of recovery, with a suggestion that there may be a second input of organic pollution between sites 8 and 9 as evidenced by a decrease in BMI taxa and increased growth of filamentous algae. Interpretation of the data for sites 6 to 9 was complicated by a deposit of calcium carbonate, which could have contributed to the reduction of BMI between sites 6 to 9.

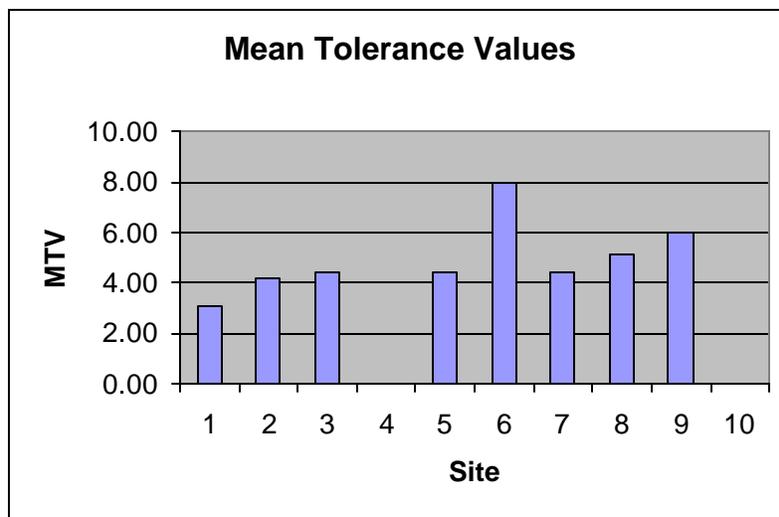
An application of a modified scheme of mean tolerance values derived by Hiselhoff suggests that most of the sites sampled have good to very good water quality, with site 1 being rated as excellent. Sites 8 and 9 showed fair and fairly poor ratings with site 6 showing very poor water quality. This information showed broad agreement with the findings of the BMI analysis.
