Sri Lanka Tsunami Reconstruction Program (SLTRP)
USAID Contract # 386-C-00-05-00166-00

Environmental Assessment for
Hikkaduwa Fishery Harbor
March 2006

SLTRPR-00003

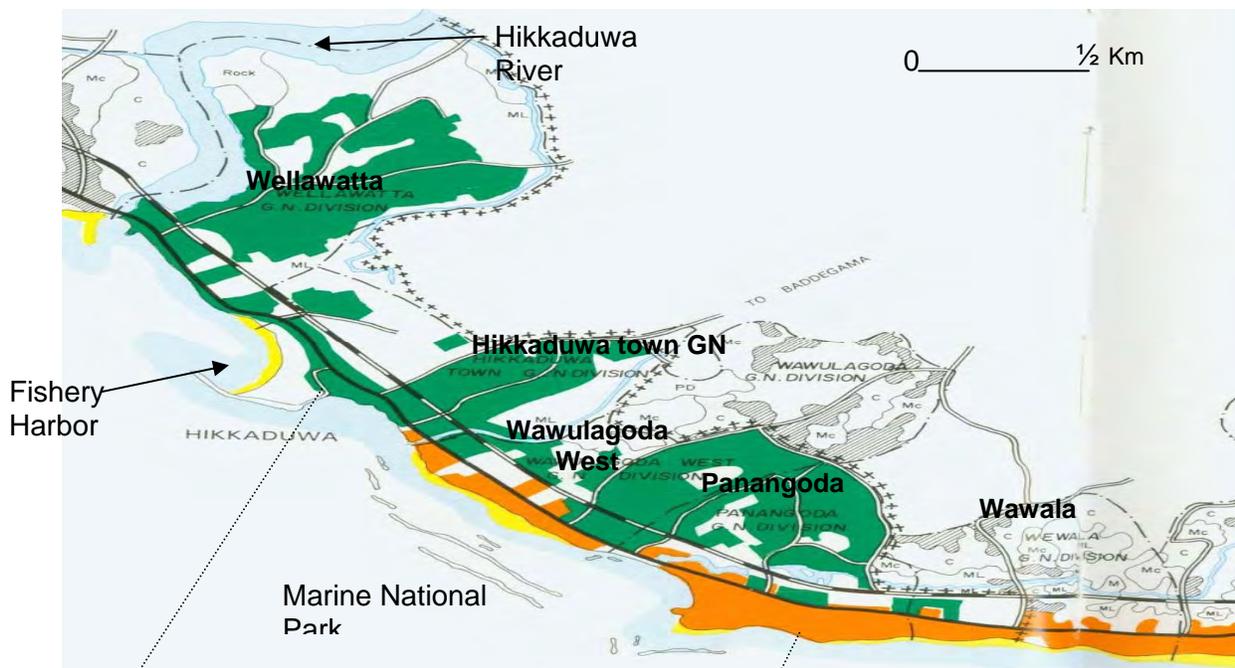
Figure 2 – Physical setting of the project area

The region of influence for determining environmental impacts is defined as the Hikkaduwa harbor and a surrounding area of one kilometer in radius both on the marine and landward directions. In determining the region of influence for social impacts, five Grama Niladhari (GN) divisions in the Hikkaduwa Divisional Secretariat (DS) division located around the Hikkaduwa fishery harbor have been selected. The general physical setting of the project area is shown in Figure 2.

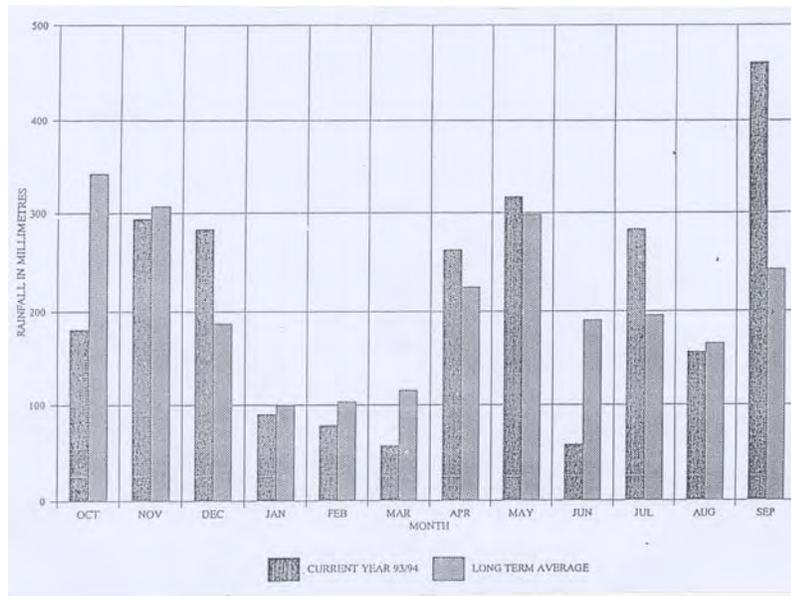
Figure 3 - Variation of rainfall (Galle)

Figure 3, below, presents the annual rainfall variation in Hikkaduwa. Hikkaduwa experiences two rainfall peaks, one in May and the other in October. The annual average rainfall is reported to be around 2073 mm (ECL, 1997).

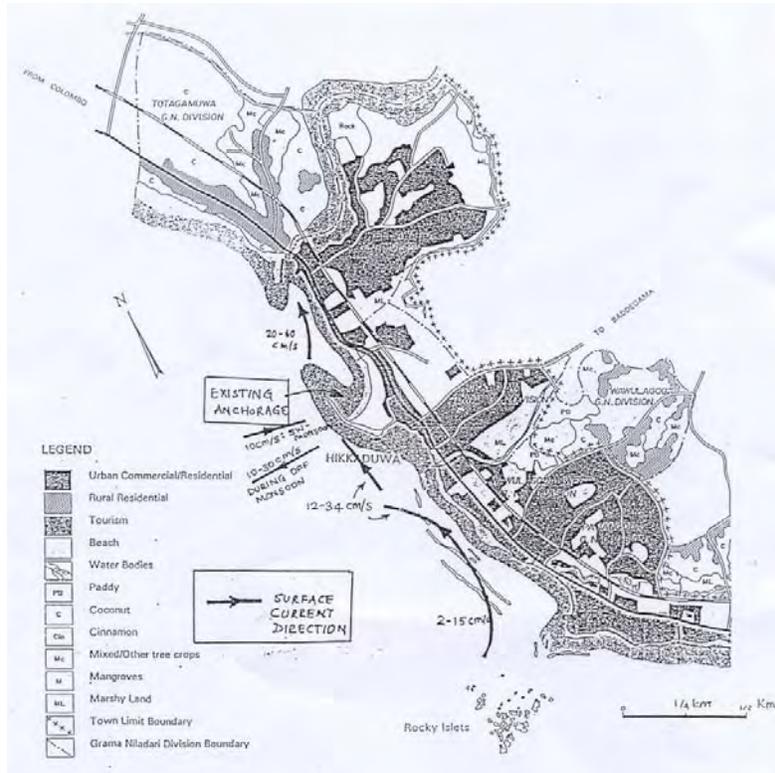
Figure 4 - Approximate surface current pattern in the Hikkaduwa area

The near-shore currents are moderate and the majority of them are in the range of two to 34 centimeters per second with the stronger currents occurring in the area immediately south of the southern breakwater. LHI model studies have also documented strong currents in the direction of the river mouth. These currents and their approximate directions in the vicinity of the project site are illustrated in Figure 4.

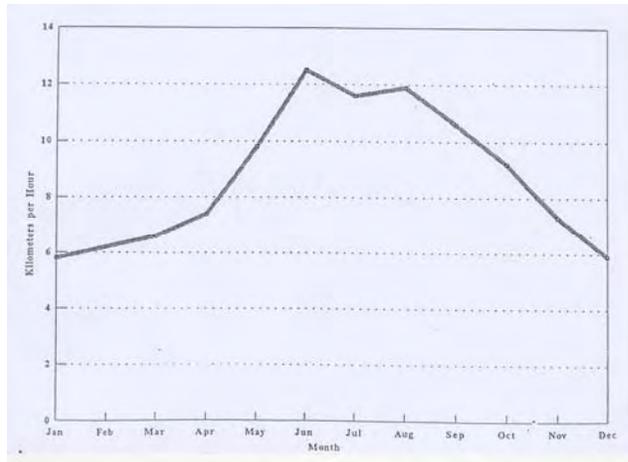
Figure 5 - Mean monthly wind speed in Galle, 1983-1992 (Meteorology Department)

Wind patterns in the Hikkaduwa area – which are similar to those in Galle – are shown in Figure 5. Wind speeds range between 5.5 and 12.5 kilometers per hour. The higher wind speeds occur between May and October, which is the southwest monsoon season. The average wind speed during this season is approximately one kilometer per hour (ECL, 1997).

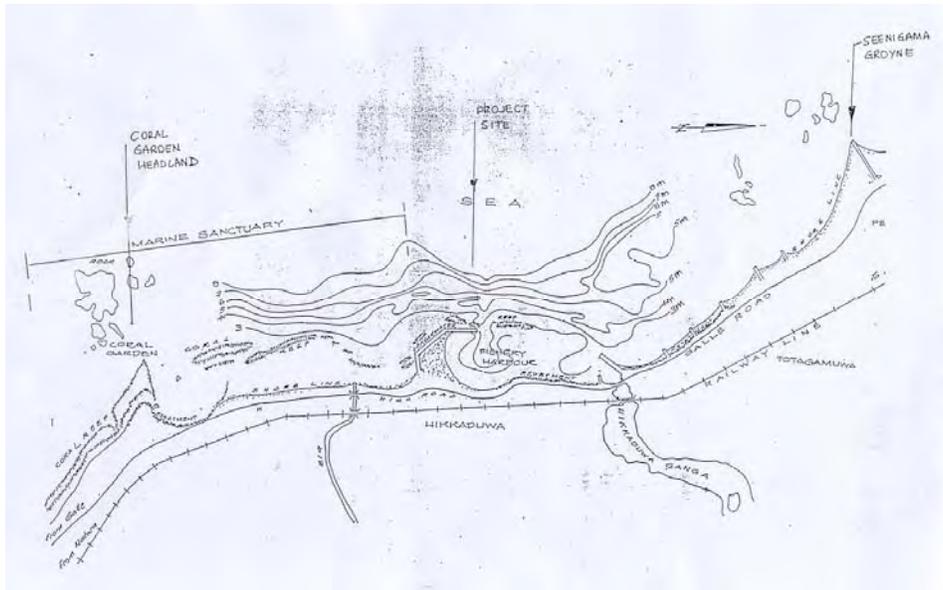
Figure 6 - Bathymetry of the project area

Bathymetry in the vicinity of the project area is illustrated in Figure 6. The nearshore area comprises coral reefs and many rock outcrops. The reef areas are shallow and have depths of one meter or less below MSL. The average slope of the continental shelf is about 1/50 (vertical/horizontal distance) (ECL, 1997).

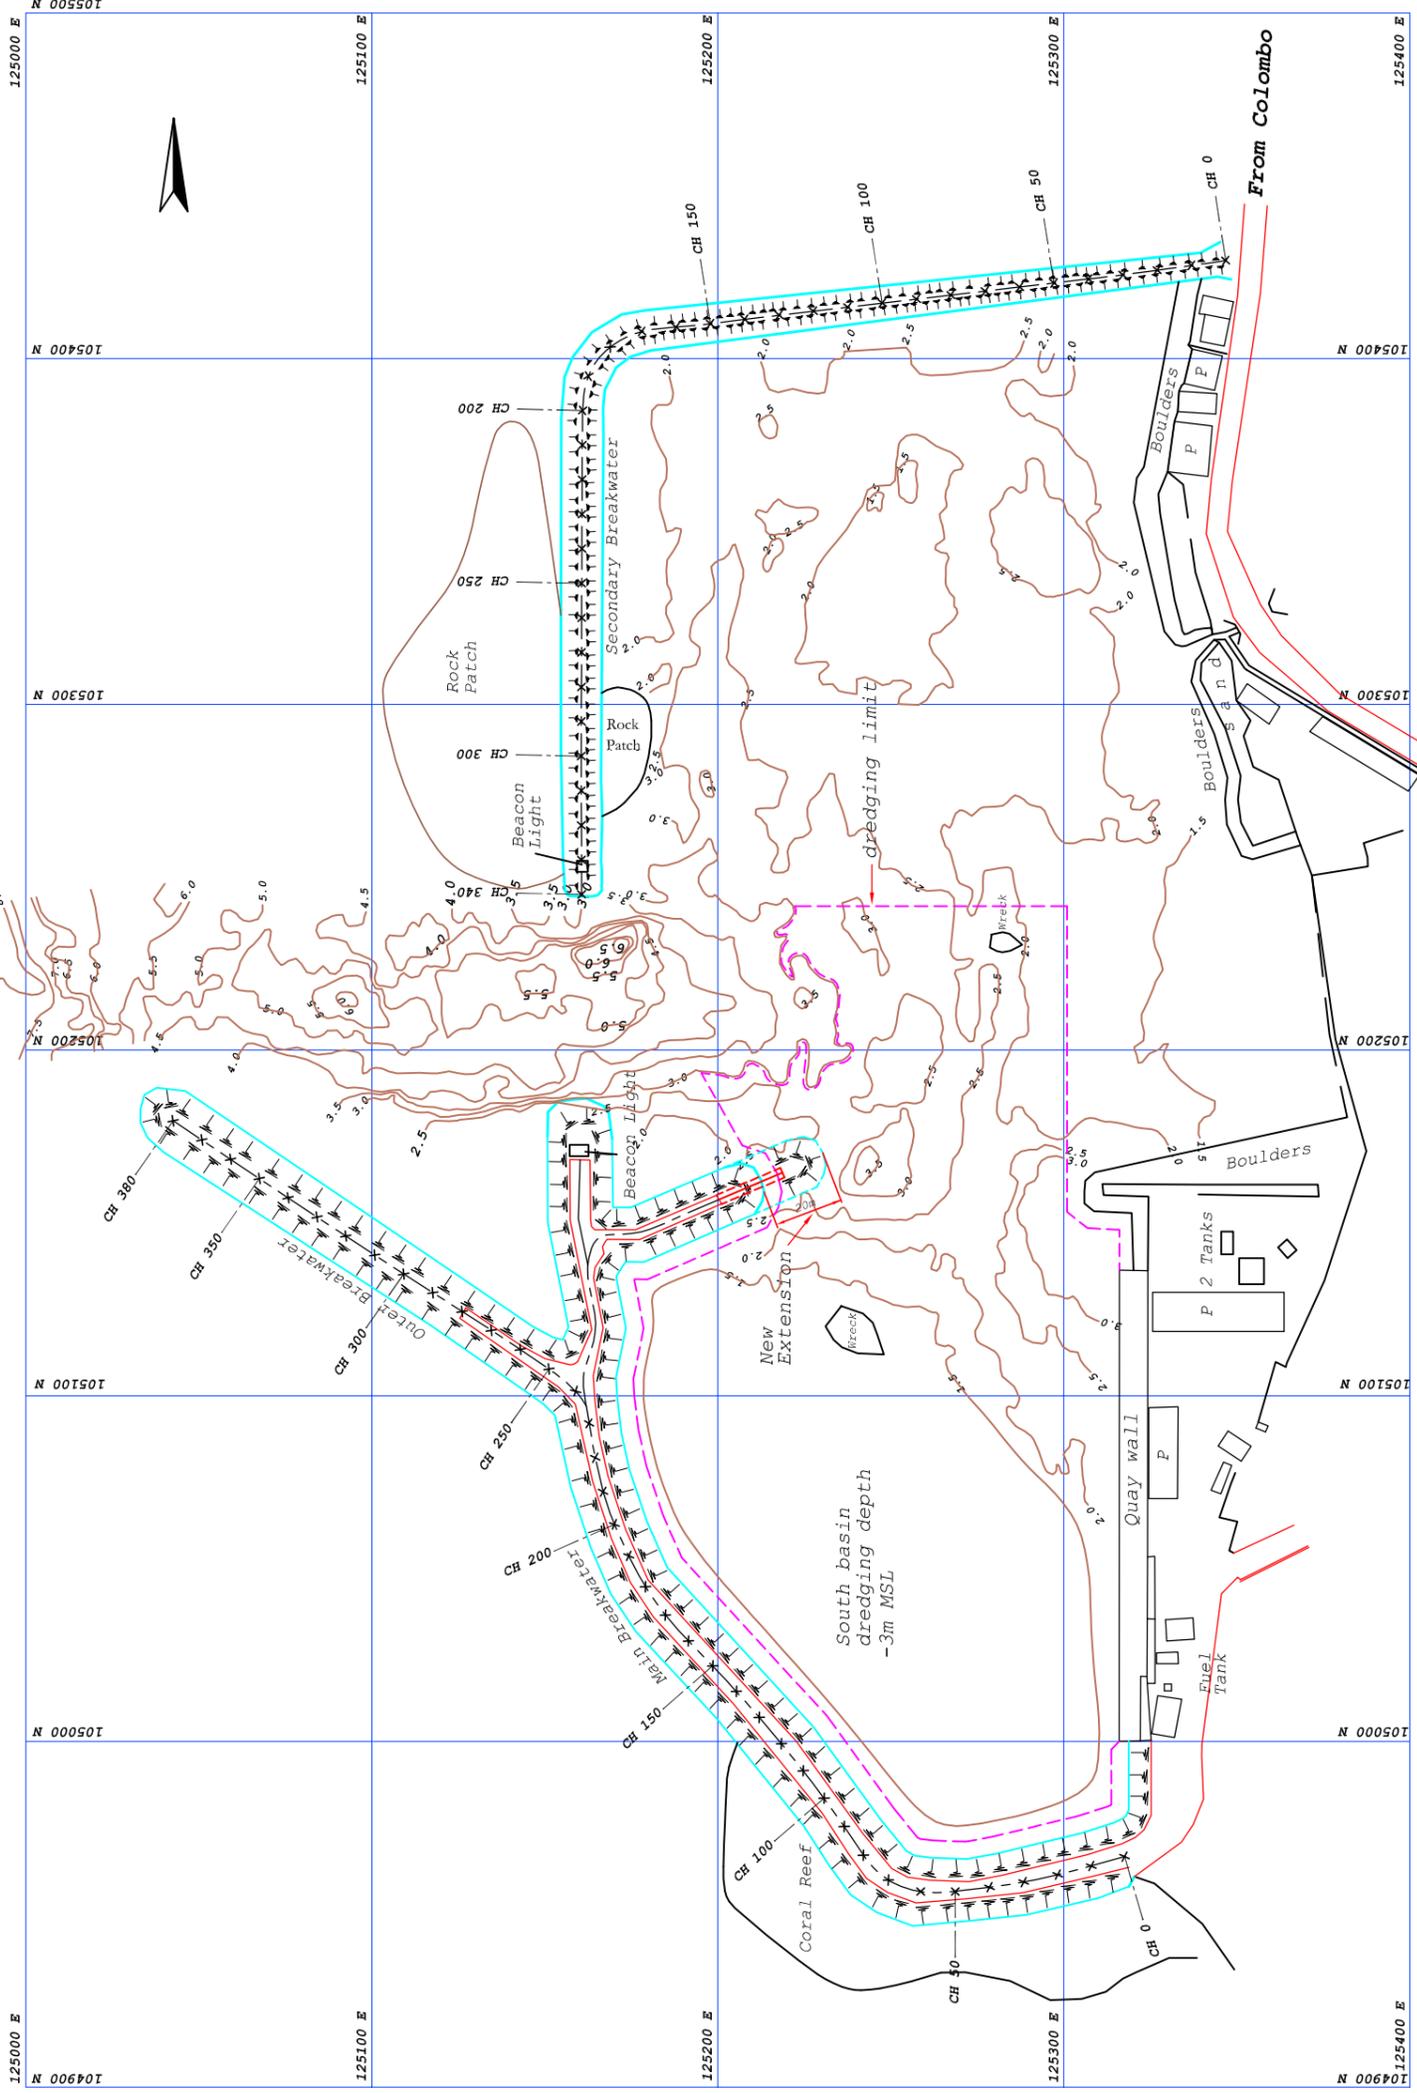
Annex 3 – Layout of proposed harbor rehabilitation work in Hikkaduwa

Work Proposed under this Project

Main Breakwater	
Location	Proposed Work
1).0-100m Sea side	Re-arrangement and Armour filling (1-3T)
2).175-200m Sea side	Re-arrangement and Armour filling (1-3T)
Outer Breakwater	
1).350-380 bothsides	Re-arrangement and Armour filling (1-3T)
2).380 - End	Provide Toe, re-arrangement and armour filling (6-8T) Row of boulders on seaside edge
Secondary Breakwater	
1).0-50m, 270-330 harbour side	Re-arrangement and Armour filling (0.25-0.5T)
2).180-200m seaside	Re-arrangement and armour filling (4-6T)
Inner Breakwater	
1).New extension of 20m	New construction with Toe and primary armour
Pavement works	
1).Main Breakwater & Secondary Breakwater	Repair & Bitumen surface
2).Outer Breakwater	Provide concrete pavement
Dredging	
Dredging	South basin up to -3m M.S.L
Navigation Aids	
Navigation Aids	Provide Beacon lamps at Outer Breakwater and new extension

LHI studies several arrangements/layouts for breakwater extension. Accordingly, the LHI proposes to extend the inner arm of the main breakwater by 20 meters. In addition deepening of the south basin to 3 meters is also proposed. These actions in combination will be able provide adequate calmness within the harbor basin. Also the proposed extension will not cause adverse impact on coral reef in terms of increasing the sand deposition over it.
