TECHNICAL ANALYSIS REPORT

Investigation of the phases of construction of the church. In situ study using observation of surfaces and stereo-microscopic analysis to arrive at a preliminary classification of the mortar types and their distribution within the various phases of construction and decoration of the church.

Conservation and Documentation of the Wall Paintings at the Red Monastery, Sohag.

September 2008

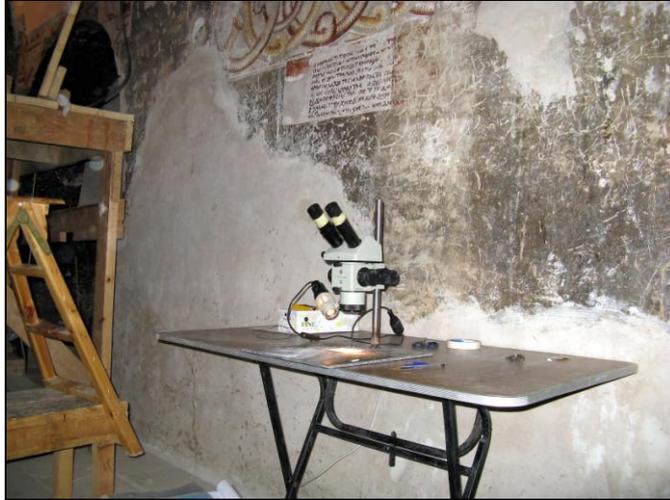
Work station set up on site with a portable stereo-microscope.

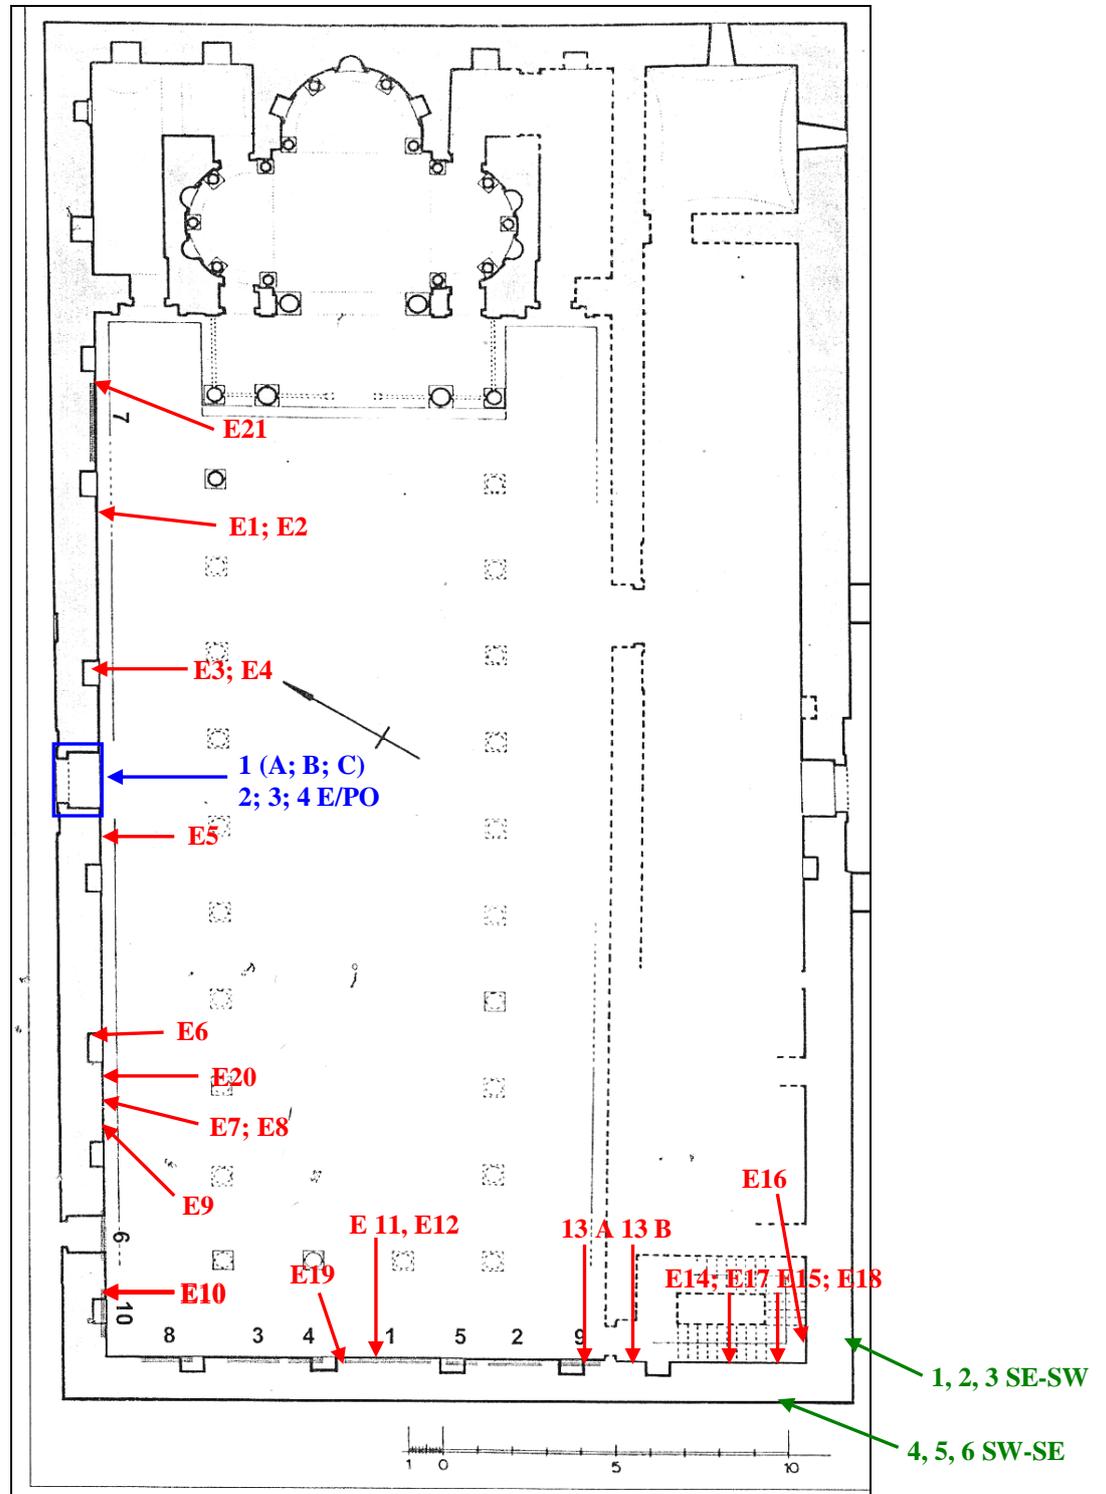
Plan of the church supplied by the client.

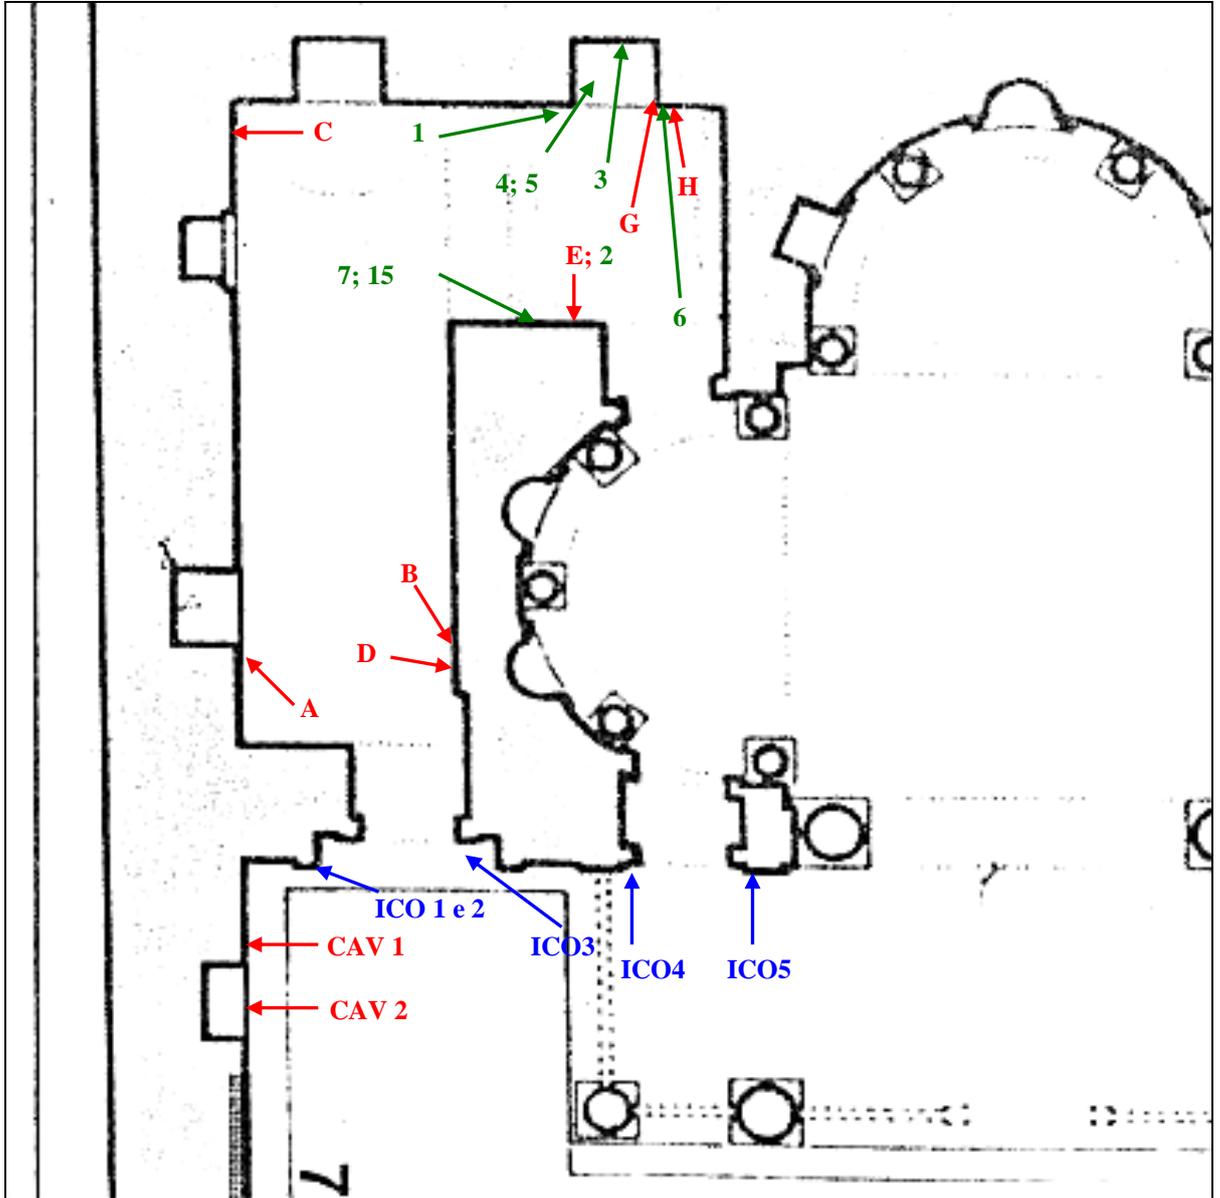
Enlargement of the previous image showing the prothesis and the north corridor.
 The green numbers refer to samples with the prefix PRO [prothesis]; the red ones indicate samples with the prefix CN [north corridor] (see the tables below).

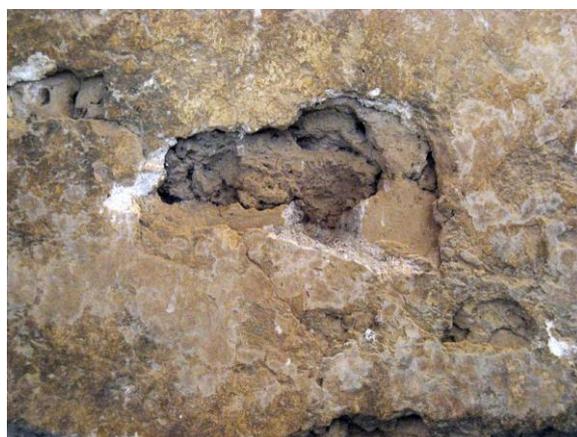
Sample E-1.

Sample number	Area sample taken from	Brief microscopic description
E 1	North west wall, approximately 1.0 m to the left of the first ogival window, at a height similar to that of the base of the window itself. The sample included both the light-colored surface plaster and the underlying gray bedding mortar which is well-smoothed and pointed.	The fragment of mortar between the bricks (no. 1) is gray in color and composed of lime, fine, well-graded sand and charcoal finely dispersed in the binder. It may also contain scattered fragments of brick. The finishing plaster (no. 2) is light-colored with a well-smoothed and compacted surface. It is made up of lime, well-graded medium to fine sand and a few vegetable fibers, probably straw. Thickness 5.0 – 6.0 mm.
E 2	North west wall, to the left of the first ogival window, at the height of the arch of the window itself. The sample included both the light-colored surface plaster and the underlying gray bedding mortar which is well-smoothed and pointed.	The mortar and plaster are identical to those in sample E1. The thickness of the mortar varies between 5.0 and 7.0 mm.

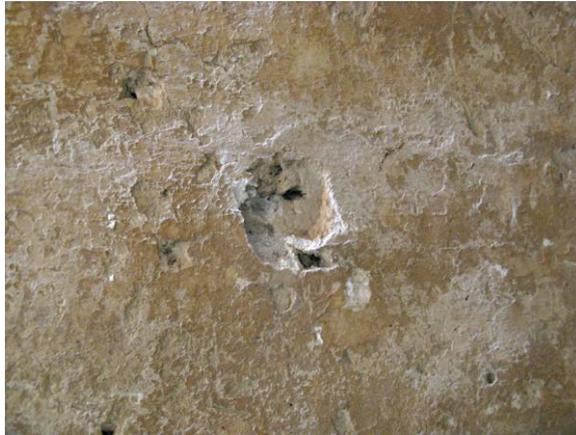
Sample E-3.

E 3	North west wall, to the right of the second window from the right, at the height of the base. The sample included both the light-colored surface plaster and the underlying, well-smoothed, gray bedding mortar.	The sample collected is identical to the previous ones. The thickness of the plaster varies between 4.0 and 5.0 mm.
E 4	North west wall, inside the second window from the right: sample taken from about half-way up the right-hand impost. The sample included both the light-colored surface plaster and the underlying, well-smoothed, gray bedding mortar.	The mortar (no. 1) and the plaster (no. 2) are identical to those in the previous samples. In addition to straw, the plaster may also contain more valuable fibers (for example, cotton or linen). The thickness of the plaster varies between 4.0 and 8.0 mm.
E 5	North west wall, area between the doorway and the embrasure, at the same height as the embrasure. The sample was taken from a particular area of the wall, namely, between the stone	The bedding mortar between the bricks (no. 1) and the overlying plaster (no. 2) are identical in terms of structure and composition to those encountered in other samples.

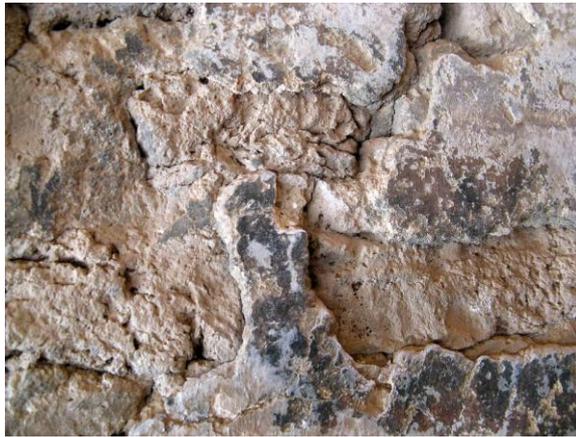
Sample E-7.

E 7	<p>North west wall, approximately 1.0 m to the left of the niche from which sample no. 6 was collected; the sample was taken at a height of approximately 5.0 m, a few centimeters lower than the first niche measuring at least 10 cm.</p> <p>The sample included both the light-colored surface plaster and the underlying, well-smoothed, gray bedding mortar.</p>	<p>The mortar (no. 1) and the plaster (no. 2) are identical to those in the previous samples. In this case there is a 'large' millimetric fragment of brick in the mortar. Furthermore, the plaster is relatively rich in straw. It varies between 5.0 mm and 7.0 mm in thickness.</p> <p>On top of the plaster we can also see: 3) a thin layer of red paint; 4) a thin blackish-brown layer that is probably an altered organic protective agent (for example, based on gum arabic).</p>
E 8	<p>North west wall, a few decimeters below sample no. 7. The sample included a small fragment of coarse brown brick present in pieces under the light-colored plaster covering the masonry. This is a repair effected during earlier restoration work.</p>	<p>The sample includes traces of the 'usual' light-colored plaster based on lime, fine sand and vegetable fibers and a layer of dark mortar made of silt and straw. The latter was applied during maintenance work to fill a gap in the underlying light-colored plaster.</p> <p>The restoration plaster is covered by a dark patina.</p>

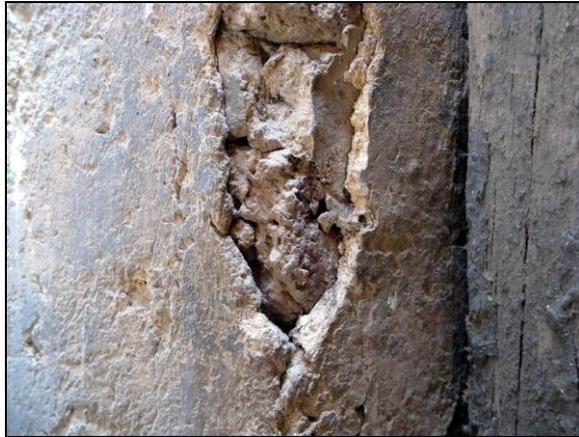
Sample E-9.

E 9	<p>North west wall, first embrasure at the top from the left near the right side of the base.</p> <p>The sample included both the light-colored surface plaster and the underlying, well-smoothed, gray bedding mortar.</p>	<p>The fragment of mortar between the bricks (no. 1) is gray in color and made up of fine, well-graded sand and charcoal finely dispersed in the binder. It also contains a few fragments of brick.</p> <p>The finishing plaster (no. 2) is light in color and has a well-smoothed and compacted surface. It is made up of lime, well-graded medium-fine sand and abundant vegetable</p>

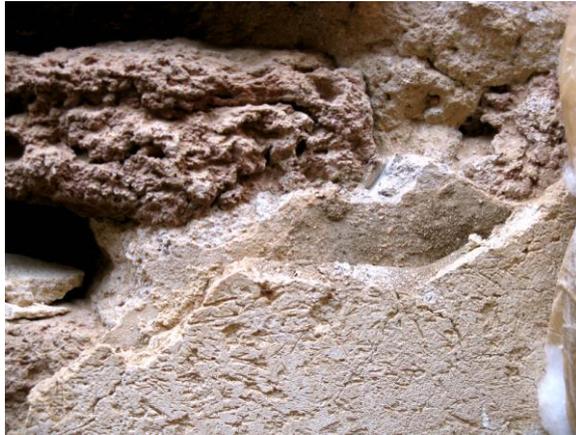
Sample E-12.

E 12	Back wall (south west), on the same vertical as sample no. 11 to the right of the second embrasure up, at a height similar to that of the base. The sample included both the light-colored surface plaster and the underlying, well-smoothed, gray bedding mortar.	The fragment of mortar between the bricks (no. 1) is gray in color and is composed of lime, fine, well-graded sand, charcoal and occasional fragments of brick finely dispersed in the binder. The material is highly porous owing to the presence of minute globular cavities. It is thin in consistency. The finishing plaster (no. 2) is light in color with a well-smoothed surface. The plaster is composed of lime, medium-fine, well-graded sand and vegetable fibers (probably straw). The fibers are clearly visible on the surface as a result either of the compacting of the surface or of subsequent differential wear sustained by the plaster. It is 5.0 – 9.0 mm thick.

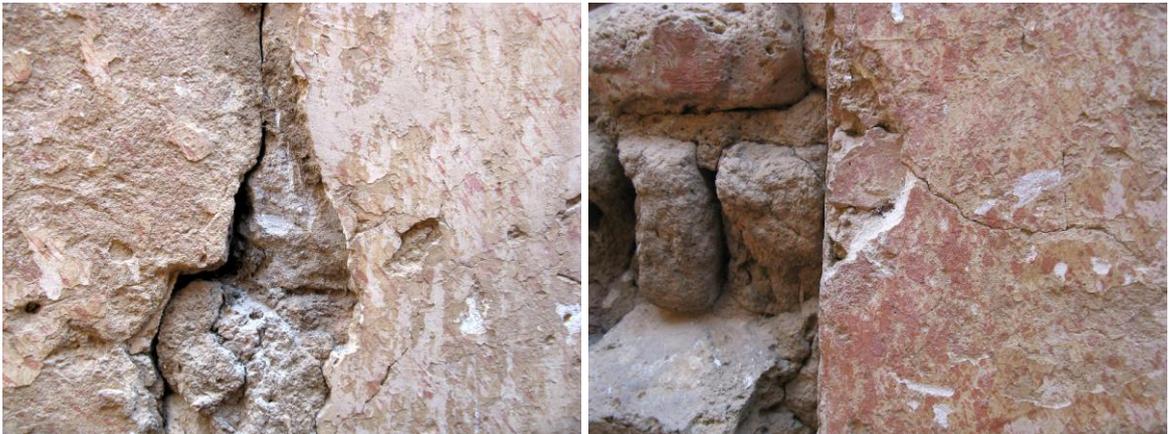
Samples E-13A and E-13B.

E 13 A	Back wall (south west), left side, a few decimeters below the small niche on the vertical external wall of the sacristy. The sample was taken to the right of the deep vertical lesion at a height similar to that of the base of the niche itself. The sample included the well-smoothed, gray bedding mortar, the light-colored surface plaster and thin layers of red and light yellow.	The fragment of mortar between the bricks (no. 1) is gray in color and is composed of lime, fine, well-graded sand, charcoal and occasional fragments of brick finely dispersed in the binder. The material is highly porous owing to the presence of minute globular cavities. It is thin in consistency. The finishing plaster (no. 2) is light in color with a well-smoothed and compacted surface. The plaster is composed of lime, medium-fine, well-graded sand and vegetable fibers. The fibers comprise straw and some cotton and linen. The more valuable fibers seem to be concentrated preferentially near the surface. The plaster is 5.0 – 6.0 mm thick.

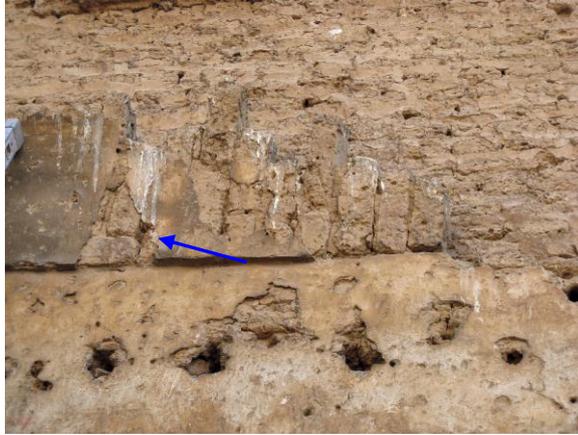
Sample E-15.

E 15	Back wall (south west) Almost at the corner with the south east wall, high up, from the cornice and the remains of the impost of a vault. The sample included the bedding mortar of the structure built of bricks positioned vertically.	The sample includes a fragment of dark-brown mortar based on silt and straw (no. 1) and a fragment of light-colored plaster (no. 2) made of lime, fine, well-graded, silicate-rich sand and abundant vegetable fibers. The plaster is 6.0 – 8.0 mm thick. The plaster is overlaid by a brown patina that may be concealing the paint layer or a finishing layer in general.
E 16	South east wall, corner with the south west wall, first embrasure up, from the base of the architrave. The sample included the light-colored finishing plaster.	The sample includes a thin fragment of light-colored finishing plaster composed of lime, medium-fine, well-graded sand and vegetable fibers, probably straw with some cotton and linen. The more valuable fibers seem to be concentrated preferentially near the surface. The plaster is less than 2.0 mm thick. The plaster is overlaid by a thin dark-brown patina.

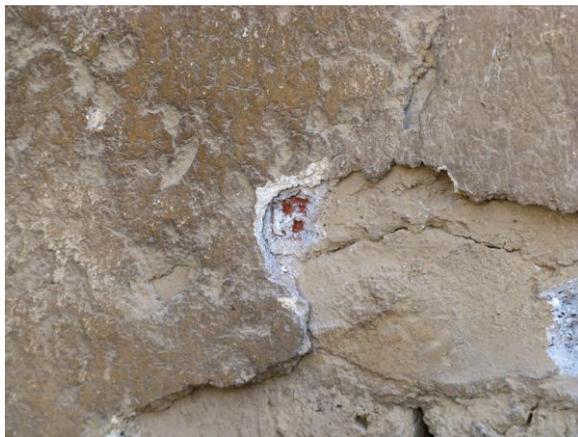
Sample E-17.

E 17	Back wall (south west) from an area very close to where sample no. 14 was taken. The sample included both the well-smoothed, gray bedding mortar and the overlying	The fragment of mortar between the bricks (no. 1) is gray in color and is composed of lime, fine, well-graded sand, charcoal and occasional fragments of brick finely dispersed in the binder. The material is highly porous owing to the

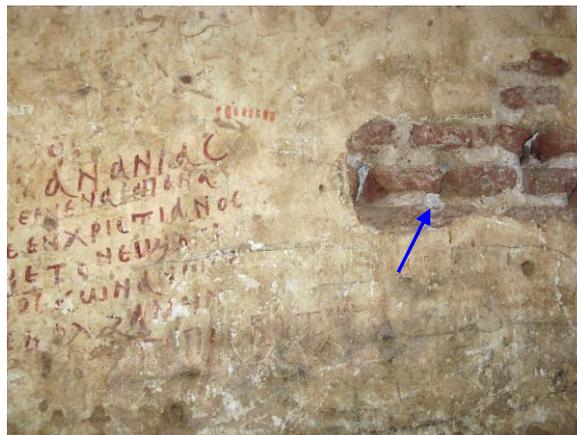
Sample E-19.

E 19	Back wall (south west), approximately 2.2 m up and taken from the gap in the plaster a few decimeters to the right of the Coptic inscription. The sample comprised the gray bedding mortar between the bricks with a well-smoothed and compacted surface.	The fragment of mortar is gray in color and is composed of lime, fine, well-graded sand, charcoal and occasional fragments of brick finely dispersed in the binder. The material is highly porous owing to the presence of minute globular cavities. Within it are occasional fragments of vegetable fiber and a few granules of calcareous rock (perhaps the remains of the original limestone that have not been entirely calcified). The material is thin in consistency.
E 20	North West Wall, approximately 1.3 m up, near the second niche to the left of the doorway. The sample comprised the gray bedding mortar between the bricks with a well-smoothed and	The structure and composition of the mortar was identical to that encountered in the previous sample. However, it did not contain vegetable fiber or calcareous rock fragments.

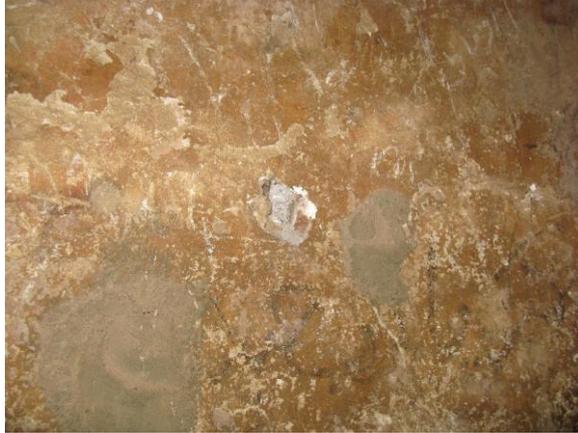
Sample E-21.

Sample number	Area sample taken from	Brief microscopic description
	compacted surface.	
E 21	North west wall, near the first niche from the right at a height of approximately 2.0 m, from within a gap in the plaster some 10 cm wide. The sample comprised the gray bedding mortar between the bricks with a well-smoothed and compacted surface.	The structure and composition of the mortar is identical to that encountered in sample E-19.

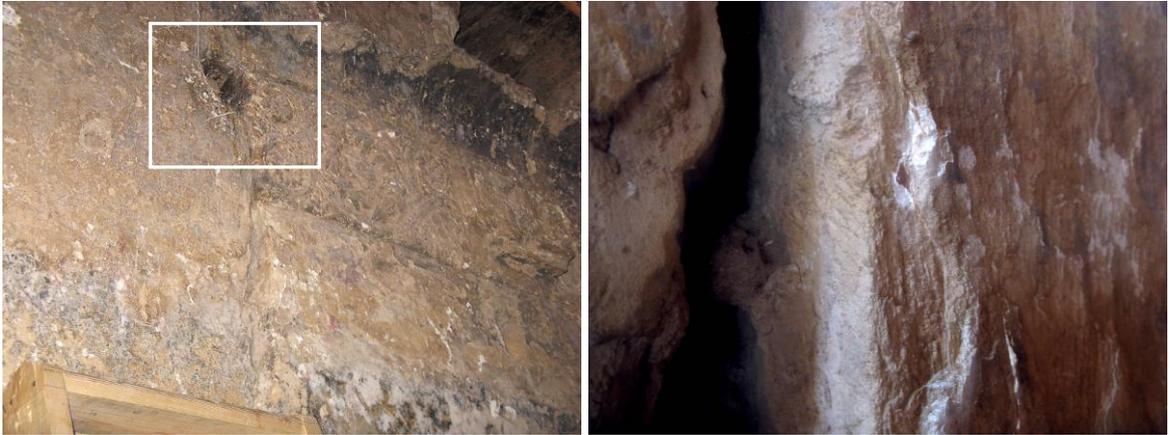
Samples E-PO – 1A, 1B and 1C.

Sample number	Area sample taken from	Brief microscopic description
E/PO – 1A	Internal doorway, architrave, left side. The sample comprises a small flake adhering to the stone, made up of a relatively thick white layer covered by a layer of red paint.	When examined under the stereo-microscope, the flake proved to be made up of the following layers: 1. thin, white, lime-based wash less than 1 mm thick, possibly incorporating occasional fragments of calcareous rock; 2. red paint layer, presumably based on hematite; 3. thin yellowish layer (patina produced by alteration).
E/PO – 1B	A few centimeters below the previous sample. The sample comprises a small flake adhering to the stone, identical to the one taken in sample no. 1 and a fragment of the overlying light-colored plaster containing vegetable fibers.	Study of the two flakes comprising the sample, plus the information acquired whilst collecting the samples have enabled us to reconstruct the stratigraphy present in situ. In particular, starting from the innermost layer, the following are visible: 1) plaster made of fine, well-graded, silicate-rich sand and lime; 2) intermittent lime-based wash; 3) red paint layer based on hematite; 4) thin yellowish layer (patina produced by alteration); 5) Restoration finishing plaster based on lime, well-graded, silicate-rich sand and vegetable fibers (plaster identical to that covering the internal walls of the church).

E/PO – 1C	The sample, taken from above the previous one, comprised a small flake made up of a white wash and a thin blue layer.	The flake is made up of the following layers, starting with the innermost: 1) traces of plaster composed of lime, fine, silicate-rich sand and vegetable fibers; 2) lime-based wash; 3) thin paint layer, probably blue in color and pigmented with lapis lazuli (the presence of a yellowish patina makes it difficult to study the paint layer with a stereo-microscope alone).
E/PO – 2	Architrave within decorated frieze at the height of the left upright. Several small flakes were collected, ranging from millimetric to submillimetric in size and comprising a white layer and a dark blue surface paint layer.	Study of the various flakes comprising the sample, plus the information acquired whilst collecting the samples have enabled us to reconstruct the stratigraphy described below. 1) calcareous stone; 2) thin, lime-based wash; 3) red, hematite-based paint layer; 4) thin, lime-based wash;

In sample E/PO – 1B, a plaster composed of lime, fine sand and straw, closely resembling that applied to the internal perimeter walls of the church (phase of the crosses: 10th – 13th centuries) was encountered on top of the presumed third phase layers.

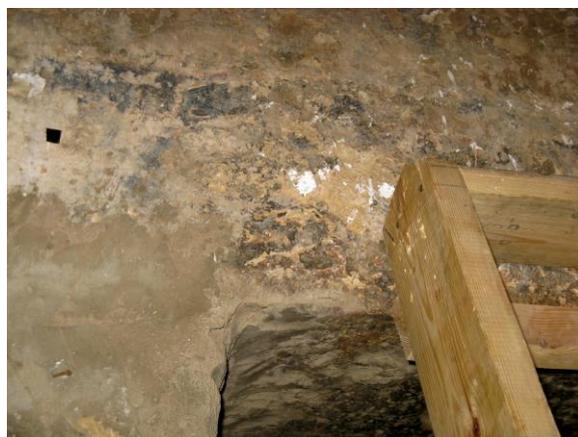
Sample E-PO – 3.

Furthermore, in sample E/PO-3, under the layers associated with the third phase there are others that can be associated with the second or first phase of work (compare with earlier reports by Artelab s.r.l.). In particular, the entire stratigraphic sequence encountered in the E/PO-3 sampling area is as follows: 1) relatively thick layer based on lime, a little sand, brick powder and a few fibers; 2) thin lime-based wash; 3) red and yellow paint layer; 4) thin lime-based wash; 5) green paint layer, probably wax-based; 6) thin black layer based on lamp black. Layers nos. 1 to 3 can be associated with the first phase whilst the rest can be associated with the third phase.

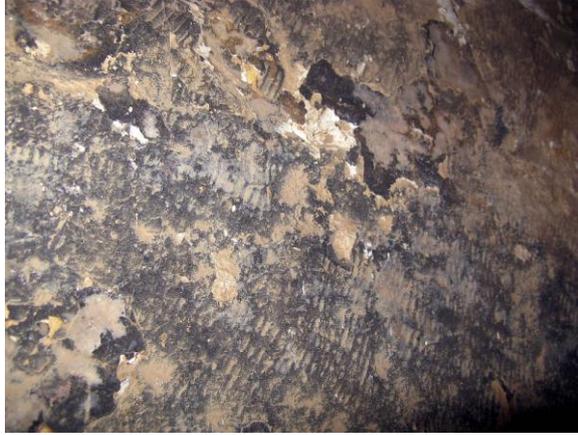
Sample E-PO – 4.

E/PO – 4	Architrave, right side at the height of the upright in an area where several overlying finishing layers have been observed, including some red and green layers. The sample included all the layers.	The flake in the sample was made up of the following layers, starting from the innermost: 1) lime-based wash; 2) red paint layer, presumably hematite-based; 3) lime-based wash; 4) red paint layer, presumably hematite-based; 5) lime-based wash; 6) thin black layer composed of very fine grains, presumably based on lamp black.

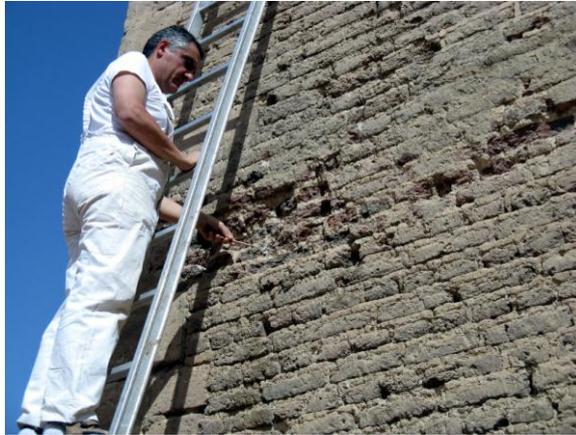
Sample SE/SW – 1.

Sample number	Area sample taken from	Brief microscopic description
1 SE/SW	South east side, near the corner with the south west side within the large cavity (over 1 m) caused by the partial fall of bricks from the wall. The sample, taken from a height of approximately 4.5 m, included the bedding mortar between the bricks.	The sample comprises a fragment of grayish mortar made with lime, fine, well-graded sand, lamp black and fragments of brick finely dispersed in the binder. The material is highly porous owing to the presence of minute globular cavities. The mortar contains a single vegetable fiber. The material is thin in consistency.
2 SE/SW	South east side, near corner with south west side, from the arch of the blocked-up window. The sample, taken from the left side of the arch, included the bedding mortar between the bricks.	The sample comprises a fragment of grayish mortar made with plenty of lime, fine, well-graded sand, lamp black and fragments of brick finely dispersed in the binder. The material is highly porous owing to the presence of minute globular cavities. The mortar contains occasional vegetable fibers. It is thin in consistency.

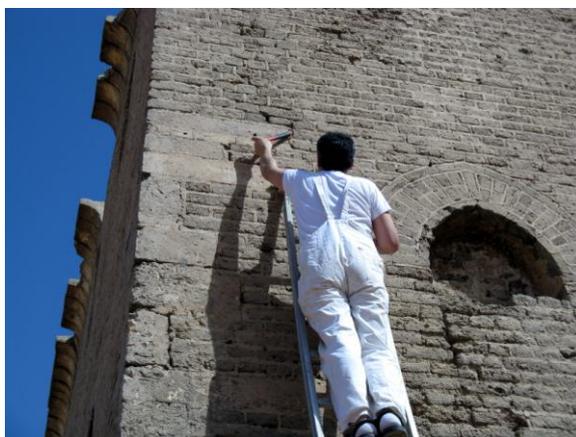
Sample SE/SW – 3.

3 SE/SW	South east side at the corner with the south west side, from the pointing of one of the corner stones.	The sample comprises a fragment of grayish mortar made with plenty of lime, fine, well-graded sand, lamp black and fragments of brick finely dispersed in the binder. The mortar contains occasional vegetable fibers. It is thin in consistency.
4 SW/SE	South west side, near the corner with the south east side, first window down, from the inside of the key of the vault of the ogive. The sample comprised the plaster adhering firmly to the mortar between the bricks.	The sample comprises a fragment of grayish mortar made with plenty of lime, fine, well-graded sand and fragments of brick finely dispersed in the binder. The mortar contains very occasional vegetable fibers. It is thin in consistency. The mortar does <u>not</u> contain charcoal.
5 SW/SE	South west side, near the corner with the south east side, first window down, from the external part of the arch, right side. The sample comprised the external pointing of the bricks.	The sample comprises a fragment of grayish mortar made with plenty of lime, fine, well-graded sand, lamp black and fragments of brick finely dispersed in the binder. The mortar contains very occasional vegetable fibers. It is thin in consistency.

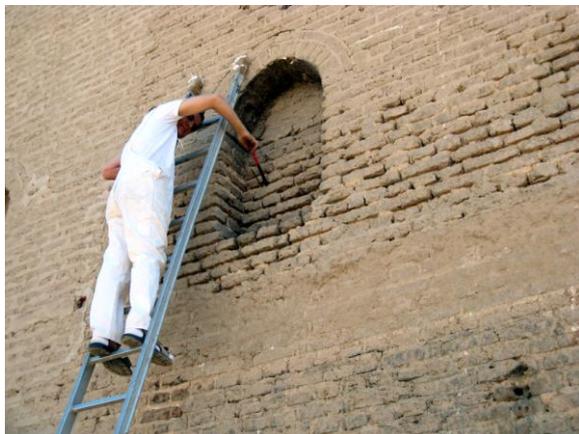
Sample SW/SE – 6.

6 SW/SE	South west side, near the	The sample comprises a fragment of grayish

Sample number	Area sample taken from	Brief microscopic description
	corner with the south east side, first window down, from the central portion. The sample comprised the bedding mortar between the bricks.	mortar made with plenty of lime, fine, well-graded sand, lamp black and fragments of brick finely dispersed in the binder. The mortar contains very occasional vegetable fibers and a few lime crumbs. It is thin in consistency.

Therefore, from the point of view of the nature of the mortar types, we have no proof or benchmarks to indicate the different ages of the masonry examined. Only one sample (1 SW/SE), taken from the external facade (south west side, near the corner with the south east side, from the inside of the key of the vault of the ogive of the first window down), proves an exception to this rule. The sample, comprising plaster adhering strongly to the masonry, differs from the others in that the mix does not seem to contain charcoal.

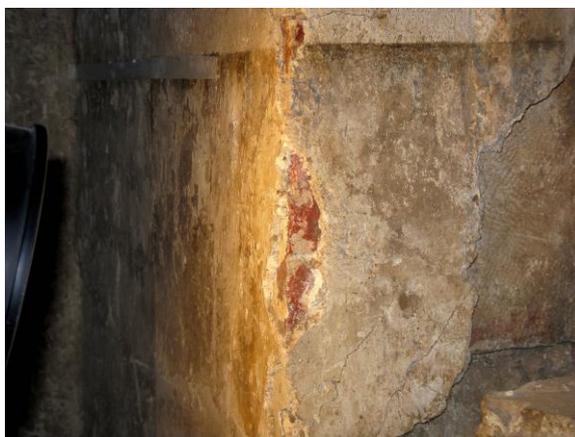
ICO - 1.

Sample number	Area sample taken from	Brief microscopic description
ICO-1	Facade, left side, from about two thirds of the way up the first pilaster, from the area above a red band, near the edge of a gap. In this area, the plaster is light in color with a well-smoothed and compacted surface. The sample included almost the entire thickness of the plaster.	The sample collected comprised a light-colored plaster made up of lime, well-graded, medium-fine sand and occasional vegetable fibers (its thickness varies between 4.0 and 5.0 mm).
ICO-2	Facade, left side, at the outer edge of the original masonry, near a gap that skirts the upper arm of the large circular cross. The sample comprised several flakes, ranging from millimetric to submillimetric in size, of the white plaster on which the cross is painted.	The plaster sampled has the same composition and texture as the previous type (sample ICO-1).

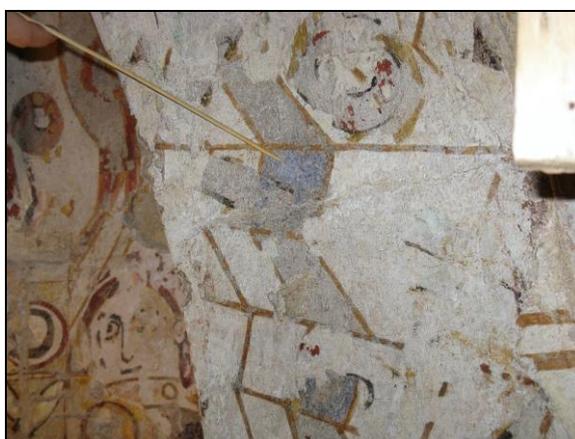
ICO - 3.

ICO-3	Facade, left side, second tier, arch, right side near the impost, from a blue geometric decoration. The sample comprised several submillimetric flakes of plaster with a blue paint layer.	A comparative examination of the flakes in the sample has enabled us to reconstruct the following stratigraphic sequence, starting with the innermost layer. 1) pink paint layer, probably resulting from the application of red lacquer in a wax medium (paint layer associated with the third phase of painting or a slightly older phase); 2) thick, white, lime-based wash; 3) thin blue paint layer, containing very fine

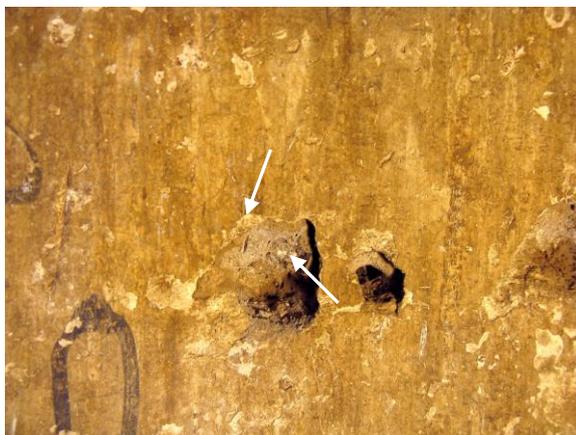
CAV - 1.

Sample number	Area sample taken from	Brief microscopic description
CAV-1	North west wall, approximately 60 cm from the facade, from the edge of a gap in the plaster at least 10 cm wide. The sample included both the gray bedding mortar from between the bricks and the overlying light-colored plaster.	The fragment of gray mortar (no. 1) proved to be made up of carbonized lime, fine, silicate-rich sand, charcoal, brick powder and occasional vegetable fibers. The overlying light-colored plaster (no. 2) proved to be made up of lime, well-graded, medium-fine sand and abundant vegetable fibers.
CAV-2	North West Wall, from the area of masonry below the embrasure; sample taken from the edge of the gap in the plaster. The sample only	The gray mortar is identical to that collected in the previous sample.

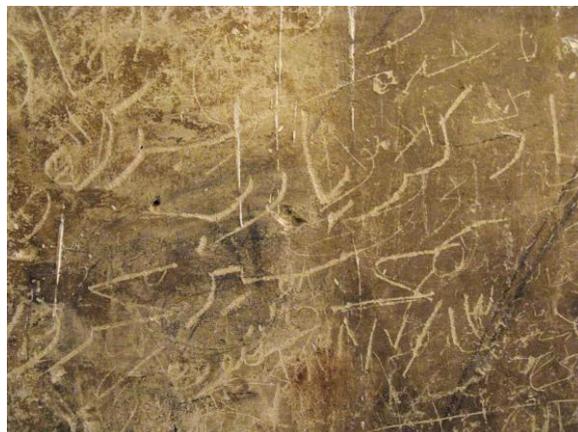
CN-A.

Sample number	Area sample taken from	Brief microscopic description
CN-A	North corridor, north west wall, area in front of the test wedge opened to the right of the niche, near the gap, at a height of approximately 1.7 m. The sample included the entire thickness of the plaster.	Examination of the flake in the sample has enabled us to reconstruct the following stratigraphic sequence, starting with the innermost layer. <ol style="list-style-type: none"> 1. light-colored plaster made up of lime, well-graded, medium-fine sand and occasional vegetable fibers. 2. gray layer probably colored with lamp black; 3. thin, light-colored layer.
CN-B	North corridor, south east wall, at the base of the test wedge that brought to light the decoration featuring polychrome circles. The sample, taken from a height of approximately 1.7 m, comprised the entire thickness of the whitish plaster overlying the phase with the circular decoration.	Examination of the fragment in the sample has enabled us to reconstruct the following stratigraphic sequence, starting with the innermost layer. <ol style="list-style-type: none"> 1. light-colored plaster made up of lime, well-graded, medium-fine sand and occasional vegetable fibers; 2. thick, lime-based wash, very well-smoothed, that has turned gray on the surface.

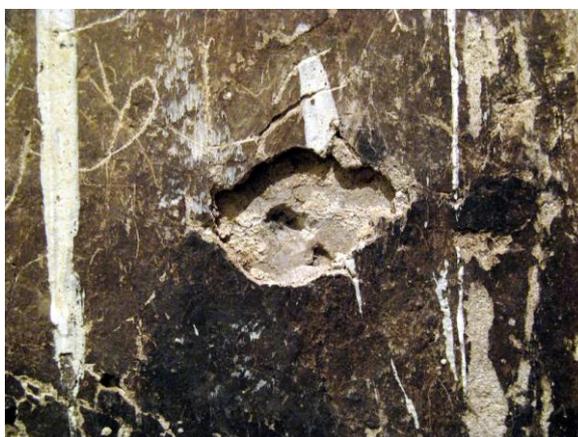
CN-C.

CN-C1	North corridor, north west wall, corner with the north east wall, from the edge of a gap at least 10 cm wide, at a height of approximately 1.1 m.	The surface fragment (C1) comprises: <ol style="list-style-type: none"> 1. light-colored plaster made up of lime, well-graded, medium-fine sand and occasional vegetable fibers (surface well-smoothed); 2. thin blackish deposit made up of particulate matter.
CN-C2	Two samples were taken in sequence. the first (C1) comprised the entire thickness of the surface plaster; the second (C2) comprised the underlying mortar with a well-smoothed surface. The two layers of mortar are partially separated by a break.	The sample comprises a fragment of grayish mortar made with lime, plenty of fine, well-graded sand, charcoal and occasional fragments of brick finely dispersed in the binder. The mortar has a high aggregate: binder ratio and is distinguished by a well-smoothed and compacted surface caused by immediate working.

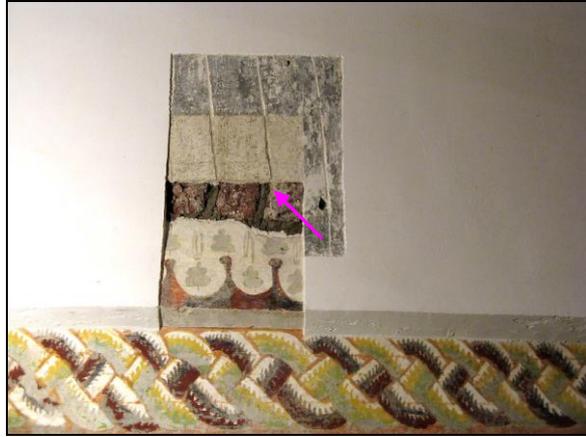
CN-D.

Sample number	Area sample taken from	Brief microscopic description
CN-D	North corridor, south east wall, from the test wedge opened on the side of the small vault. The sample comprised the entire thickness of the plaster covering the brick masonry.	<p>Examination of the fragment in the sample has enabled us to reconstruct the following stratigraphic sequence, starting with the innermost layer.</p> <ol style="list-style-type: none"> 1. light-colored plaster made up of lime, well-graded, medium-fine sand and abundant vegetable fibers; 2. traces of a gray layer probably produced by the presence of a carbon-based pigment; 3. traces of a whitish layer, probably lime-based.
CN-E	Prothesis, south west wall, to the right of the access door to the church at a height of approximately 1.2 m. The sample comprised a fragment of very well-smoothed, gray plaster.	<p>The sample comprises a fragment of grayish mortar made with lime, fine, well-graded sand, abundant charcoal and occasional fragments of brick finely dispersed in the binder. Some of the fragments of charcoal still retain the original cellular structure of the wood they were made from.</p> <p>The mortar is distinguished by a well-smoothed surface.</p>

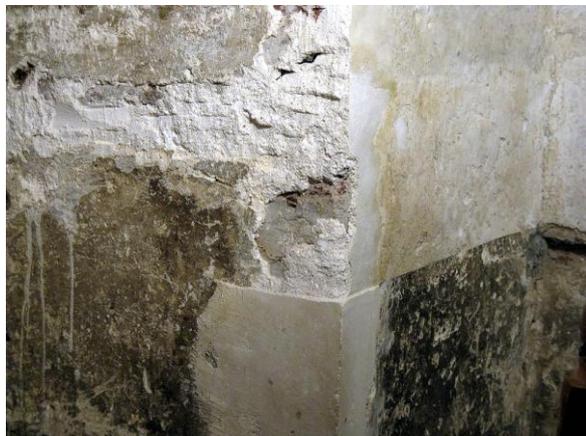
CN-G.

CN-G1	Prothesis, north east wall, niche, right impost.	Sample G1 comprises a fragment of light-colored plaster made up of lime, well-graded, medium-fine sand and relatively abundant vegetable fibers;
CN-G2	Two samples were taken in sequence. The first (G1) comprised the entire thickness of the surface plaster; the second (G2) comprised the underlying mortar with a well-smoothed surface. The latter was adhering very firmly to the brick masonry.	Sample G2 comprises a fragment of grayish mortar made with lime, fine, well-graded sand, charcoal and occasional fragments of brick finely dispersed in the binder. The mortar is distinguished by a well-smoothed surface produced by compacting with an appropriate tool.
CN-H1	Prothesis, north east wall to the right of the niche, at the top, from the edge of a gap at least 10 cm wide, repaired with a mud and straw mortar.	Sample H1 comprises a fragment of light-colored plaster made up of lime, well-graded, medium-fine sand and vegetable fibers.

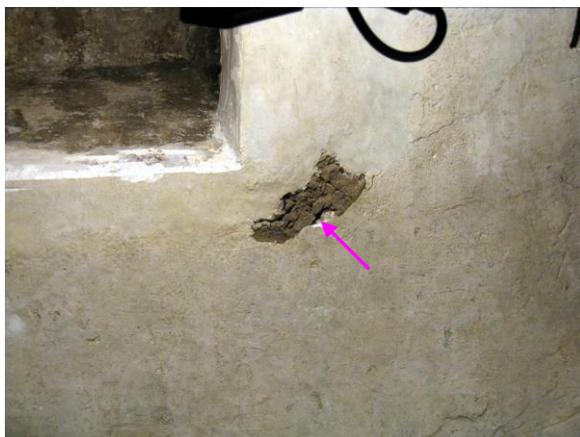
CN-H.

CN-H2	Two samples were taken in sequence. The first (H1) comprised the entire thickness of the whitish surface plaster; the second (H2) comprised the underlying gray mortar with a	Sample H2 comprises a fragment of grayish mortar made with lime, fine, well-graded sand, charcoal and possibly, occasional fragments of brick finely dispersed in the binder. The mortar has a high aggregate: binder ratio and is distinguished by a well-

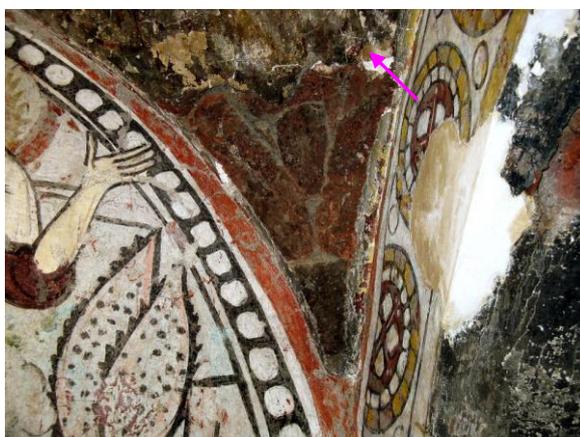
PRO-7.

PRO-7	Prothesis, South west wall bearing the painting of the Madonna and Saint, impost of the vault, from the corner with the large gap in the plaster. Bedding mortar from the bricks of the vault.	Dark-brown mortar made of silt and fairly coarse vegetable fibers, probably straw.
PRO-15 (*)	Prothesis, south west wall bearing the painting of the Madonna and Saint, right side, from the gap in the plaster near the red cross. In the sampling area, three plaster types overlying the masonry can be distinguished. As a result of the stratigraphic information collected in situ, the first plaster type can be associated with the first or second phase of construction of the church; the second layer can be attributed to the third phase, whilst the outermost, light-colored plaster is associated with the 10th-13th century phase. The sample comprised a fragment including the only plaster associated with the presumed third	The fragment of plaster in the sample (thickness varying between 4.0 and 4.5 mm) is in turn comprised of two layers applied in rapid succession. The innermost comprises lime, well-graded medium sand and occasional vegetable fibers; the other layer however comprises a white mortar made of slaked lime and powdered calcareous rock (alabastrine limestone). The latter layer has been very well smoothed and compacted.

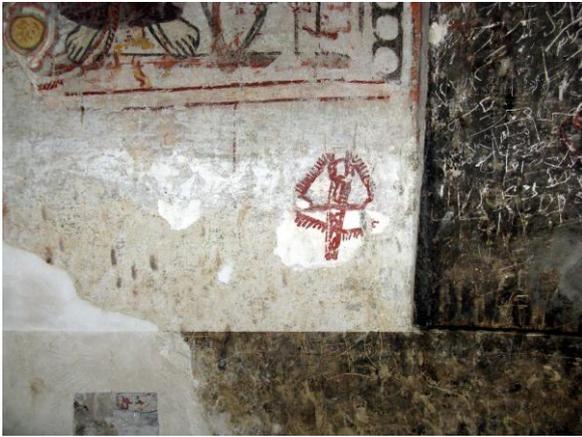
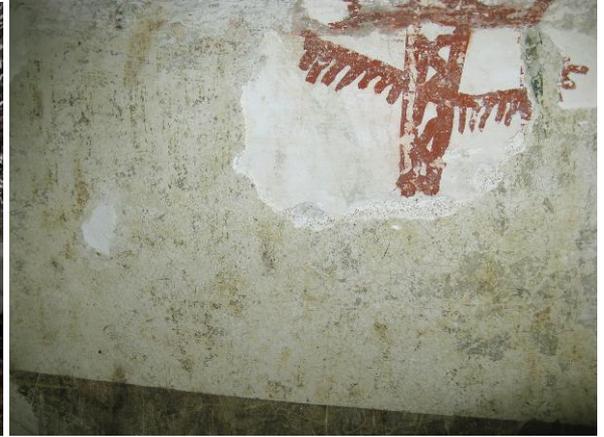
PRO-15.

² See the reports by Artelab s.r.l. produced after the previous missions and the information obtained from the examination of sample PRO-15, taken on this occasion.
