Projet de santé et d'hygiène de la région nord, Tombouctou, Mali

Rapport Semi-Annuel
25 Septembre 25 – 31 Décembre 2000

**Rapport sur la Visite Technique en Eau et Assainissement
Du Consultant Mr. William Hoadley**

**REPORT ON
TECHNICAL ASSISTANCE TO
NORTHERN REGION HEALTH AND HYGIENE PROJECT
(NRHHP)**

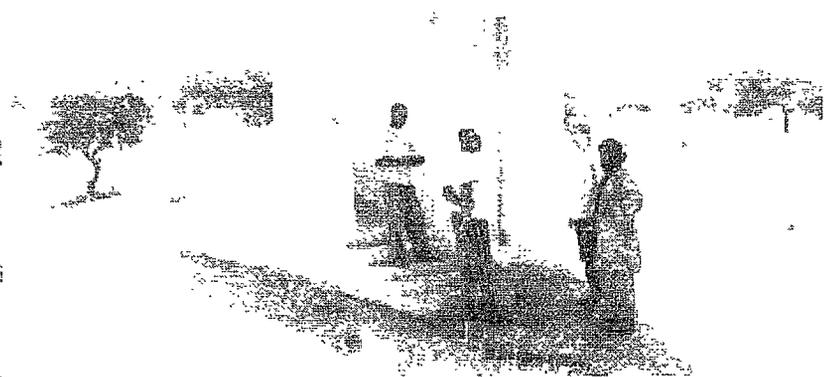
The latrine, constructed by Guindo, had four stalls housing squat holes, two for boys, and two for girls. It was kept locked and, while not heavily used, it was being used and was maintained in a very clean condition. The structure, vent pipes and mosquito netting were in good condition save for minor peeling of plaster and undermining of sand around the steps.

Latrine for Community School in Teideini
