2. TITLE AND SUBTITLE  
Trail suspension bridge study. Part A: Effects of trail bridges; Vol. V: Case history, analysis and findings on bridges studied in Eastern Development Region

# TRAIL SUSPENSION BRIDGE STUDY

VOLUME 5 CASE HISTORY, ANALYSIS AND FINDINGS

Bridges Studied in Eastern Development Region

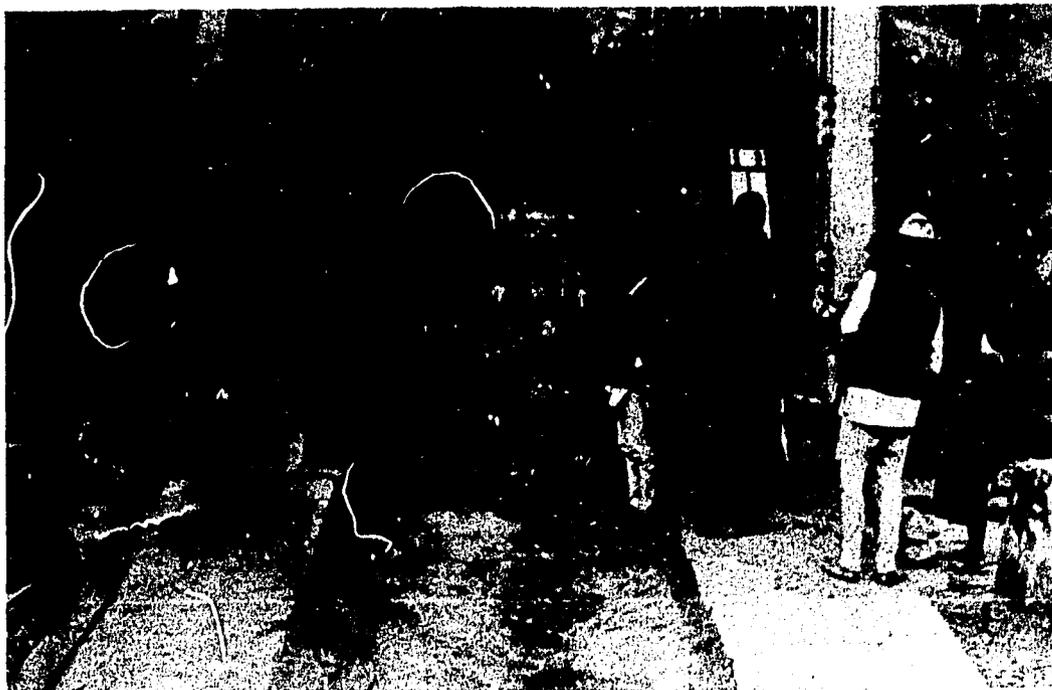
13-P-1: Toll collector, travellers and bystanders at the right side of the bridge. Tolls are collected under a contract system and provide about Rs. 6,000 per year, as fixed tax, for the districts concerned.

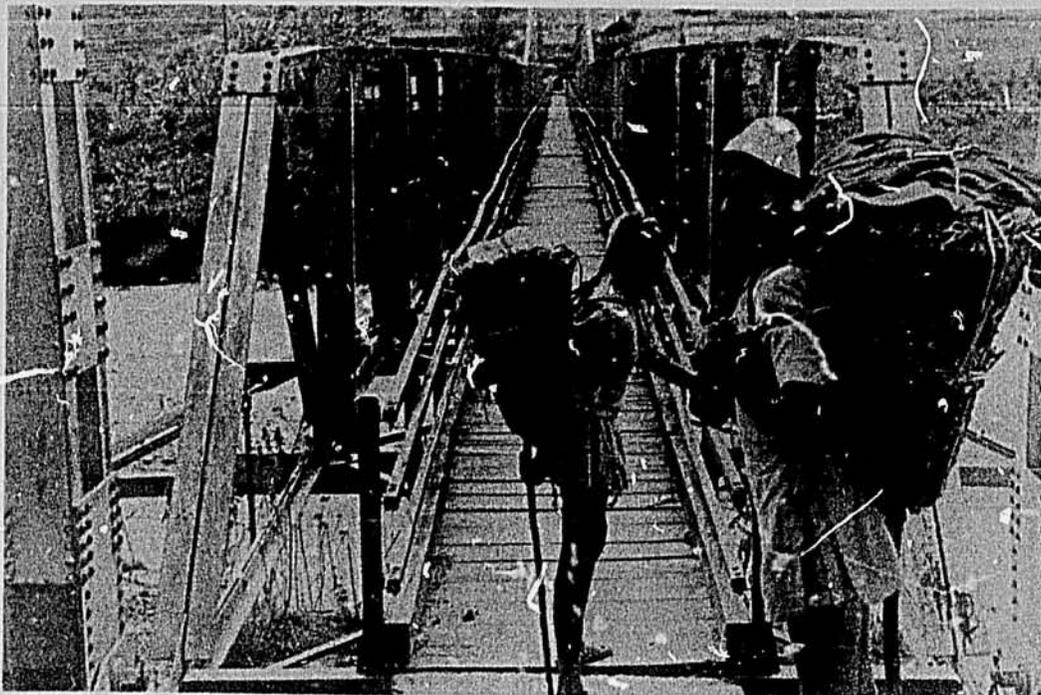
13-P-2: Porters with loads. The clear width of the heavy stiffening truss is 7.75 ft. It is felt that with minor modifications, the bridge could admit light motor vehicles. Note the pinned hinges of the tower visible at lower left and lower right.

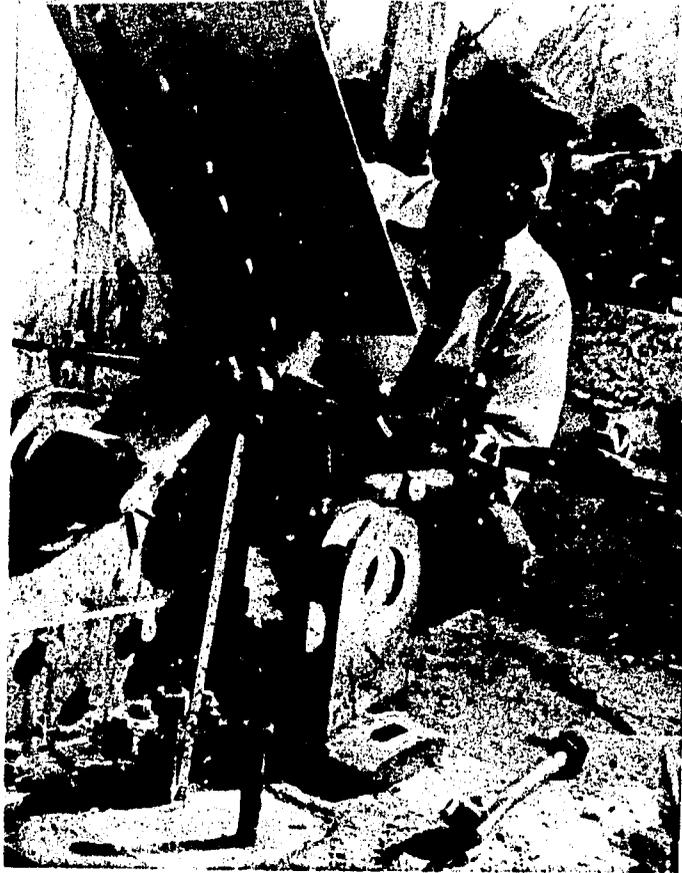
13-P-6: Maintenance work was done in April 1973 on supports connecting the stiffening truss to the foundation on the right bank.

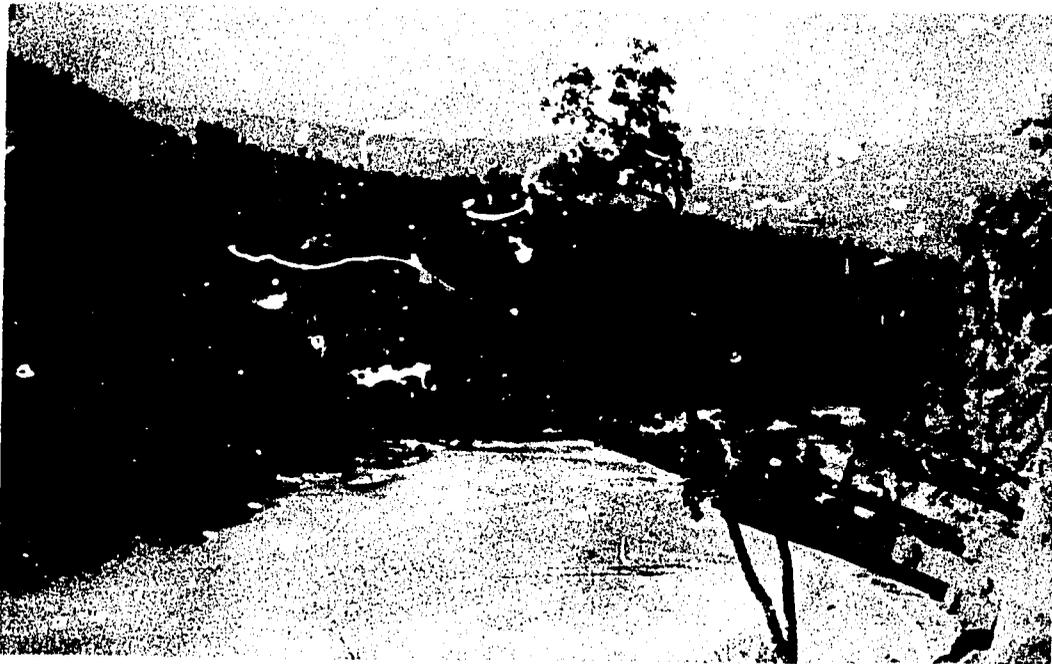
13-P-7: Collapse of the bridge at the time of initial completion of construction occurred when main cables came loose from the left anchor. It was said that the bulldog grips had been tightened incorrectly in an upside down position. Undoubtedly as an overreaction to the disastrous collapse, a much larger number of grips than necessary, according to specifications, were installed on the cables at the time of repair.

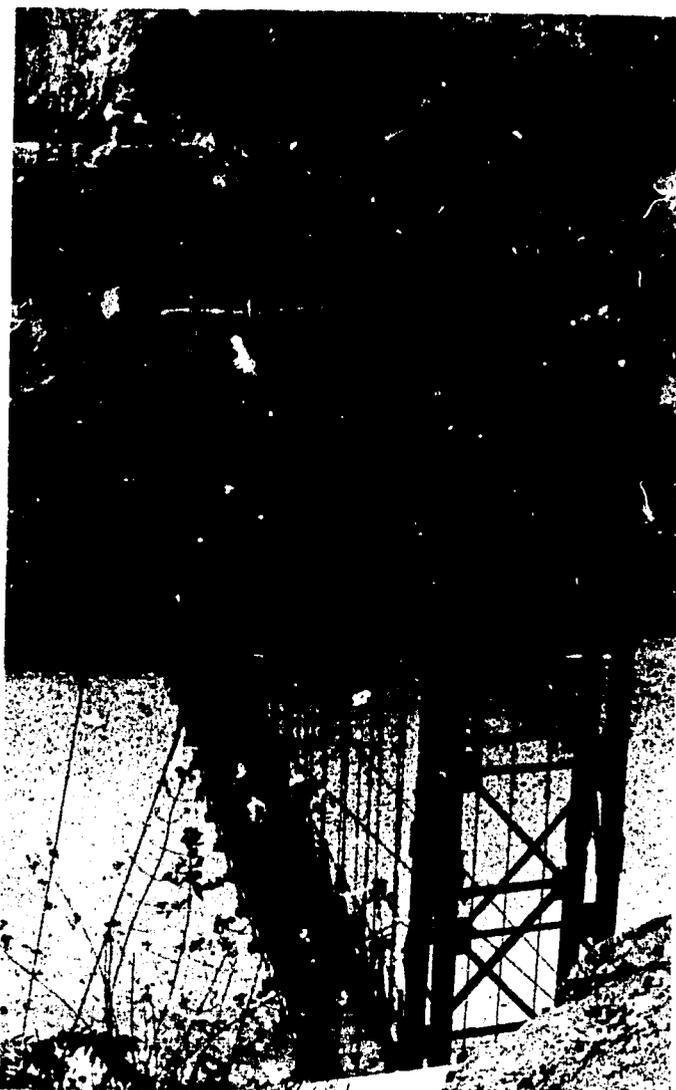
13-P-10: Sabhaya Khola Bridge about  $1\frac{1}{4}$  hours walk downstream along the Arun River from Tumlingtar, on the main trail from Khadbari (Sankhuwasabha District Headquarters) to Dhankuta. The bridge, of approximately 344 ft. span, was built less than a year ago by SBD. Even though the bridge is directly on the main trail some people find it easier to cross by fording the river just slightly upstream from the bridge.

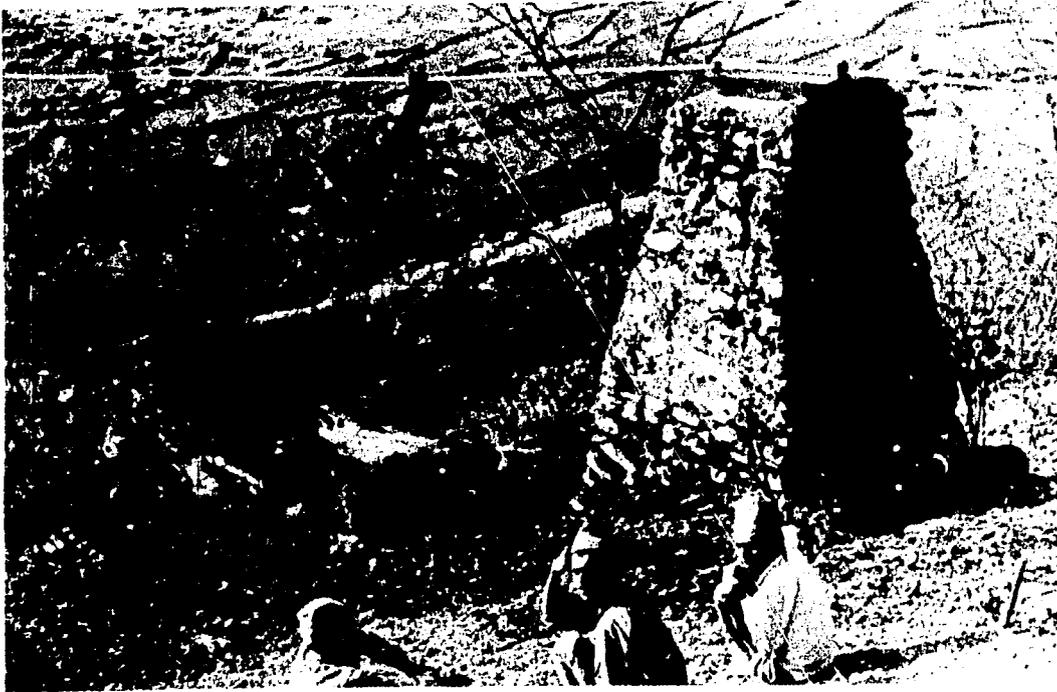
14-P-1: Left bank support pillar for track cable of Leguwaghat Cableway. Cranking mechanism is in the background. Haulage cable passes over the wheel mounted on track cable.

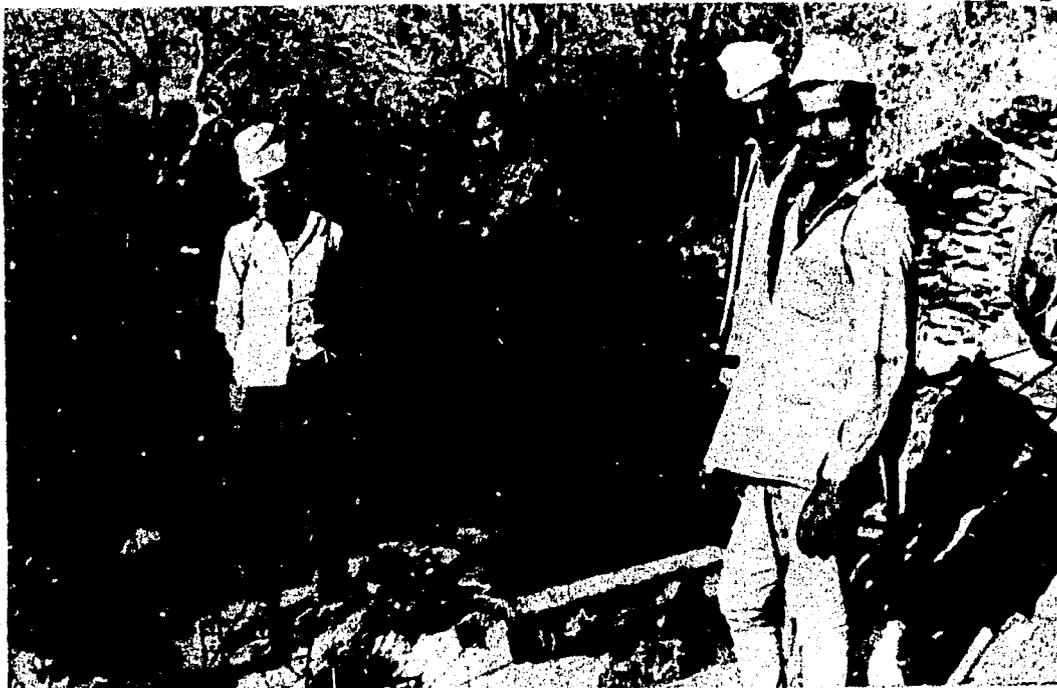
14-P-2: The non-functional cranking mechanism on the left bank.

The cableway is non-functional and has been ever since the first day it was tested. The winding mechanism for the haulage cable is rusty and the gear train does not work. The haulage cable has come off of some of the wheels on which it should run. The cable car hangs uselessly about 150 ft. from the left bank support pillar and the track cable at the support pillar is inclined steeply at about 15° from the horizontal. Anchorages and track cable support pillars are in good condition.
