Adaptive Mooring Management Plan
Sandy Island Oyster Bay Marine Protected Area
Carriacou, Grenada

Written by Monica Reed, Sustainable Grenadines Inc.

October 2016

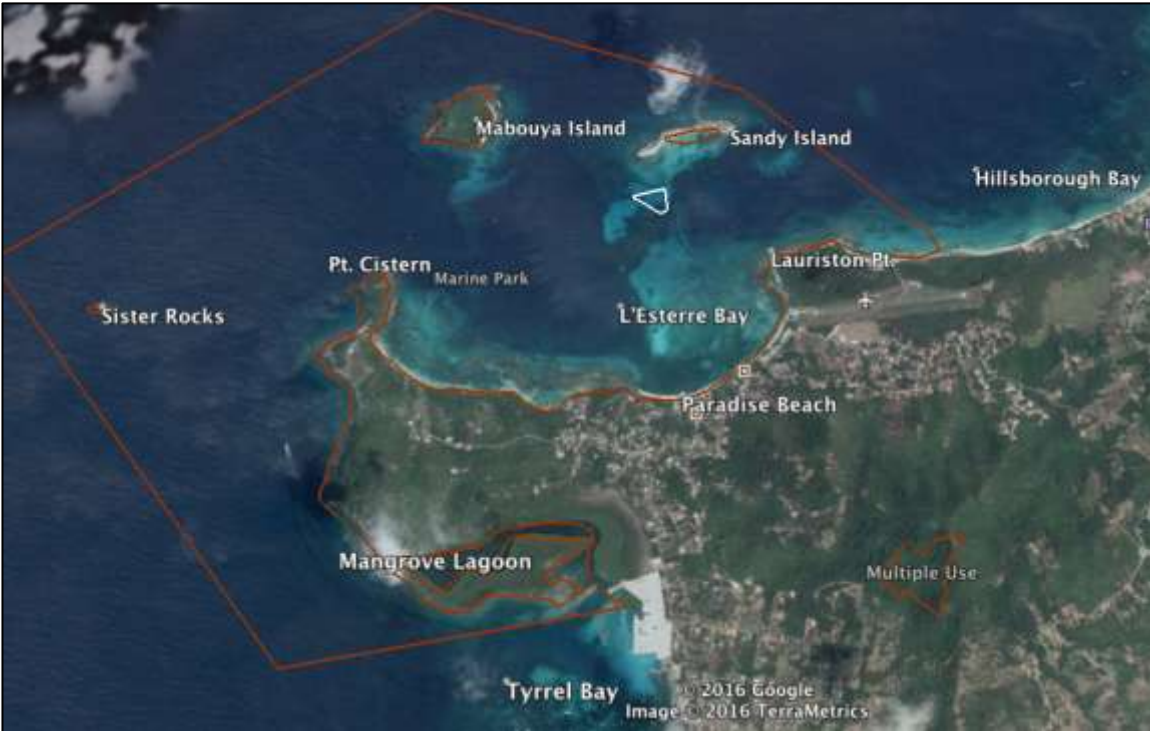
Figure 5. Map showing the MPA boundary (red) of the SIOBMPA, Carriacou, Grenada (Google Earth, 2016).

The Sandy Island/Oyster Bed Marine Protected Area (SIOBMPA) is located on the southwest coast of Carriacou, the largest of the Grenadine islands in Grenada (Figure 5). The volcanic island is inhabited by approximately 8 000 residents. The majority of local livelihoods rely on the agriculture or fisheries sectors. The primary activities that occur within the SIOBMPA are spear fishing, pot fishing, seine fishing, SCUBA diving, recreational use, water taxi use and charter craft usage (MCMPPA, 2015).

The MPA boundaries encompass the mangroves of Lauriston Pt. in Hillsborough Bay, the shoreline through L'Esterre Bay, Pt. Cistern, and the north end of Tyrrel Bay (Figure 5). Islands within the MPA include Sandy Island, Mabouya Island, and the Sister Rocks.

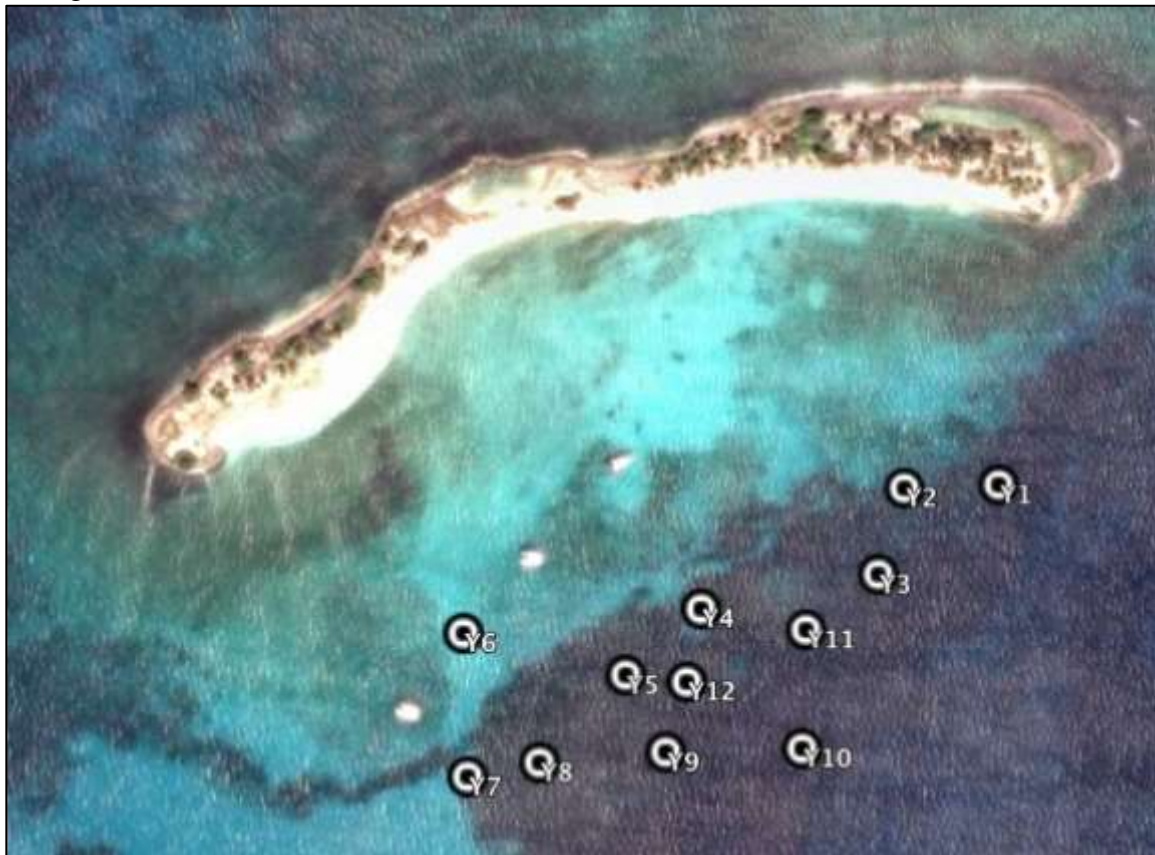
unusable. Twelve yacht moorings south of Sandy Island were examined and mapped (Figure 6). Five yacht moorings and six small boat moorings were assessed near Paradise Beach in L’Esterre Bay (Figure 7). The yacht moorings have manta and pin style anchors and are in sandy patches amongst seagrass and corals. Data collected was used to map mooring locations and create a mooring systems database in Microsoft Excel for the SIOBMPA. Photographs taken to document standard and abnormal features of the mooring systems and seafloor are included in Appendix B to clarify observations noted during the assessments.

Figure 6. Current overnight yacht moorings located south of Sandy Island, SIOBMPA (Google Earth, 2016).

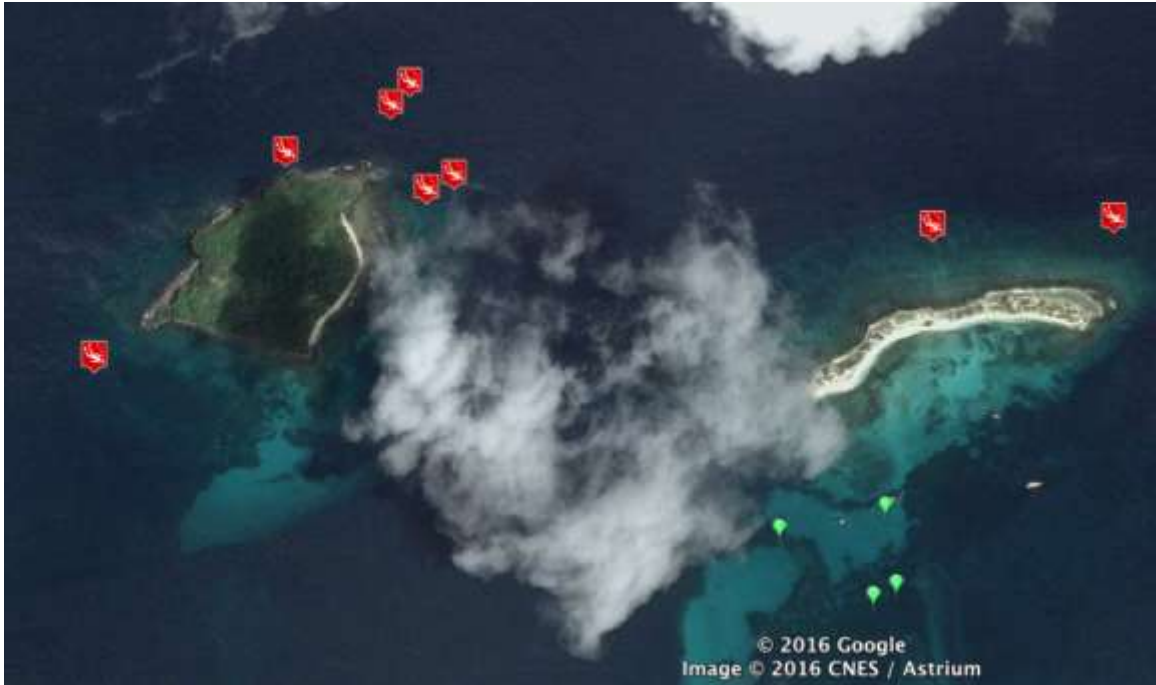
Dive mooring GPS coordinates were provided by Richard of Lumba Dive. Red dive flags indicate current moorings, while the four orange dive flags indicate sites requiring dive moorings (Figure 13, 14). The current anchorage zone is the area within the green placemarkers shown in Figure 13. This sandy area is where boats anchor that exceed the size limit of the mooring systems. It is recommended that a professional mooring company be contracted to site and install moorings for superyachts and small cruise ships.

Figure 13. Map showing current dive mooring sites (red flags) near Mabouya (left) and Sandy Island (right), as well the anchorage zone south of Sandy Island, SIOBMPA, 2016.

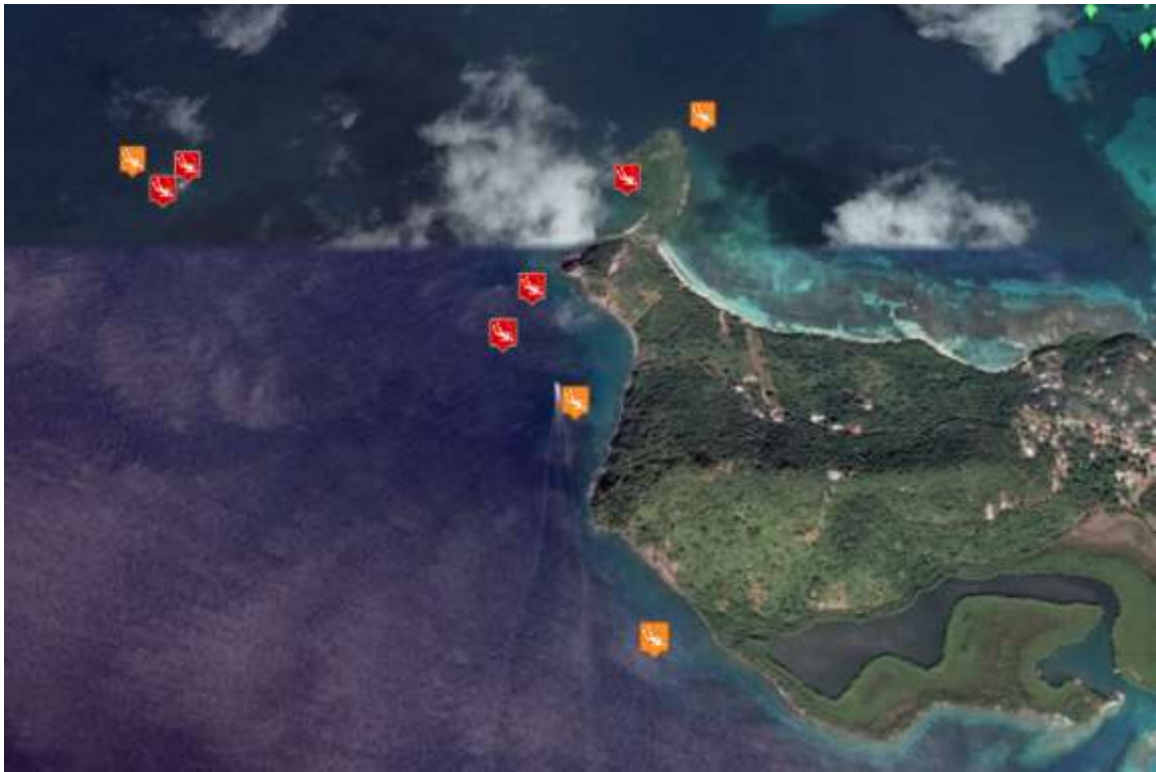
Figure 14. Map showing current dive mooring sites (red flags) and dive sites requiring mooring systems (orange) near Sister Rocks (top left) and around Cistern Point, SIOBMPA, 2016.

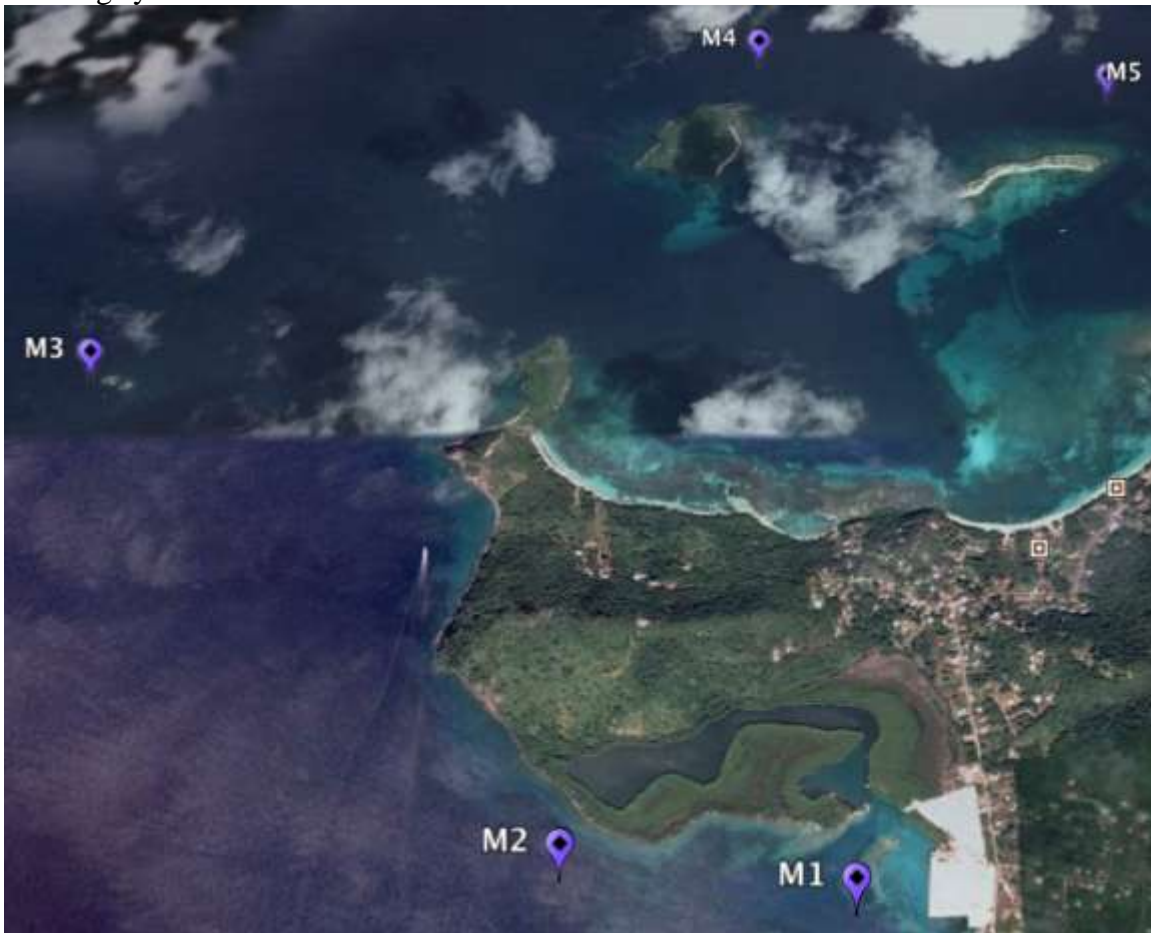
From Lumba Dive’s records of past mooring system locations, five key sites requiring mooring systems for boundary demarcation buoys were identified (Figure 15). These sites were identified based on the record’s notes that indicated SIOBMPA staff had requested the removal of other demarcation buoys and the upkeep of the moorings at these five sites. SIOBMPA has demarcation buoys, which can be redeployed once the mooring systems have been installed at the five sites.

Figure 15. Map of SIOBMPA with suggested boundary demarcation mooring sites (purple flags).

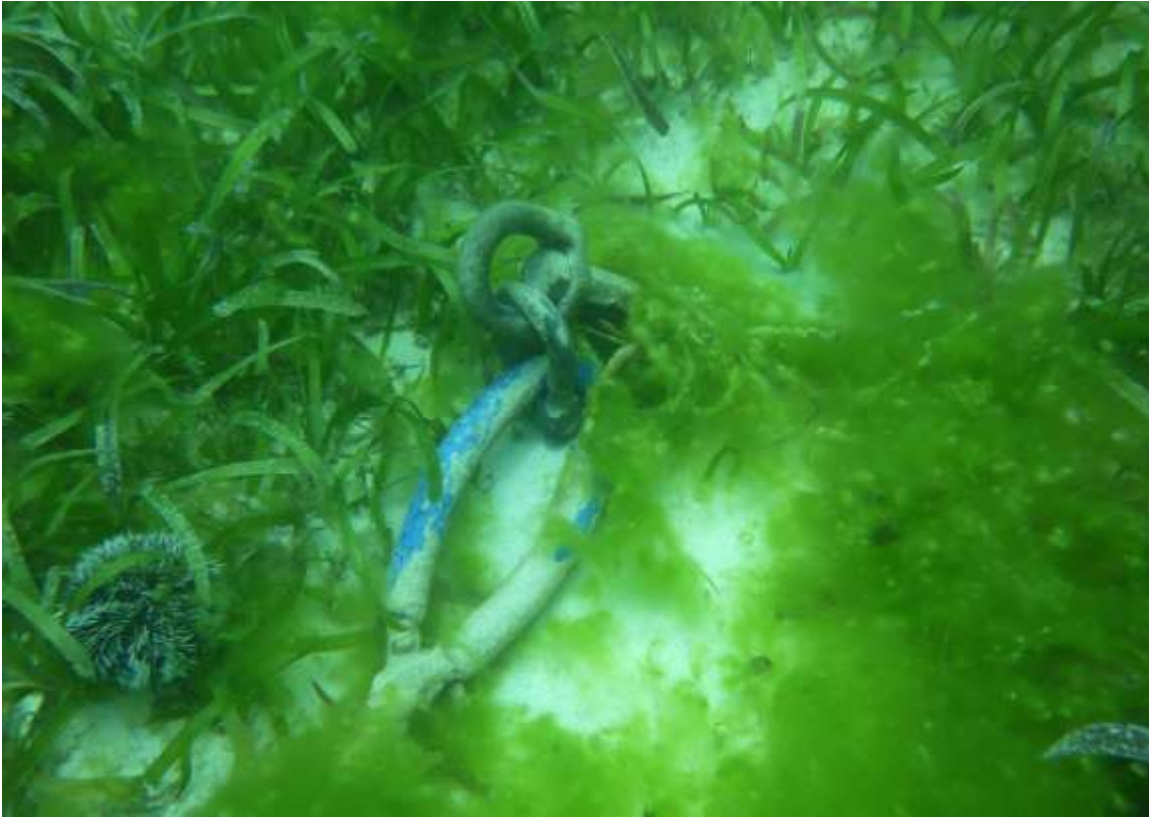
Figure 20. Image showing a single manta pin anchor with downline attached, surrounded by seagrass and green algae (Reed, 2016).

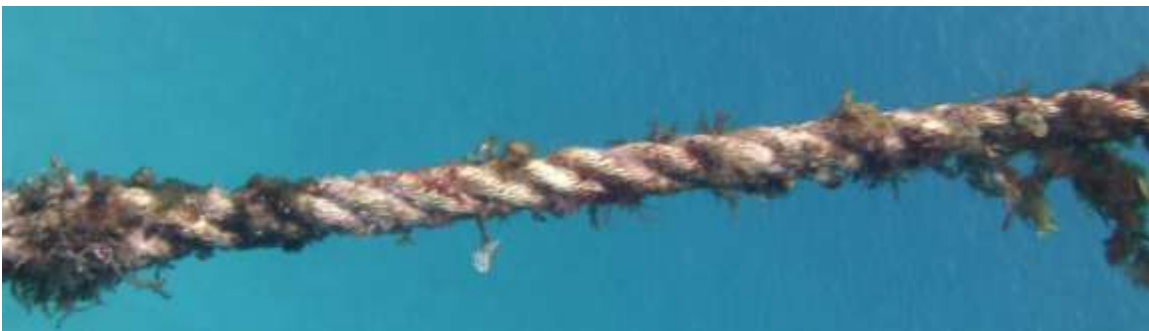
Figure 21. Image of downline with moderate fouling (Reed, 2016).

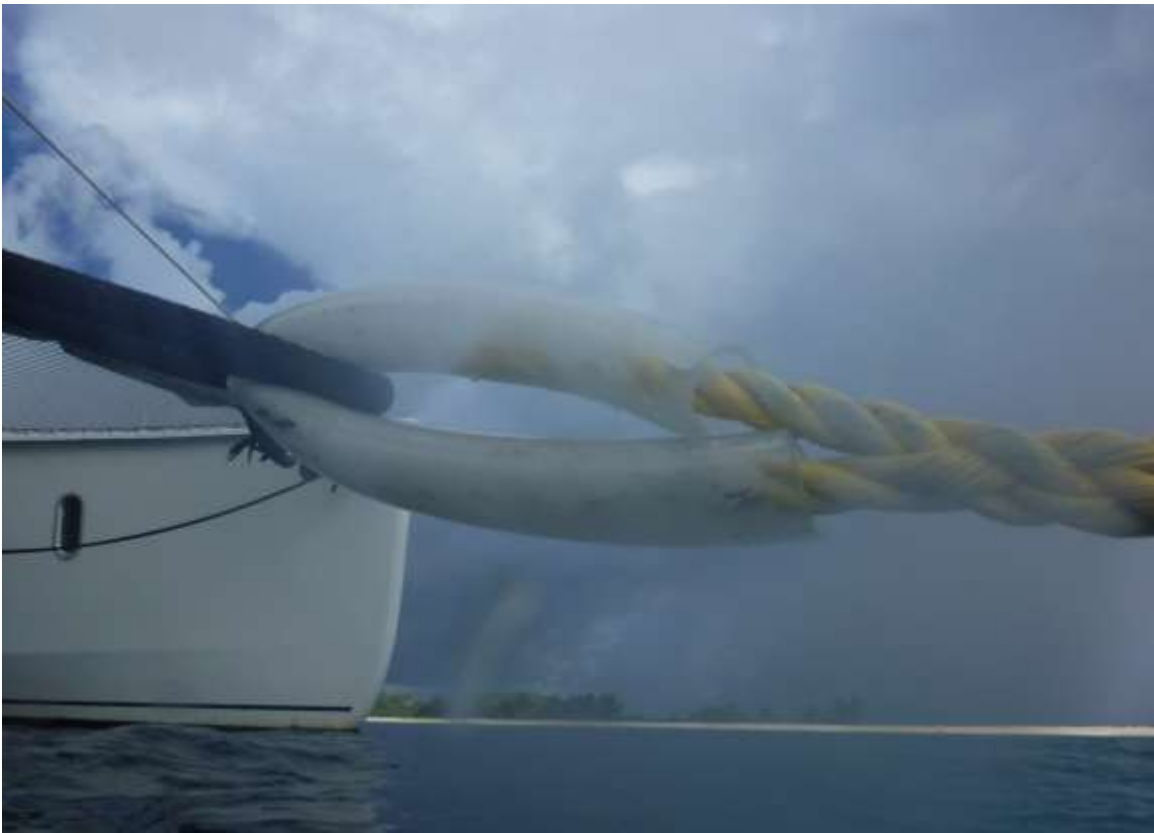
Figure 23. Image of the standard pick-up line with spliced rope loop reinforced with plastic piping to reduce abrasion from vessel lines (Reed, 2016).

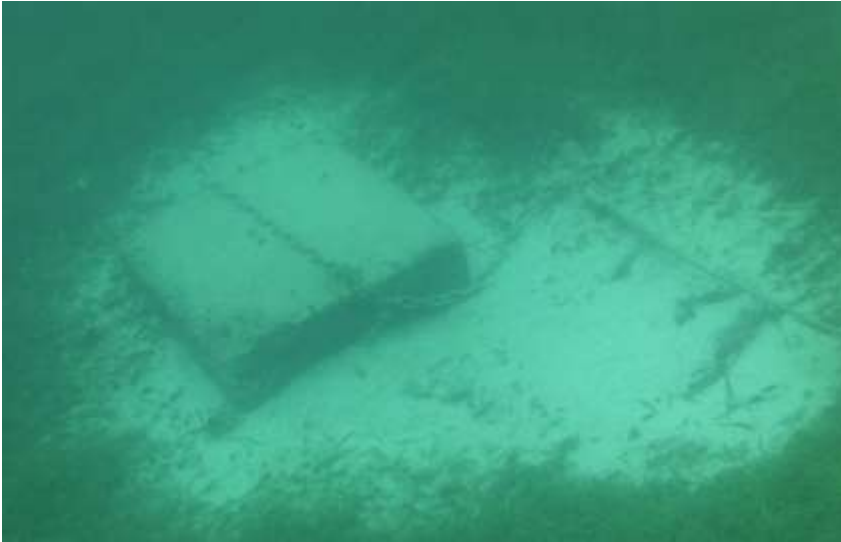
Figure 24. Image showing scouring of seagrass from anchor chain without a float (Reed, 2016).

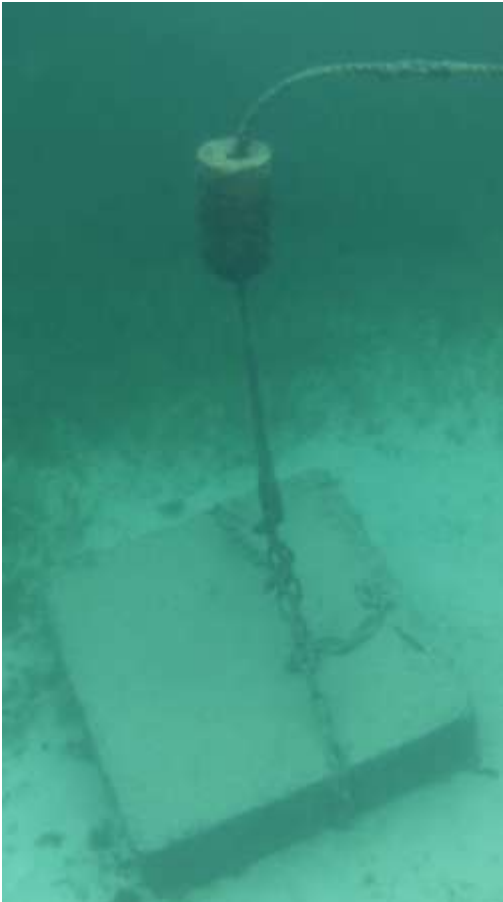
Figure 25. Image showing concrete block anchor with chain and float that is preventing scouring of the surrounding seabed (Reed, 2016).

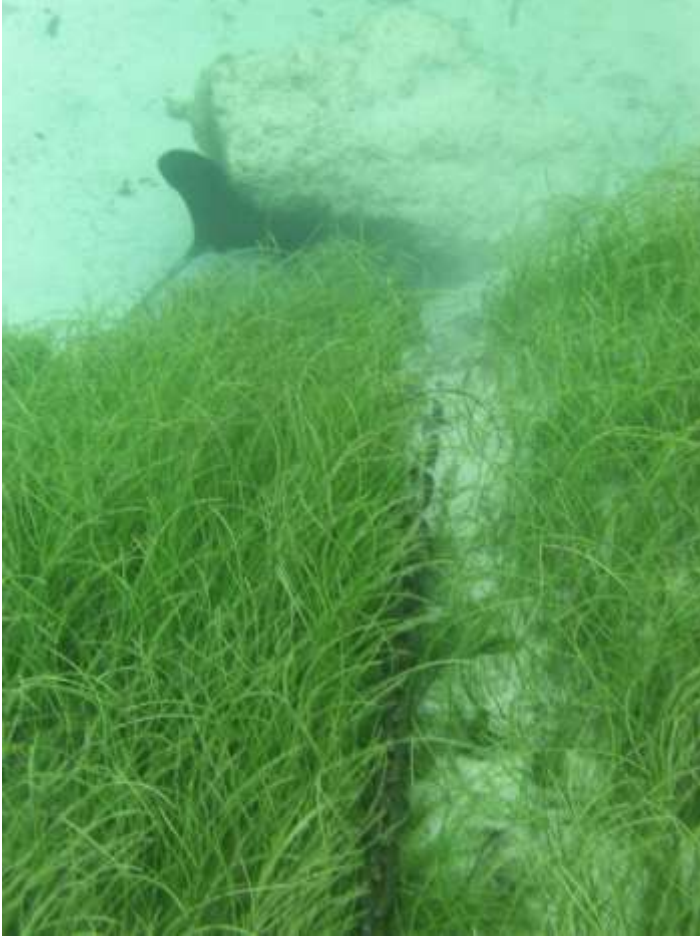
Figure 26. Image showing a yacht anchor and chain that is damaging a seagrass bed (Reed, 2016).

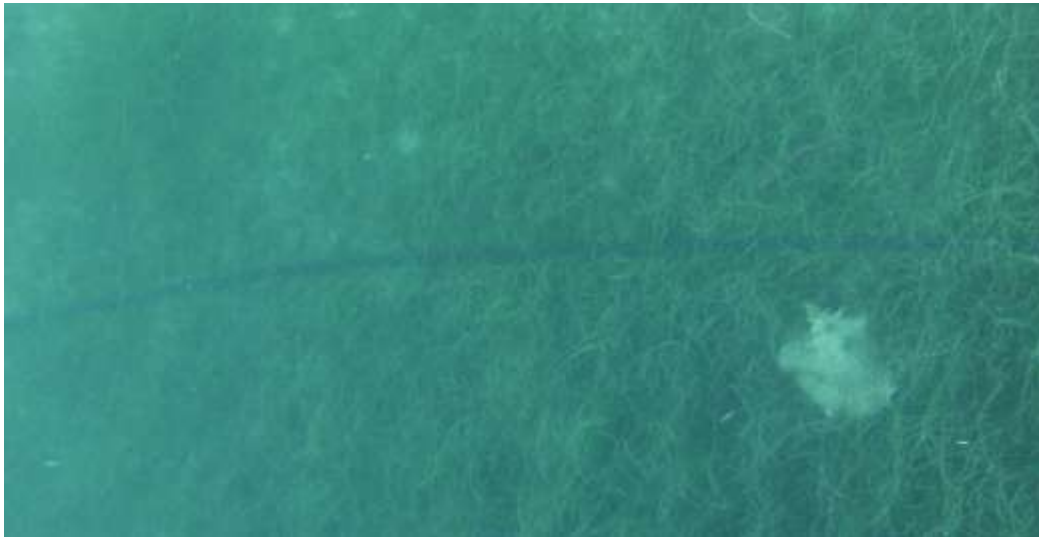
Figure 26. Image showing chain from yacht anchor lying on top of a seagrass meadow next to a conch (Reed, 2016)

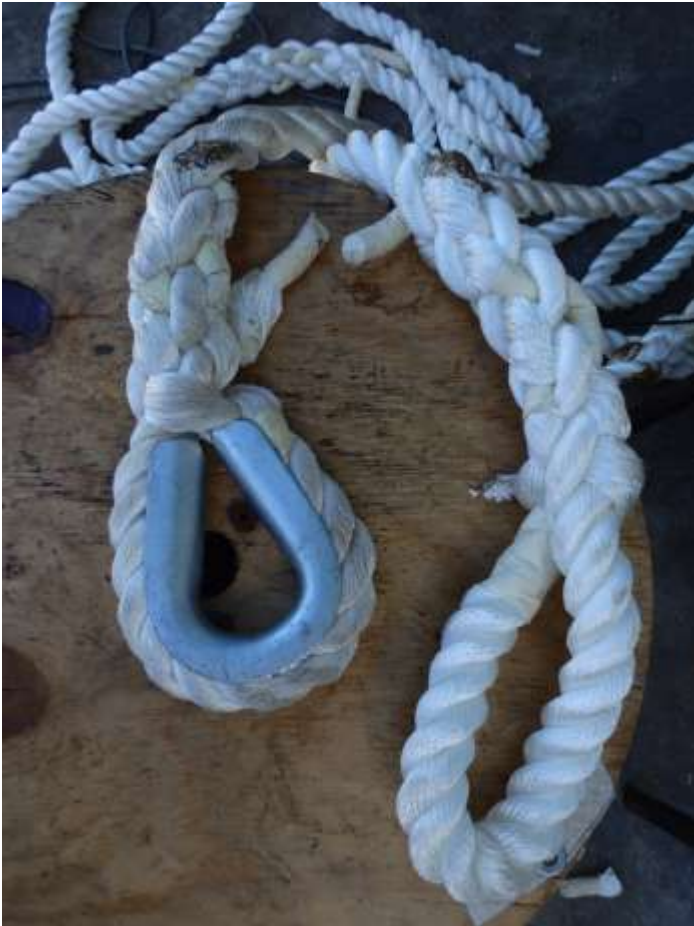
Figure 27. Image of a pickup line made with a spliced rope loop reinforced with steel (Reed, 2016).
