**SUSTAINABLE MANAGEMENT PLAN
for the
RED MONASTERY, SOHAG**

**Cultural Heritage Tourism Project in Egypt (APS)
USAID Agreement No. 263-A-15-00007**

31 March, 2019

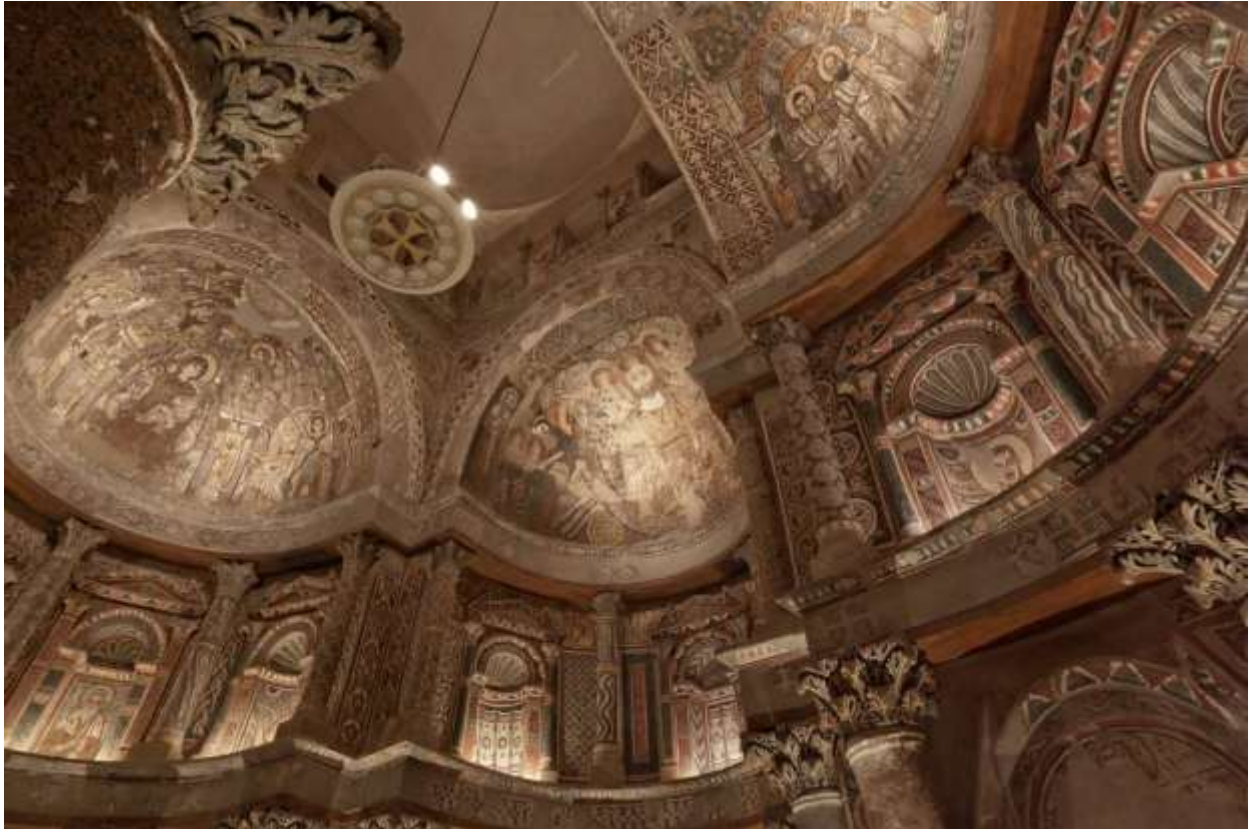
Figure 1: The sanctuary in its post-conservation condition [Photo: P. Gomez, 2014]

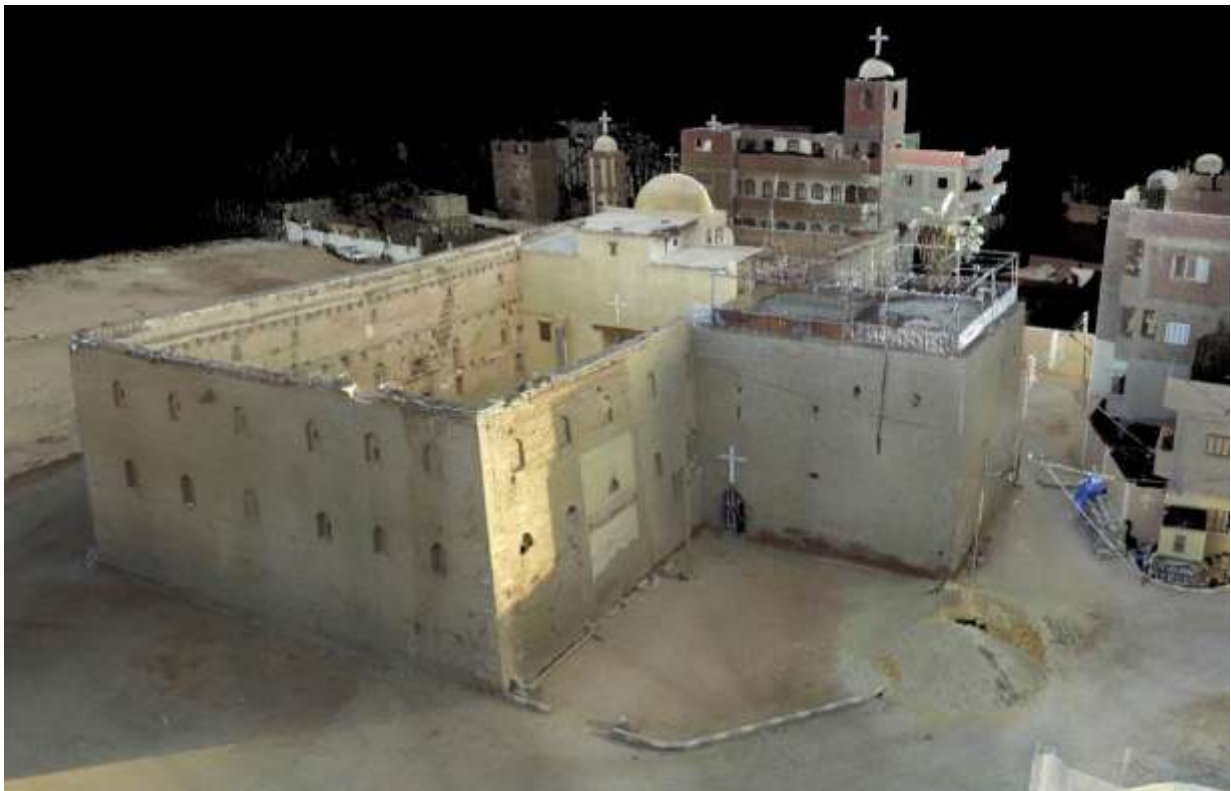
Figure 2: View of the Red Monastery church and tower from southeast in 2015 with monastic rest-house behind (image generated by 3D Laser Scan by P. Gasparri)

Of particular concern is the monastic resthouse built only six metres away from the east wall of the church (seen in the background of Figure 2). This contains numerous sanitary installations and is clearly responsible for the concentration of termite activity in and around the sanctuary. The building, which is also taller than the historic church should be demolished, but it remains extremely difficult to persuade the monastic authorities to embark on such a course of action. The surrounding urban growth and agricultural projects to the west of the church may partly contribute to a marginal increase in the water table, but not to the extent of endangering the building at present.

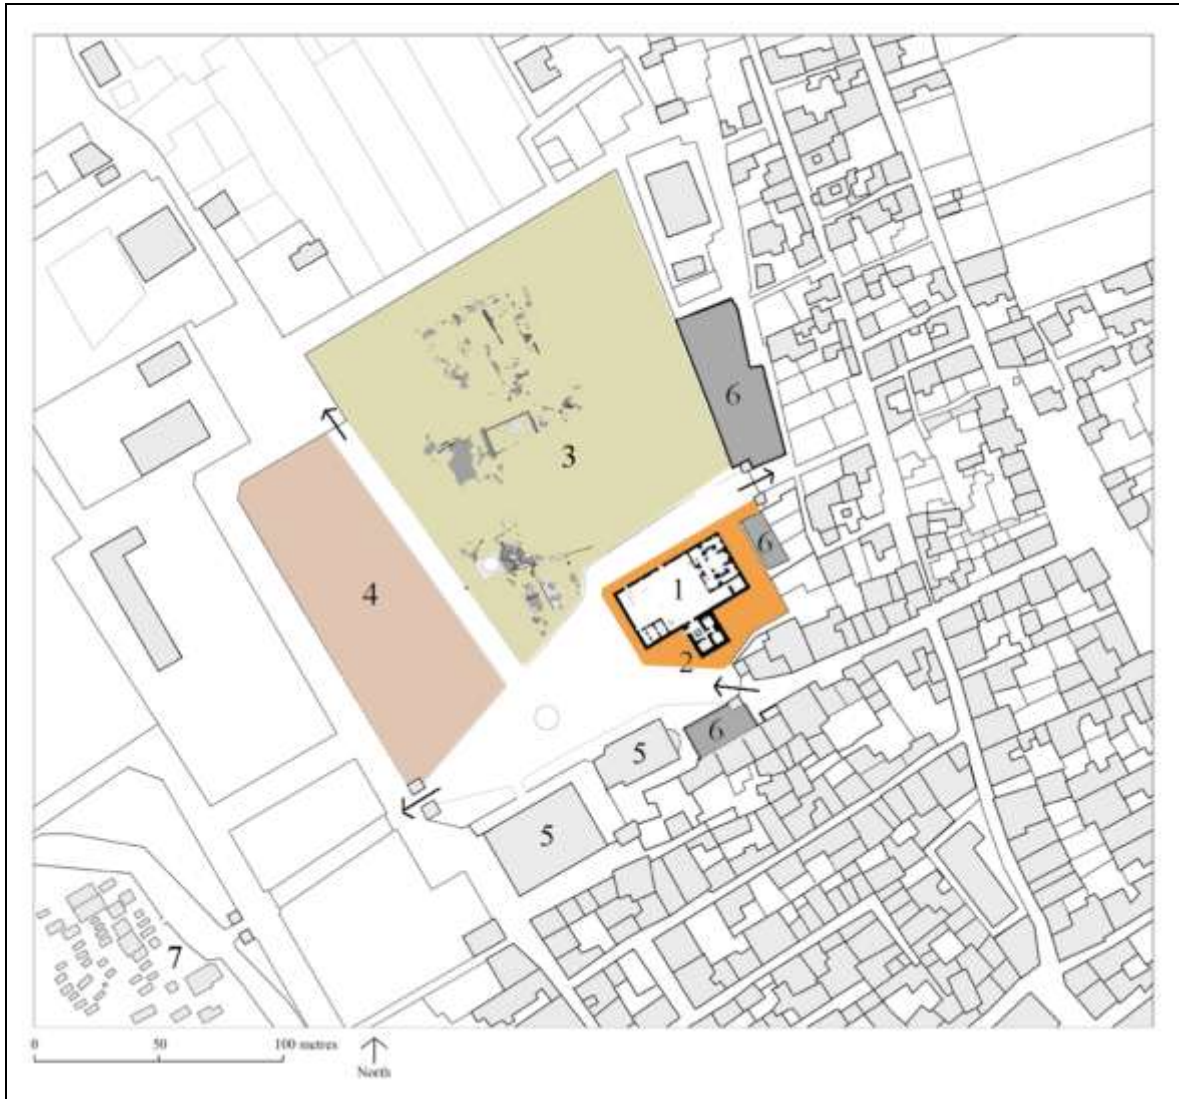
Figure 3: Site plan of the Red Monastery church (1) and tower (2) in 2018 with archaeological area (3), car parking (4), new churches (5), monastic resthouses (6) and cemetery (7) behind

Traffic management: Since 2017, visitor parking has been concentrated in an area to the west of the church with the agreement of the MoA although this is no doubt within the archaeological area (see Figure 3, above). The 2018 project to create a pedestrian only zone around the church has greatly eased the threat of damage to the historic fabric from traffic circulation in its proximity. ARCE has recommended that large tour buses do not drive past the north side of the church, as vibrations do cause stress to the building. It is unlikely that these recommendations will be heeded, however, and equally unlikely that traffic restrictions will be enforced by the MoA. Although there is a large entrance to the monastery northeast of the church, this will never be used by large vehicles as the street layout of the village beyond does not allow such vehicles space to maneuver. Thus, all traffic will continue to enter the monastery by the present main gate to the south

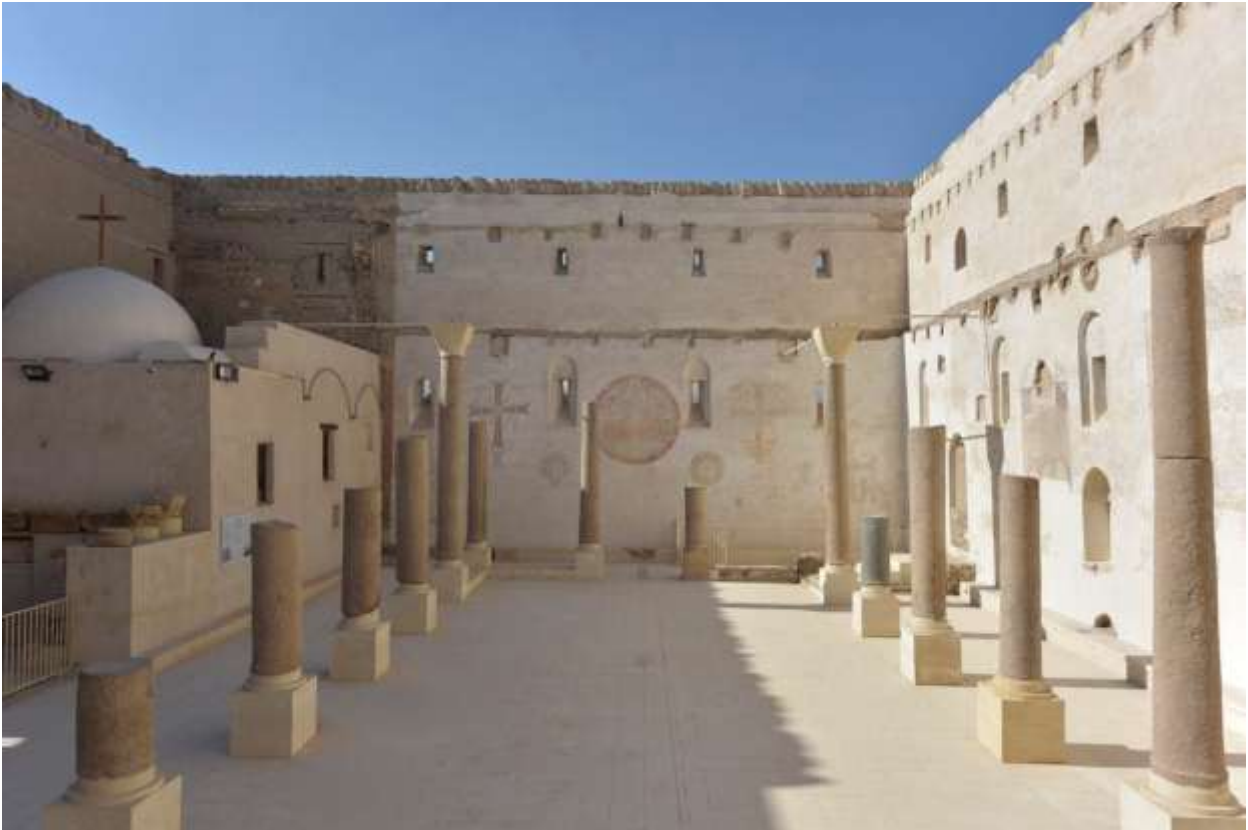
Figure 5: The nave looking west after anastylosis of columns and conservation of wall-paintings

- Nave: installation of a new limestone floor, anastylosis of column shafts, display of sculptural fragments

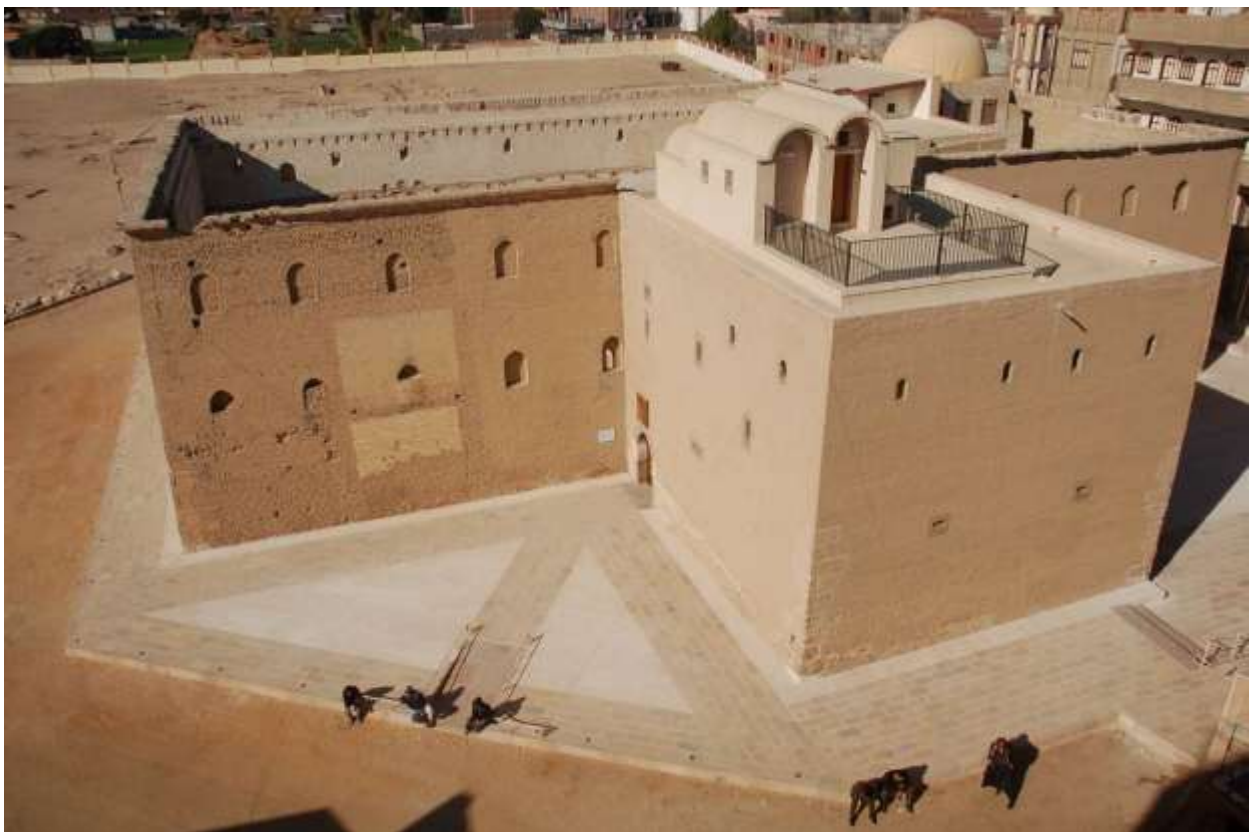
Figure 6: Completed hard landscaping on the south side of the church and tower [Photo: N. Warner, 2018]

3. Site management. Tasks included the installation of metal railings to protect paintings at the west end of the nave, and the installation of a barrier along the south side of the nave to prevent accidents occurring due to changes in levels. Visitor information panels were also installed in key locations, as well as prohibitional signs discouraging visitors from damaging the paintings. Visitor access to the sanctuary of the church was improved by the provision of an additional door in the modern west wall to allow for a separate entrance and exit to the sanctuary. This is an important safety feature, which had been rejected by the MoA from 2011 to 2017 but was then approved. To deal with solid waste generated by visitors, the church management has installed waste receptacles inside and around the church. Caretakers dispose of the garbage daily and also sweep the floors inside and outside the sanctuary on a regular basis, as well as the paved areas outside the perimeter wall.

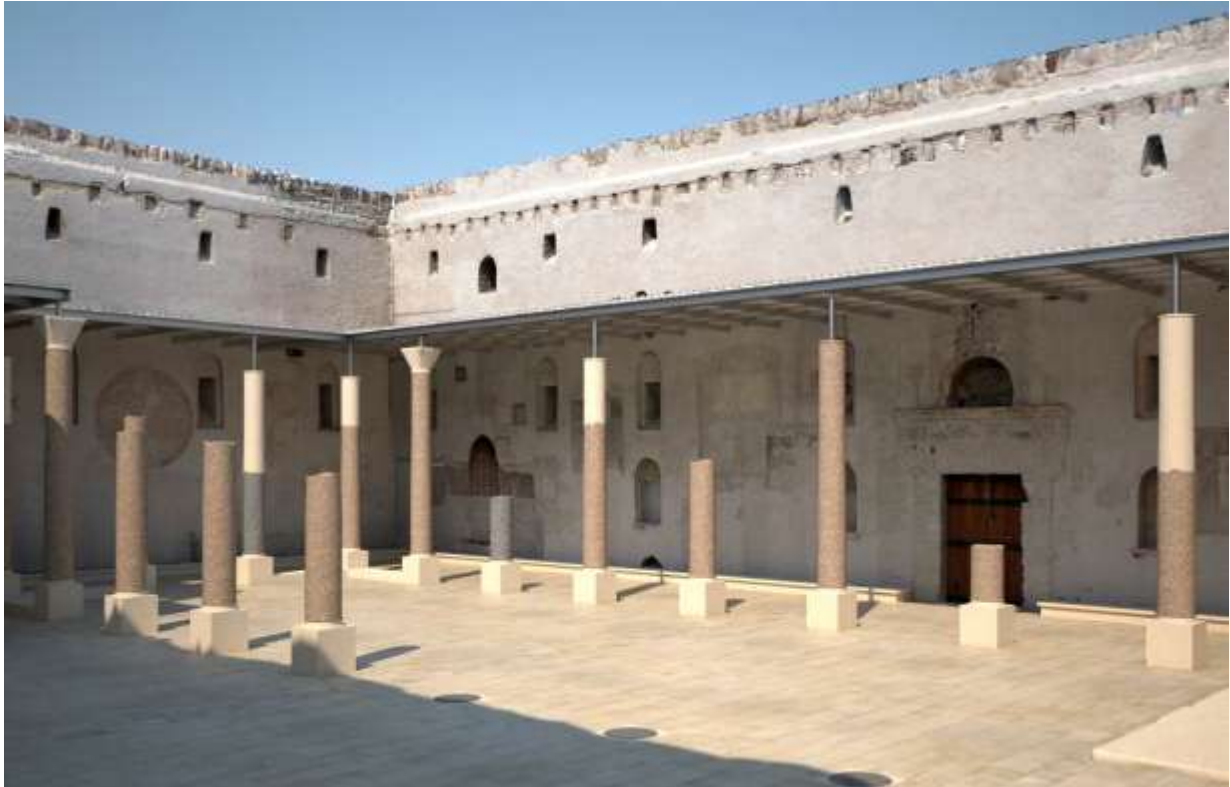
Figure 9: Computer model of the nave showing proposed location of protective shelter and extent of shade on 25 March 2019 (image: P. Gasparri. 2019)

The risks that still remain pertinent, however, are the protection of wall paintings from environmental factors in the nave, and the reduction in potential anthropogenic damage generally. The answer to the former is the construction of a permanent shelter along the north and west walls of the nave, and the latter can only now be addressed through awareness raising as all physical protection measures are already in place. A preparatory sunshade study, commissioned by ARCE independently of the CHTE and based on the existing computer model of the scanned church made in 2015, has indicated the optimal position for this shelter and the results will be presented to the MoA in the near future.

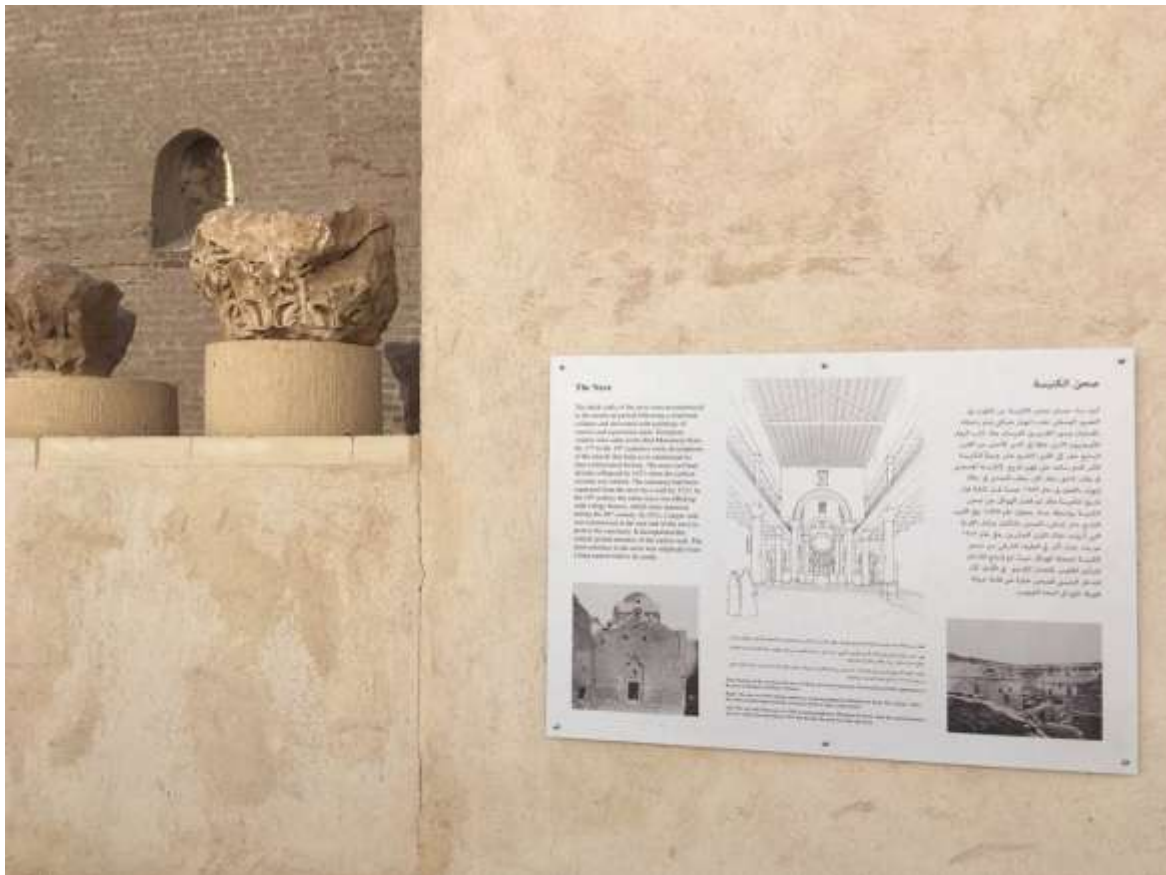
Figure 11: One of the Visitor Information panels in the church (Photo: N. Warner, 2018)

- Six information panels installed in the church:
 - Dedication panel for donors and partners in the project
 - General information panel on the history of the church and the project

- The Tower of St. Helena
 - The Nave
 - The Sanctuary
 - The Paintings in the Sanctuary
