WORK PLAN FOR NO-EXTENSION PERIOD

July 1, 2018 – December 31, 2018

**Cultural Heritage Tourism Project in Egypt (APS)
USAID Agreement No. 263-A-15-00007**

**Awarded to
THE AMERICAN RESEARCH CENTER IN EGYPT (ARCE)
Address: 909 N. Washington Street, Suite 320, Alexandria, VA 22 314, Tel: (703) 721 3479**

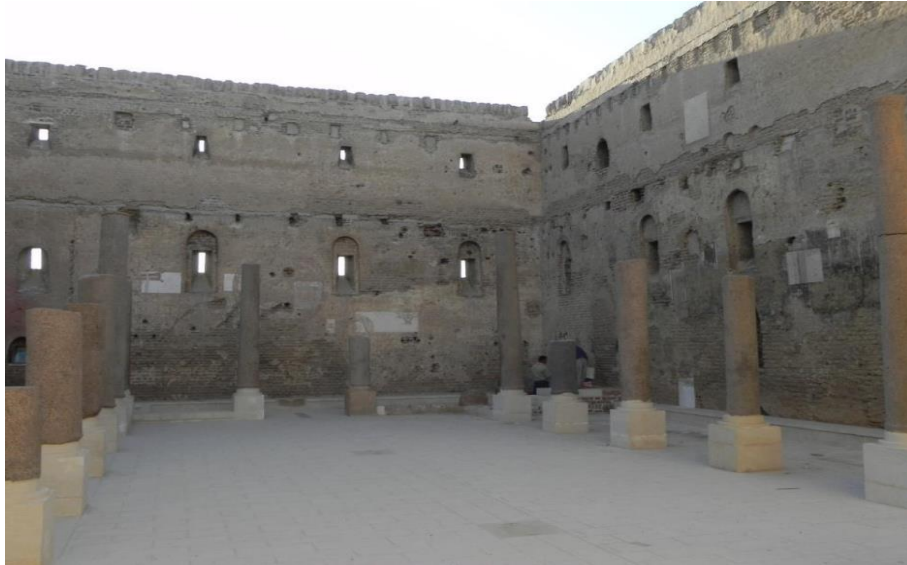
Figure 1: View of the nave walls after Fall 2015 campaign

Assessment Season (23 November - 12 December 2015) - Ten test cleanings that acted as samples, enabling us to study the state of preservation and working methods in various representative areas of the nave. On the basis of these observations, we were able to identify which restoration techniques should be employed. The test cleanings contain sufficient information to predict what the final result in terms of esthetics and conservation of the future restoration work will be for each area of the nave. The conservators explored in greater depth the methods that will form the basis of the on-the-job training program during future restoration campaigns. Number of Italian conservators: 7

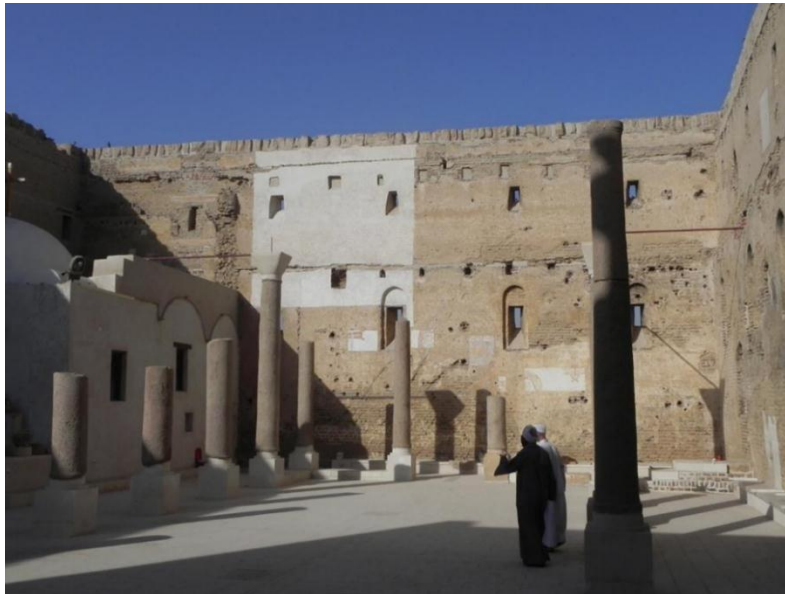
Figure 2: View of the nave walls after Spring 2016 campaign

Campaign #1 (30 March - 20 April 2016) - Test cleanings carried out on the right side of the north wall assisted the conservators to ascertain whether there are wall paintings in the area where the current state of preservation of the surfaces has prevented them from formulating a solid theory. The restoration of a section of the west wall was completed (comprised of unpainted surfaces), working from the top downward. No MoA clearance was received to resume conservation of painted decorations. Number of conservators: 7

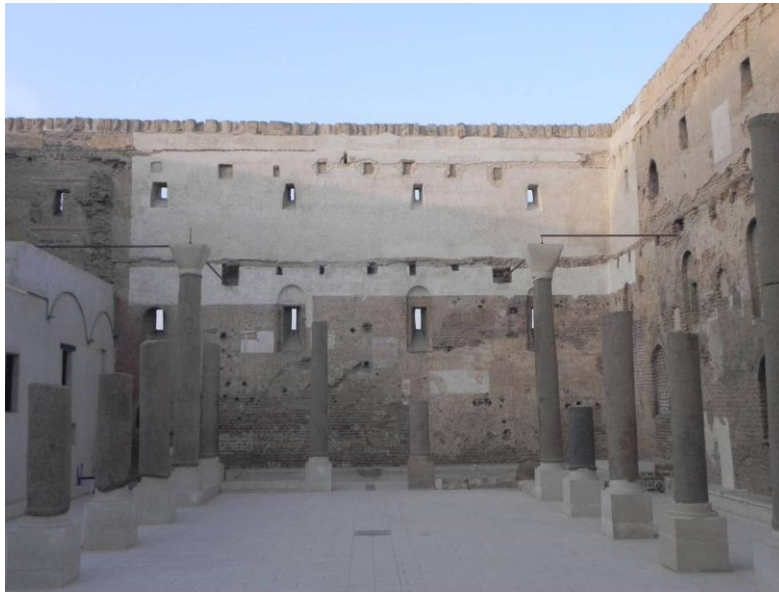
Figure 3: View of the Nave walls after the Fall 2016 campaign

Campaign #2 (7 November - 17 December 2016) - During this campaign the Conservation Team did not have clearance to work on any painted surfaces since a final solution had not been reached for protecting the paintings after conservation is completed. No MoA clearance was received to resume conservation of painted decorations. A three-week on-the-job training course was run for 11 Egyptian conservators, all graduates of Faculties of Conservation of Art in Egypt. Number of Italian conservators: 7

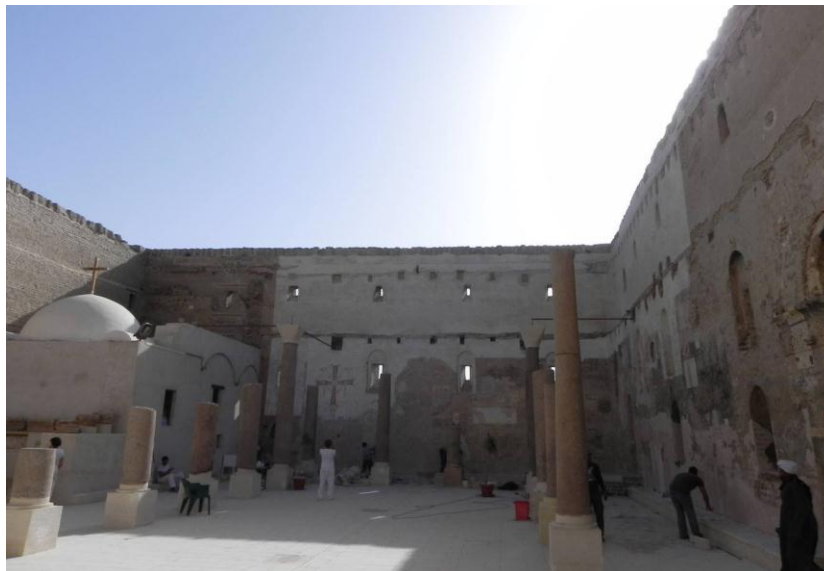
Figure 4: View of the Nave walls after the Spring 2017 campaign

Campaign #3 (27 February- 7 April 2017) - During the campaign, all the areas with exposed bricks in the lower parts of both the north and west walls were re-plastered. A good part of the plaster in the lower tier of the west wall was cleaned, completing the window splays and tracing the profile of the disc with the cross in the center of the wall. On the left side of the west wall, a large area of plaster was covered with a thick layer of the modern red paint used to paint the exterior of the small church in the south west corner. MoA clearance was received to conserve the painted decorations. The paint had completely obscured a medieval painted cross which was revealed and conserved during the campaign. A three-week training course was conducted for ten Egyptian conservators who are graduates of or students at faculties of conservation in Egypt. Number of Italian conservators: 10

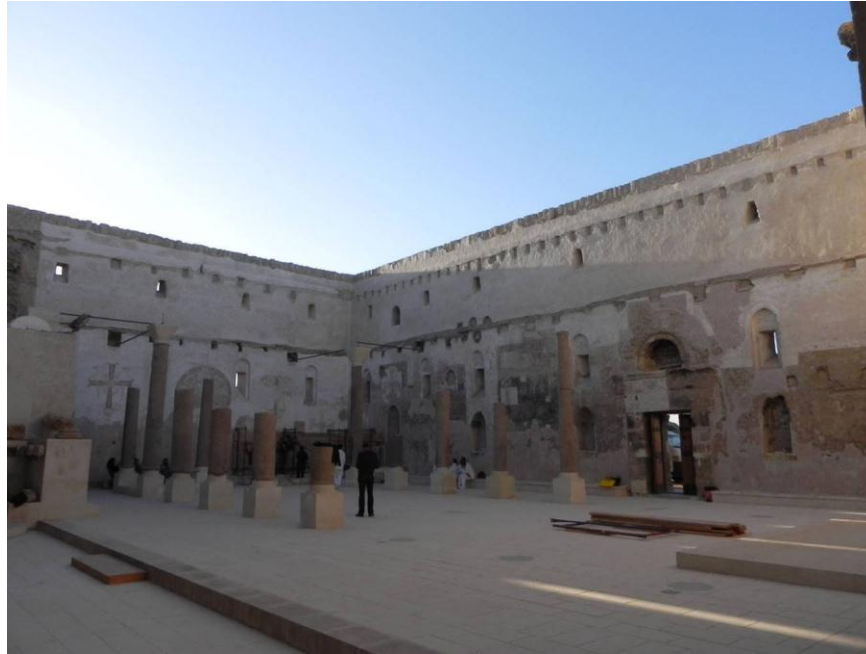
Figure 5: View of the Nave walls after the Fall 2017 campaign

Campaign #4 (6 November - 16 December 2017) – During the campaign restoration of the whole section of the north wall above the line of the gallery was completed, as well as certain sections underneath in the lower tier. Work was done on the bas-relief decoration on the architrave of the north door. The cross

inscribed within the disc at the center of the west wall, another cross to its right, mirroring the one restored during the Spring campaign, and one lower down near the north-west corner of the west wall were all revealed in their entirety. Work was done on the two crosses at the far left of the north wall. A five-week on-the-job training course for four newly joined Egyptian conservators in addition to 14 from previous campaigns. Number of Italian conservators: 9

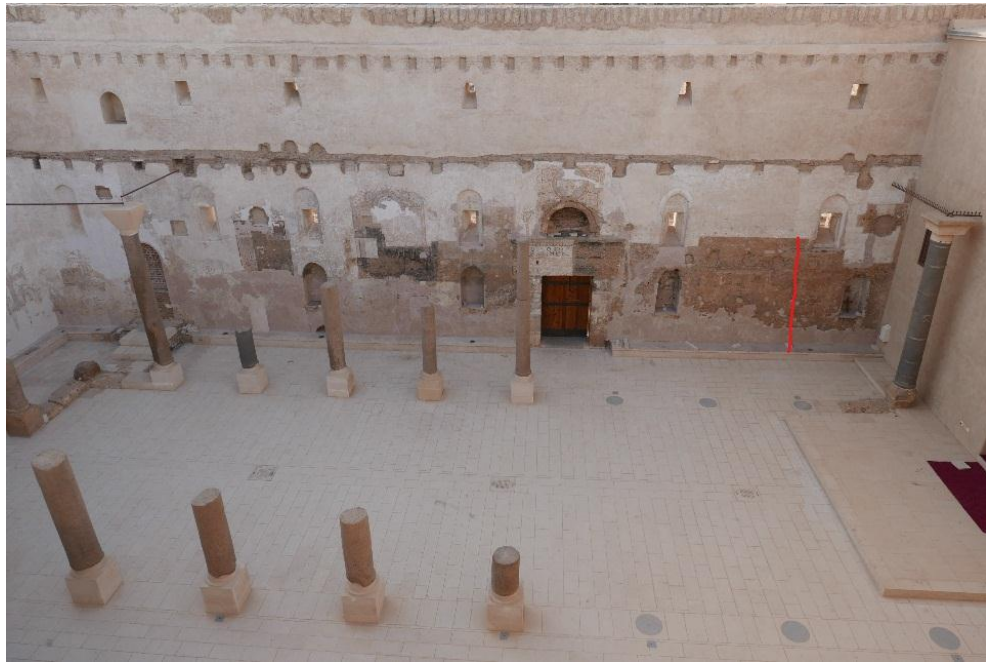
Figure 6: View of the Nave walls after the Spring 2018 campaign

Campaign #5 (26 March - 27 April 2018) - During the campaign the aesthetic presentation of the crosses on the west wall and the cleaning of all the plaster below them was completed. On the north wall, treatment of all the unpainted plaster to the left of the entrance was completed and, in the same area, work was carried out on all the icons including a newly discovered one over the entrance. A new painted roundel was discovered, also on the north wall, together with new details above the icon of the Saint on Horseback. All the pointing on the west wall was completed. A test cleaning undertaken on the right side of the entrance (north wall) revealed the face of a saint - one of a row of several saints painted the length of the lower tier. On-the-job training continued for 8 Egyptian conservators from previous campaigns. Number of Italian conservators: 6

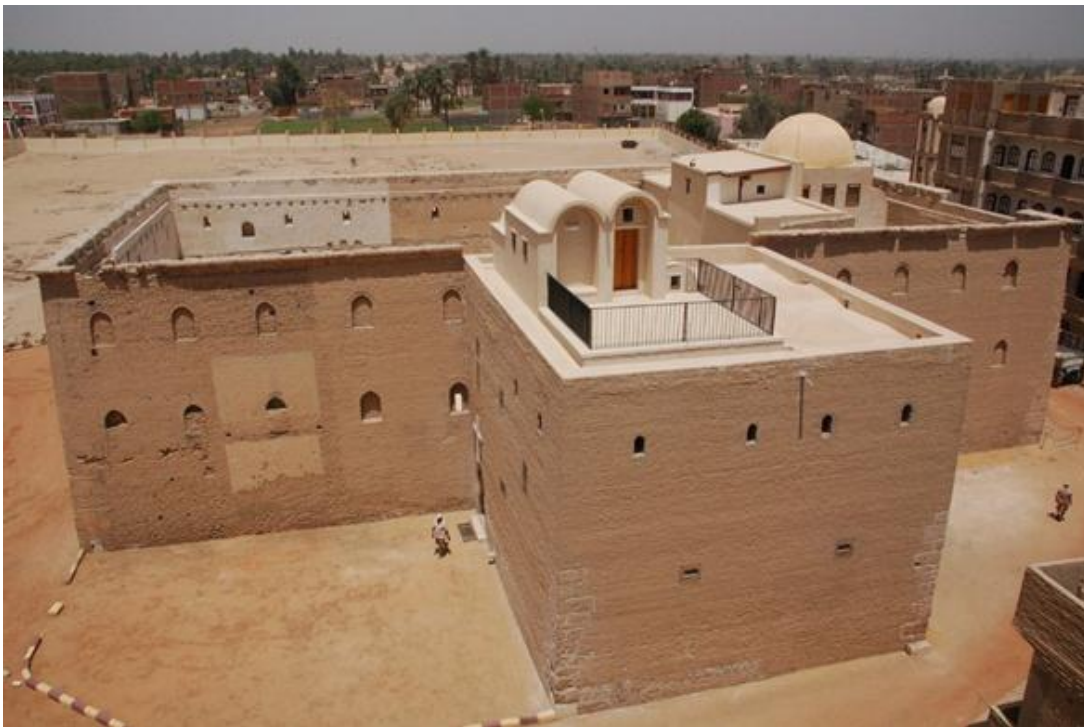
Figure 7: The Tower of the Red Monastery Church

Campaign #3 (24 September – 10 November 2016) Work on the tower continued in Fall 2016, including: stonework and flooring throughout the tower and roof, installation of steel balustrades, handrails, decks, and doors, replacement of termite-infested beams in the roof, brickwork and related construction on the stairway, roof and electrical installation.

Campaign #5 (10 April – 4 May 2017) Work was completed in the tower, involving repointing of external stone quoins at the corners of the tower, removal of a reinforced concrete beam at the base of the east wall of the tower and the south wall of the tower, additional repointing and repairs to the lower sections of the walls where water damage has occurred, treatment of movement joint at junction between east wall of tower and south wall of church, new lime re-plastering [as per request from the Sohag Inspectorate] in rooms on the ground floor, staircase and all corridor spaces, and installation of two display cabinets in northwest room on ground floor of tower.
