CARE/BOLIVIA WATER SUPPLY AND SMALL SCALE IRRIGATION PROGRAM : A FINAL EVALUATION OF THE USAID-FINANCED PROJECT

WASH FIELD REPORT NO. 162

APRIL 1986

J. Ellis Turner
Jerri Kay Romm

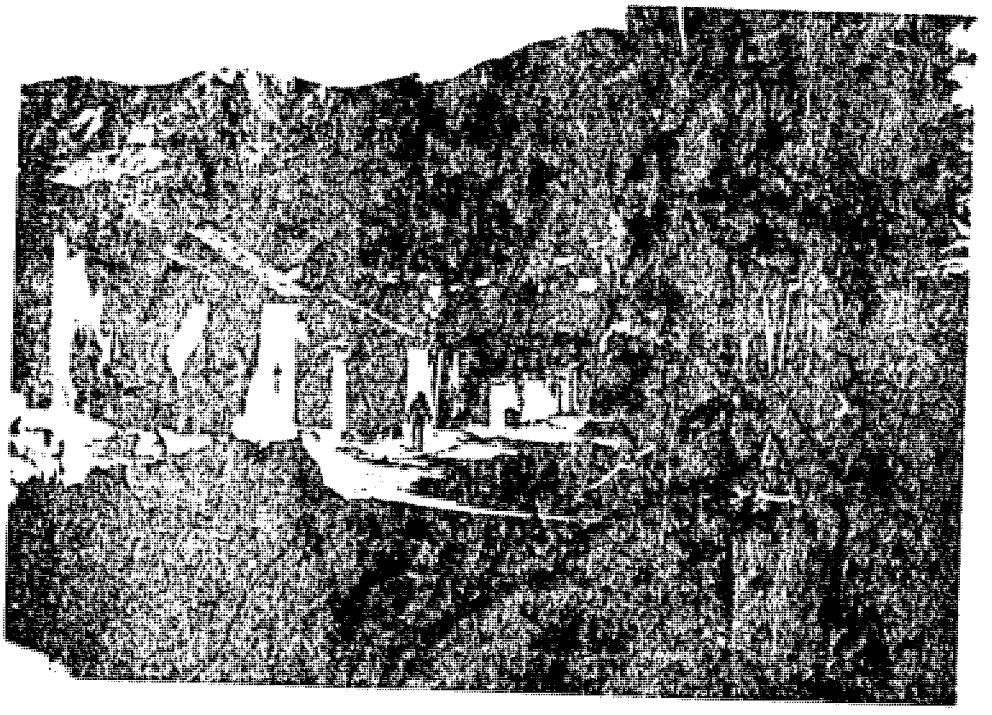
Photo 1. Typical CARE community - Vila Vila, Chuquisaca

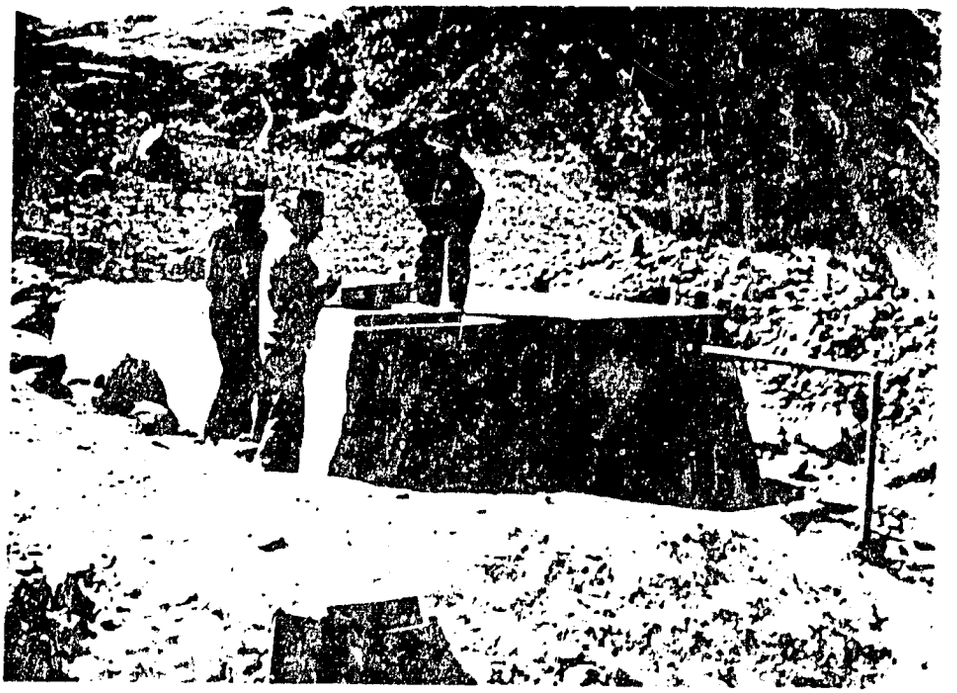
Photo 3. Typical water distribution system storage tank.

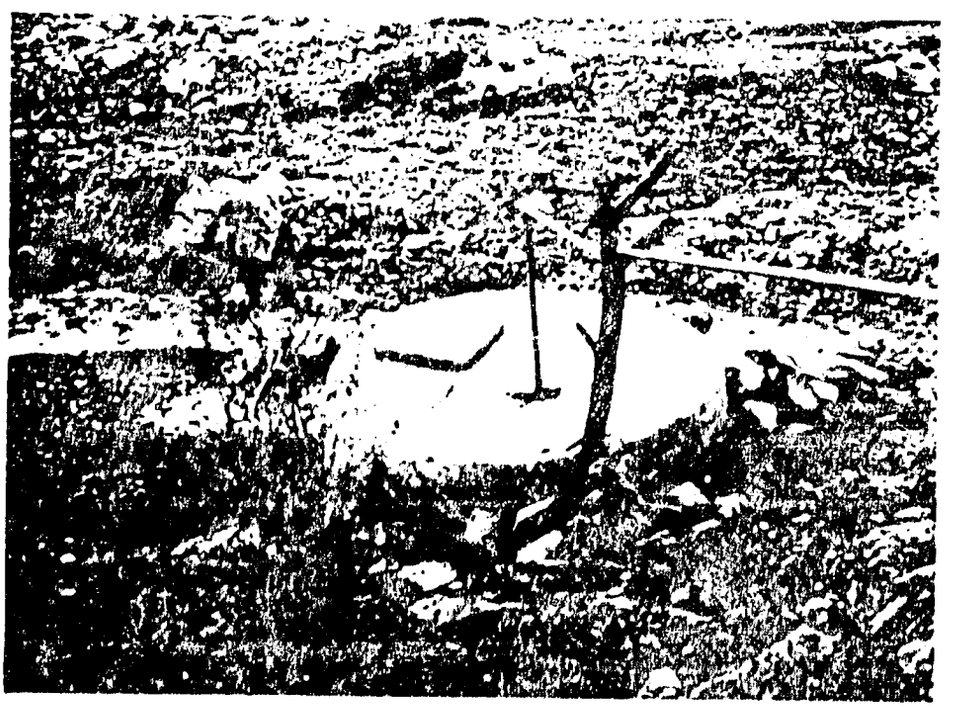
Photo 4. Well and unstable suction pipe, Carvajal, Chuquisaca.

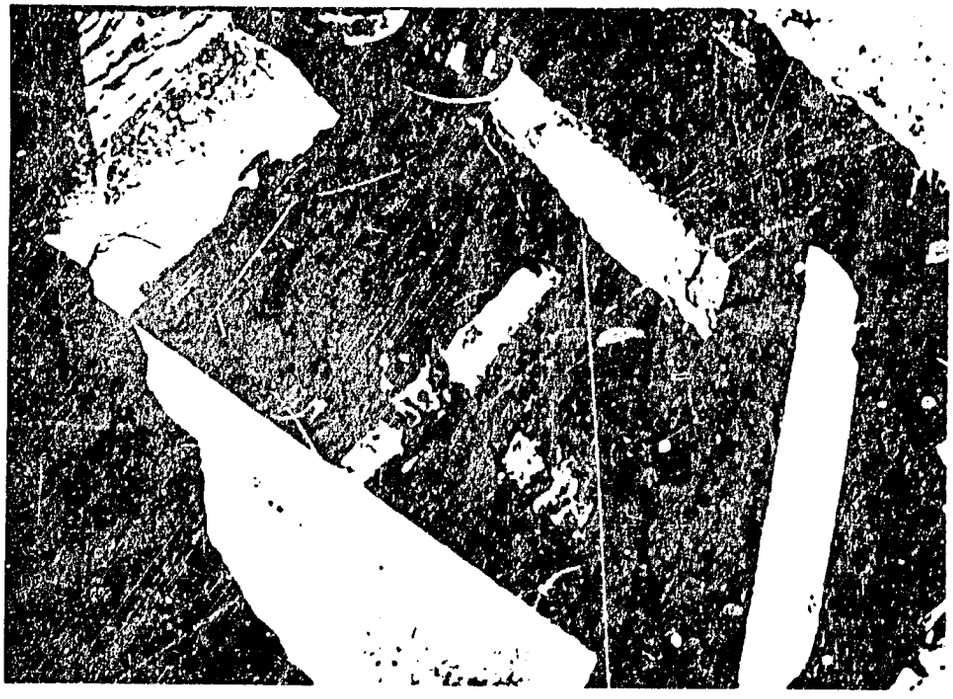
- In many cases valve pits were allowed to fill with water, causing premature rusting of the pipes.

Photo 9. Flooded chamber with valve removed, Copacabana, Oruro.

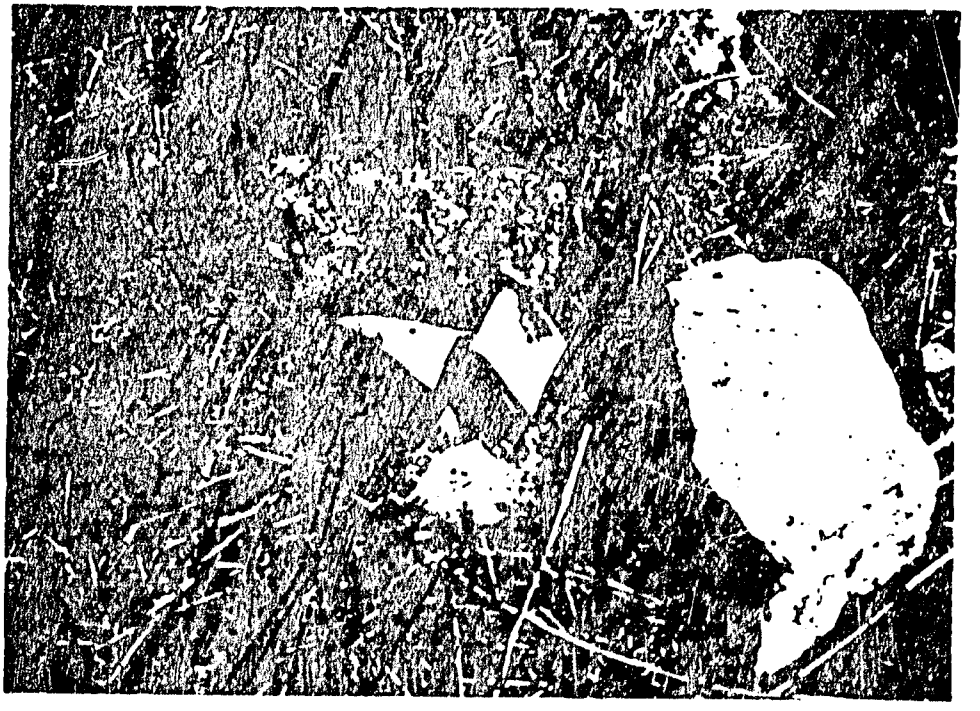
Photo 11. Pipe folded to reduce leakage, Copacabana, Oruro.

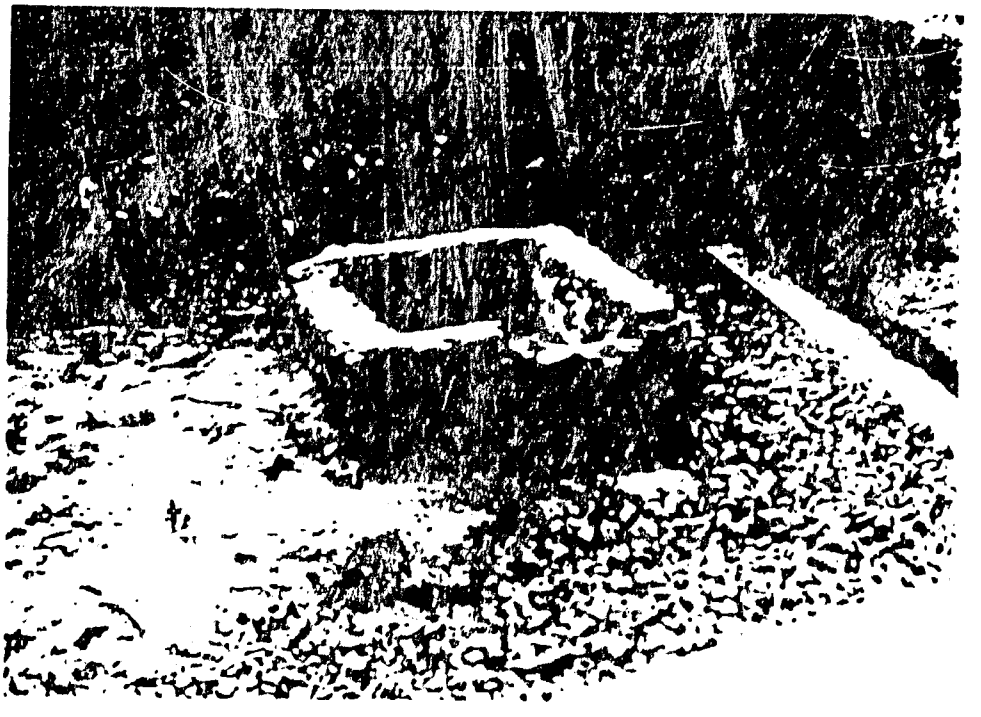
Photo 12. Abandoned well next to spring intake, Vila Vila, Chuquisaca.

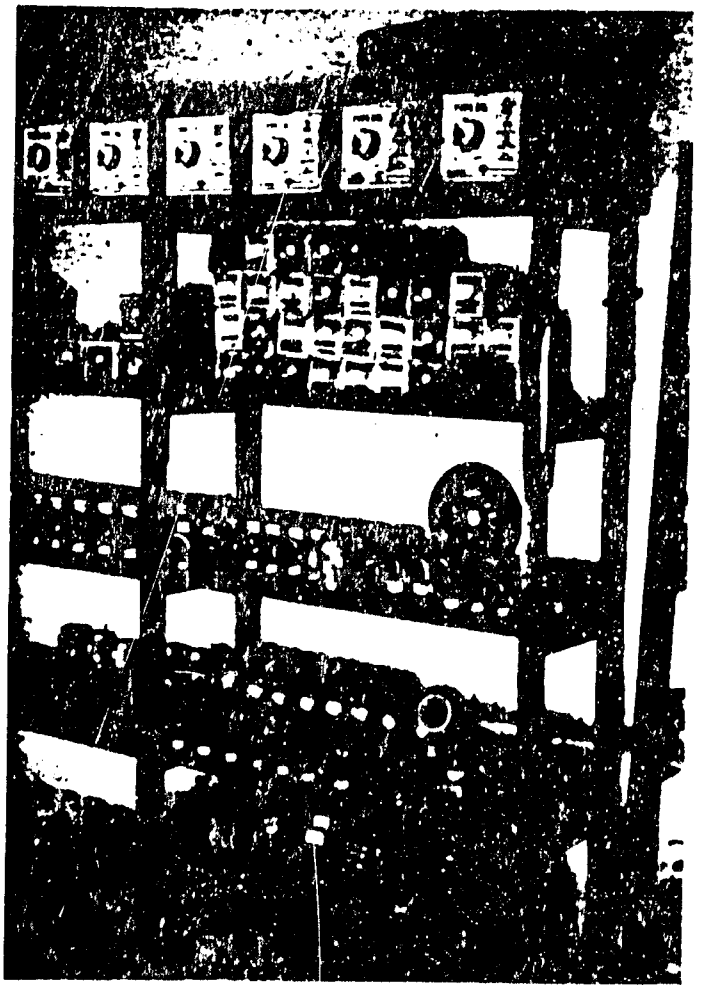
Photo 17. Well organized stock room, Sucre, Chuquisaca.

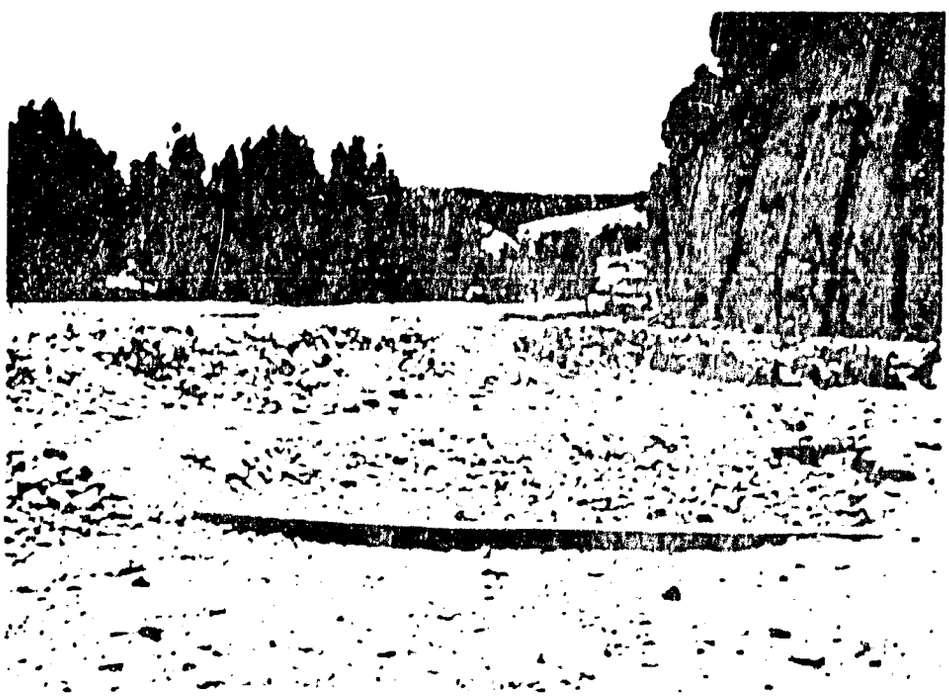
Photo 19. Headwall of infiltration gallery
Suanaca/Jachisivi, La Paz
