FIELD EVALUATION OF STEEL FABRICATED HANDPUMPS FOR THE USAID/DOMINICAN REPUBLIC HEALTH SECTOR II PROJECT

WASH FIELD REPORT NO. 139

FEBRUARY 1985

Ken McLeod
and
David Donaldson

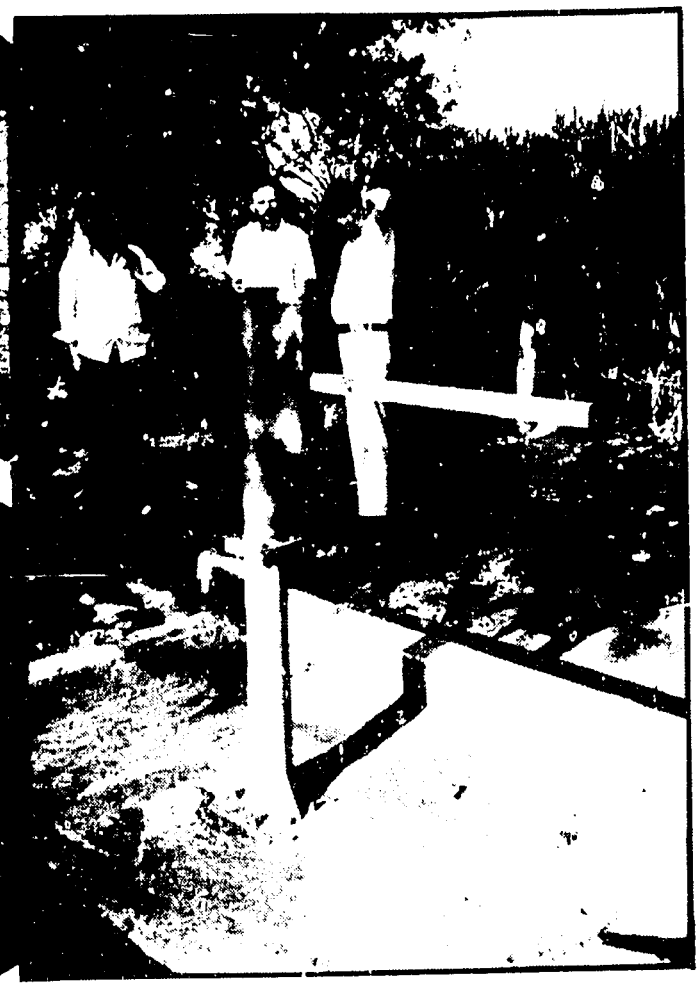
All of the handpumps observed in the field revealed a common design problem that does not allow the base to make a positive, unbreakable sanitary seal. The current design depends on the bond between the base plate and the top of the platform. (The top of the well casing is level with the top of the platform.) Cracks in the grout used to level the base were observed to allow small amounts of water to enter the water. Over the years, this condition can be expected to get worse (see Illustrations 8 and 9).

Illustration 8. Note grout used to level the platform to accommodate the flat plate of the base. Cracks in this grout allow water to enter the well as the casing is flush with the platform.

Illustration 9. Note that platform grouting will cause water to pond at pump base and raise the potential of infiltration into the well through cracks in the grout.

To ensure a hygienic seal, the present base should be modified to have a separate mounting plate that fits over the casing pipe. This plate becomes part of the platform by being grouted into the concrete around the casing (see Figure 5). The unit must be completely galvanized, and overspecified in fabrication, as it will remain in place for the life of the installation (20 to 30 years). The pump pedestal is then mounted on this fixed plate by means of standard bolts, thereby allowing easy replacement.

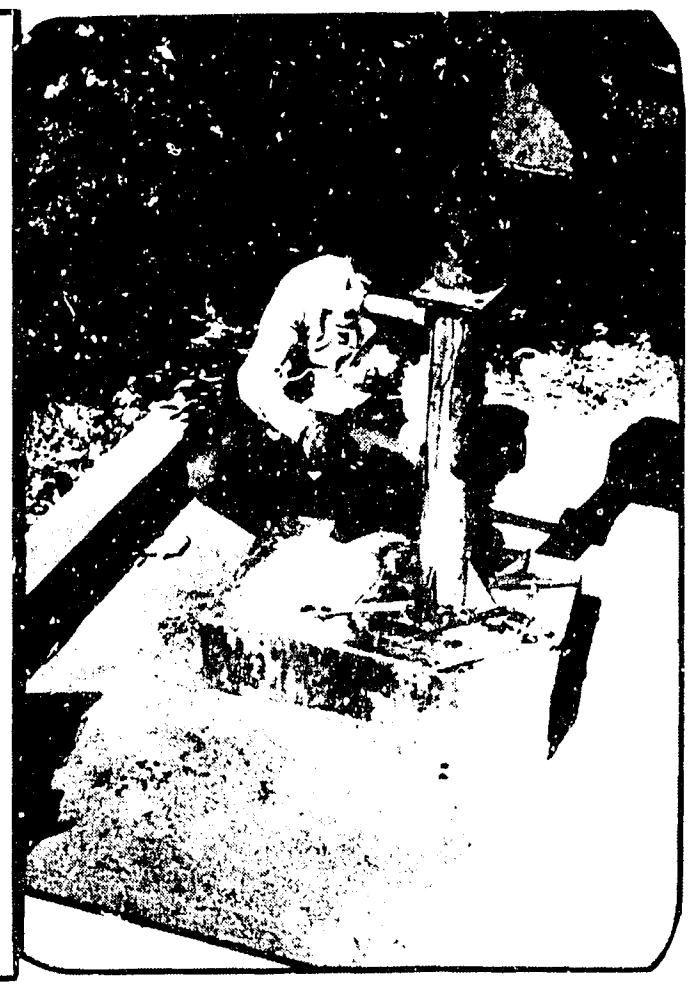
Illustration 15 shows the diversity of tools that the field crews are currently using during pump repair visits. WASH feels that the numerous tools should be standardized to a few simple key ones. Such standardization would help to reduce the broken bolts and the tendency of field personnel to use pliers and lockgrips which tend to destroy bolts quickly.

Illustration 15. Field maintenance crews have few tools. Thus, they tend to make extensive use of lockgrips and pliers. As a result, many bolts have been either chewed or stripped.

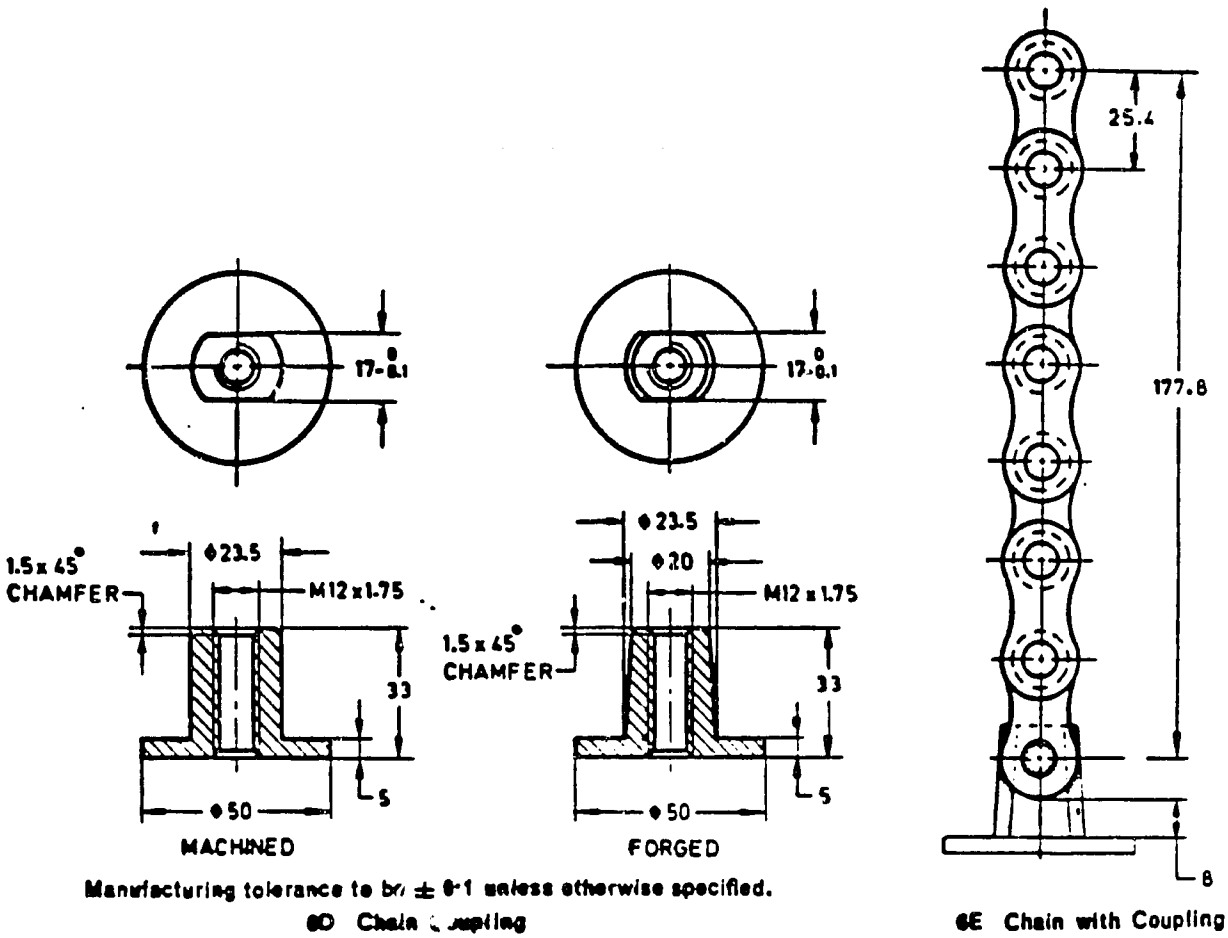
Figure 4. Details of Coupling Between Chain and Drop Rod

A common failure was that the connecting pin at the quadrant and drop rod were too light. To correct this situation, the Dominican Republic had modified some of the units to use a chain connection link instead of a pin. The modification seems to be working well. Whereas, the original pins were continuing to fail, the problem was noted to be at its worst where the lift was greatest (see Illustration 11).

Illustration 11. Note the small diameter of the pin used to attach the chain to the handle. The current design must be modified at the quadrant and the drop rod connector to replace the pin with a chain link connector.
