## Kandahar Helmand Power Project (KHPP)

**CONTRACT: 306-C-00-11-00506-00**

**Kajaki Hydro Power Plant Transmission and  
Distribution Facility Assessment Report - DRAFT**

**March 17, 2011**

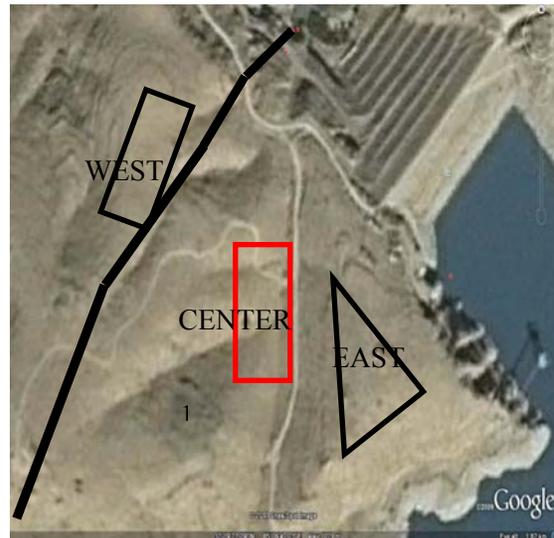
**Figure 1-1 Potential Substation Sites**

Then, an assessment of potential sites for the new 110 kV air insulated transmission substation was performed and a proposed site was located in a saddle/valley south of the existing KHPP 110 kV substation. The entire site is located over exposed Triassic limestone dolomite bedrock. The three sites provide each can provide an adequate base for the substation. Two of the sites would require a significant quantity of rock removal effort to provide level areas for the facility. The site proposed will require significant fill quantities (work). However, there is a substantial amount of shot rock fill on the north side of the dam that can be used for fill and only minimal excavation at the proposed site would be required.

The preferred substation site is the Center site, located east of the existing 110 kV transmission line. A detailed assessment of the site is located in Section 6.

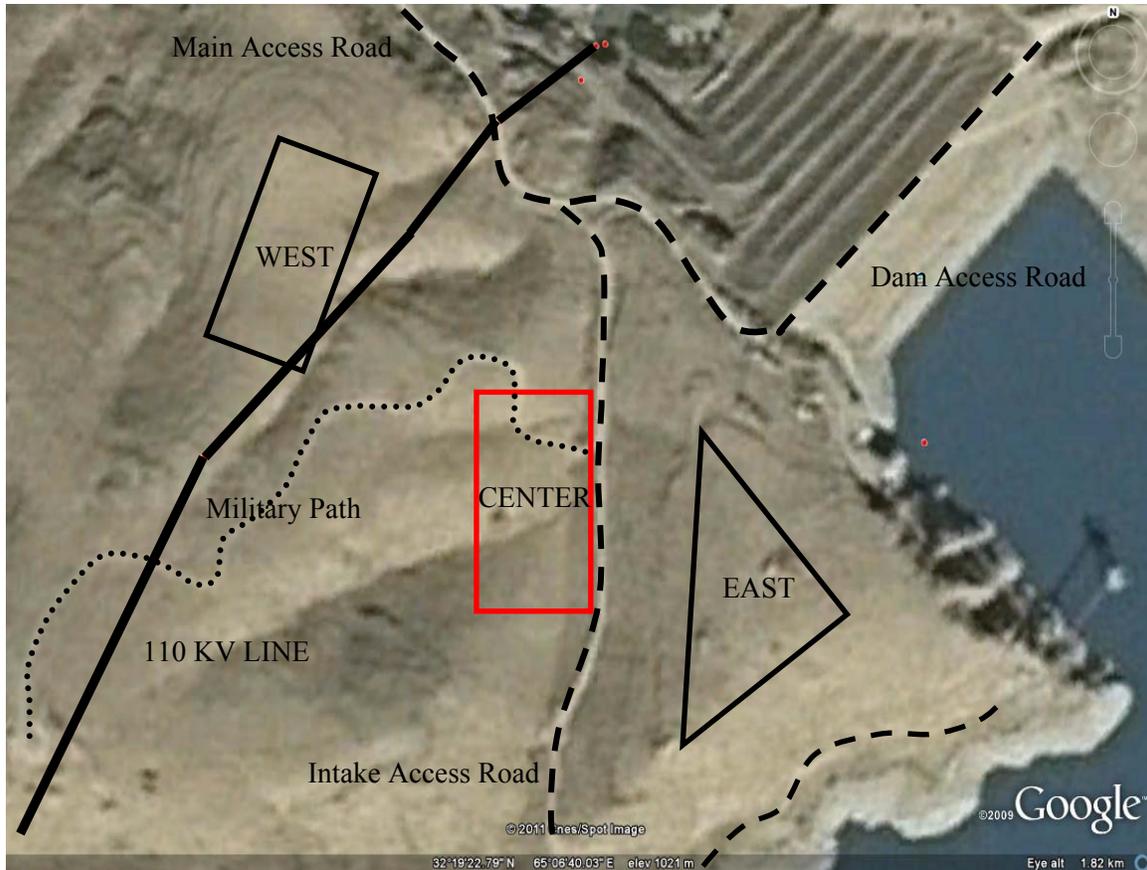
**Figure 6-1 Layout of Assessed 110 kV Substation Sites**

The west site is located west of the existing 110 kV lines on a relatively flat lying bench below the Military outpost. The site has the advantage of requiring minimal cut and fill, and is the largest of the three sites. Disadvantages of the west site are access and its location west of the 110 kV line. An access road will have to be built roughly following the exiting path and travelling under the 110 kV lines to the site. Access from the west, north and southeast would be prohibitive.
