CONSTRUCTION MONITORING & EVALUATION PROGRAM

**STRENGTHENING & IMPROVEMENT OF PESHAWAR – TORKHAM
ROAD (N-5), KHYBER AGENCY, FATA**

MONTHLY PROGRESS REPORT # 04

MARCH 2013

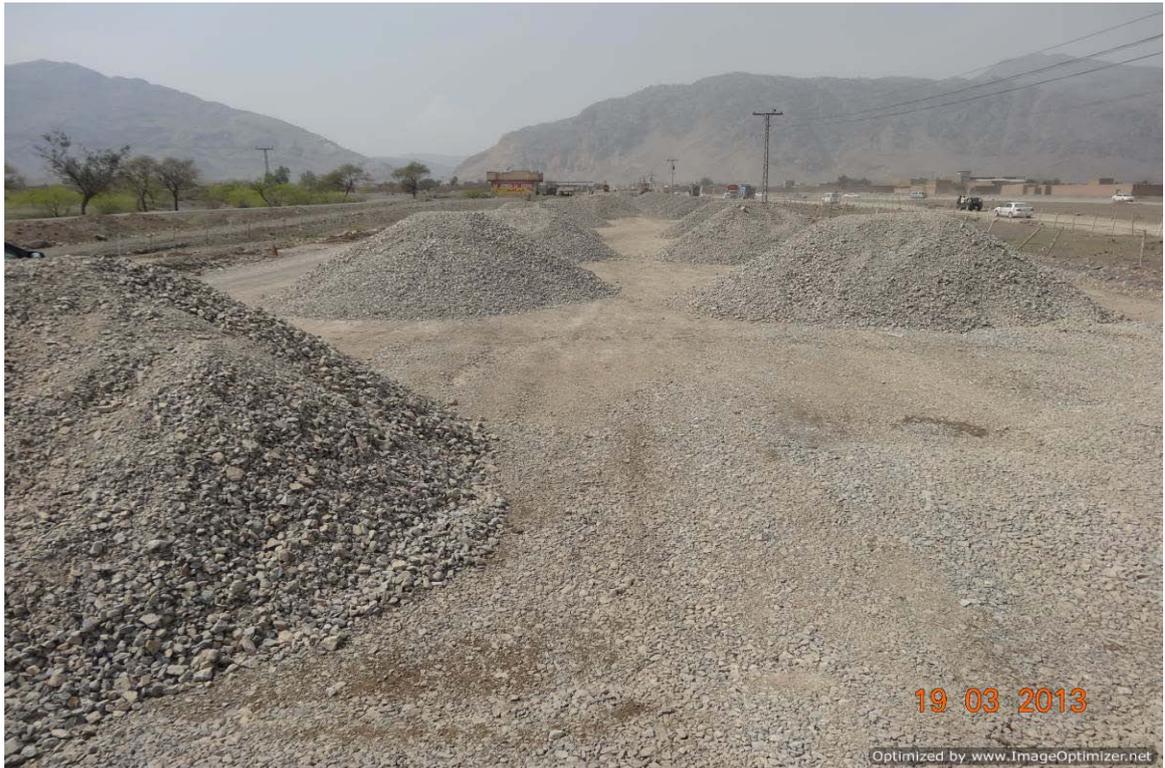
KM: 7+575 To 7+725

The contractor (FWO) prepared a Trial Section for Aggregate base course at KM: 7+425 to 7+500 in full width but the section was highly segregated due to poor workmanship of the contractor's personnel at site. The samples were collected from the subject section and tested in the AGES laboratory as well as in the contractor's laboratory. The analysis of the subject material meets the specifications; however, the workmanship needs improvement to avoid segregation. The contractor has been advised to hire technical and skilled staff to control such type of deficiencies at site. The NESPAK Material Engineer has already rejected the subject Trial section and promised that they will improve the methodology for Aggregate base course stock piling, laying and compaction.

Aggregate base course windrows for trial section

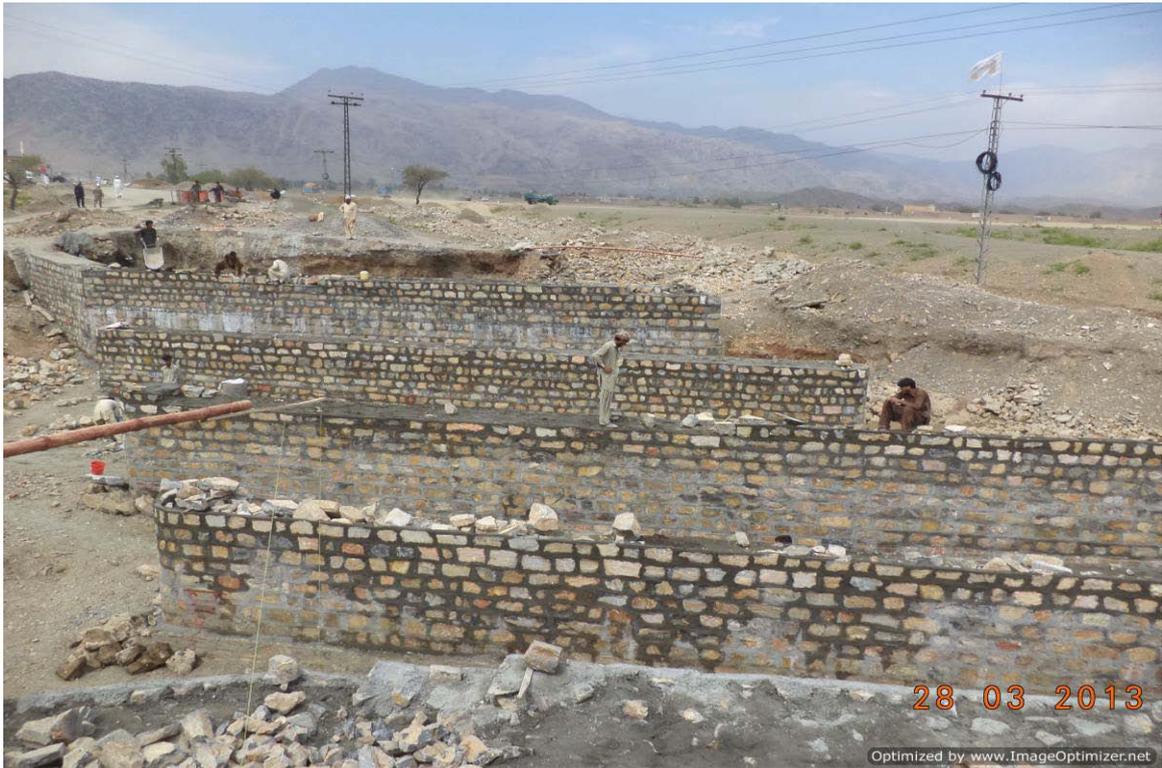
Lat 34; 0; 10.876, Lon 71; 21; 25.325
KM: 6 + 501 (Culvert) Stone masonry construction of Abutments & Piers is in progress

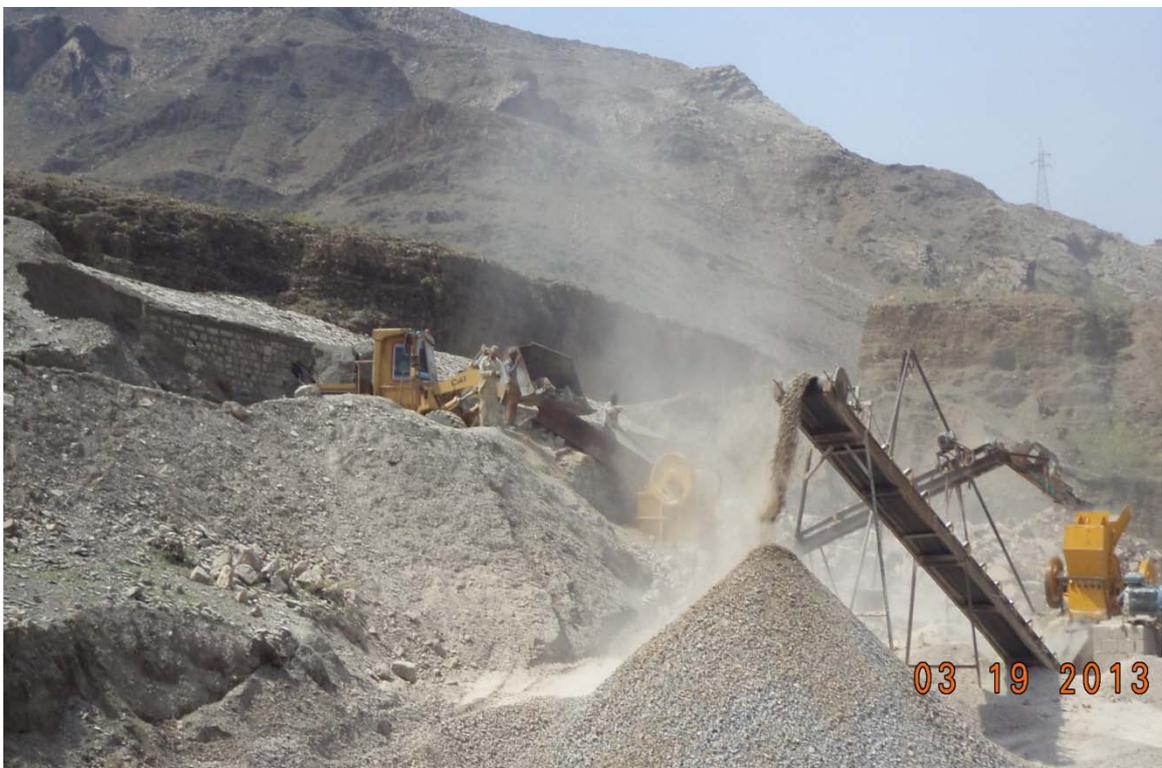
Lat 34; 0; 1.7, Lon 71; 19; 27.8
KM: 9 + 000 Aggregate base course material Crush plant production is in progress

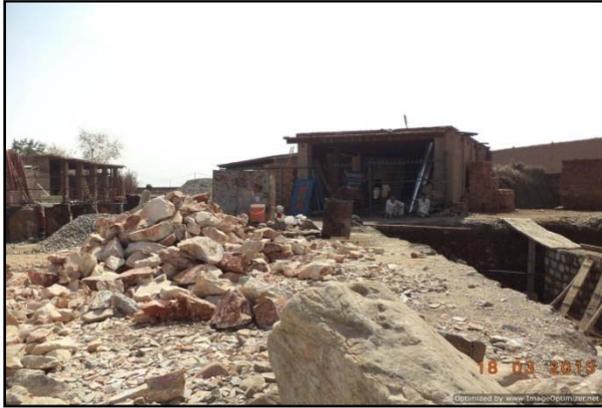
Photo # 1

Construction material haphazard dumping, drainage problem and other social issues due to culvert construction at KM: 3+375 (Photo # 1, 2)

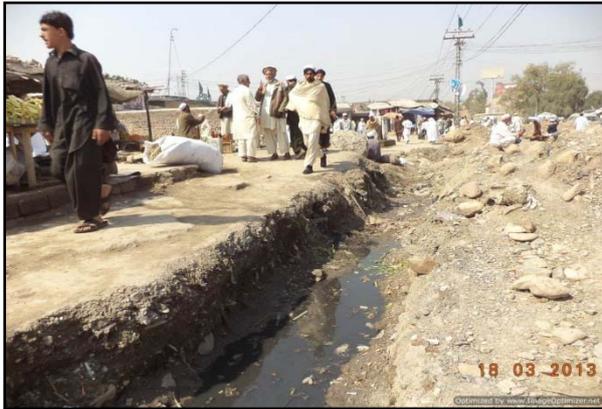
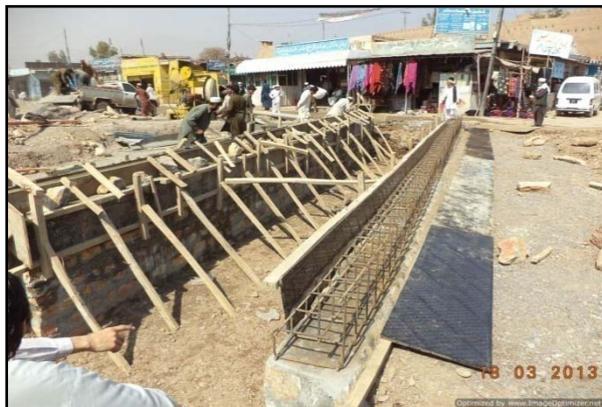
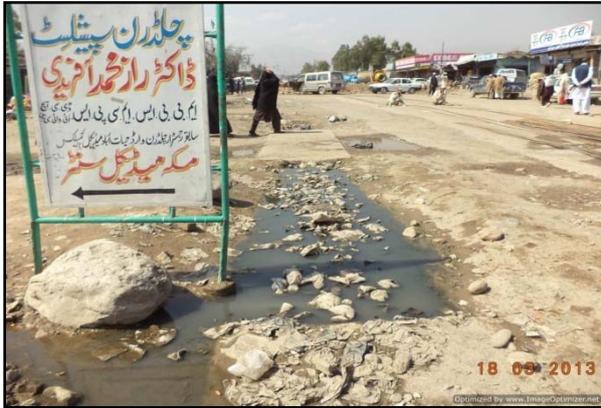
Stagnant sewerage water due to construction of culvert at start of Jamrud bazaar at KM: 4+600 (Photo # 3, 4, 5, 6, 7, 8)

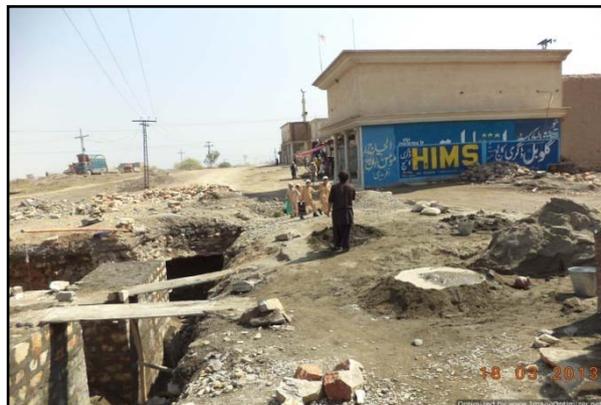
Photo # 11

Blockage of sewerage water and other social problems due to culvert construction at KM: 6+191 (Photo # 11, 12)

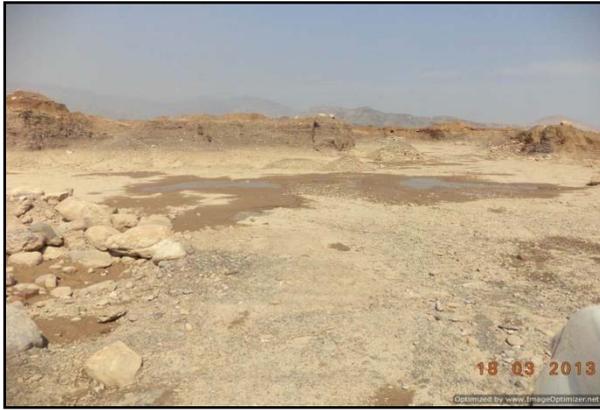
Photo # 13

Stagnant water, land pits of quarry area require proper land leveling, proper drainage and reuse of land at KM: 6+50 (Photo # 13, 14, 15, 16)

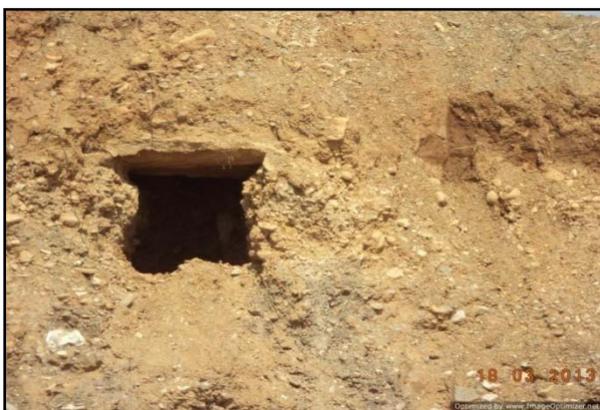
Photo # 17

During excavation process in the quarry area near KM: 6+50, some graves were exposed at site (near KM: 6+50) but the contractor did not repair the graves. The contractor should have stopped the work at site immediately and restore the damage graves with proper protective measures. Due to this negligence social problems may arise. At the time of incidence, Mr Hanif L Niak (FWO) was present at site. (Photo # 17, 18)

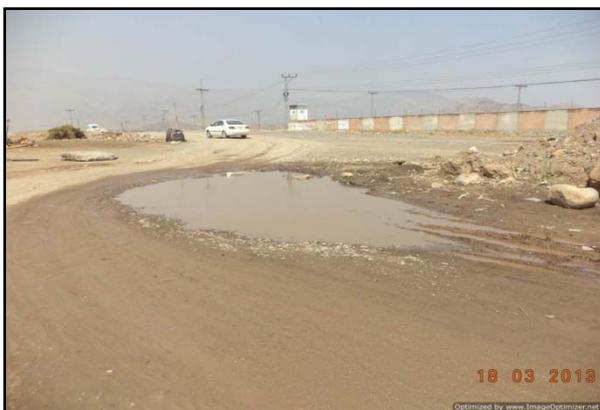
Photo # 23

Stagnant water though no construction activities at KM: 4+850 (Photo # 23, 24)

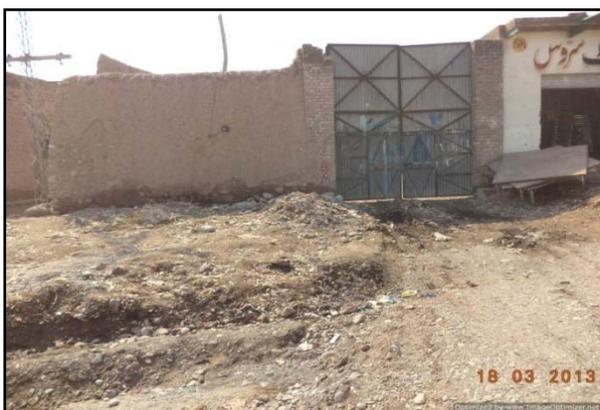
Photo # 29

Solid waste dumping and stagnant water in front of houses along the road due to construction activities (KM: 1+600) (Photo # 28, 29)

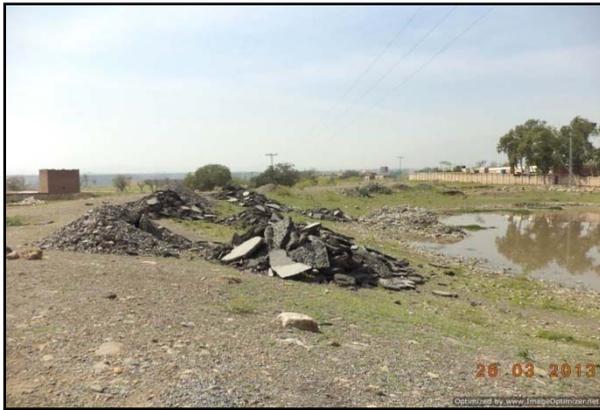
Photo # 31

Dumped excavated and Solid Waste materials, and Stagnant water due to construction of road at KM: 3+550 (Photos-31, 32)

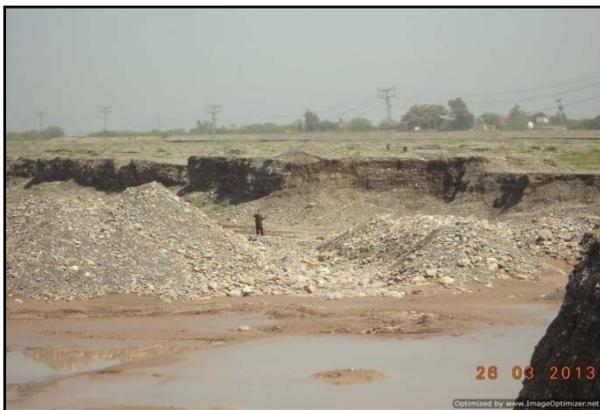
View of new quarry area at KM: 2+000 (Photos-33, 34)

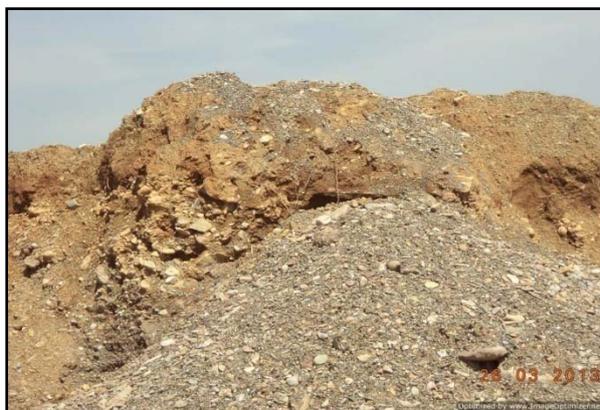
(Photo-35) View of Graves, open during excavation which is not properly cover at quarry area near KM: 6+050

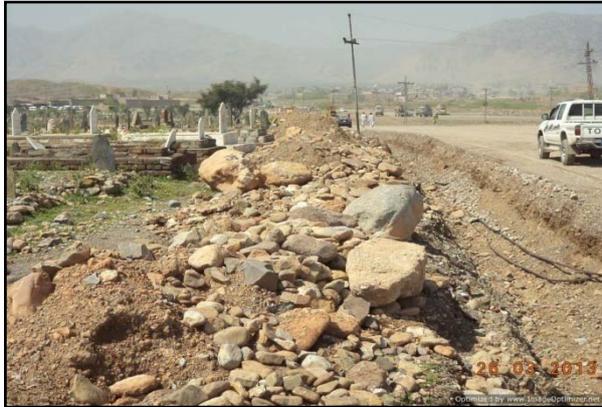
(Photos-37, 38) Dumped materials in graveyard due to construction of road near KM: 5+630

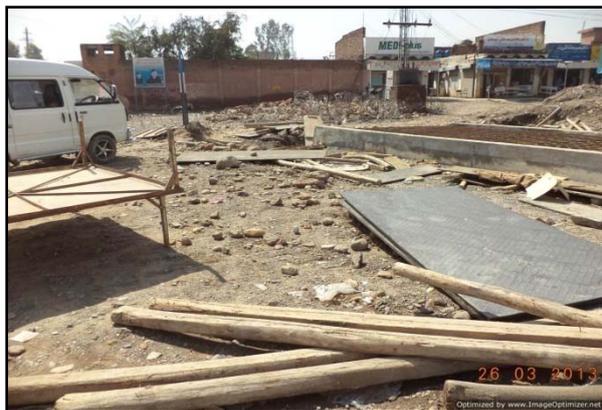
Haphazard placement of construction materials at Culvert's construction in middle of Jamrud Bazar KM: 4+600 (Photos-39, 40)

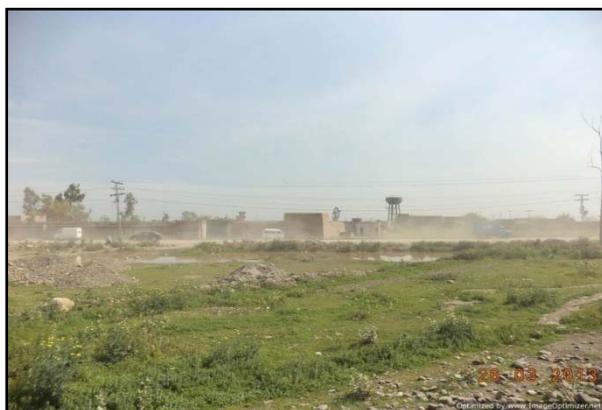
Dust due to no sprinkling water near KM: 3+00 and KM: 8+500 (Photos-41, 42)
