USAID/El Salvador Tropical Storm Ida Reconstruction Project

Programmatic Environmental Mitigation Plan for Schools

February 2013

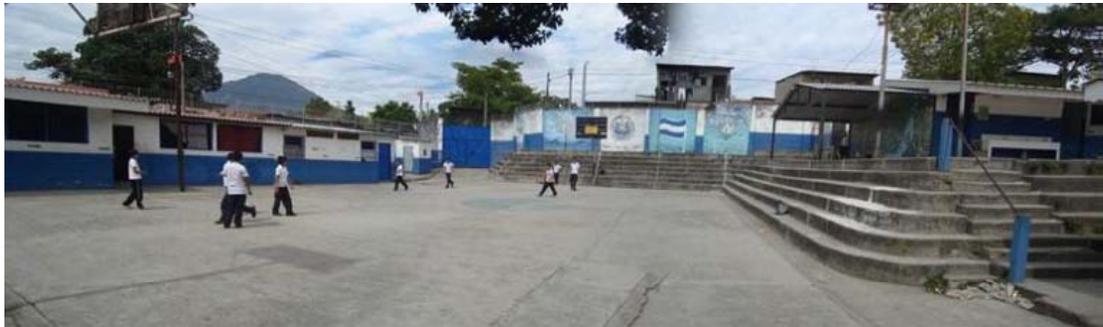
Image 3: View of the Facilities, CE Antonio Najarro.

In general, classroom floors and ceilings/roofing are deteriorated.

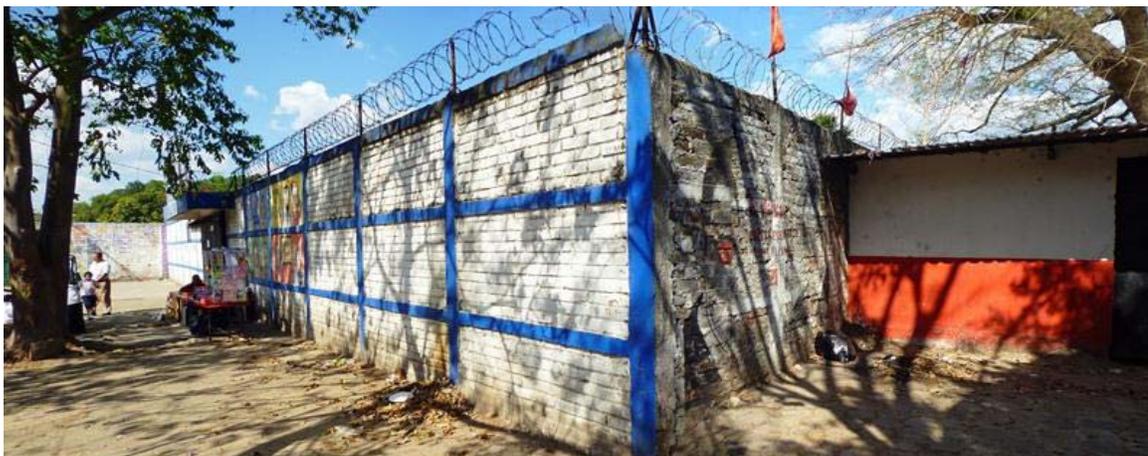
Image 4: External view, CE República de Francia.

In general, the floor of the classrooms is in poor condition, the metal doors have rusted areas, dents and failing paint, the bolts are defective, some classrooms do not have windows or the window bars show rust, roof structure is without maintenance, and roofing is in need of replacement. PVC rainwater drainpipes are deteriorated and metal rainwater drainpipes are deteriorated. Certain walls are deteriorated and have not been sufficiently maintained. The ceiling is deteriorated due to the infiltration of rainwater.

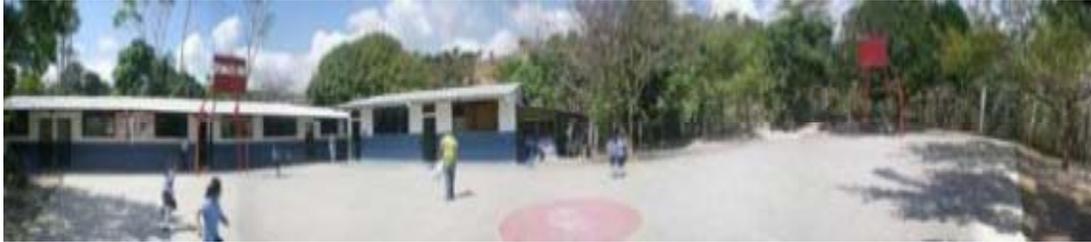
Image 5: View of Facilities, CE El Progreso.

In general, all steel sheet covers are in good condition, the floors are in fair condition with worn areas and with the final step damaged, the paint shows certain deterioration, fading, the roof structure of the classroom modules is in good condition.

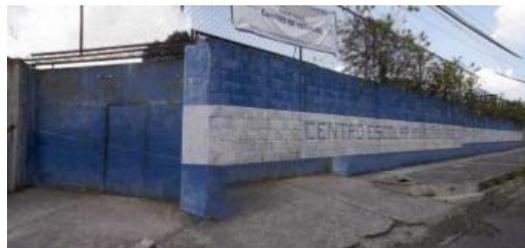
Image 6: Main entrance, CE Monseñor Basilio Plantier.

In general, the roofing are very deteriorated, generating leaks, downspouts are dirty and deteriorated due to garbage accumulation, ceilings and awnings are stained or broken, plaster is in poor condition, as is wall paint, window panes are dirty or stained and in certain cases missing, window guards and doors are rusty and even corroded in certain places, floors have water stains, some skirting board pieces are missing, toilet fixtures are dirty, stained or broken, the collective urinal does not work, the tile in basins is stained and broken, basin faucets are damaged, electrical connections are in poor condition.

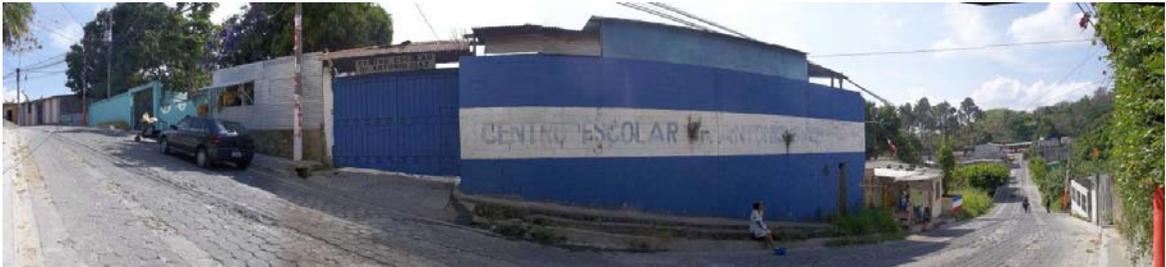
Image 7: Main access to CE Dr. Antonio Díaz.

In general, the electrical and hydraulic facilities have largely failed; there are no access ramps in any buildings. Rainwater downspouts are deteriorated and are not sufficient for the rainwater flow.

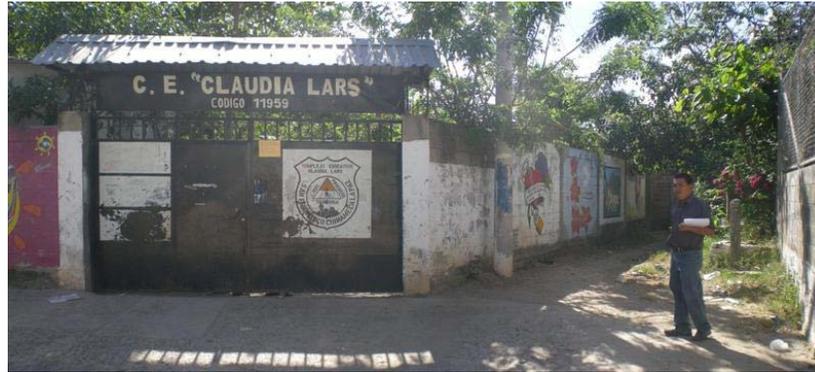
Image 8: View of main facade, CE Claudia Lars.

In general, all roofing is badly damaged, the floors are in fair condition with worn areas and with the final step damaged, paint shows certain deterioration and fading, roof structure has anticorrosive paint and roof leaks are generating rust in the metal structure, the electrical system is in fair condition.

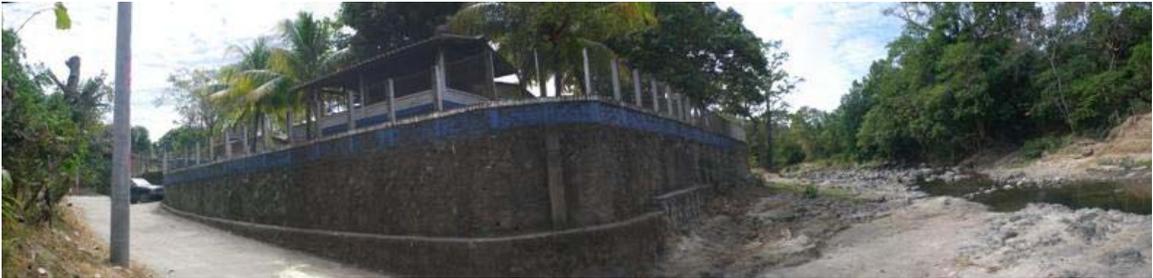
Image 9: External view of the facilities, CE Cantón San Sebastián Abajo.

In general, all roofing are badly damaged, the floors are in fair condition, with worn areas and with the final step damaged, paint shows certain deterioration and fading, roof structure has anticorrosive paint and roof leaks are generating rust in the metal structure, the electrical system is in a fair state.

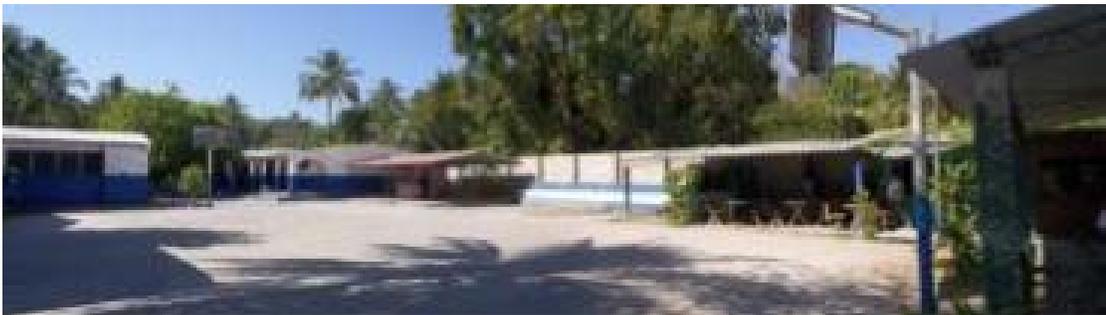
Image 12: View of school facilities school, CE Instituto Nacional San Luis La Herradura.

In general, the electrical and hydraulic facilities are collapsed, lack of access ramp in all buildings and in the school's main access. Rainwater downspouts are deteriorated.

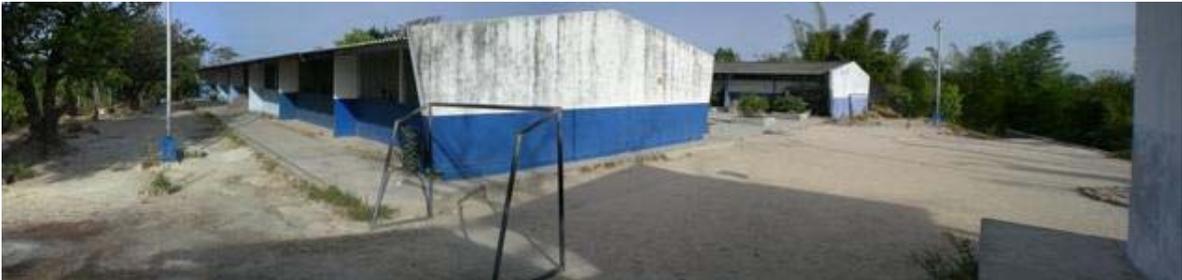
Image 13 : Panorama of existing facilities, CE Felipe Soto.

In general, all roofing is badly damaged, the floors are in fair condition, with worn areas and with the final step damaged, paint shows certain deterioration and fading, roof structure has anticorrosive paint and roof leaks are generating rust in the metal structure, the electrical system is in fair condition.

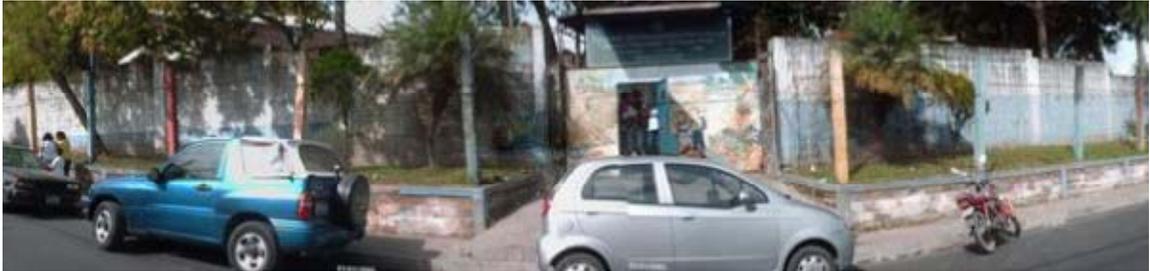
Image 15: View of main entrance, CE Escuela Parvularia Reynaldo Galindo Pohl.

In general, all roofing is badly damaged, the floors are in fair condition, with worn areas and with the final step damaged, paint shows certain deterioration and fading, roof structure has anticorrosive paint and roof leaks are generating rust in the metal structure, the electrical system is in fair condition.

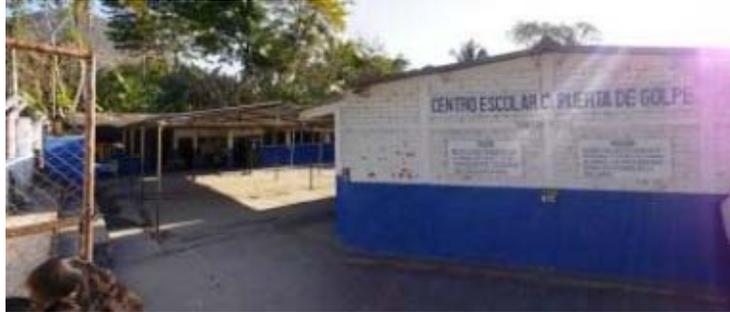
Image 17: View of entrance, CE Cantón Puertas del Golpe.

In general, the electrical and hydraulic facilities are collapsed, lack of access ramp in all buildings and in the school's main access. Rainwater downspouts are deteriorated.

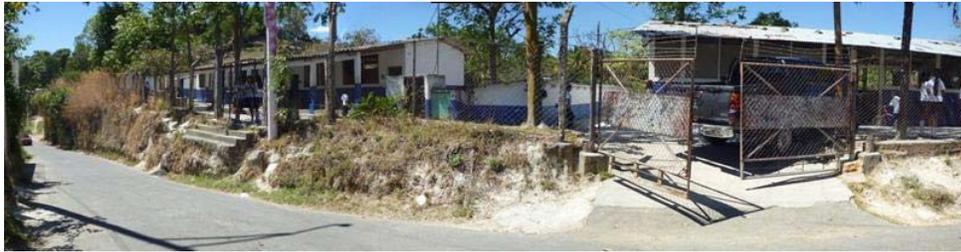
Image 19: View of main building, CE Cantón Ojos de Agua.

In general, the electrical and hydraulic facilities have failed, lack of access ramps in all buildings and in the school's main point of entry. Rainwater downspouts are deteriorated.

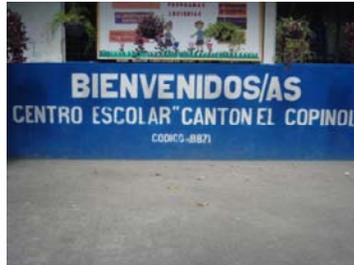
Image 21: Main access, CE Cantón El Copinol.

In general, the floors of the classrooms, multi-use hall and kitchen/warehouse are in fair condition, there is deterioration and fading of wall paint, roofing is deteriorated, thus generating leaks, the roof structure is missing paint and rusty, the lack of windows in the building allows rainwater to enter, there are no wall clamps, electrical system is deficient, the kitchen does not have a chimney, thus generating smoke contamination, door locks are not working.

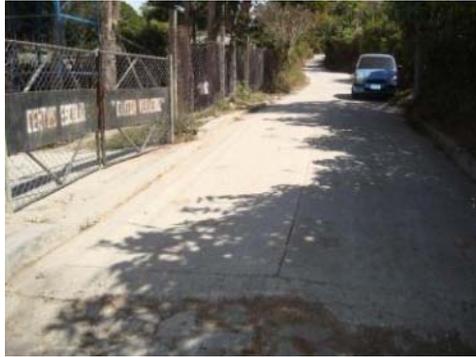
Image 23: Access to school, CE Cantón Veracruz.

In general, classroom floors are in fair condition, windows are damaged, window guards are rusted, roofing is deteriorated, generating leaks, roof structure is unpainted and rusty, doors are unpainted and wall paint is faded.

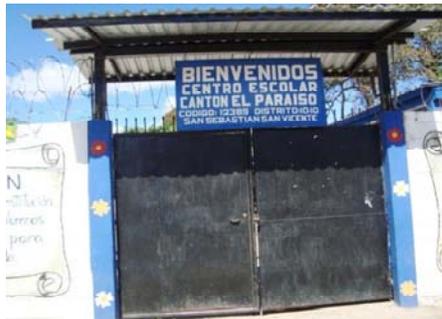
Image 25: Entrance view, CE Cantón El Paraíso.

In general, classroom floors are deteriorated and raised, the building does not have windows on its southern side, only a fence with metal supports located where the windows should be; in the northern side, the windows are aluminum and glass, but deteriorated, and window guards are rusty, doors are unpainted and there is deterioration and fading of wall and column paint. The classrooms have wood and plywood divisions in poor condition.

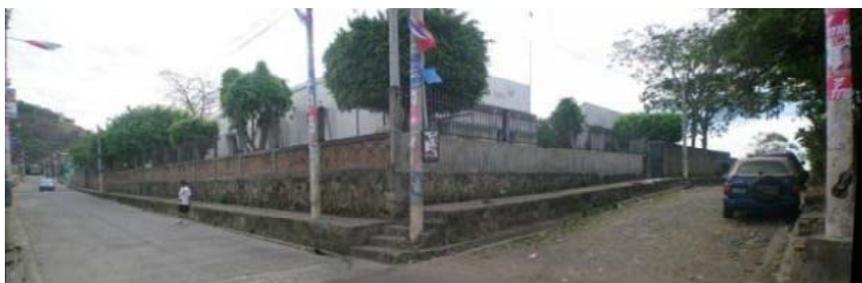
Image 27: View of main access, CE Dr. Adrián García.

In general, classroom floors are in fair conditions, with significant damage in the final step of the floor, the ceilings are very stained and damaged by roof leaks, roofing is very deteriorated, generating leaks, there is paint deterioration and fading of the walls, wooden windows are significantly damaged or missing in certain areas, plaster is deteriorated, rainwater downspouts have failed, there are no wall clamps and pests live within the ceiling, electrical system is deficient, the rainwater exit allows for stagnation of rainwater, etc.

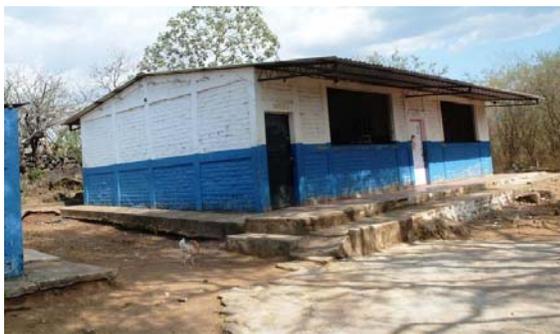
Image 29: External view, CE Caserío El Júcaro.

In general, internal classroom floors are in fair condition, with significant damage in the circulation aisle, there is no ceiling, the roof cover is metallic, recently installed, but without clamps in contact with the walls, there is wall deterioration and fading, windows are metal frames with rebar grids that need maintenance, the electrical system is deficient. Toilet facilities are totally inadequate, pit-type, roofs and floors are collapsed.

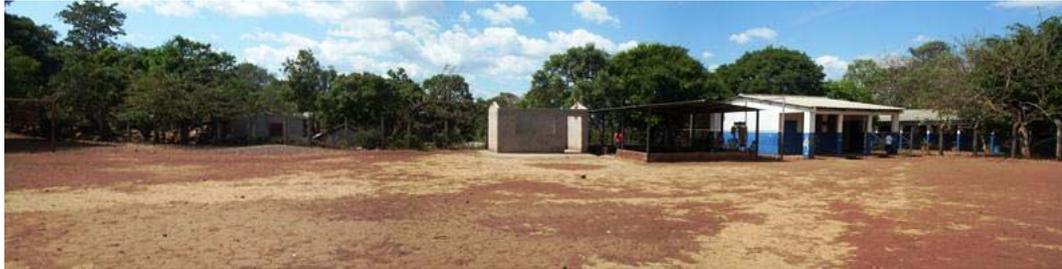
Image 30: External view, CE San Francisco de la Cruz.

In general, the floors at the principal's office are in fair condition, ceilings are pretty stained and damaged by roof leaks, roofing is very deteriorated, generating leaks, there is paint deterioration and fading in walls, and the warehouse-kitchen has completely stained walls, windows need cleaning and some glass replacement, electrical system is deficient, the basin in the warehouse-kitchen does not have a water supply, etc.

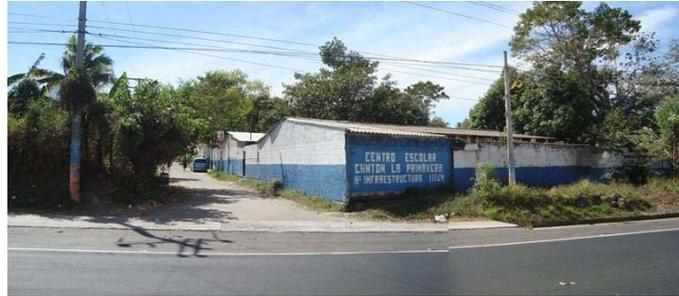
Image 32: External view, CE Cantón La Primavera.

In general, the concrete floors of the classrooms are in poor condition, with significant damage in the final step of the floor and the wear of time, the ceilings are stained and damaged by roof leaks, the column frames and metal beams are unpainted and rusted, the plywood divisions are deteriorated, roofing is very deteriorated provoking leaks, there is wall paint deterioration; there are no windows, therefore, during the rainy season, water splashes into the classrooms and alleys. The electrical system is deficient.

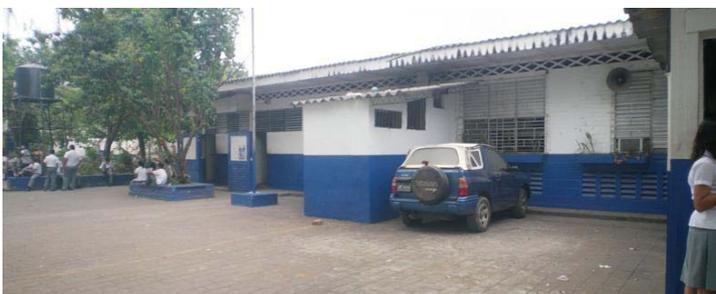
Image 34: View of existing facilities, CE Instituto Nacional José María Peralta Lagos.

In general, all roofing is severely damaged, floors are in fair condition with worn areas and with the final step damaged, paint shows certain deterioration, fading, roof structure has anticorrosive paint and roof leaks are generating rust in the metal structure, the electrical system is in fair condition but operating.

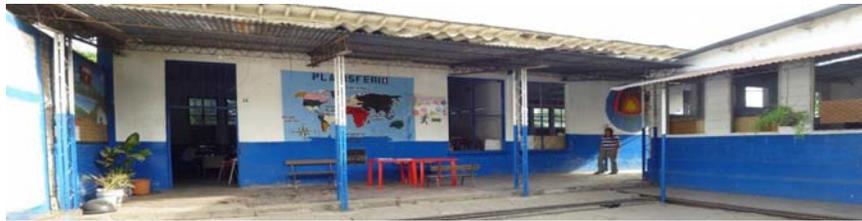
Image 36: Main frontal view, CE José Dolores Larreynaga.

In general, classroom floors are deteriorated.

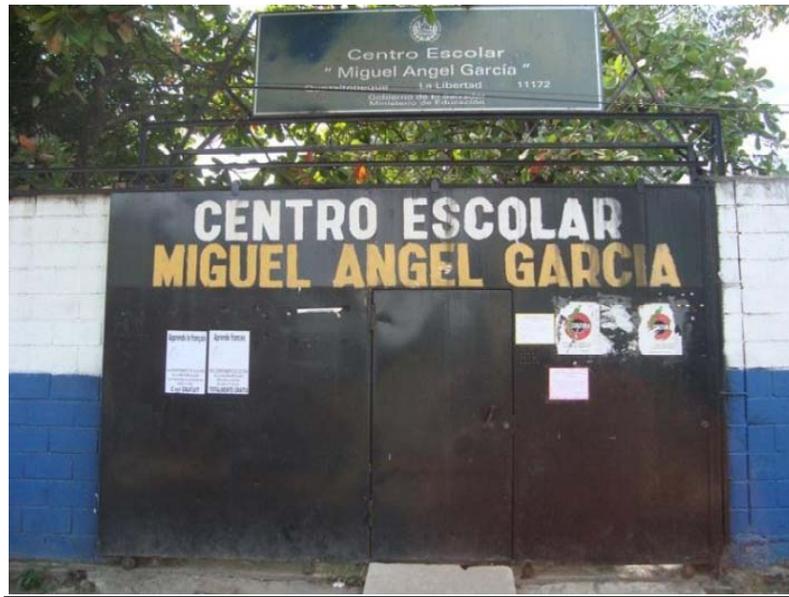
Image 38: Main gate, CE Miguel Ángel García.

In general, classroom floors are deteriorated.

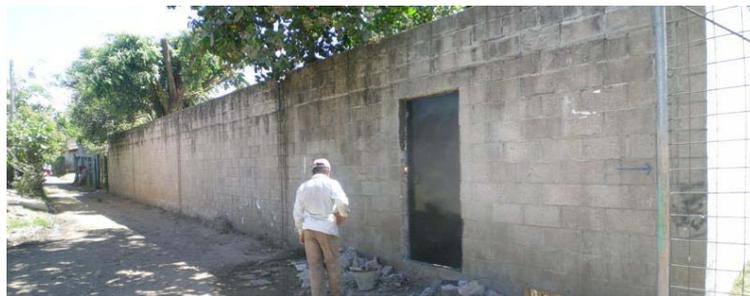
Image 41: External view, CE Colonia Las Margaritas 1 y 2.

In general, all roofing is badly damaged, floors are in fair condition with worn areas and with the final step damaged, paint shows certain deterioration, fading, roof structure has anticorrosive paint and roof leaks are generating rust in the metal structure, the electrical system is in fair condition.

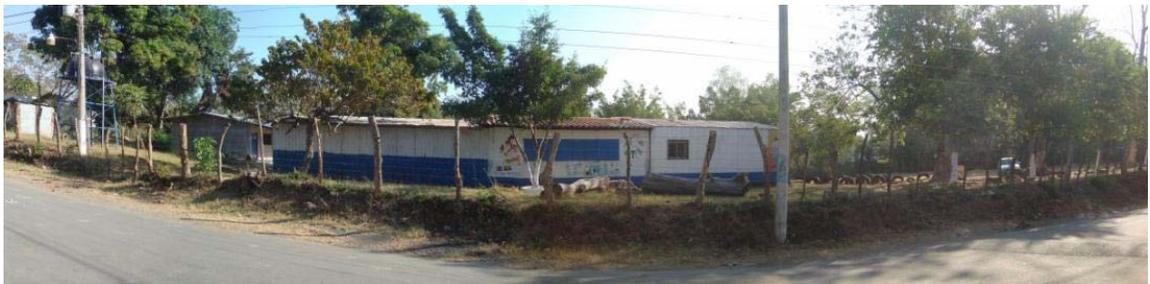
Image 43: Main frontal view, CE Cantón Chantusnene.

In general, classroom floors are deteriorated.

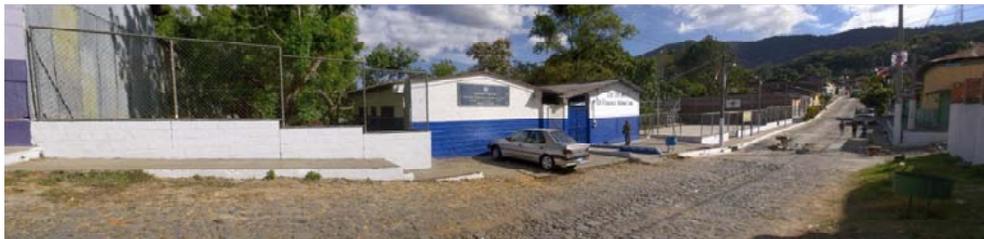
Image 45: View of main entrance, CE Dr. Francisco Antonio Lima.

In general, the electrical system is deteriorated. Likewise all gutters and rainwater downspouts are deteriorated and rusty.

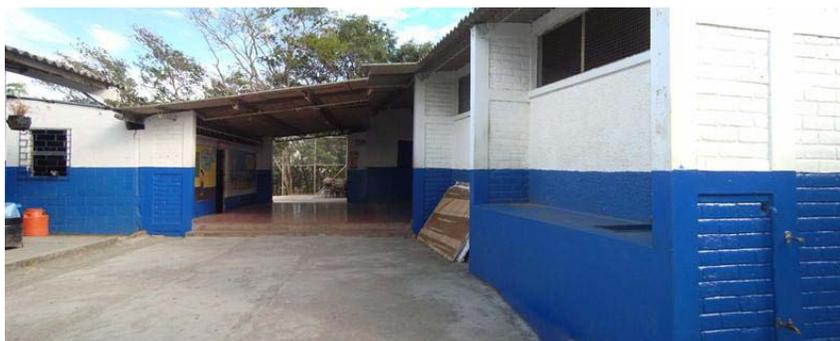
Image 47: View of main entrance, CE Cantón Ojo de Agua.

In general, classroom floors are damaged in certain areas, there is no ceiling, a rainwater gutter located where the building joins the added pre-school classroom is in very poor condition and needs replacement. The roof structure must be cleaned and painted, roofing is badly deteriorated, wall paint is deteriorated and faded, the lack of windows allows rainwater to splash, and windows have a metal frame and a rebar grid which needs maintenance. All walls that have been added to the building should be demolished or in any case, reinforced, as they appear to have been constructed with little quality control.

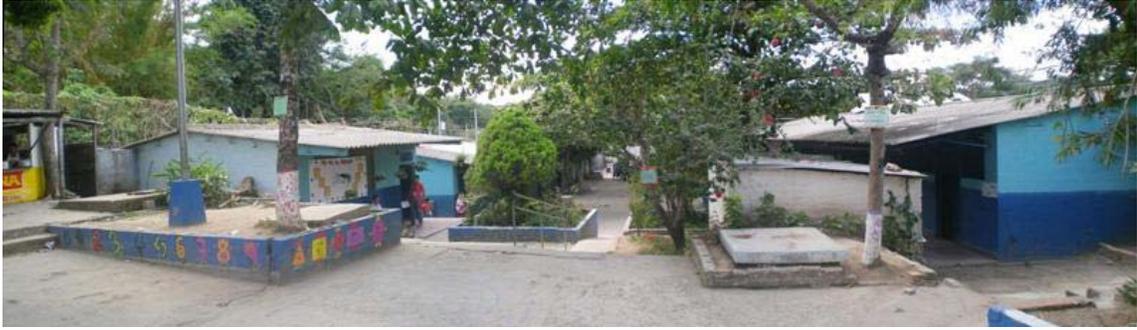
Image 49: Internal view, CE Pablo Castillo.

In general, all roofing is badly damaged, floors are in fair condition with worn areas and with the final step damaged, paint shows certain deterioration, fading, roof structure has anticorrosive paint and roof leaks are generating rust in the metal structure, the electrical system is in fair condition.
