ENGINEERING SUPPORT PROGRAM

Tarakhil Thermal Power Plant Site and Power Block "B"
Control Assessment

Final Report

April 22, 2014

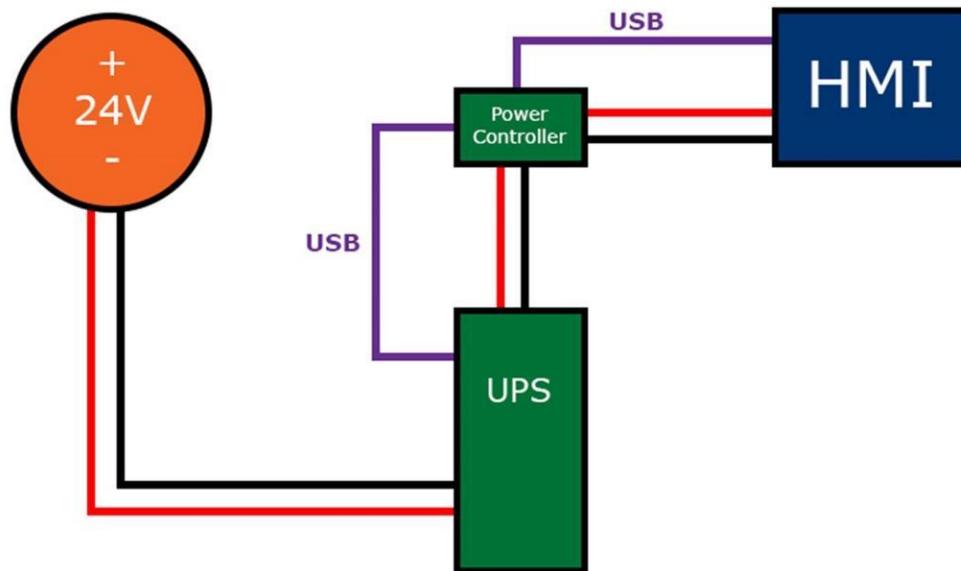
Figure 19: Proposed Power Supply Management Circuit Diagram

The genset HMI’s are also at risk of failure due to power-cycling. Because the existing UPS does not last long enough to protect the system, and because the existing UPS does not properly shut down the software before powering down, we offer the following solution.

An off-the-shelf microcontroller-based device should be utilized, along with accompanying software, to act as a power controller. It would also manage the power supply to the HMI, monitor UPS battery health, and issue shutdown and startup commands when appropriate. A basic outline of the circuit is outlined in Figure 19.

A UPS will be used to provide battery backup power to sustain the HMI when power to the station is lost. A power controller circuit will then be designed which acts as an interface between the UPS and HMI. Through USB interface, it will communicate with the UPS to monitor operational status and battery health. When operating on battery power, the power controller would issue an orderly shutdown command to the HMI through the USB interface when remaining battery life reached a specified low value. Corresponding software on the HMI would receive the command and then exit the HMI SCADA application and shut down Windows properly. After station power is restored, the power controller would sense this through the USB interface to the UPS and restart the HMI. In addition to this, the device would provide external controls for turning the HMI on/off properly and hard-power-cycling the unit when necessary.
