STATUS OF THE AID TYPE HANDPUMP IN THE DOMINICAN REPUBLIC

WASH FIELD REPORT NO. 98

AUGUST 1983

Prepared for:
USAID Mission to the Dominican Republic
Order of Technical Direction No. 143

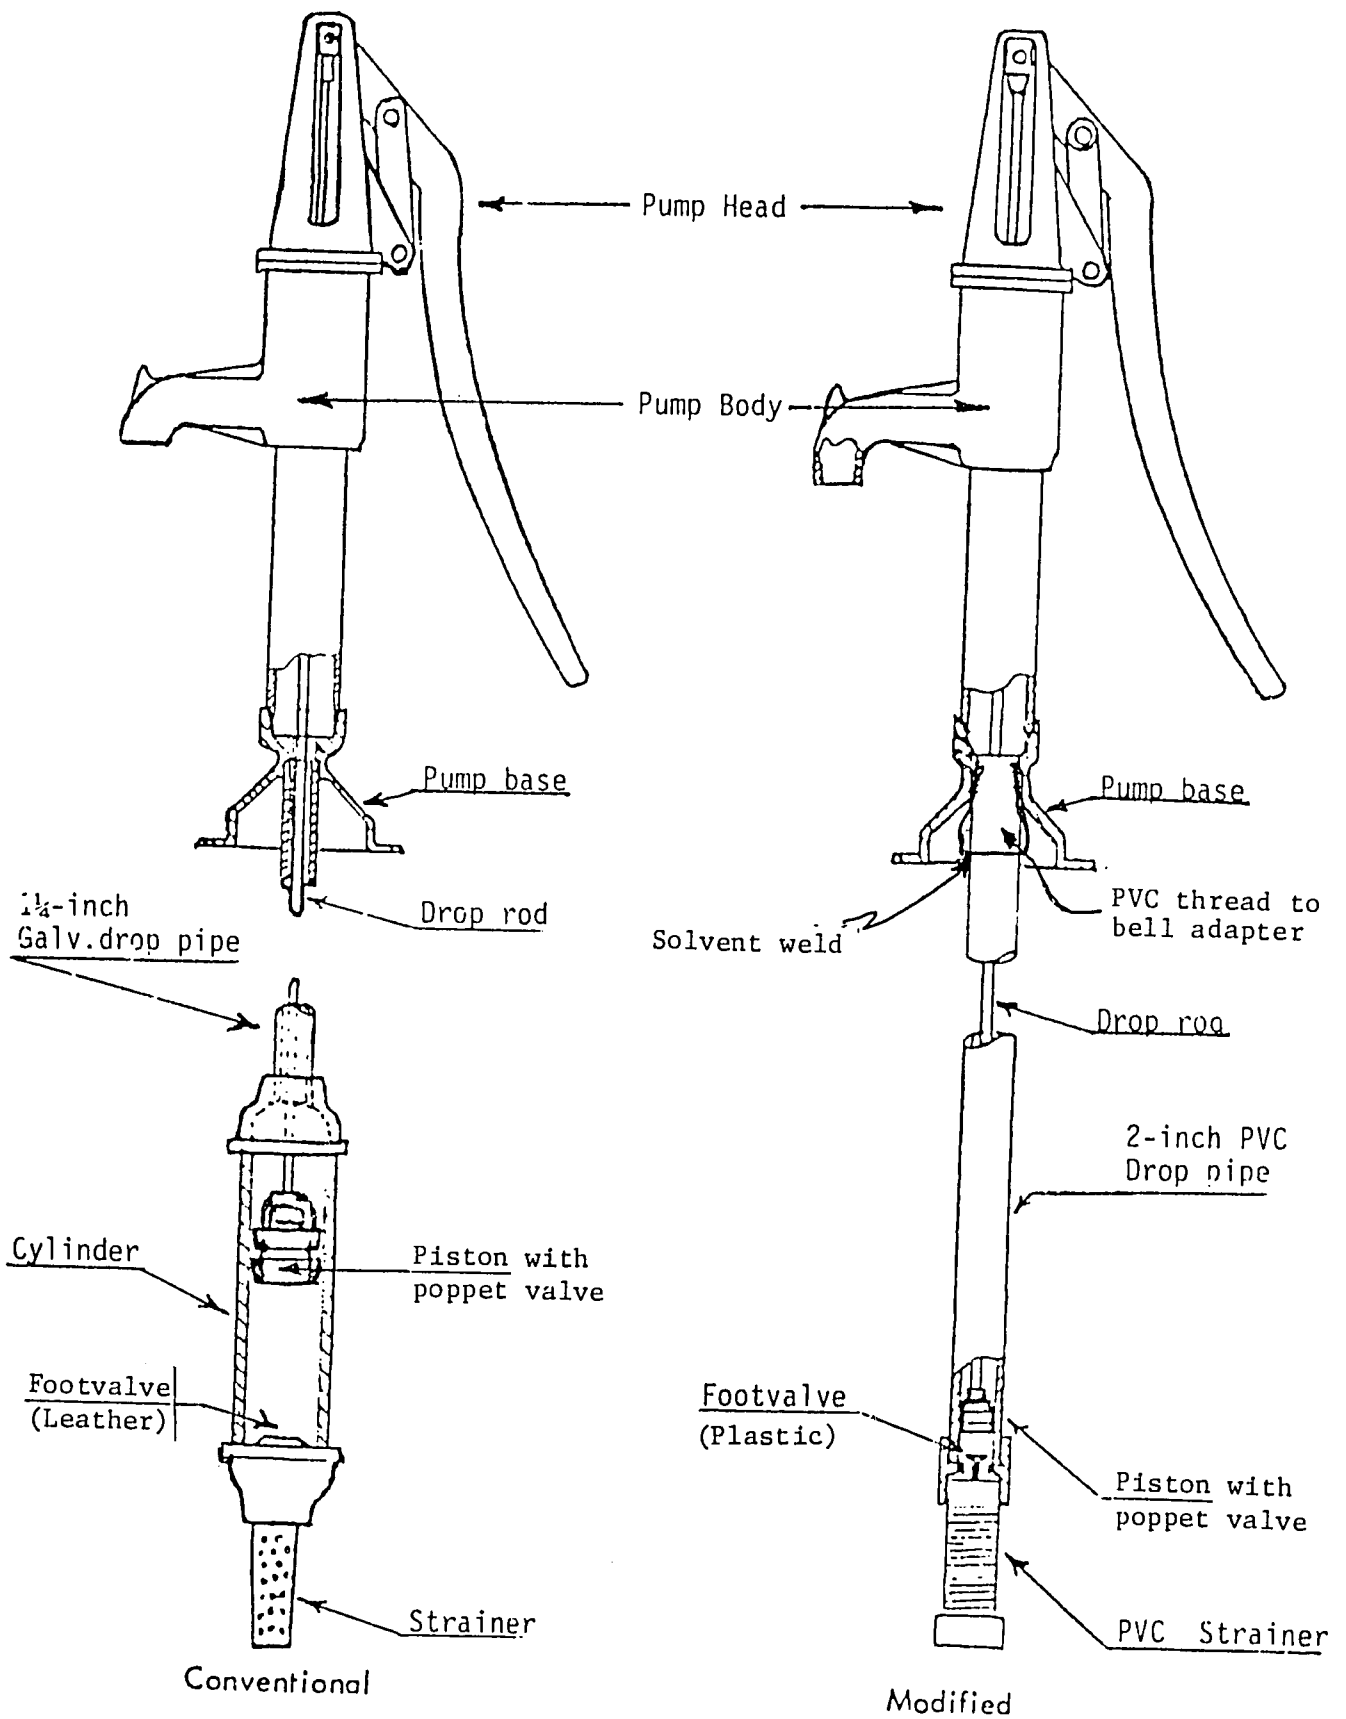
Figure 1

In January 1983 a technical/management review team visited the Dominican Republic to look at its AID handpump program and found evidence that the program was experiencing problems with a modified version of the AID handpump that featured a 2-inch PVC drop pipe and a PVC foot valve. The modified pump differs from the conventional AID-design handpump in that the conventional one uses a 1.25-inch galvanized steel drop pipe and a 3-inch cylinder (see Figure 1). A substantial percentage of the pumps were failing to operate properly just a few weeks after installation. The review team suggested a field investigation be conducted to determine the cause of failure of the modified pump. Based on this investigation a corrective course of action could be recommended.
