TECHNICAL ASSISTANCE FOR HANDPUMP COMPONENT OF THE HEALTH SECTOR LOAN II PROJECT IN THE DOMINICAN REPUBLIC

WASH FIELD REPORT NO. 101

JANUARY 1984

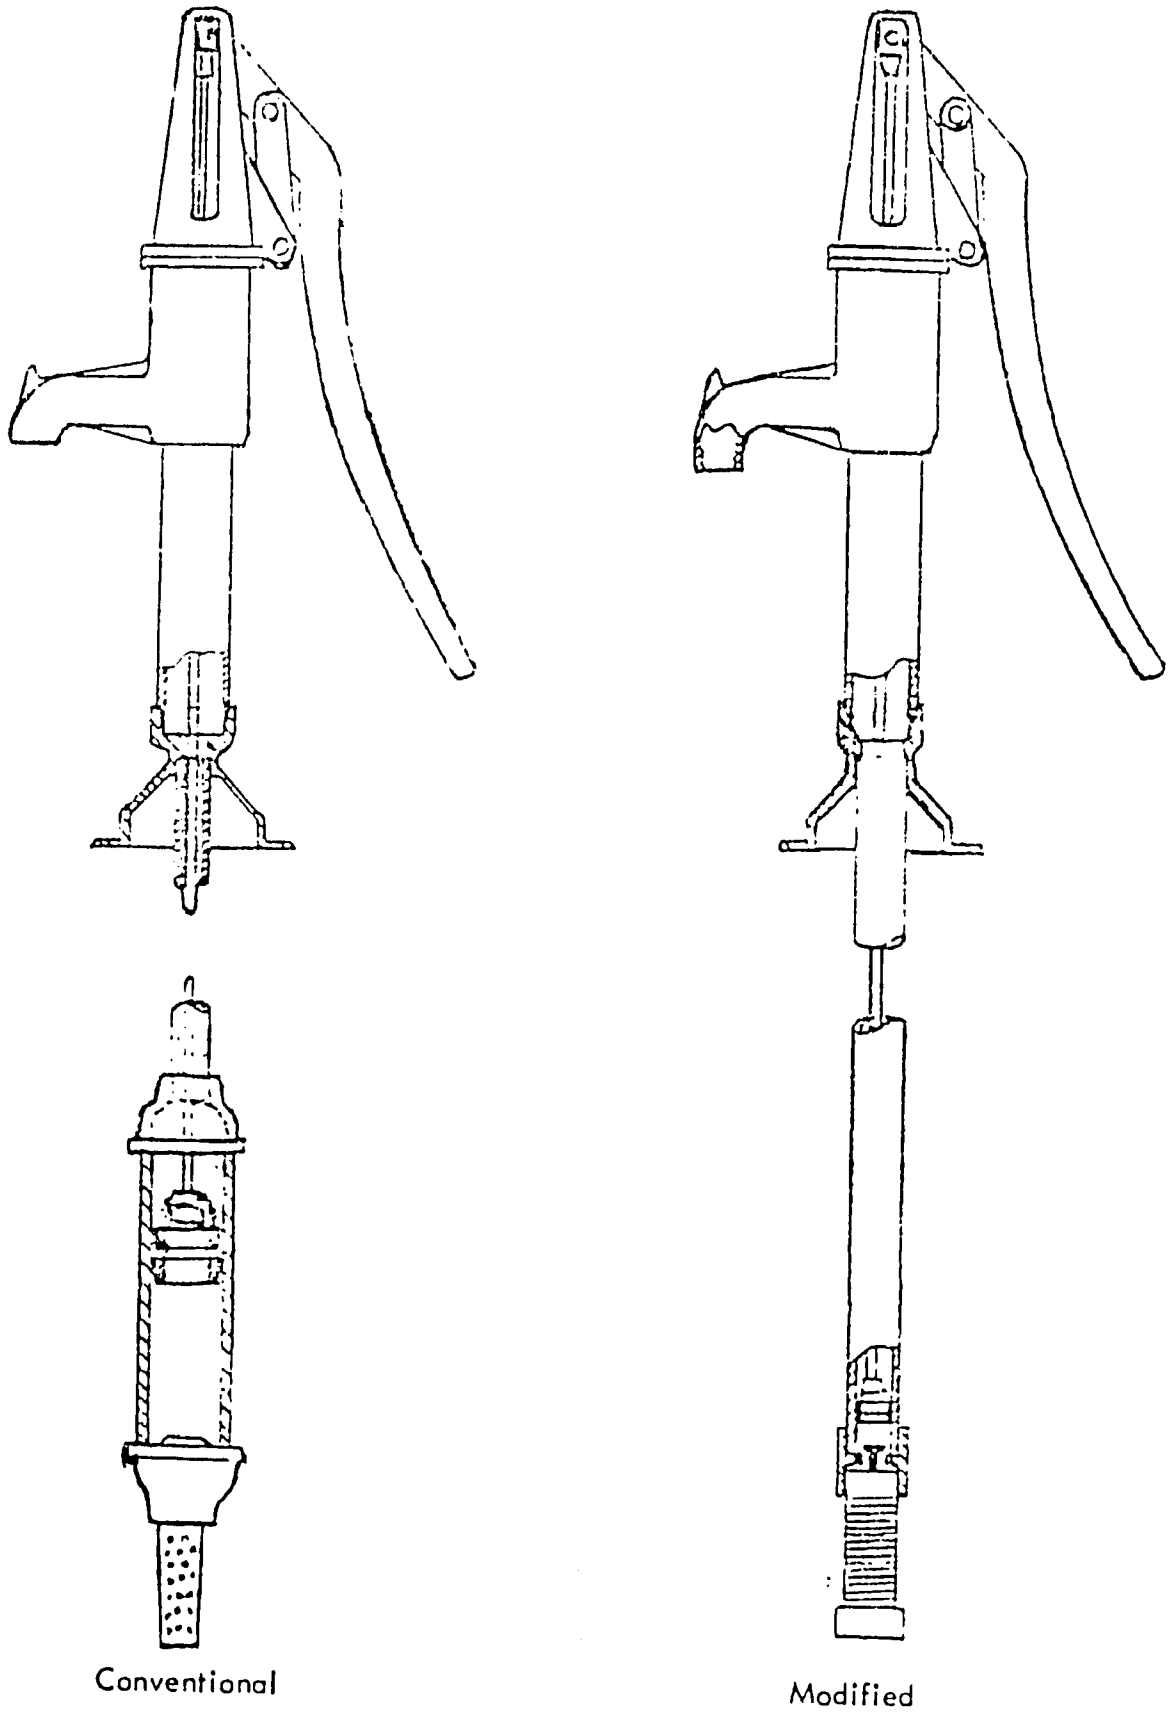
Figure 1

This change plus the addition of plastic stabilizers (see Figure 3) has been very successful. One pump with such changes has been in operation for more than a year to date.

The change recommended in June 1982 was to further increase the diameter of the bolt holes in the pump base to $5/8$ ".

Proposed Changes in Current Pump Design

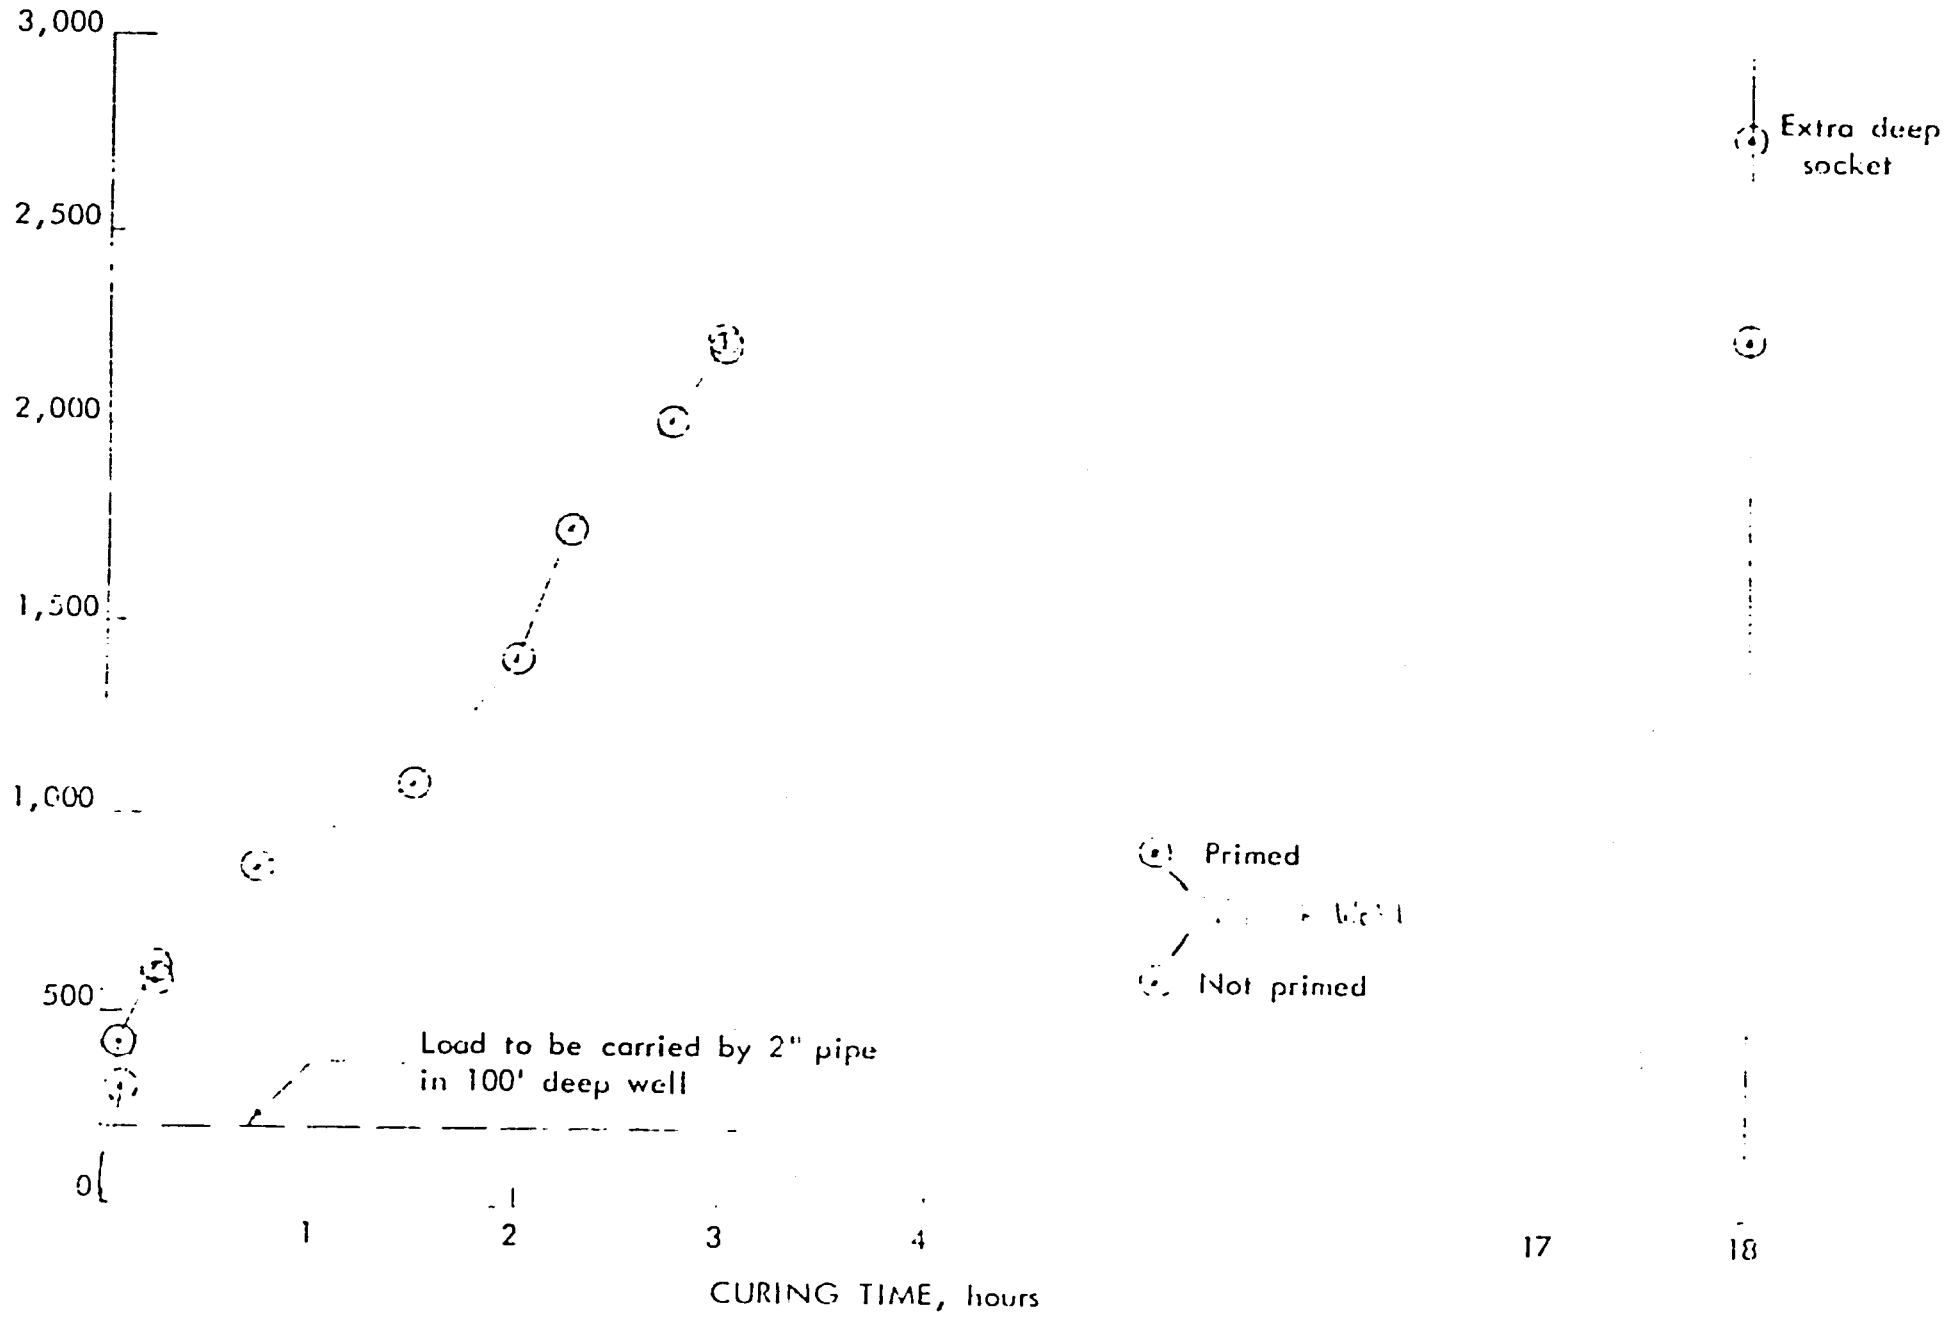
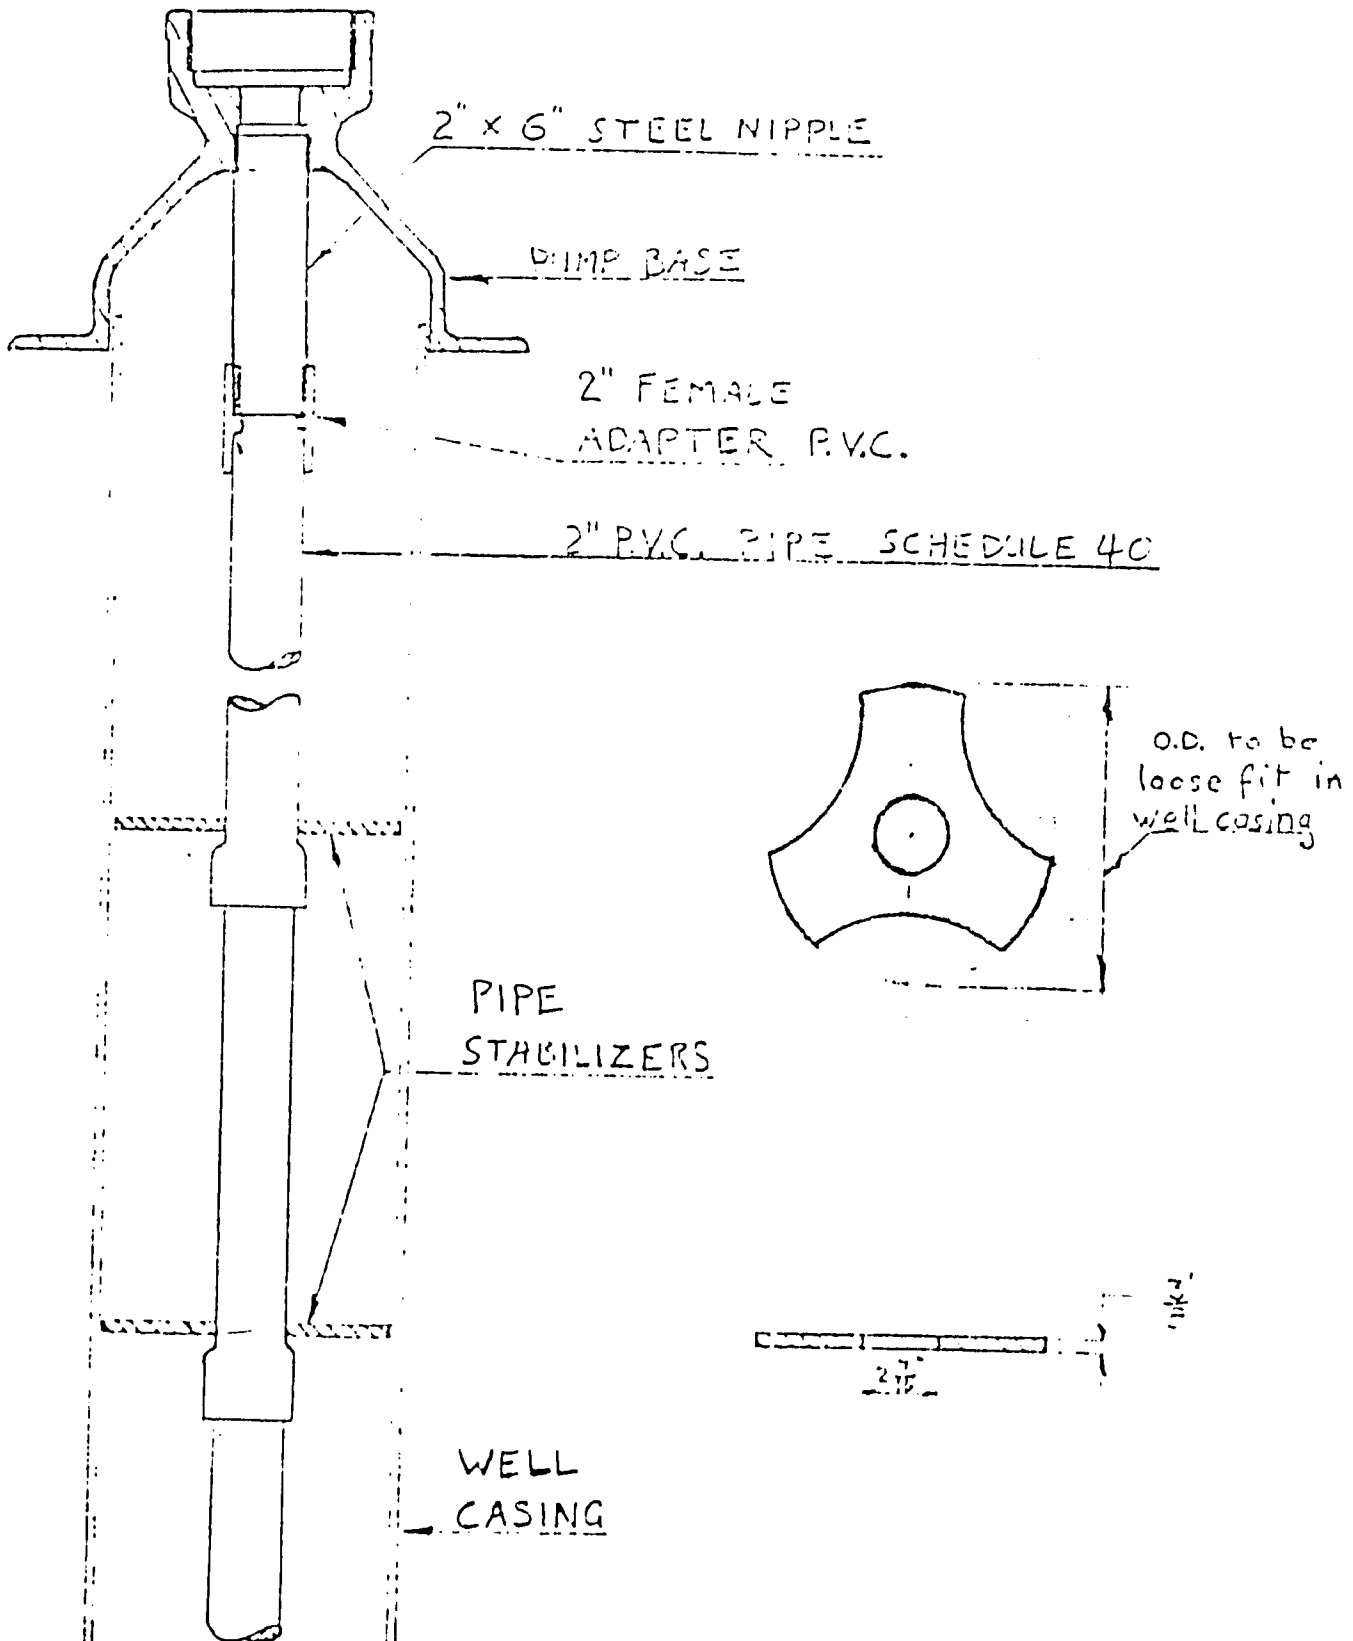
Note : For test pump, stabilizers were made of ply used. Or for each 20' length of pipe.

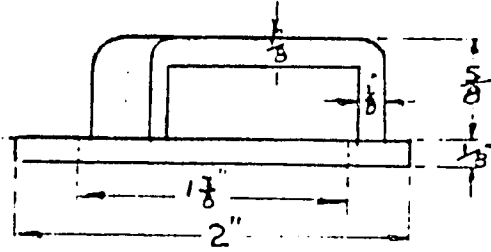
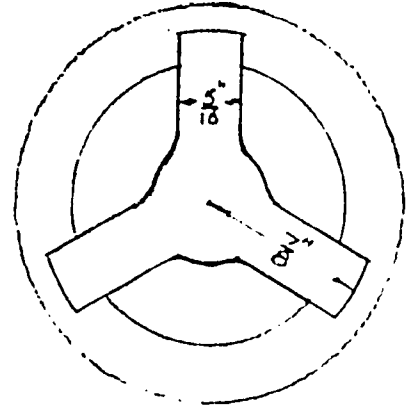
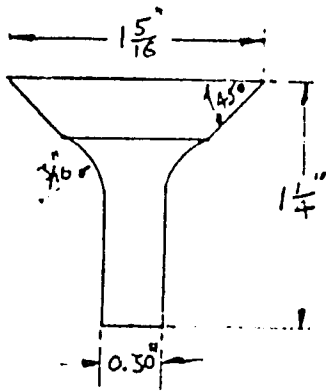
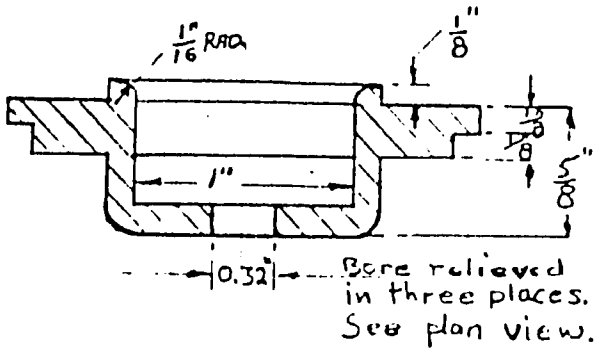
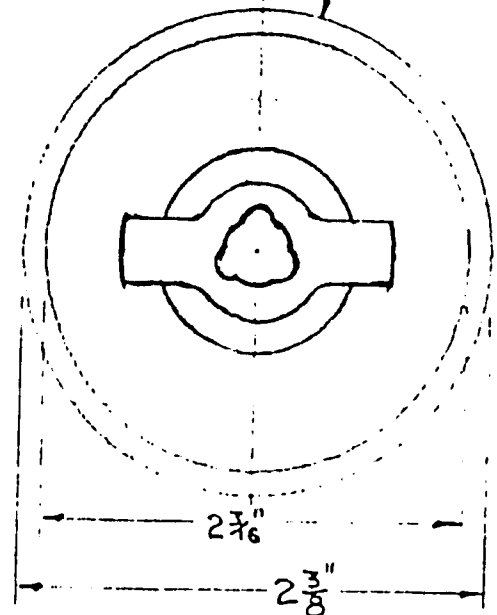
Fig. 4 -29-

In March 1981 I fabricated 10 PVC check valves (see Figure 4). With 2" PVC couplings, and caps, and 10-6" lengths 2" Roboscreen I made up 10 check valve and strainers assemblies, to be used in the 10 pump test program. I also conducted tests on PVC solvent welded pipe joints. For results see Figure 2.

Bore relieved in three places. See plan view.

To fit inside 2" P.V.C. coupling

All unmarked radii should be 1/8.

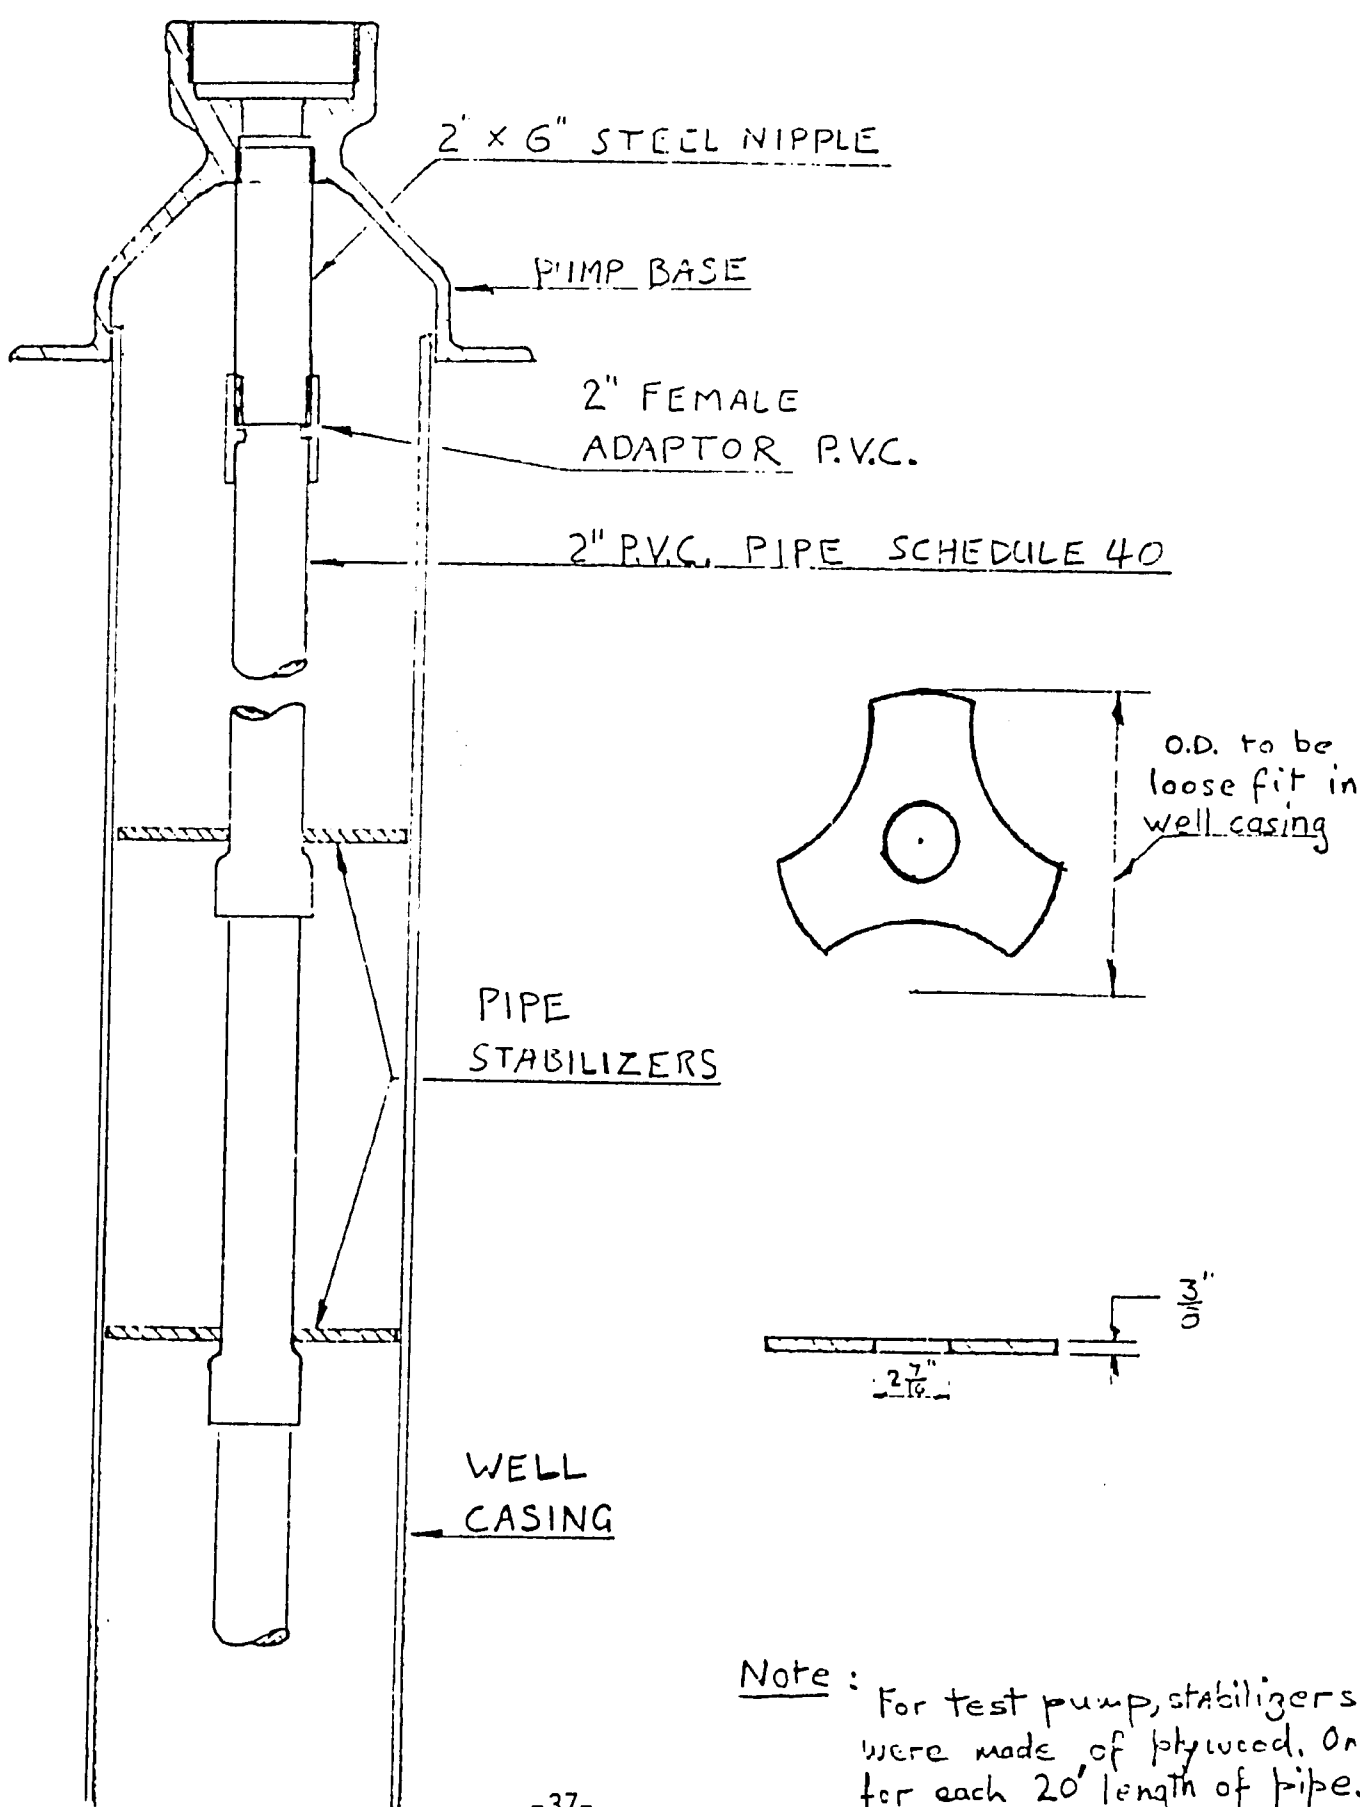
Appendix D

Modifications Proposed by Mr. R. Knight
To Increase Strength Of Base Connection
In Pull-Through-The Base Pump

Note: For test pump, stabilizers were made of plywood. One for each 20' length of pipe.

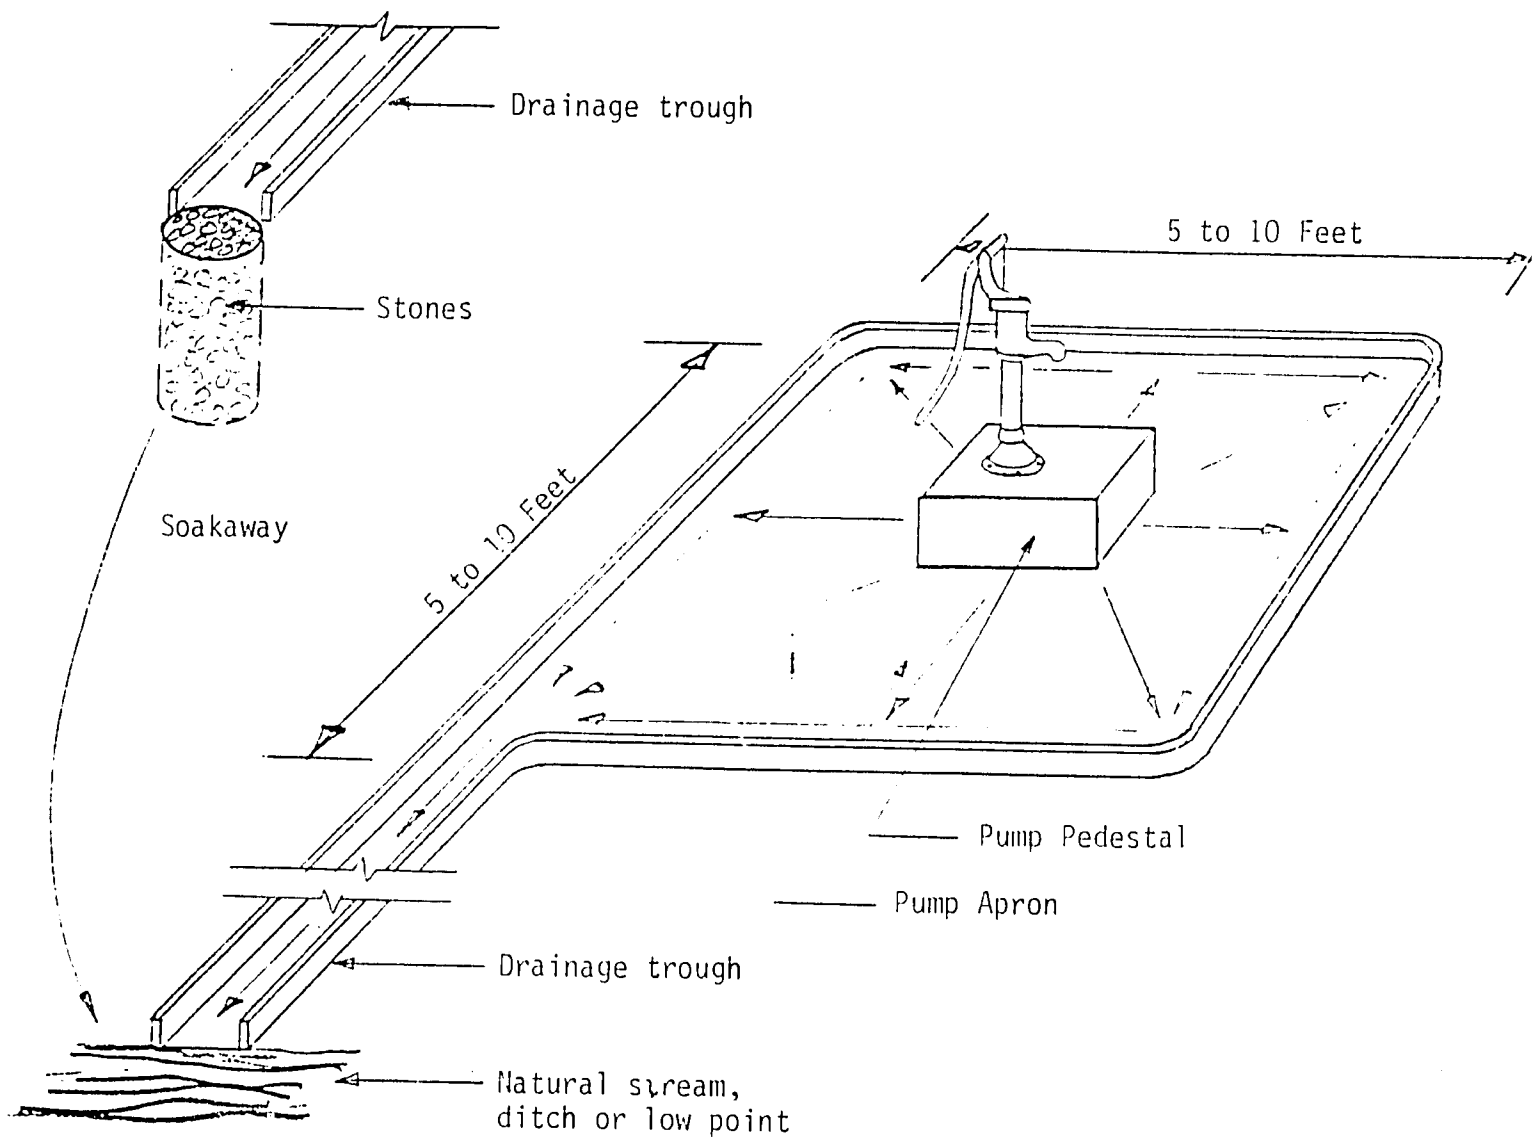
Figure 7

Pump Apron and Drainage Trough
(not to scale)

- Notes:
1. If it is not possible or convenient to drain the trough to a natural stream, ditch or low point, drain it to a soakaway, which is a hole filled with stones.
 2. It is important that apron drainage not be allowed to create mud or pools of water.

1. Institute a quality control system for handpump installation for the supervising engineers that would include a check list and sign-off.
2. Do a training course for the crews that build aprons, using models which demonstrate the correct practice. The models could be constructed at the UAPODAN field office. (See Figure 7.)
3. Supply chlorine for disinfecting the wells, and add this to the sign-off checklists.
