Inspection of Vocational Education Centers Built Under BEST II

SEPTEMBER 2000

Contract No. 522-G-00-00-00243-00
USAID/Honduras

INSPECTION OF VOCATIONAL EDUCATION CENTERS BUILT UNDER BEST II

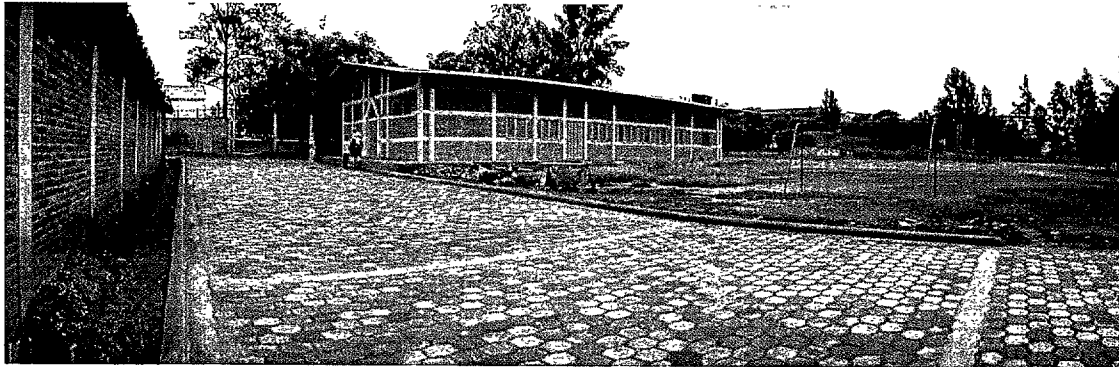
This structure lies next to a soccer field and is surrounded by a 6'-6" walkway elevated 6" to 18" above grade. The steel roof deck extends beyond the walkway's footprint providing shelter from torrential rains.

Except for cracks at the walkway, caused by poorly executed shallow control joints, and some *chipping away (spalling)* of plaster from the base of the NW corner column, the fairly new concrete frame and brick structure is in sound structural condition and needs no structural retrofitting.

Even the NE column that was erected out of plumb causes no serious structural concern being tied by the three ring beams placed all around the building.

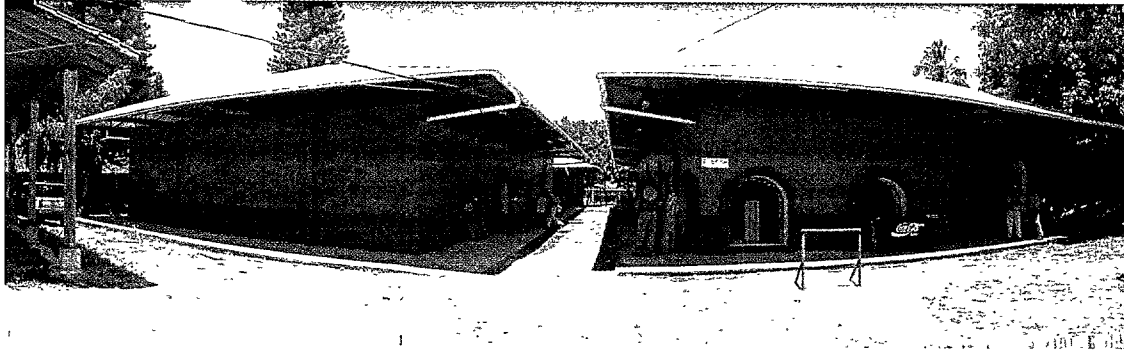
The three buildings that constitute the VTC in San Marcos are a 1,800s.f sewing training center (left foreground), a 5,600s.f administration section and welding training center (at right), and a 4,800s.f woodwork-training center (in the background).

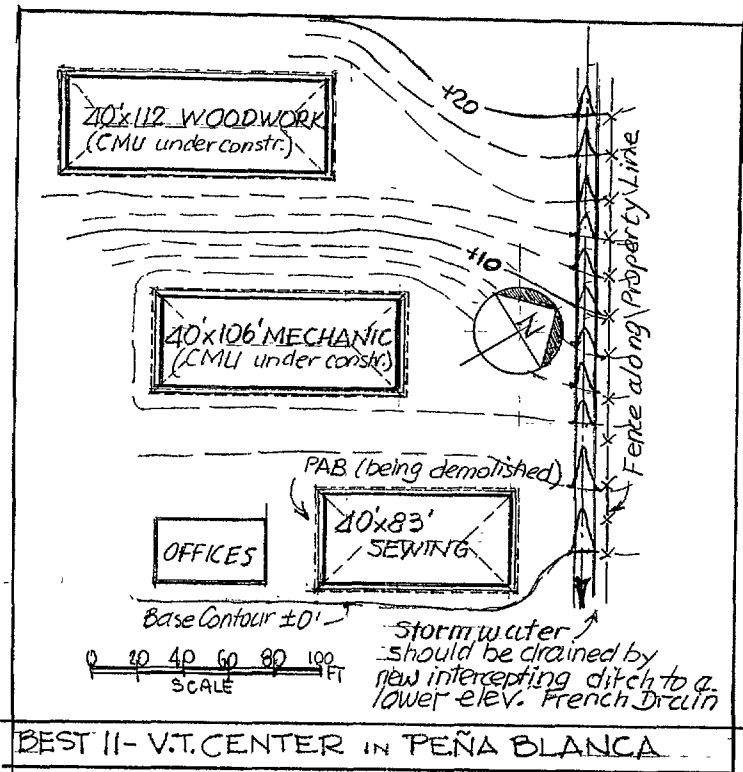
Along the northern route to San Pedro Sula, we stop to visit the VTCs in Peña Blanca and El Mochito. In **Peña Blanca**, the last of the three buildings of the Stephen Youngberg VTC, completed in 1997, is being demolished. We ask why and the work superintendent tells us that the adobe bearing walls were too soft and absorbed moisture and the administration feared a possible collapse. In fact, when subject to a drop test, two of the randomly selected units shattered. (We would also learn from Ms. Leach that the structures developed cracks during an earthquake.)

The contractor has already demolished the other two buildings, which are being rebuilt with hollow concrete blocks.

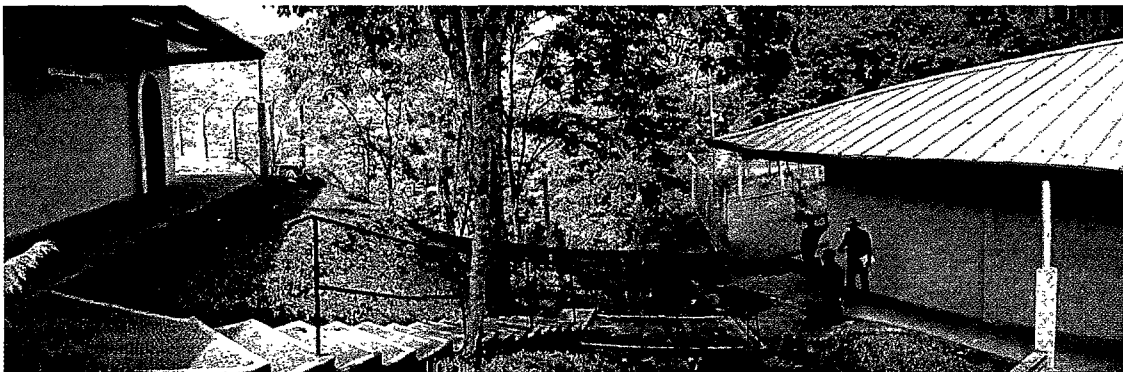
The VTC in **El Mochito**, on the other hand, was completed in 1998 with plastered bearing adobe walls reinforced by buttresses and without the use of concrete col-

umns. The center consists of three 4,275s.f, 12' high structures and a 530s.f toilet facility attached to the western building.

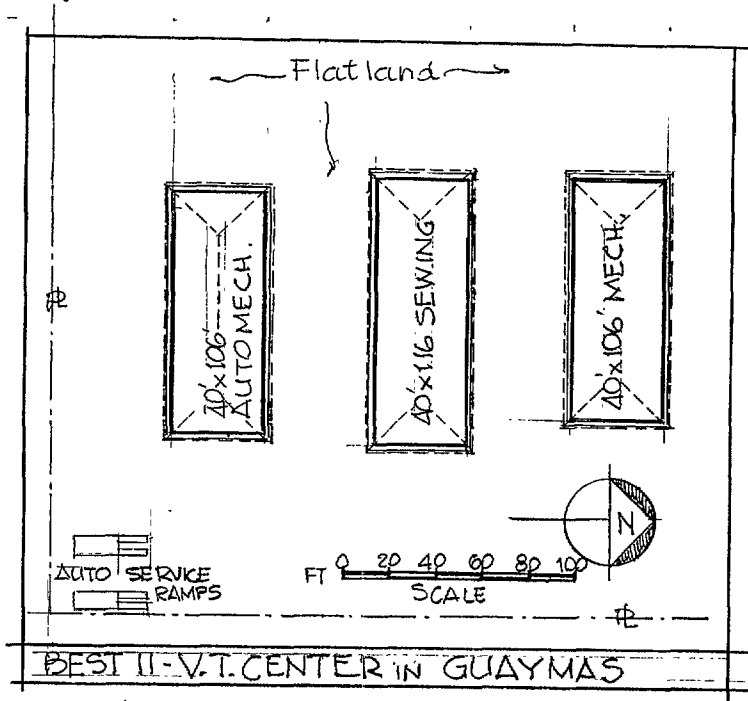
The Ernesto Ponce VTC in **Guaymas**, completed in December 1999 and which, in addition to a 550s.f toilet facility and two auto service ramps, consists of three 12' high concrete-frame and adobe with steel-hip-roof buildings, two of which measure 4,275s.f for the auto- and industrial-mechanics respectively, and one 4,700s.f for the industrial cut and sewing training. Severe cracks at walls, a bond beam that is more rigid than

those previously observed in other sites but causing additional horizontal cracks, *poorly-poured unbound aggregate-exposed concrete (honey-combing)*, less than desirable down-spout design,

contributing to weakening and potentially flooding the interior of the adobe walls, characterize this center.

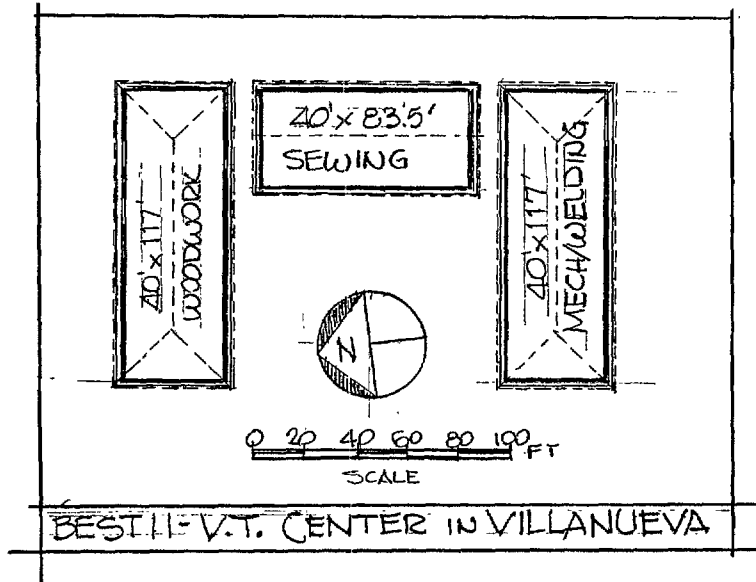
The Centro Tecnológico Prof. Nestor Danilo Amaya VTC in Villanueva, also completed in 1999, exhibits two 12' high buttressed adobe-wall-bearing with steel-hip-roof buildings for industrial woodwork and welding training, respectively, and one similar building, except for a gable roof at the south end, dedicated to industrial cutting and sewing training.

A 450s.f toilet facility abuts the west end of the welding training building, where some foundation settlement has occurred creating minor cracks at the walls. Although the material used for the adobe is less than optimal, we are informed that the blocks used in this center were cured before construction began. Lack of severe cracks,

a stiff bond beam at the top of longitudinal walls supporting the non-connected trusses characterizes this center erected on flat land.

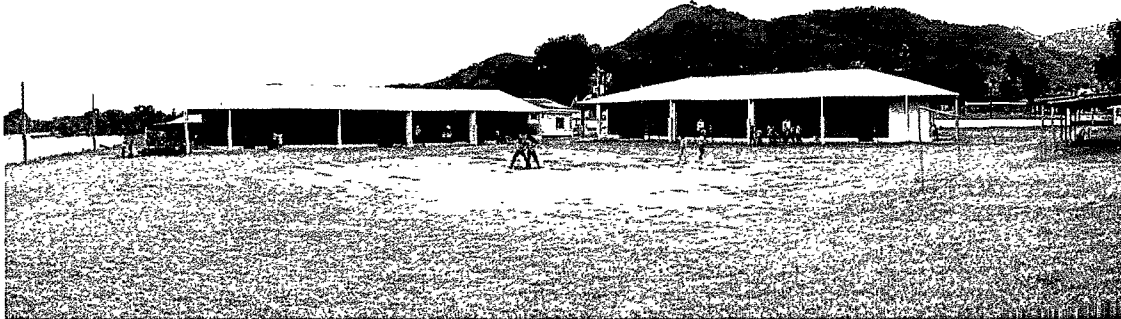
The Mario Ugarte VTC in Choloma, completed in 1999 and which, in addition to a 800s.f abutting the north end of the middle building and one auto service ramp next to the east end of the south building, consists of three 12' high buttressed adobe-wall-bearing and timber-roof-truss buildings. The northern building has a hip roof and measures 3,200s.f; it is dedicated

to industrial cut and sewing training. The middle building measures 4,275s.f and is shared by both industrial mechanics and sewing training; the additional concrete block structure was added at the western end of this building where the roof structure is gabled. The third and southernmost building, to train students in auto me-

chanics, has a hip roof and measures 4,275s.f Poor workmanship, less than optimal material used for adobe (causing the walls to crumble easily), moderate cracking of the walls and vaults, small 8" x 8" pilasters at the end walls, roof trusses tied at their seats against wind uplift with field-bent rebar (the only site observed with tied down wood trusses) characterize this center.

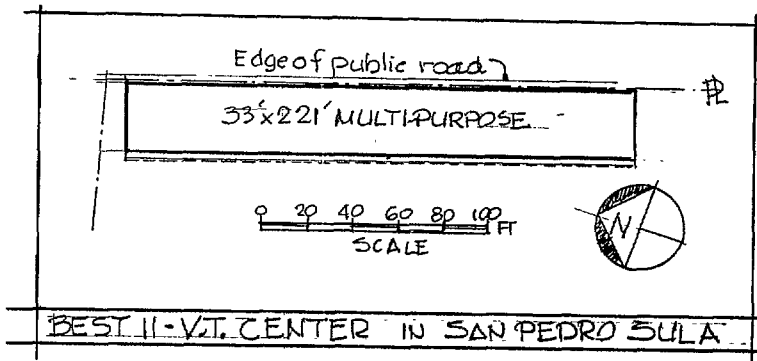
The VTC Hogares Manantial in **San Pedro Sula** was recently completed (August 2000) and consists of only one 221' x 33', or 7,300s.f building laid on a north-south direction. It is a reconstruction of and an addition to a pre-existing structure

demolished by the contractor who left standing, next to a road, only one 8" thick and 15'-7" high concrete block wall, portions of the top few courses of which were re-

of new deeper joists—minus one, that had to be cut at the supports to allow for erection. The roof is precariously unsafe as are the walls that lack dependable columns/pilasters or a bond beam that could assist in lateral stability.

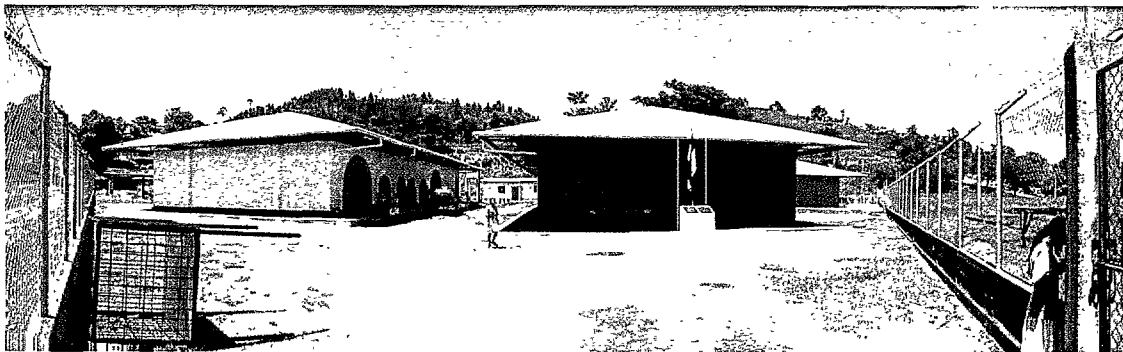
tor Assencio informs us that the walls were erected using fresh adobe as the extensive severe cracks in these six-month-old buildings witness!

From south to north, we inspect the three buildings: a white painted 2,900s.f for industrial woodwork, a red 6,600s.f for mechanics, and one yellow 3,750s.f for cutting/sewing training.

Despite being the only center where the contractor braced vertically and longitudinally the middle of all trusses, these buildings show the poorest workmanship in adobe construction responsible for some of the worse cracks we observed during this assignment. Moreover, the electrical distribution system, with wires lying directly on the ground from one building to the next, is utterly unacceptable.
